Site visit summary of the former Mitigations Land Trust (MLT) property along Reach 2B of the San Joaquin River.

From: Joel Sturm, Geologist; Matthew Merson, Geologist (MP-230)

Date of visit: July 05, 2019

Purpose of visit: To document the recent repairs completed June 2019, and the condition of the MLT property in response to the repairs.

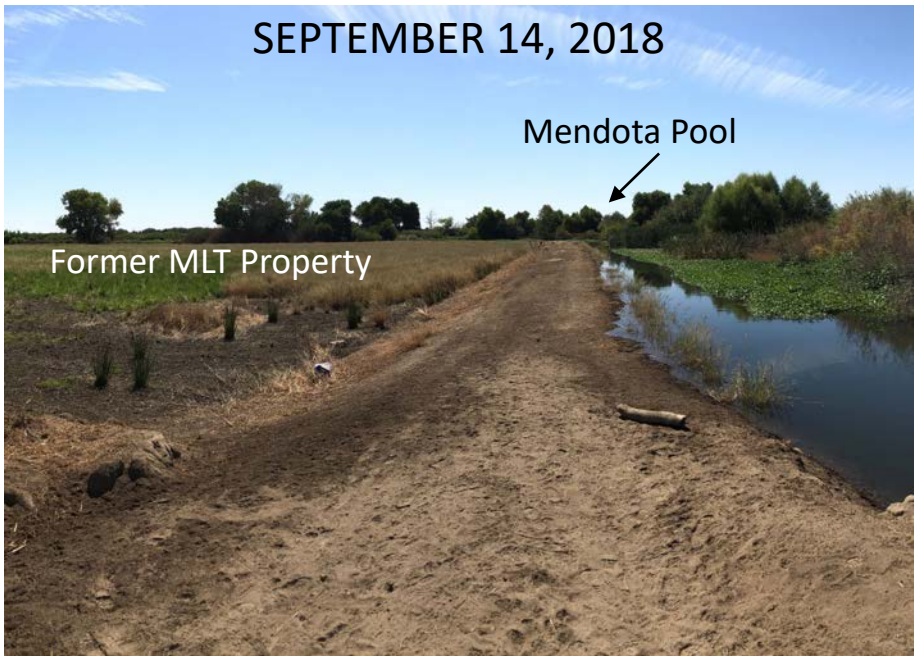
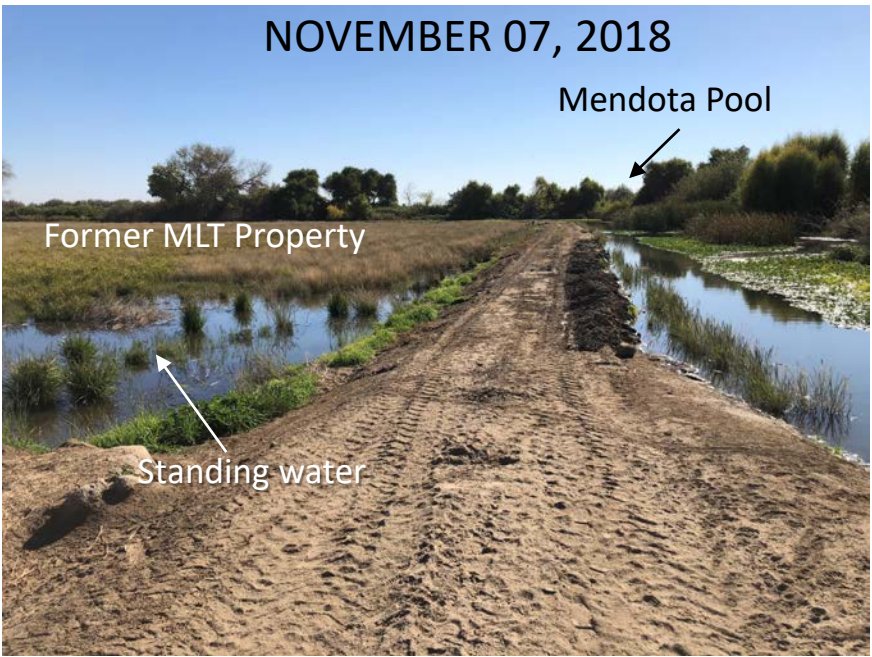
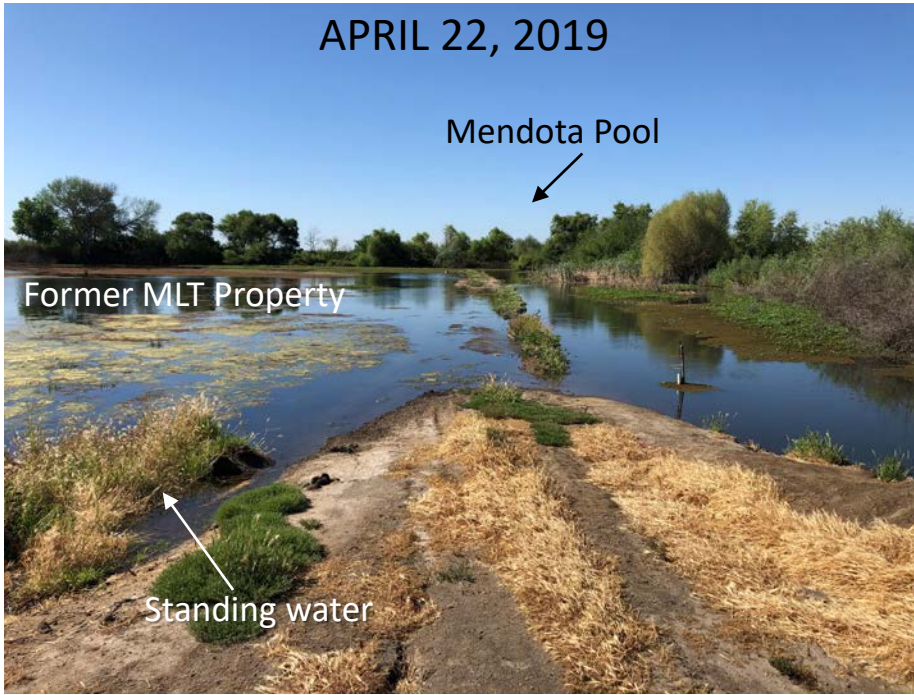
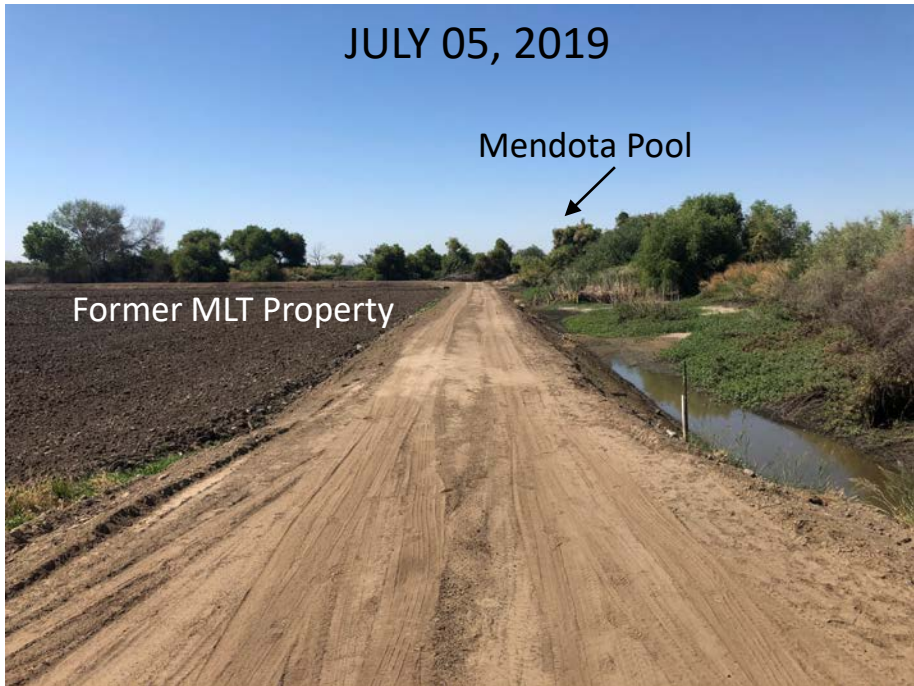
Photo 1

Looking to the south of the former MLT property, inner berm, and western most ditch.

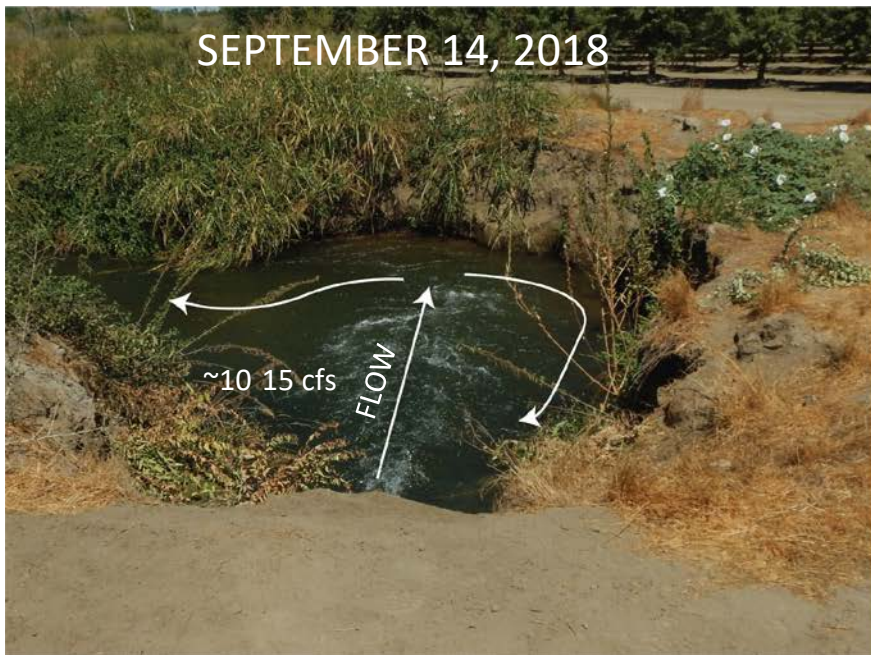
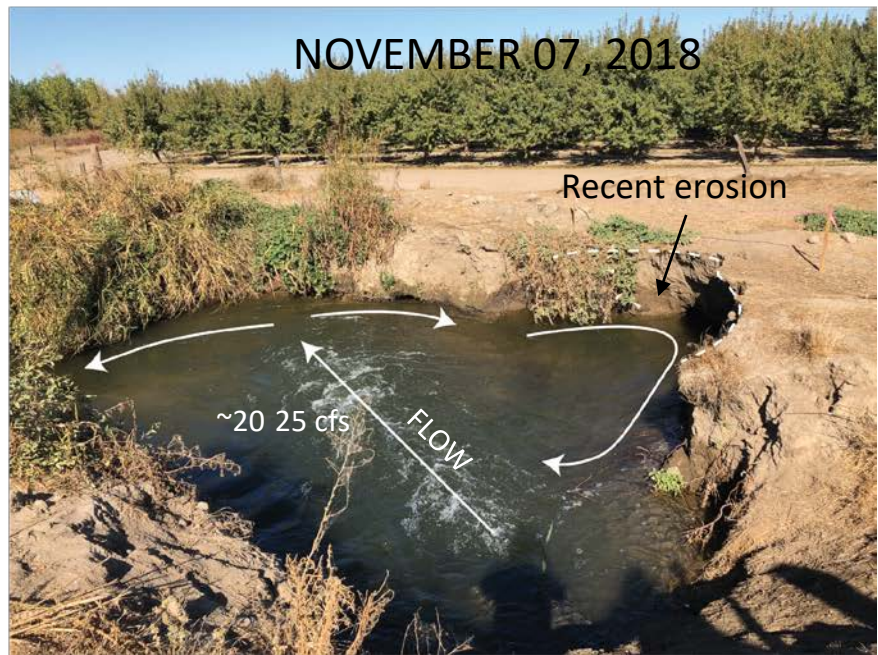
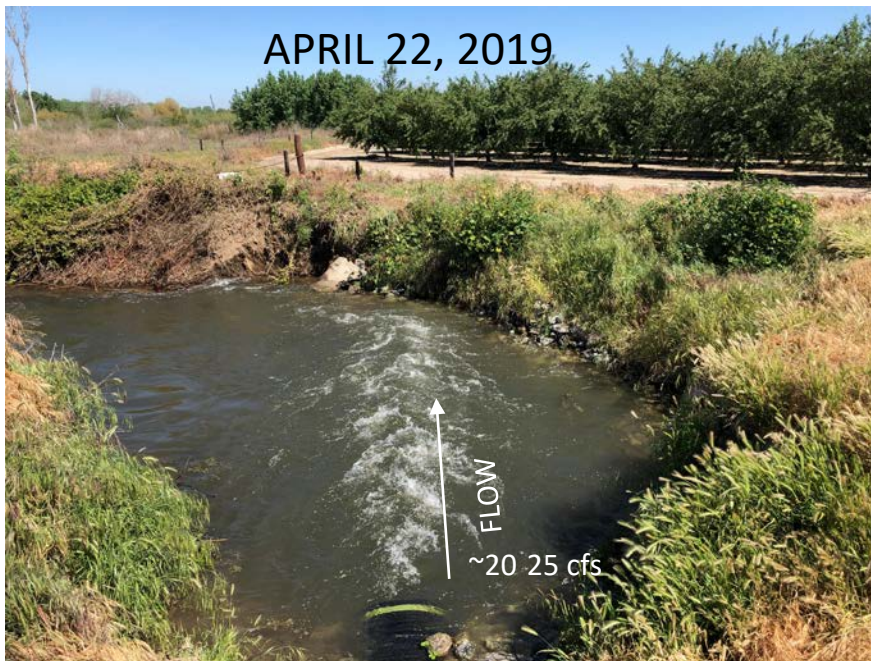
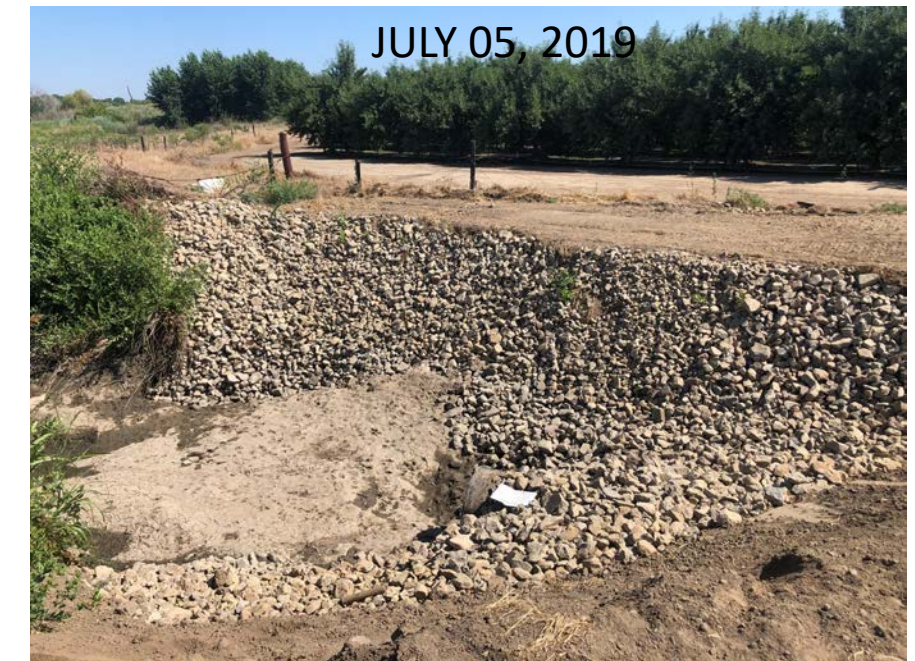
Photo 2 Looking north at the discharge area of the drainage ditch. The HDPE pipe crosses beneath Columbia Road in the northwest corner of the property and was recently modified with a 45° bend to direct any future flow away from the armor lined embankment.

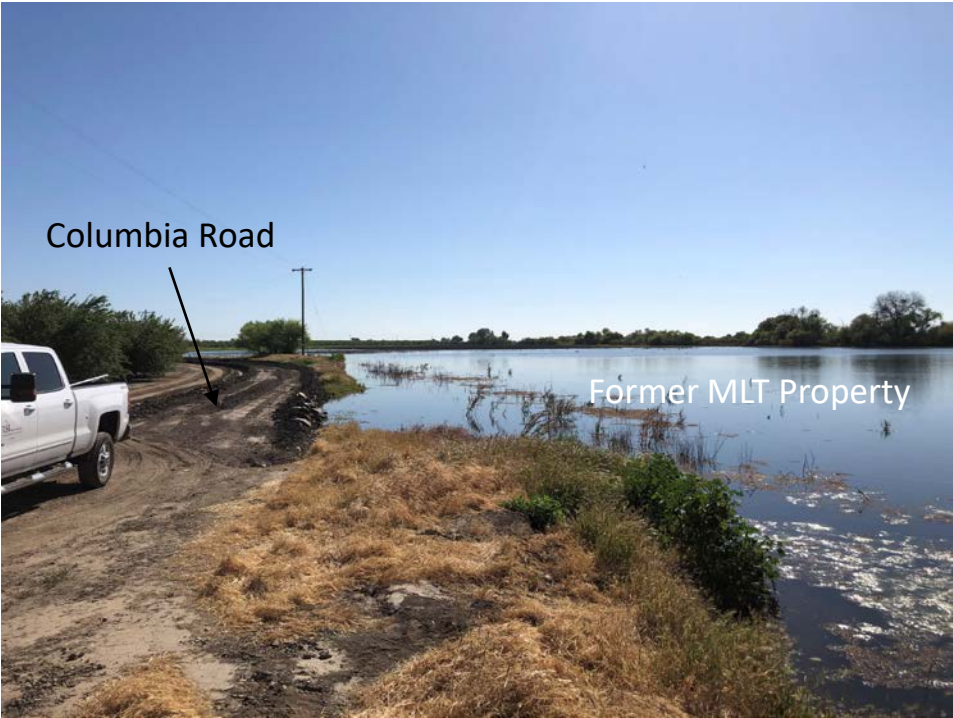
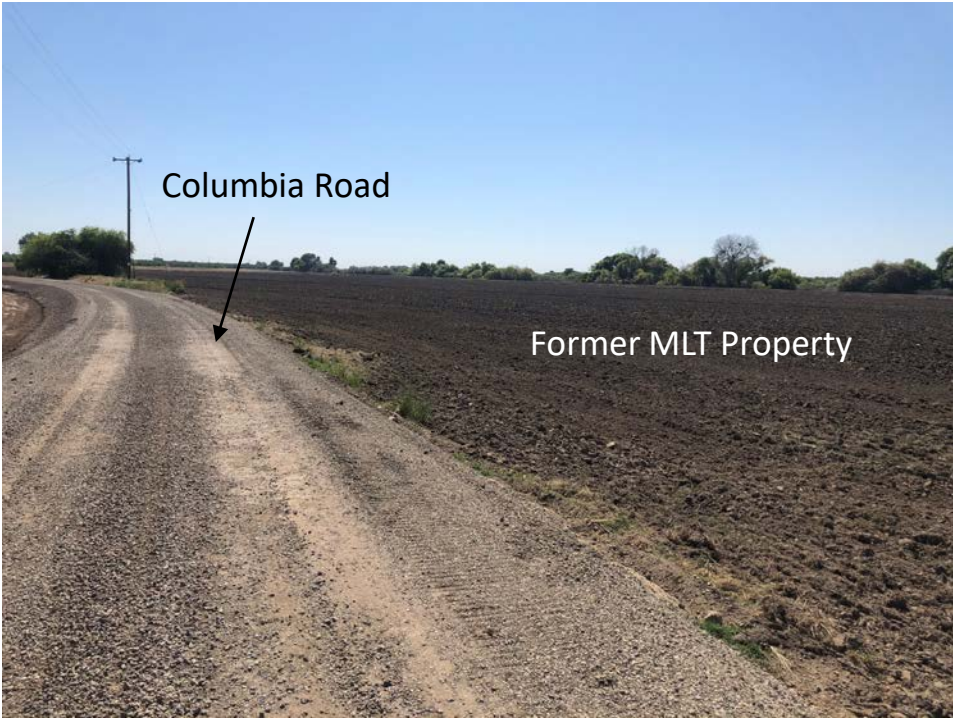
Photo 3

Looking east towards Columbia Road and the former MLT property.

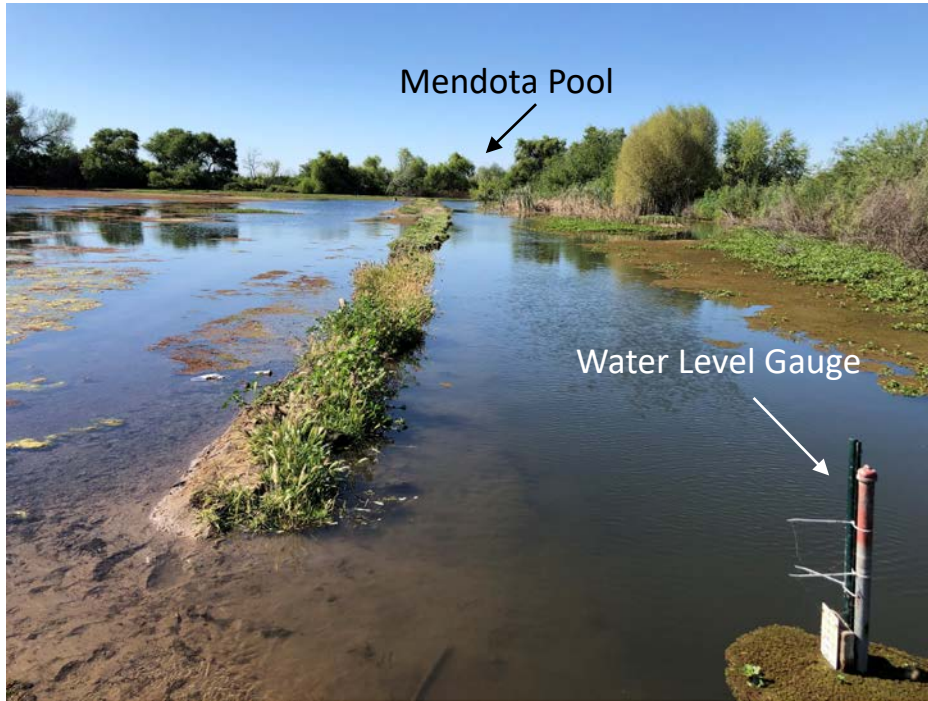
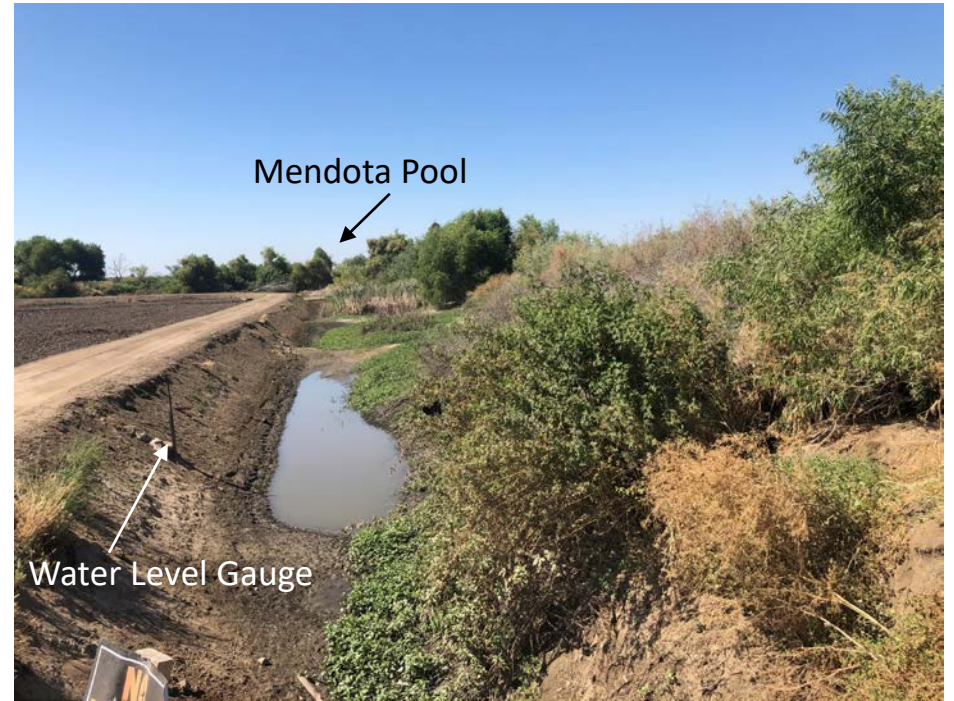
Photo 4

Looking south along the western most drainage ditch.

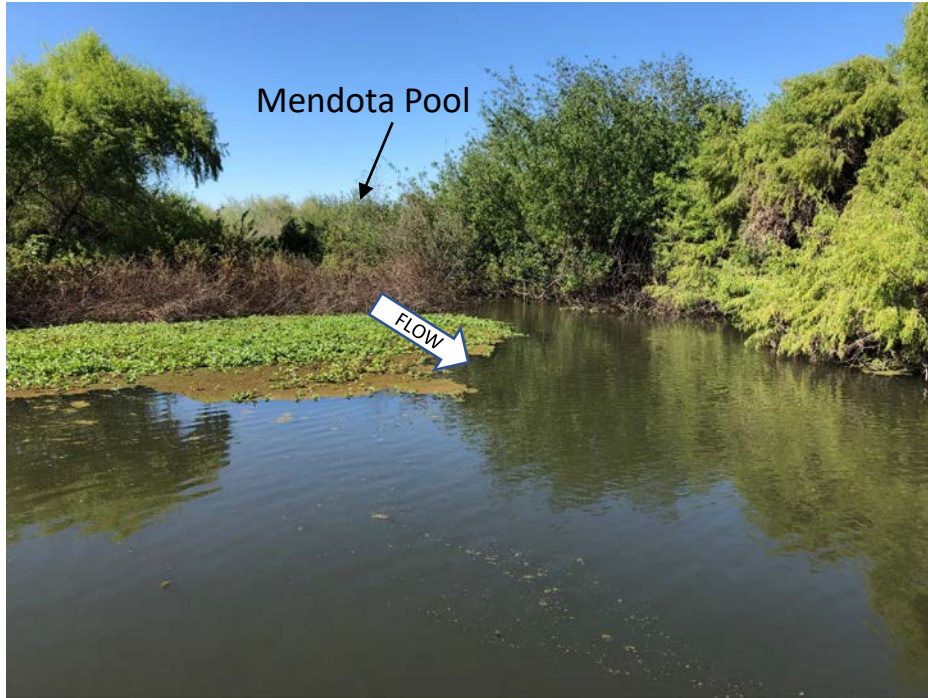
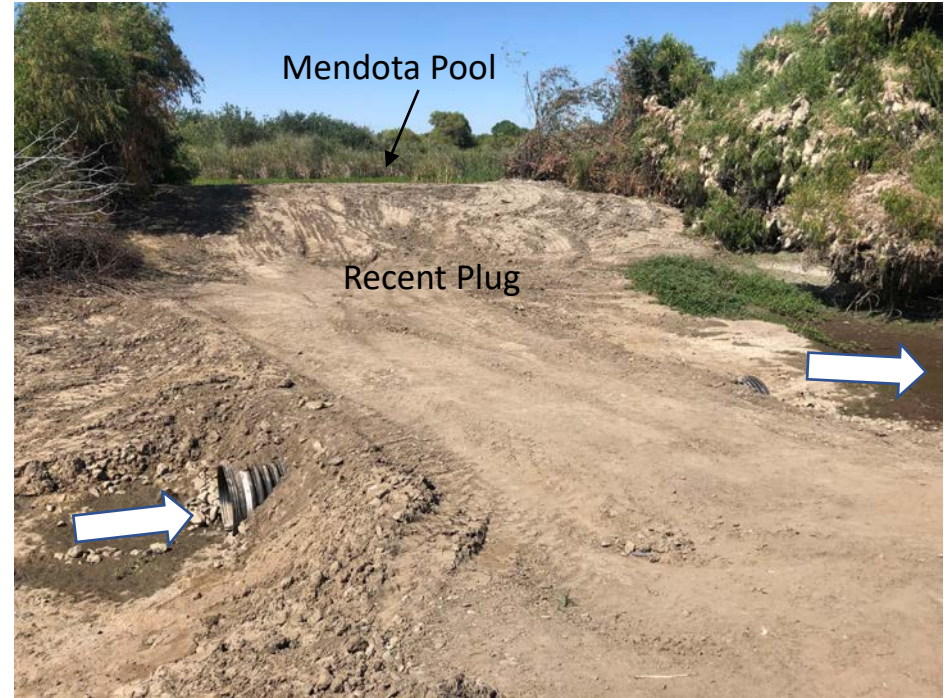
Photo 5

Looking south from the southwest corner of the property. This area was originally described as "Seep #2" as this was the location where the outer berm was breached and allowed water from the Mendota Pool to flow into the ditch. The recent plug repaired the outer berm in this location and the HDPE allows for the ditch to remain functional.

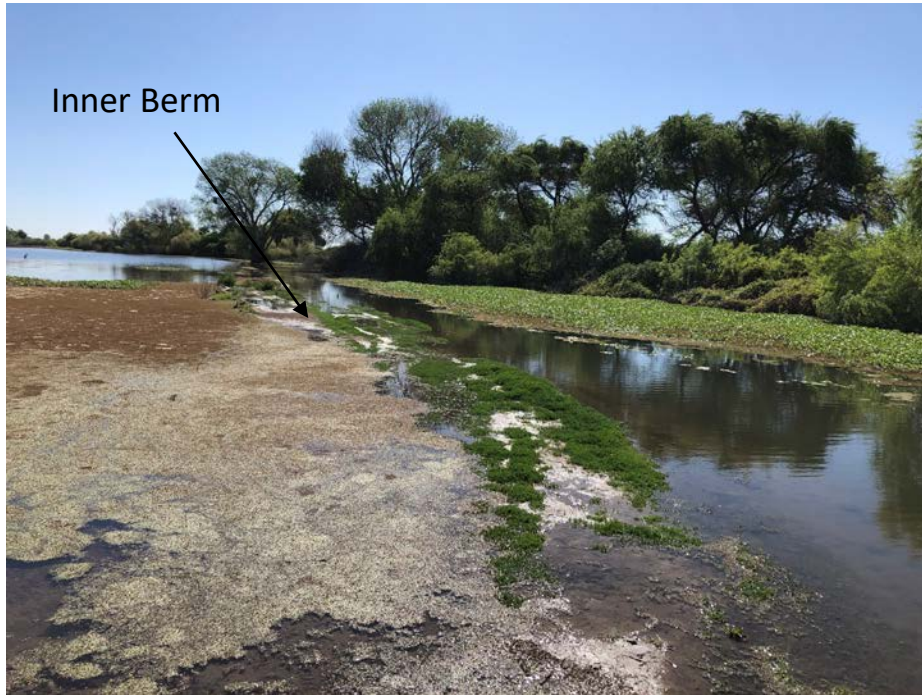
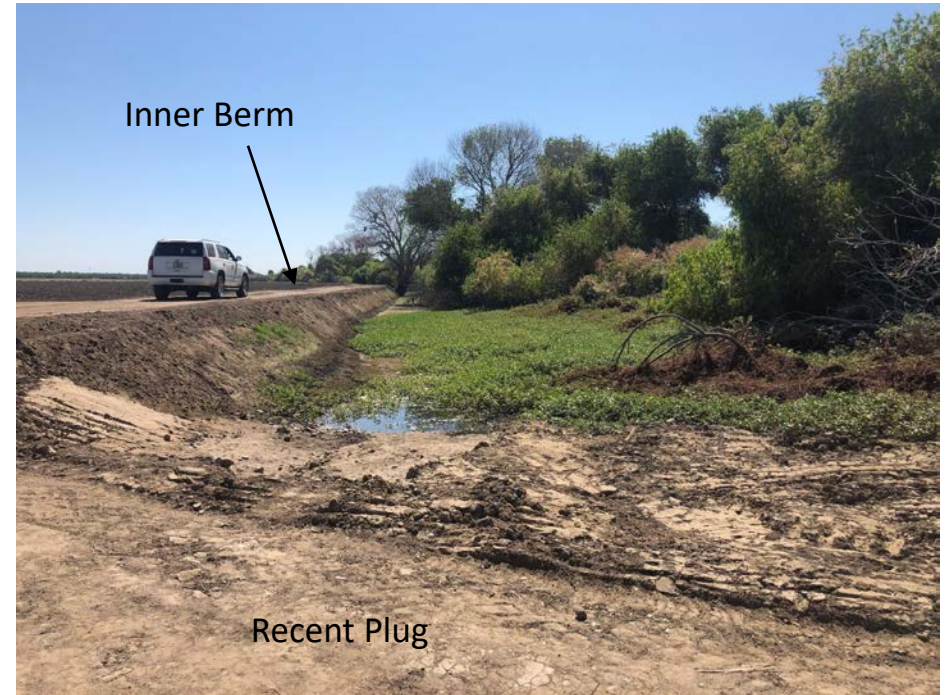
Photo 7

Looking east from the southwest corner of the property. The vehicle in the right photograph is parked on the inner berm which separates the ditch from the former MLT field. This inner berm was breached when the ditch was filled beyond capacity – allowing for water to flow freely into the former MLT field.

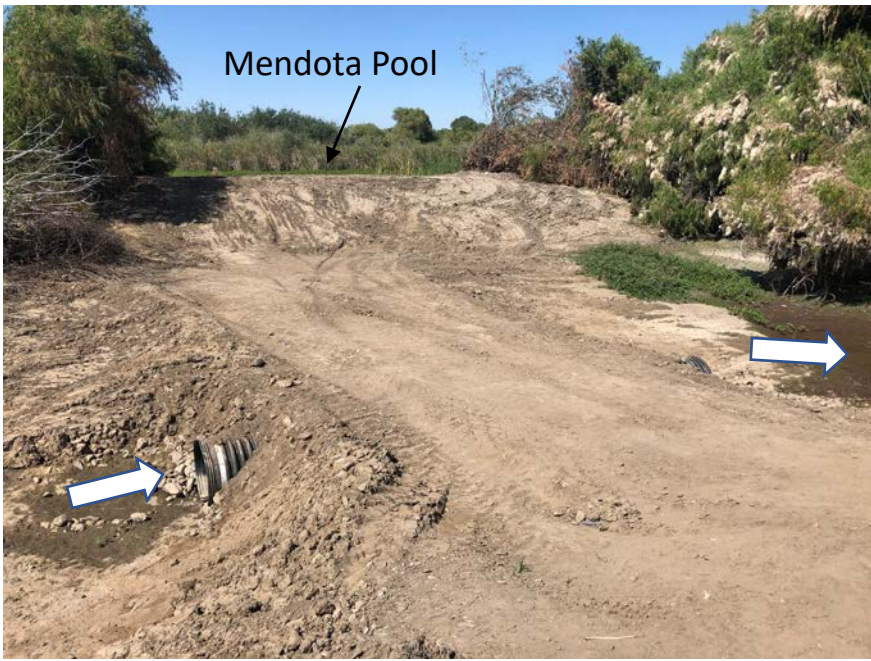
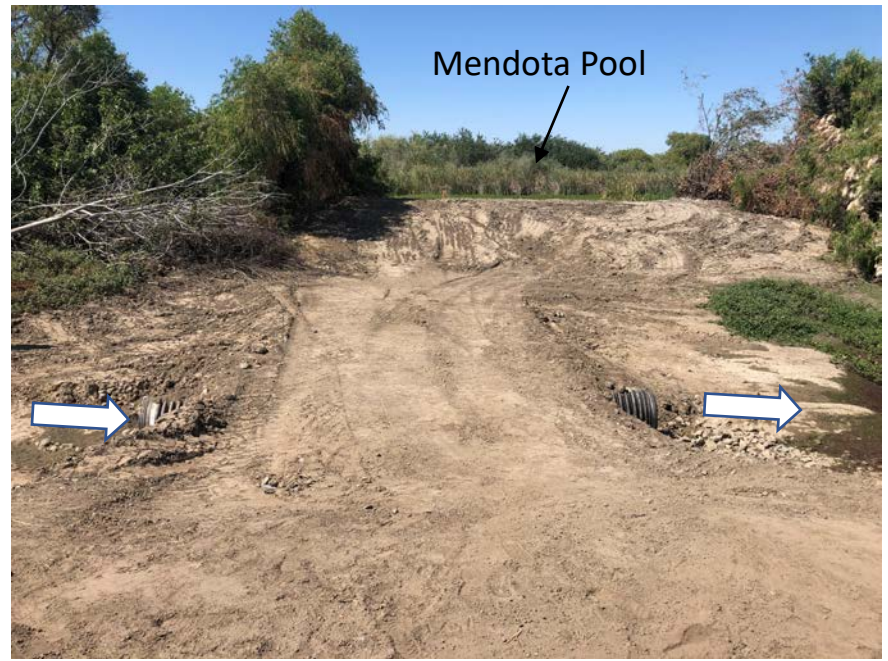
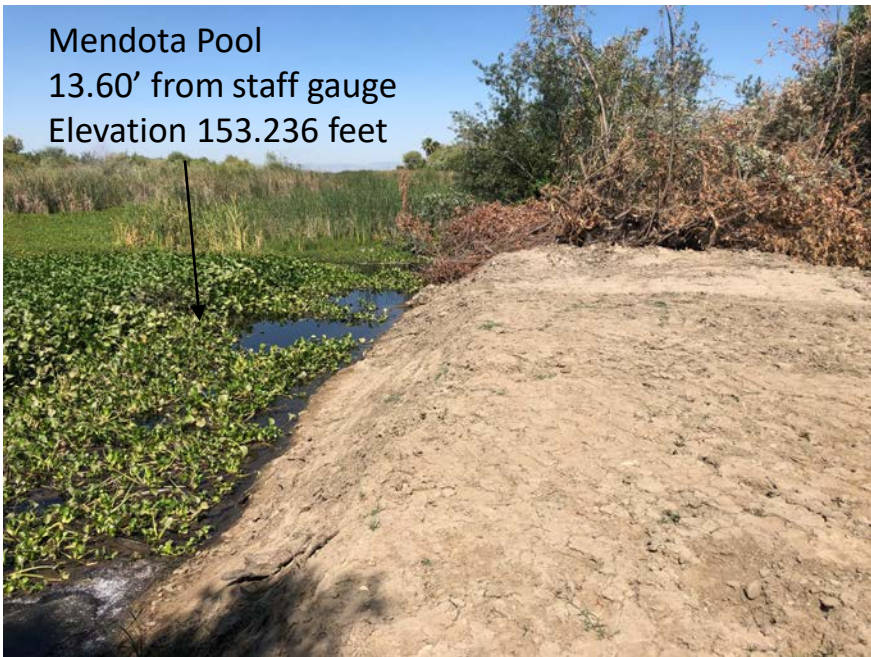
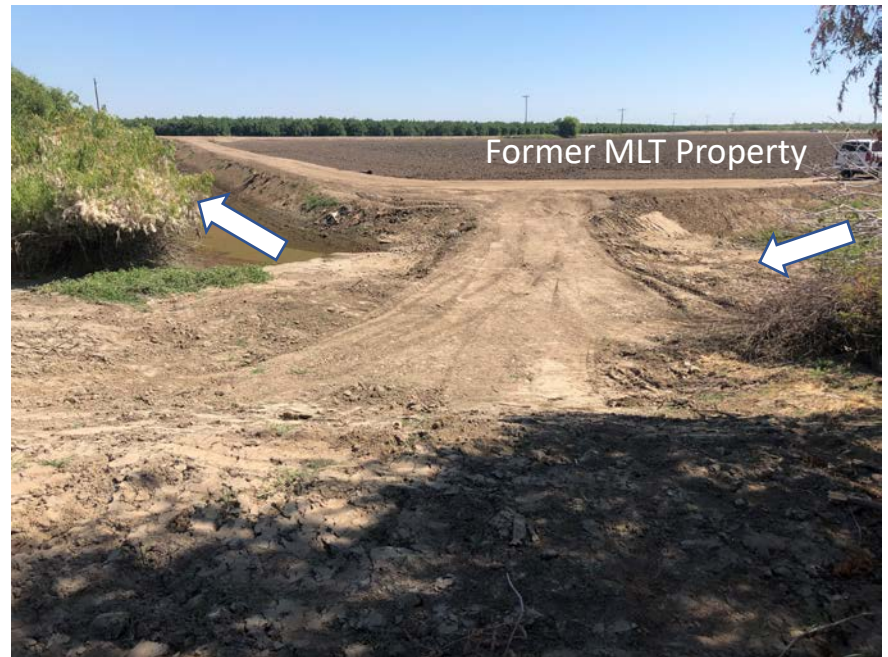
Photo 9

Photographs of the recent plug constructed to repair the outer berm and stop Seep #2.

1. Rebuilding and resurfacing Columbia Road (Photo 10)
2. Rebuilding and resurfacing the inner berm (Photo 10)
3. Installing an earthen filled plug to the outer berm breach (Photo 9)
4. Installing a 45° angle to the HDPE pipe that drains the ditch (Photo 4 in additional photos)

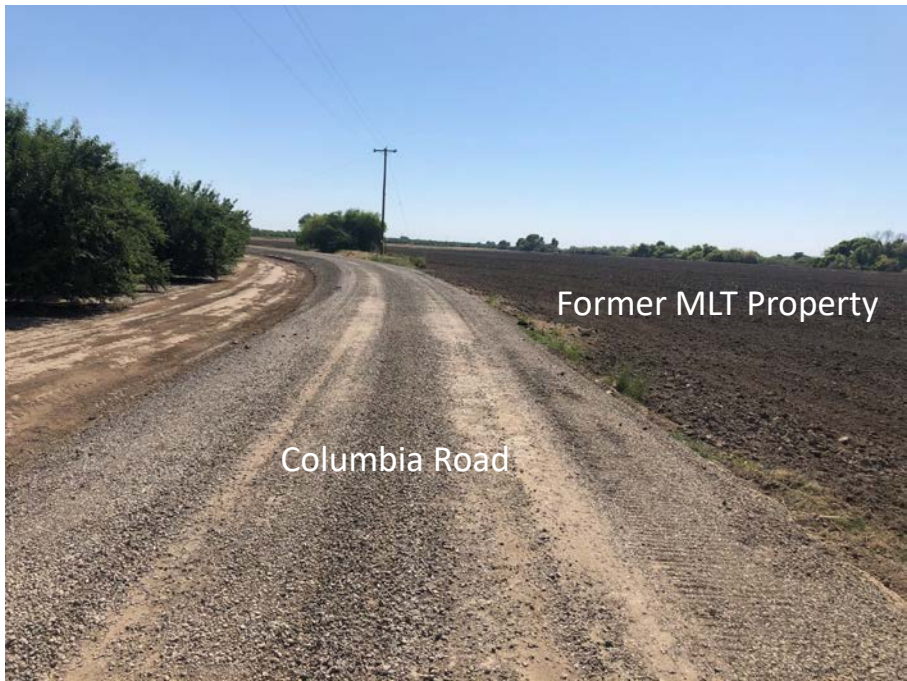
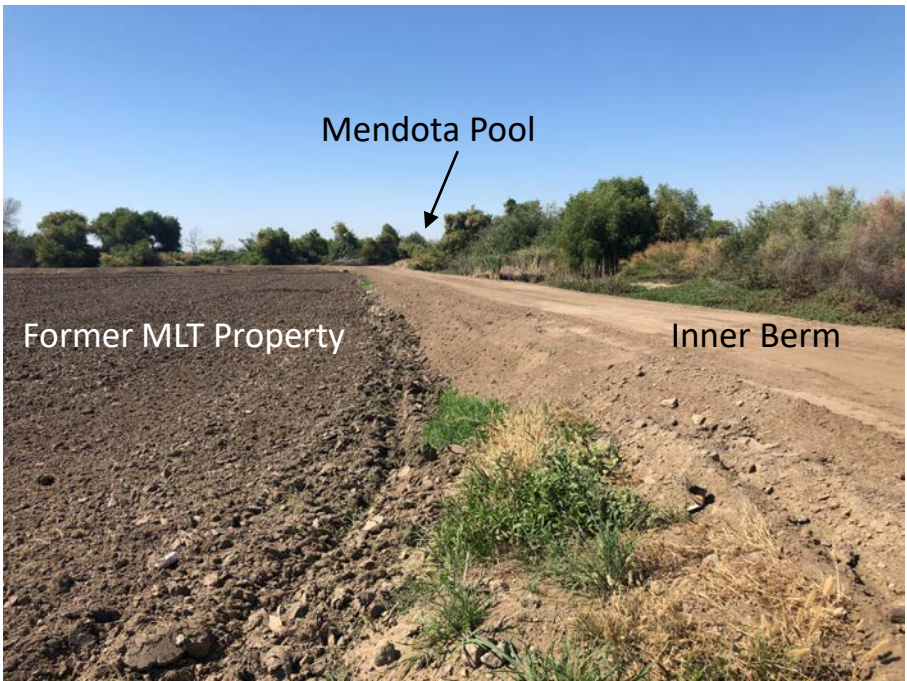
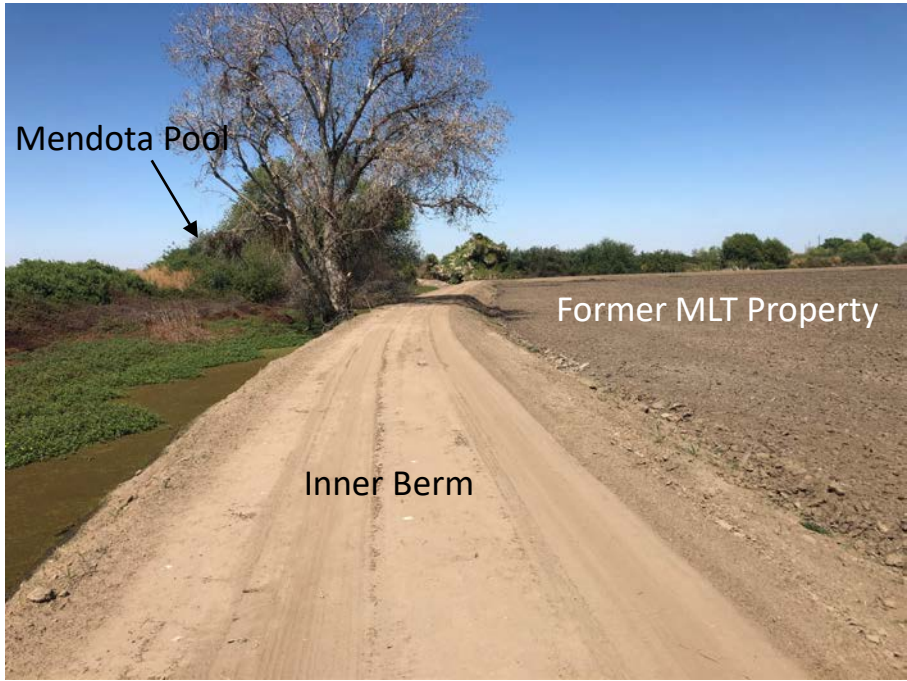
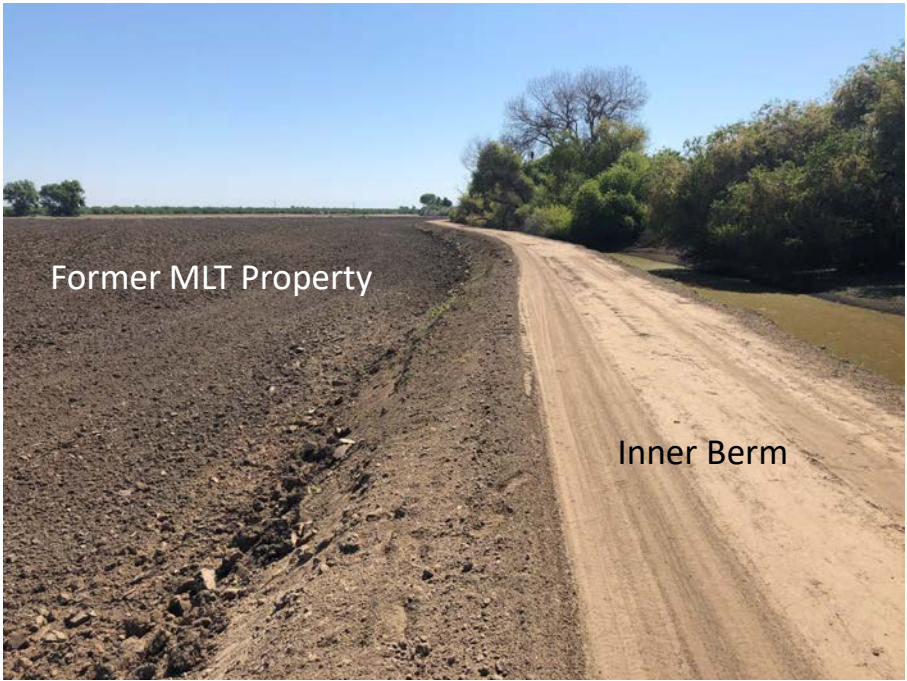
Photo 10

Photographs of the recent repairs to Columbia Road and the inner berm.

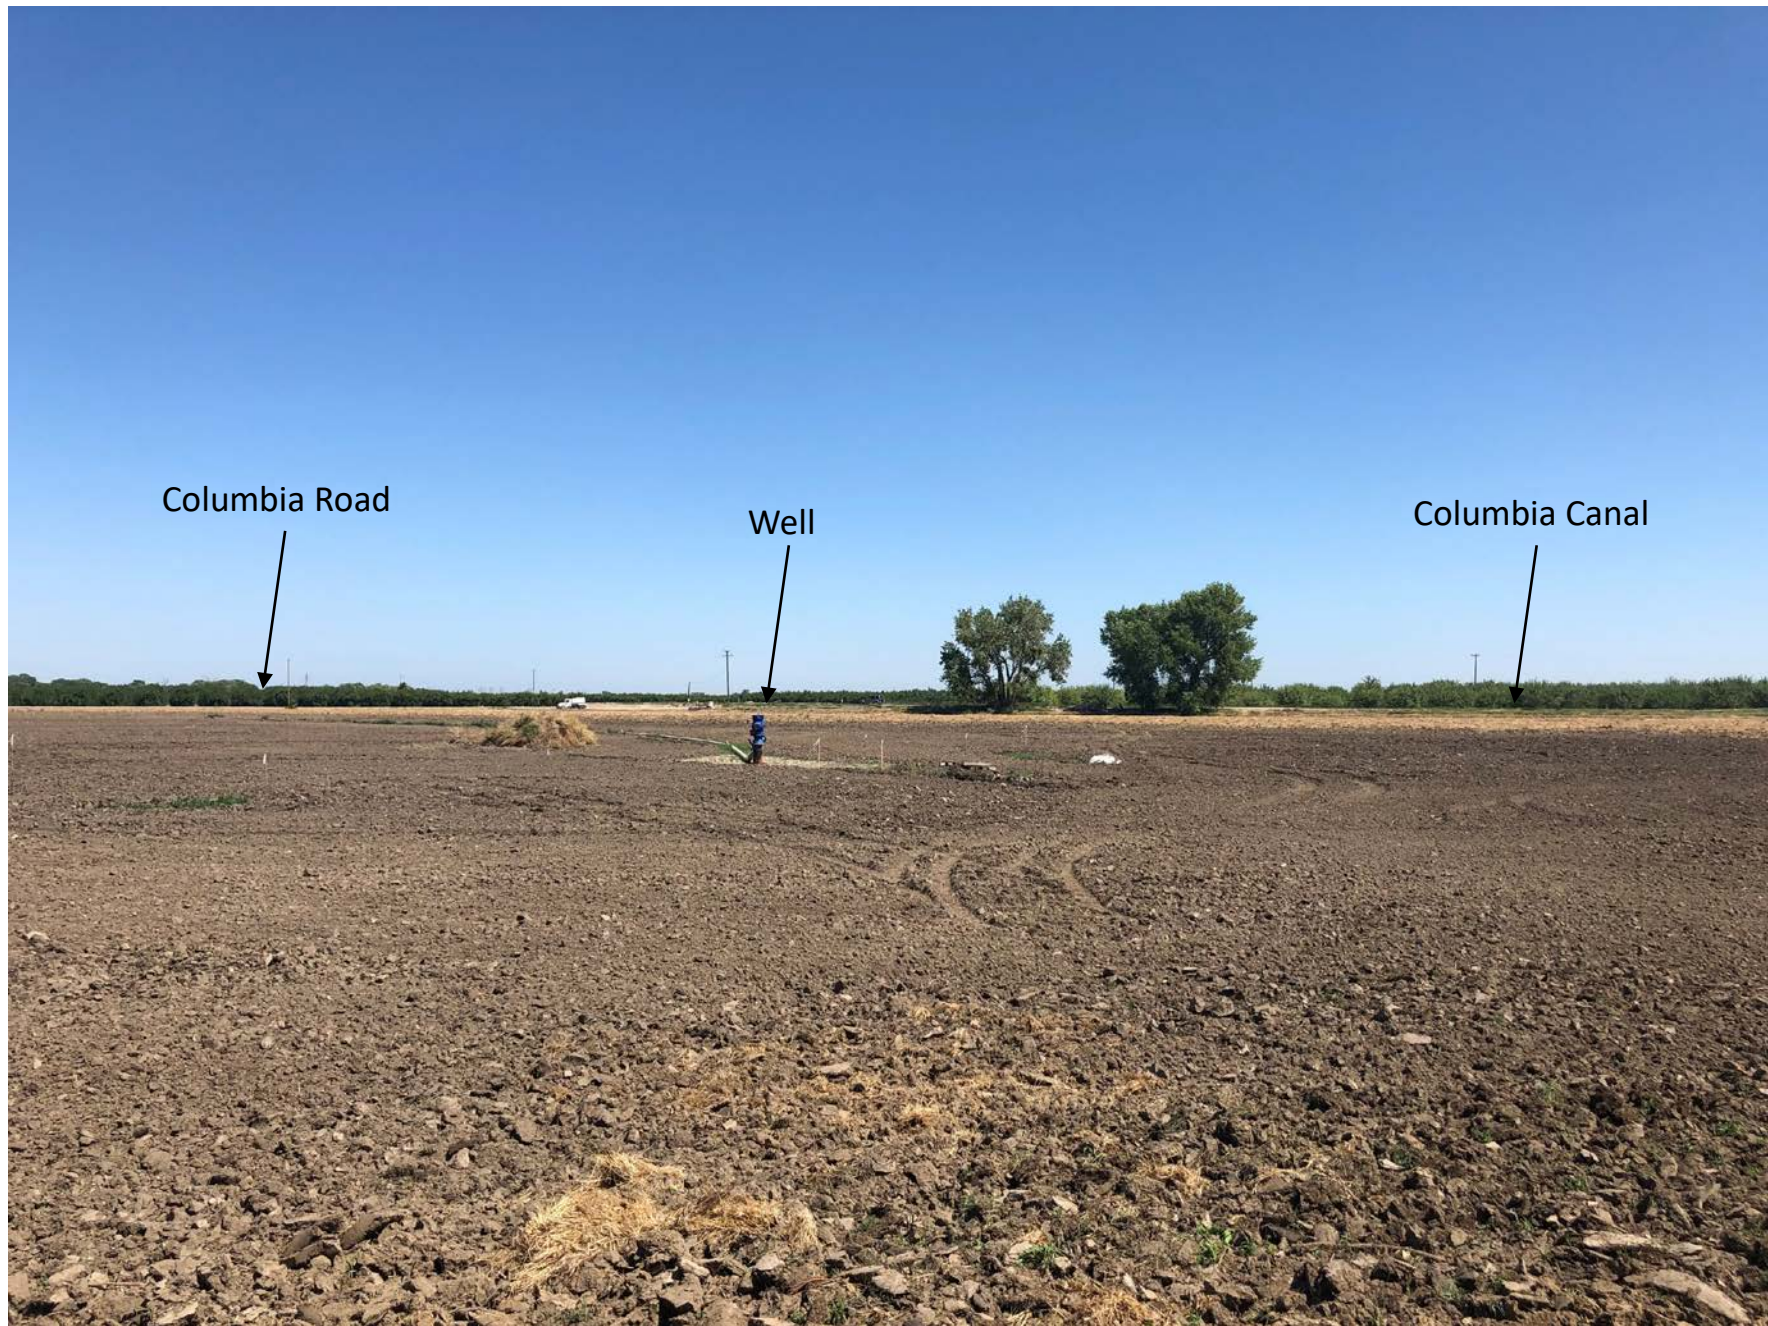
Photo 11

Well that was installed during the fall of 2018 for future pump out tests. As of July 05, 2019, the area around the well was dry and accessible by vehicles.

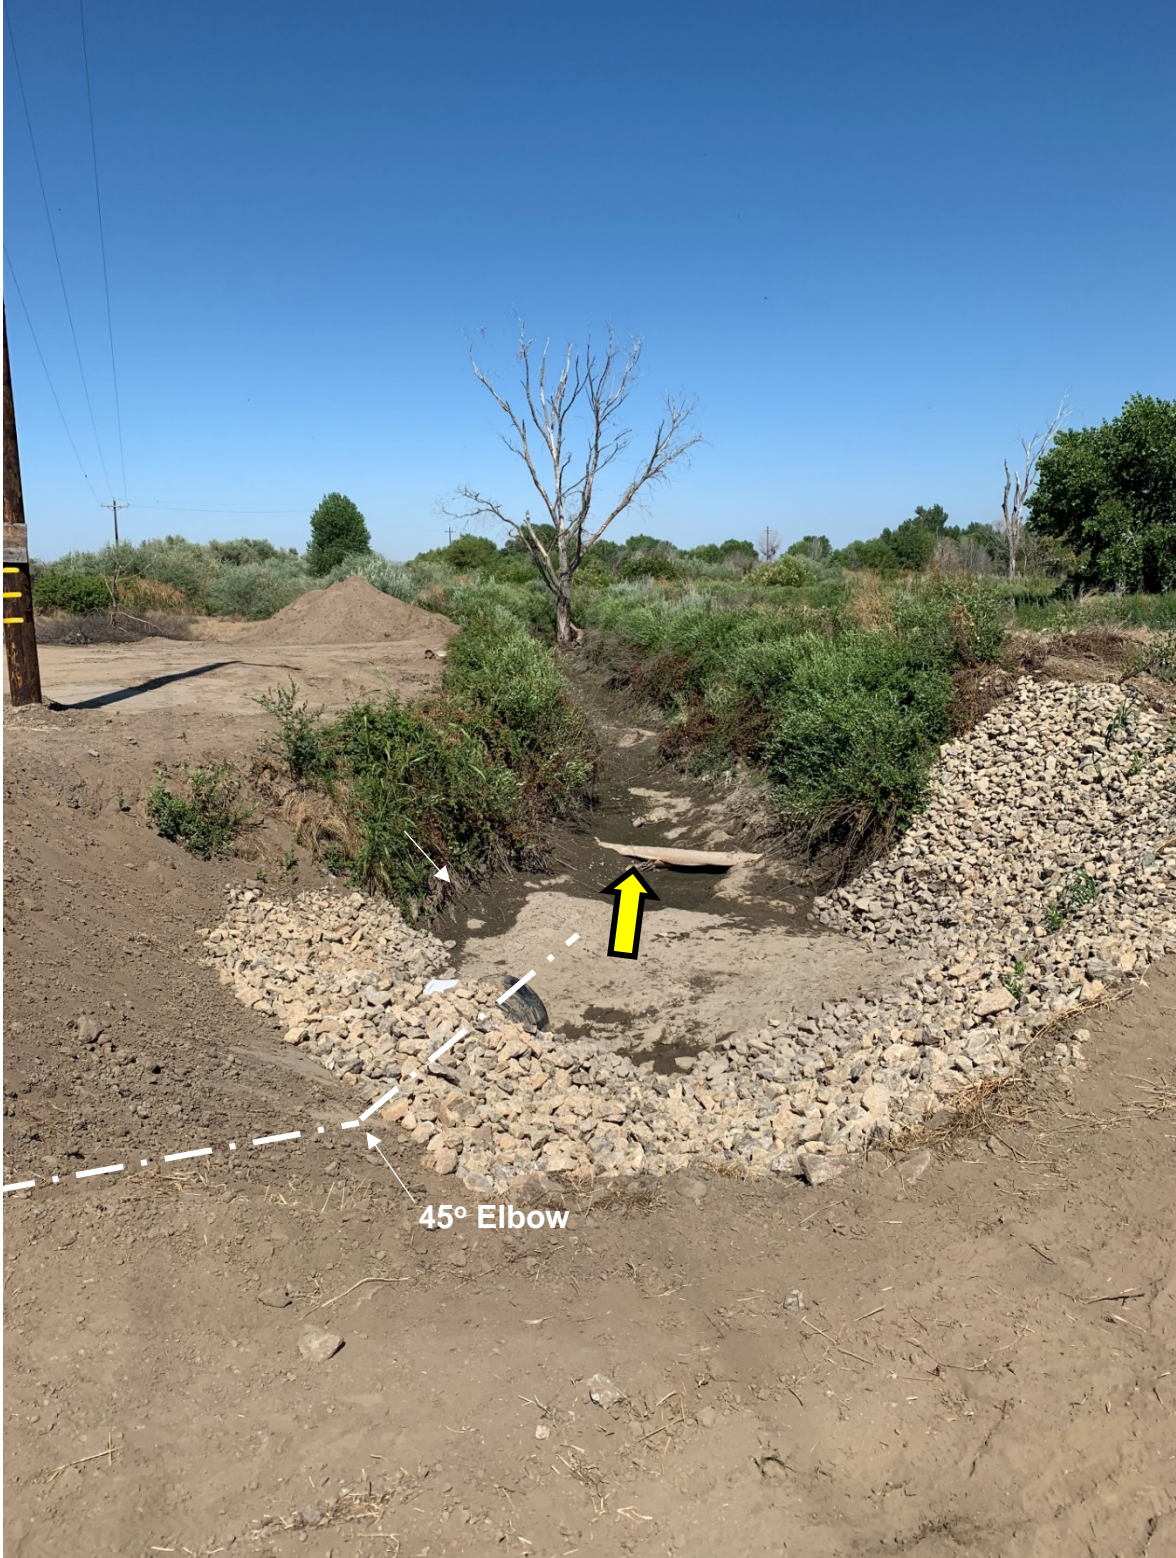
Photo 4

**OUTLET DISCHARGE CULVERT AND DISCHARGE CHANNEL
NW CORNER**

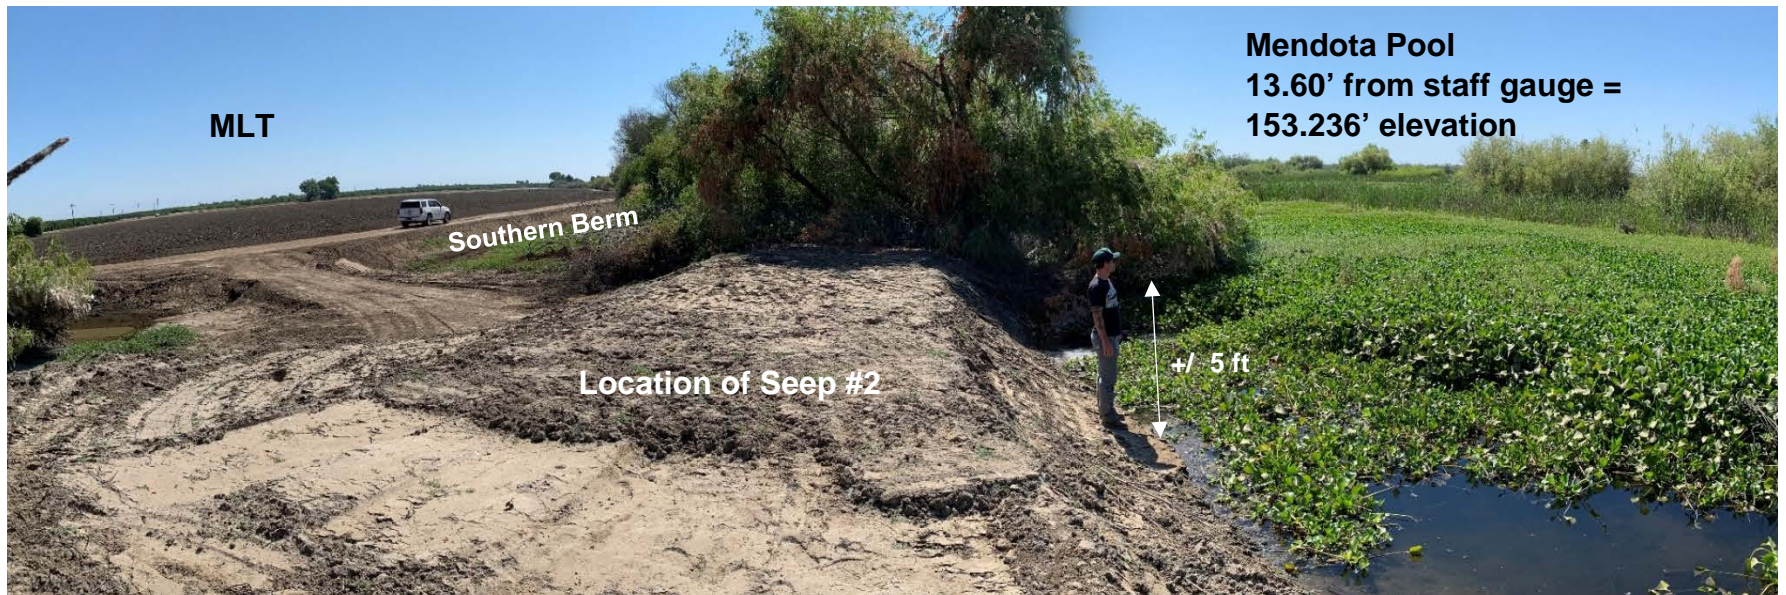
Photo 9

SEEP #2 REPAIR

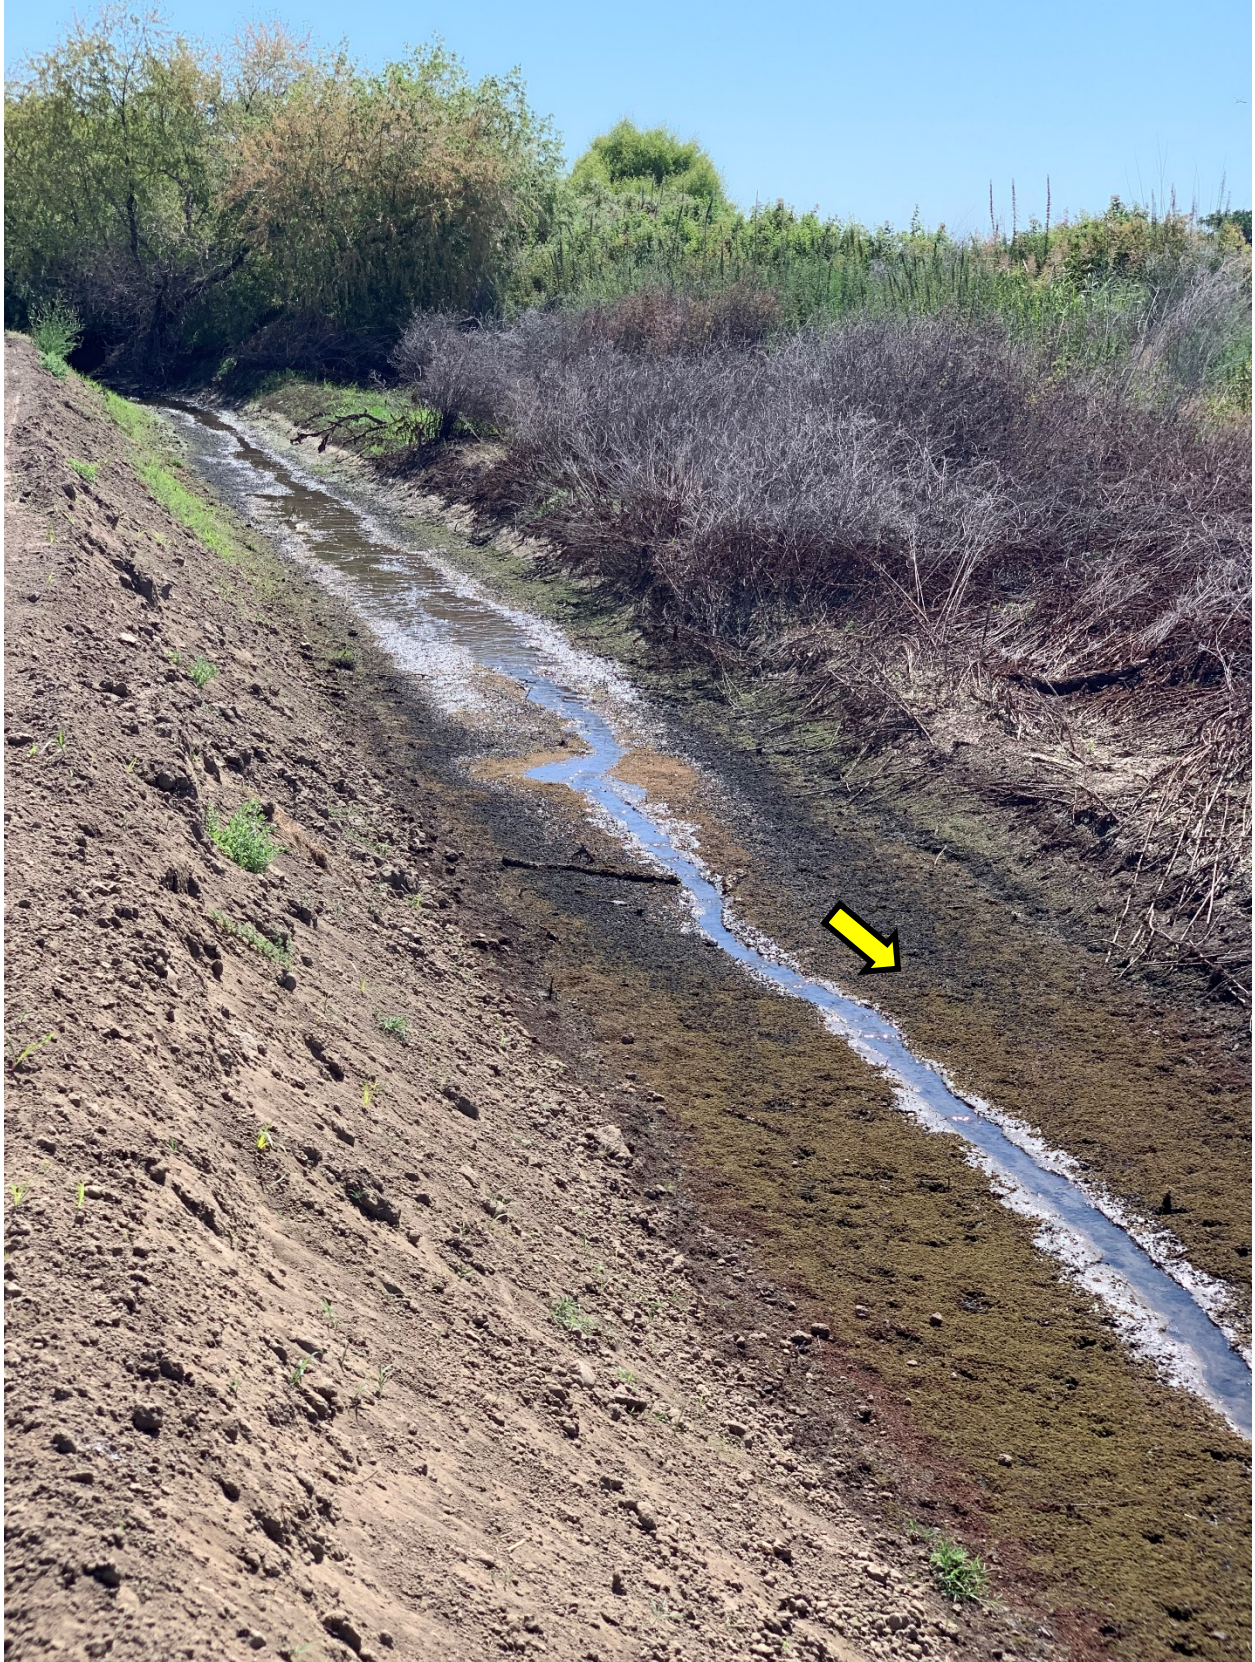
Photo 13

1. The former MLT field was dry with evidence of recent agricultural disking.
2. The ditch was approximately 80% drained with localized areas of standing water with unknown depth.
3. On July 5, a small amount of seepage entered the southside ditch near its midpoint and flowed downstream (west) (Photo 13 in additional photos). The southside ditch was dry upstream (east) of the midpoint.
4. The outer berm plug had completely shut off any surface communication with the Mendota Pool.
5. The inner berm was passable with a large vehicle or equipment and was a few feet higher in elevation than its original height above the MLT field.
6. Columbia Road was also a few feet higher in elevation and has a fine gravel surface.
7. The area around the previously installed well, designed for future pump out tests, was dry and accessible by vehicles and equipment.

SOUTHERN DITCH
