Bank Erosion Monitoring Report

San Joaquin River Restoration Program

July 2021

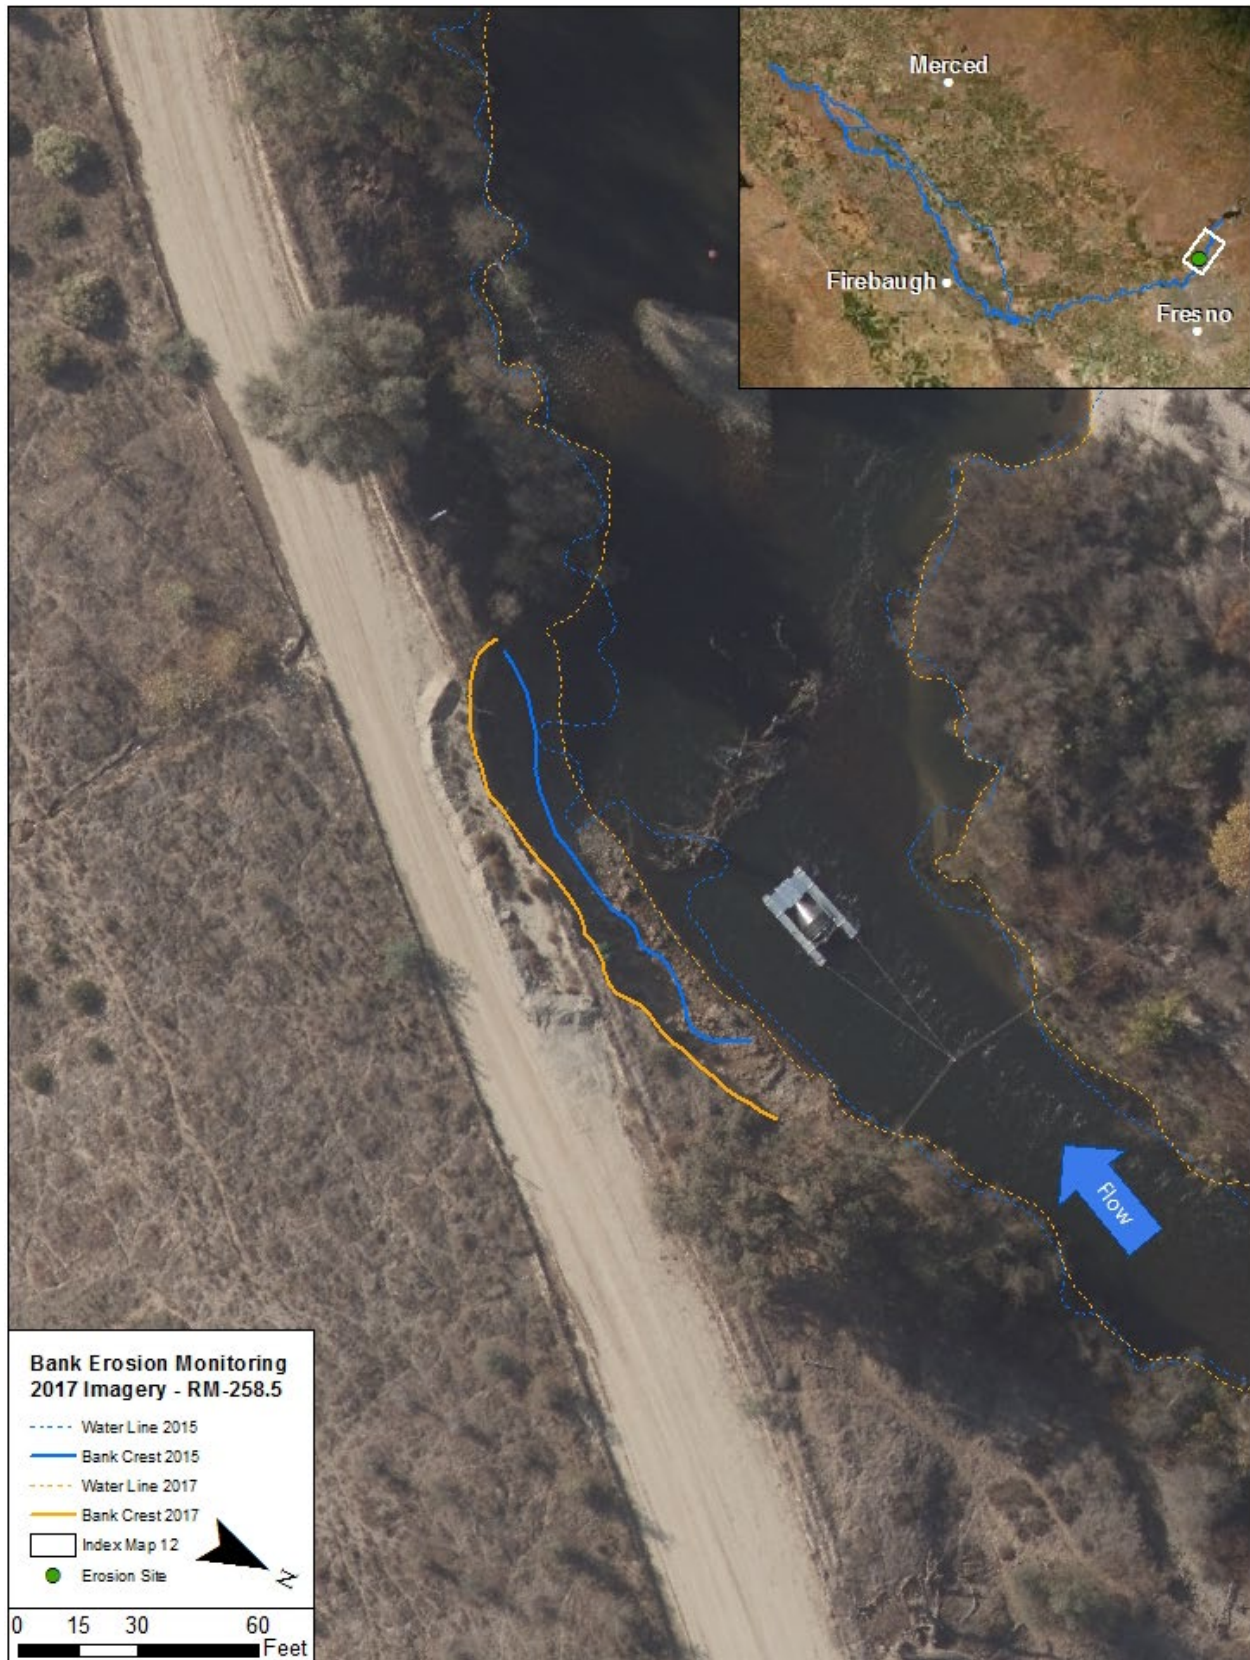
This site is in Reach 1A near Owl Hollow and depicts a bare bank with no bank protection. The nearest structure threatened is an embankment road that separates a gravel mining pit from the river, the bank of which is currently being eroded. Up to 12 feet of lateral erosion occurred over a longitudinal distance of 136 feet on the river-left side. From Google Earth imagery, most of the erosion appears to have occurred between March 18, 2015, and March 31, 2017. During that time frame, a dirt berm was built on top of the embankment road. Threat ratio is 0.0; threat level is high; see Figure 5 and Index Map 12.

Figure 5 San Joaquin River Reach 1, RM 258.5; Threat Ratio 0.0, Threat Level: High; Index Map 12

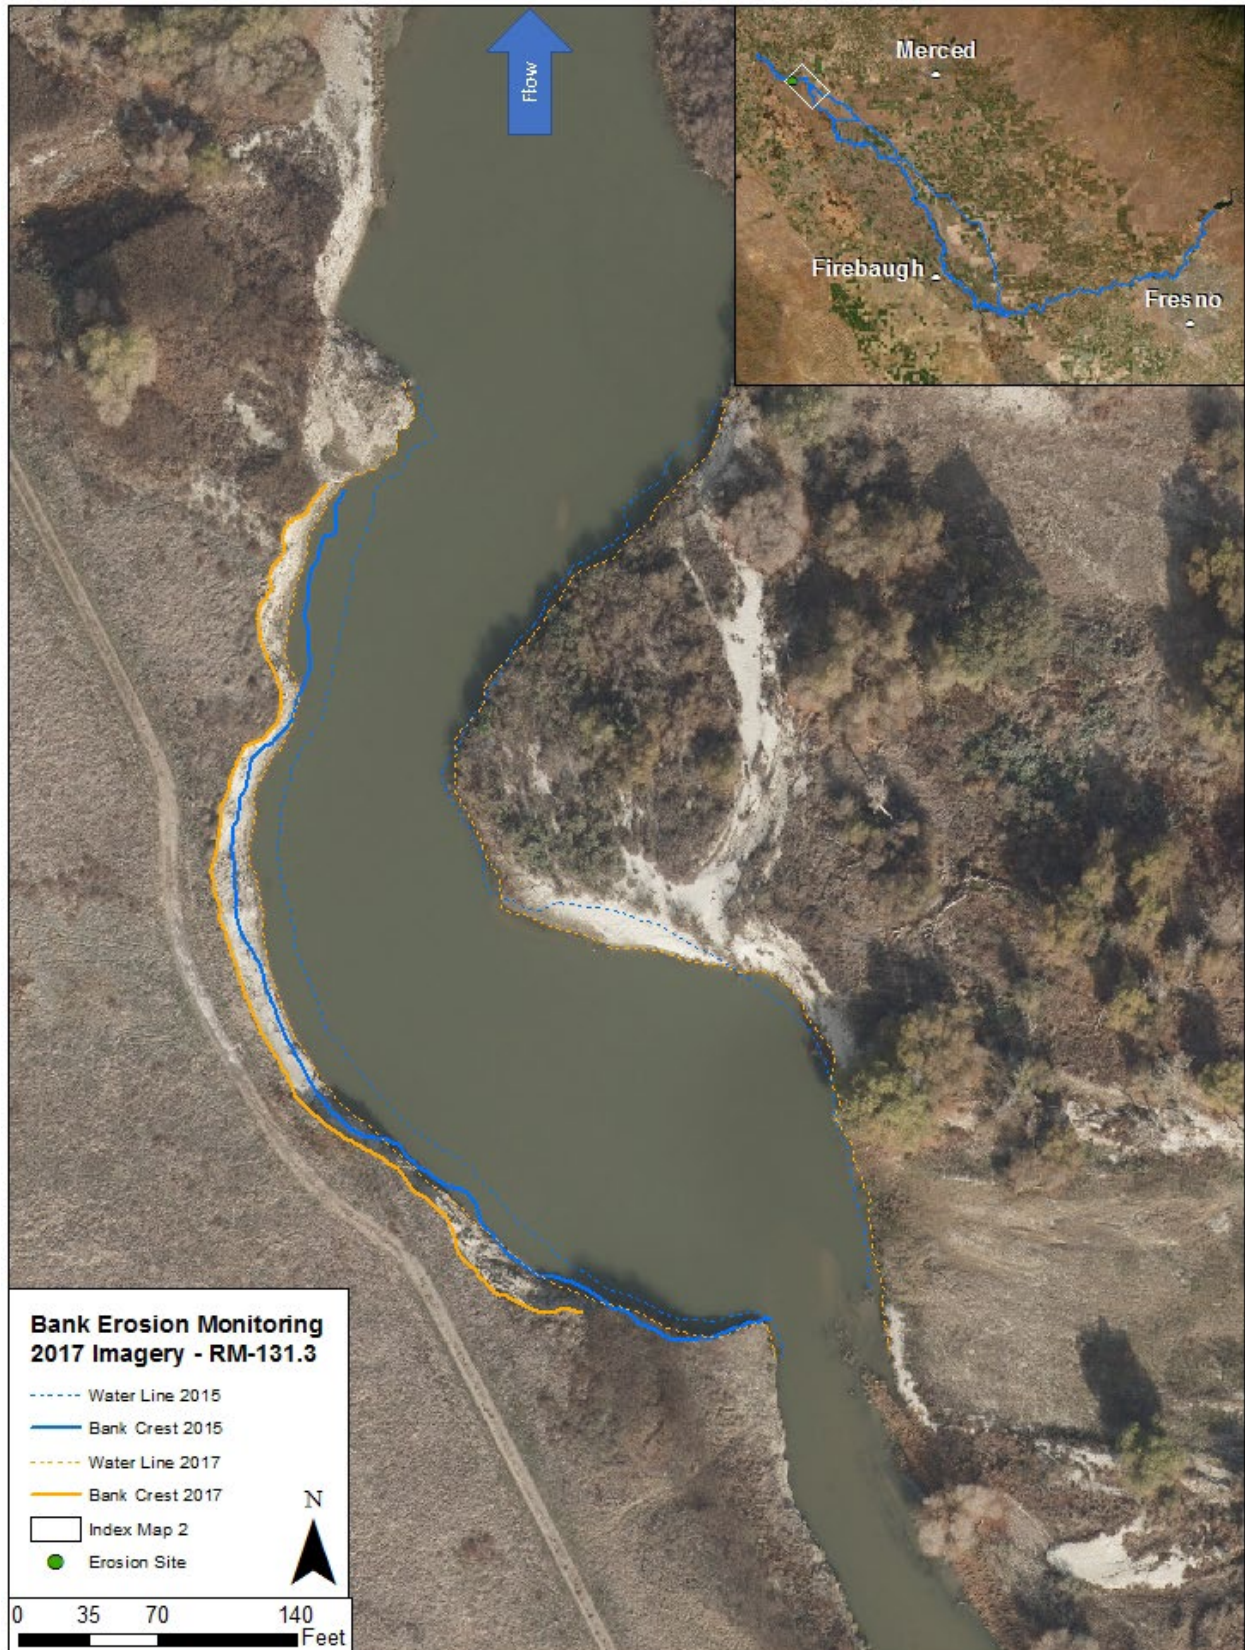
This site is in Reach 5 and depicts a barren bank with no bank protection. A 430-foot-long stretch of bank is actively eroding and encroaches a flood control levee on the river-left side. Up to 20 feet of lateral erosion occurred here. As seen by the bend in the road, motorists must drive off of the eroding levee as a detour to continue on their way. This levee is part of the State Plan of Flood Control levees that protect adjacent lands. As high flows overtop a bank and bypass the river bend, they then encounter and erode the outside bank; continual high flows may establish this path until it becomes the main channel and cuts off the outer bend. Threat ratio is 0.0; threat level is high; see Figure 6 and Index Map 2.

Figure 6 San Joaquin River Reach 5, RM 131.3; Threat Ratio 0.0, Threat Level: High; Index Map 2

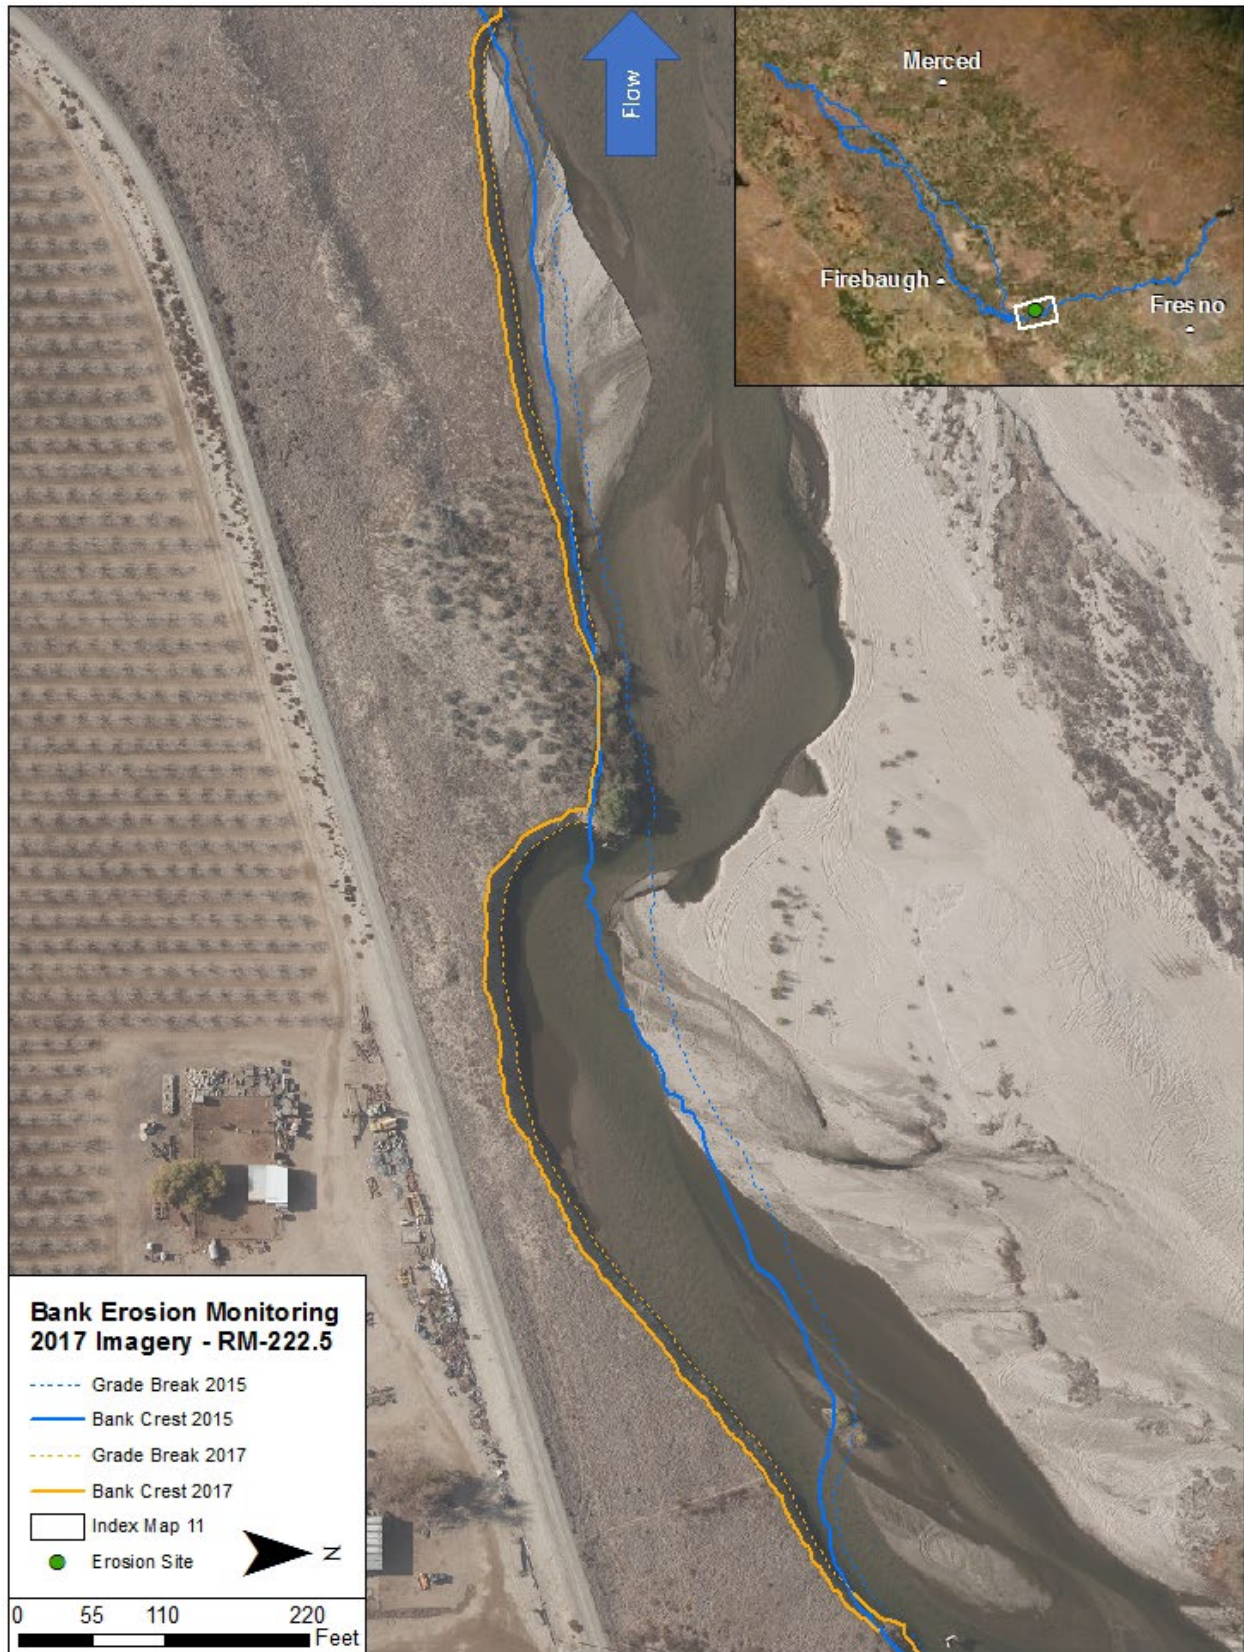
This site is in Reach 2A and depicts sparse vegetation with no bank protection. The nearest threatened structure is a levee 45 feet away, with farm buildings and an orchard beyond it. There is a maximum of 140 feet of lateral erosion along 1,270 feet of bankline on the river-left side. The river is single-threaded

during low flow and becomes braided and shallow with increased flow. Most of the erosion occurred during flood flows between March 31, 2017, and August 7, 2017, as depicted by Google Earth imagery. This site likely contributes significant amounts of sand downstream. Threat ratio is 0.3; threat level is high; see Figure 8 and Index Map 11.

Figure 8 San Joaquin River Reach 2A, RM 222.5; Threat Ratio 0.3, Threat Level: High; Index Map 11

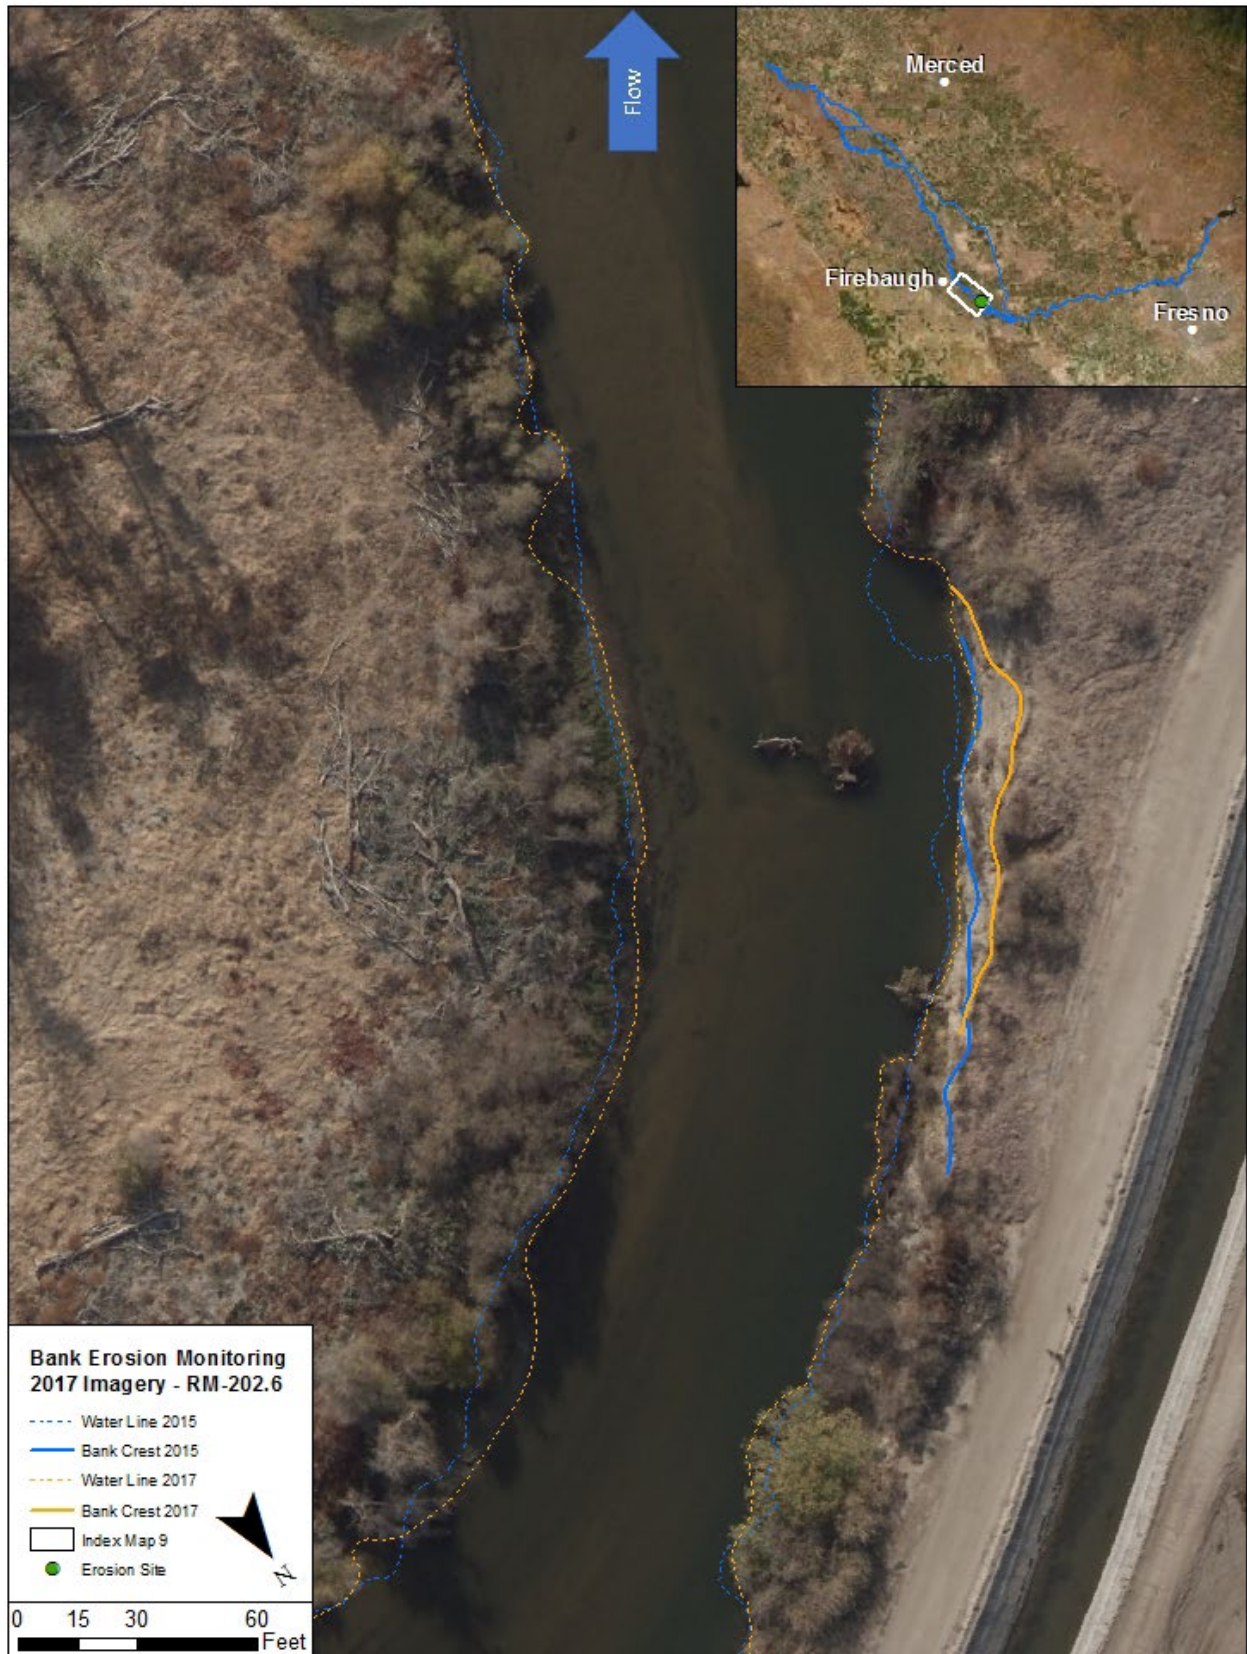
This site is in Reach 3 and depicts a sparsely vegetated bank with no bank protection. The nearest threatened structure is a service road and canal 20 feet from the bank crest. Evidence of 12 feet of lateral erosion is apparent from a missing tree and scalloped bank for 112 feet longitudinally on the river-right side. The bank scarp is noticeably encroaching on the service road and canal embankment. Threat ratio 1.6; threat level high; see Figure 10 and Index Map 9.

Figure 10 San Joaquin River Reach 3, RM 202.6; Threat Ratio 1.6, Threat Level: High; Index Map 9
