Bank Erosion Monitoring Report

San Joaquin River Restoration Program

July 2021

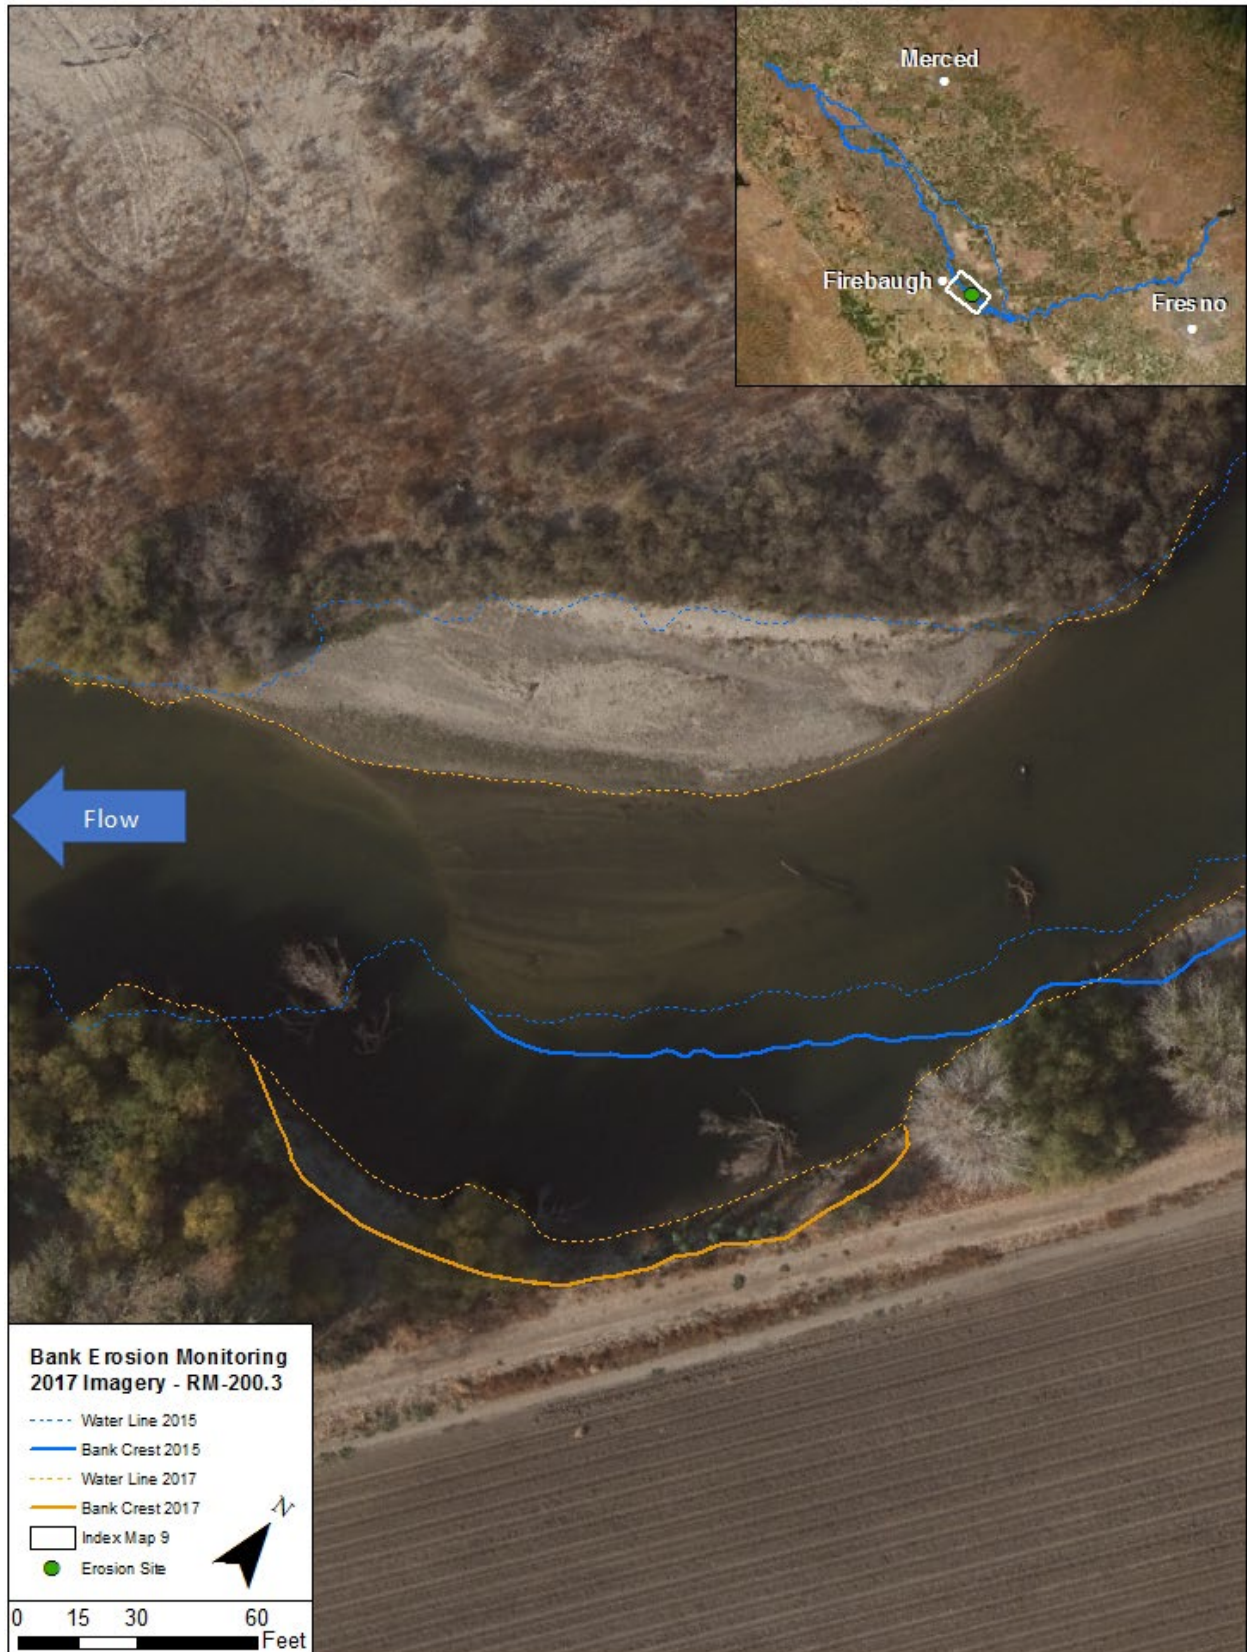
RM 200.30

This site is in Reach 3 and depicts vegetation loss and no bank protection. The nearest structure threatened is a service road and row crops 3 feet from the bank crest. Imagery comparison shows a multi-stage terrace with possible 55 feet of lateral bank erosion along 270 feet of bankline. Waterline migration pattern supports channel migration evidence. Deposition is apparent on opposite side of channel. Threat ratio is 0.1; threat level is high; see Figure 7 and Index Map 9.

Figure 7 San Joaquin River Reach 3, RM 200.3; Threat Ratio 0.1, Threat Level: High; Index Map 9

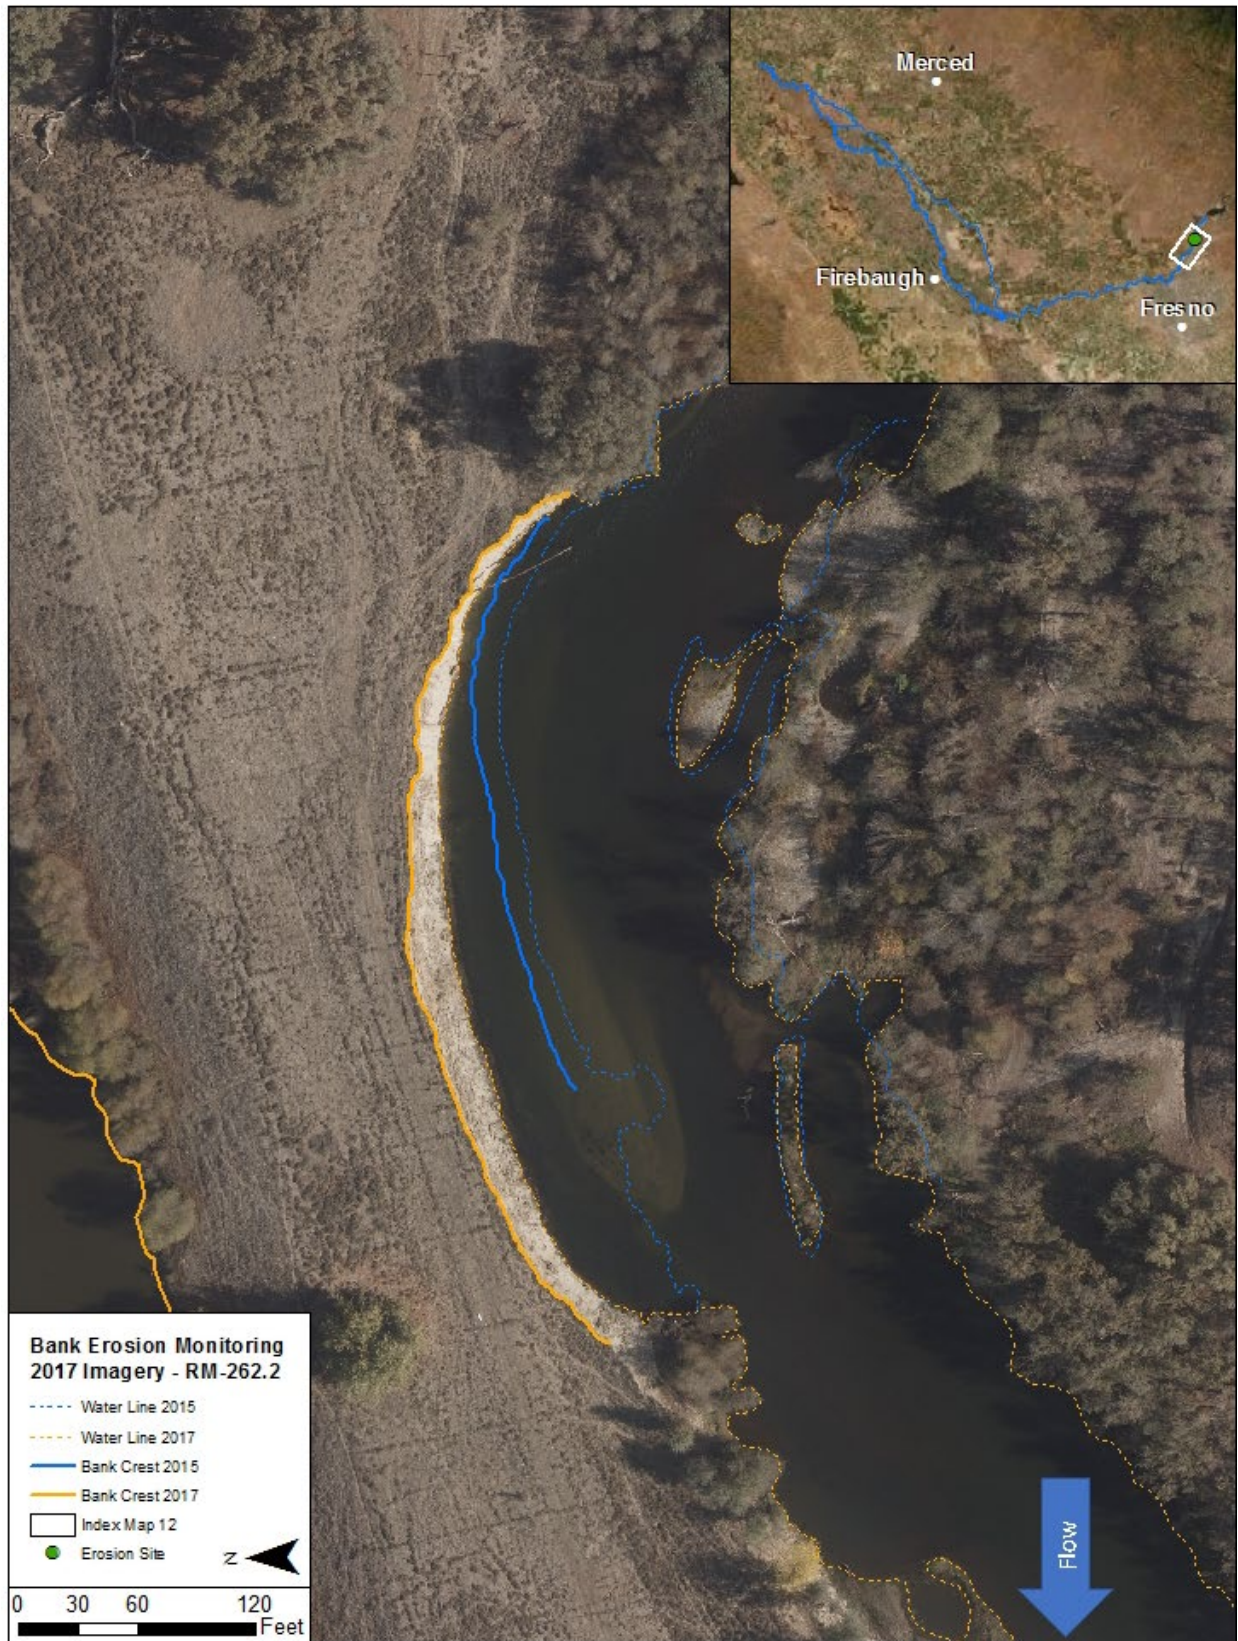
RM 262.20

This site is in Reach 1A at the southern end of Ledger Island and depicts a bare bank with no bank protection. The nearest structure threatened is a gravel mining pit 85 feet from the river, separated by an eroding bank. This site shows up to 55 feet of lateral erosion along 420 feet of bankline on the river-right side. This erosion provides a significant amount of sand to the spawning reach, and connectivity with the pond would have other adverse impacts to salmonids. Threat ratio is 1.5; threat level is high; see Figure 9 and Index Map 12.

Figure 9 San Joaquin River Reach 1, RM 262.2; Threat Ratio 1.5, Threat Level: High; Index Map 12

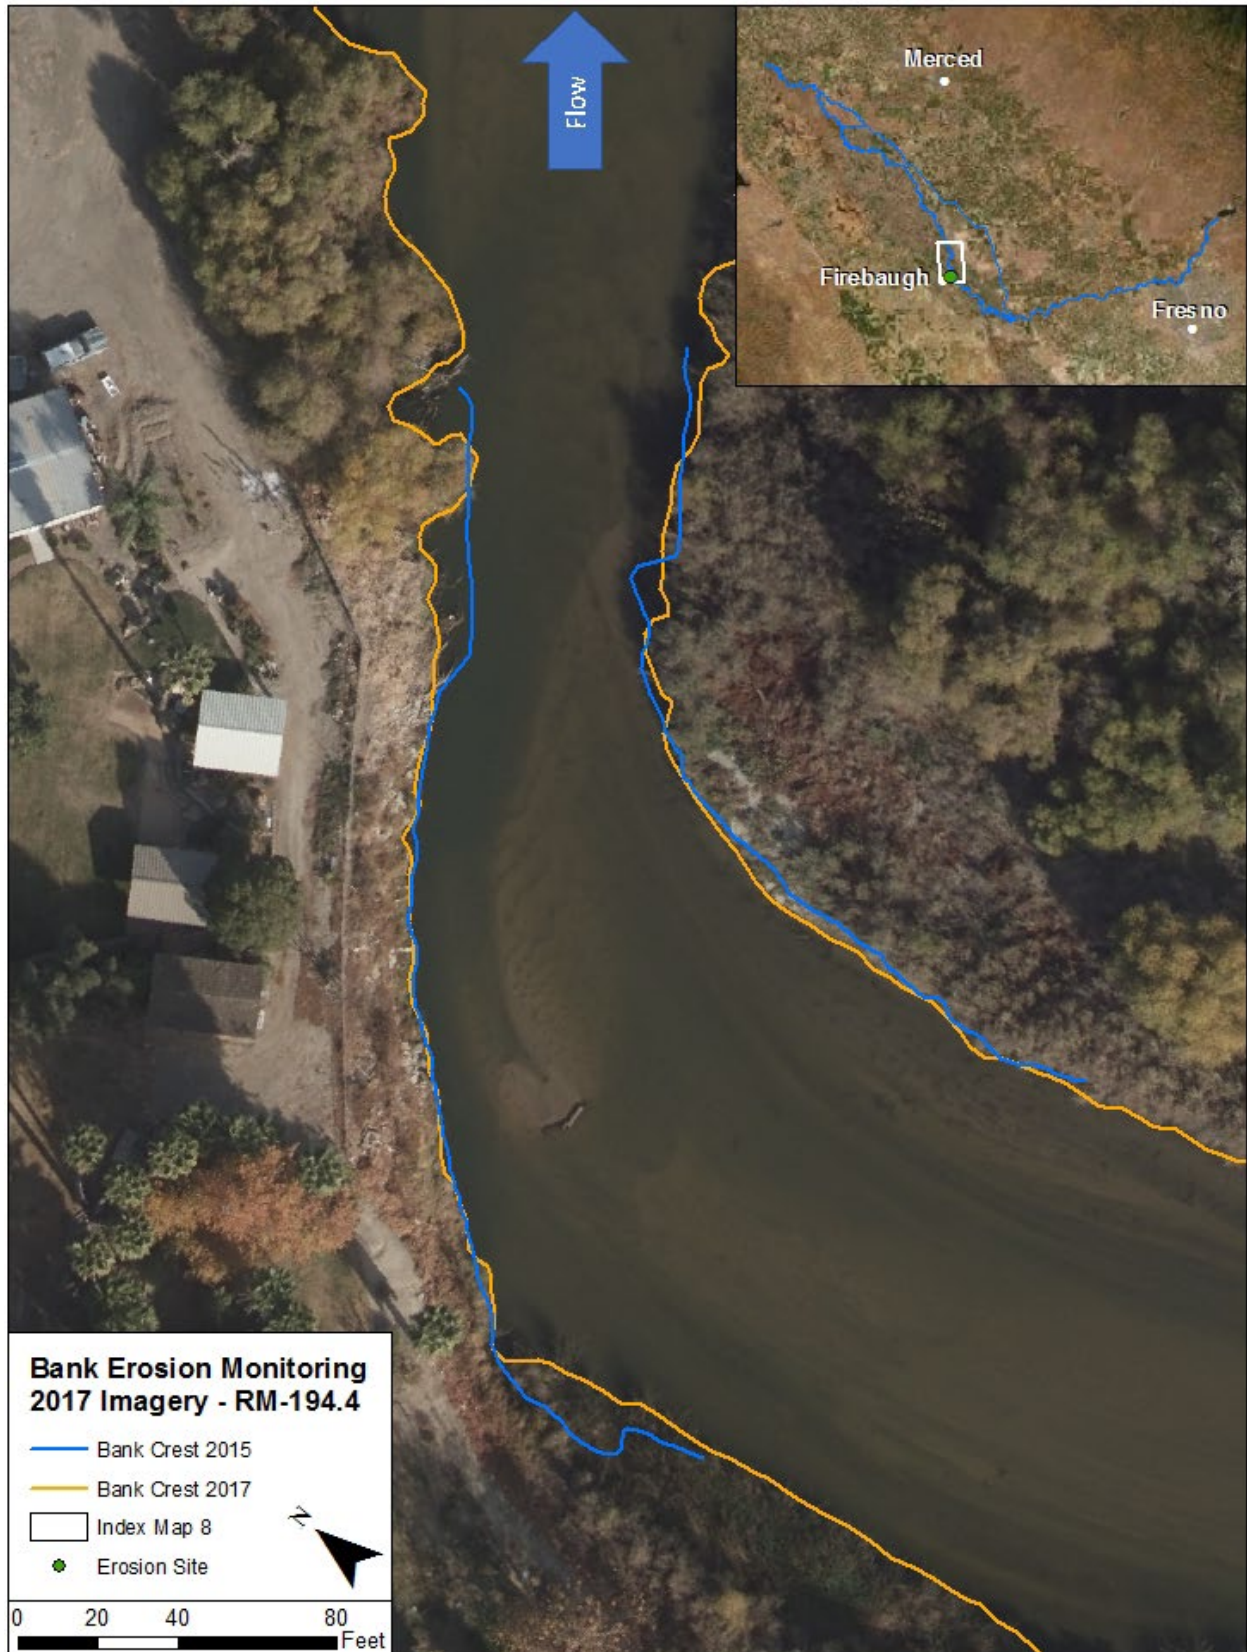
RM 194.40

This site is in Reach 3 within the city of Firebaugh and depicts light vegetation with riprap serving as bank protection. The nearest threatened structure is a residential neighborhood 24 feet away. There is evidence of 12 feet of lateral erosion along 40 feet of river-left bankline at the downstream end. Large woody vegetation loss at this site increases its vulnerability to erosion. Threat ratio 2.0; threat level high; see Figure 11 and Index Map 8.

Figure 11 San Joaquin River Reach 3, RM 194.4, Threat Ratio 2.0, Threat Level: High, Index Map 8

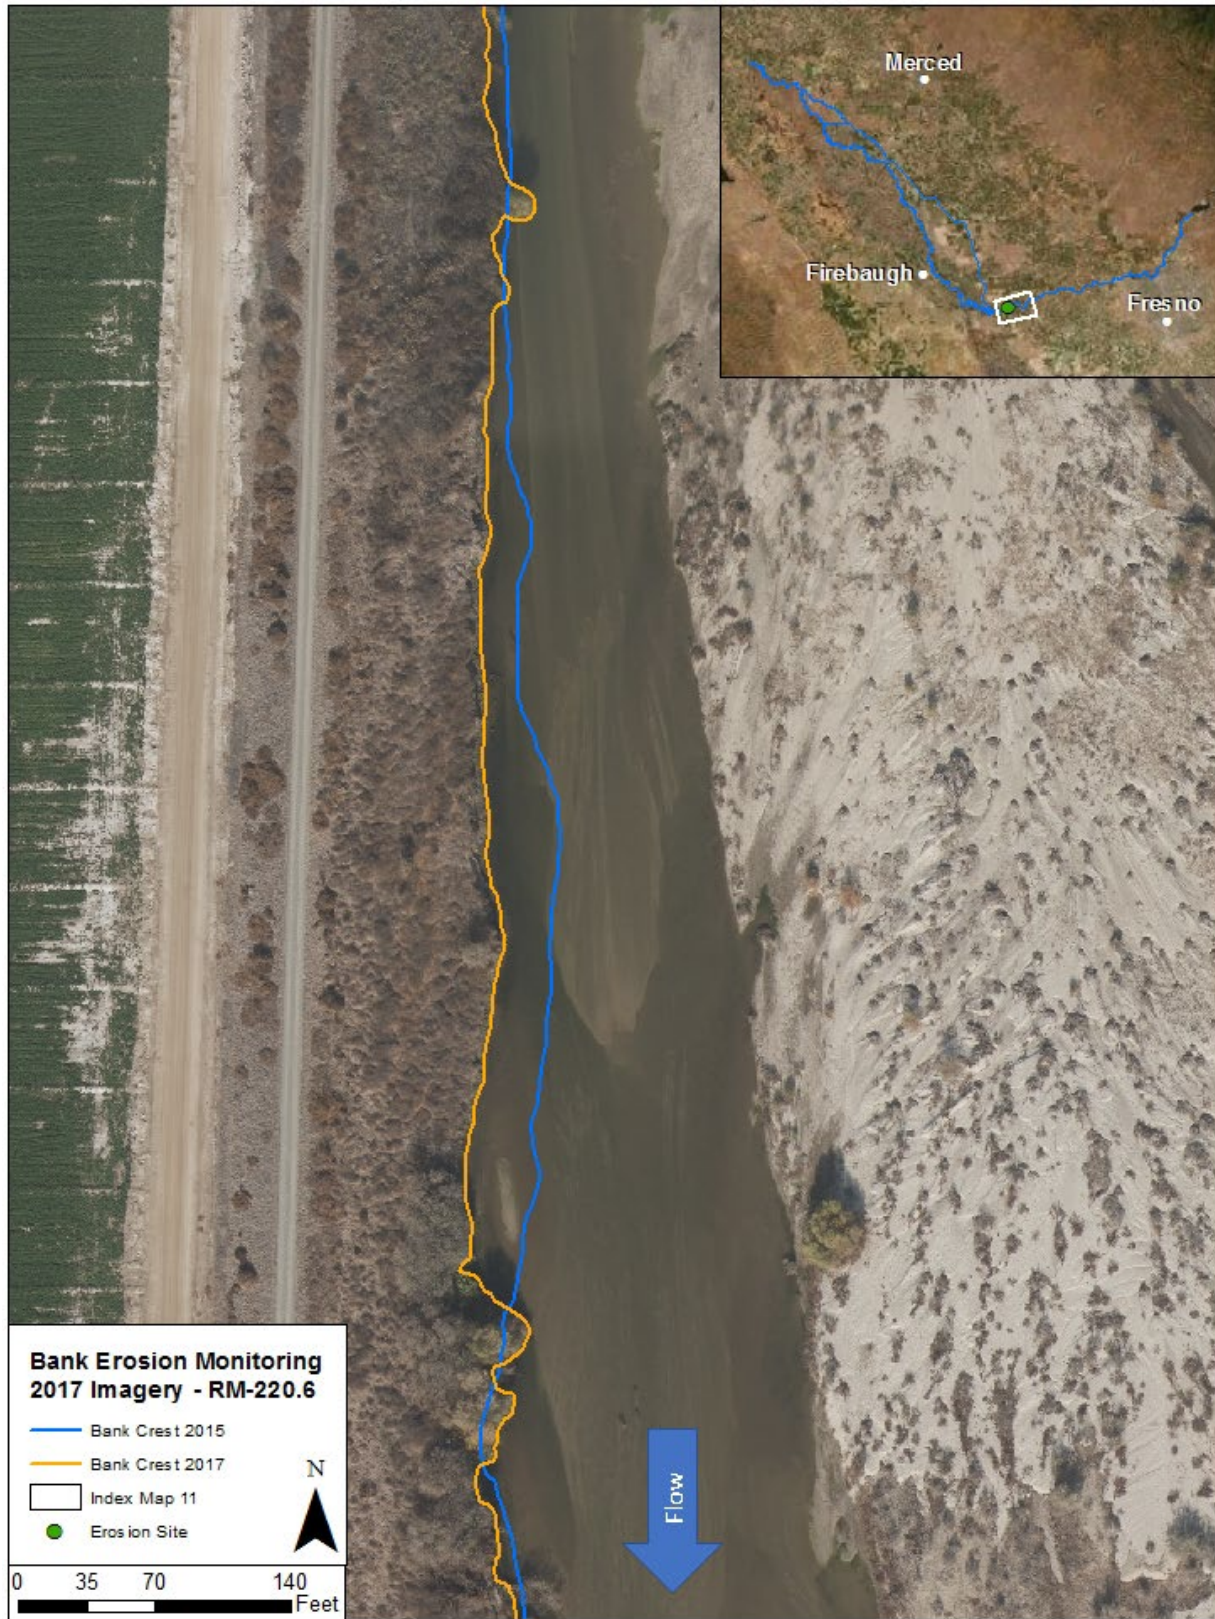
RM 220.60

This site is in Reach 2A and depicts sparse vegetation with no bank protection. The nearest threatened structure is a levee 75 feet away and row crops beyond. This is a shallow braided channel where the riverbed was dry in 2015. There is a maximum of 37 feet of lateral erosion along 900 feet of river-right bankline. As shown in Figure 12, the area is between the two high risk sites RM 220.5 and RM 220.7. Although this site endured similar flows and durations in 2011, the flood releases from 2017 appear to have caused most of the erosion. Threat ratio is 2.0; threat level is high; see Figure 12 and Index Map 11.

Figure 12 San Joaquin River Reach 2A, RM 220.6; Threat Ratio 2.0, Threat Level: High; Index Map 11
