Public Draft
Channel Capacity Report
2025 Restoration Year

Bank Erosion Monitoring Report (2024 Update)

San Joaquin River Restoration Program

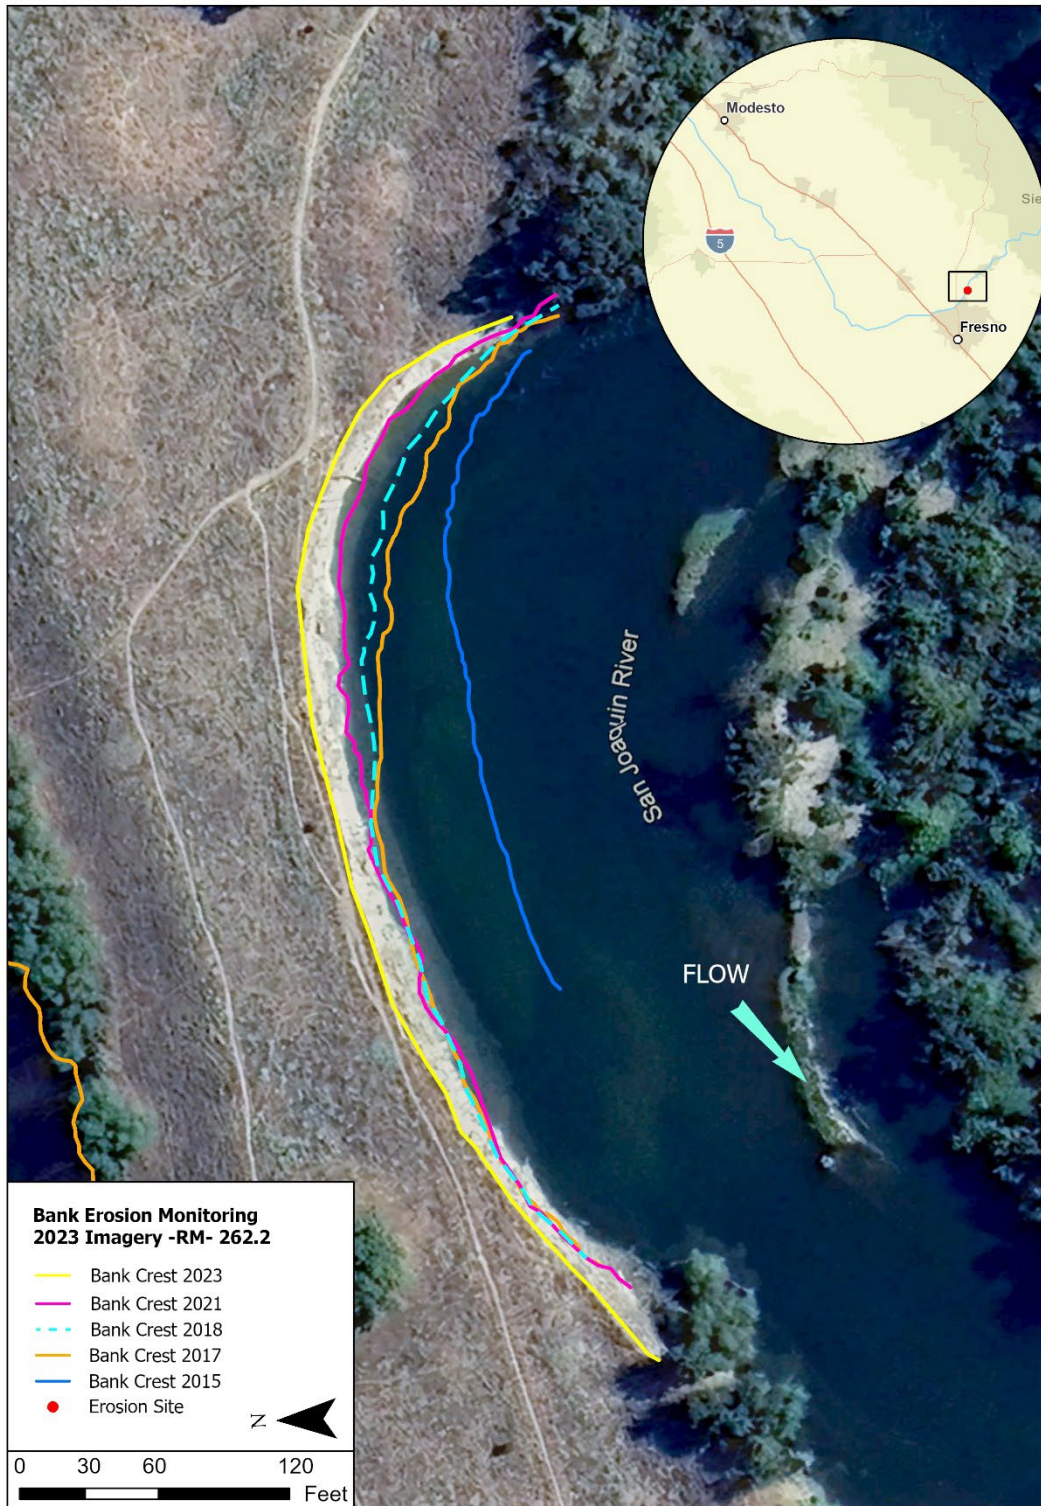
The site is located in Reach 1A at the southern end of Ledger Island and features an unprotected riverbank that was identified in a previous report as a high-threat area due to its proximity to a gravel mining pit separated by an eroding bank (Figure 3). From 2015 to 2017, a maximum lateral erosion of 55 feet was observed, reducing the minimum distance to the structure to 85 feet. Most of the erosion during this period occurred around the middle of the eroding bank and was likely due to flood management releases in 2017. In August 2018, using Google Earth imagery, the maximum lateral erosion between 2017 and 2018 was measured at 10 feet at a different location, and the minimum distance to the structure slightly

Most of the erosion continued towards the upstream end of the site and relatively less erosion downstream where it is closer to the gravel pit. The erosion trends observed at this site appear to be influenced by the different flow types over the years. Between 2017 and 2018, additional erosion was relatively less as a result of Restoration Flows and appeared to occur only at the upstream area of the site. This erosion trend continued through 2021 as Restoration Flows continued along with 74 days of flood control releases with peak flows up to 6,500 cfs in 2019. Based on these observations, most of the additional erosion up to 2023 that impacts the minimum distance to the structure is assumed to occur because of the 2023 flood management releases where substantial flood control flows were released for 173 days, with peak flows up to 10,000 cfs. Following this flood event, erosion was observed throughout the entire extent leading to an erosion pattern similar to what was observed after the 2017 flood. Monitoring at this site showed distinct differences in erosion trends based on flow type, where erosion from Restoration Flows is relatively less and focused only on the upstream half of the site compared to the magnitude and extent of erosion after a significant flood event.

Figure 3 San Joaquin River Reach 1, RM 262.2; Threat Ratio 1.15, Threat Level: High

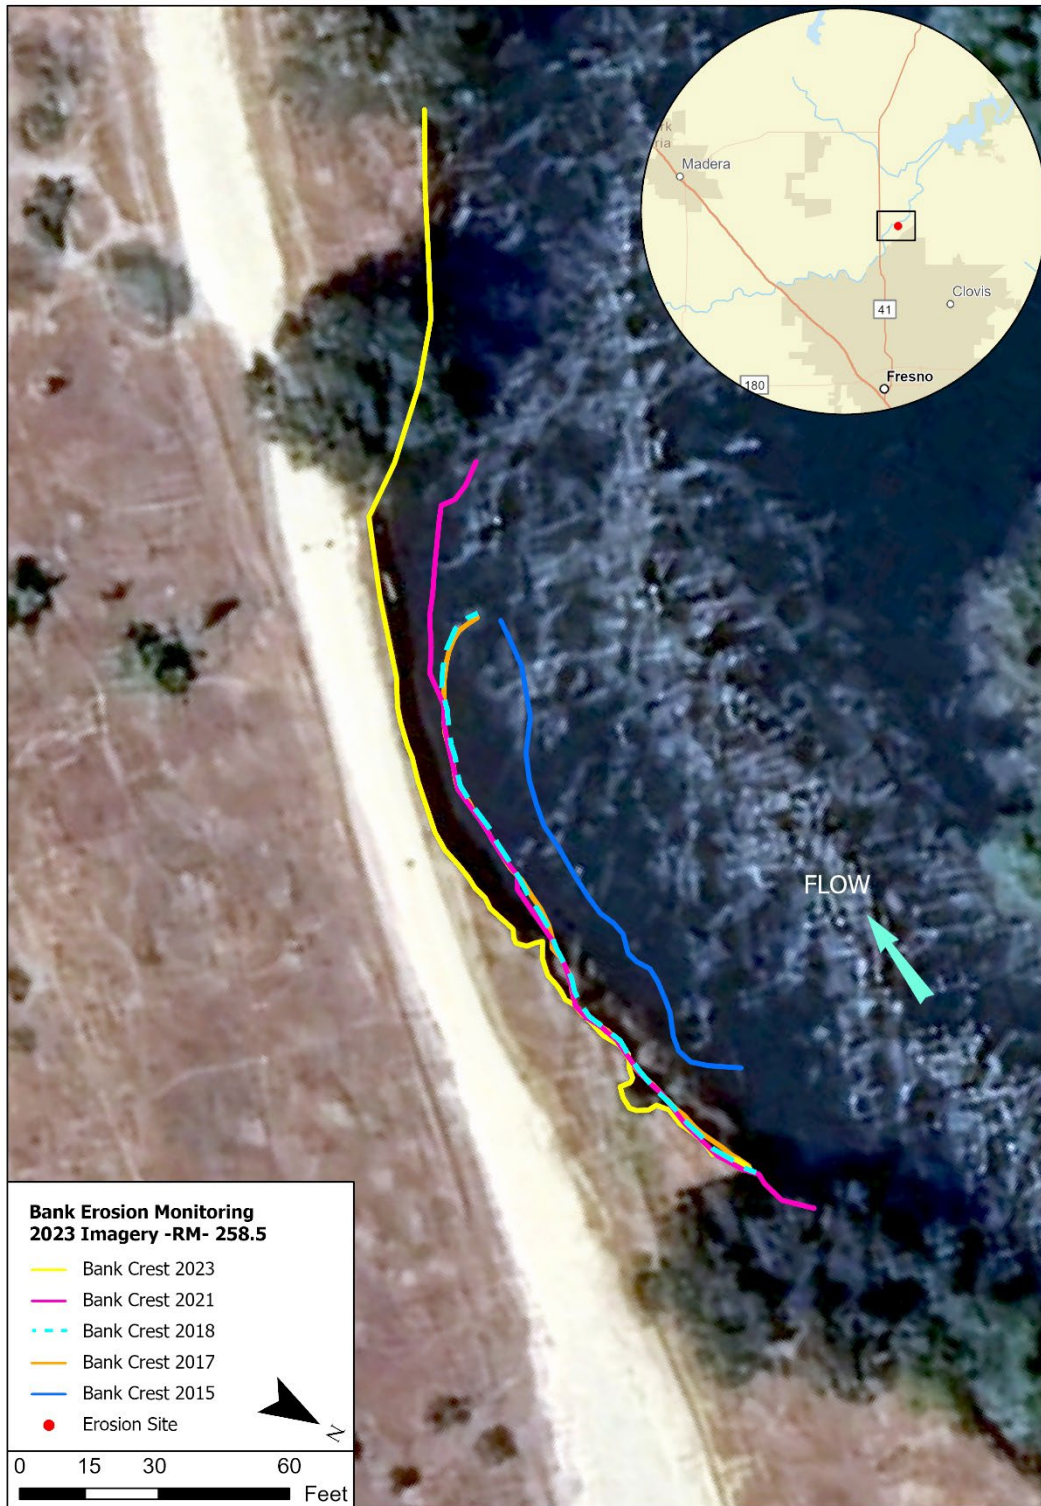
This site is located near Owl Hollow within Reach 1A and features an unprotected riverbank with an embankment dirt road as the nearest threatened structure, separating a gravel mining pit from the river (Figure 4). In 2017, the maximum lateral erosion was 10 feet and began to erode into the dirt road. In August 2018, significant erosion was not observed with continuous Restoration Flows, but by April 2021, erosion increased an additional 12 feet at the downstream end following Restoration Flows and 74 days of flood control releases in 2019. Additional erosion between this timeframe was likely caused by flood management releases based on trends observed at this site during Restoration Flows between 2017 and 2018. Additional erosion of up to 15 feet was observed after the 2023 flood. Erosion trends at this site appear to be largely influenced by flood management releases where most of the changes were observed; minor erosion was observed during Restoration Flows.

Figure 4 San Joaquin River Reach 1, RM 258.5; Threat Ratio 0.0, Threat Level: High

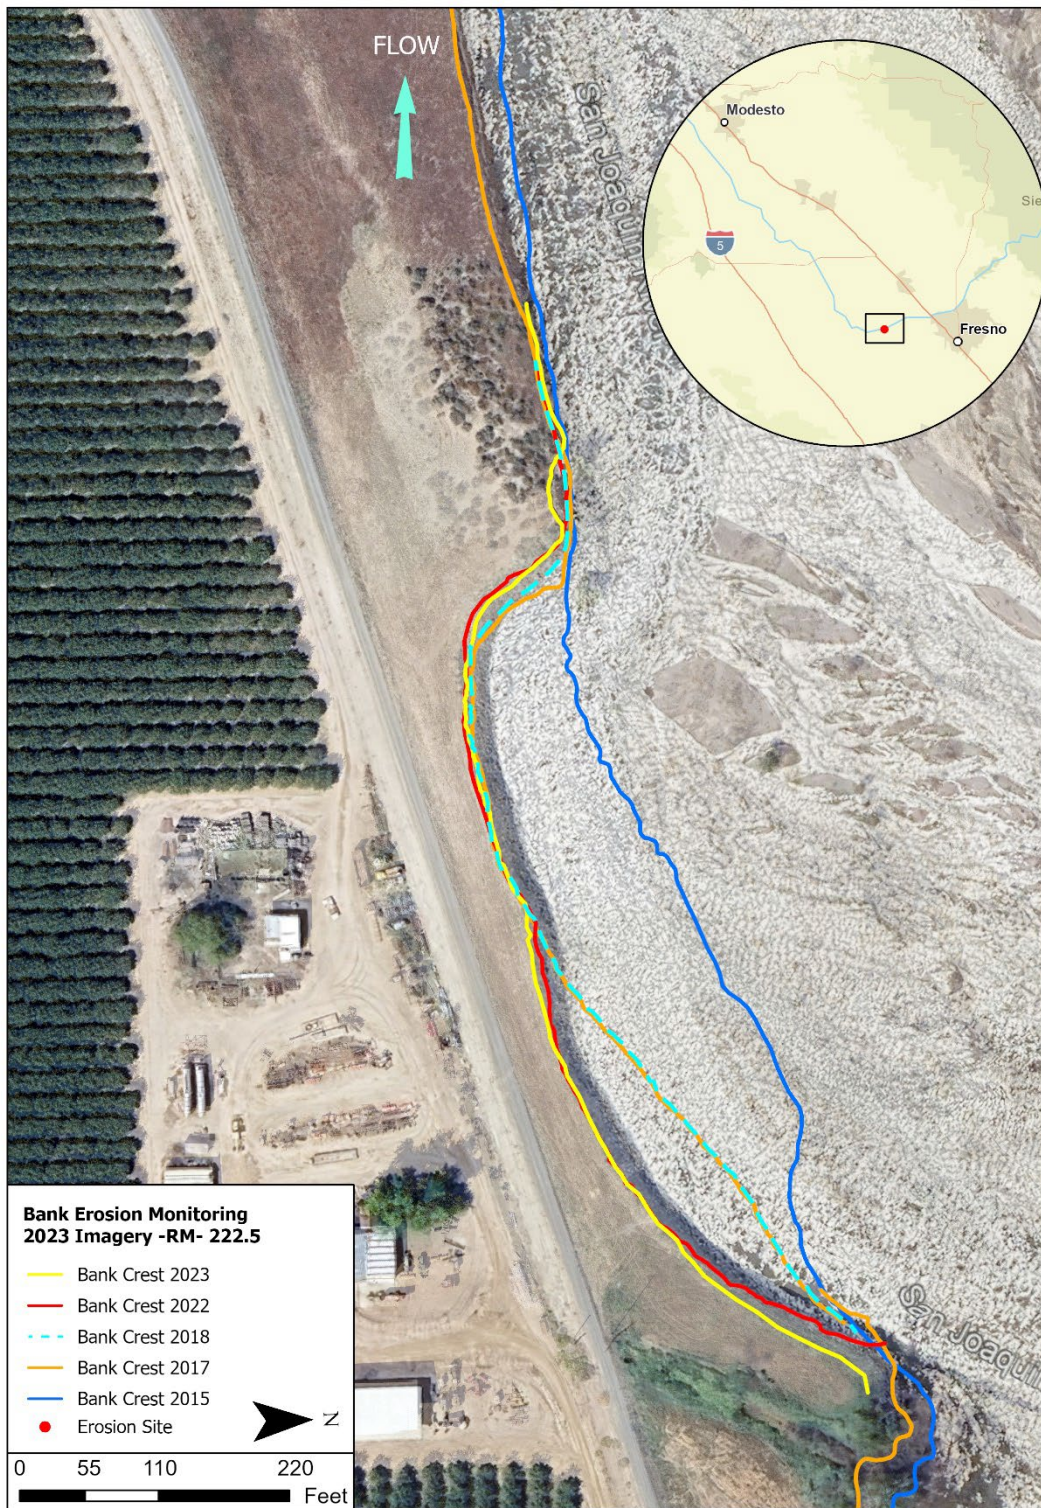
This site is located within Reach 2A and is a threat to a levee with farm buildings and an orchard beyond it (Figure 5). Between 2015 and 2017, the maximum lateral erosion was 140 feet, with the minimum distance to the levee at 45 feet, primarily around the middle section. In August 2018, no significant erosion was observed. In September 2022, an additional 72 feet of erosion was observed, particularly at the upstream area and the minimum distance to the structure reduced to 40 feet. By October 2023, an additional 10 feet of erosion was observed; however, the minimum distance to the levee did not change because erosion occurred at the upstream end further away from the levee. This site was protected by the LSJLD during the 2023 flood where rock slope protection was placed along the eroding bank. The erosion trends at this site appear to be influenced by varying flow types; Restoration Flows between 2017 and 2018 caused minimal erosion, while flood management releases from 2019 and 2023 had a considerable impact on erosion patterns.

Figure 5 San Joaquin River Reach 2A, RM 222.5; Threat Ratio 0.29, Threat Level: High

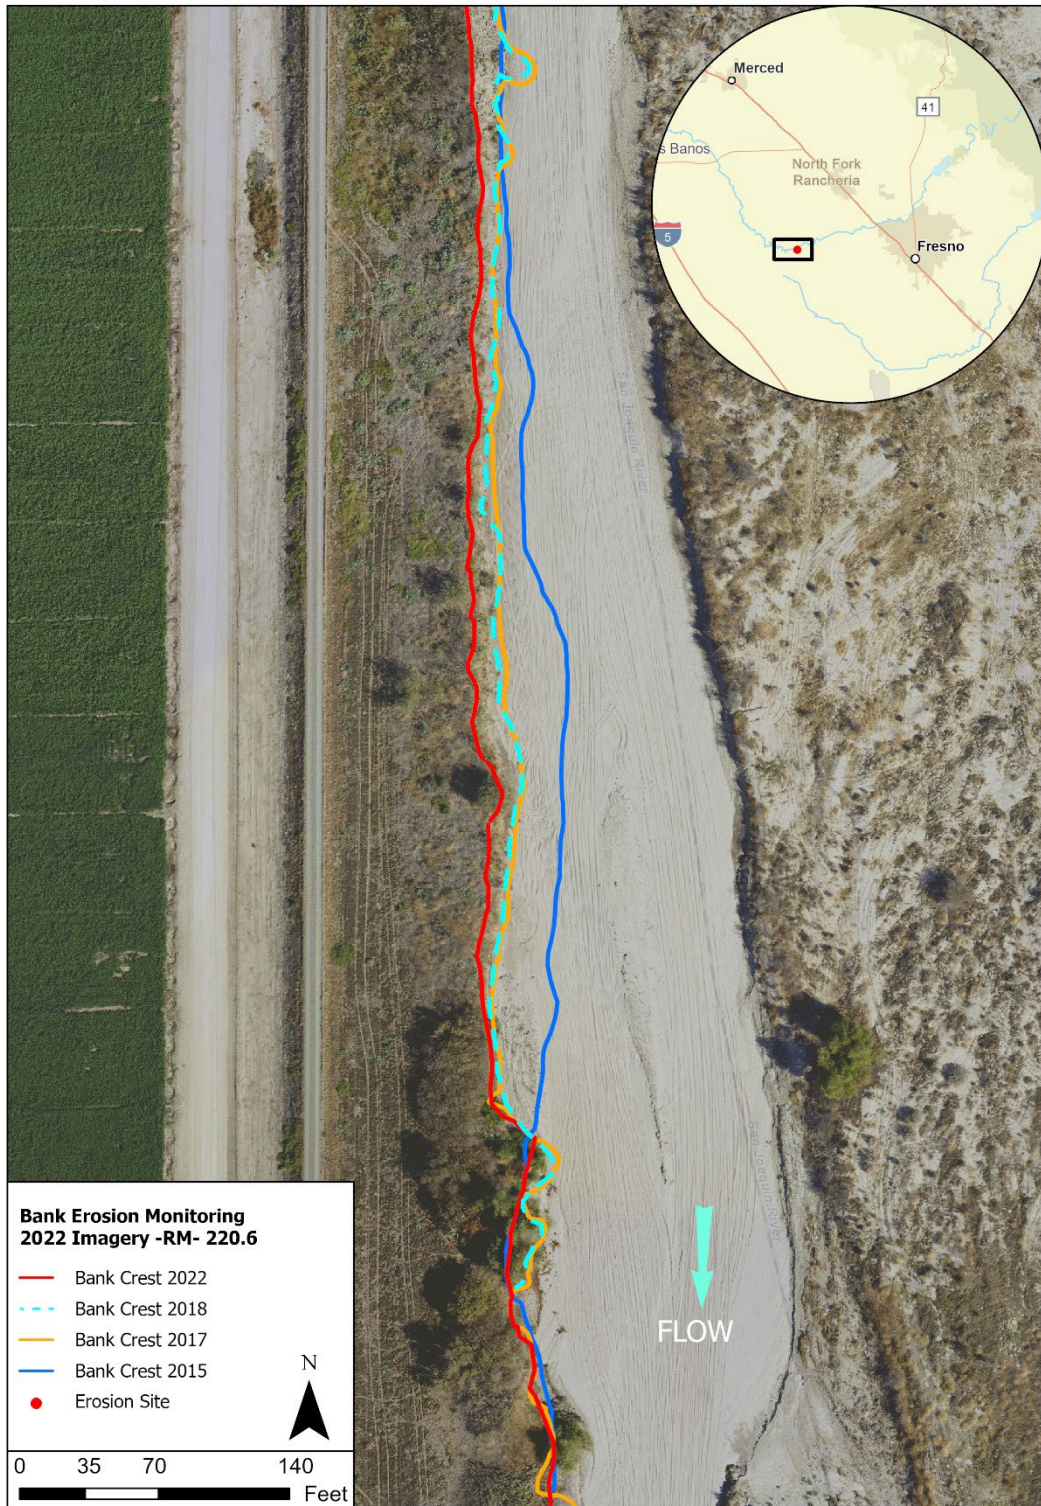
This site is located within Reach 2A, with the nearest threatened structure being a levee and row crops beyond it (Figure 6). Between 2015 and 2017, the maximum lateral erosion was recorded at 37 feet with the most significant erosion observed around the middle of the site; and the minimum distance to the levee was equal to 75 feet. In August 2018, Google Earth imagery showed additional erosion up to 8 feet, but the minimum distance to the structure remained unchanged at 75 feet. Erosion occurred only at a few locations, but a majority of the site remained unchanged during this period. By September 2022, additional erosion up to 19 feet was observed throughout the site, reducing the minimum distance to the levee to 60 feet. During this period, uniform erosion along the entire bankline was observed. The 2019 flood control releases are believed to have contributed to new erosion observed up to 2022. Erosion after the 2023 flood was not delineated because the bankline was not clear in the imagery. In general, this site shows a uniform erosion trend along the bankline after major flood releases and relatively less erosion during periods of Restoration Flows.

Figure 6 San Joaquin River Reach 2A, RM 220.6; Threat Ratio 0.67, Threat Level: High

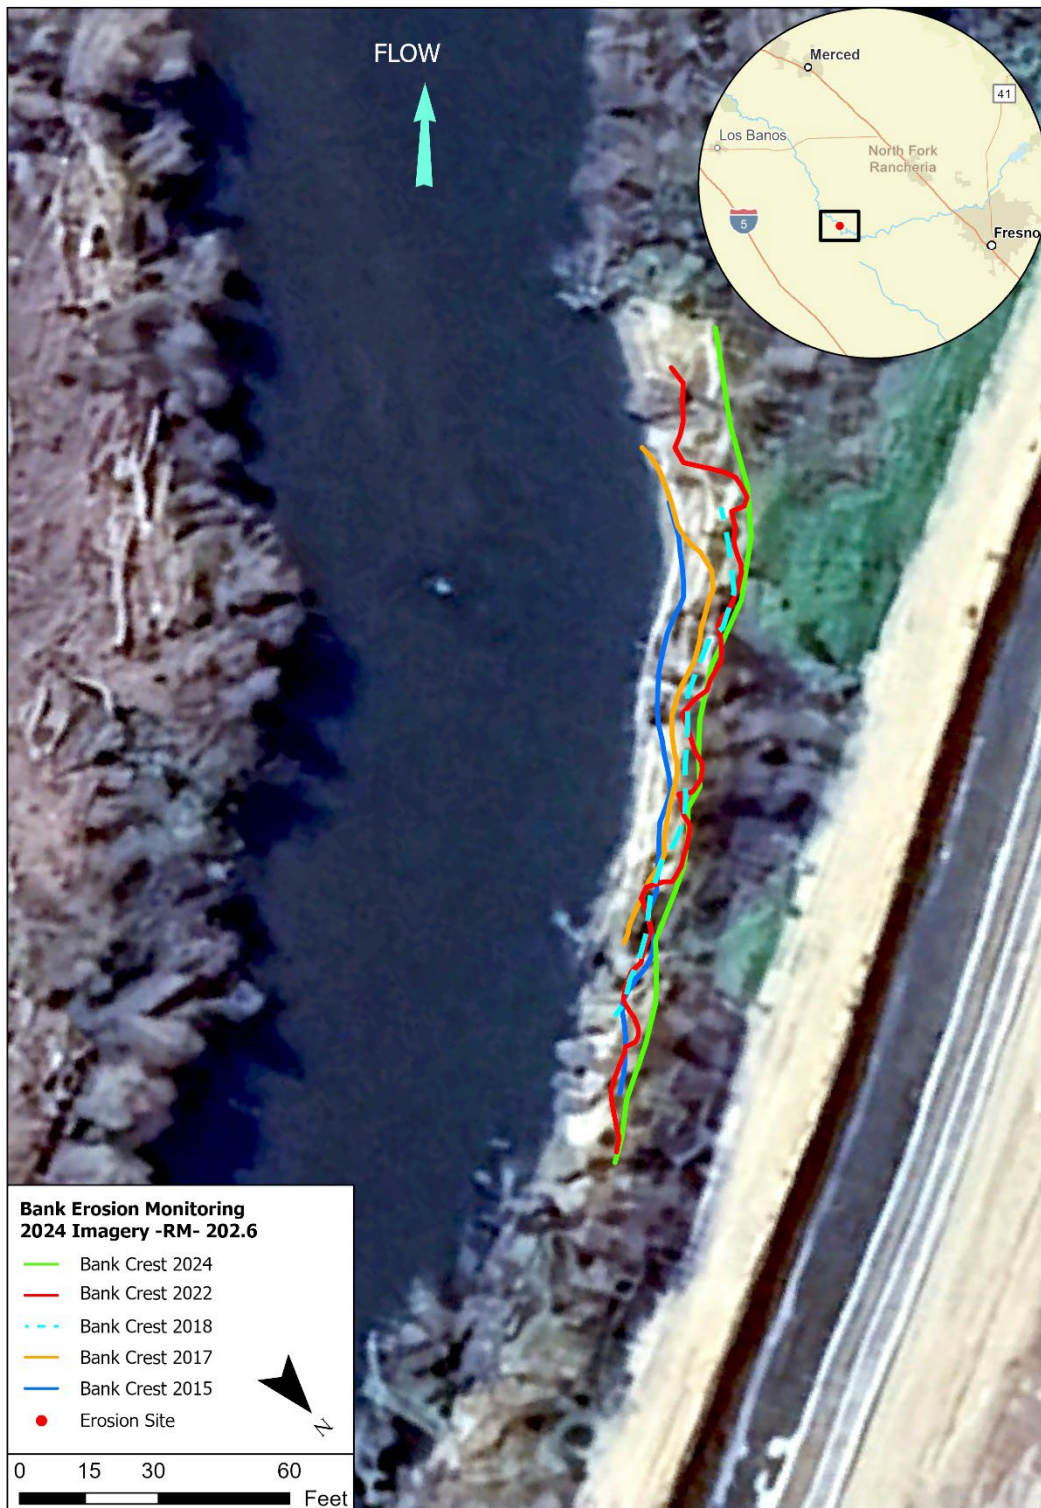
This site is located within Reach 3 and features a sparsely vegetated riverbank without any bank protection (Figure 7). The nearest threatened structure is a service road along a canal. From 2015 to 2017, the site experienced a maximum lateral erosion of 20 feet, reducing the minimum distance to the structure to 33 feet. Most of the erosion occurred at the downstream end. In August 2018, additional erosion up to 5 feet was observed, but occurred away from the minimum distance to the service road, leaving that distance unchanged. By 2022, an additional 4 feet of erosion was observed again at the downstream end and not impacting the minimum distance to the road. Following the 2023 flood, an additional 10 feet of erosion was observed at the downstream end. These changes can be attributed to varied flow types where erosion appears to be expanding downstream more after a flood event compared to Restoration Flows.

Figure 7 San Joaquin River Reach 3, RM 202.6; Threat Ratio 1.1, Threat Level: High

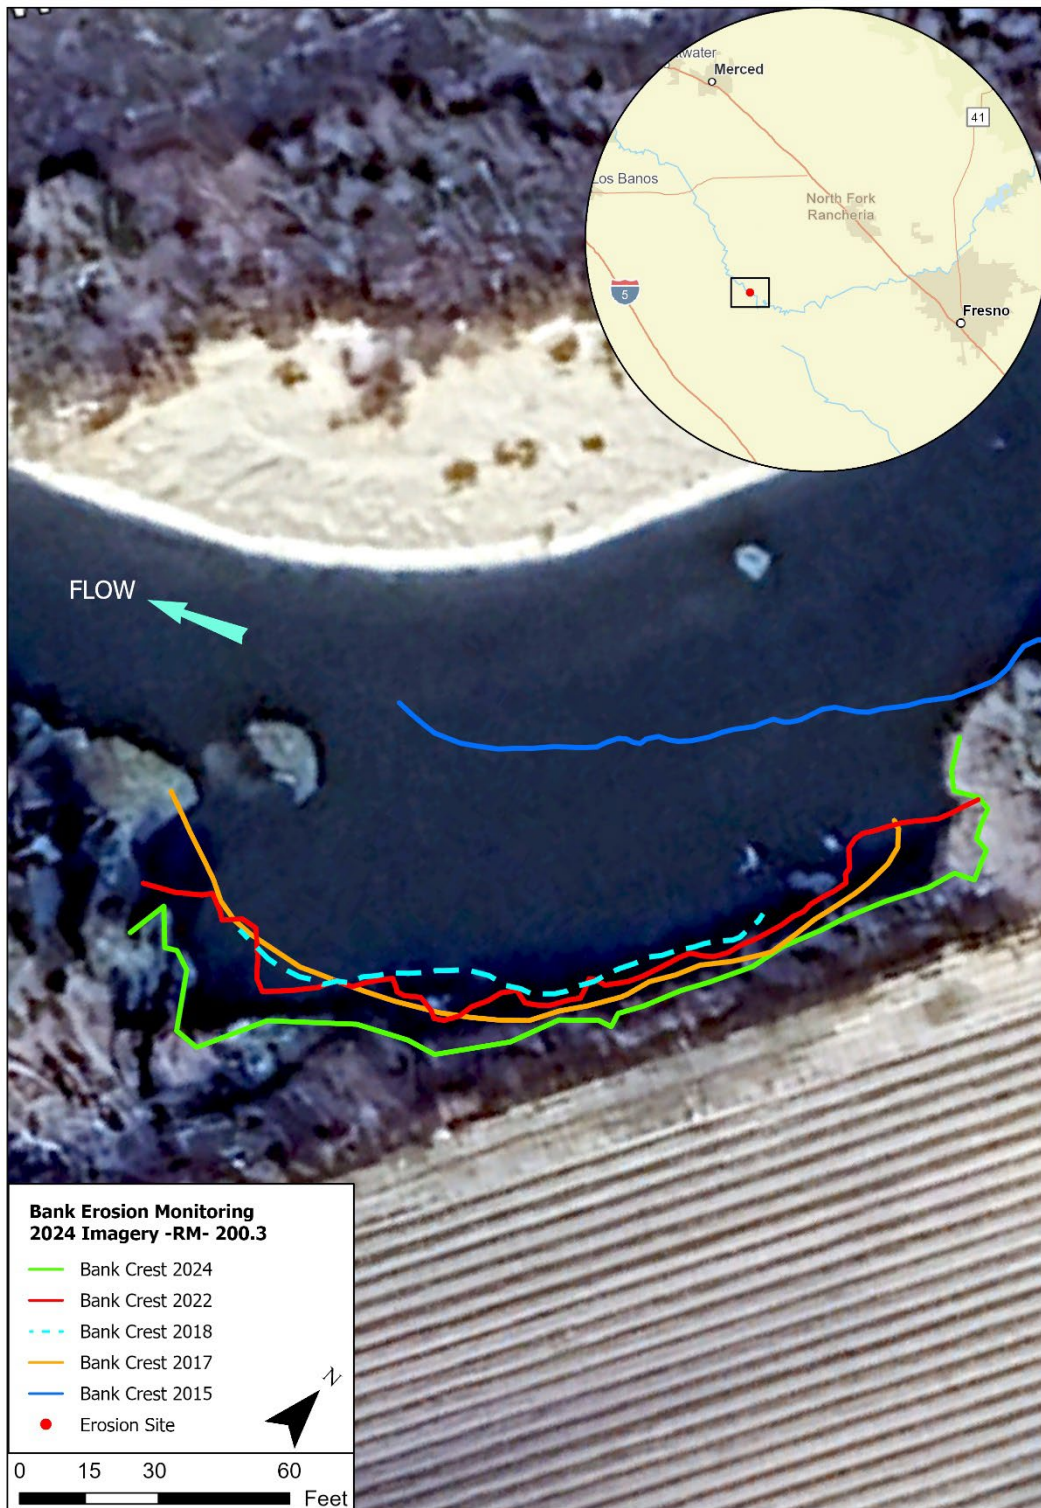
This site is in Reach 3 and depicts vegetation loss and no bank protection (Figure 8). As identified in the previous report, the nearest structure threatened is a service road and row crops just south of the site. The 2017 bankline delineation for this site is uncertain in some areas because of overhanging vegetation and shadows caused by them. Due to this reason the 2017 delineation crosses over the delineations for 2018 and 2022 banklines.

From 2015 to 2017, the site experienced a maximum lateral erosion of 55 feet, with a minimum distance to the structure at 3 feet. By August 2018, additional erosion was observed up to 2 feet at the downstream end, not impacting the minimum distance to the structure. By 2022, additional erosion up to 8 feet continued at the downstream end. The latest imagery from February 2024 shows additional erosion up to 21 feet throughout the site following the 2023 flood. Erosion observed between 2022 and 2024 is likely caused by the 2023 flood. For this site, the effect of Restoration Flows between 2017 and 2018 is not clear due to uncertainties of the 2017 bankline delineation, but considerable erosion was observed between 2018 and 2024 along the upstream and downstream ends, which is likely due to flood management releases.

Figure 8 San Joaquin River Reach 3, RM 200.3; Threat Ratio 0.0, Threat Level: High

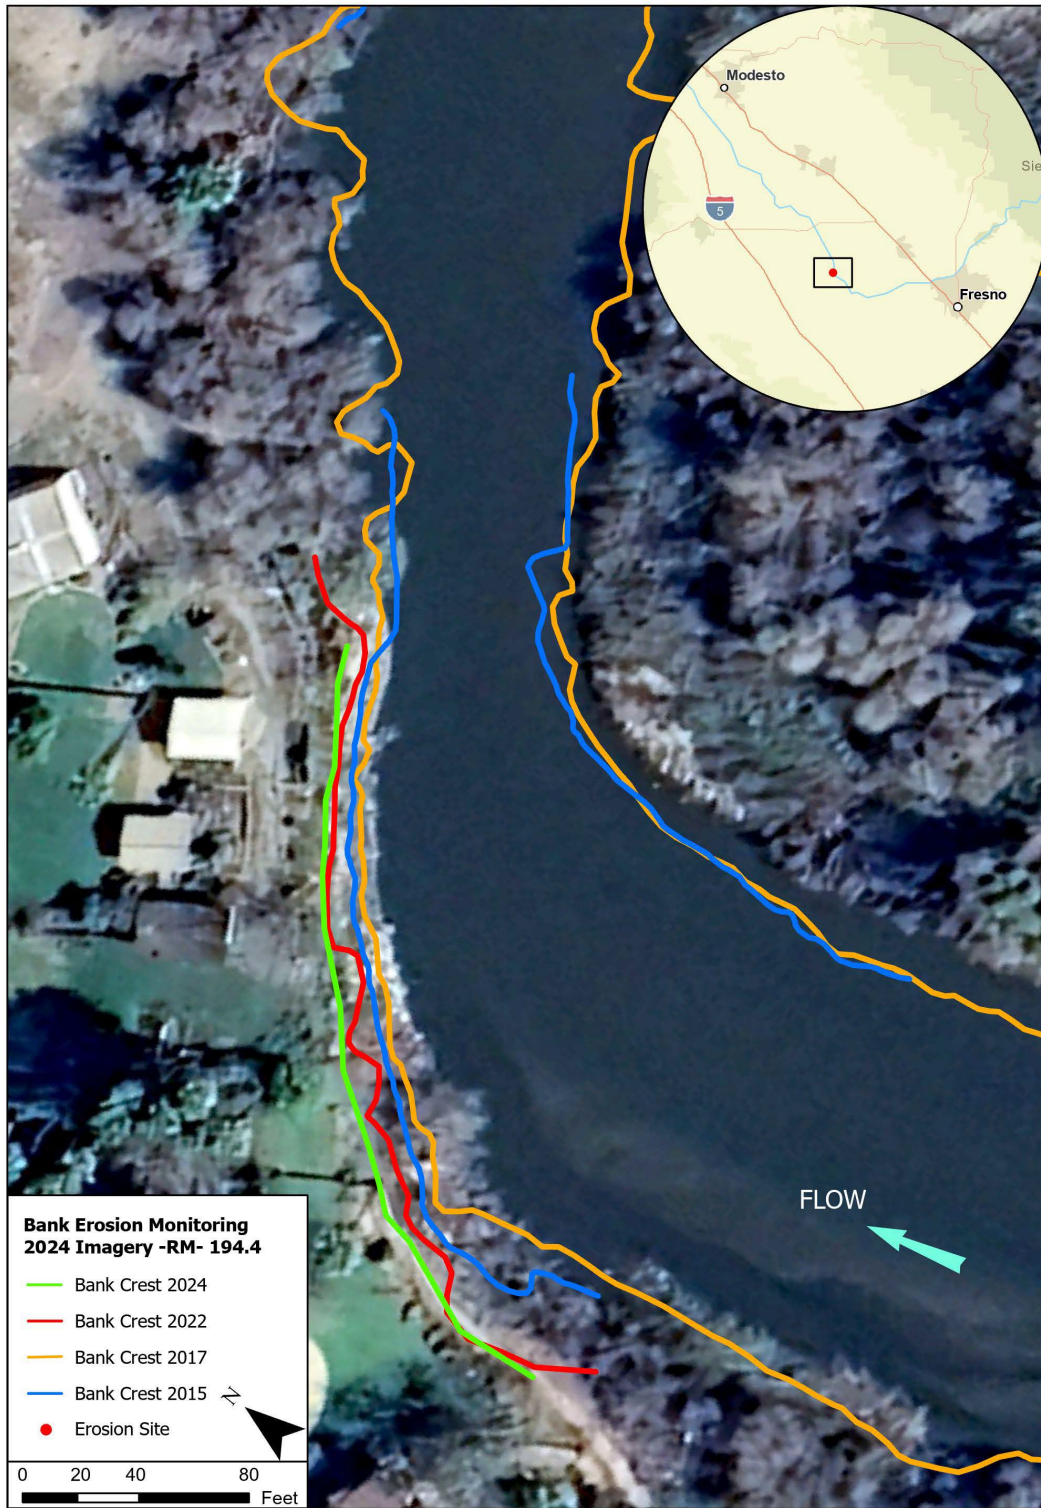
Figure 9 San Joaquin River Reach 3, RM 194.4, Threat Ratio 1.38, Threat Level: High

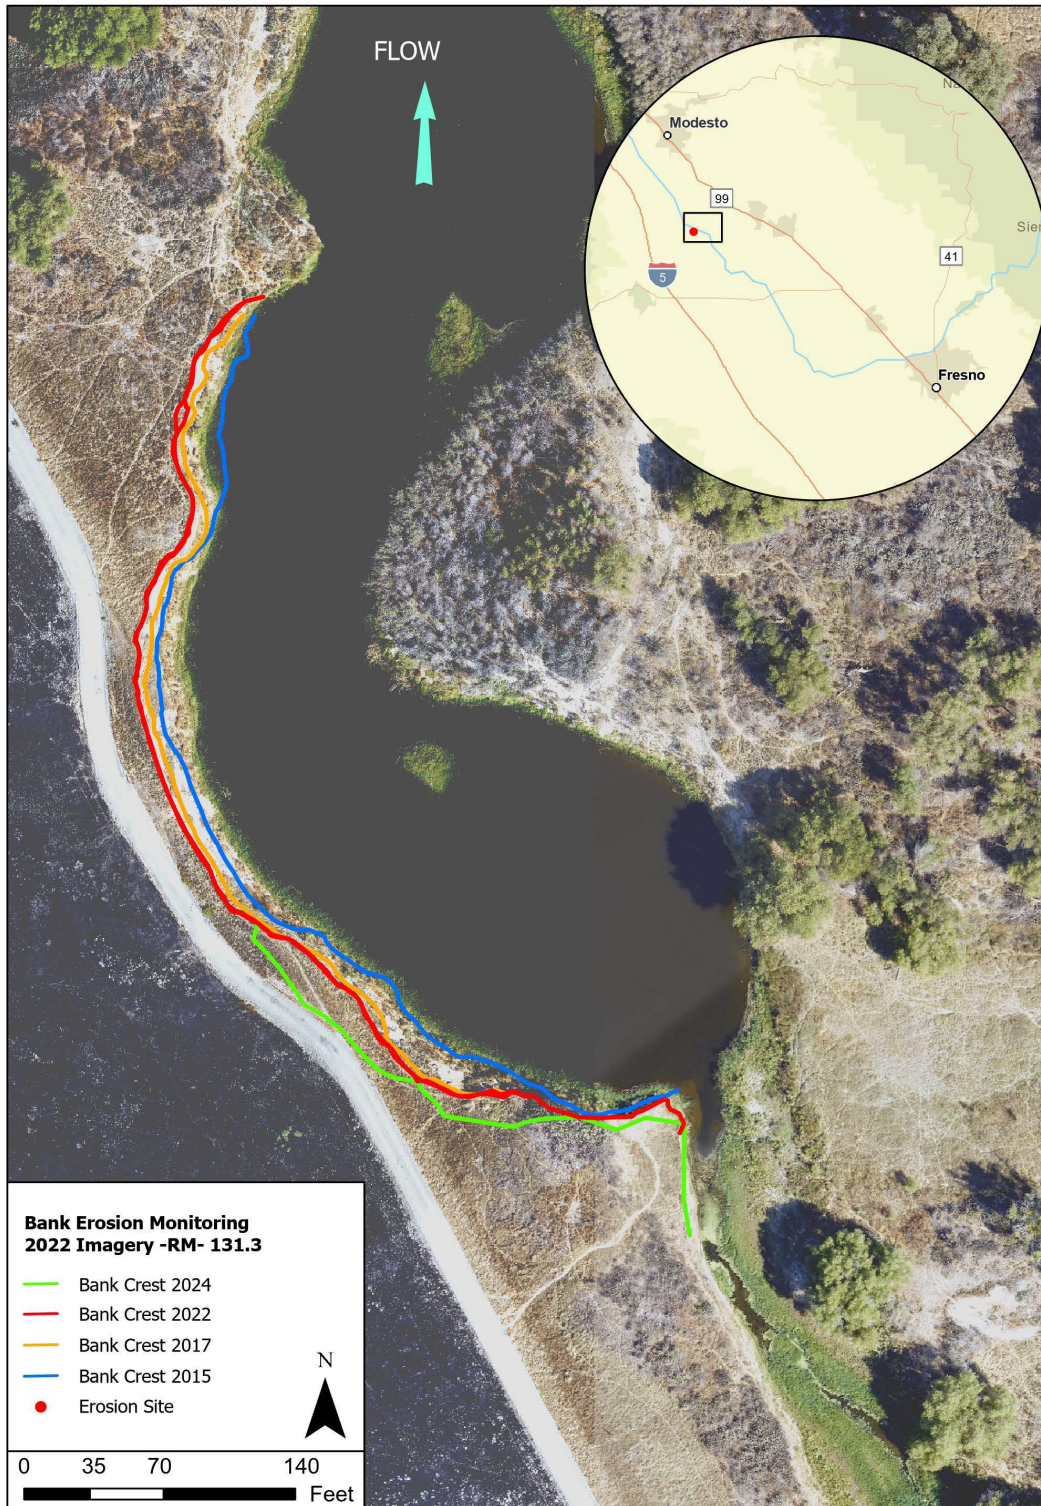
This site is located in Reach 5 and features a 430-foot-long barren bank that is actively eroding and encroaching within the side slope of a levee. Between 2015 and 2017, the site experienced up to 11 feet of erosion, which continued to increase an additional 9 feet by 2022; and by February 2024, the upstream area eroded an additional 18 feet. Google Earth imagery for 2024 does not cover the full extent of this site and further evaluation will be needed to identify the extent of erosion downstream. Most of the additional erosion observed in 2022 and 2024 are likely caused by flood management releases in 2019 and 2023. After communicating with the LSJLD, this site may no longer be classified as a high-threat site because the area is within the Great Valley Grasslands State Park where they have begun breaching the levee to flood native ground and restore floodplain habitat.

Figure 10 San Joaquin River Reach 5, RM 131.3; Threat Ratio 0.0, Threat Level: High
