Technical Memorandum

Channel Capacity Report 2025 Restoration Year

Bank Erosion Monitoring Report (2024 Update)

San Joaquin River Restoration Program

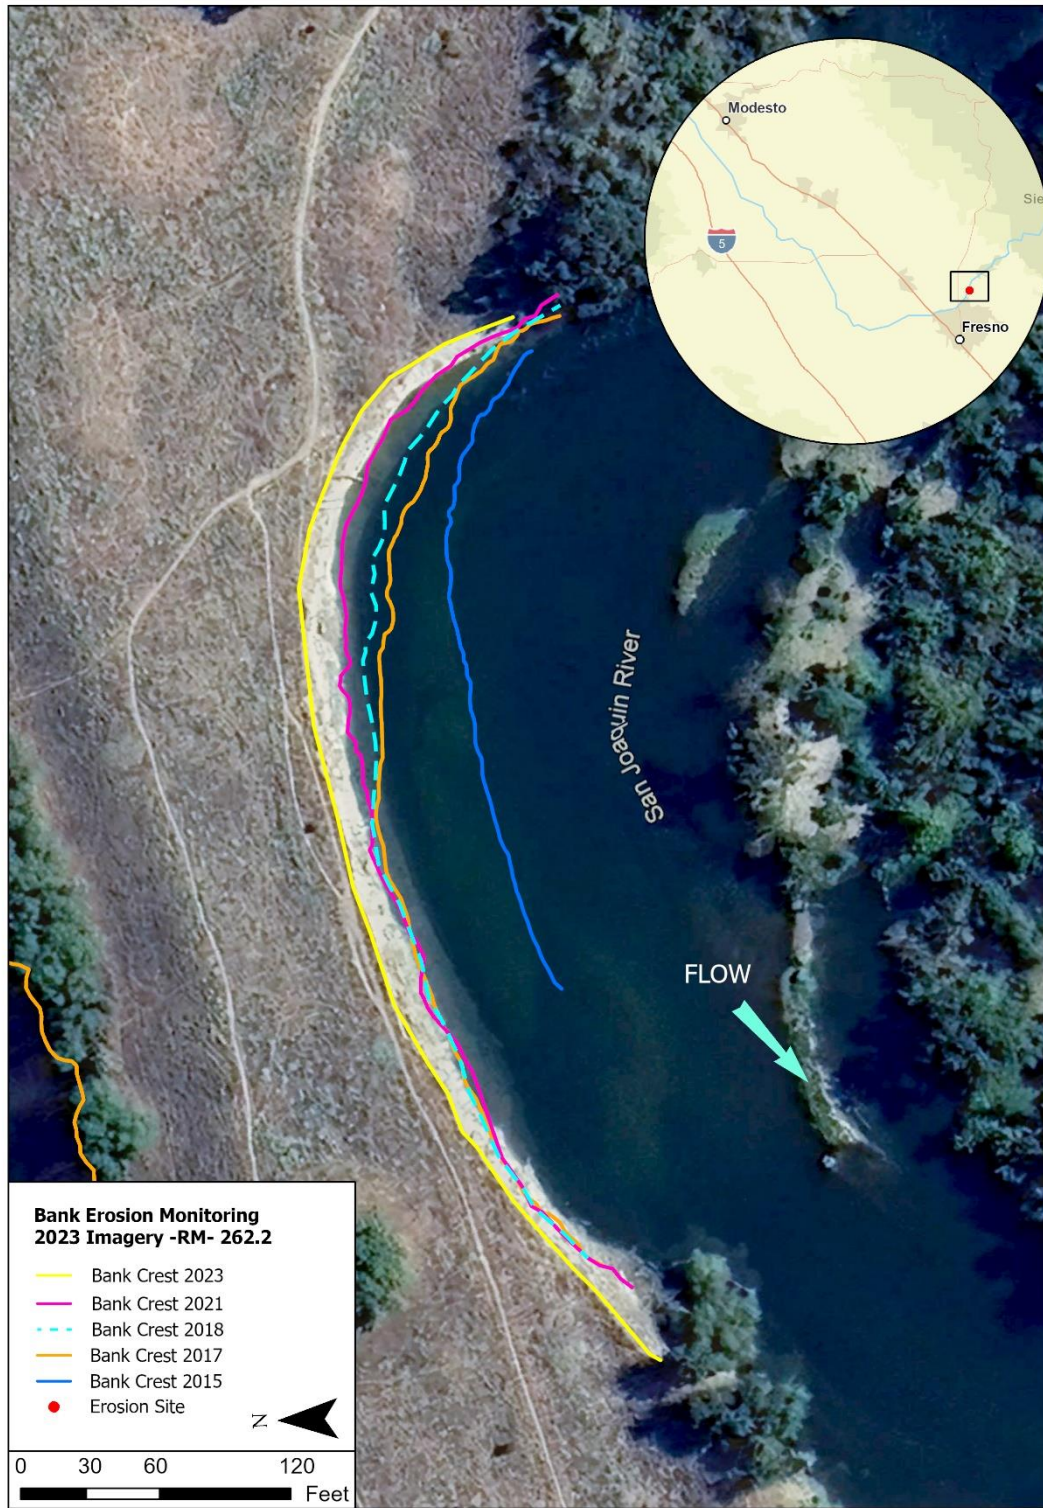
The site is located in Reach 1A at the southern end of Ledger Island and features an unprotected riverbank that was identified in a previous report as a high-threat area due to its proximity to a gravel mining pit separated by an eroding bank (Figure 3). From 2015 to 2017, a maximum lateral erosion of 55 feet was observed, reducing the minimum distance to the structure to 85 feet. Most of the erosion during this period occurred around the middle of the eroding bank and was likely due to flood management releases in 2017. In August 2018, using Google Earth imagery, the maximum lateral erosion between 2017 and 2018 was measured at 10 feet at a different location, and the minimum distance to the structure slightly

Most of the erosion continued towards the upstream end of the site and relatively less erosion downstream where it is closer to the gravel pit. The erosion trends observed at this site appear to be influenced by the different flow types over the years. Between 2017 and 2018, additional erosion was relatively less as a result of Restoration Flows and appeared to occur only at the upstream area of the site. This erosion trend continued through 2021 as Restoration Flows continued along with 74 days of flood control releases with peak flows up to 6,500 cfs in 2019. Based on these observations, most of the additional erosion up to 2023 that impacts the minimum distance to the structure is assumed to occur because of the 2023 flood management releases where substantial flood control flows were released for 173 days, with peak flows up to 10,000 cfs. Following this flood event, erosion was observed throughout the entire extent leading to an erosion pattern similar to what was observed after the 2017 flood. Monitoring at this site showed distinct differences in erosion trends based on flow type, where erosion from Restoration Flows is relatively less and focused only on the upstream half of the site compared to the magnitude and extent of erosion after a significant flood event.

Figure 3 San Joaquin River Reach 1, RM 262.2; Threat Ratio 1.15, Threat Level: High

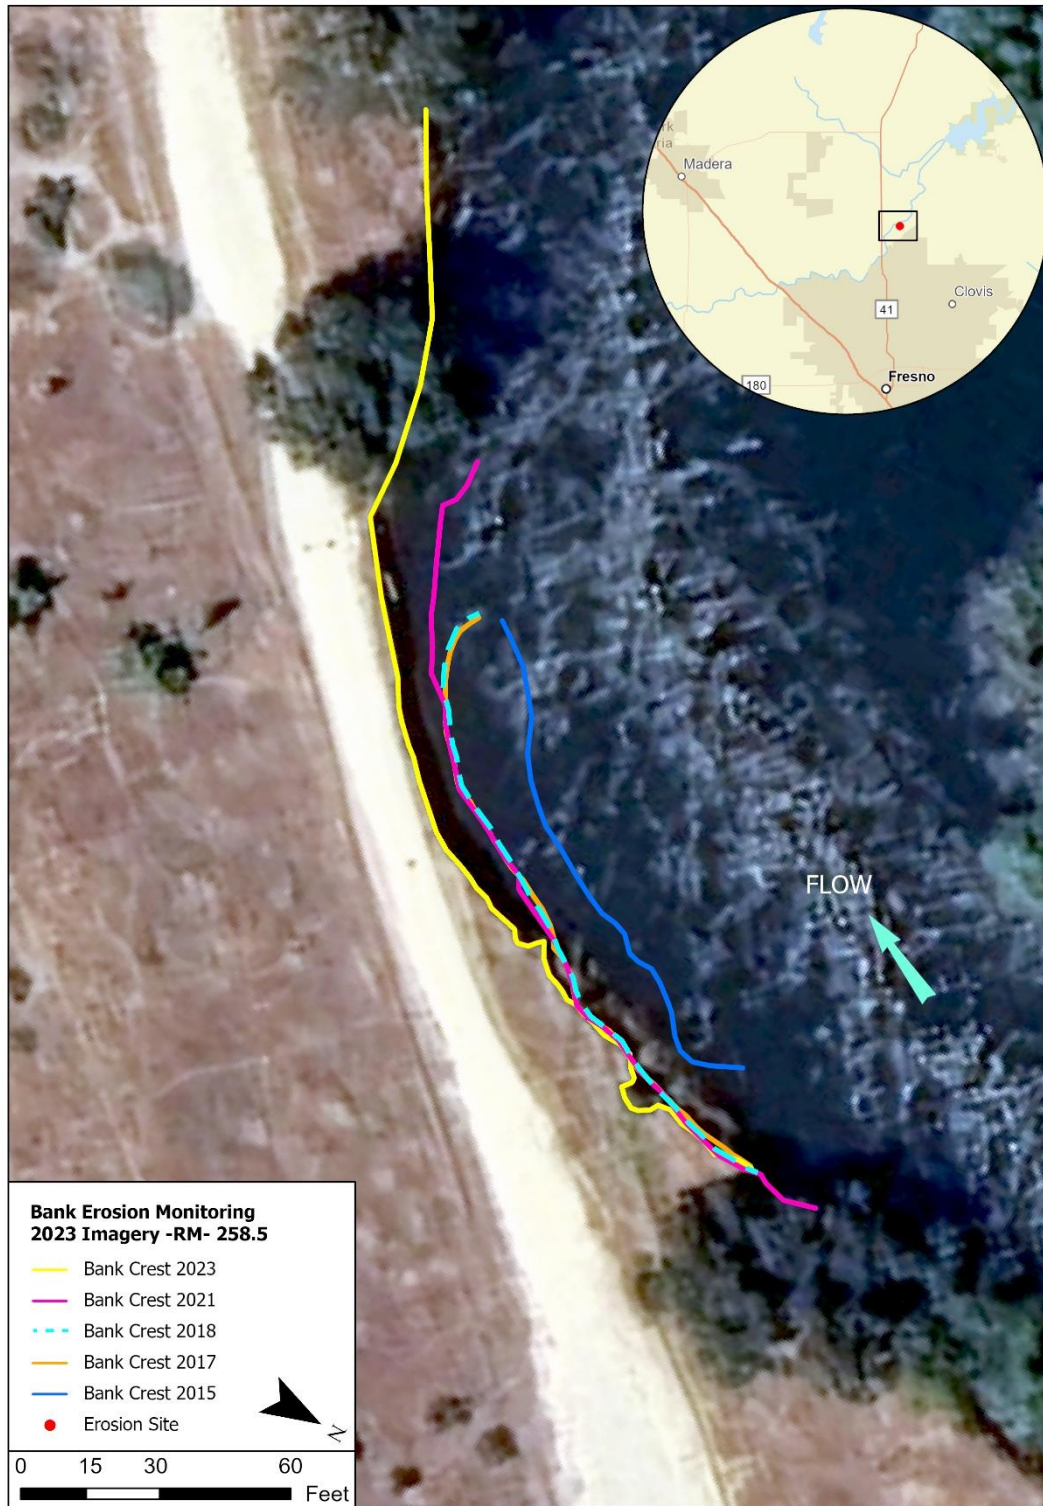
This site is located near Owl Hollow within Reach 1A and features an unprotected riverbank with an embankment dirt road as the nearest threatened structure, separating a gravel mining pit from the river (Figure 4). In 2017, the maximum lateral erosion was 10 feet and began to erode into the dirt road. In August 2018, significant erosion was not observed with continuous Restoration Flows, but by April 2021, erosion increased an additional 12 feet at the downstream end following Restoration Flows and 74 days of flood control releases in 2019. Additional erosion between this timeframe was likely caused by flood management releases based on trends observed at this site during Restoration Flows between 2017 and 2018. Additional erosion of up to 15 feet was observed after the 2023 flood. Erosion trends at this site appear to be largely influenced by flood management releases where most of the changes were observed; minor erosion was observed during Restoration Flows.

Figure 4 San Joaquin River Reach 1, RM 258.5; Threat Ratio 0.0, Threat Level: High

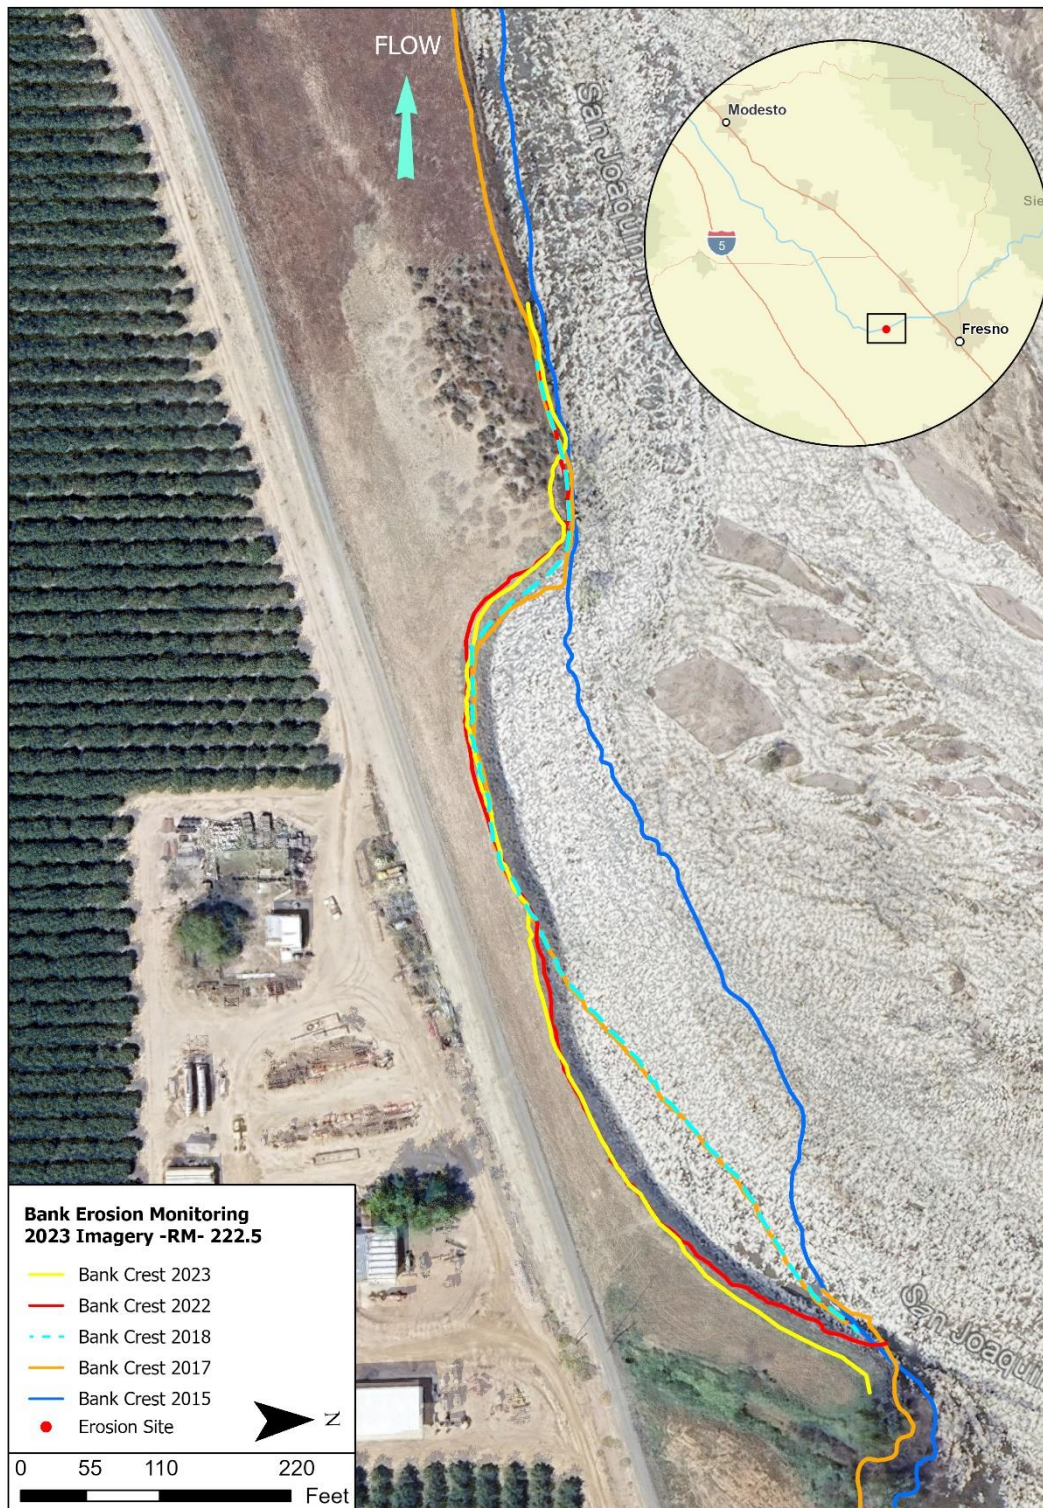
This site is located within Reach 2A and is a threat to a levee with farm buildings and an orchard beyond it (Figure 5). Between 2015 and 2017, the maximum lateral erosion was 140 feet, with the minimum distance to the levee at 45 feet, primarily around the middle section. In August 2018, no significant erosion was observed. In September 2022, an additional 72 feet of erosion was observed, particularly at the upstream area and the minimum distance to the structure reduced to 40 feet. By October 2023, an additional 10 feet of erosion was observed; however, the minimum distance to the levee did not change because erosion occurred at the upstream end further away from the levee. This site was protected by the LSJLD during the 2023 flood where rock slope protection was placed along the eroding bank. The erosion trends at this site appear to be influenced by varying flow types; Restoration Flows between 2017 and 2018 caused minimal erosion, while flood management releases from 2019 and 2023 had a considerable impact on erosion patterns.

Figure 5 San Joaquin River Reach 2A, RM 222.5; Threat Ratio 0.29, Threat Level: High

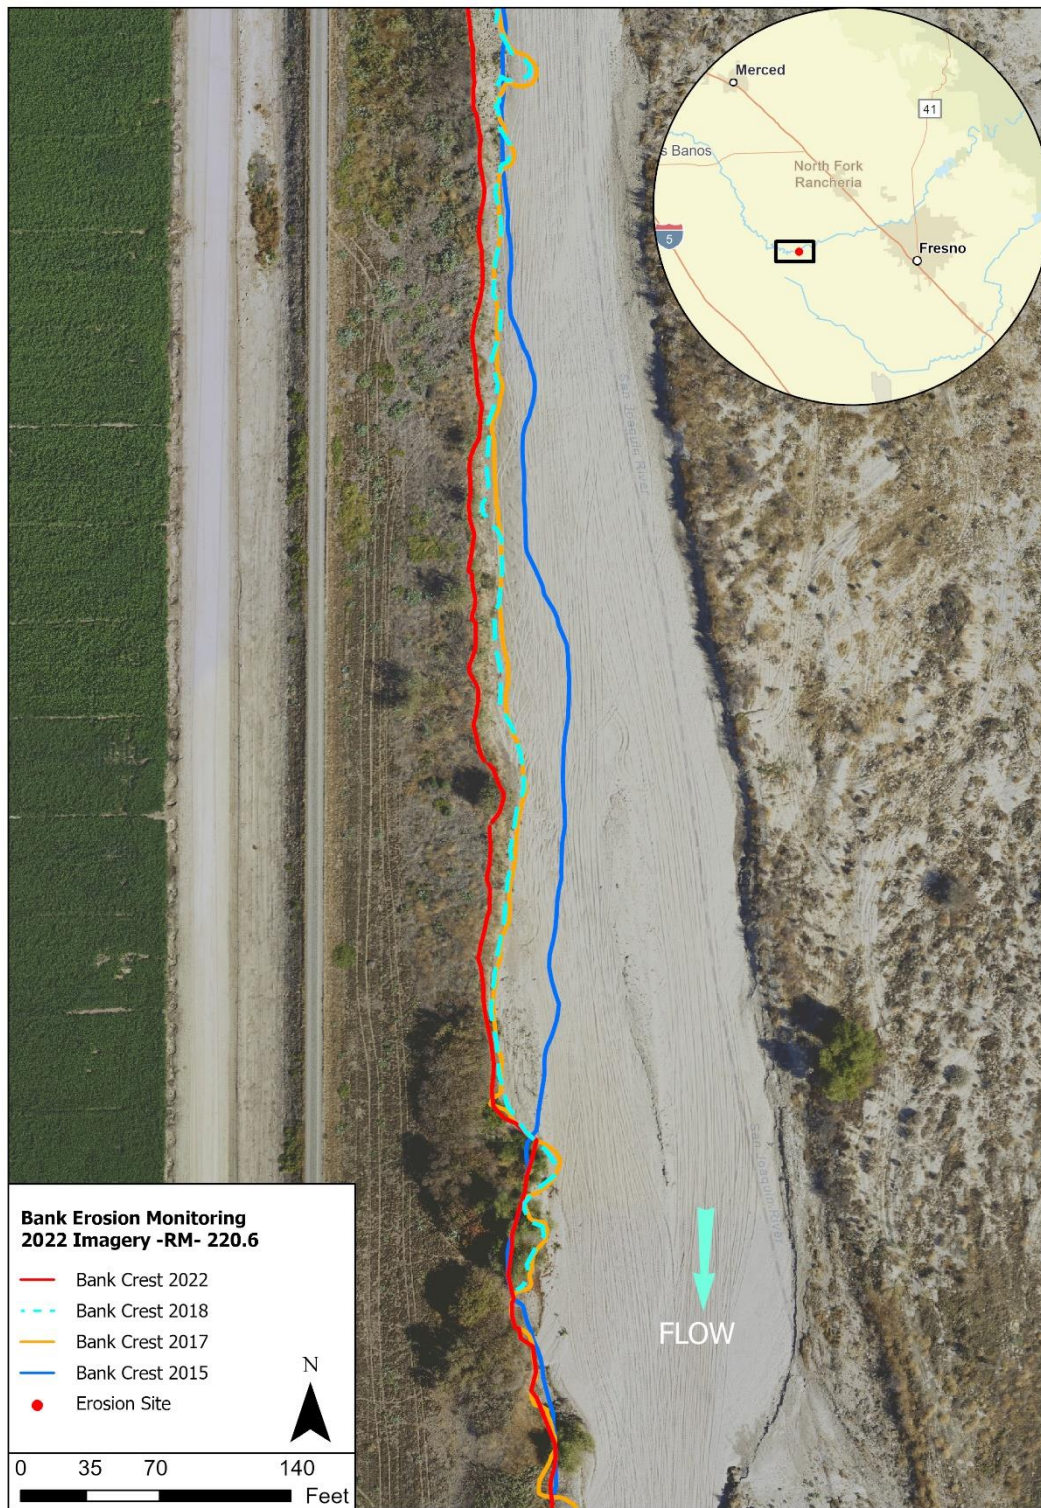
This site is located within Reach 2A, with the nearest threatened structure being a levee and row crops beyond it (Figure 6). Between 2015 and 2017, the maximum lateral erosion was recorded at 37 feet with the most significant erosion observed around the middle of the site; and the minimum distance to the levee was equal to 75 feet. In August 2018, Google Earth imagery showed additional erosion up to 8 feet, but the minimum distance to the structure remained unchanged at 75 feet. Erosion occurred only at a few locations, but a majority of the site remained unchanged during this period. By September 2022, additional erosion up to 19 feet was observed throughout the site, reducing the minimum distance to the levee to 60 feet. During this period, uniform erosion along the entire bankline was observed. The 2019 flood control releases are believed to have contributed to new erosion observed up to 2022. Erosion after the 2023 flood was not delineated because the bankline was not clear in the imagery. In general, this site shows a uniform erosion trend along the bankline after major flood releases and relatively less erosion during periods of Restoration Flows.

Figure 6 San Joaquin River Reach 2A, RM 220.6; Threat Ratio 0.67, Threat Level: High

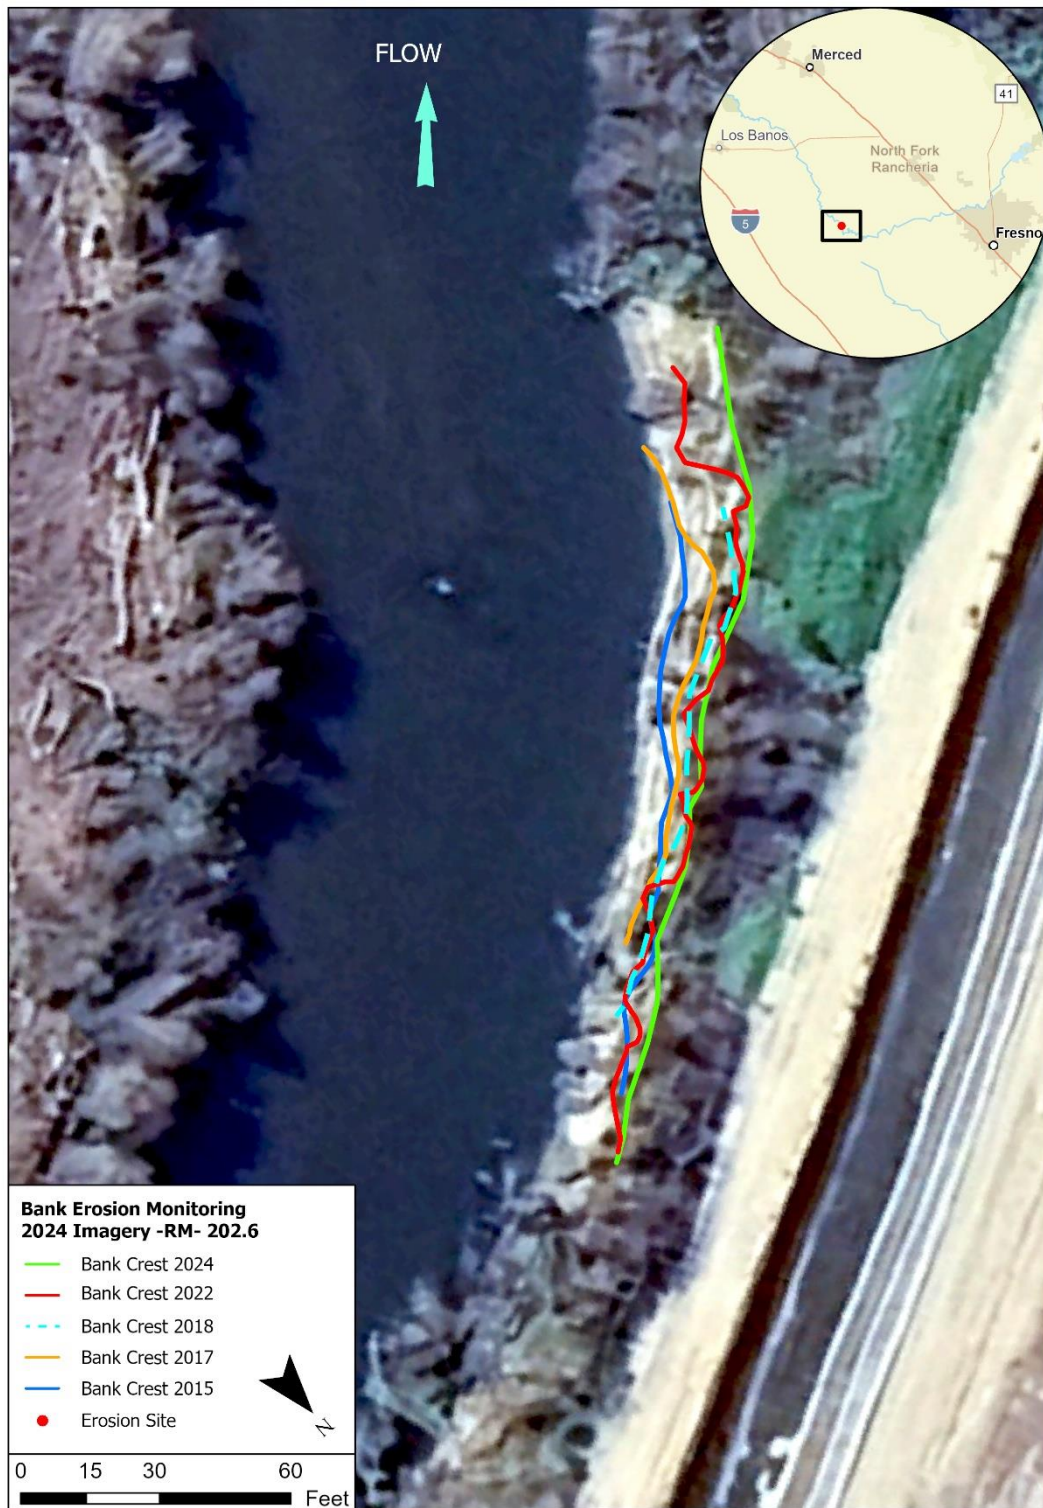
This site is located within Reach 3 and features a sparsely vegetated riverbank without any bank protection (Figure 7). The nearest threatened structure is a service road along a canal. From 2015 to 2017, the site experienced a maximum lateral erosion of 20 feet, reducing the minimum distance to the structure to 33 feet. Most of the erosion occurred at the downstream end. In August 2018, additional erosion up to 5 feet was observed, but occurred away from the minimum distance to the service road, leaving that distance unchanged. By 2022, an additional 4 feet of erosion was observed again at the downstream end and not impacting the minimum distance to the road. Following the 2023 flood, an additional 10 feet of erosion was observed at the downstream end. These changes can be attributed to varied flow types where erosion appears to be expanding downstream more after a flood event compared to Restoration Flows.

Figure 7 San Joaquin River Reach 3, RM 202.6; Threat Ratio 1.1, Threat Level: High

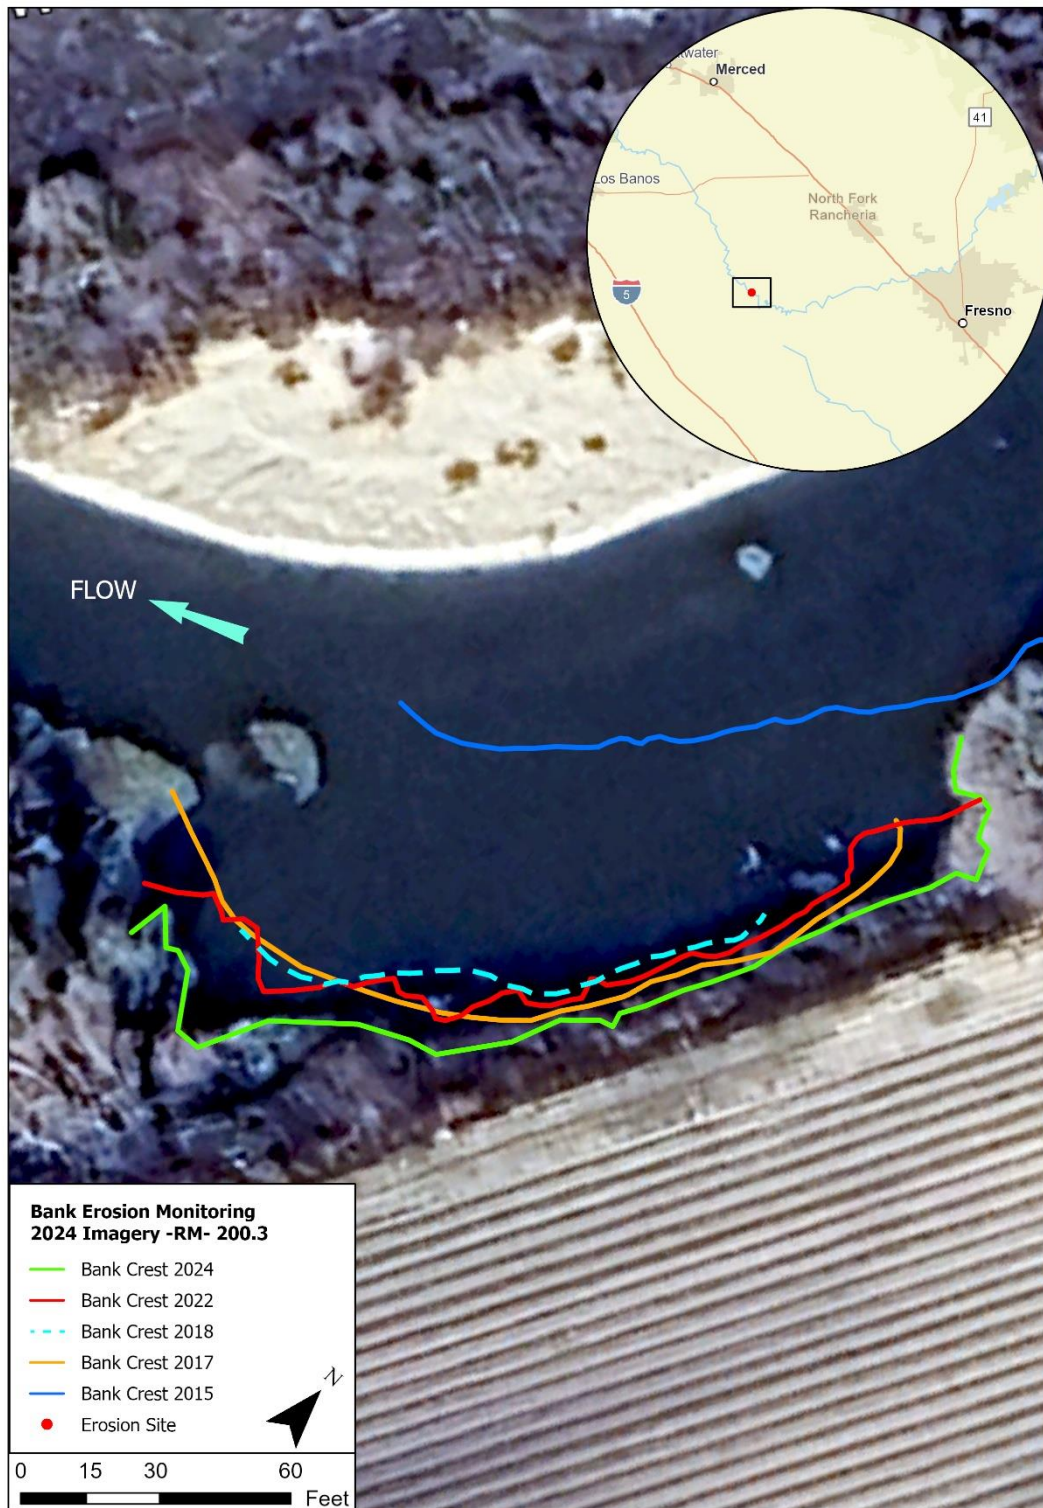
This site is in Reach 3 and depicts vegetation loss and no bank protection (Figure 8). As identified in the previous report, the nearest structure threatened is a service road and row crops just south of the site. The 2017 bankline delineation for this site is uncertain in some areas because of overhanging vegetation and shadows caused by them. Due to this reason the 2017 delineation crosses over the delineations for 2018 and 2022 banklines.

From 2015 to 2017, the site experienced a maximum lateral erosion of 55 feet, with a minimum distance to the structure at 3 feet. By August 2018, additional erosion was observed up to 2 feet at the downstream end, not impacting the minimum distance to the structure. By 2022, additional erosion up to 8 feet continued at the downstream end. The latest imagery from February 2024 shows additional erosion up to 21 feet throughout the site following the 2023 flood. Erosion observed between 2022 and 2024 is likely caused by the 2023 flood. For this site, the effect of Restoration Flows between 2017 and 2018 is not clear due to uncertainties of the 2017 bankline delineation, but considerable erosion was observed between 2018 and 2024 along the upstream and downstream ends, which is likely due to flood management releases.

Figure 8 San Joaquin River Reach 3, RM 200.3; Threat Ratio 0.0, Threat Level: High

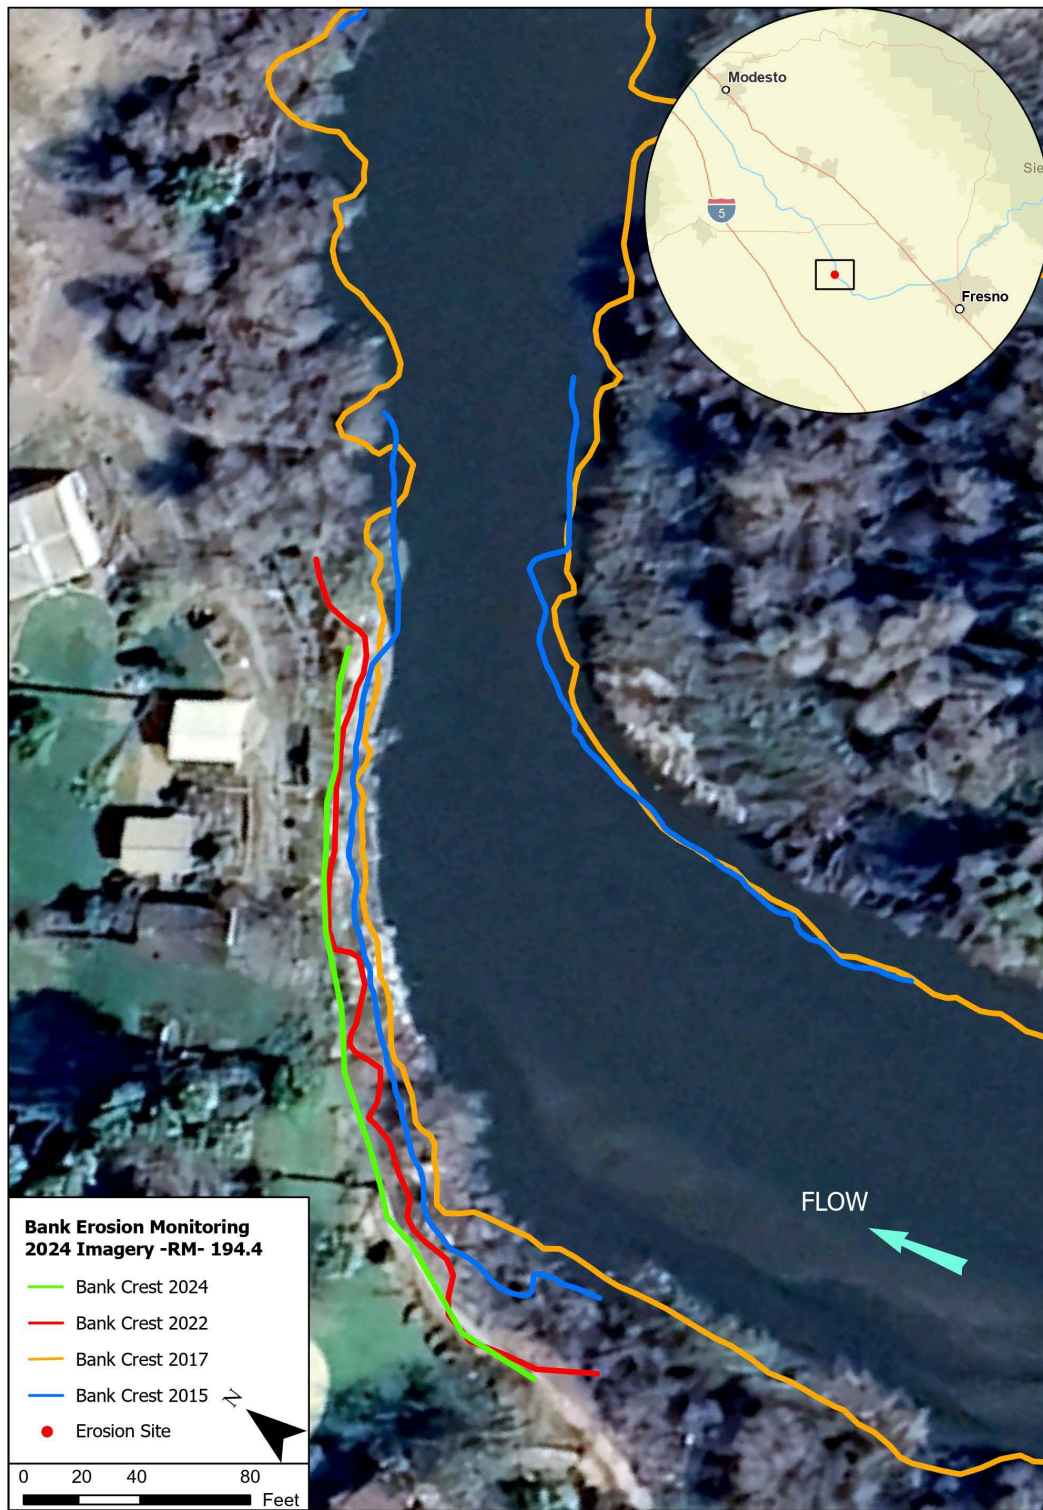
Figure 9 San Joaquin River Reach 3, RM 194.4, Threat Ratio 1.38, Threat Level: High

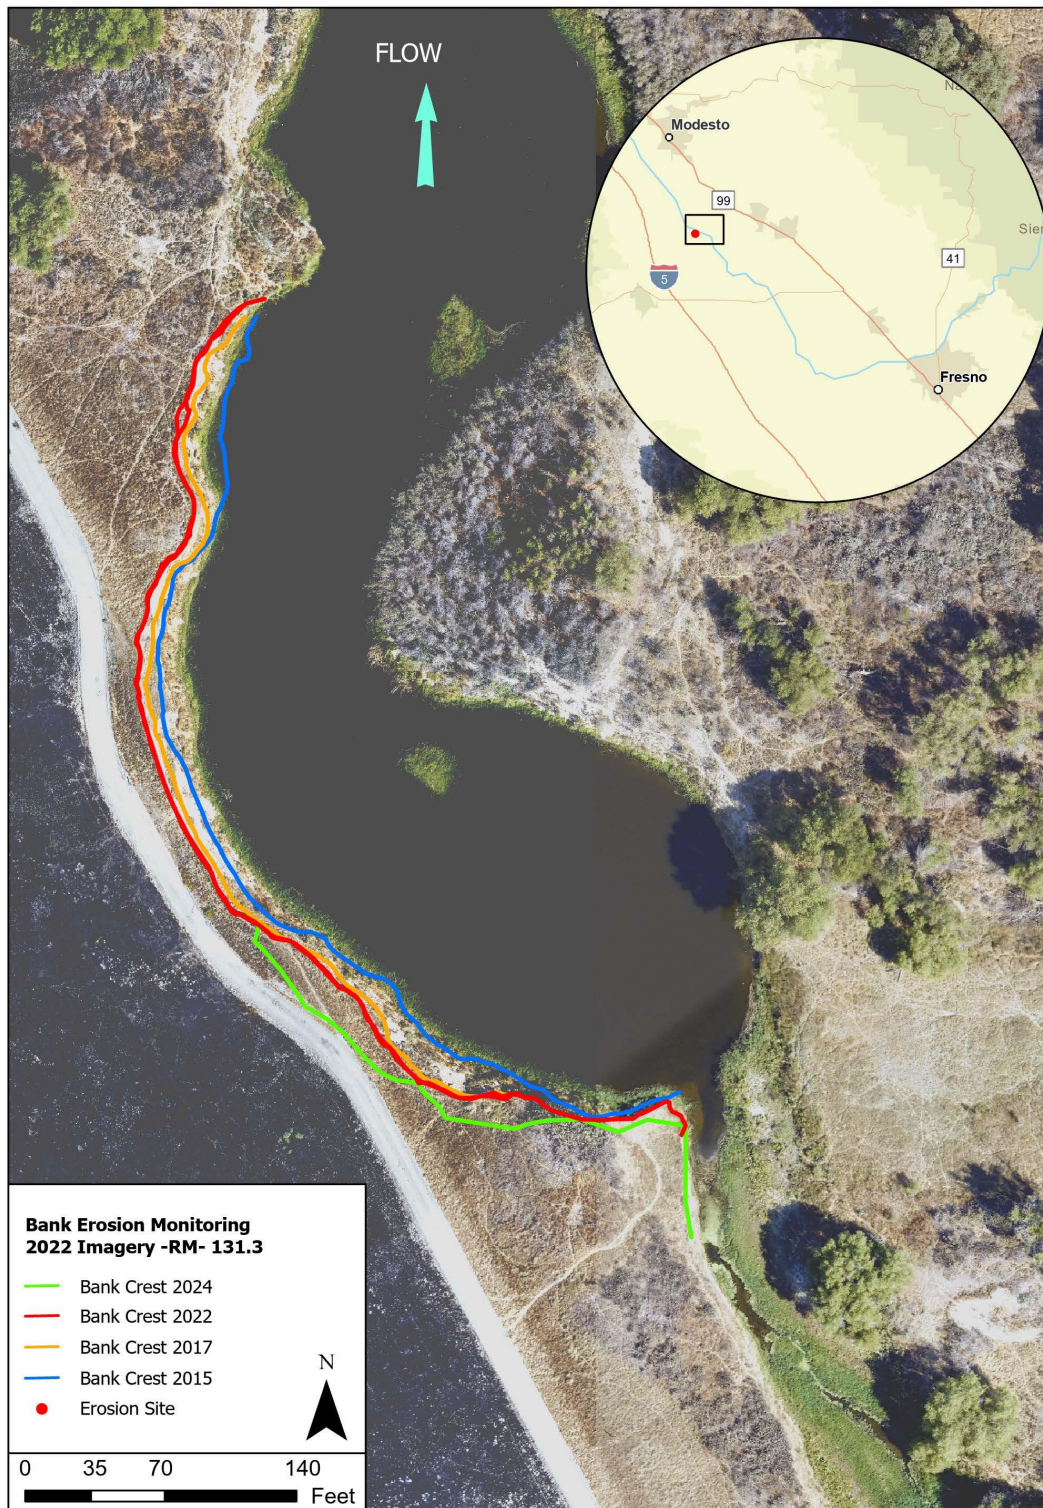
This site is located in Reach 5 and features a 430-foot-long barren bank that is actively eroding and encroaching within the side slope of a levee. Between 2015 and 2017, the site experienced up to 11 feet of erosion, which continued to increase an additional 9 feet by 2022; and by February 2024, the upstream area eroded an additional 18 feet. Google Earth imagery for 2024 does not cover the full extent of this site and further evaluation will be needed to identify the extent of erosion downstream. Most of the additional erosion observed in 2022 and 2024 are likely caused by flood management releases in 2019 and 2023. After communicating with the LSJLD, this site may no longer be classified as a high-threat site because the area is within the Great Valley Grasslands State Park where they have begun breaching the levee to flood native ground and restore floodplain habitat.

Figure 10 San Joaquin River Reach 5, RM 131.3; Threat Ratio 0.0, Threat Level: High
