## Appendix B

# Reports

### 2011 Draft Annual Technical Report

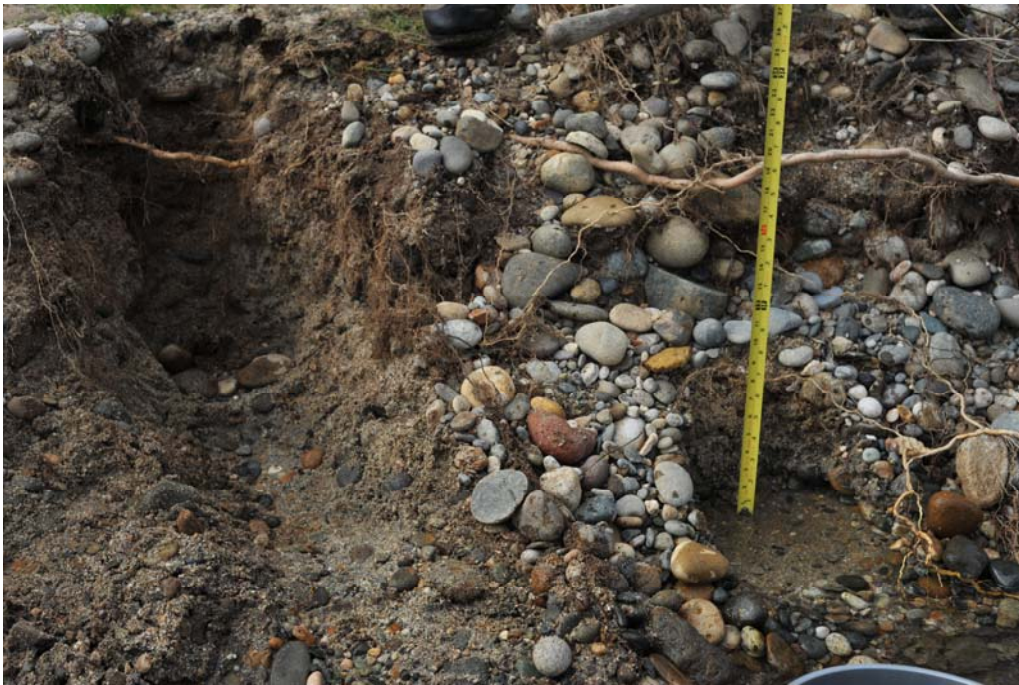
3 Figure 8-2: The right bank at RC38 between XS2 and XS3 that is eroding during elevated  
4 flow events. Above is the bank near the sampling location. Below are the sample  
5 excavations for the bank (left) and the lag material at the toe of bank (right)

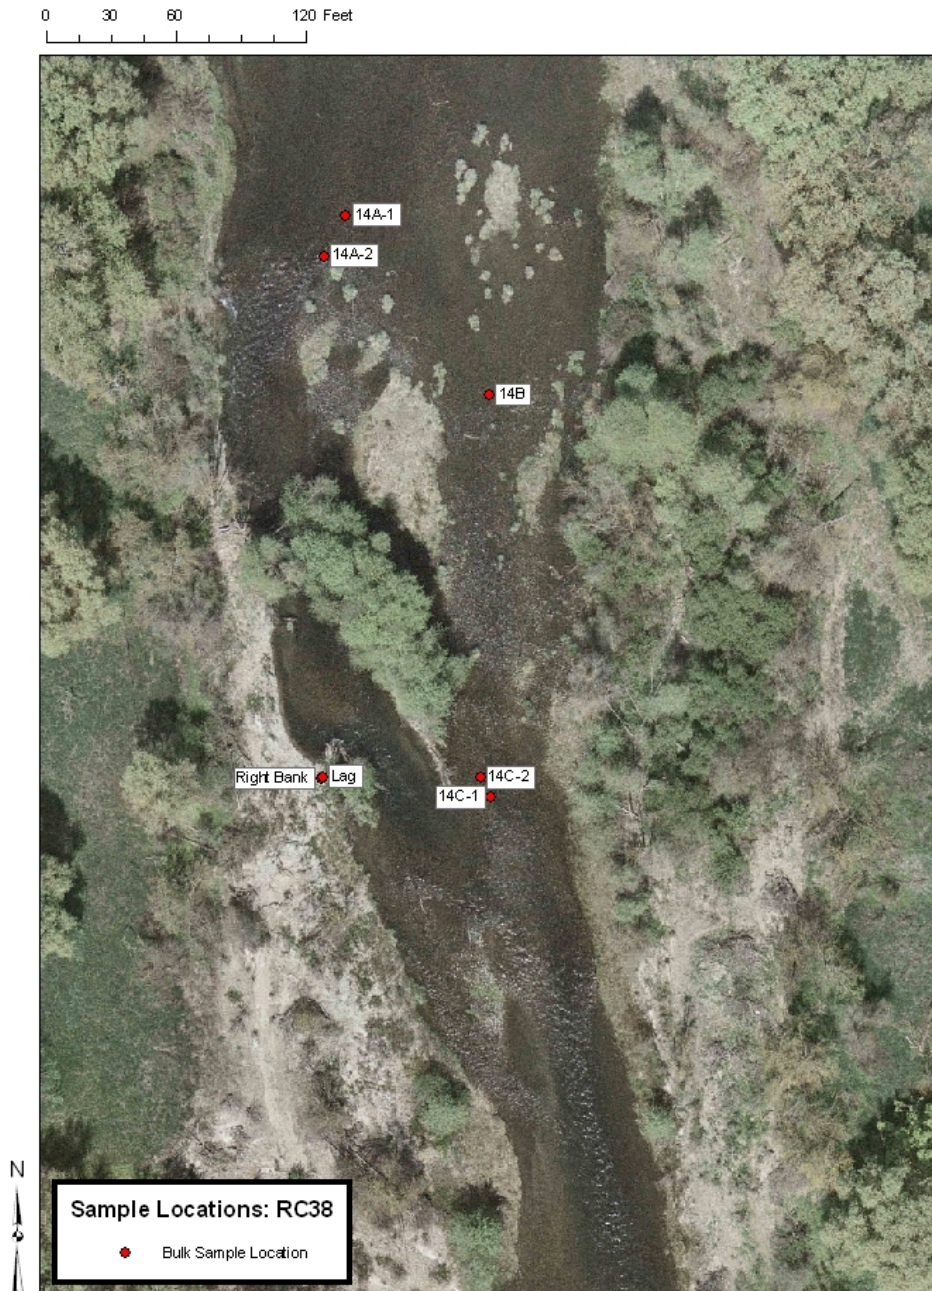
1  
 2 Figure 8-3: February 2011 sample locations at RC38. Samples 14A, B, and C are re-  
 3 sampled locations. Each of these sample locations was previously sampled in 2008.  
 4 Additional samples were collected on the right bank and the lag deposits along the right  
 5 bank. Note: the “Right Bank” and “Lag” sample locations are actually on the bank edge.  
 6 This aerial photo predates the erosion of the tree and bank to the east of these locations.

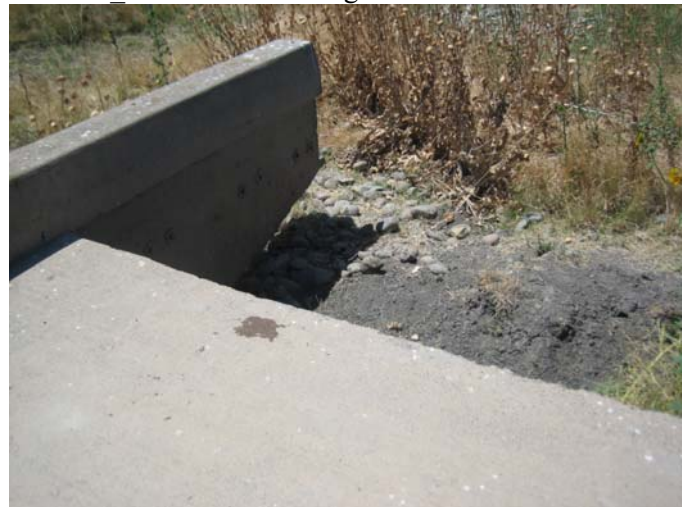
Photo 50\_B. Erosion of bridge on left bank
