RECLAMATION
Managing Water in the West

Reach 5 Temperature Monitoring Sites

Preliminary Data

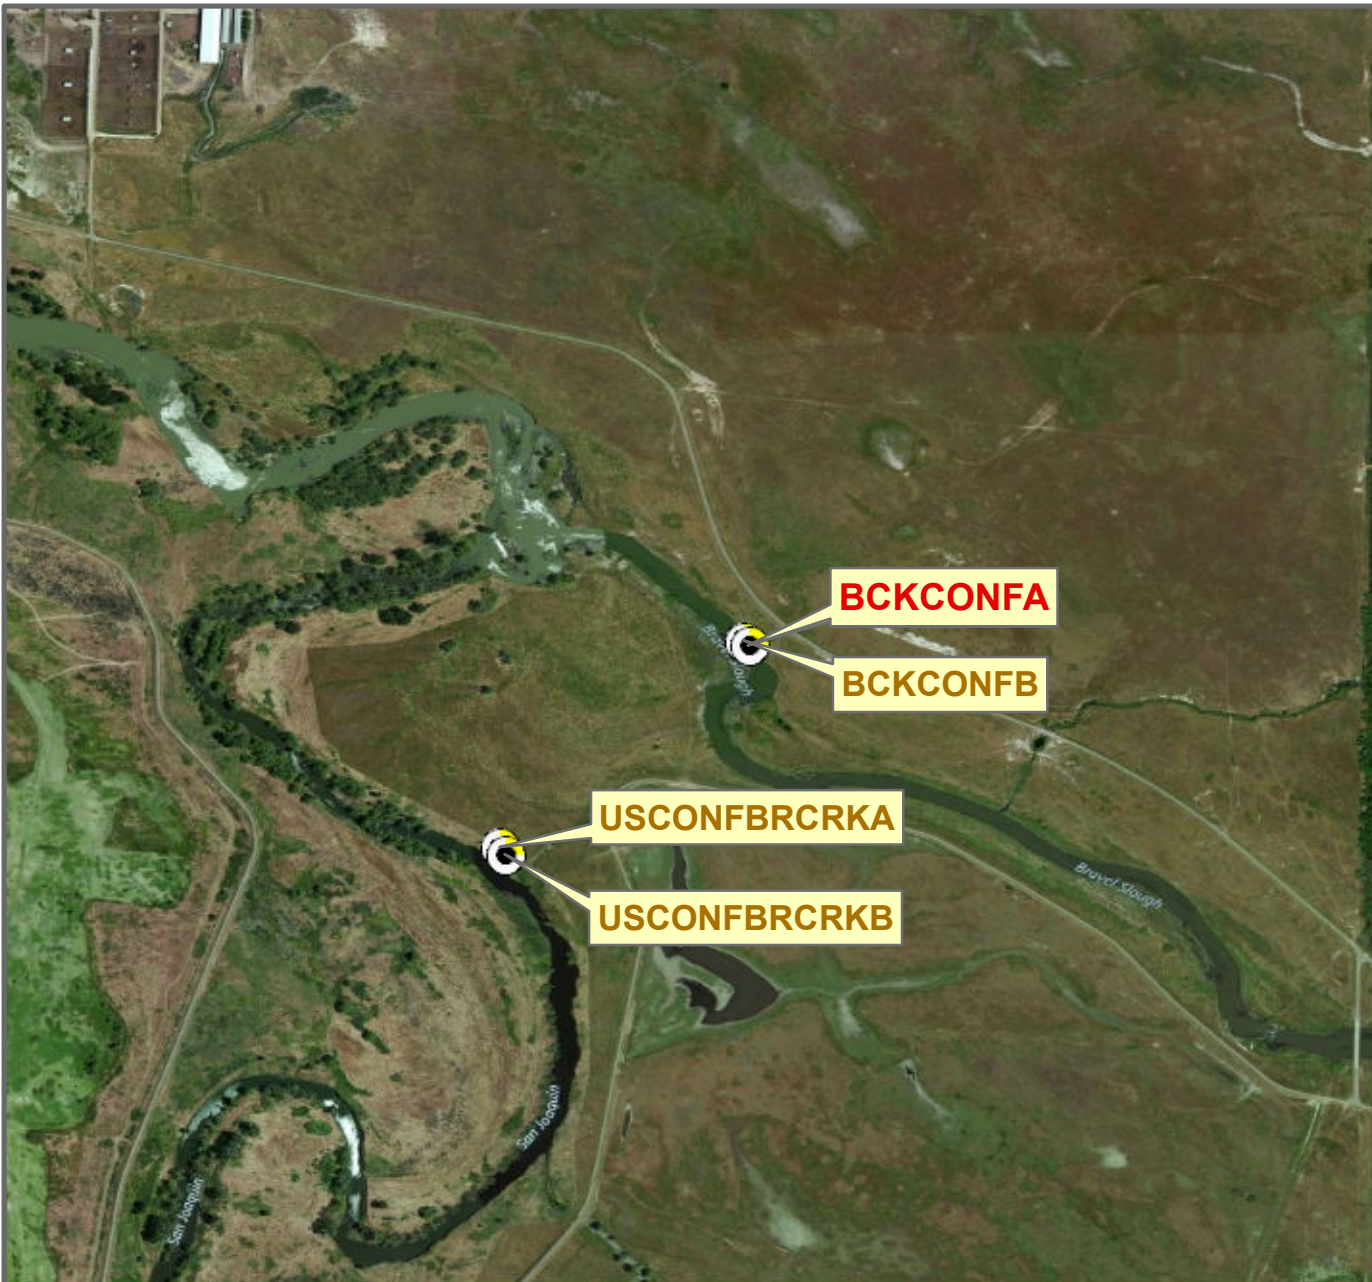
Monitoring Location BCKCONFA

Reach = 5
 River Mile = NA
 Merced County
 Right Bank

X = -120.8240 Y = 37.2779 Status = Existing
 (Horizontal Datum is NAD83)
 Distance From River Centerline (ft)=
 Reference Elevation (ft NAVD88) =
 Site = Bear Creek Upstream of Confluence with SJR

Agency = USBR
 Measurements:
 Type = Datalogger
 Interval = Hourly
 Timeseries unavailable

Description:
 Cabled to 2 ft dia. willow tree at outfall of drainage swale. 30 ft downstream of BEARBRKUSCONFSJRA.

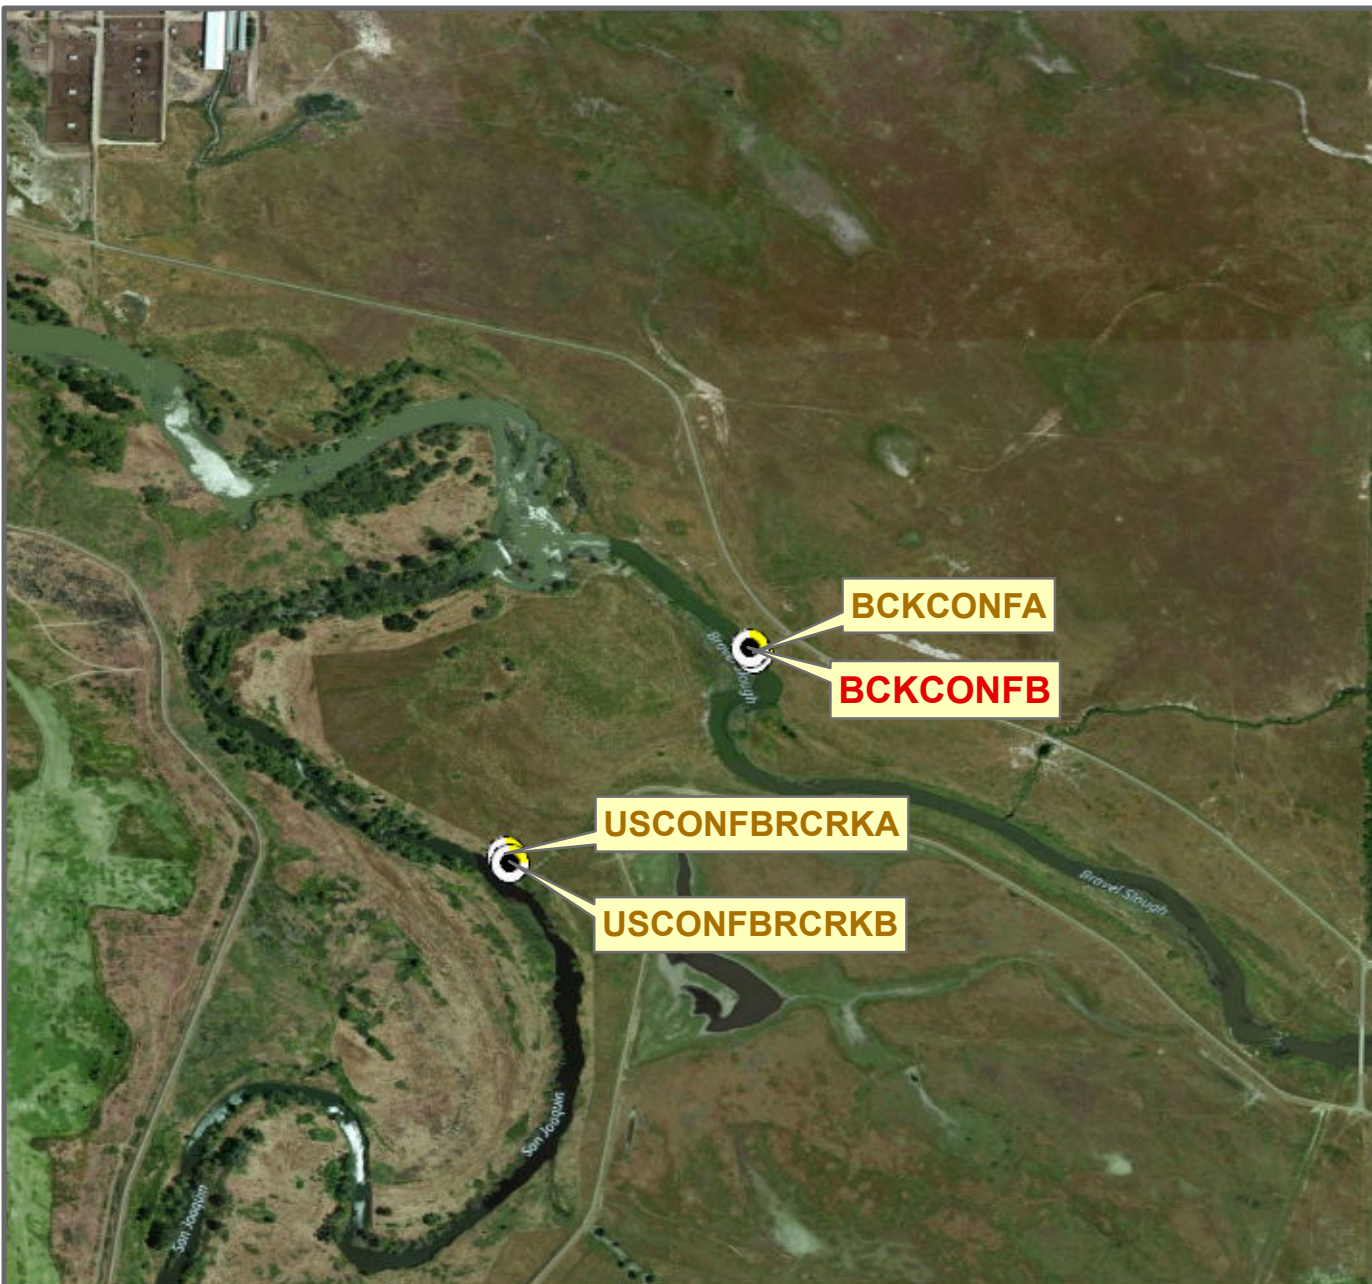
Monitoring Location BCKCONF B

Reach = 5
 River Mile = NA
 Merced County
 Right Bank

X = -120.8241 Y = 37.2779 Status = Existing
 (Horizontal Datum is NAD83)
 Distance From River Centerline (ft)=
 Reference Elevation (ft NAVD88) =
 Site = Bear Creek Upstream of Confluence with SJR

Agency = USBR
 Measurements:
 Type = Datalogger
 Interval = Hourly
 Timeseries unavailable

Description:
 Cabled to 5 ft dia. willow tree at outfall of drainage swale. 30 ft upstream of BEARBRKUSCONFSJRB.

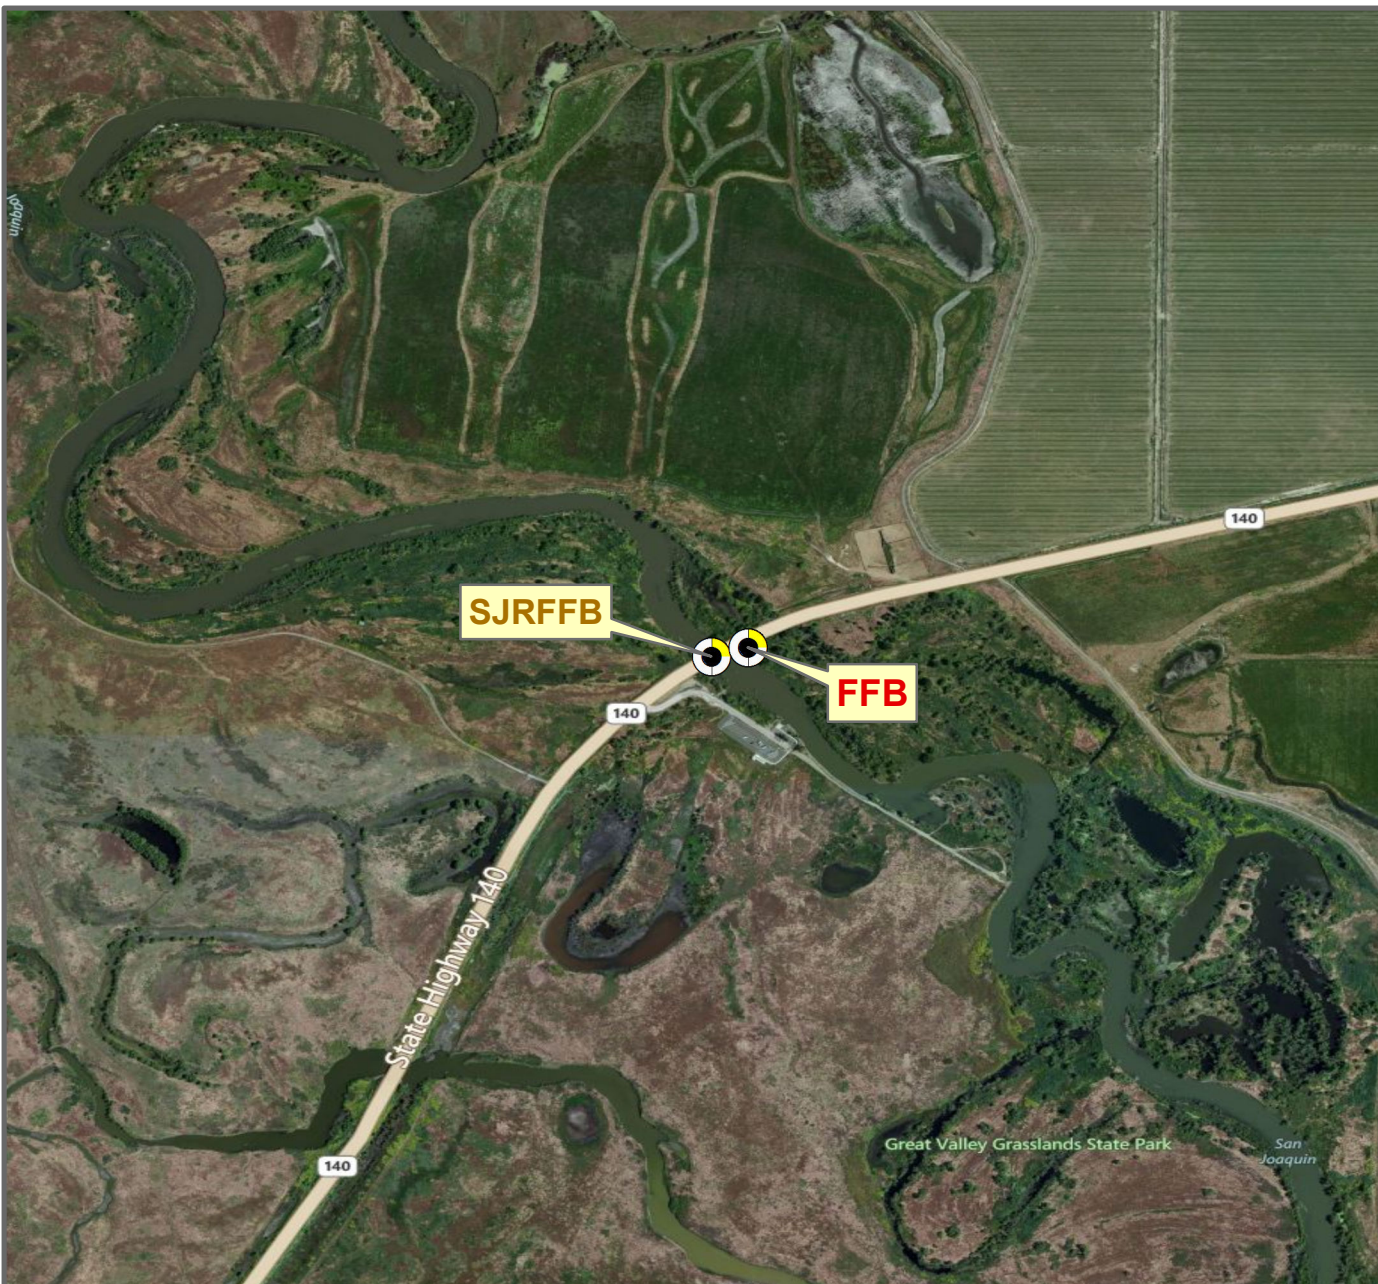
Monitoring Location FFB

Reach = 5
 River Mile = 125.1
 Merced County
 Channel Bank

X = -120.9300 Y = 37.3100 Status = Existing
 (Horizontal Datum is NAD83)
 Distance From River (ft) = 139
 Reference Elevation (ft NAVD88) =
 Site = Fremont Ford Bridge

Agency = USGS
 Measurements:
 Type = Telemetry
 Interval = 15 min
 Date Range = 5/8/2004 - 5/8/2012

Description:
 Sensor at real-time flow gaging station

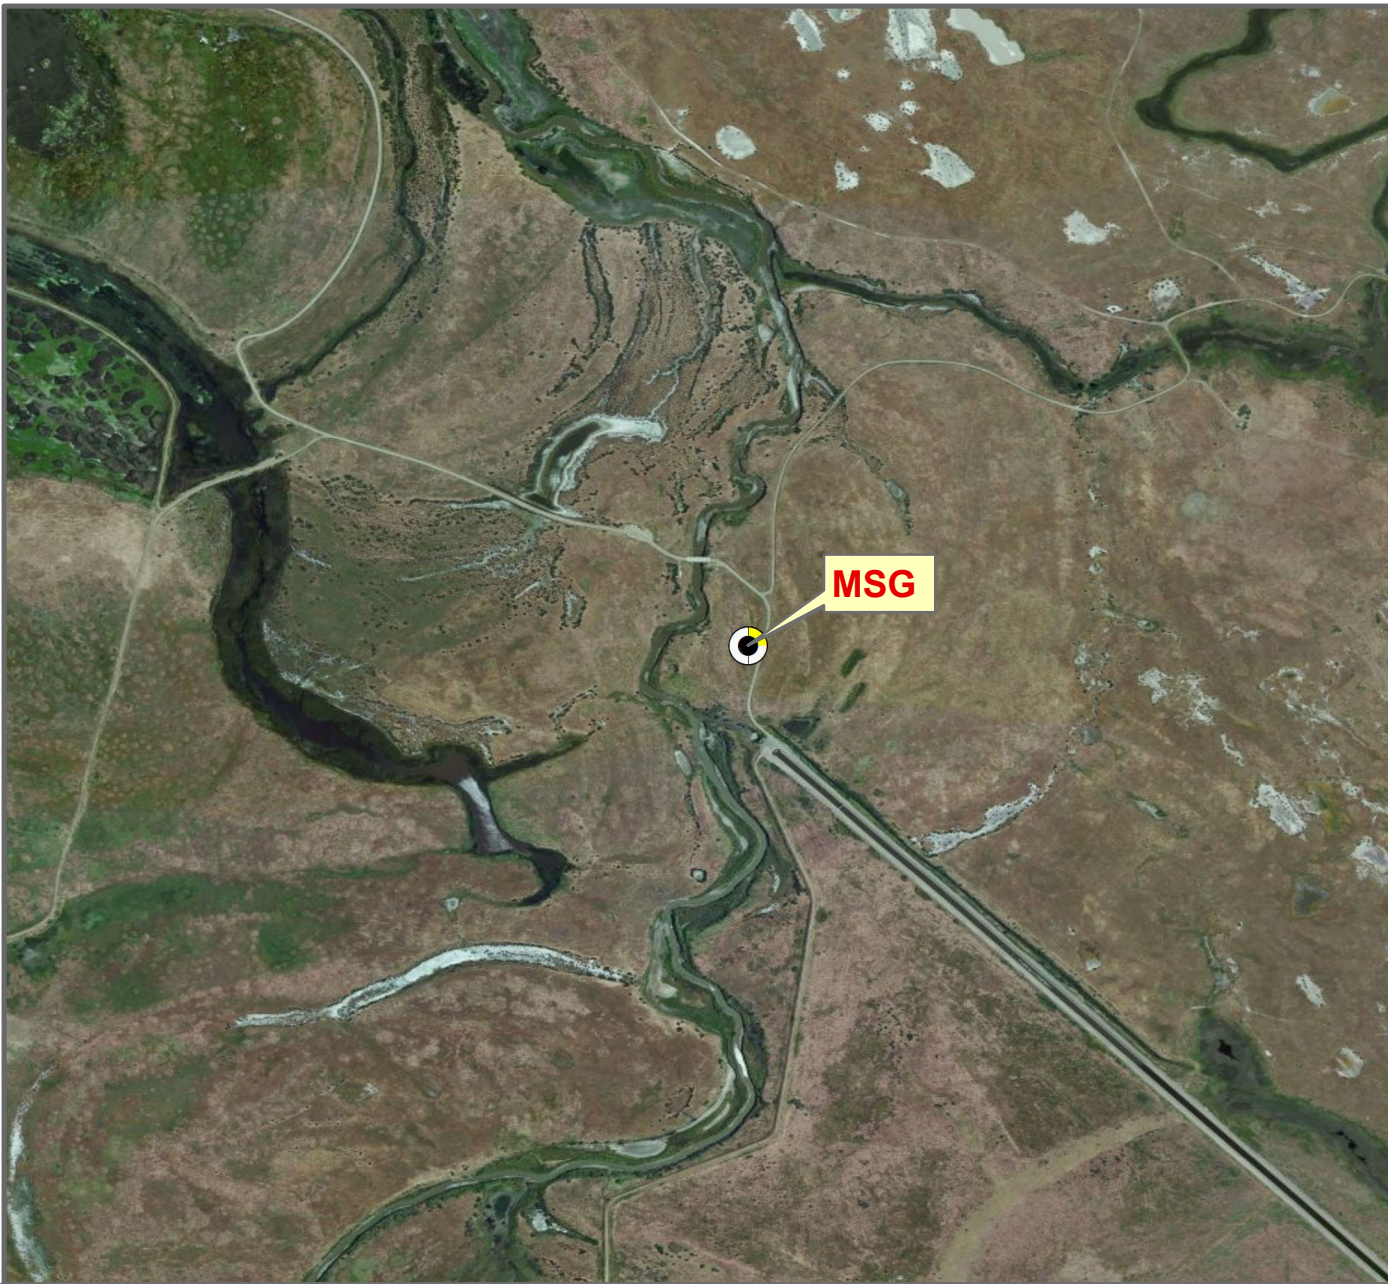
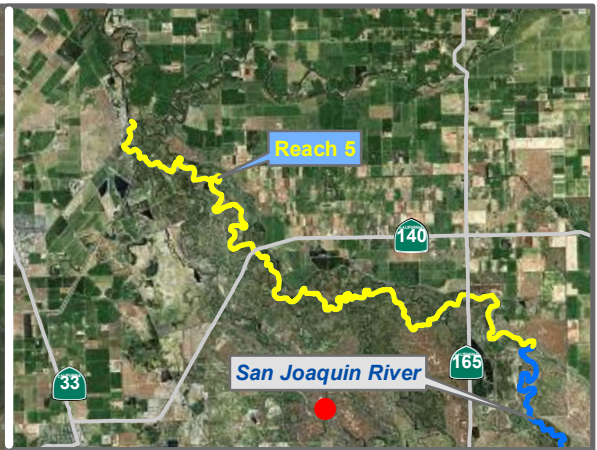
Monitoring Location MSG

Reach = 5
 River Mile = 131.0
 Merced County
 Left Bank

X = -120.9056 Y = 37.2625 Status = Existing
 (Horizontal Datum is NAD83)
 Distance From River (ft)= 10150
 Reference Elevation (ft NAVD88) =
 Site = Mud Slough

Agency = USGS
 Measurements:
 Type = Telemetry
 Interval = 15 min
 Date Range = 6/4/2004 - 5/8/2012

Description:
 Sensor at real-time flow gaging station

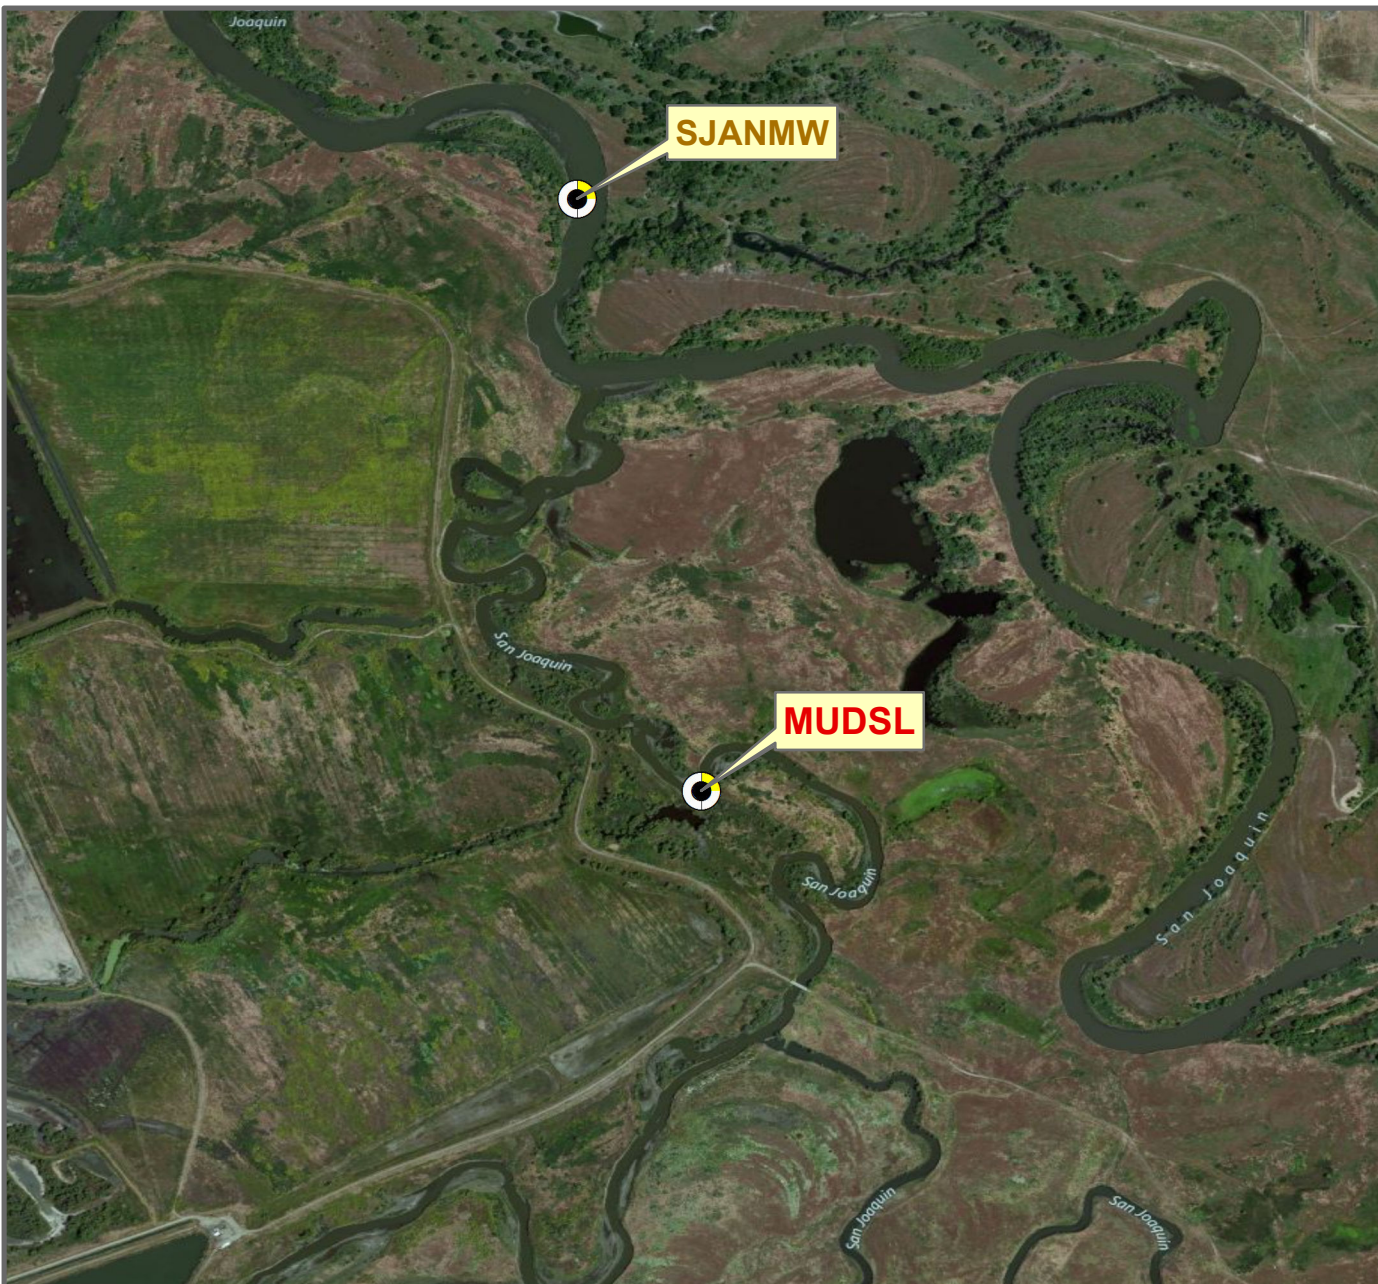
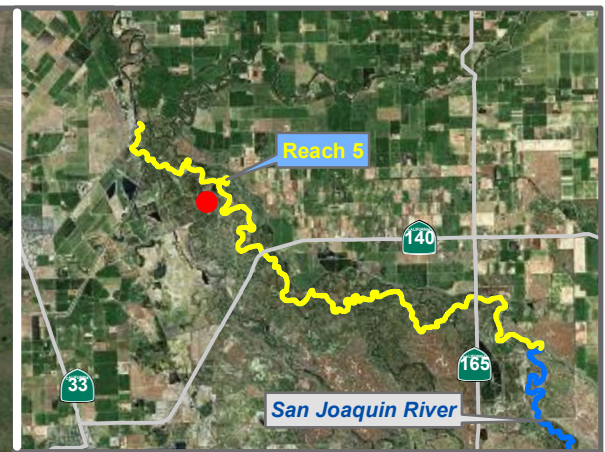
Monitoring Location MUDSL

Reach = 5
 River Mile = 121.2
 Merced County
 Left Bank

X = -120.9508 Y = 37.3255 Status = Existing
 (Horizontal Datum is NAD83)
 Distance From River (ft) = 2030
 Reference Elevation (ft NAVD88) =
 Site = Mud Slough

Agency = DFG
 Measurements:
 Type = Datalogger
 Interval = Hourly
 Date Range = 6/15/2010 - 10/25/2010

Ground Surface Elevation (ft) =
 Monitoring Depth (ft) = 1 ft above gs

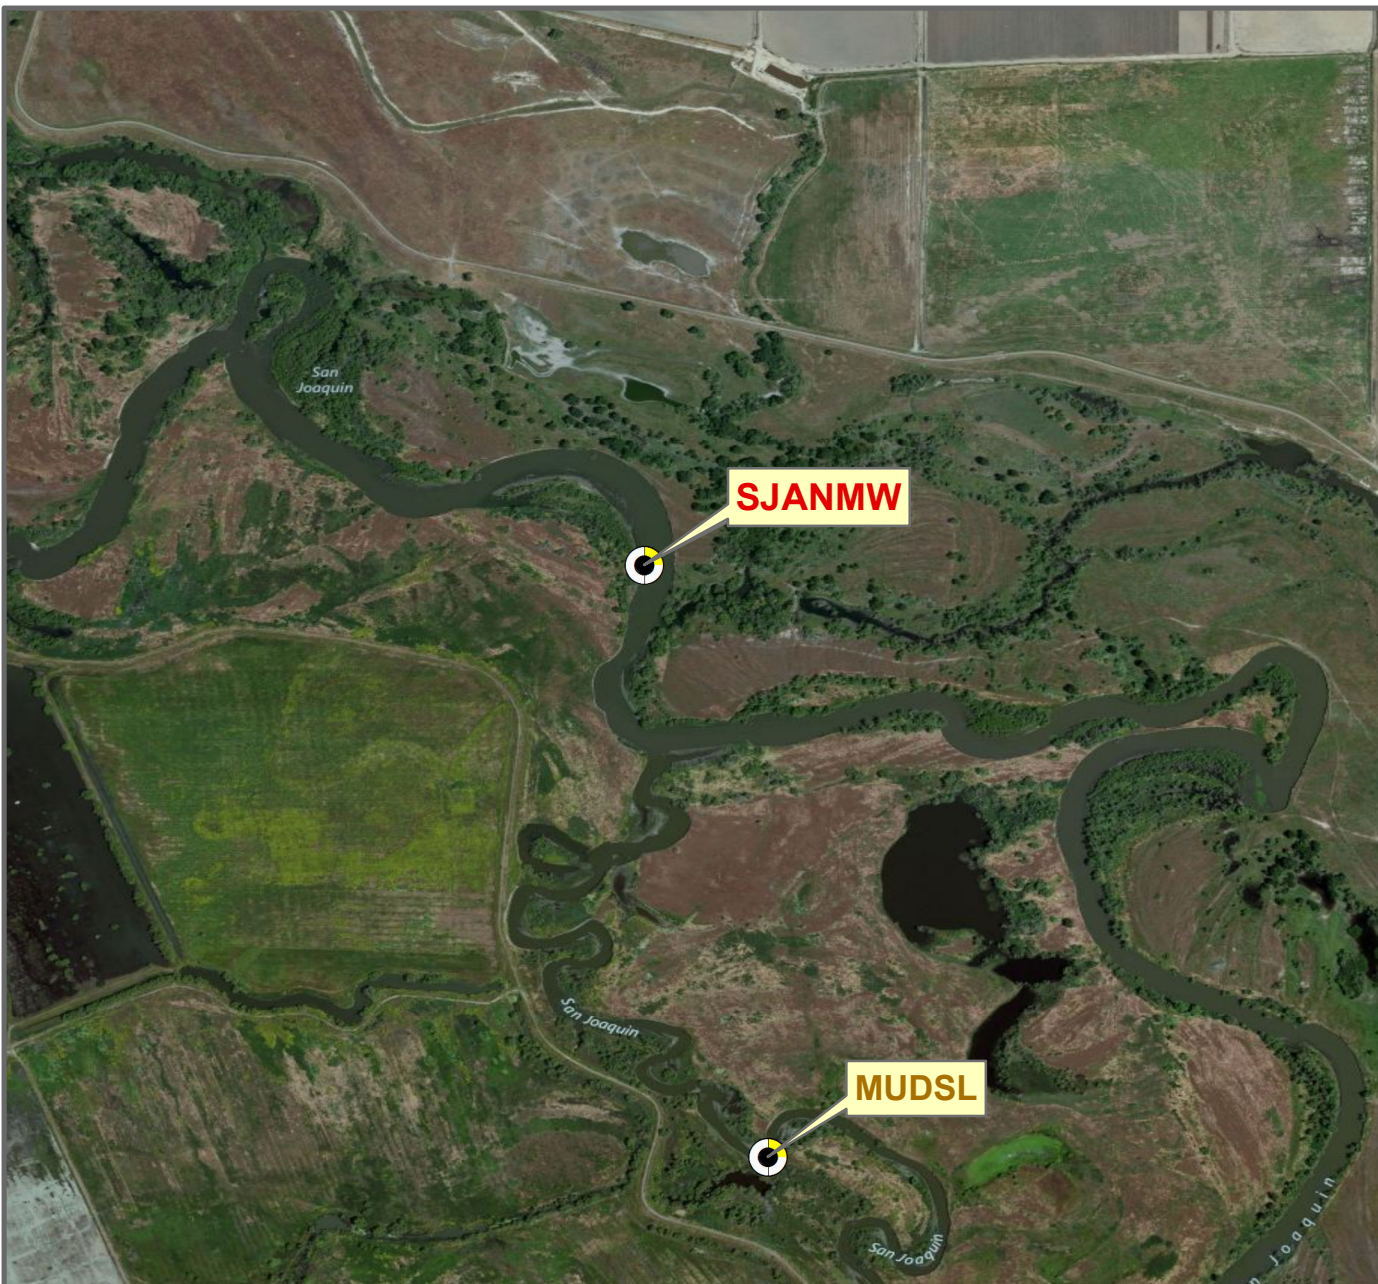
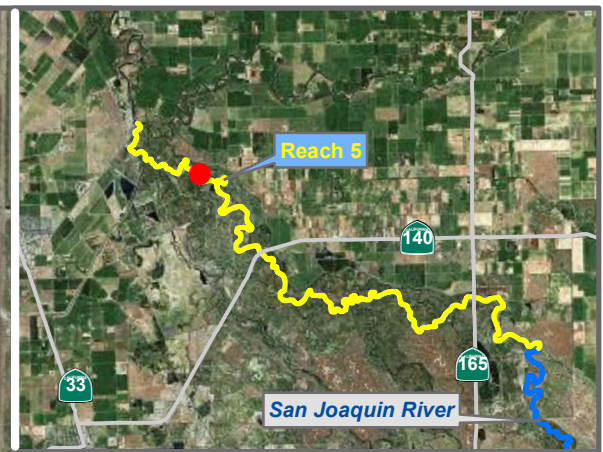
Monitoring Location SJANMW

Reach = 5
 River Mile = 121.0
 Merced County
 Channel Bank

X = -120.9526 Y = 37.3339 Status = Existing
 (Horizontal Datum is NAD83)
 Distance From River (ft) = 74
 Reference Elevation (ft NAVD88) =
 Site = Newman Wasteway

Agency = DFG
 Measurements:
 Type = Datalogger
 Interval = Hourly
 Date Range = 6/15/2010 - 7/14/2010

Description:
 Upstream of Newman Wasteway - data still needs to be retrieved for IFP

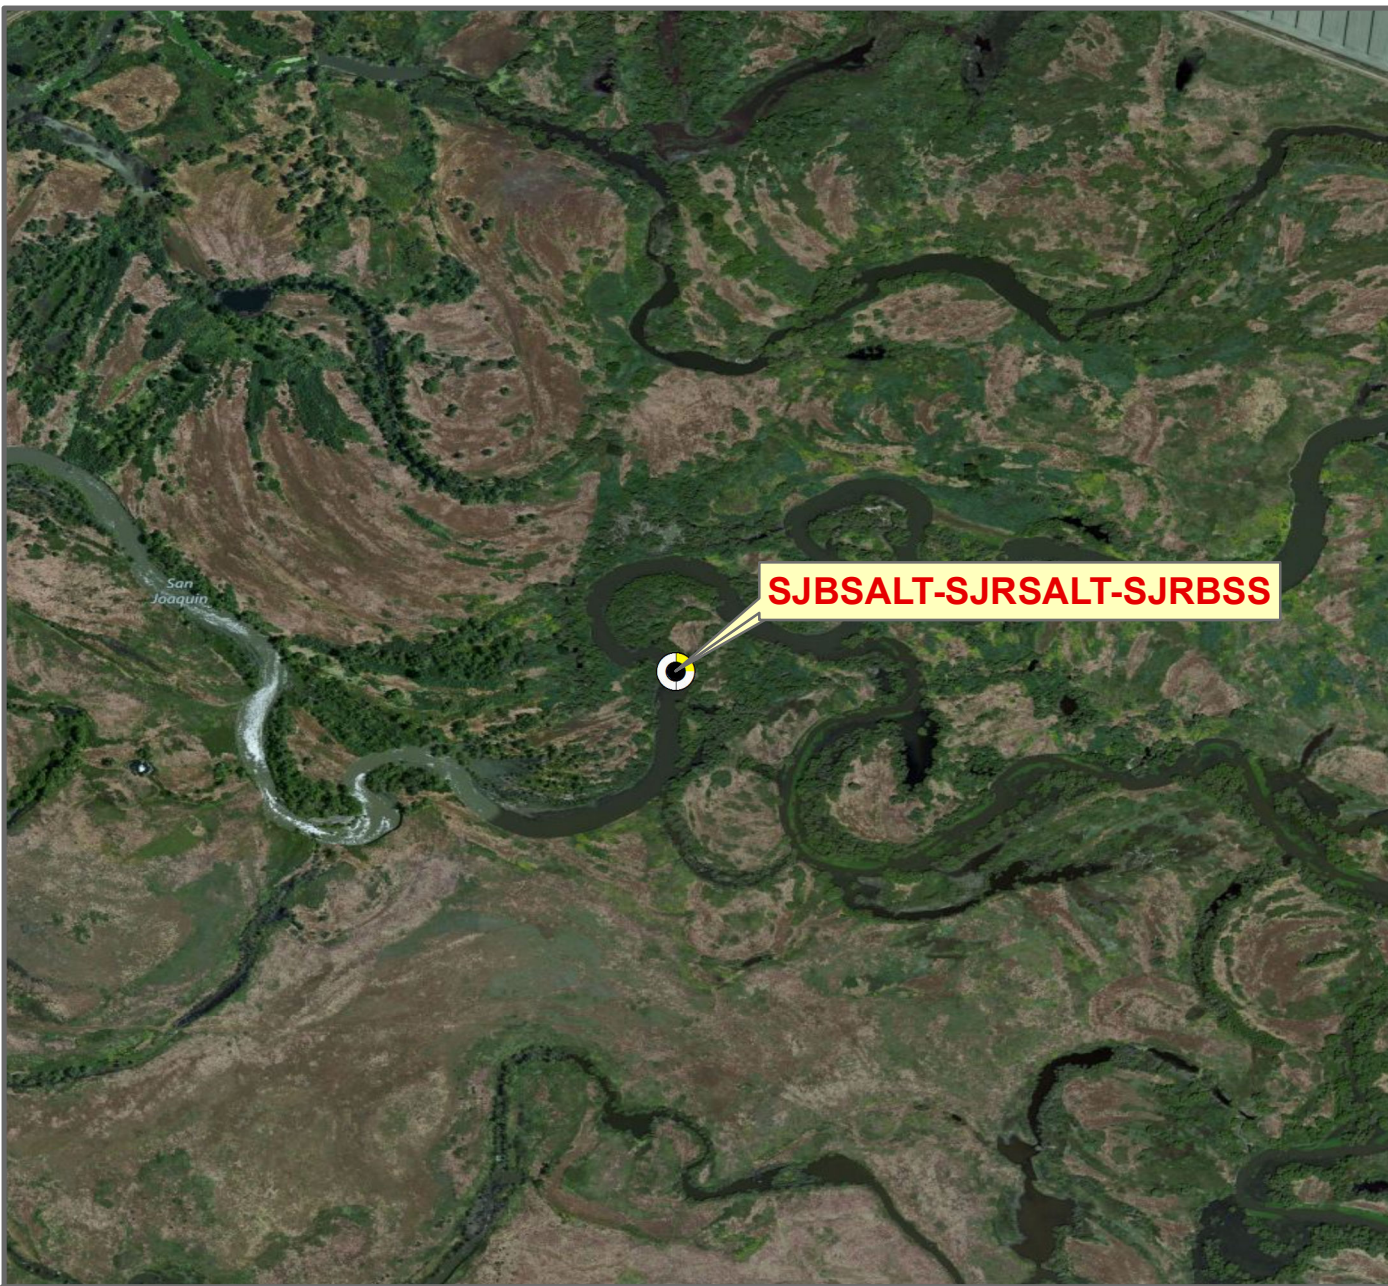
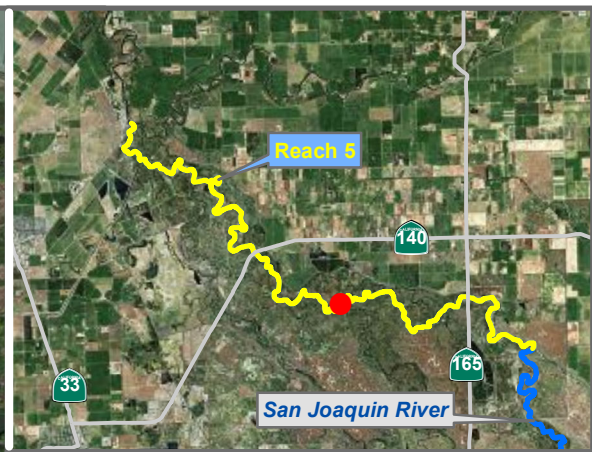
SJBSALT-SJRSALT-SJRBSS

Reach = 5
 River Mile = 127.5
 Merced County
 Left Bank

X = -120.8990 Y = 37.2940 Status = Existing
 (Horizontal Datum is NAD83)
 Distance From River (ft) = 6
 Reference Elevation (ft NAVD88) =
 Site = Salt Slough

Agency = DFG
 Measurements:
 Type = Datalogger
 Interval = Hourly
 Timeseries unavailable

Description:
 downstream of Salt Slough confluence - data still
 needs to be retrieved for IFP

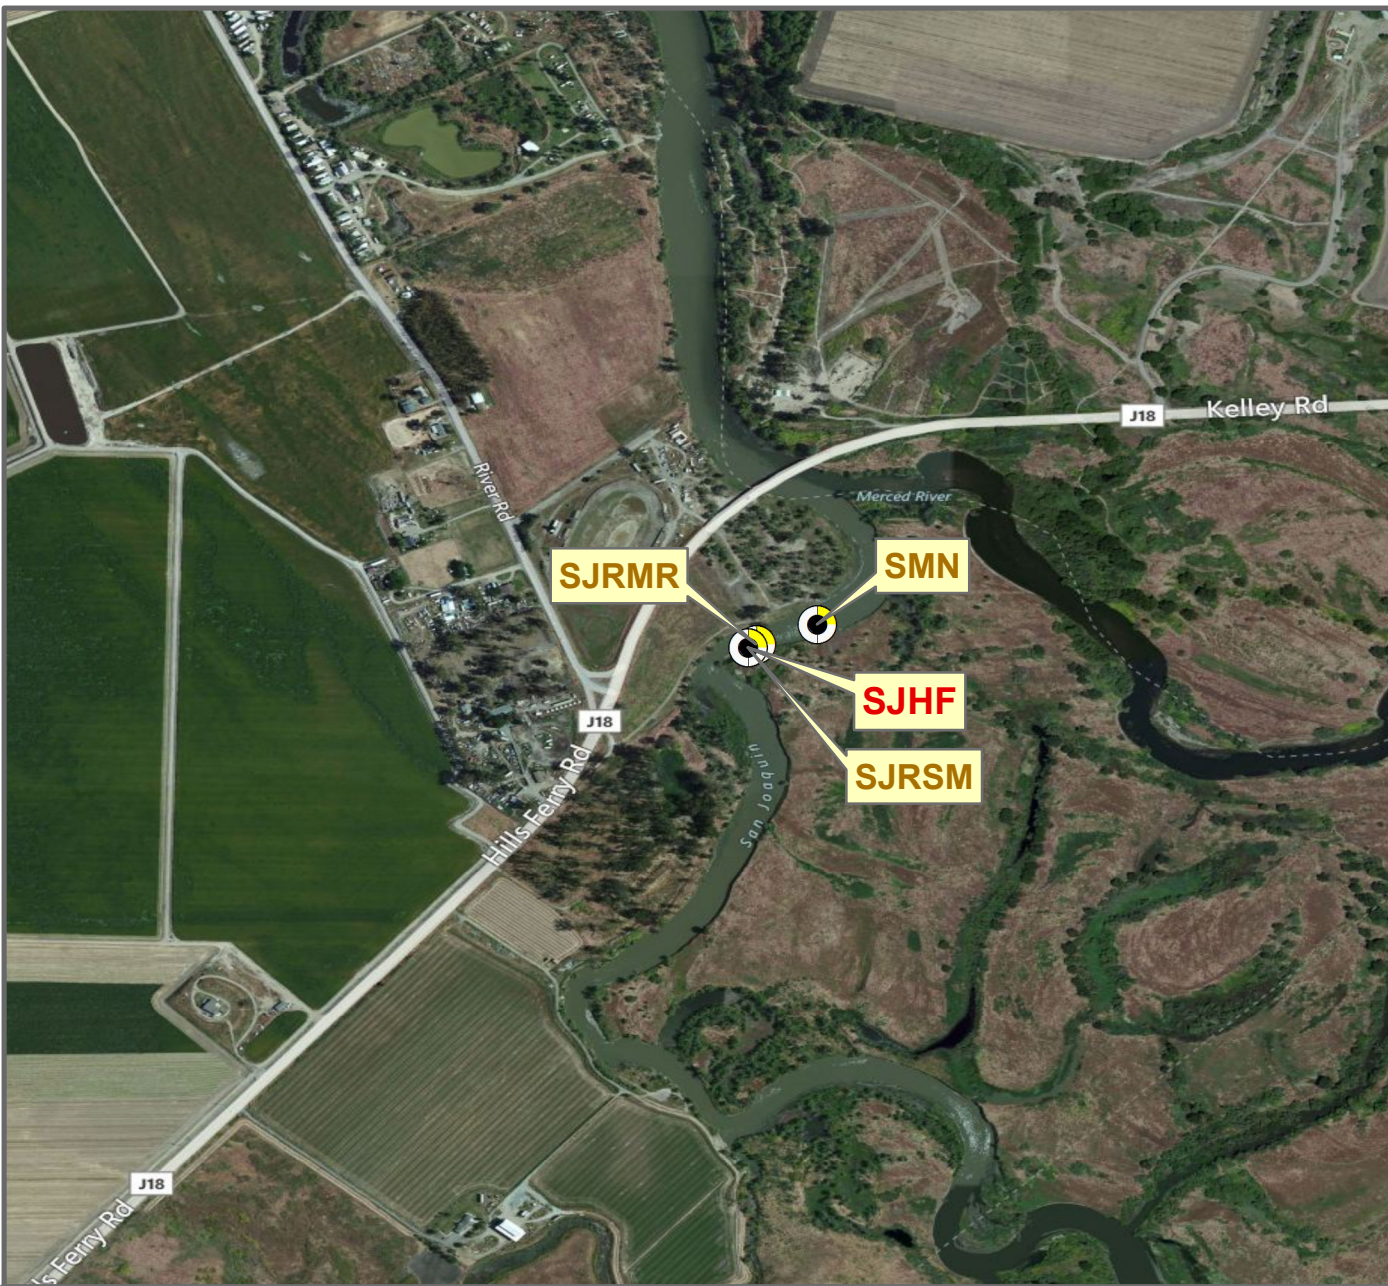
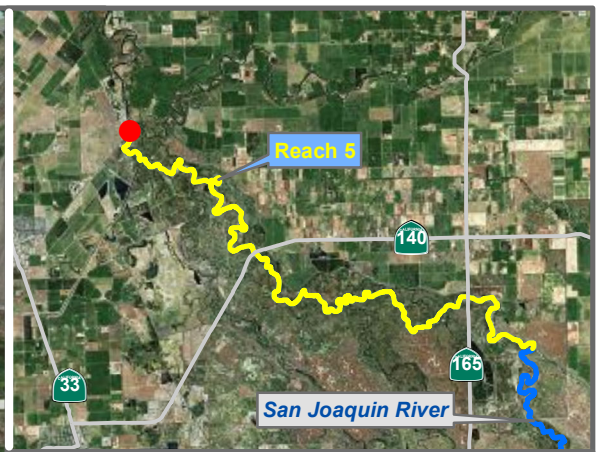
Monitoring Location SJHF

Reach = 5
 River Mile = 118.5
 Stanislaus County
 Channel Bank

X = -120.9761 Y = 37.3470 Status = Existing
 (Horizontal Datum is NAD83)
 Distance From River (ft) = 14
 Reference Elevation (ft NAVD88) =
 Site = Merced Confluence

Agency = DFG
 Measurements:
 Type = Datalogger
 Interval = Hourly
 Timeseries unavailable

Description:
 Downstream of Hills Ferry barrier - data still needs
 to be retrieved for IFP

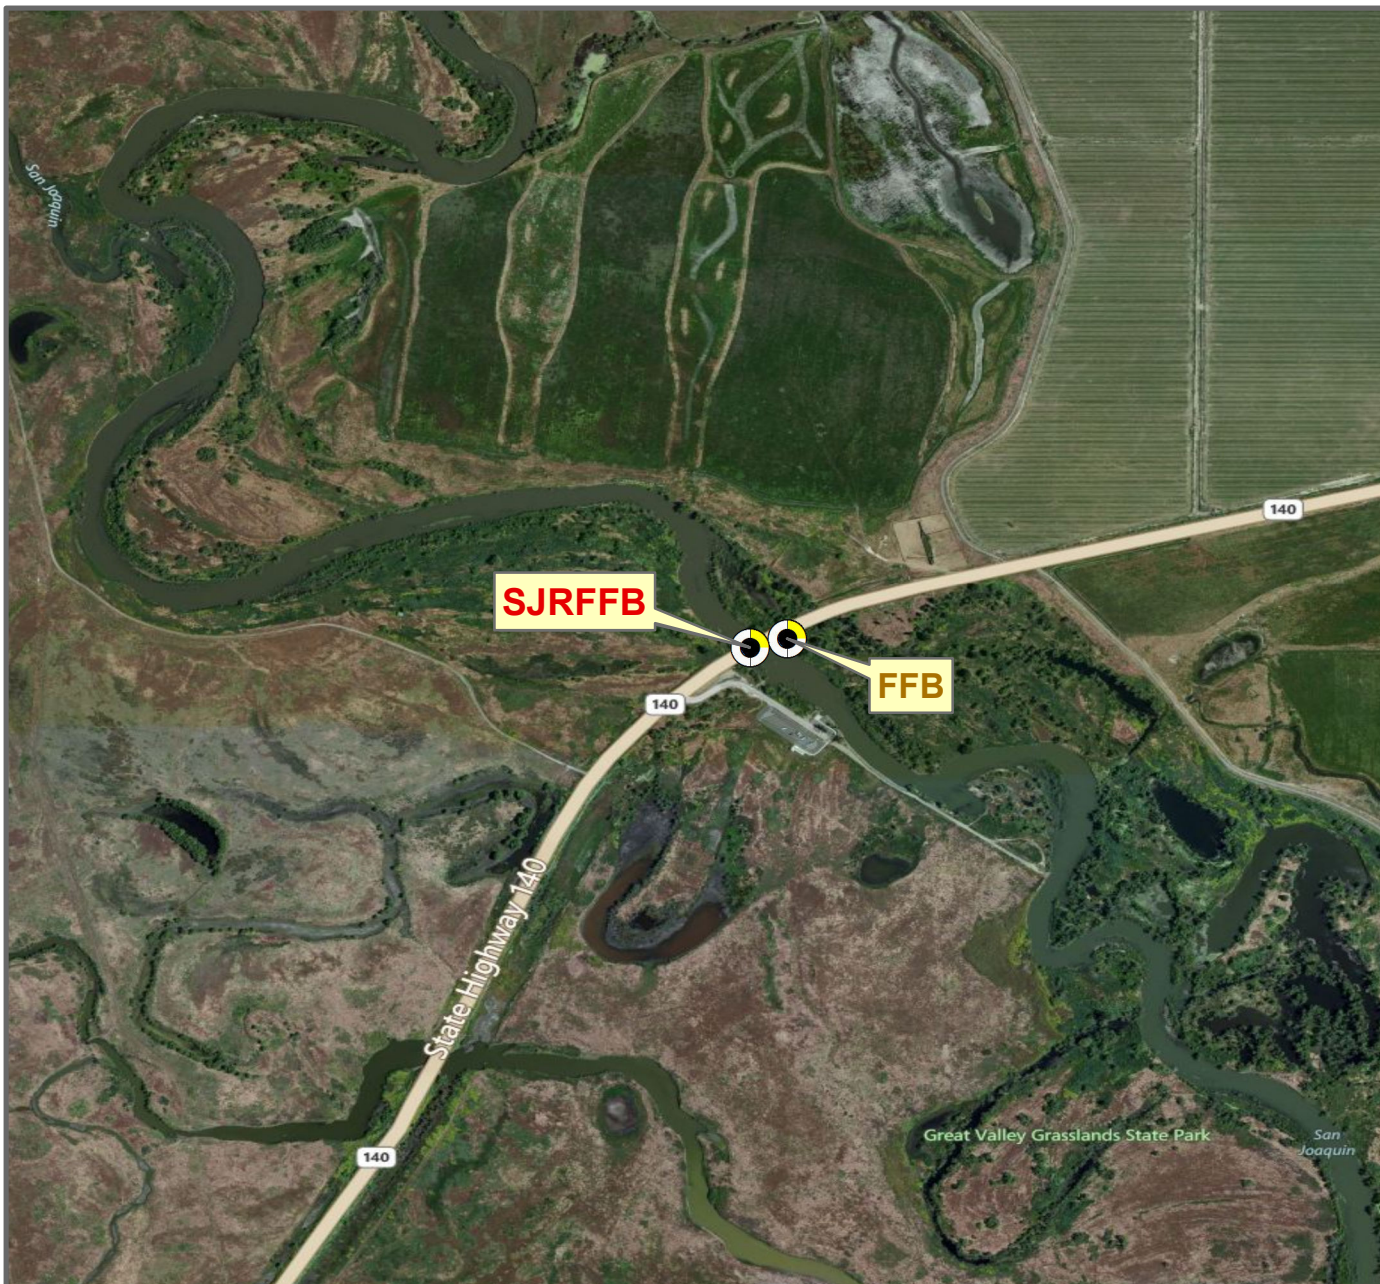
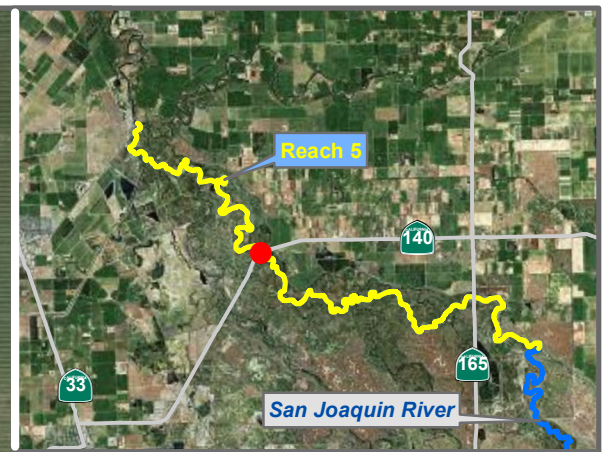
Monitoring Location SJRFFB

Reach = 5
 River Mile = 125.0
 Merced County
 Channel Bank

X = -120.9305 Y = 37.3099 Status = Existing
 (Horizontal Datum is NAD83)
 Distance From River (ft)= 4
 Reference Elevation (ft NAVD88) =
 Site = Fremont Ford Bridge

Agency = DFG
 Measurements:
 Type = Datalogger
 Interval = Hourly
 Timeseries unavailable

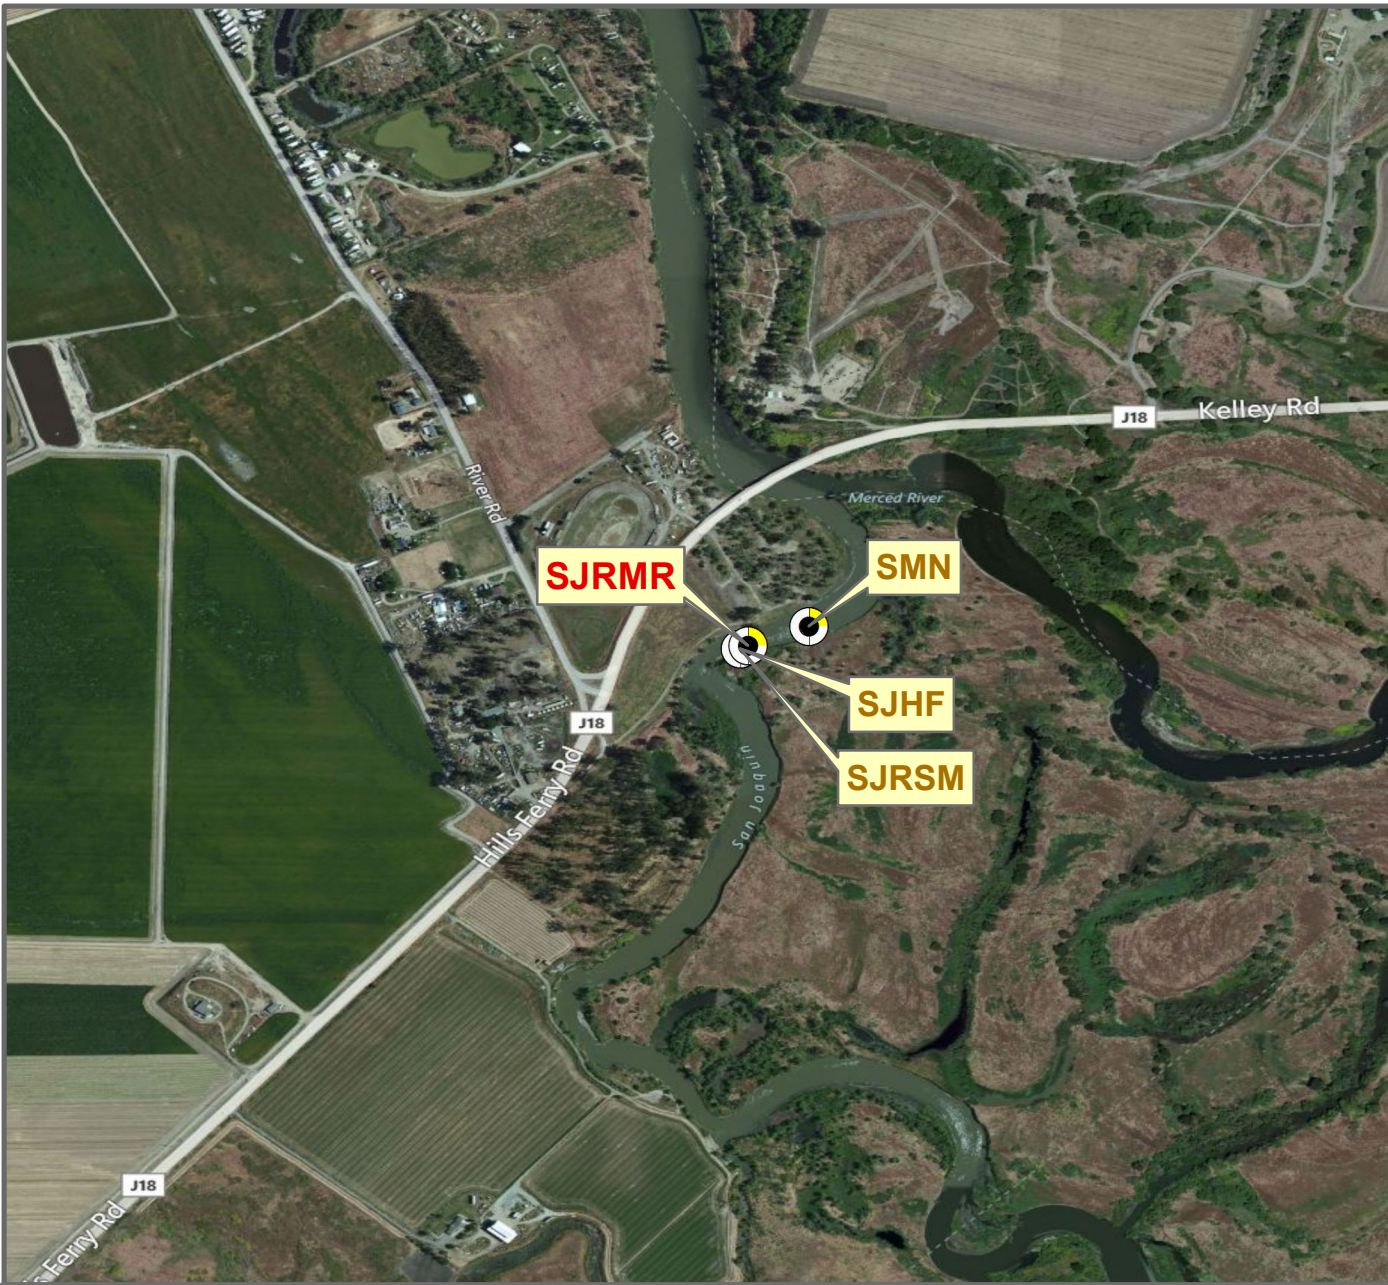
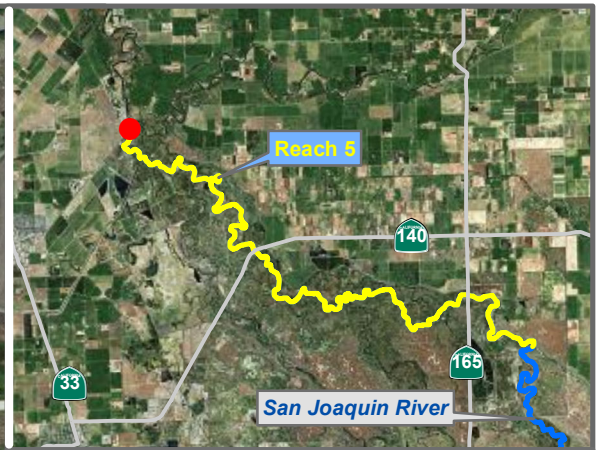
Monitoring Location SJRMR

Reach = 5
 River Mile = 118.5
 Stanislaus County
 Channel Bank

X = -120.9760 Y = 37.3470 Status = Existing
 (Horizontal Datum is NAD83)
 Distance From River (ft) = 10
 Reference Elevation (ft NAVD88) =
 Site = Merced Confluence

Agency = DFG
 Measurements:
 Type = Datalogger
 Interval = Hourly
 Timeseries unavailable

Description:
 downstream of Merced River confluence

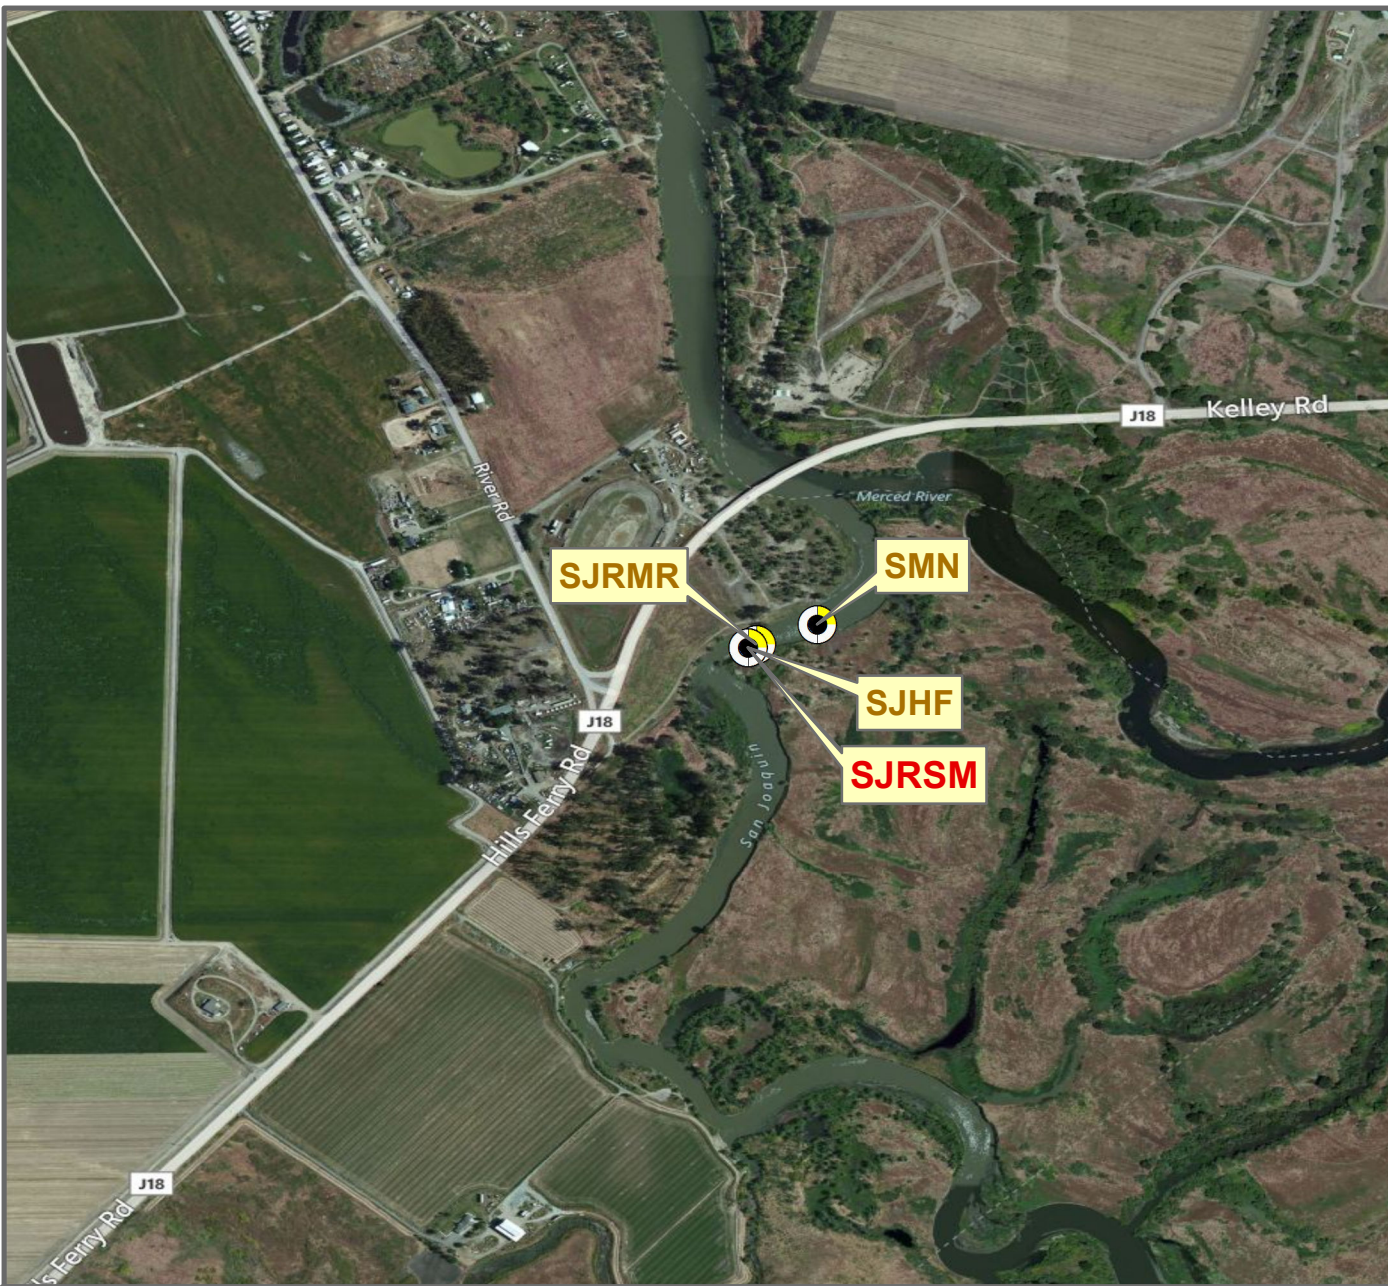
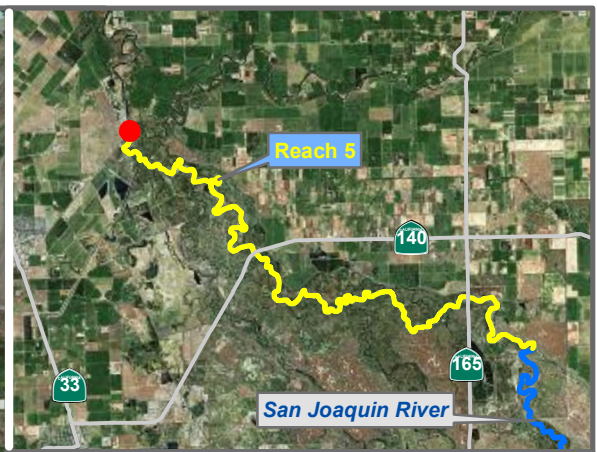
Monitoring Location SJRSM

Reach = 5
 River Mile = 118.5
 Stanislaus County
 Left Bank

X = -120.9761 Y = 37.3470 Status =
 (Horizontal Datum is NAD83)
 Distance From River (ft) = 14
 Reference Elevation (ft NAVD88) =
 Site = San Mateo Crossing

Agency = DFG
 Measurements:
 Type = Datalogger
 Interval =
 Date Range = 4/19/2011 - 12/22/2011

Description:
 Attached to stream guage at San Mateo Road
 crossing
