RECLAMATION
Managing Water in the West

Reach 5 Temperature Monitoring Sites

Preliminary Data

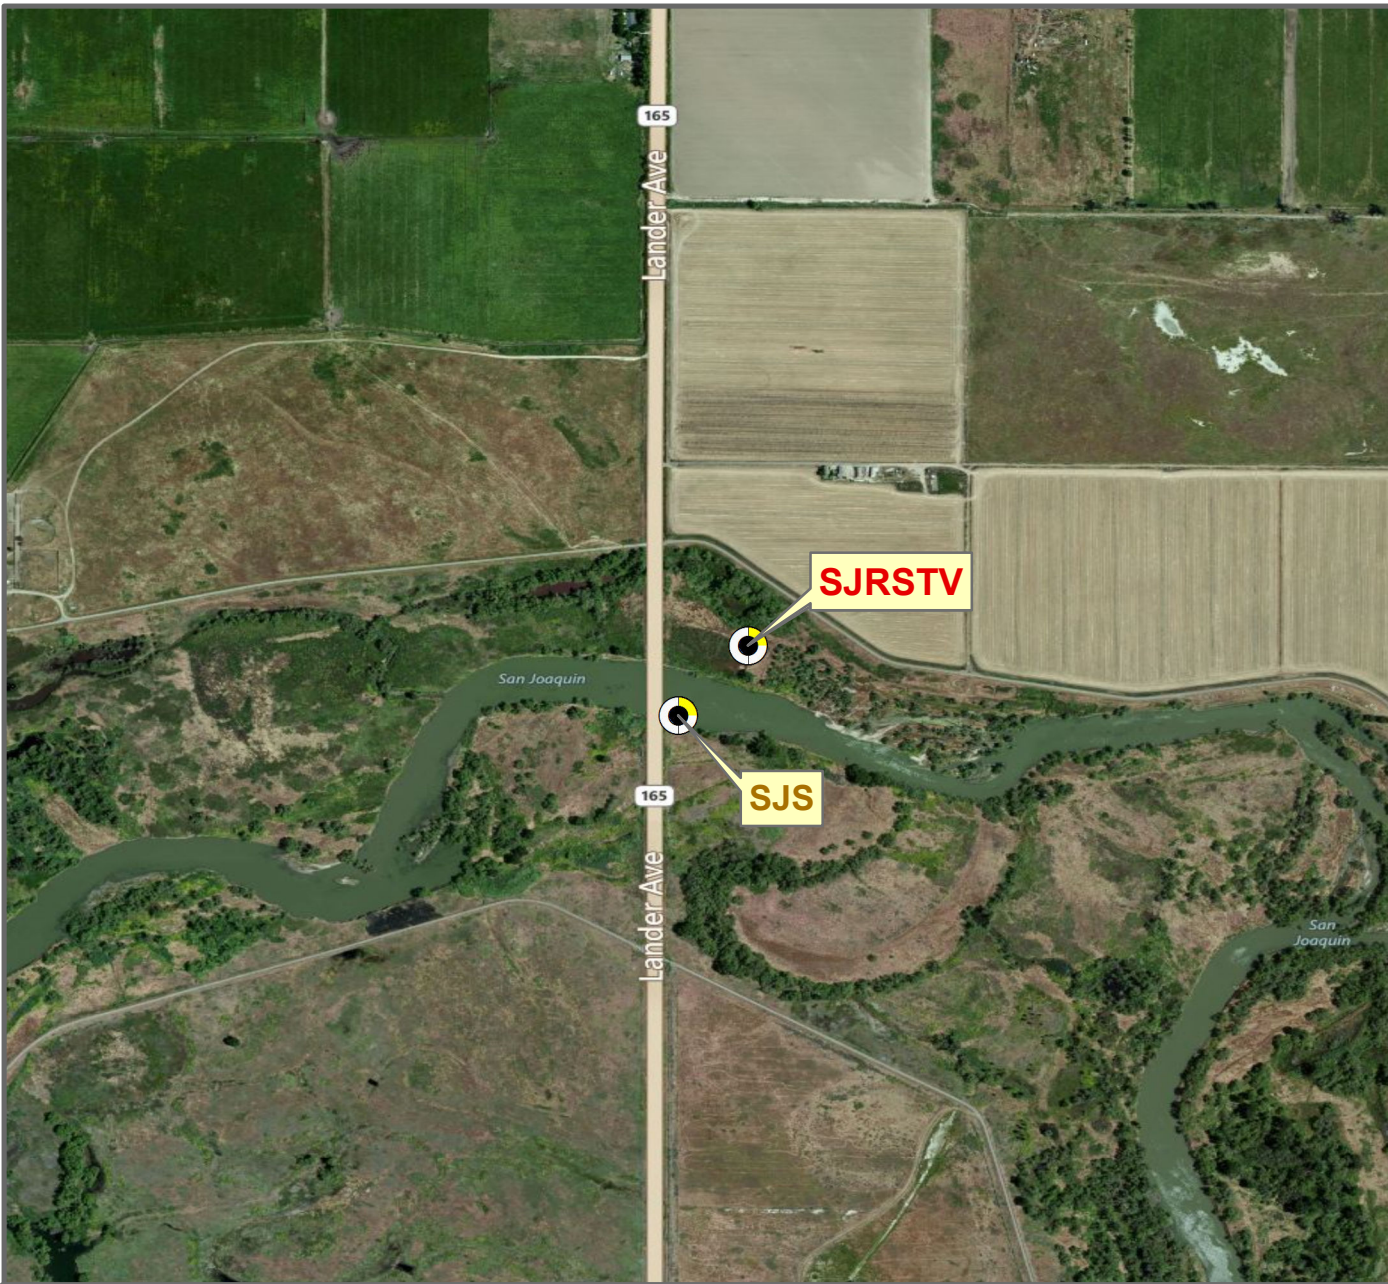
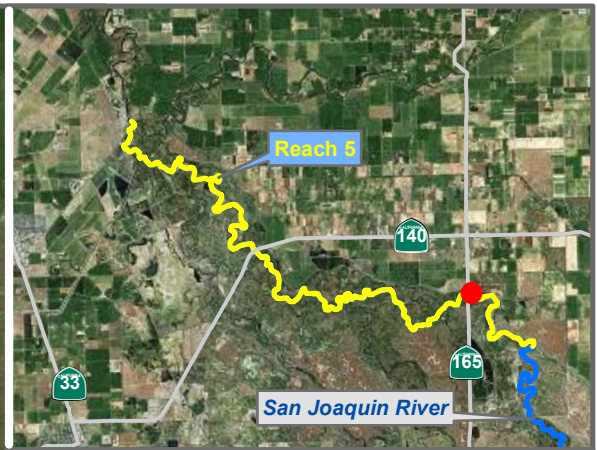
Monitoring Location SJRSTV

Reach = 5
River Mile = 132.8
Merced County
Channel Bank

X = -120.8500 Y = 37.2960 Status = Existing
(Horizontal Datum is NAD83)
Distance From River (ft) = 334
Reference Elevation (ft NAVD88) =
Site = Stevinson Bridge

Agency = DFG
Measurements:
Type = Datalogger
Interval = Hourly
Date Range = 7/31/2008 - 10/26/2010

Description:
Hwy 140 bridge - data still needs to be retrieved for
IFP

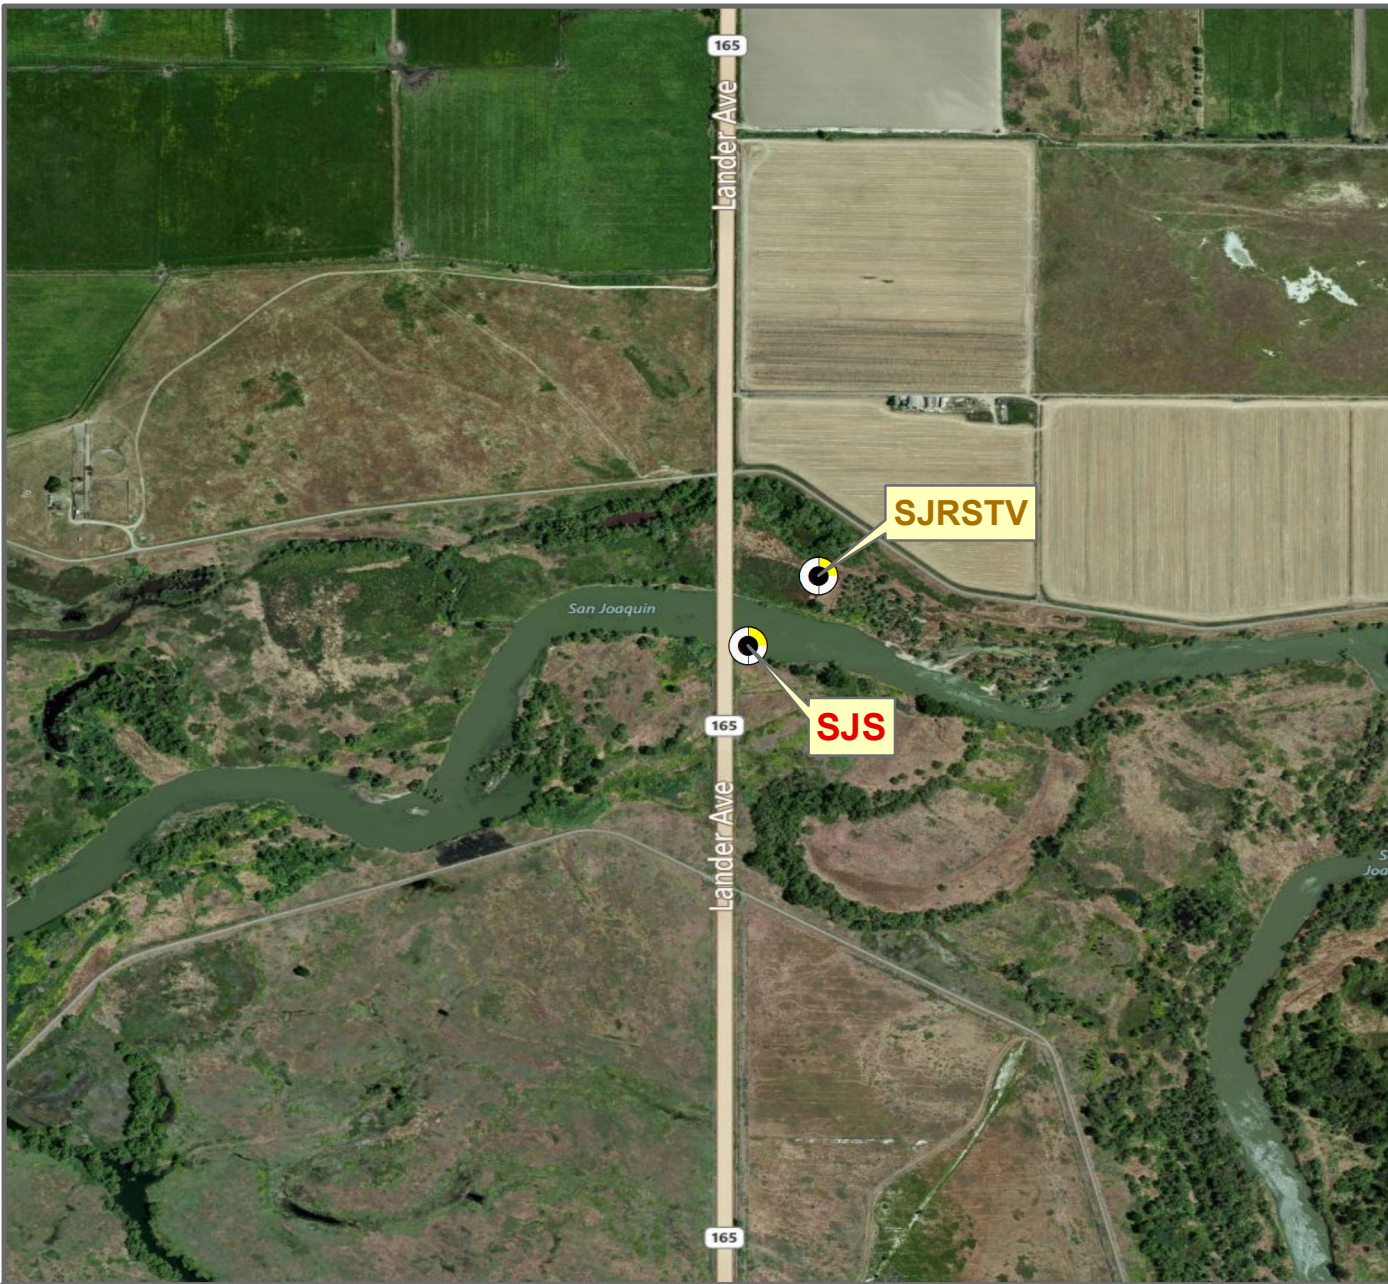
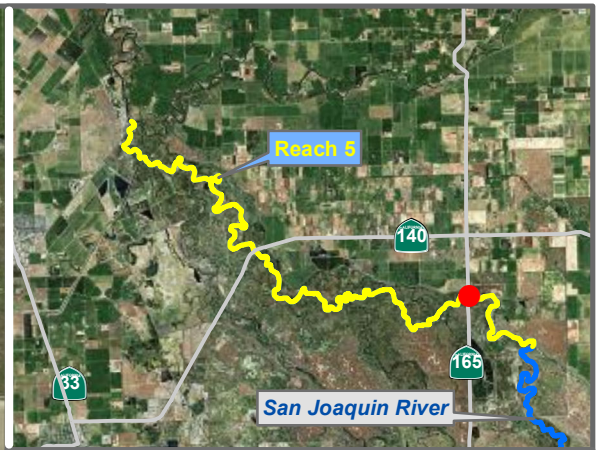
Monitoring Location SJS

Reach = 5
 River Mile = 132.8
 Merced County
 Channel Bank

X = -120.8510 Y = 37.2950 Status = Existing
 (Horizontal Datum is NAD83)
 Distance From River (ft) = 92
 Reference Elevation (ft NAVD88) =
 Site = Stevinson

Agency = DWR
 Measurements:
 Type = Telemetry
 Interval = Hourly
 Date Range = 12/6/2011 - 5/8/2012

Description:
 Sensor at real-time flow gaging station

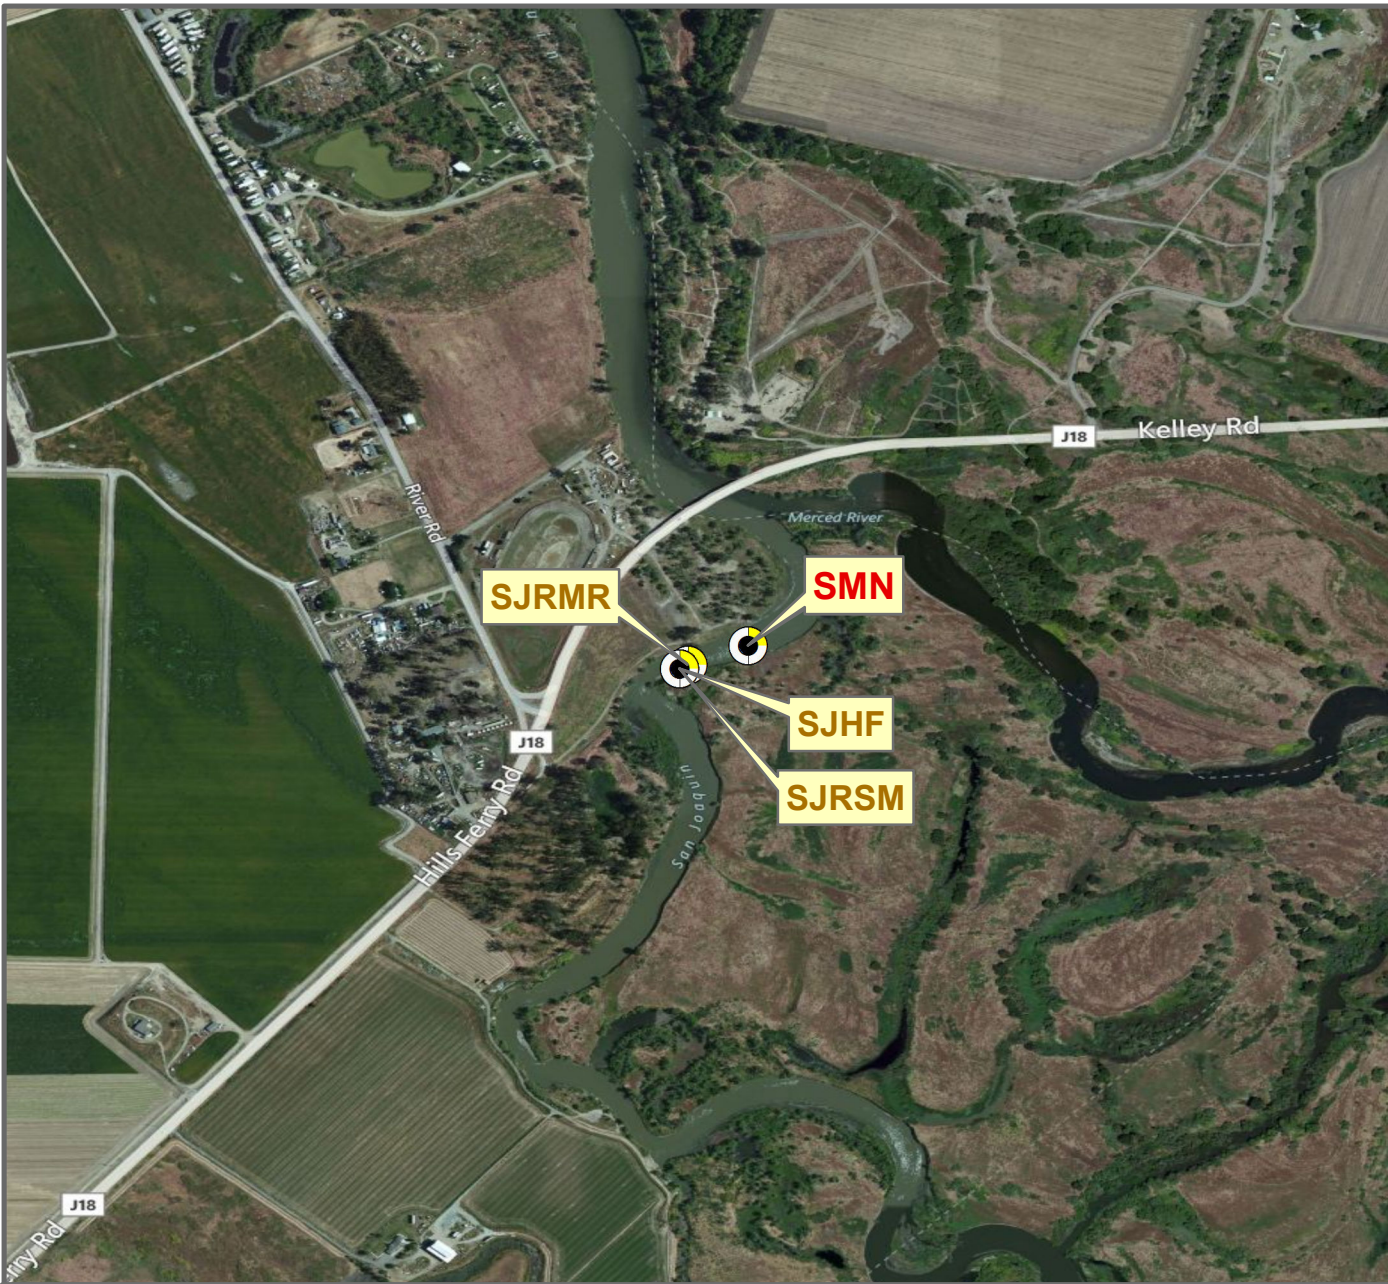
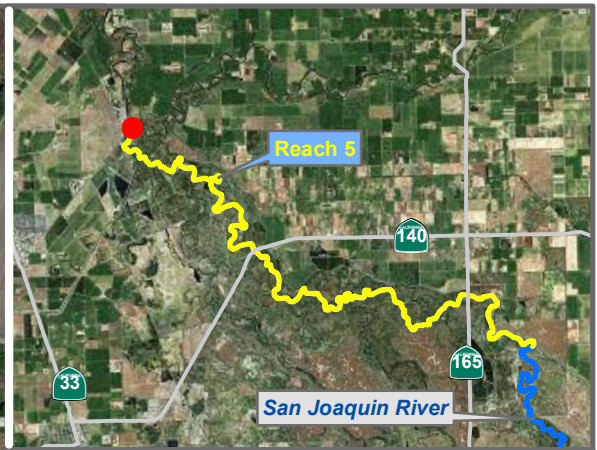
Monitoring Location SMN

Reach = 5
 River Mile = 118.4
 Stanislaus County
 Channel Bank

X = -120.9751 Y = 37.3473 Status = Existing
 (Horizontal Datum is NAD83)
 Distance From River (ft) = 22
 Reference Elevation (ft NAVD88) =
 Site = Near Newman

Agency = USGS
 Measurements:
 Type = Telemetry
 Interval = 15 min
 Timeseries unavailable

Description:
 Sensor at real-time flow gaging station

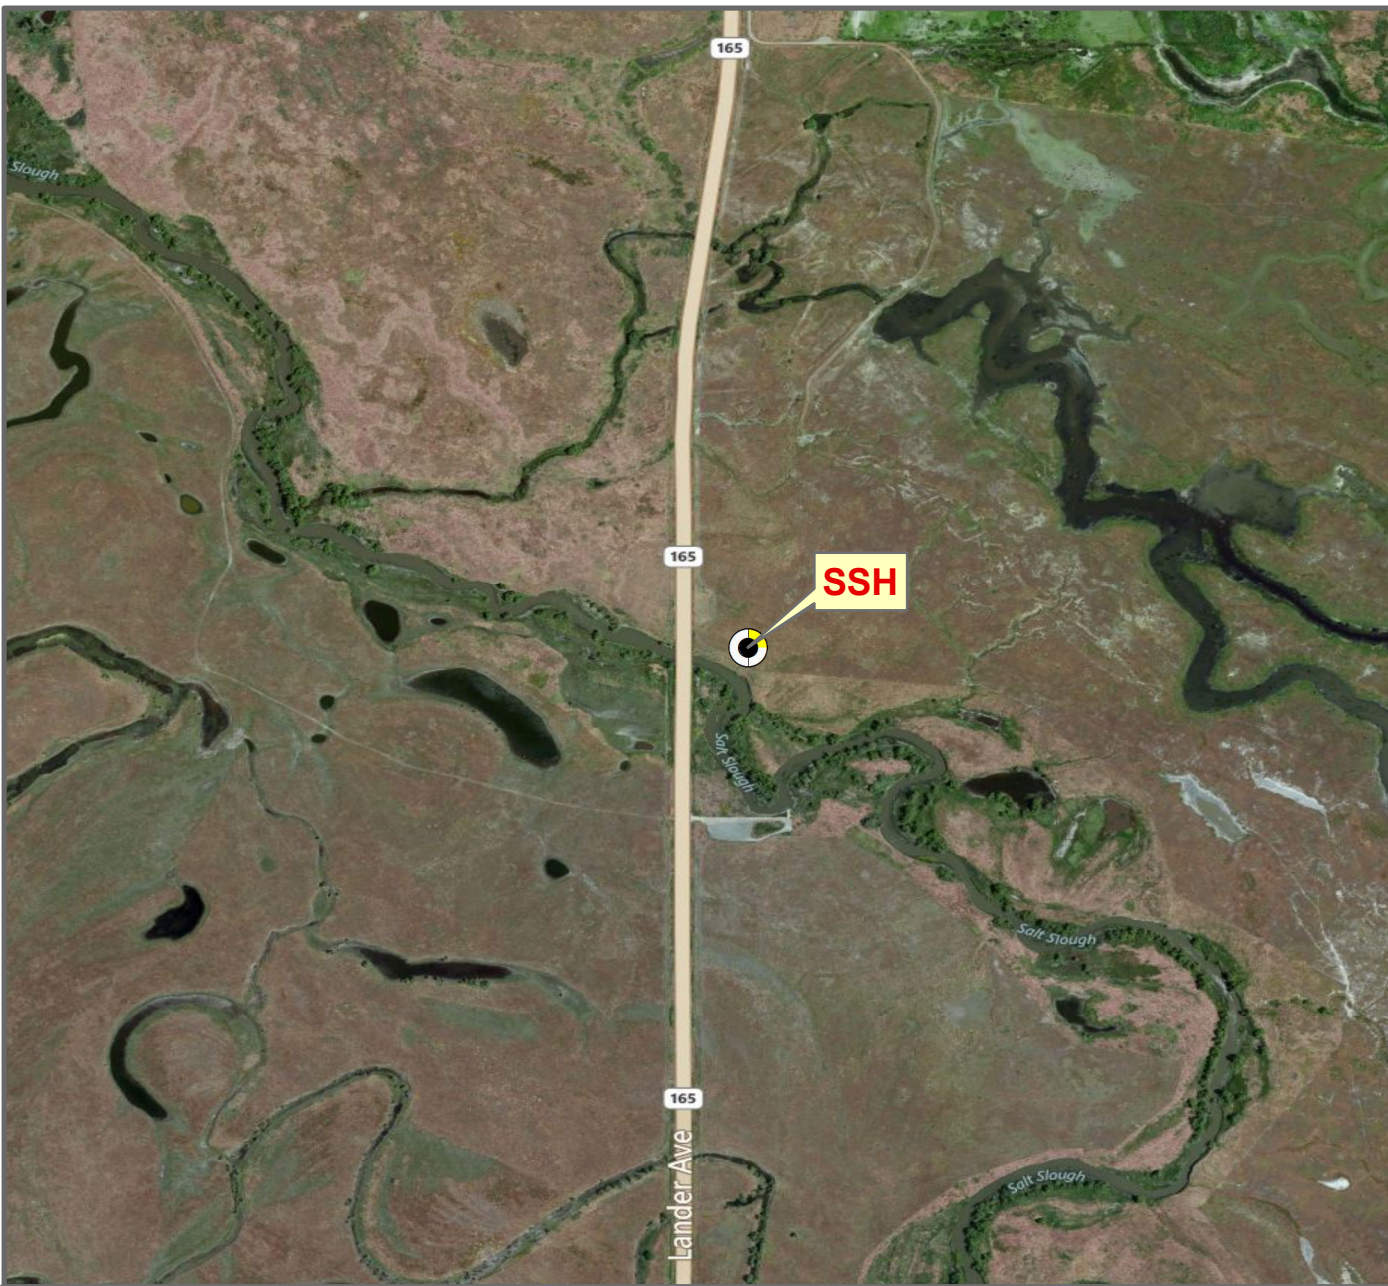
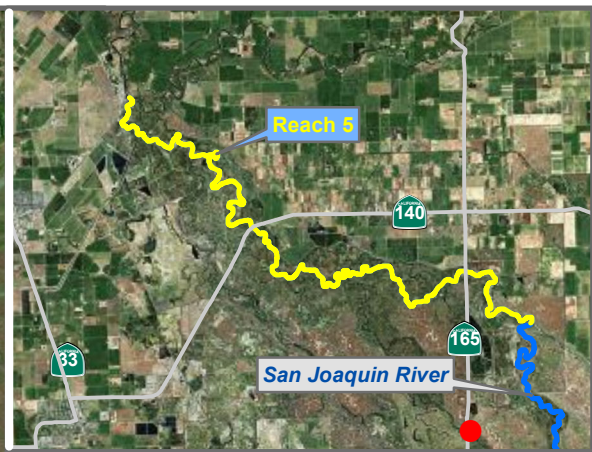
Monitoring Location SSH

Reach = 5
 River Mile = 139.0
 Merced County
 Left Bank

X = -120.8511 Y = 37.2478 Status = Existing
 (Horizontal Datum is NAD83)
 Distance From River (ft) = 8353
 Reference Elevation (ft NAVD88) =
 Site = Salt Slough

Agency = USGS
 Measurements:
 Type = Telemetry
 Interval = 15 min
 Date Range = 1/1/2009 - 5/8/2012

Description:
 Sensor at real-time flow gaging station

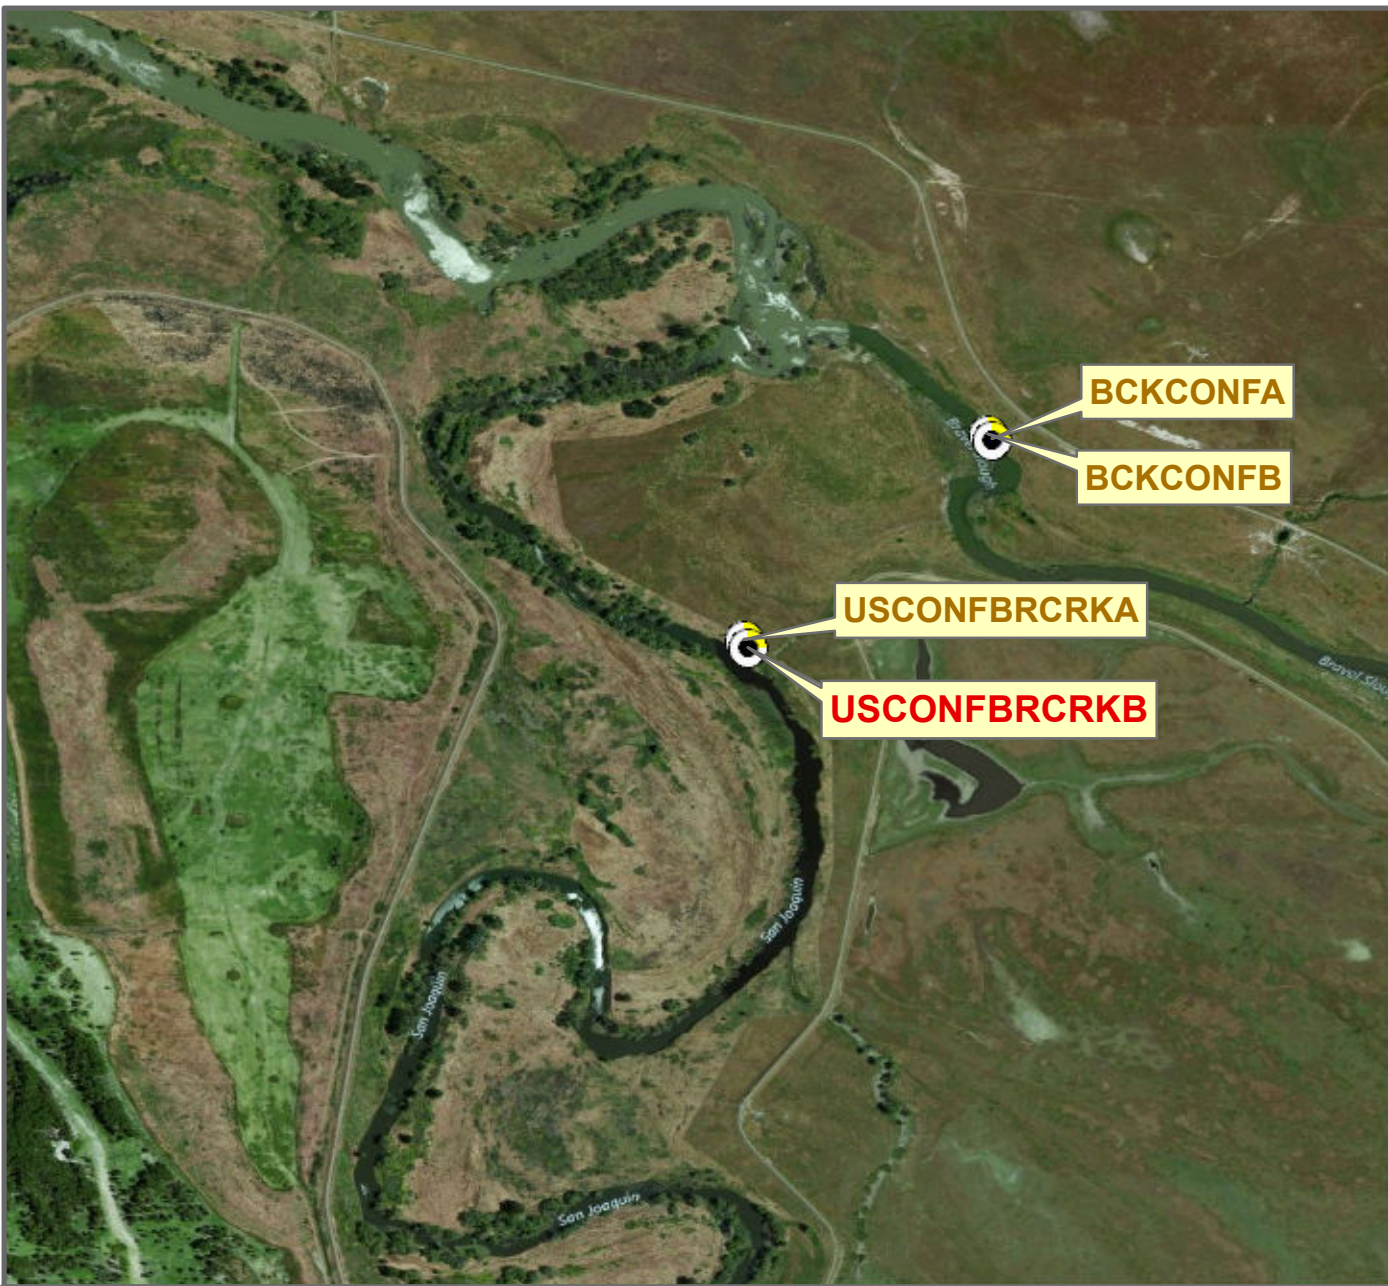
Monitoring Location USCONFBRCKB

Reach = 5
 River Mile = 136.4
 Merced County
 Right Bank

X = -120.8275 Y = 37.2749 Status = Existing
 (Horizontal Datum is NAD83)
 Distance From River Centerline (ft)=
 Reference Elevation (ft NAVD88) =
 Site = SJR Upstream of Confluence with Bear
 Creek

Agency = USBR
 Measurements:
 Type = Datalogger
 Interval = Hourly
 Timeseries unavailable

Description:
 Cabled to willow tree downstream of access ramp
 from levee road. 20 ft upstream of
 SJRCONFBEARCREKA.
