RECLAMATION
Managing Water in the West

Reach 3 Temperature Monitoring Sites

SAN JOAQUIN RIVER
RESTORATION PROGRAM

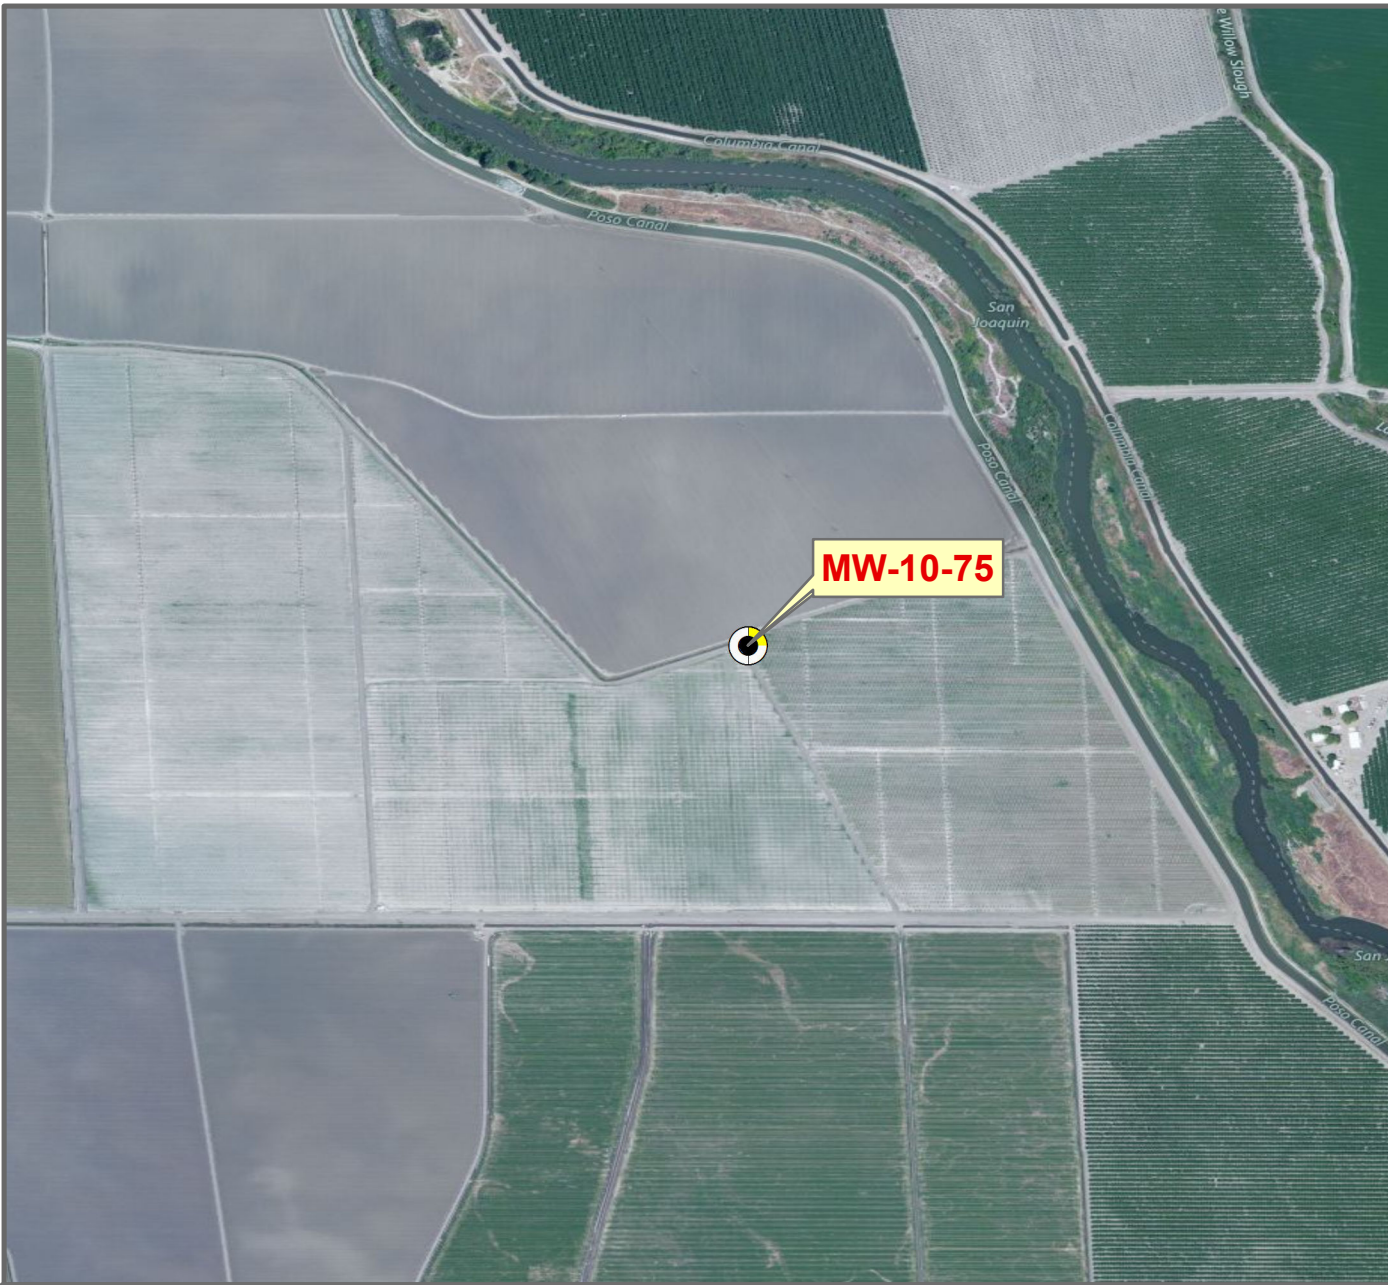
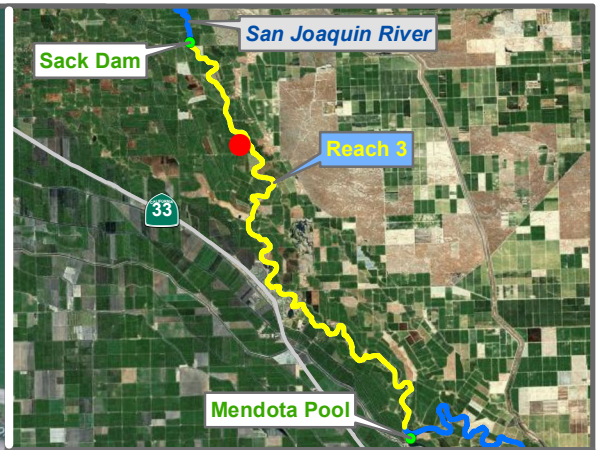
Monitoring Location MW-10-75

Reach = 3
 River Mile = 187.0
 Status = Existing
 (Horizontal Datum is NAD83)
 Distance From River (ft) = 1741
 Reference Elevation (ft NAVD88) = 133.10
 Site = Oxalis Ave

Agency = USBR
 Measurements:
 Type = Realtime
 Interval = Hourly
 Timeseries unavailable

Description:
 2 inch PVC casing AG

Ground Surface Elevation (ft) = 131.80
 Monitoring Depth (ft) = 13.7 - 28.7 ft below gs

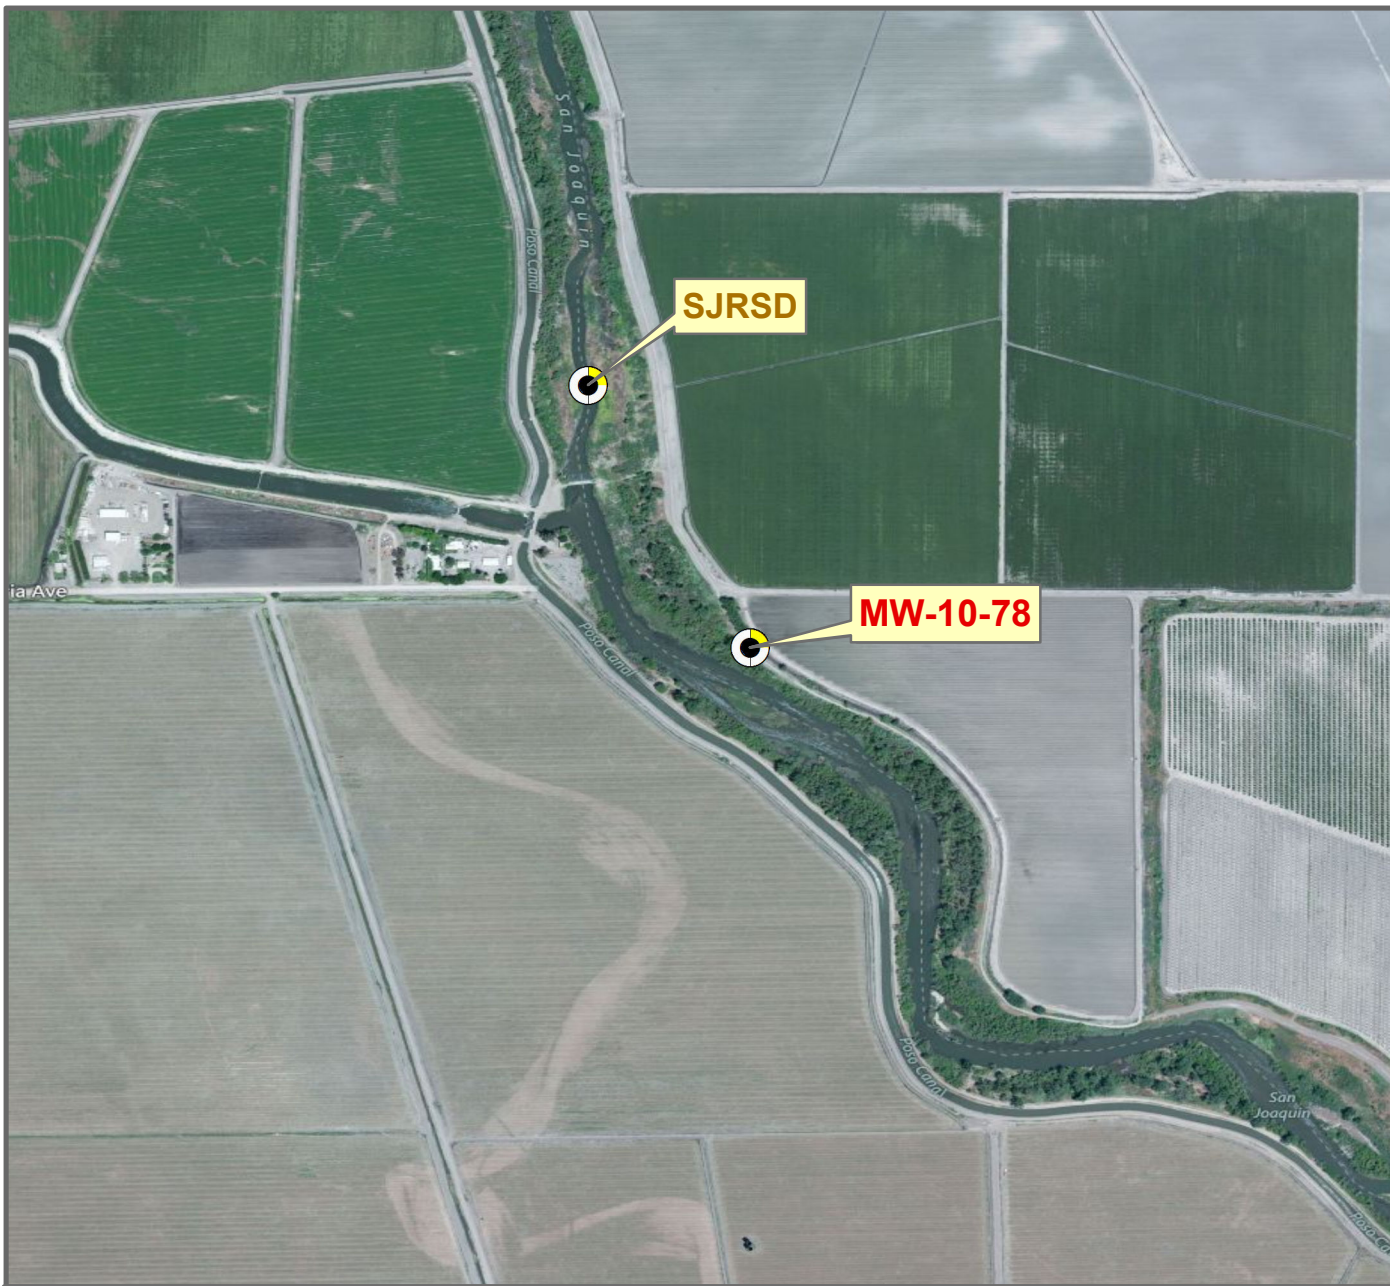
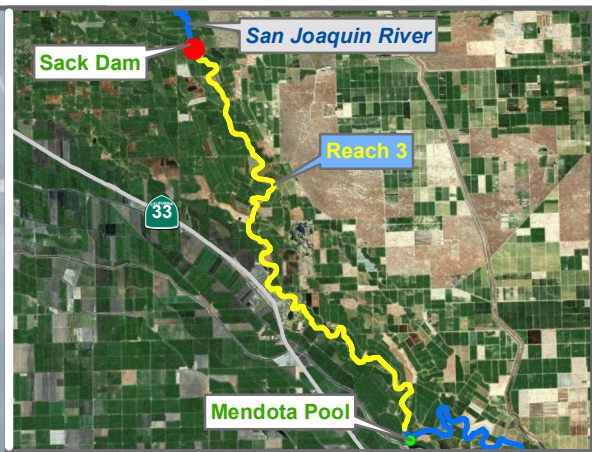
Monitoring Location MW-10-78

Reach = 3
 River Mile = 182.2
 Madera County
 Right Bank

X = -120.4977 Y = 36.9813 Status = Existing
 (Horizontal Datum is NAD83)
 Distance From River (ft)= 204
 Reference Elevation (ft NAVD88) = 127.80
 Site = TBD

Agency = USBR
 Measurements:
 Type = Datalogger
 Interval = Hourly
 Timeseries unavailable

Description:
 2 inch PVC casing AG

Ground Surface Elevation (ft) = 125.30
 Monitoring Depth (ft) = 10-25 ft below gs

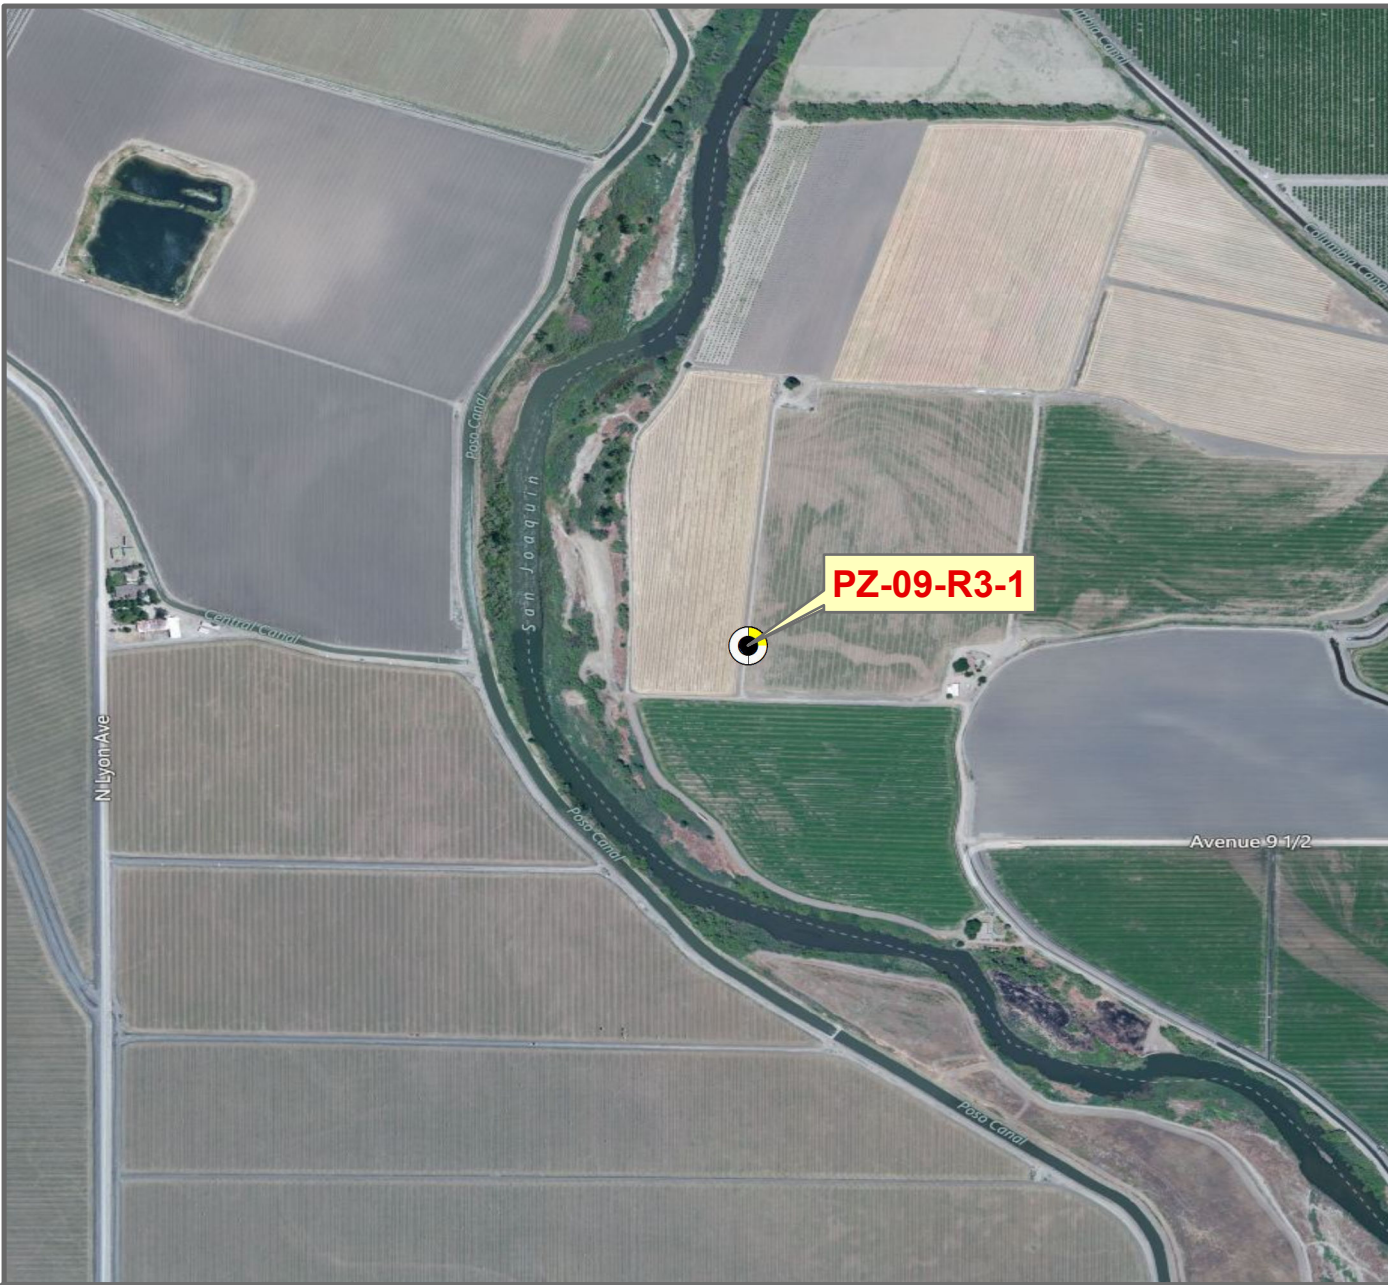
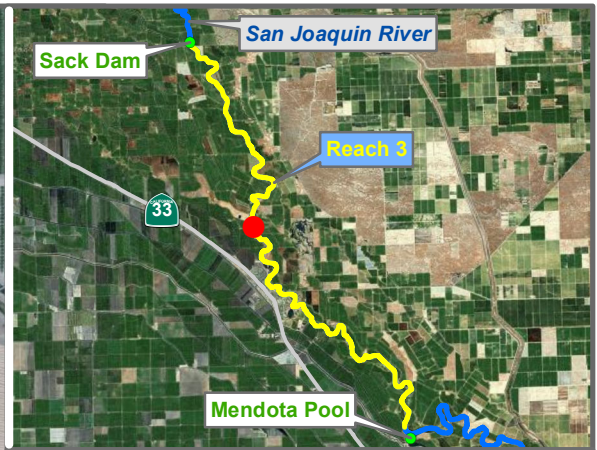
Monitoring Location PZ-09-R3-1

Reach = 3
 River Mile = 191.6
 Madera County
 Right Bank
 X = -120.4636 Y = 36.8901 Status = Existing
 (Horizontal Datum is NAD83)
 Distance From River (ft) = 1058
 Reference Elevation (ft NAVD88) = TBD
 Site = NA

Agency = USBR
 Measurements:
 Type = Realtime
 Interval = Hourly
 Timeseries unavailable

Description:
 1.25 inch galv pipe

Ground Surface Elevation (ft) = TBD
 Monitoring Depth (ft) = 9-24 ft below gs

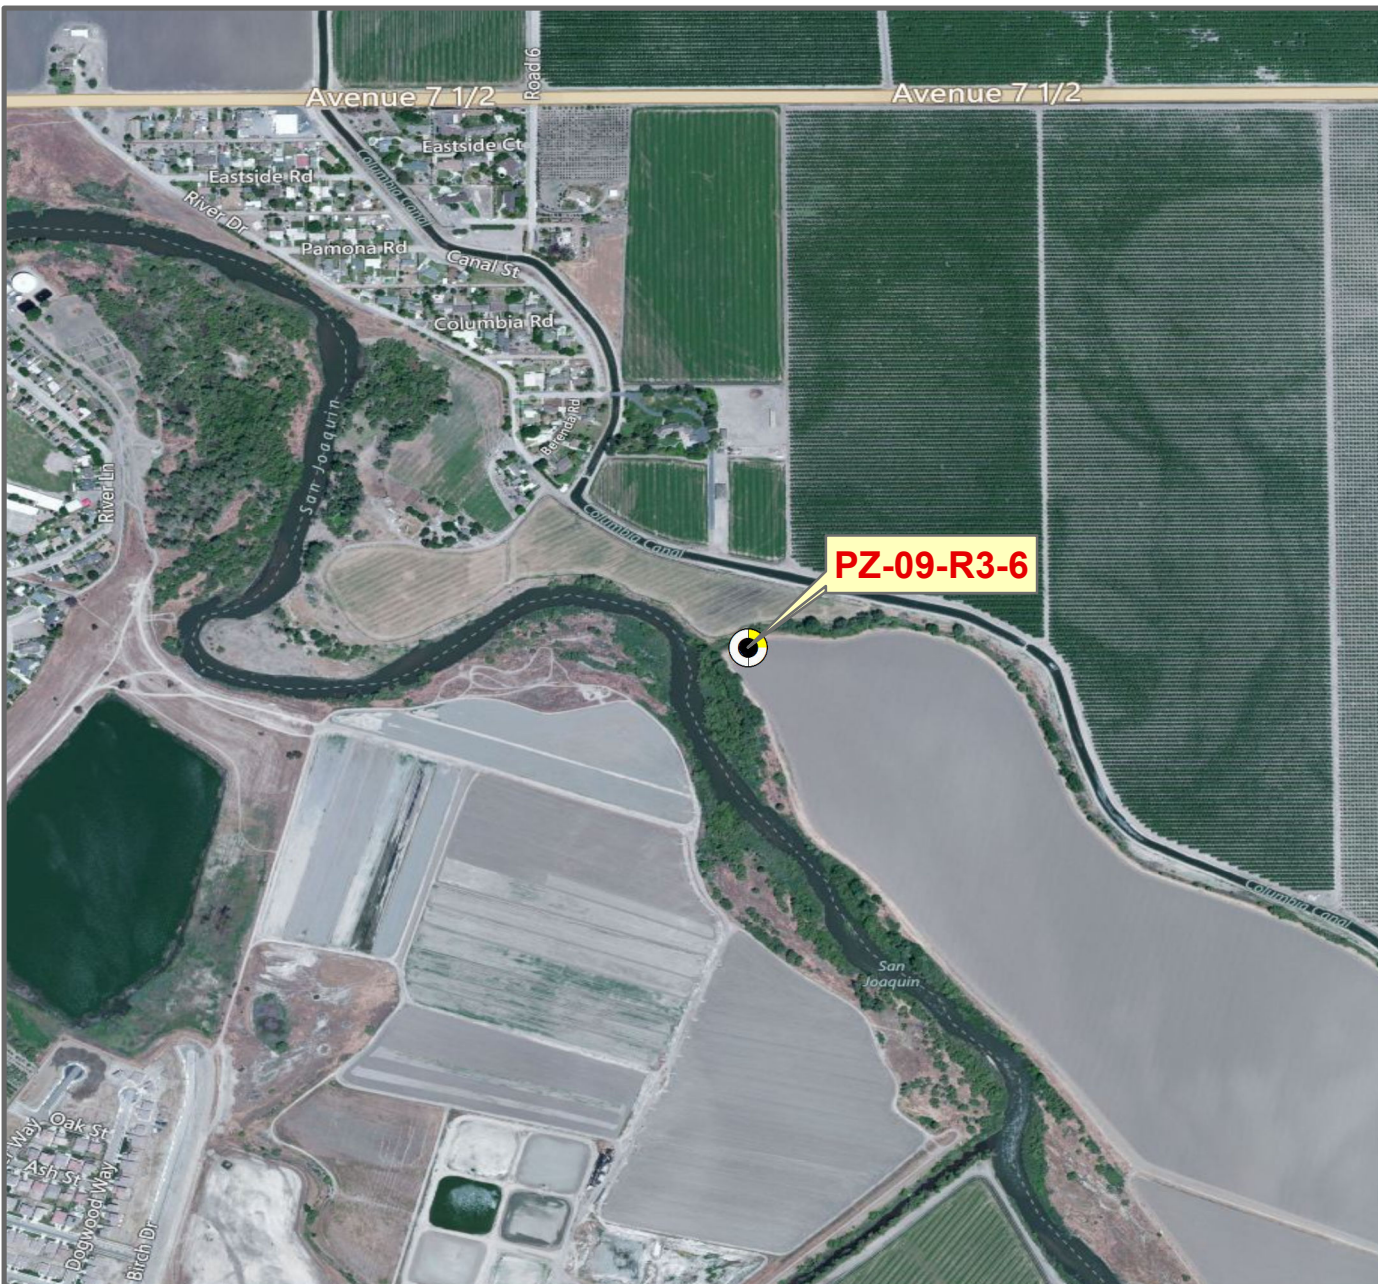
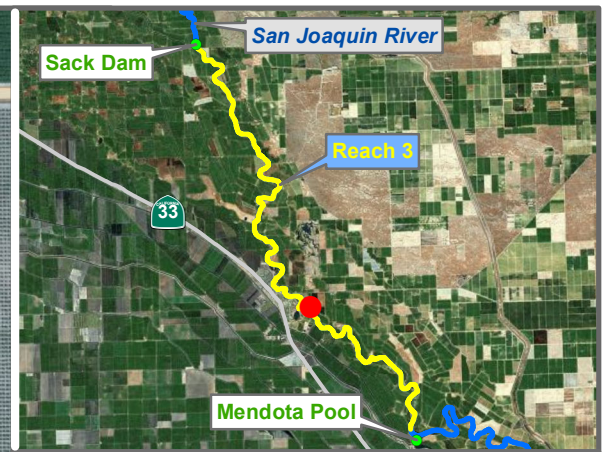
Monitoring Location PZ-09-R3-6

Reach = 3
 River Mile = 196.6
 Madera County
 Right Bank
 X = -120.4328 Y = 36.8505 Status = Existing
 (Horizontal Datum is NAD83)
 Distance From River (ft) = 341
 Reference Elevation (ft NAVD88) = TBD
 Site = NA

Agency = USBR
 Measurements:
 Type = Datalogger
 Interval = Hourly
 Timeseries unavailable

Description:
 1.25 inch galv pipe

Ground Surface Elevation (ft) = TBD
 Monitoring Depth (ft) = 17-20 ft below gs

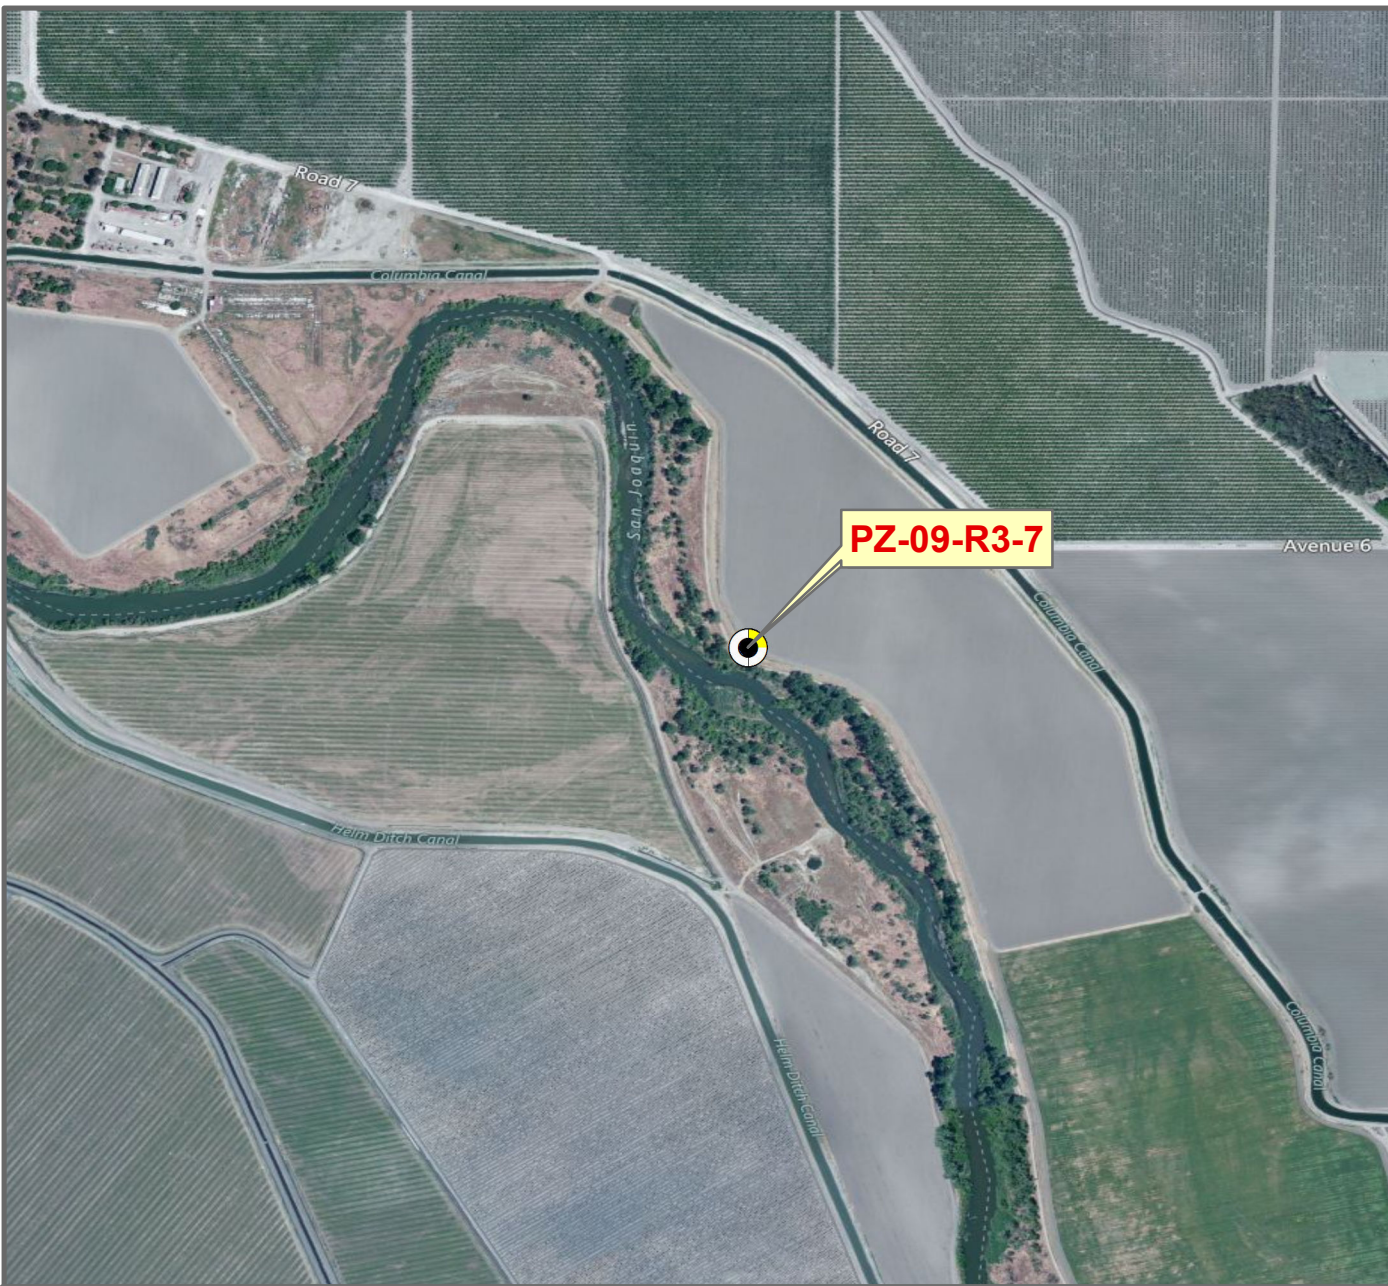
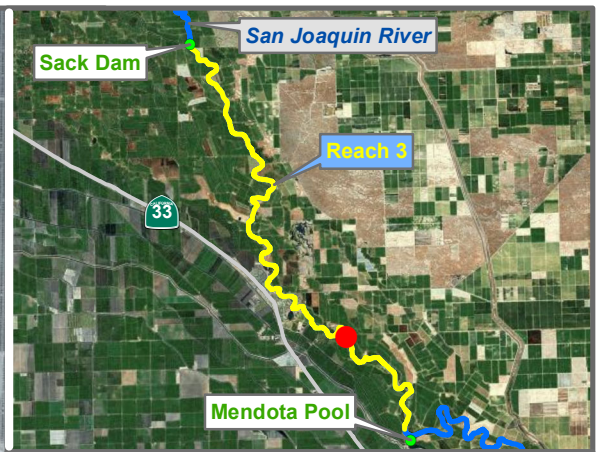
Monitoring Location PZ-09-R3-7

Reach = 3
 River Mile = 199.2
 Status = Existing
 (*Horizontal Datum is NAD83*)
 Distance From River (ft) = 195
 Reference Elevation (ft NAVD88) = TBD
 Site = NA

Agency = USBR
 Measurements:
 Type = Realtime
 Interval = Hourly
 Timeseries unavailable

Description:
 2 inch galv casing

Ground Surface Elevation (ft) = TBD
 Monitoring Depth (ft) = 17-20 ft below gs

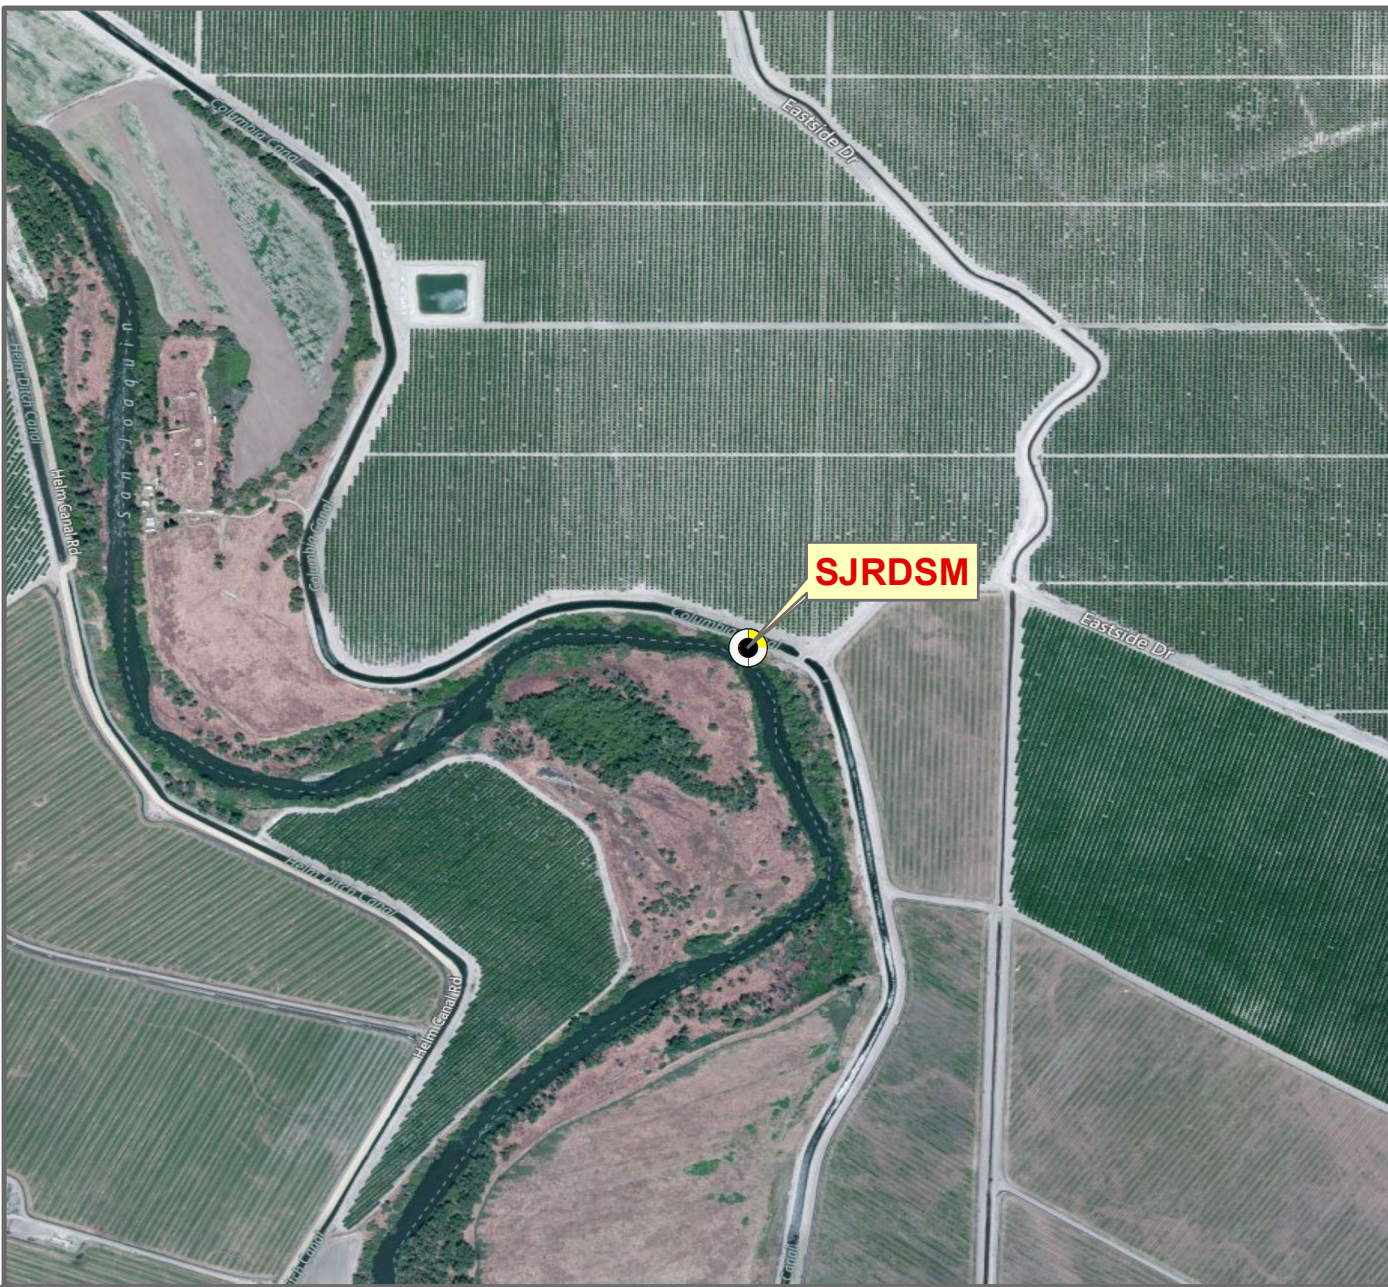
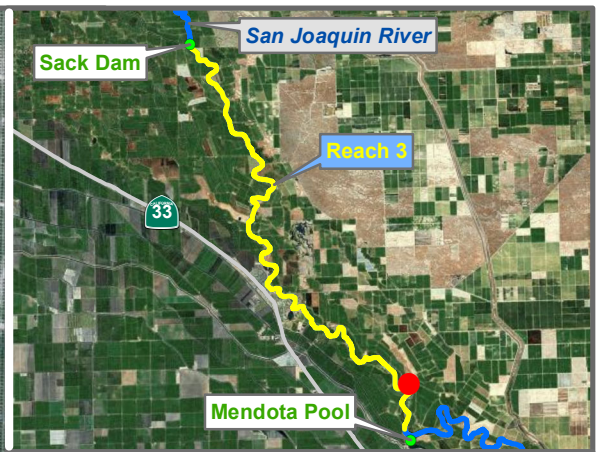
Monitoring Location SJRDSM

Reach = 3
 River Mile = 202.9
 Madera County
 Right Bank
 X = -120.3692 Y = 36.8105 Status = Existing
 (Horizontal Datum is NAD83)
 Distance From River (ft) = 75
 Reference Elevation (ft NAVD88) =
 Site = Downstream Mendota

Agency = DFG
 Measurements:
 Type =
 Interval =
 Date Range = 10/3/2011 - 12/22/2011

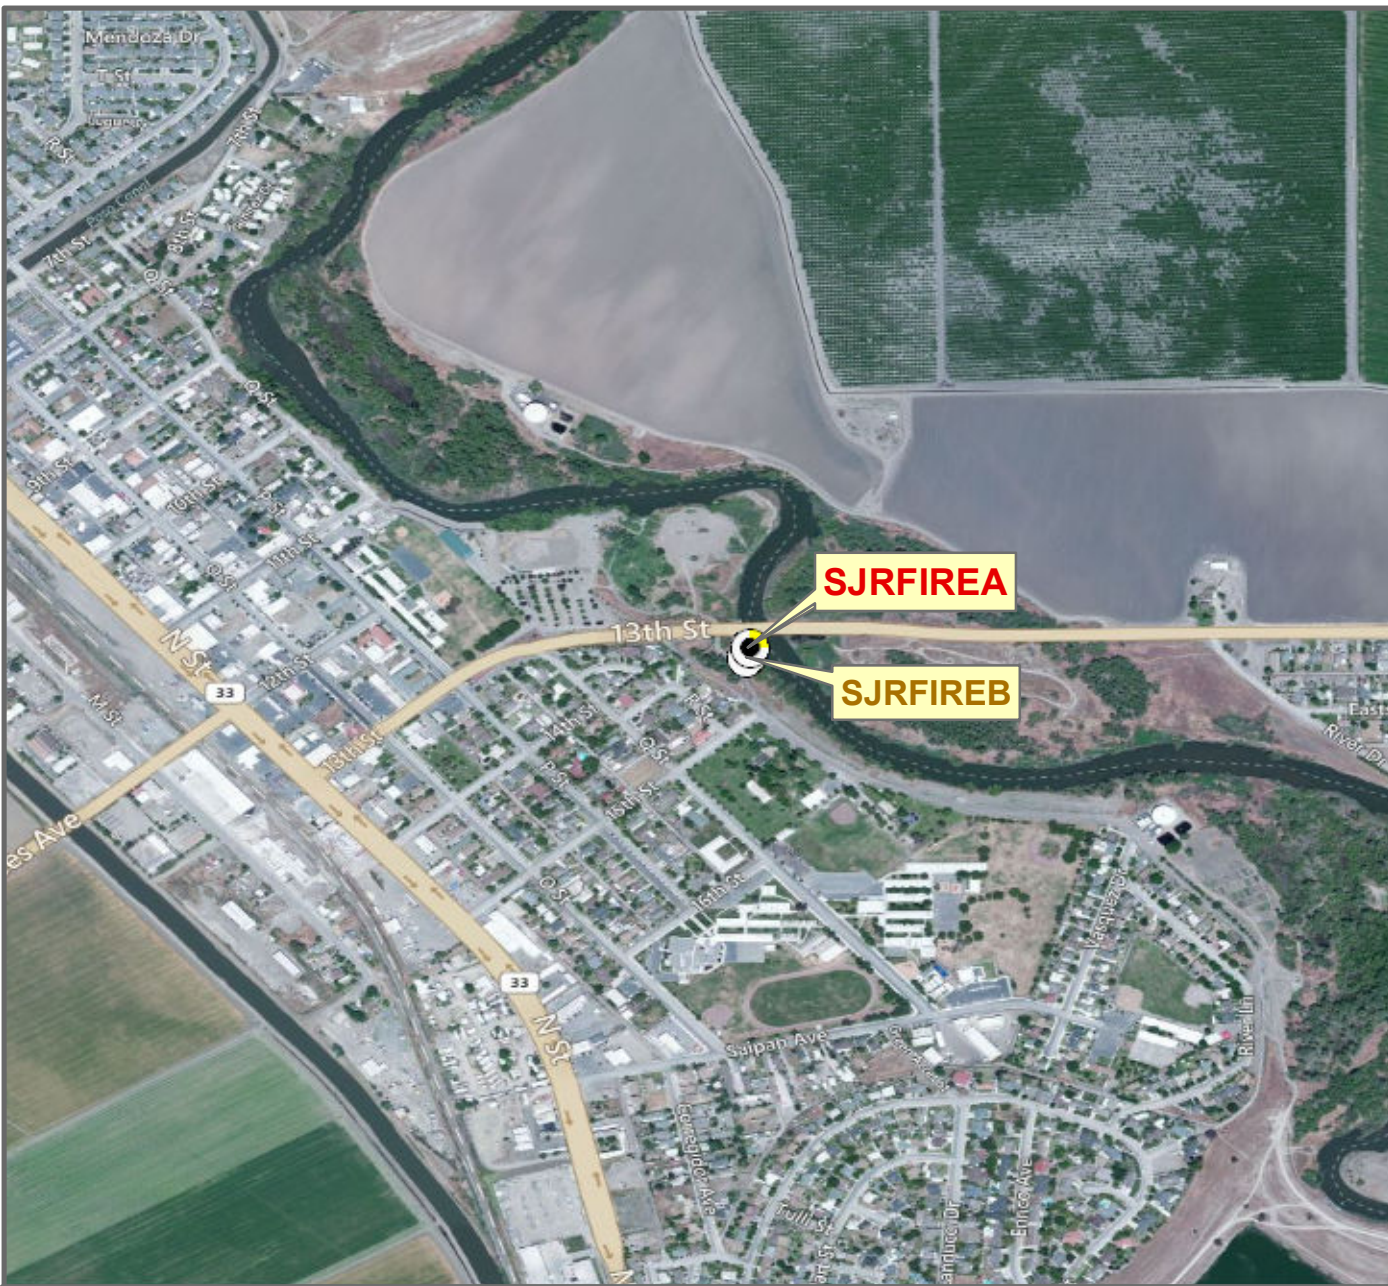
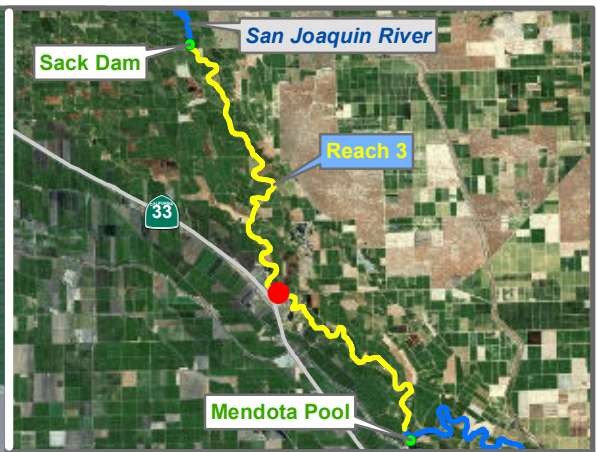
Monitoring Location SJR FIREA

Reach = 3
 River Mile = 195.1
 Status = Existing
 (Horizontal Datum is NAD83)
 Distance From River Centerline (ft)=
 Reference Elevation (ft NAVD88) =
 Site = Firebaugh Bridge, Ave 7 1/2 at SJR

Agency = USBR
 Measurements:
 Type = Datalogger
 Interval = Hourly
 Timeseries unavailable

Description:
 Cabled to tree root. 150 ft upstream of south end of bridge. 10 ft downstream of SJR FIREB.

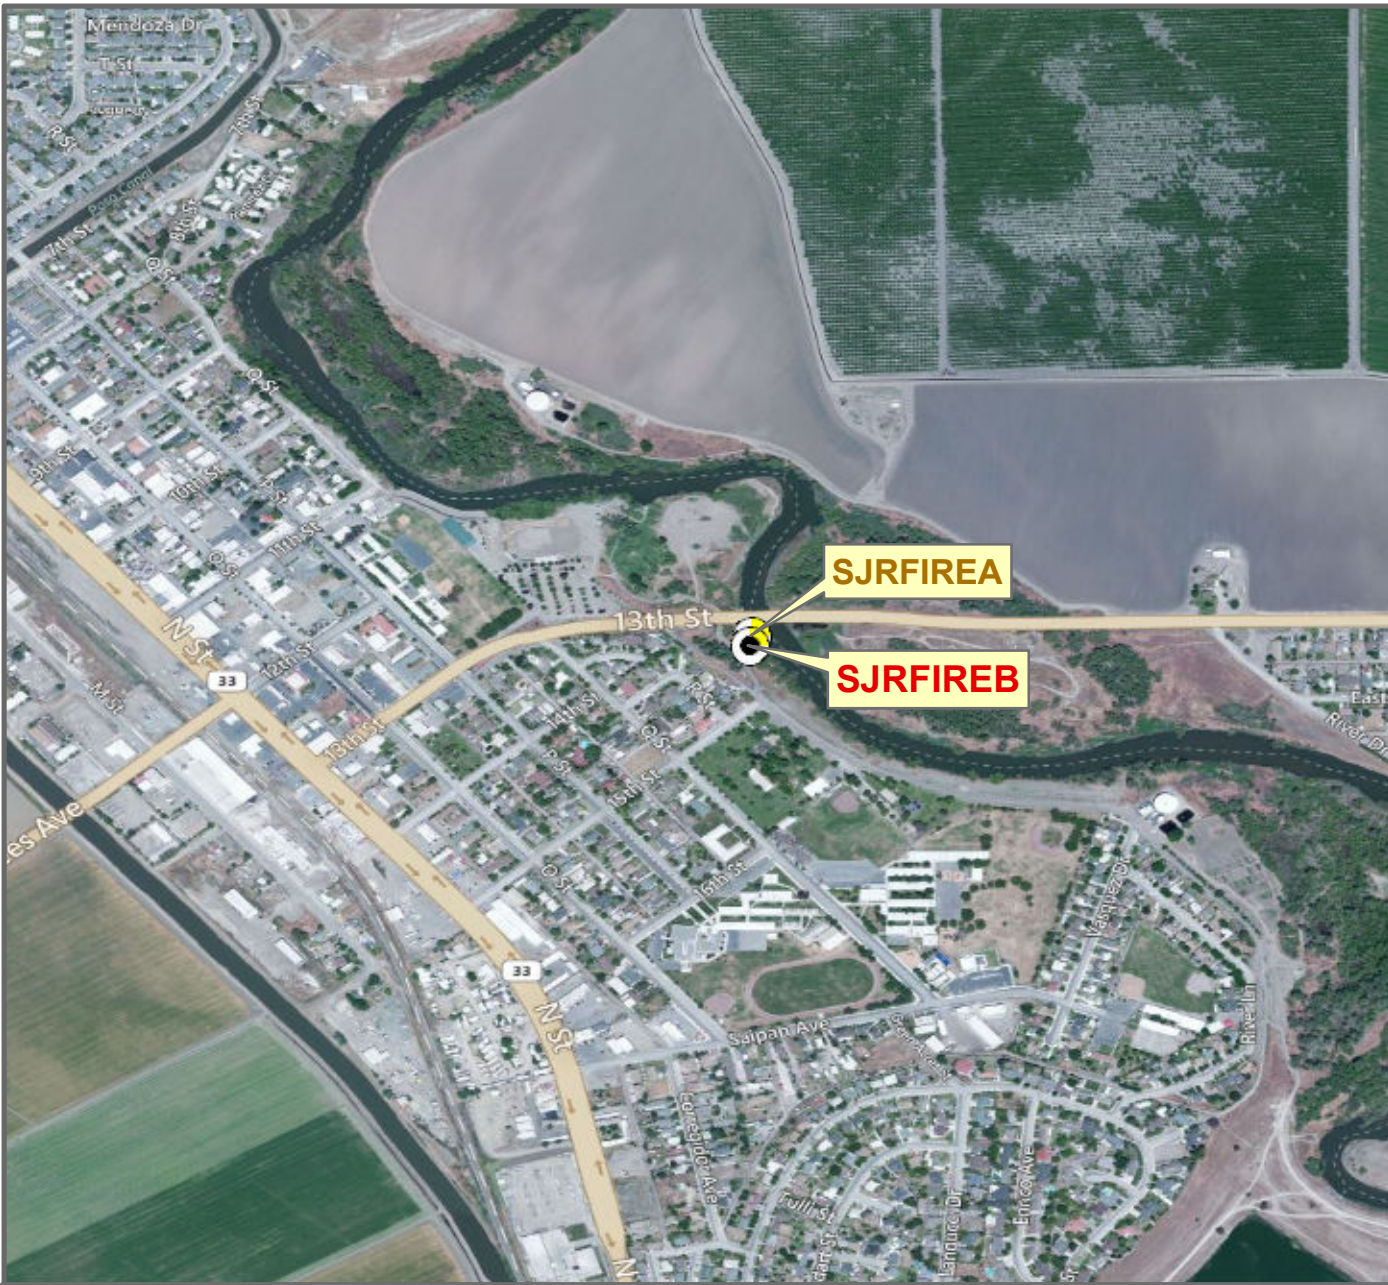
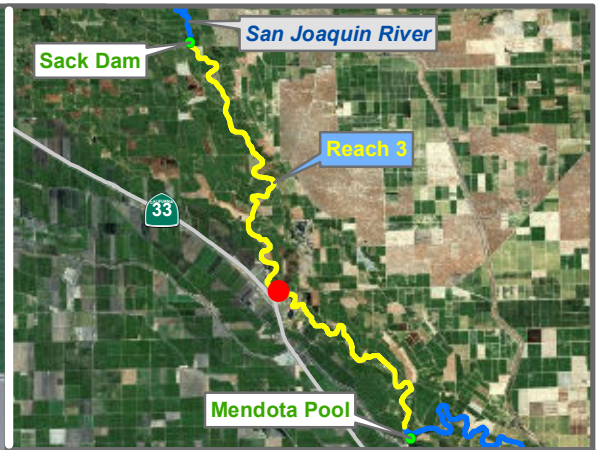
Monitoring Location SJR FIREB

Reach = 3
 River Mile = 195.1
 Fresno County
 Left Bank

X = -120.4491 Y = 36.8579 Status = Existing
 (Horizontal Datum is NAD83)
 Distance From River Centerline (ft)=
 Reference Elevation (ft NAVD88) =
 Site = Firebaugh Bridge, Ave 7 1/2 at SJR

Agency = USBR
 Measurements:
 Type = Datalogger
 Interval = Hourly
 Timeseries unavailable

Description:
 Cabled to downed tree. 150 ft upstream of south end of bridge. 10 ft upstream of SJRFIREA.

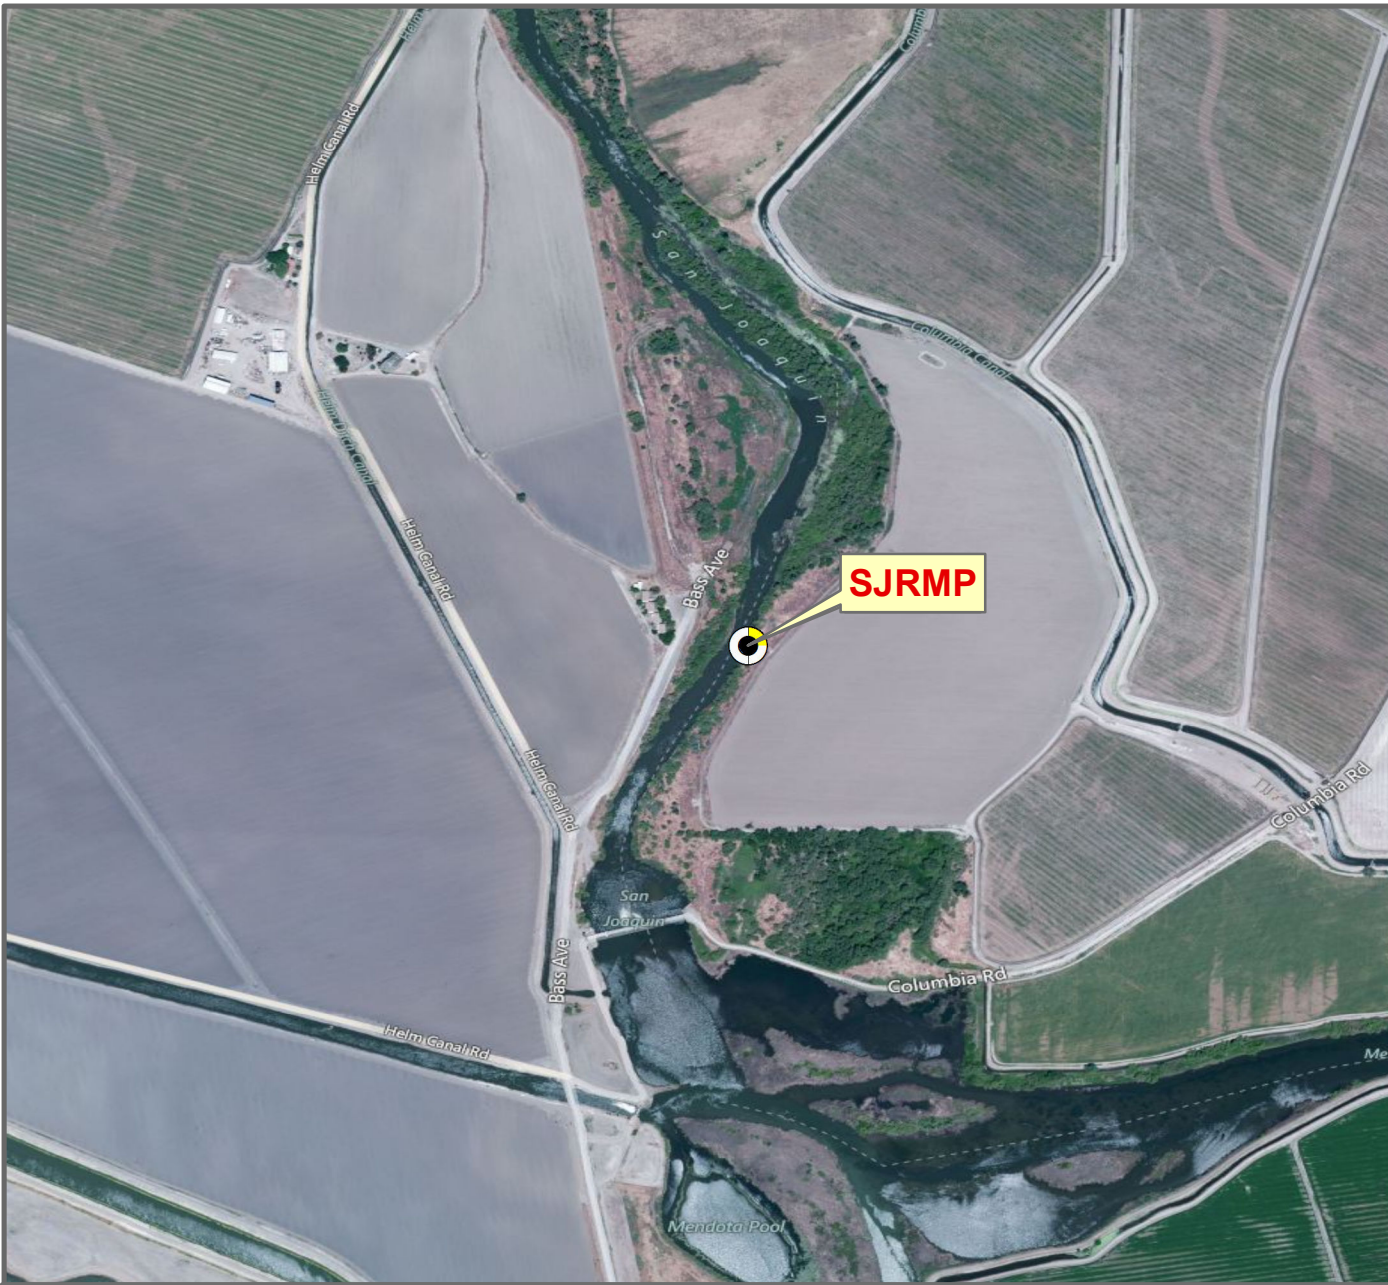
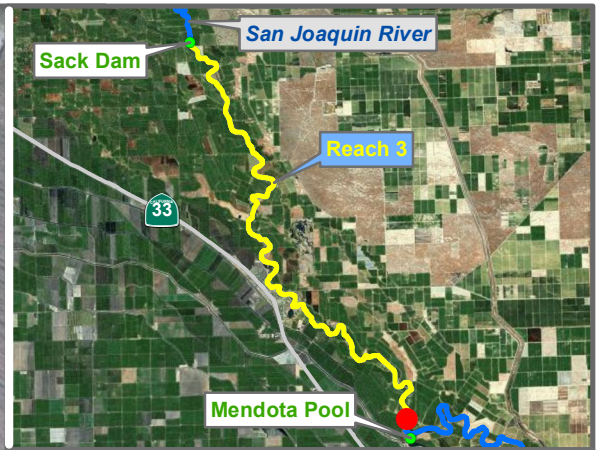
Monitoring Location SJRMP

Reach = 3
 River Mile = 204.5
 Madera County
 Right Bank
 X = -120.3712 Y = 36.7921 Status = Existing
 (Horizontal Datum is NAD83)
 Distance From River (ft) = 66
 Reference Elevation (ft NAVD88) =
 Site = Mendota Pool

Agency = DFG
 Measurements:
 Type = Datalogger
 Interval = Hourly
 Date Range = 4/30/2009 - 10/3/2011

Description:
 Downstream of Mendota Pool. Cabled to tree on RR.

Ground Surface Elevation (ft) =
 Monitoring Depth (ft) = 1 ft above gs

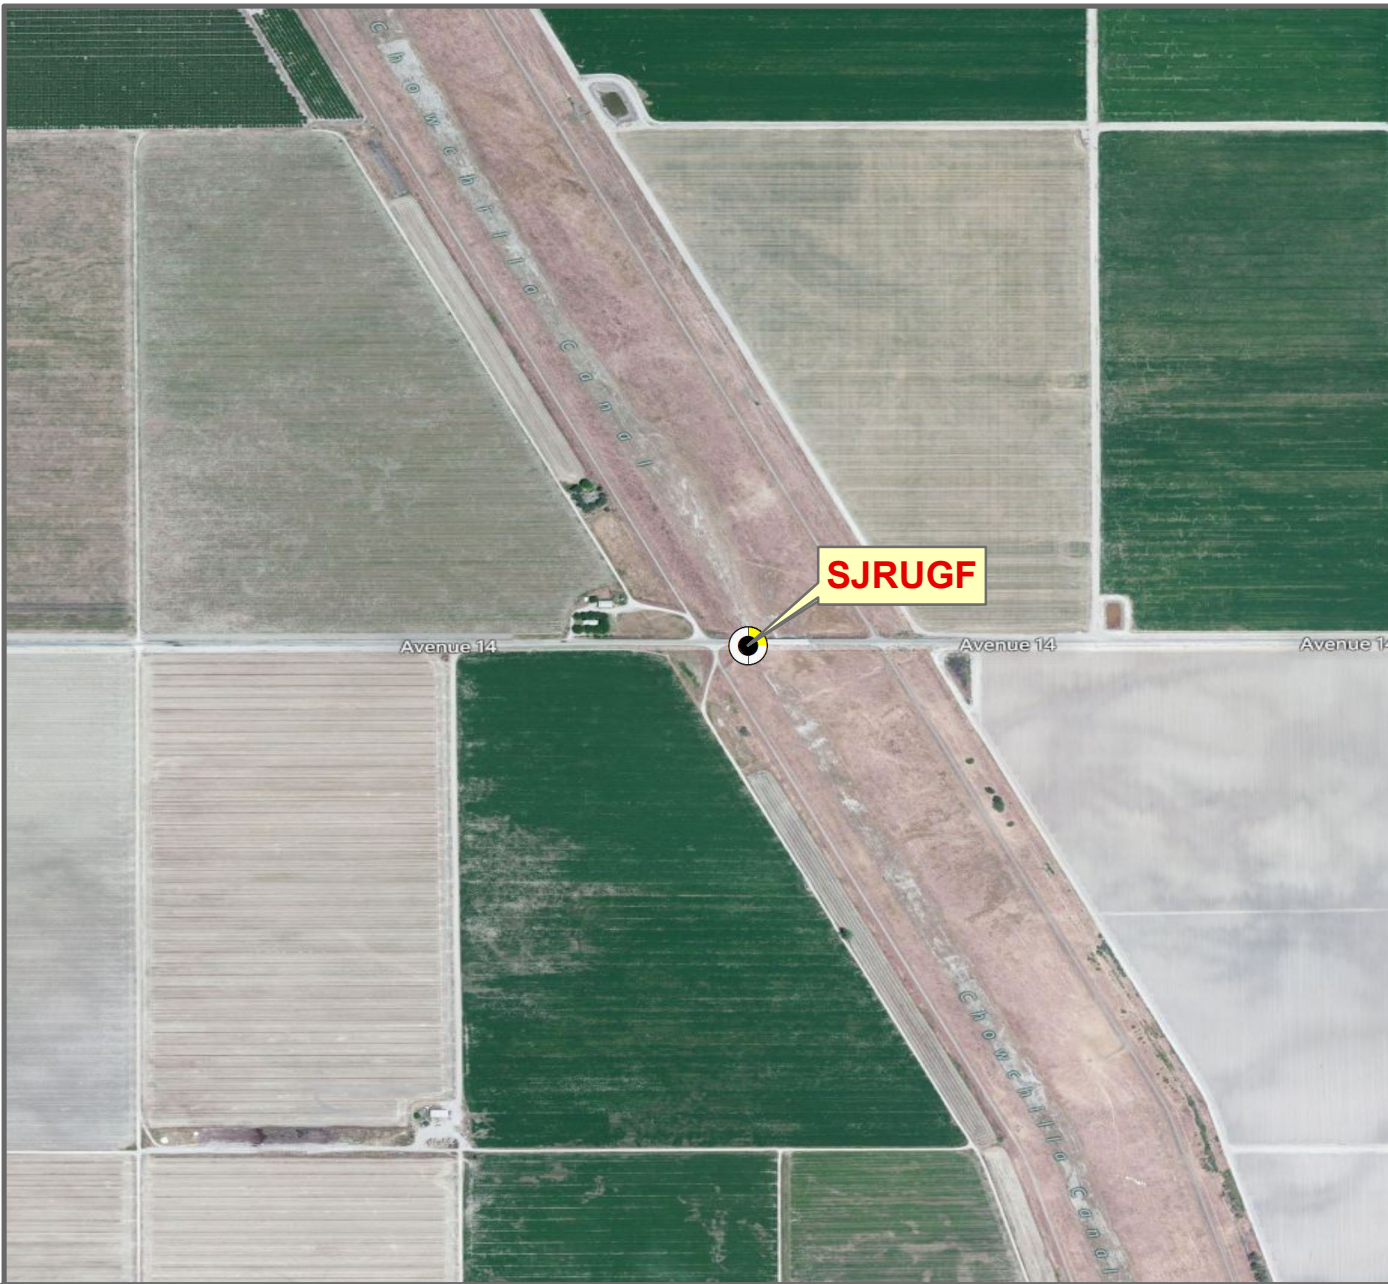
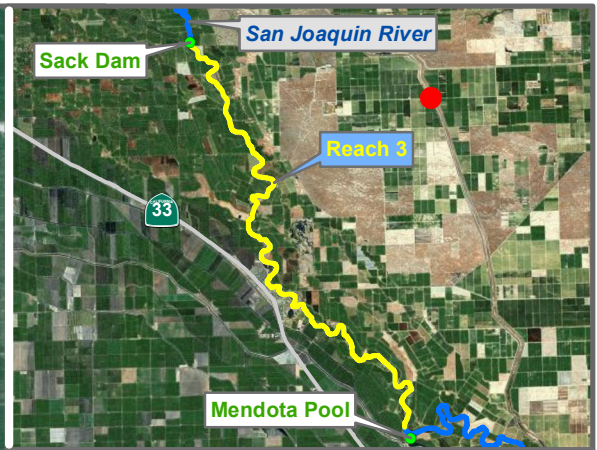
Monitoring Location SJRUGF

Reach = 3
 River Mile = Madera County
 Right Bank

X = -120.3509 Y = 36.9525 Status =
 (Horizontal Datum is NAD83)
 Distance From River (ft) = 56
 Reference Elevation (ft NAVD88) =
 Site = Gravelly Ford

Agency = DFG
 Measurements:
 Type = Datalogger
 Interval =
 Timeseries unavailable

Description:
 Approx. one mile downstream of Skaggs Park.
 Cabled to tree on RR.
