Reach 2B

Temperature Monitoring Sites

Preliminary Data

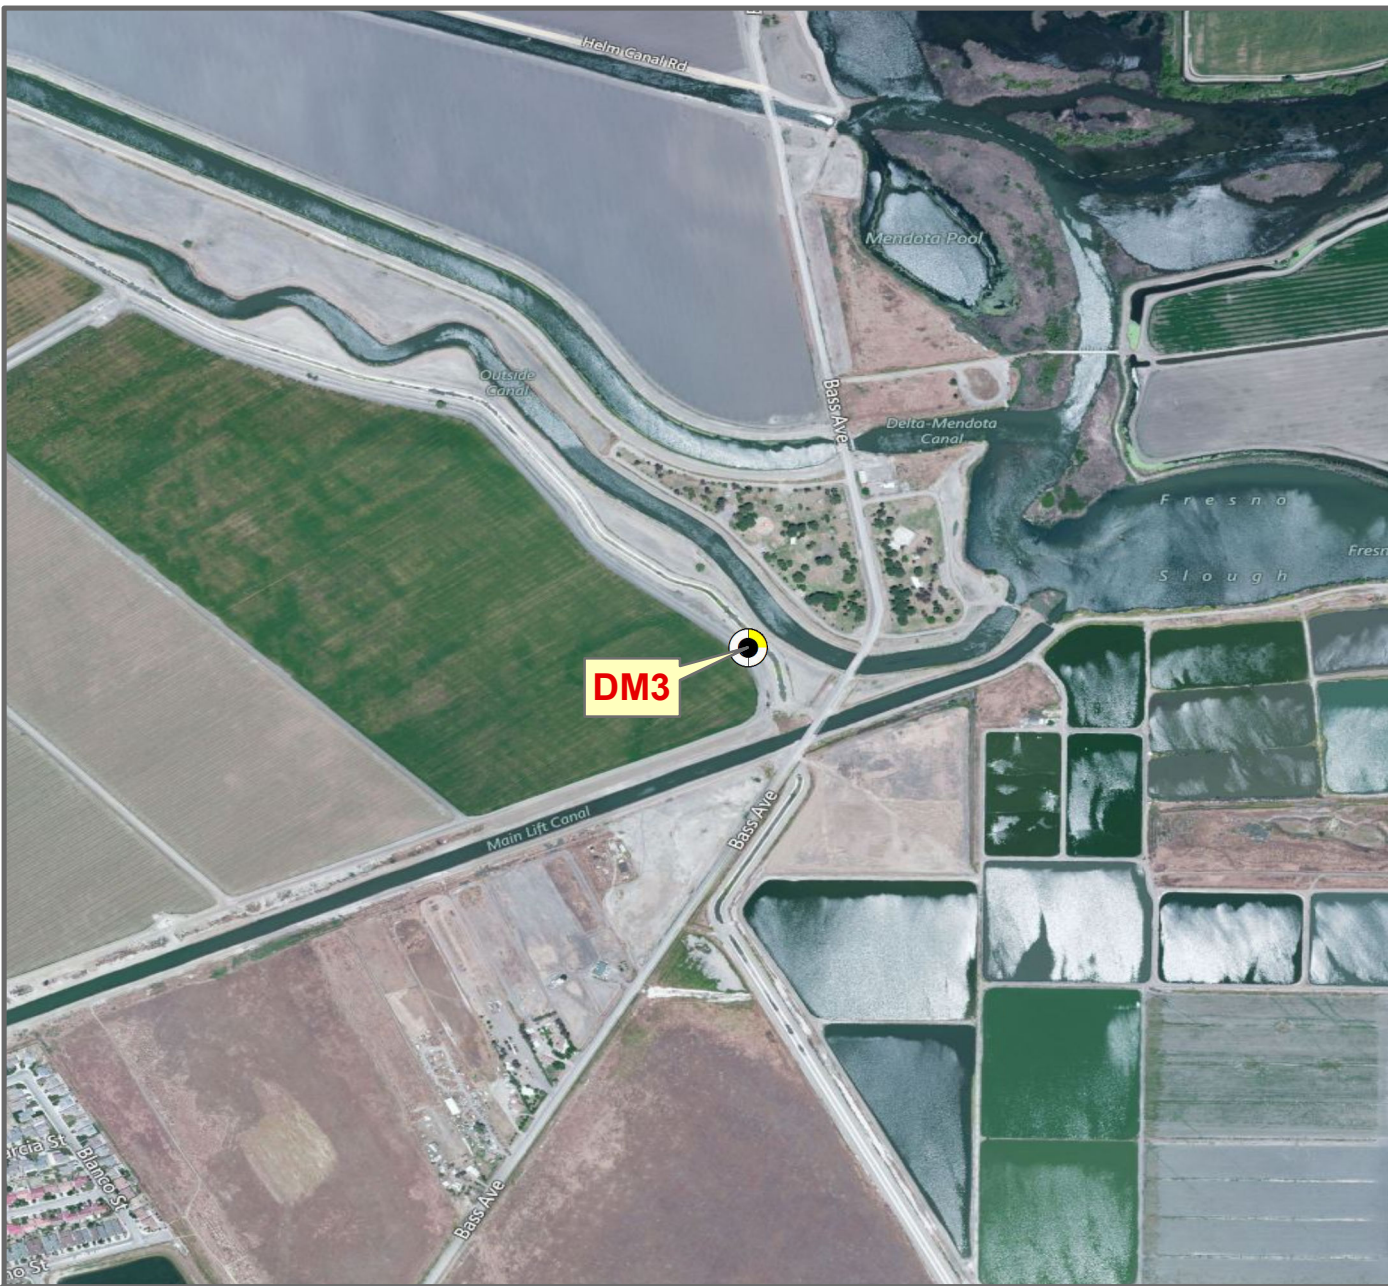
Monitoring Location DM3

Reach = 2B
 River Mile = 205
 X = -120.3740 Y = 36.7780 Status = Existing
 (Horizontal Datum is NAD83)
 Distance From River (ft) = 2814
 Reference Elevation (ft NAVD88) =
 Site = Delta Mendota Canal Check 21

Agency = USBR
 Measurements:
 Type = Telemetry
 Interval = Hourly
 Timeseries unavailable

Description:
 Sensor at real-time flow gaging station

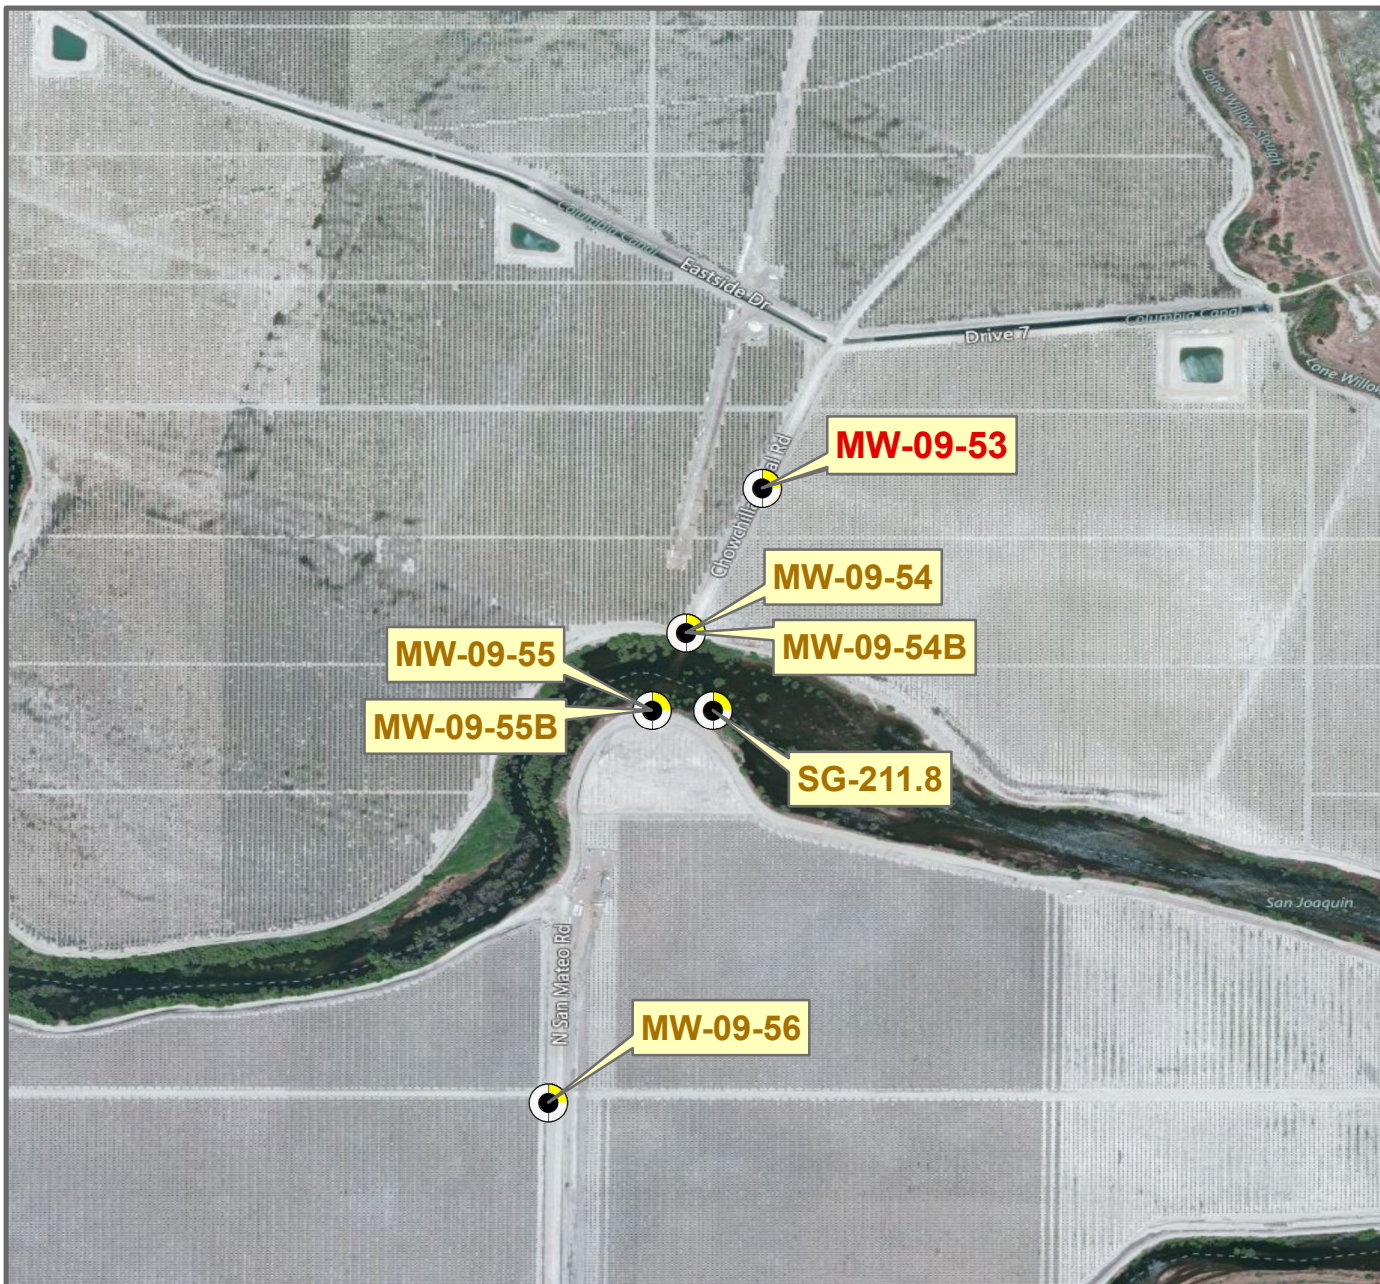
Monitoring Location MW-09-53

Reach = 2B
 River Mile = 211.8
 Madera County
 Right Bank

X = -120.3112 Y = 36.7847 Status = Existing
 (Horizontal Datum is NAD83)
 Distance From River (ft)= 1037
 Reference Elevation (ft NAVD88) = 162.60
 Site = San Mateo Ave.

Agency = USBR
 Measurements:
 Type = Datalogger
 Interval = Hourly
 Timeseries unavailable

Description:
 2 inch PVC casing FM

Ground Surface Elevation (ft) = 162.80
 Monitoring Depth (ft) = 33.0 - 48.0 ft below gs

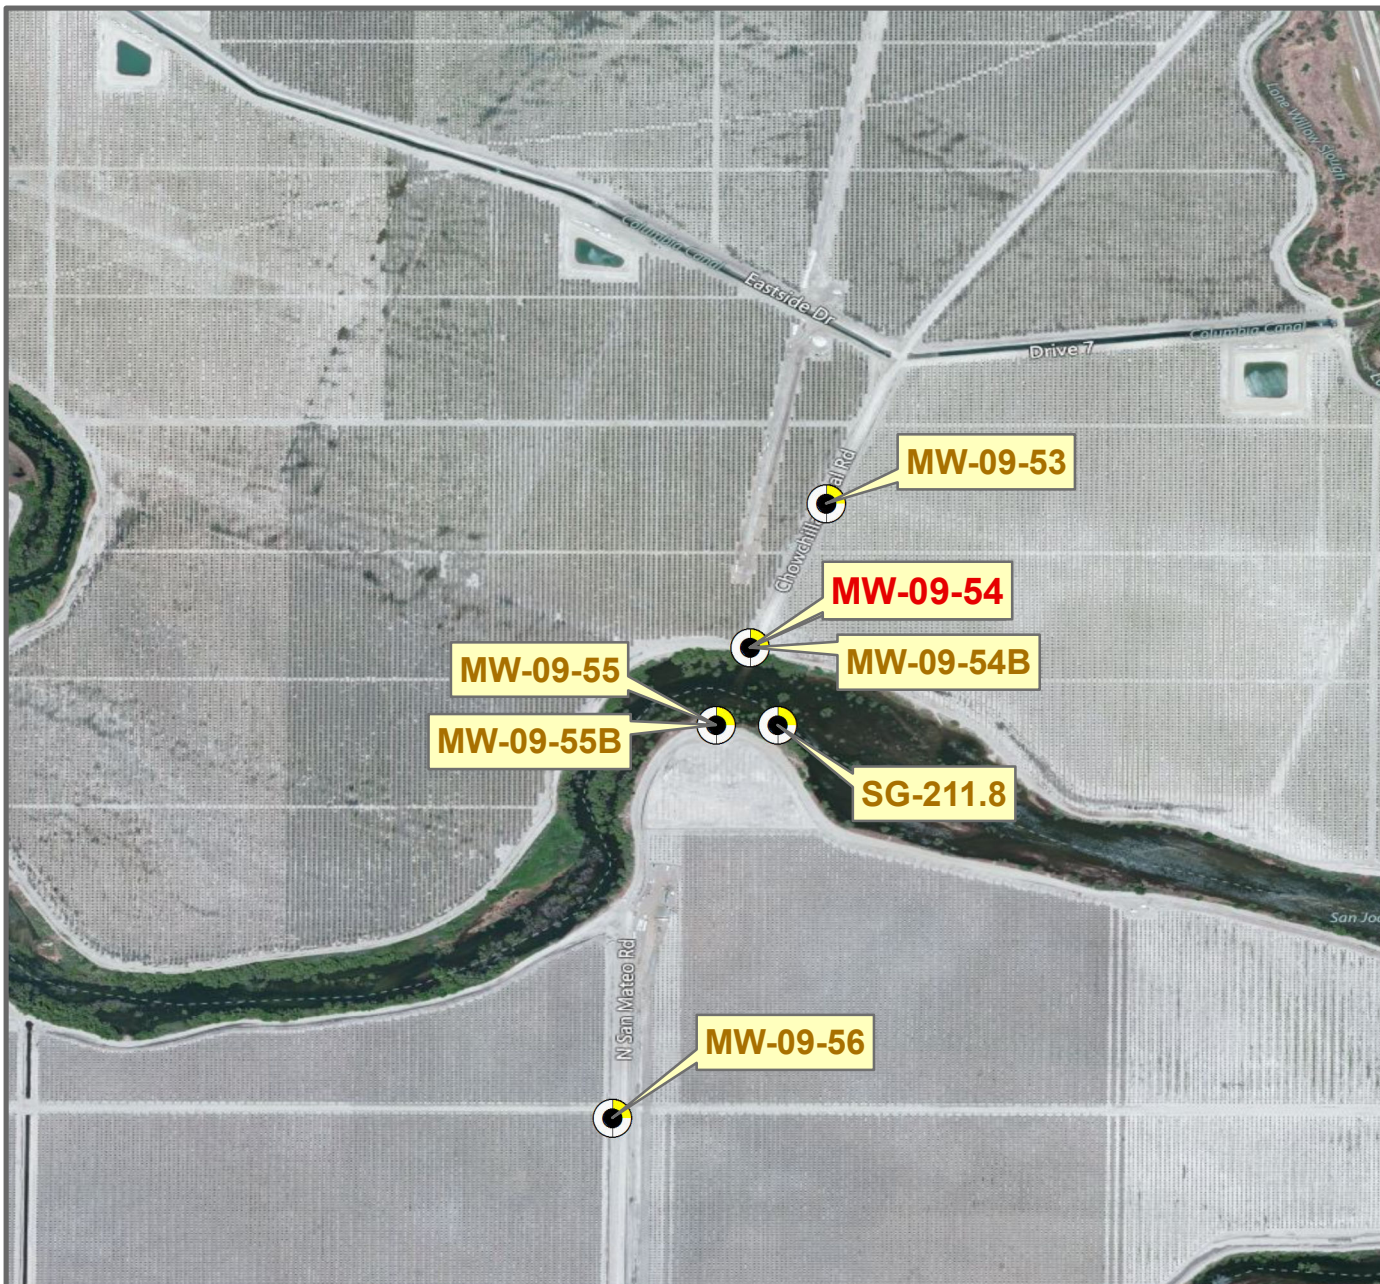
Monitoring Location MW-09-54

Reach = 2B
 River Mile = 211.8
 Madera County
 Right Bank

X = -120.3123 Y = 36.7826 Status = Existing
 (Horizontal Datum is NAD83)
 Distance From River (ft) = 258
 Reference Elevation (ft NAVD88) = 167.80
 Site = San Mateo Ave.

Agency = USBR
 Measurements:
 Type = Datalogger
 Interval = Hourly
 Timeseries unavailable

Description:
 2 inch PVC casing FM

Ground Surface Elevation (ft) = 168.00
 Monitoring Depth (ft) = 36.2 - 51.2 ft below gs

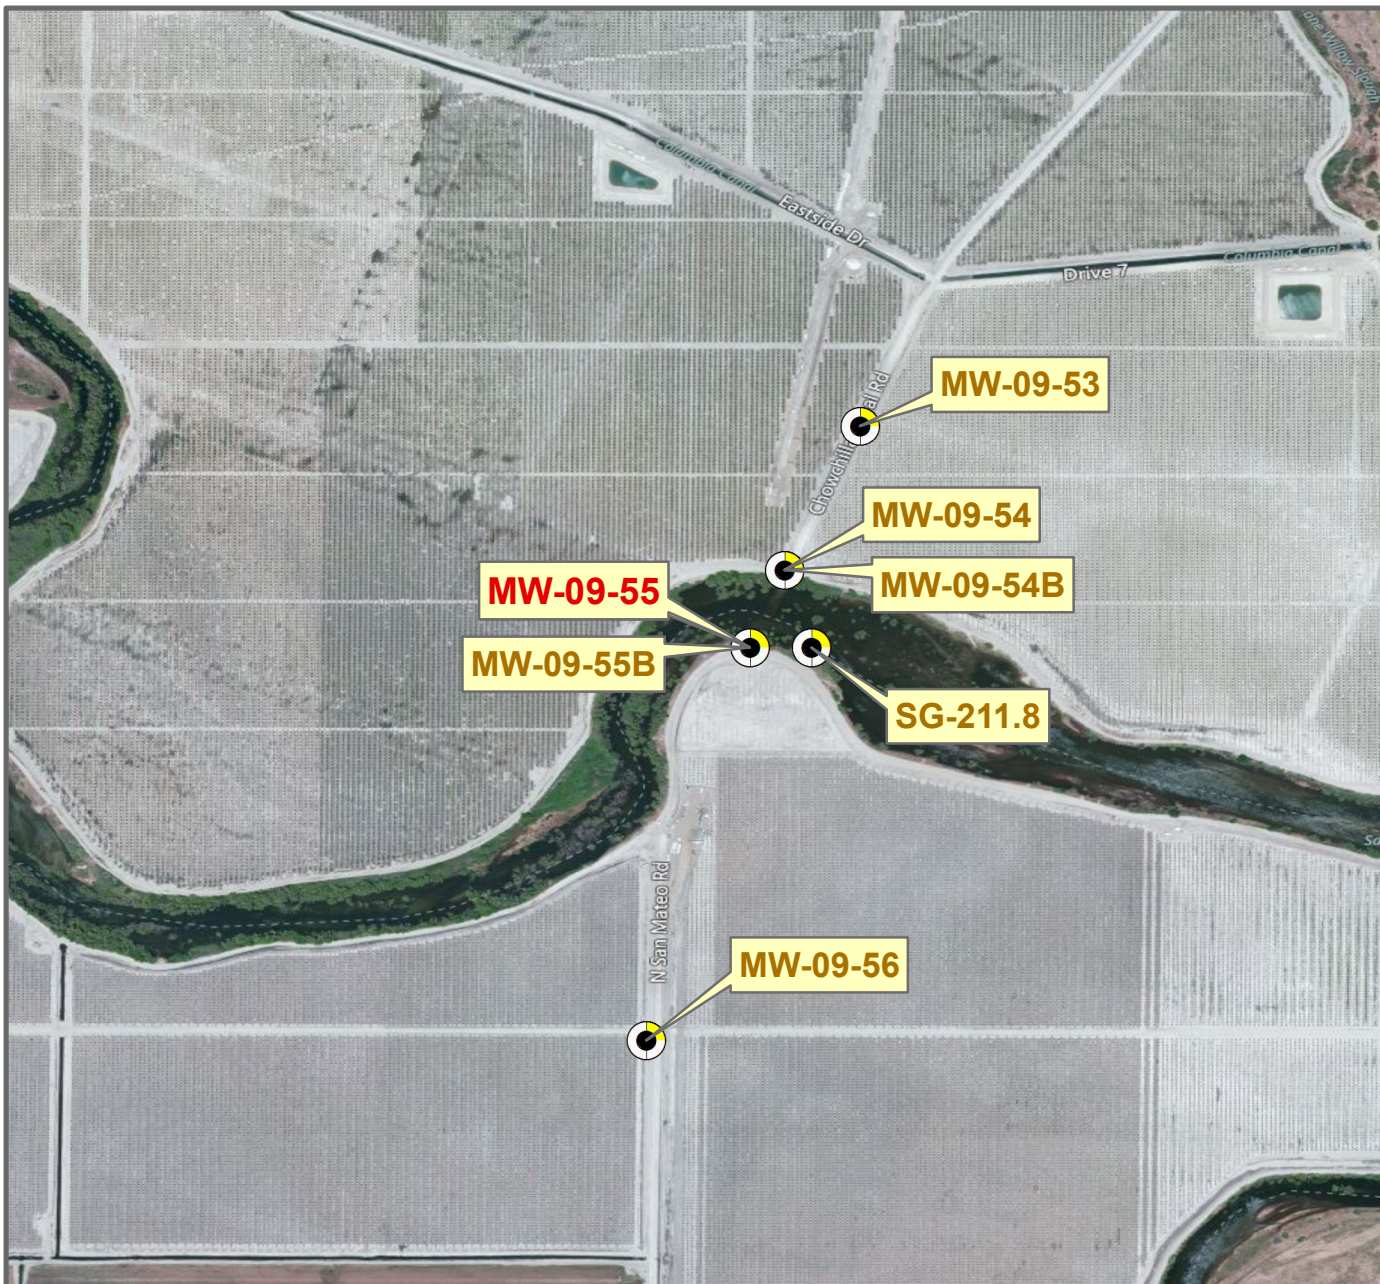
Monitoring Location MW-09-55

Reach = 2B
 River Mile = 211.8
 Status = Existing
 (Horizontal Datum is NAD83)
 Distance From River (ft) = 172
 Reference Elevation (ft NAVD88) = 168.70
 Site = San Mateo Ave.

Agency = USBR
 Measurements:
 Type = Datalogger
 Interval = Hourly
 Timeseries unavailable

Description:
 2 inch PVC casing AG

Ground Surface Elevation (ft) = 166.10
 Monitoring Depth (ft) = 40.0 - 50.0 ft below gs

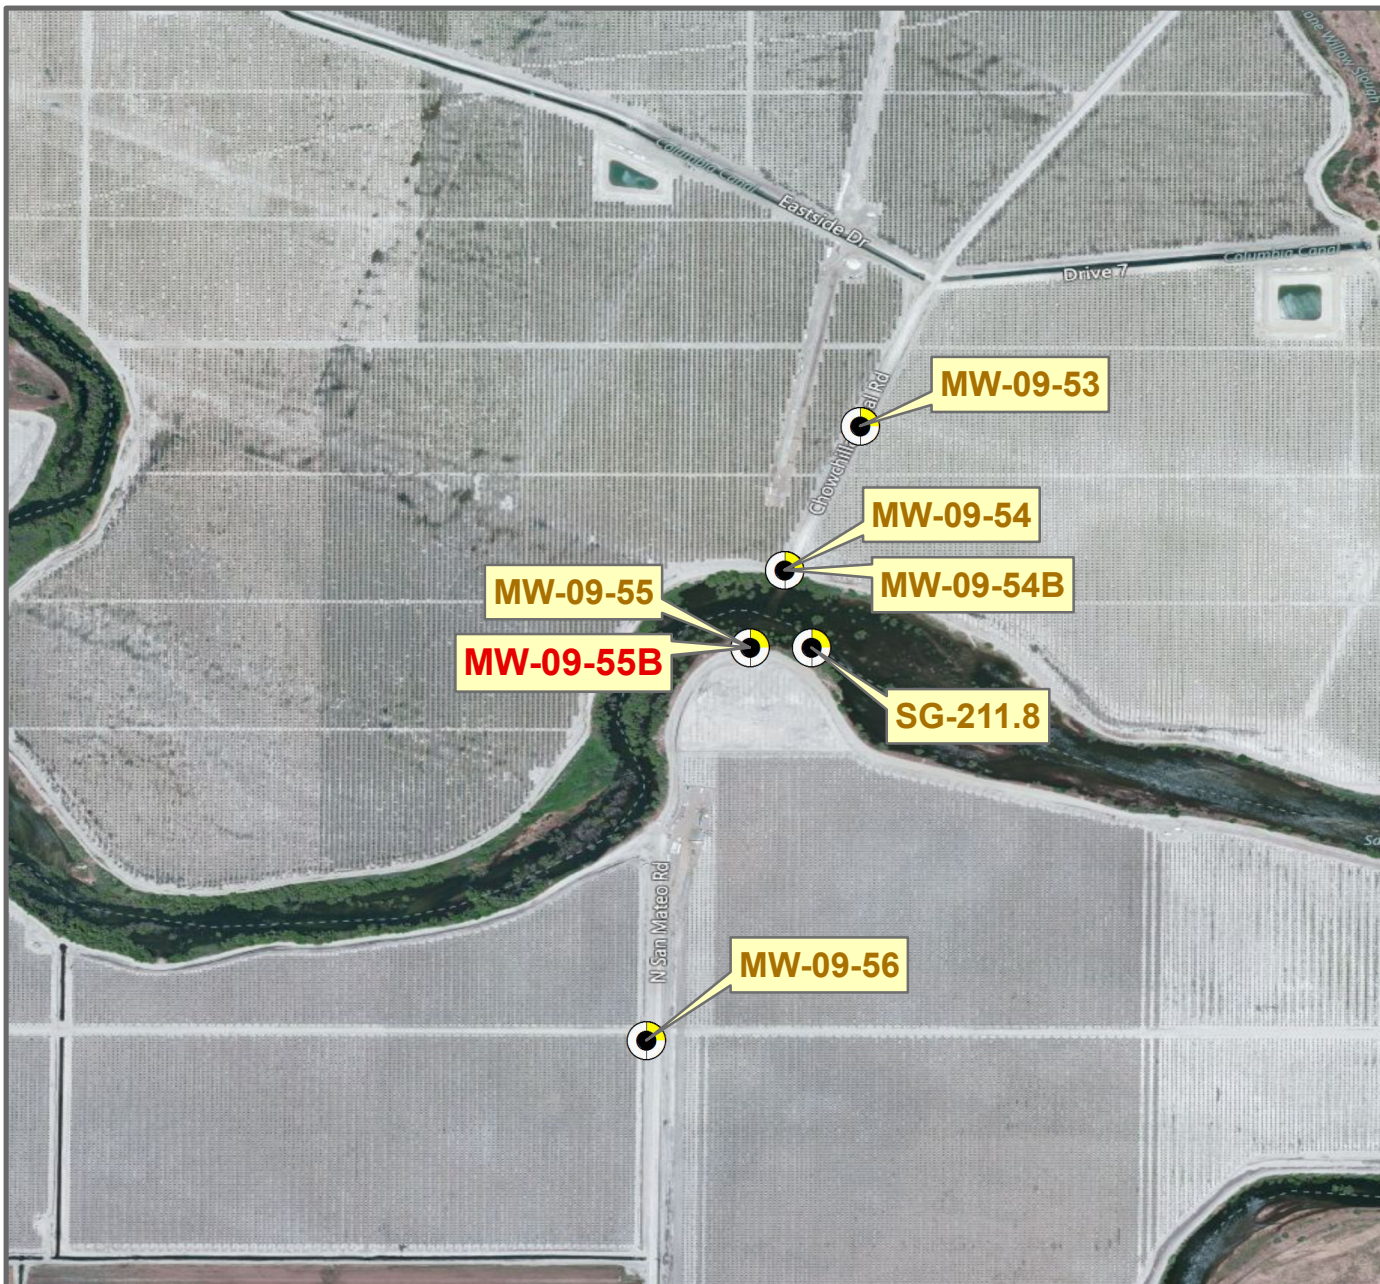
Monitoring Location MW-09-55B

Reach = 2B
 River Mile = 211.8
 X = -120.3128 Y = 36.7815 Status = Existing
 (Horizontal Datum is NAD83)
 Distance From River (ft) = 172
 Reference Elevation (ft NAVD88) = 165.54
 Site = San Mateo Ave.

Fresno County
 Left Bank

Agency = USBR
 Measurements:
 Type = Datalogger
 Interval = Hourly
 Timeseries unavailable

Description:
 2 inch PVC casing FM

Ground Surface Elevation (ft) = 165.70
 Monitoring Depth (ft) = 10.0 - 15.0 ft below gs

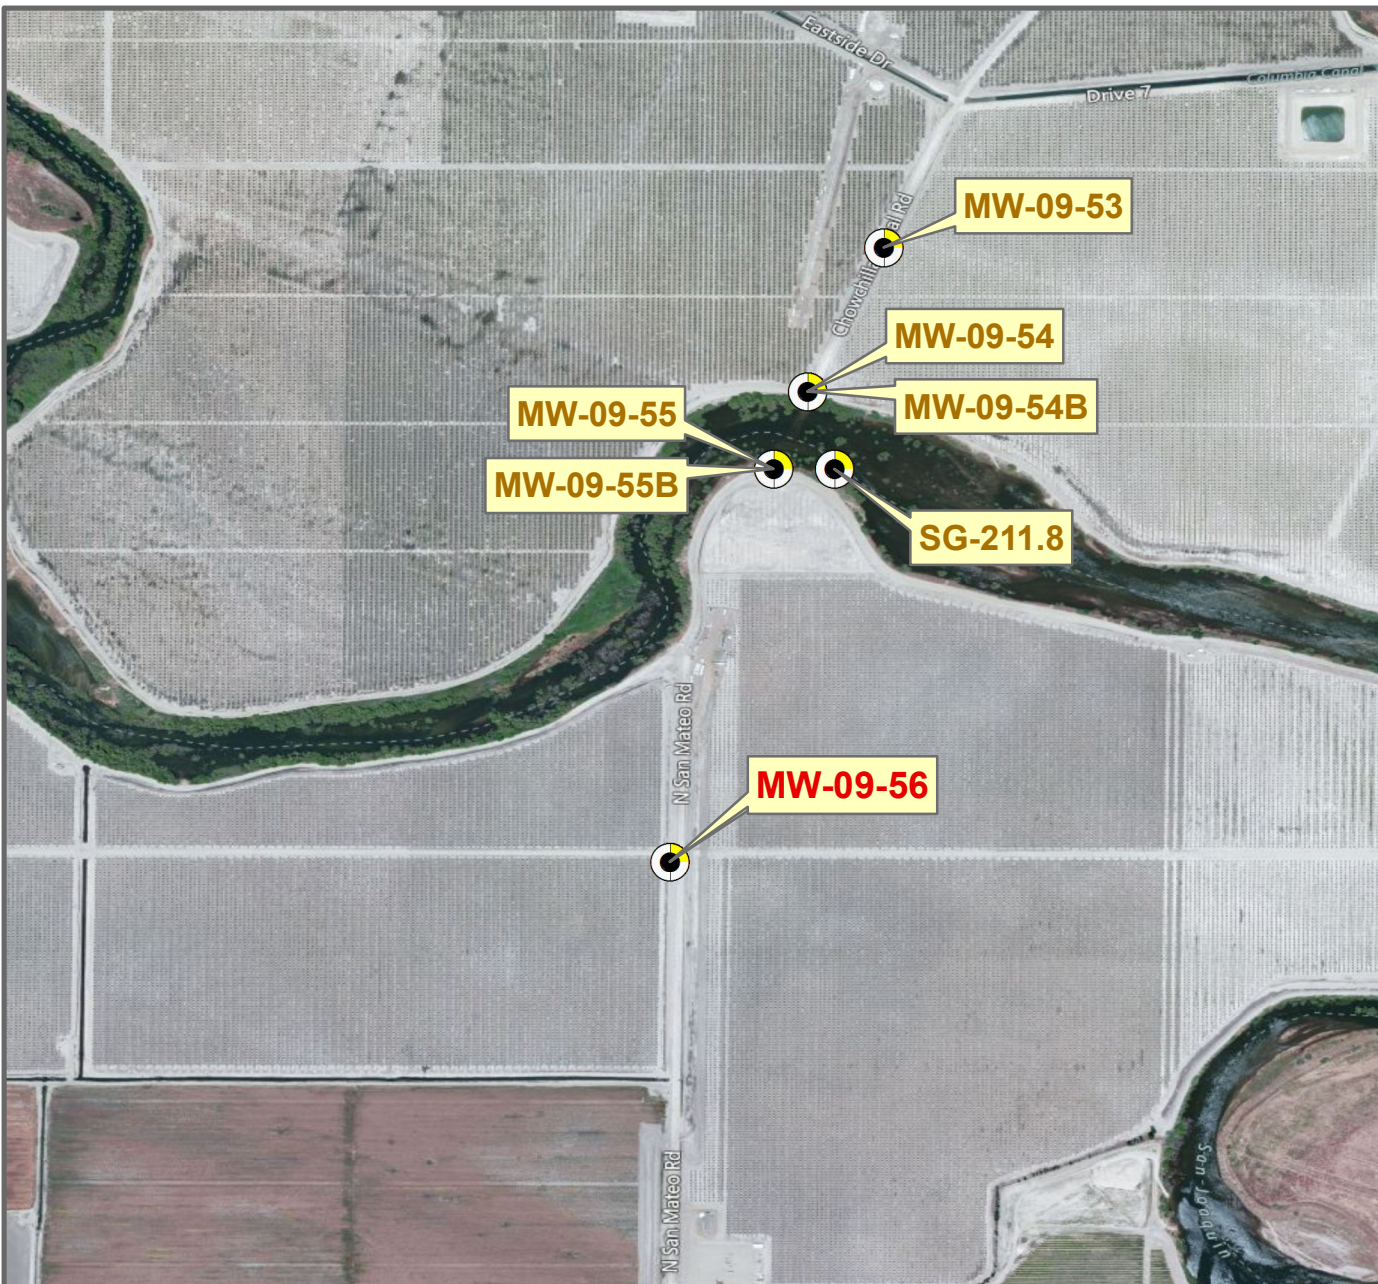
Monitoring Location MW-09-56

Reach = 2B
 River Mile = 211.8
 Status = Existing
 (Horizontal Datum is NAD83)
 Distance From River (ft) = 945
 Reference Elevation (ft NAVD88) = 161.01
 Site = San Mateo Ave.

Fresno County
 Left Bank

Agency = USBR
 Measurements:
 Type = Datalogger
 Interval = Hourly
 Timeseries unavailable

Description:
 2 inch PVC casing FM

Ground Surface Elevation (ft) = 161.20
 Monitoring Depth (ft) = 22.0 - 42.0 ft below gs

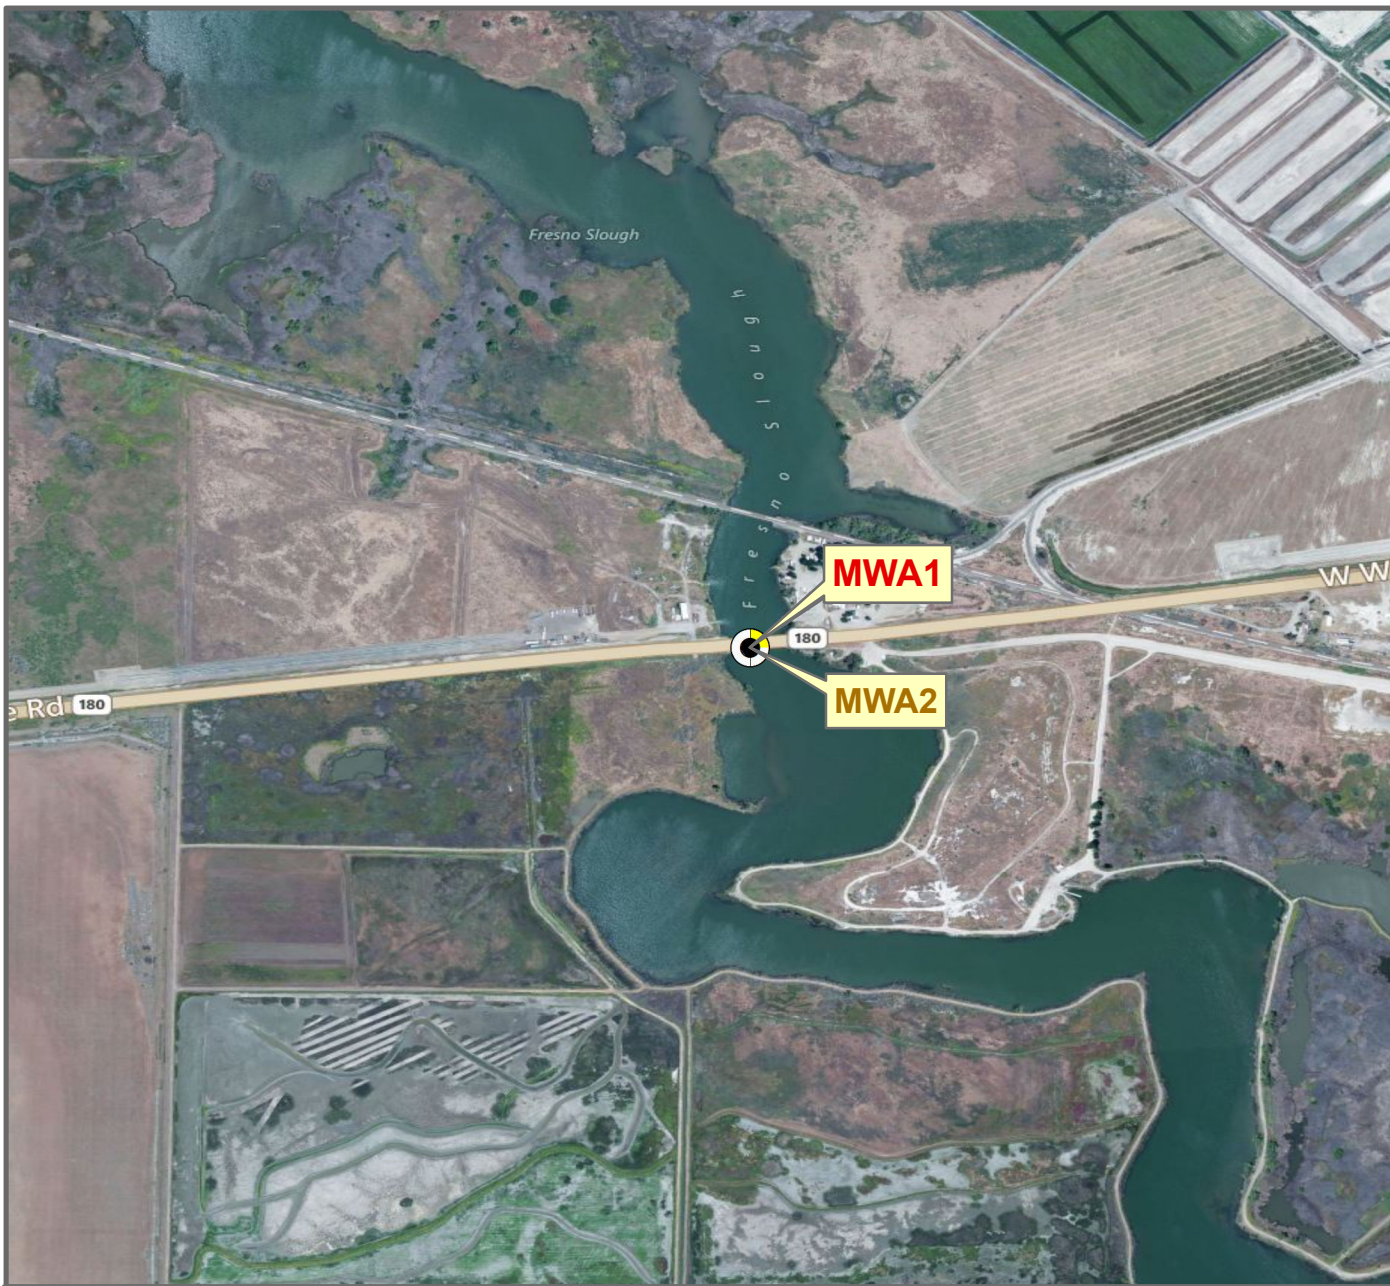
Monitoring Location MWA1

Reach = 2B
 River Mile = 211.0
 Fresno County
 Left Bank

X = -120.3428 Y = 36.7327 Status = Existing
 (Horizontal Datum is NAD83)
 Distance From River (ft)= 17460
 Reference Elevation (ft NAVD88) =
 Site = Mendota Wildlife Area 1

Agency = DFG
 Measurements:
 Type =
 Interval =
 Date Range = 6/16/2011 - 1/4/2012

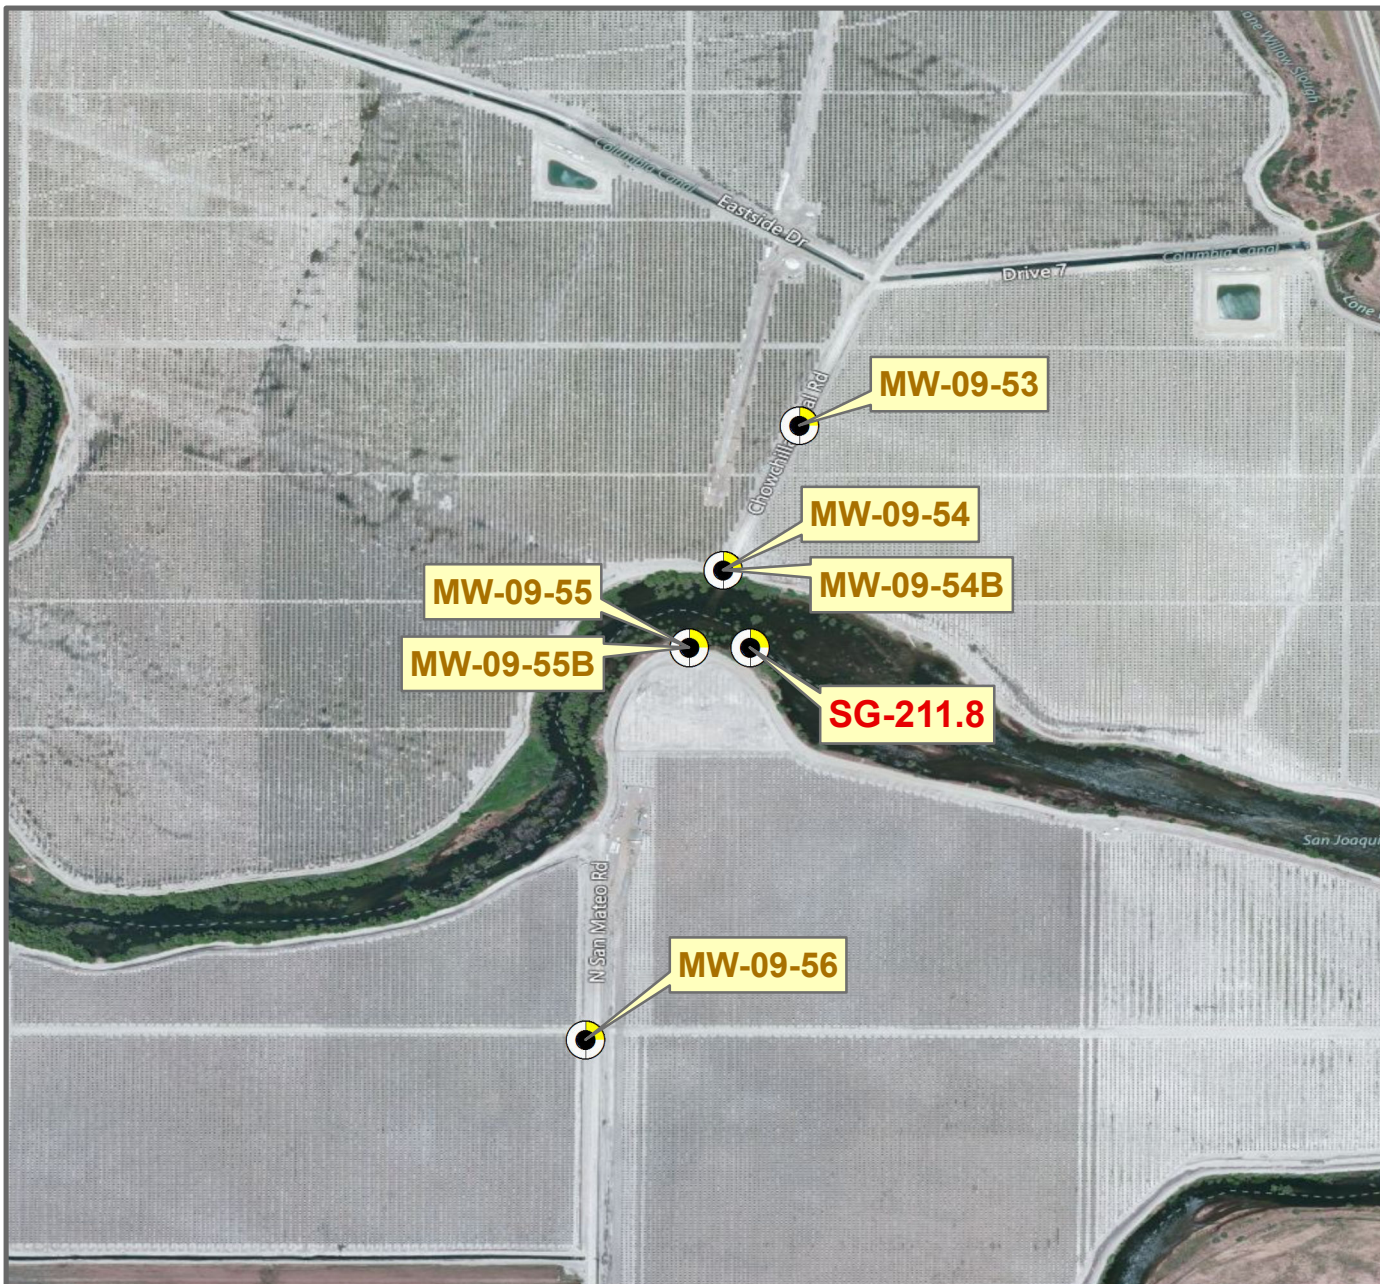
Monitoring Location SG-211.8

Reach = 2B
 River Mile = 211.8
 Status = Existing
 (Horizontal Datum is NAD83)
 Distance From River (ft) = 56
 Reference Elevation (ft NAVD88) =
 Site = San Mateo Ave.

Fresno County
 Left Bank

Agency = USBR
 Measurements:
 Type = Datalogger
 Interval = Hour?
 Timeseries unavailable

Ground Surface Elevation (ft) = 160.00
 Monitoring Depth (ft) =

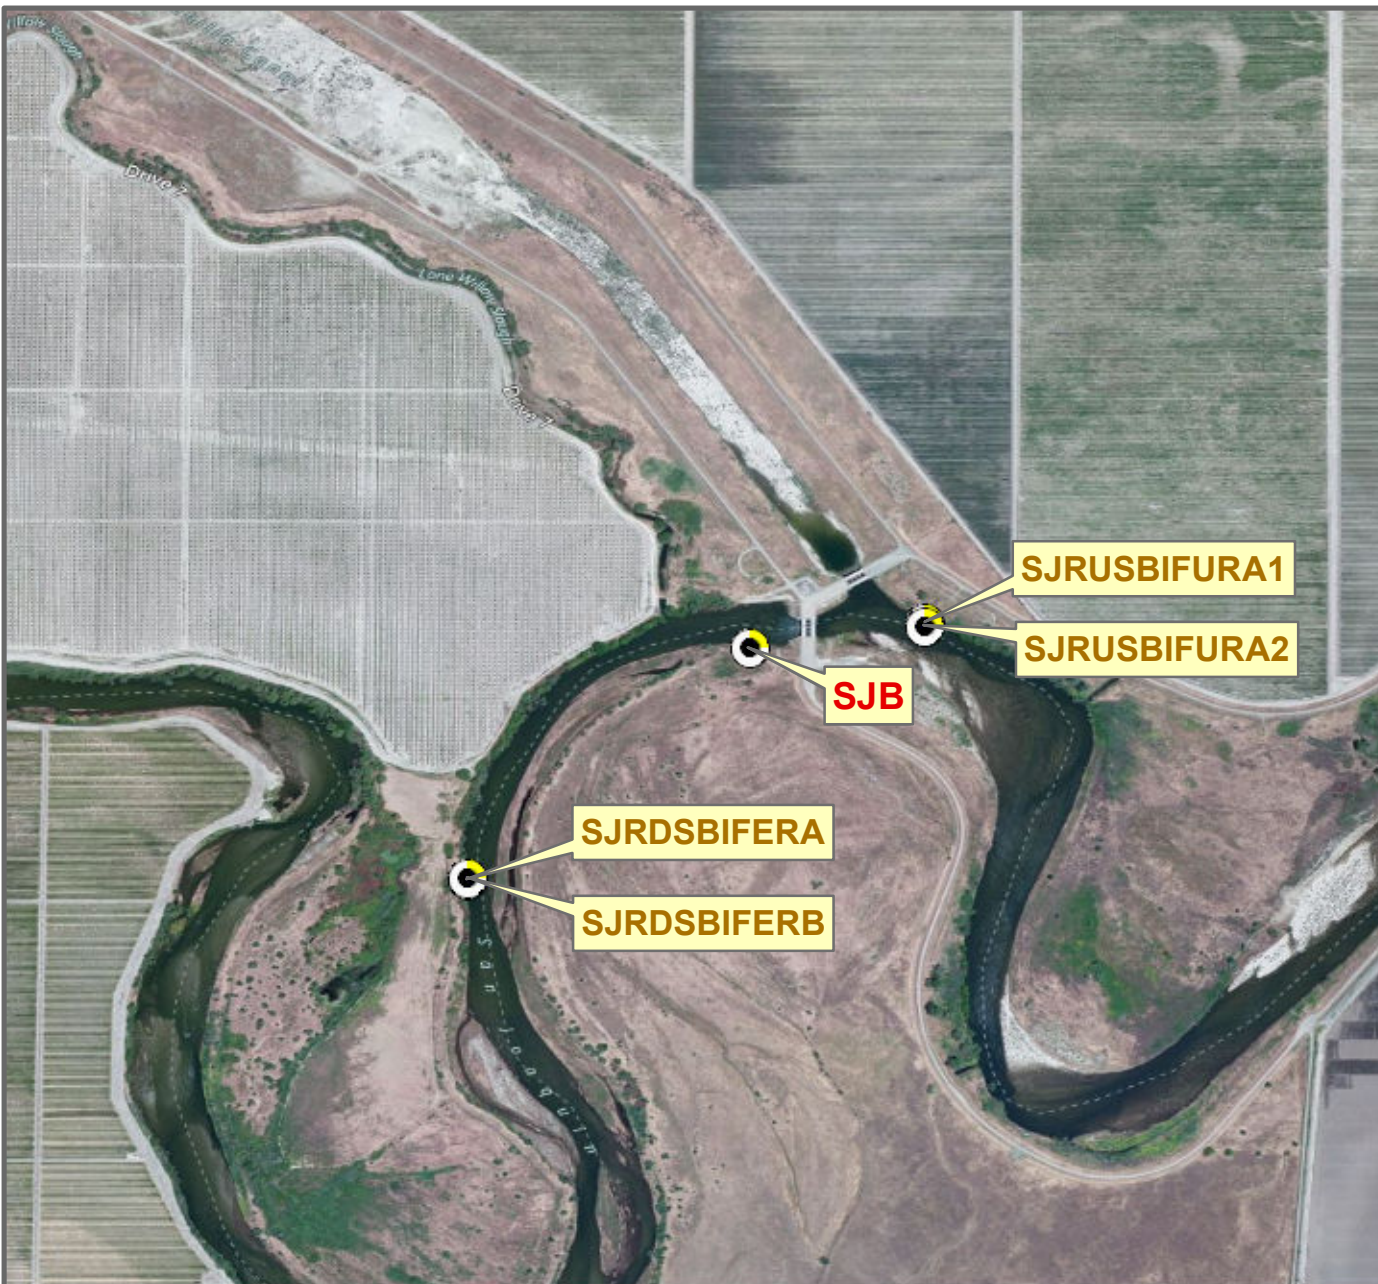
Monitoring Location SJB

Reach = 2B
 River Mile = 215.9
 Fresno County
 Channel Bank

X = -120.2860 Y = 36.7730 Status = Existing
 (Horizontal Datum is NAD83)
 Distance From River Centerline (ft) = 107
 Reference Elevation (ft NAVD88) =
 Site = Below Bifurcation

Agency = USBR
 Measurements:
 Type = Telemetry
 Interval = 15 min
 Date Range = 11/12/2009 - 5/8/2012

Description:
 Sensor at real-time flow gaging station

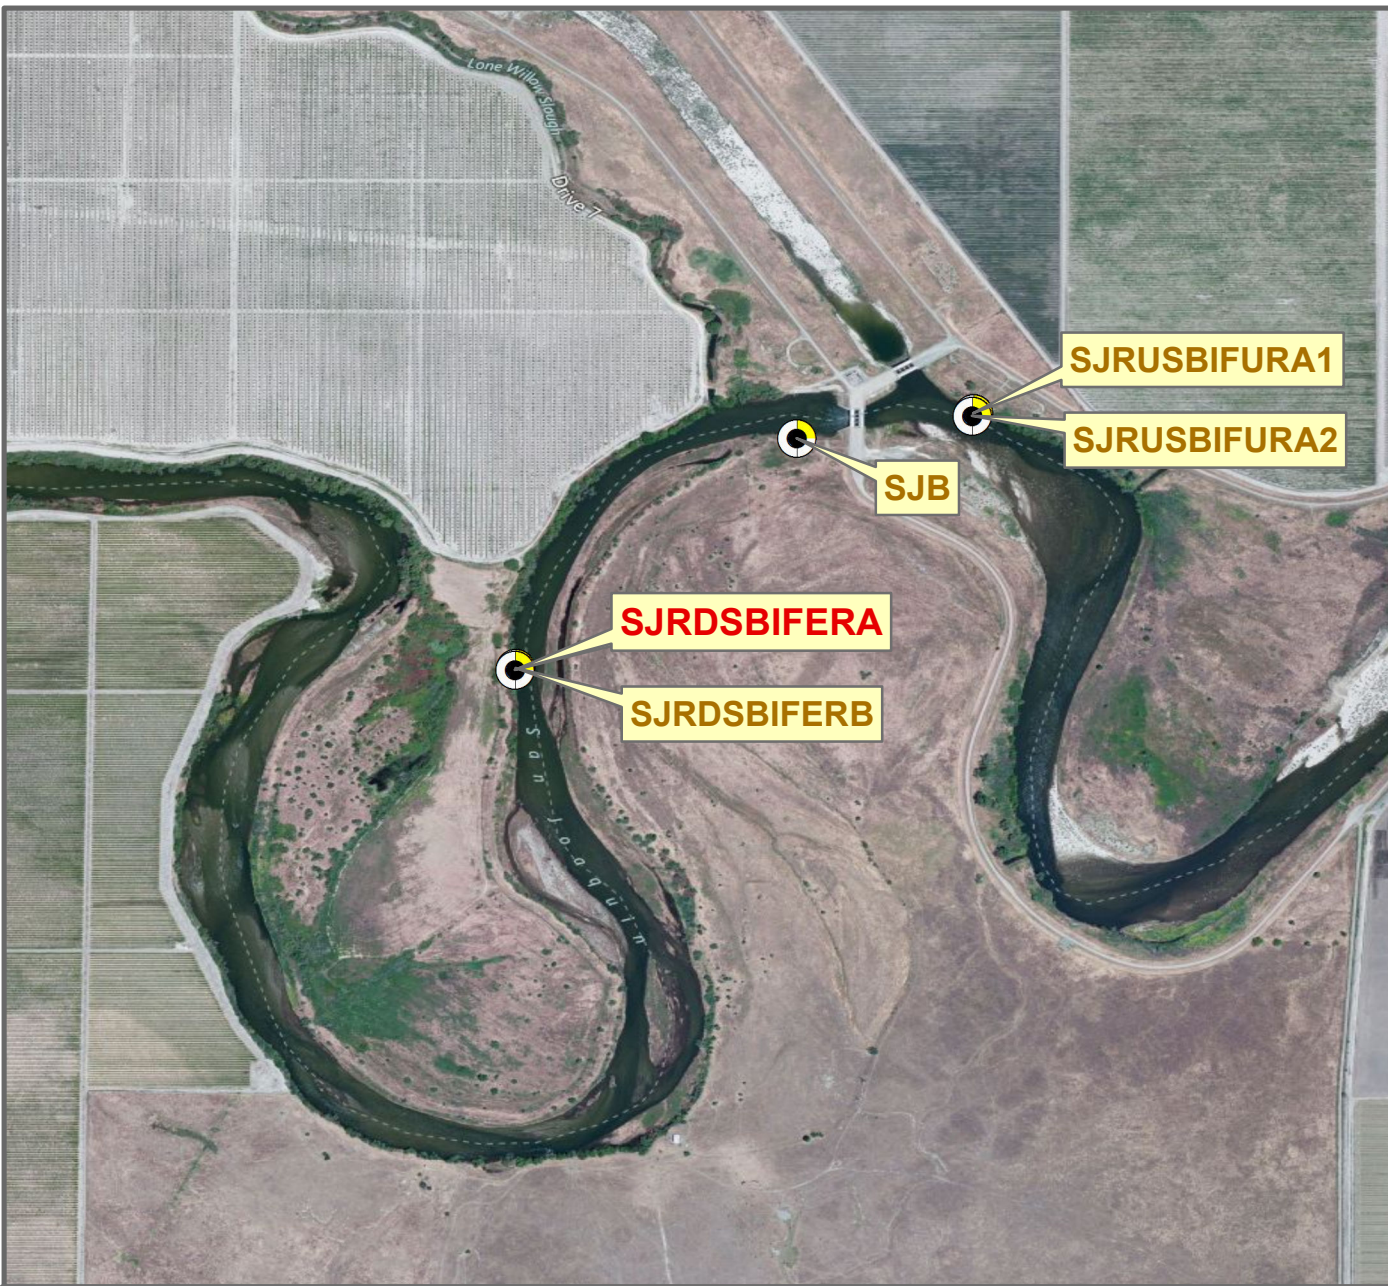
Monitoring Location SJRDSBIFERA

Reach = 2B
 River Mile = 215.7
 Madera County
 Right Bank

X = -120.2900 Y = 36.7697 Status = Existing
 (Horizontal Datum is NAD83)
 Distance From River Centerline (ft)=
 Reference Elevation (ft NAVD88) =
 Site = SJR Downstream of Bifurcation Struture
 (Farmers WD property)

Agency = USBR
 Measurements:
 Type = Datalogger
 Interval = Hourly
 Timeseries unavailable

Description:
 Cabled to tree root. 85-90 ft upstream of 3rd power pole from access road along farmed field. 5 ft upstream of SJRBIFERB

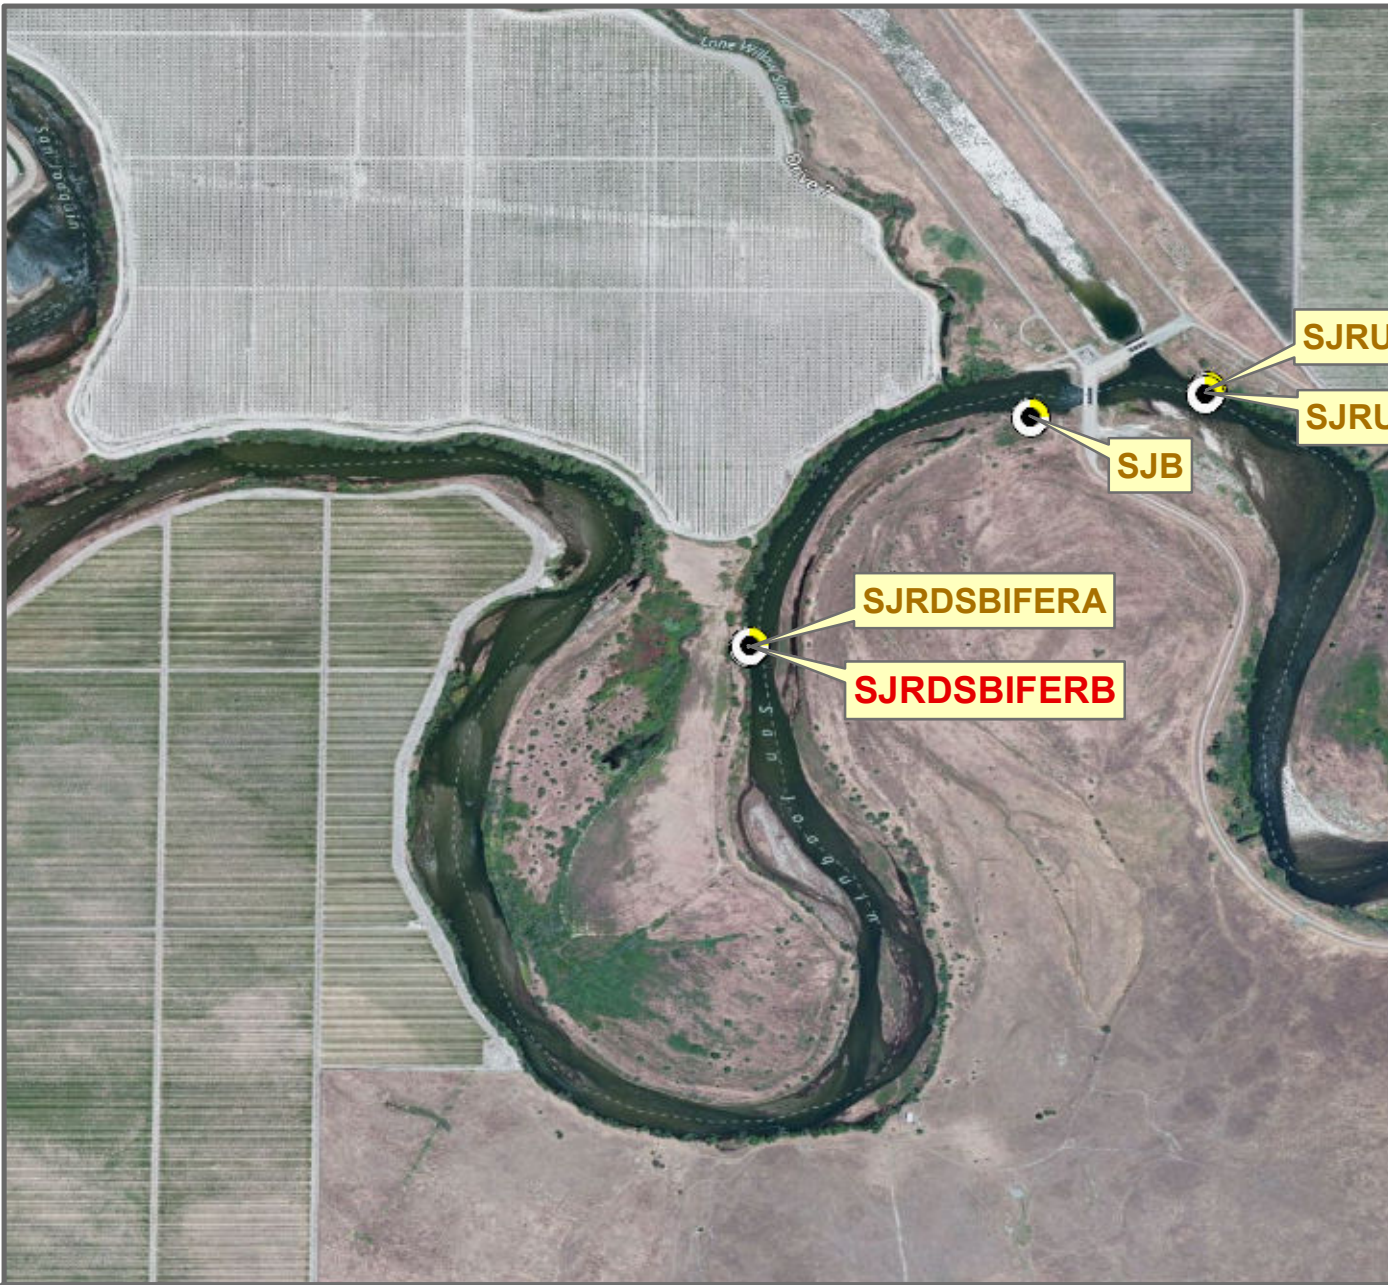
Monitoring Location SJRDSBIFERB

Reach = 2B
 River Mile = 215.7
 Madera County
 Right Bank

X = -120.2900 Y = 36.7697 Status = Existing
 (Horizontal Datum is NAD83)
 Distance From River Centerline (ft)=
 Reference Elevation (ft NAVD88) =
 Site = SJR Downstream of Bifurcation Struture
 (Farmers WD property)

Agency = USBR
 Measurements:
 Type = Datalogger
 Interval = Hourly
 Timeseries unavailable

Description:
 Cabled to tree root. 85-90 ft upstream of 3rd power pole from access road along farmed field. 5 ft downstream of SJRBIFERA
