RECLAMATION
Managing Water in the West

Reach 1B Temperature Monitoring Sites

Preliminary Data

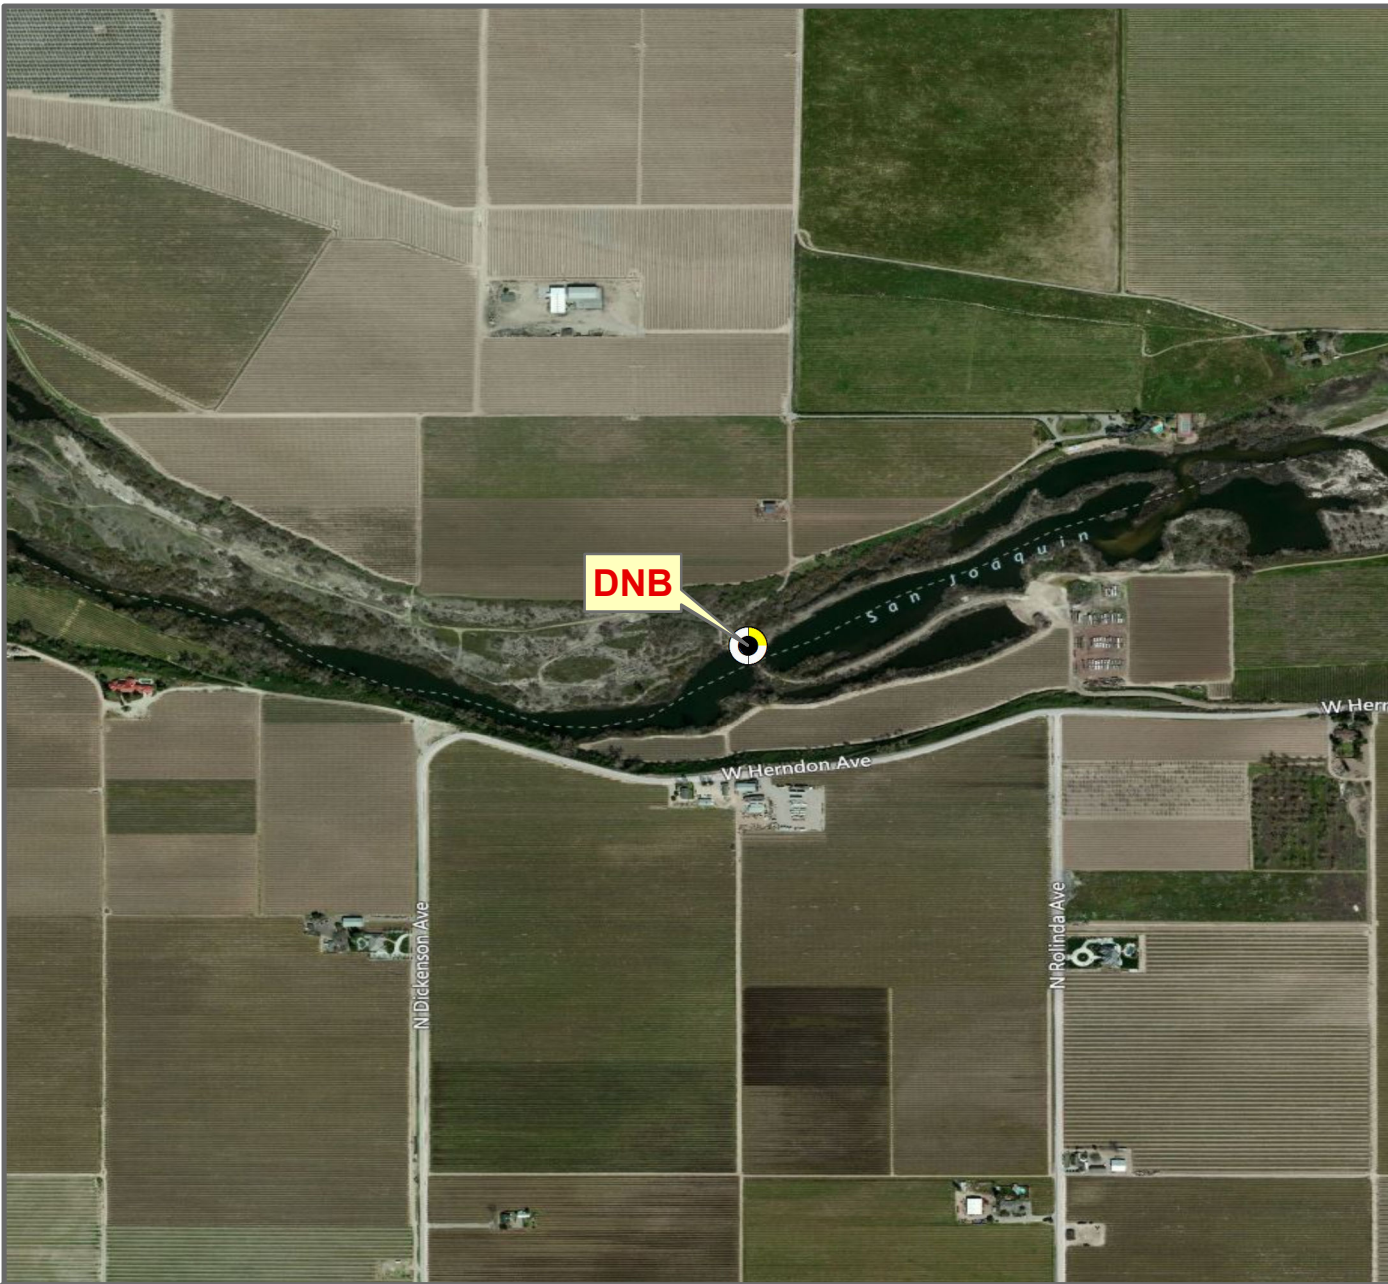
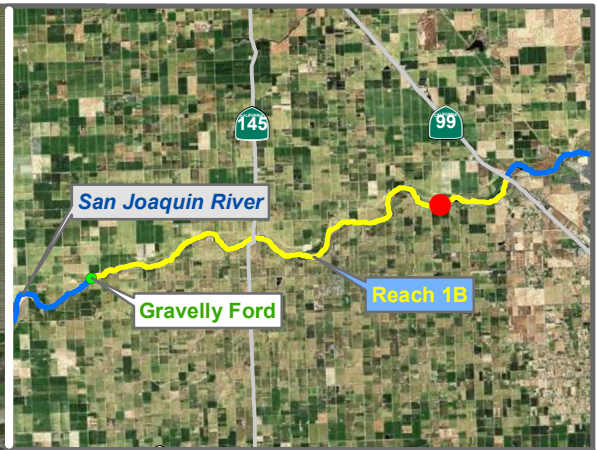
Monitoring Location DNB

Reach = 1B
 River Mile = 240.7
 Madera County
 Channel Bank

X = -119.9658 Y = 36.8335 Status = Existing
 (Horizontal Datum is NAD83)
 Distance From River (ft) = 69
 Reference Elevation (ft NAVD88) =
 Site = Donny Bridge (Rd 32)

Agency = USBR
 Measurements:
 Type = Telemetry
 Interval = 15 min
 Date Range = 6/23/2004 - 5/8/2012

Description:
 Sensor at real-time flow gaging station

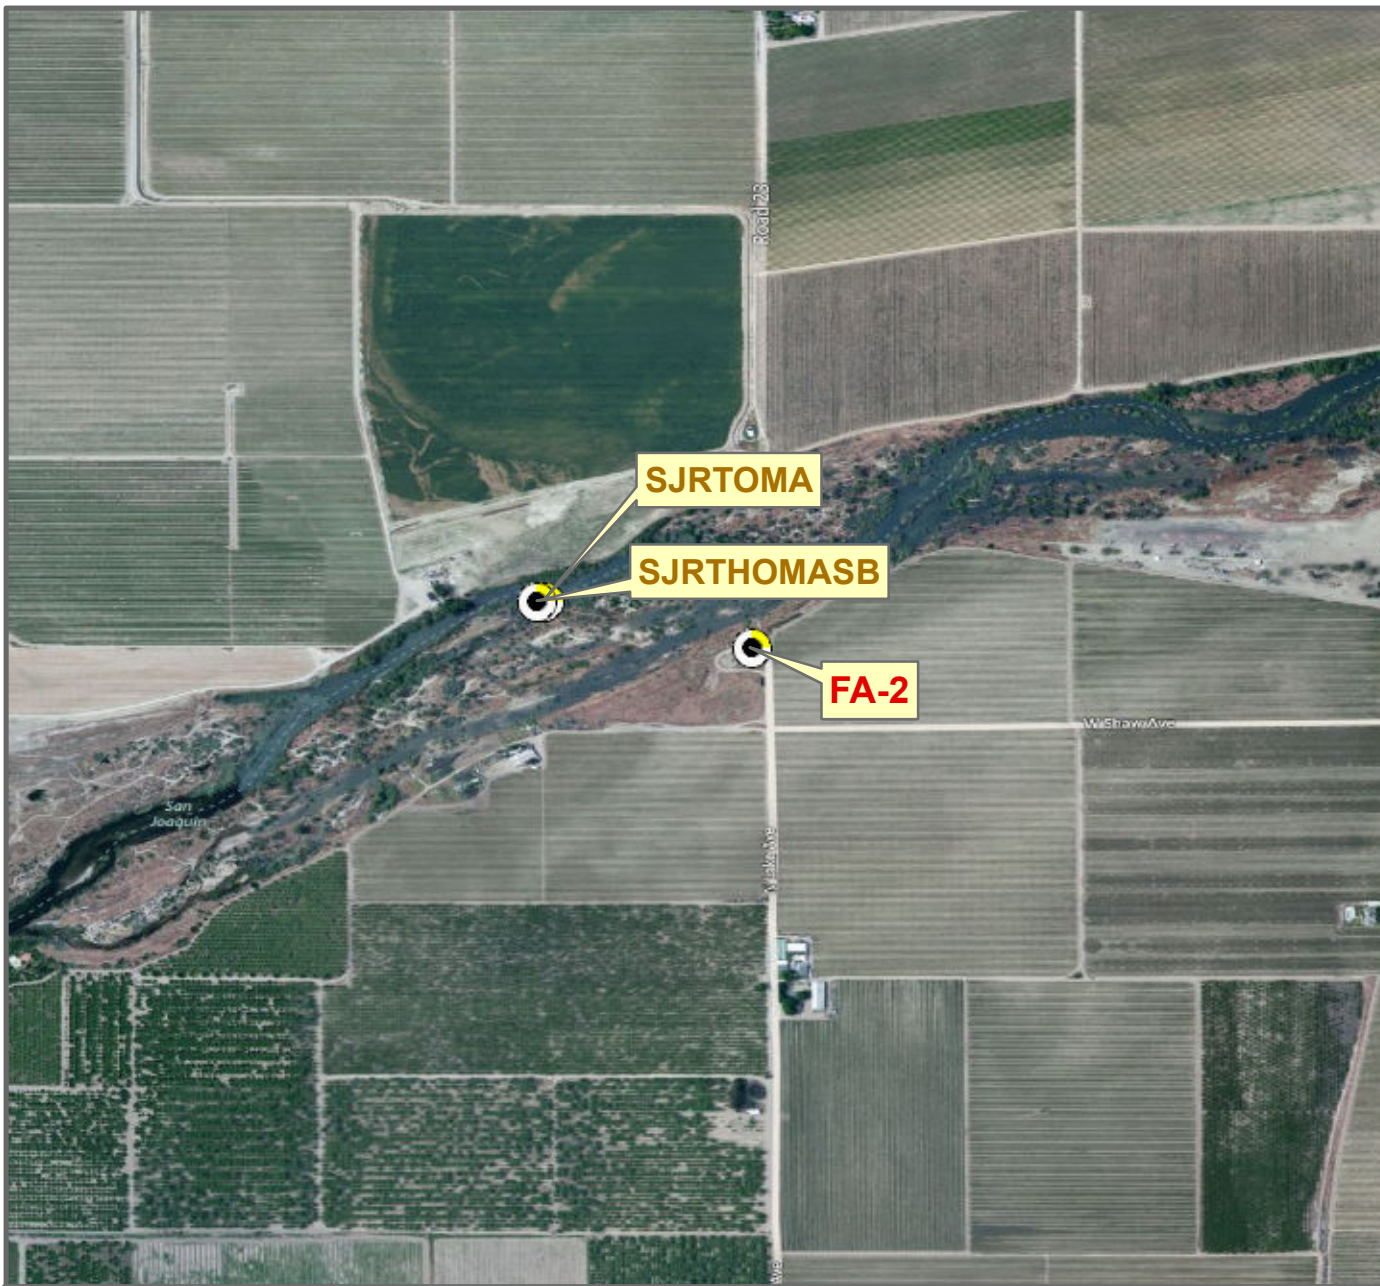
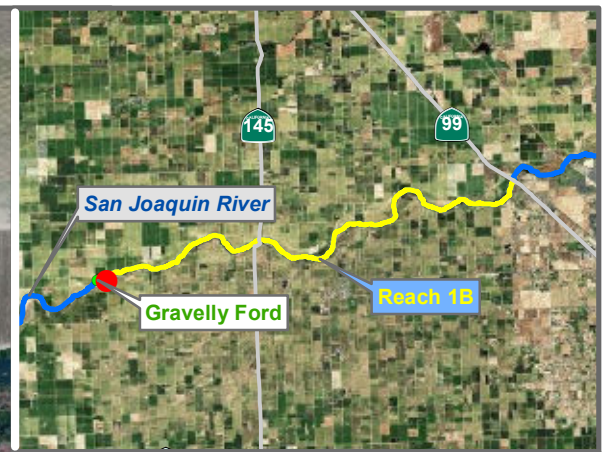
Monitoring Location FA-2

Reach = 1B
 River Mile = 229.2
 Status = Existing
 (Horizontal Datum is NAD83)
 Distance From River Centerline (ft) = 486
 Reference Elevation (ft NAVD88) =
 Site = Lake Ave.

Fresno County
 Left Bank

Agency = USBR
 Measurements:
 Type = Datalogger
 Interval = Hourly
 Timeseries unavailable

Description:
 2 inch PVC well

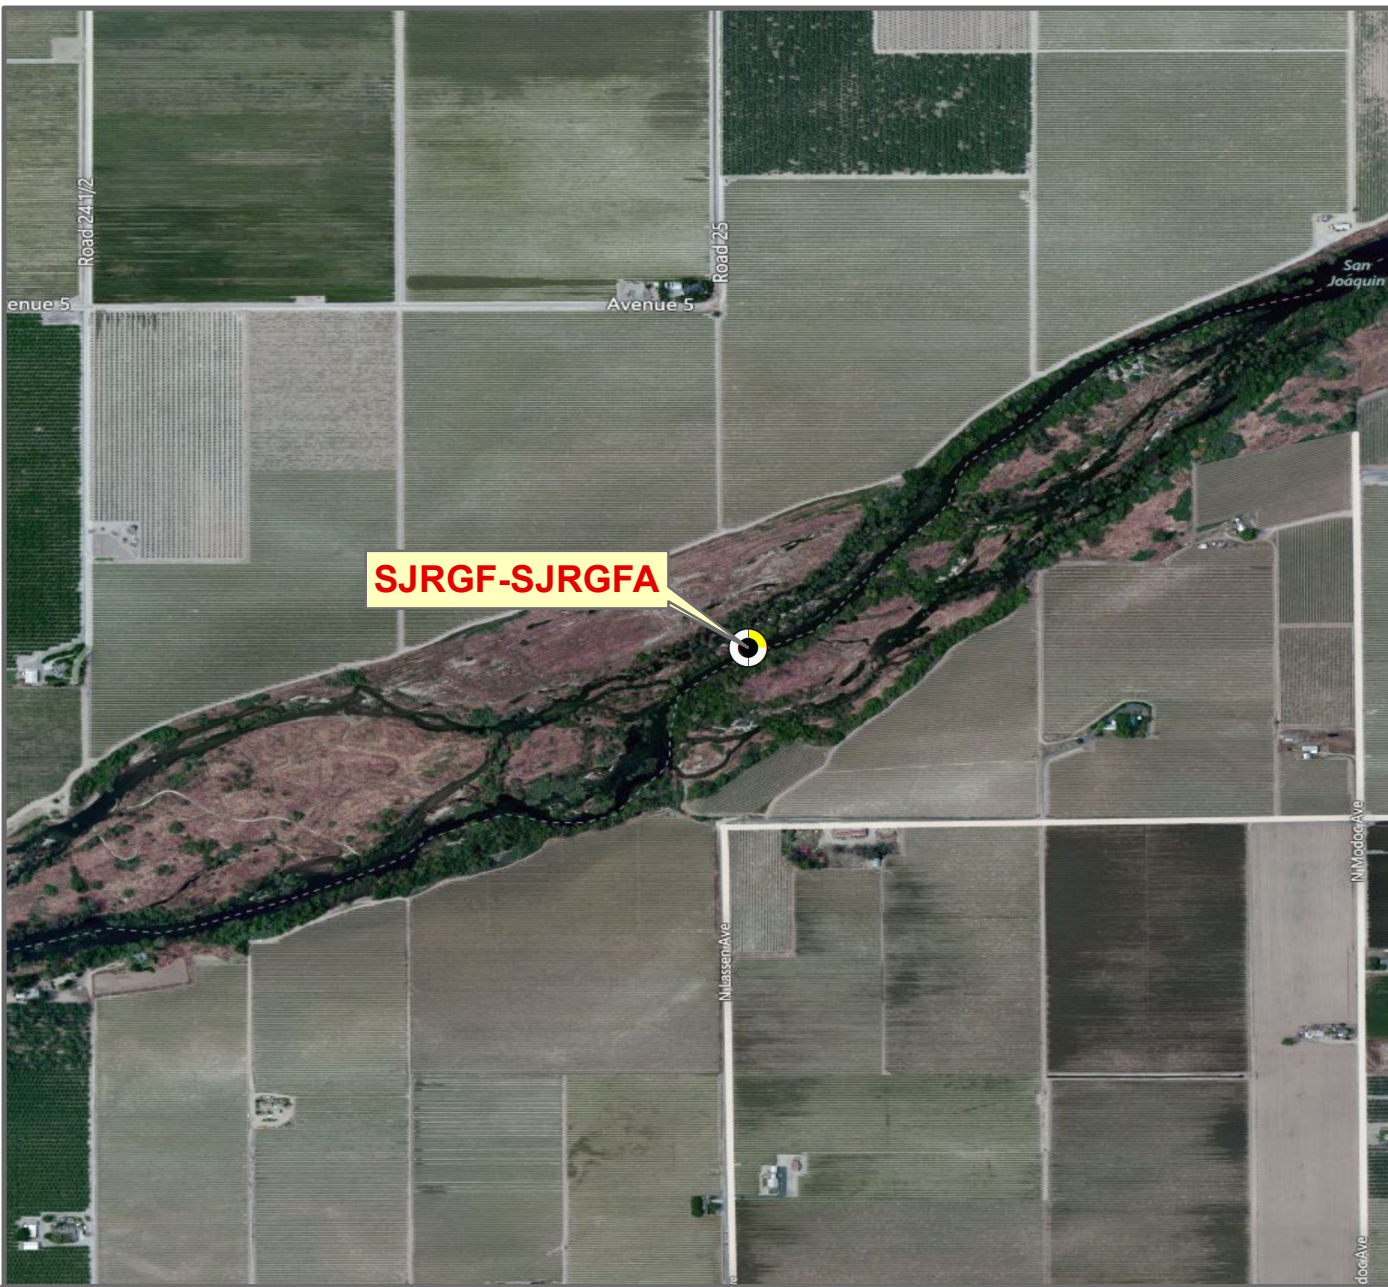
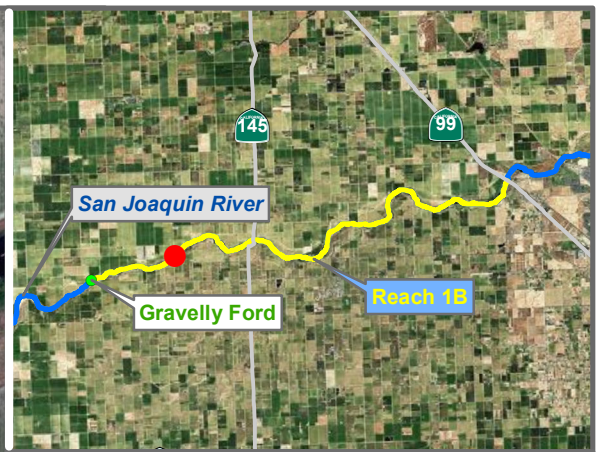
Monitoring Location SJRGF-SJRGFA

Reach = 1B
 River Mile = 231.2
 Madera County
 Right Bank

X = -120.0964 Y = 36.8174 Status = Existing
 (Horizontal Datum is NAD83)
 Distance From River (ft)= 40
 Reference Elevation (ft NAVD88) =
 Site = Gravelly Ford

Agency = DFG
 Measurements:
 Type = Datalogger
 Interval = Hourly
 Timeseries unavailable

Description:
 Approx. one mile downstream of Skaggs Park.
 Cabled to tree on RR.

Ground Surface Elevation (ft) =
 Monitoring Depth (ft) = 1 ft above gs

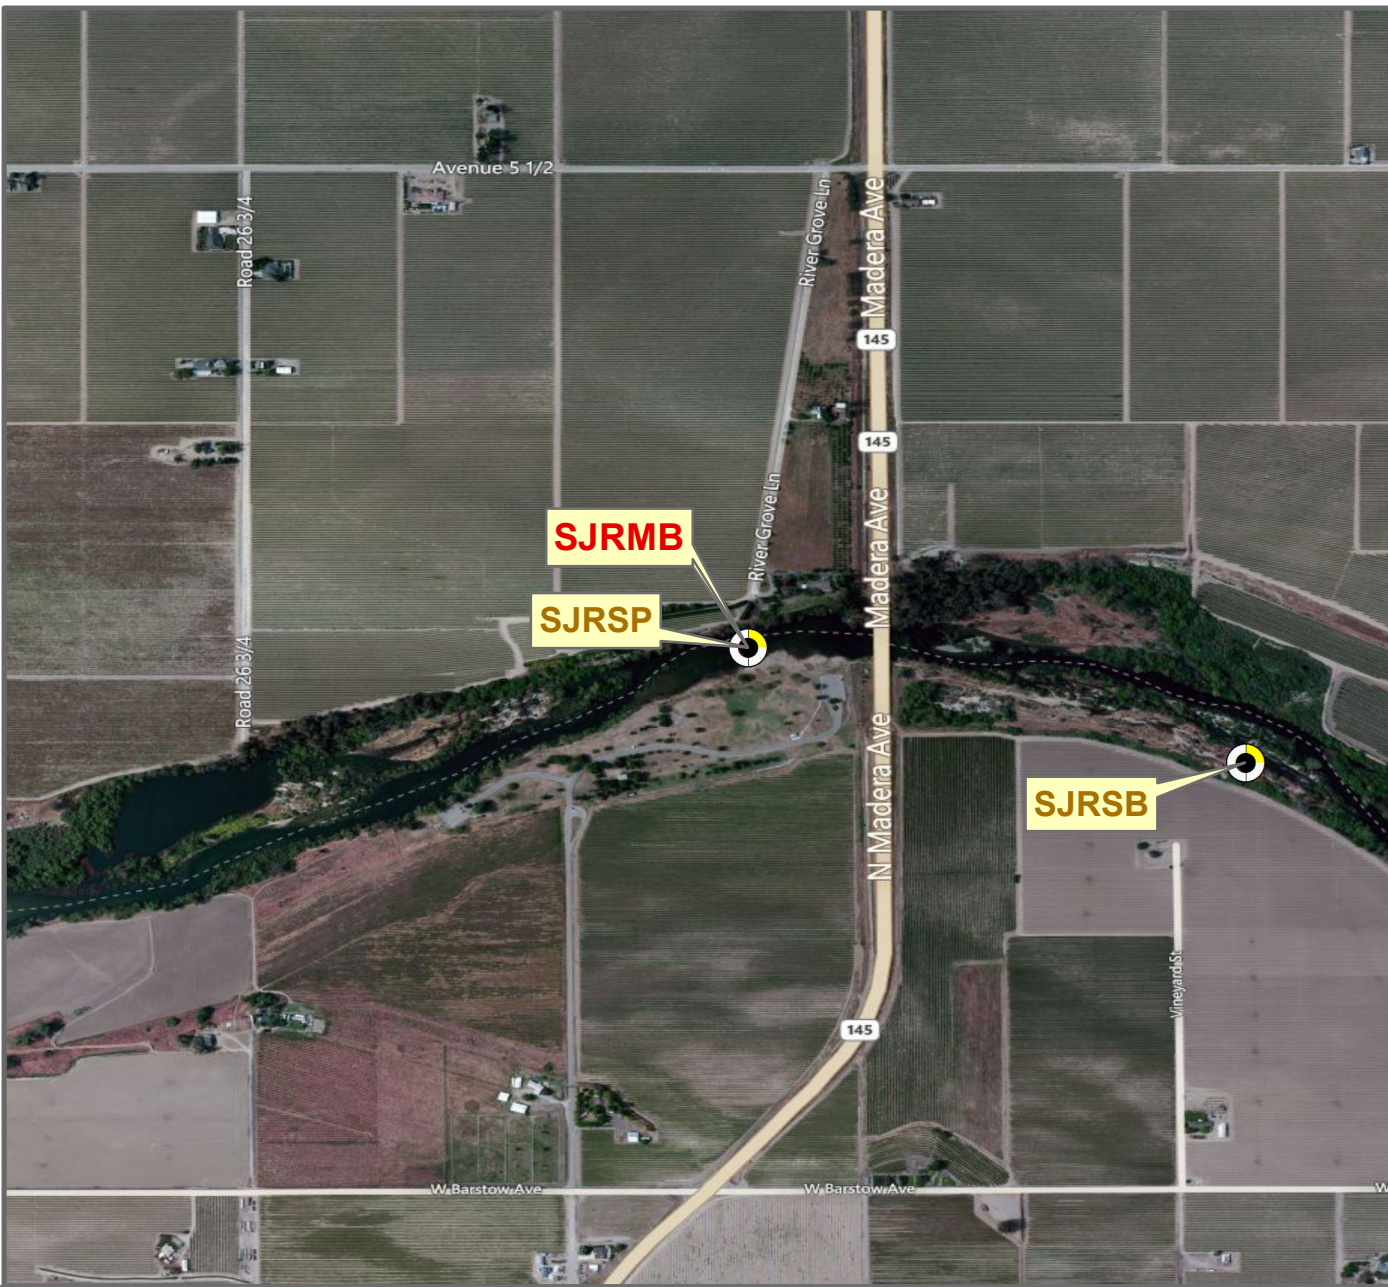
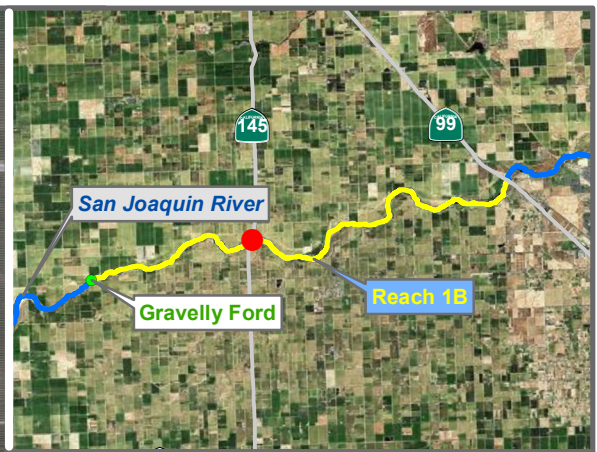
Monitoring Location SJRMB

Reach = 1B
 River Mile = 234.0
 Fresno County
 Channel Bank

X = -120.0581 Y = 36.8227 Status =
 (Horizontal Datum is NAD83)
 Distance From River (ft) = 56
 Reference Elevation (ft NAVD88) =
 Site = Mariposa Bypass

Agency = DFG
 Measurements:
 Type = Datalogger
 Interval =
 Timeseries unavailable

Description:
 Cabled to telemetry receiver in Mariposa Bypass

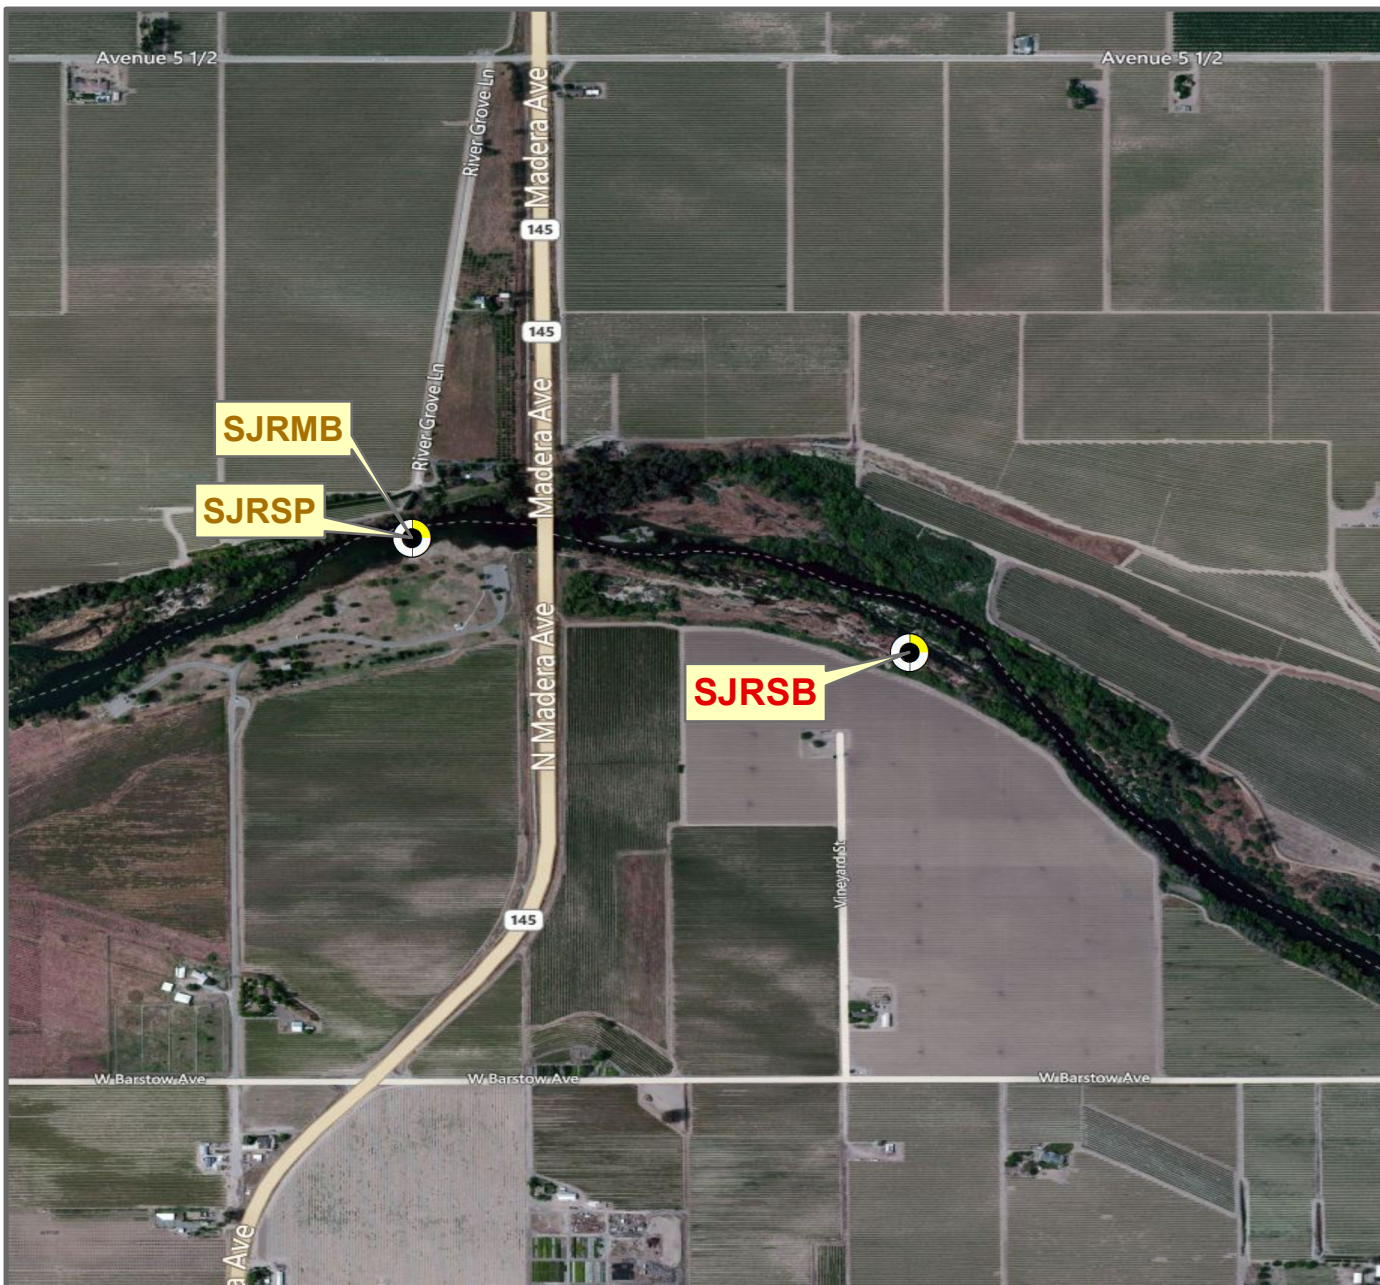
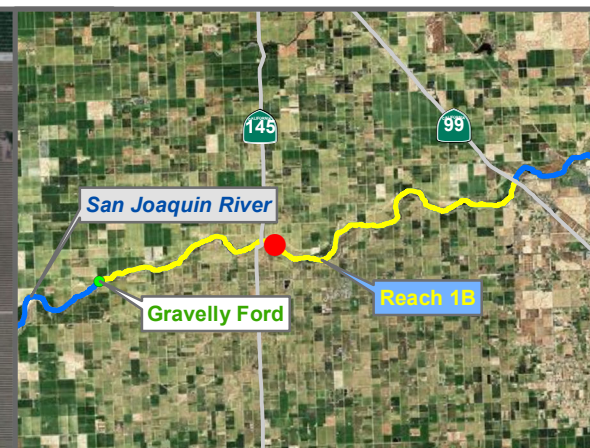
Monitoring Location SJRSB

Reach = 1B
 River Mile = 234.5
 Fresno County
 Left Bank

X = -120.0510 Y = 36.8211 Status = Lost
 (Horizontal Datum is NAD83)
 Distance From River (ft) = 250
 Reference Elevation (ft NAVD88) =
 Site = Skaggs Bridge

Agency = DFG
 Measurements:
 Type = Datalogger
 Interval = Hourly
 Timeseries unavailable

Description:
 Upstream of Skaggs Park Bridge. Cabled to tree on RR. Data lost during IFP 2010.

Ground Surface Elevation (ft) =
 Monitoring Depth (ft) = 1 ft above gs

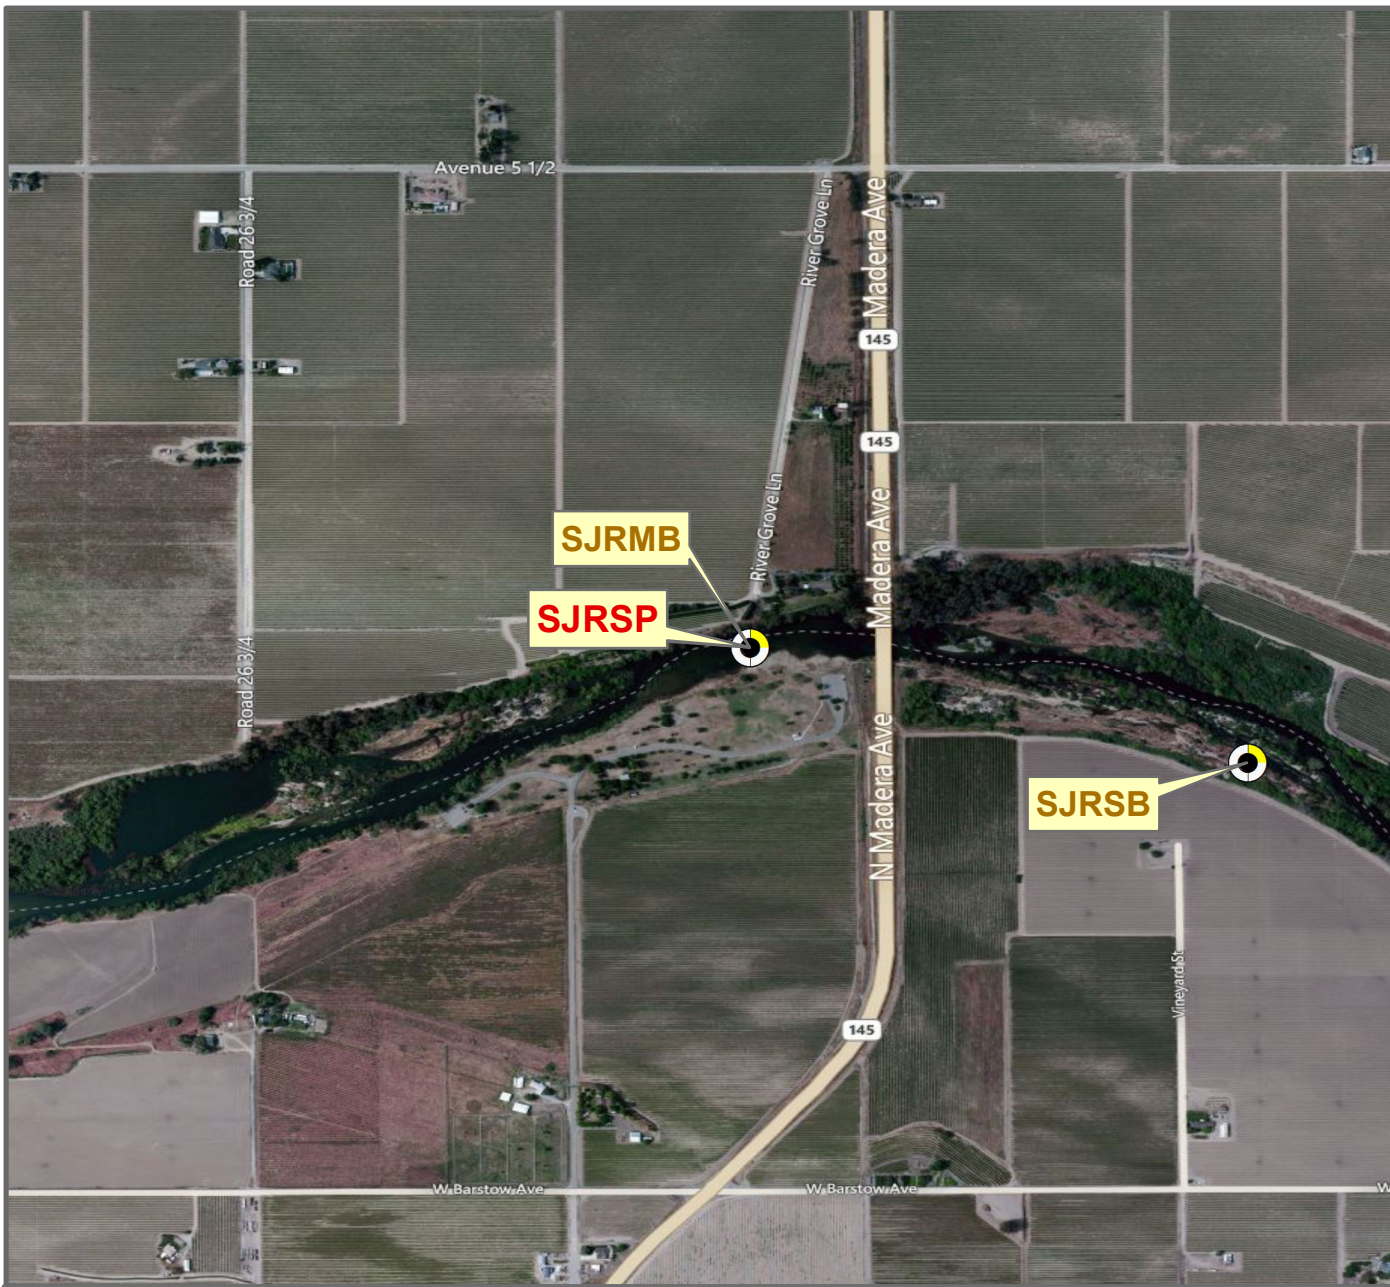
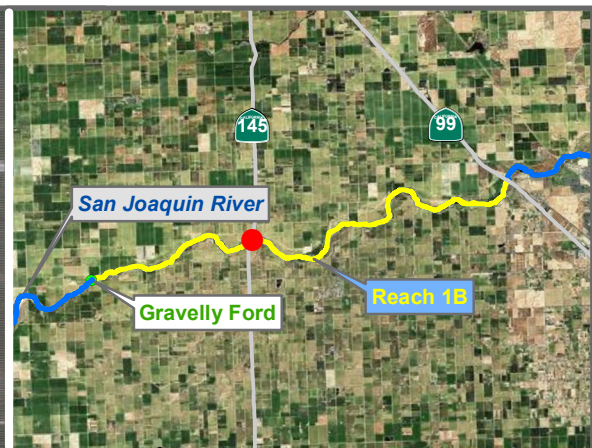
Monitoring Location SJRSP

Reach = 1B
 River Mile = 243.1
 Fresno County
 Left Bank

X = -120.0581 Y = 36.8227 Status = Existing
 (Horizontal Datum is NAD83)
 Distance From River (ft) = 56
 Reference Elevation (ft NAVD88) =
 Site = Skaggs Park

Agency = DFG
 Measurements:
 Type = Datalogger
 Interval = Hourly
 Date Range = 10/6/2010 - 1/3/2012

Description:
 Downstream of Skaggs Bridge. Cabled to root wad.

Ground Surface Elevation (ft) =
 Monitoring Depth (ft) = 1 ft above gs
