San Joaquin River Major Tributaries Sediment Transport Study

J. Toby Minear*, Scott Wright, Matt Marineau

USGS

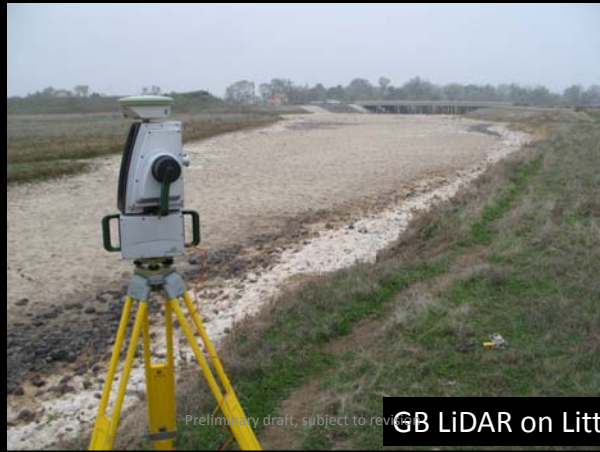
Ground-based LiDAR

- rapid 3D acquisition, range of 1.5km but we typically only use points within 100m

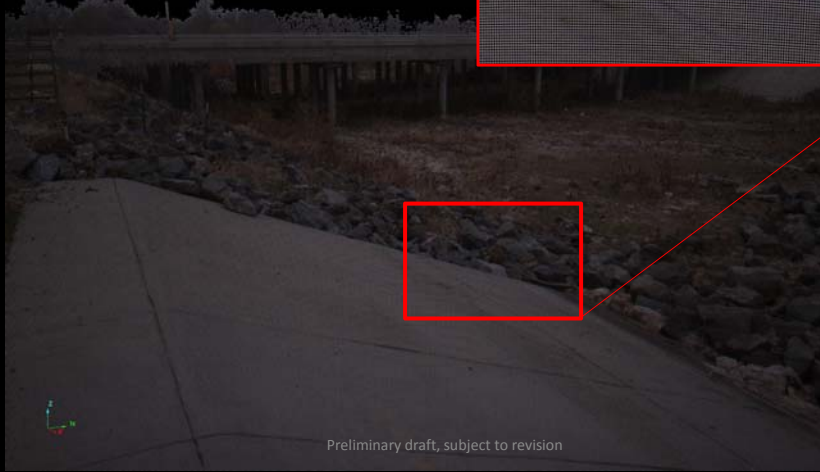
Ground-based LiDAR data:
(looks like photo but they are points)

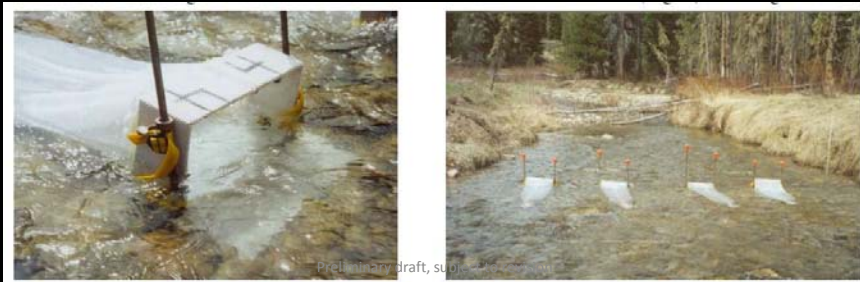
Bunte traps

- ISCO autosamplers
- Hobo water level recorders
- Bunte traps*, BLH-84
- Surface grain size

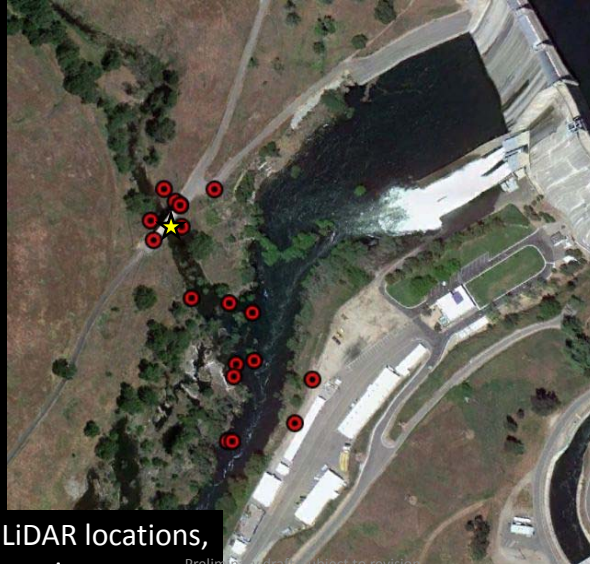
Cottonwood Creek

Circles = GB LiDAR locations,
Star = ISCO location

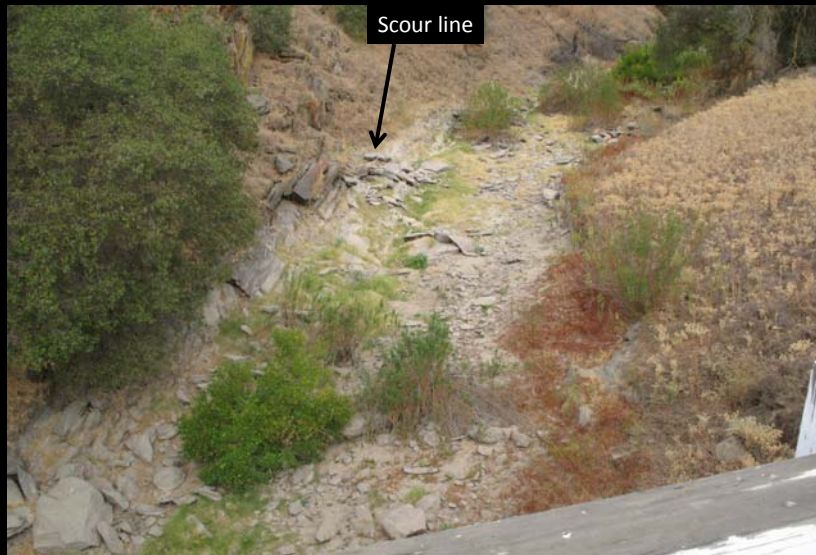
Cottonwood Creek

View from Bureau Rd bridge, October 2011,
Preliminary draft, subject to revision
Following $\sim 1,004 \text{ ft}^3 \text{ s}^{-1}$ flow in March, 2011

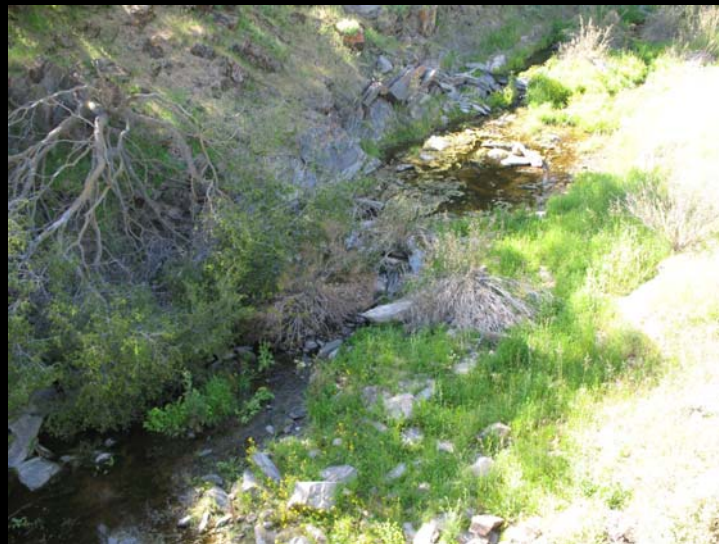
Cottonwood Creek

Preliminary draft, subject to revision
April 2012, vegetation recovering

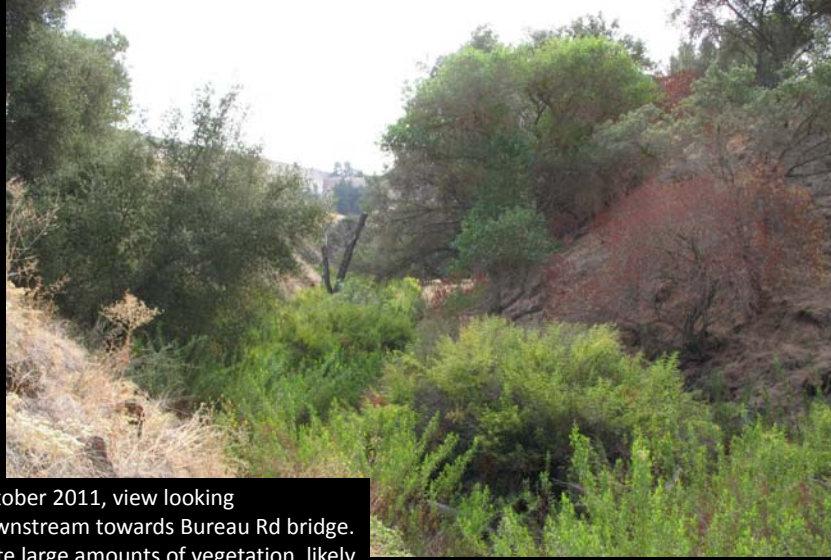
Cottonwood Creek

October 2011, view looking downstream towards Bureau Rd bridge. Note large amounts of vegetation, likely helped by canal seepage

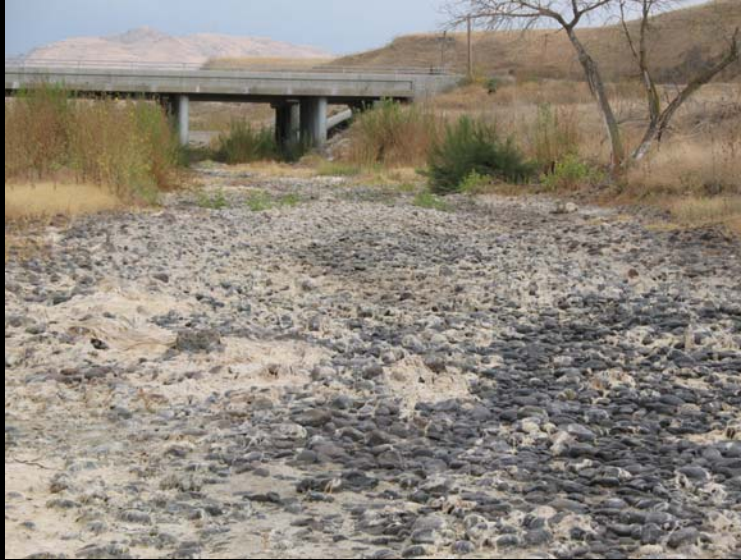
Little Dry Creek

Looking upstream at North Friant Rd Bridge. Note cobble and gravel bed

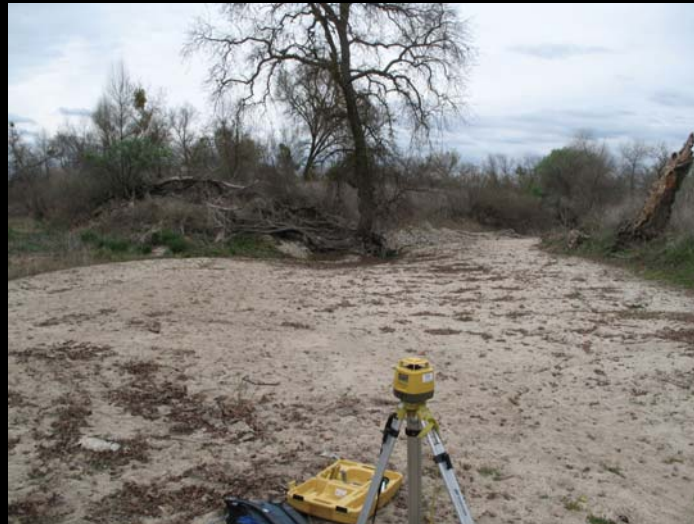
Little Dry Creek

Looking upstream at confluence of LDC and gravel pit return flow. Note large amount of sand stored in channel.

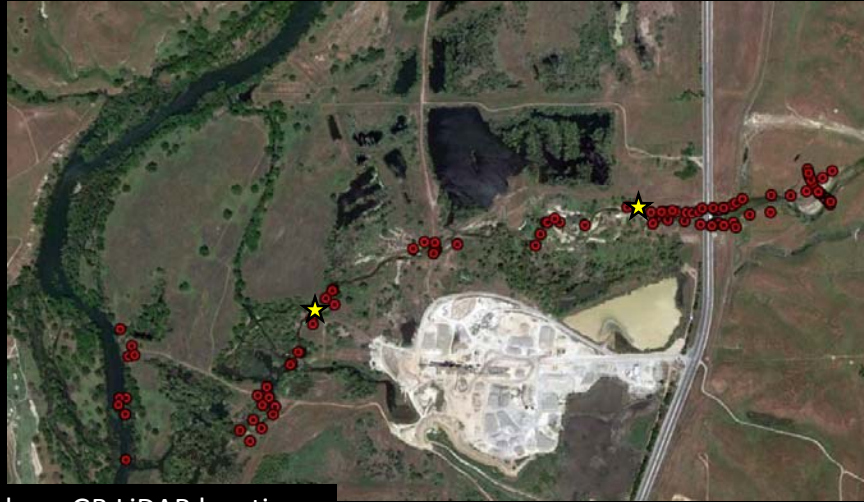
Little Dry Creek

Circles = GB LiDAR locations,
Star = ISCO location

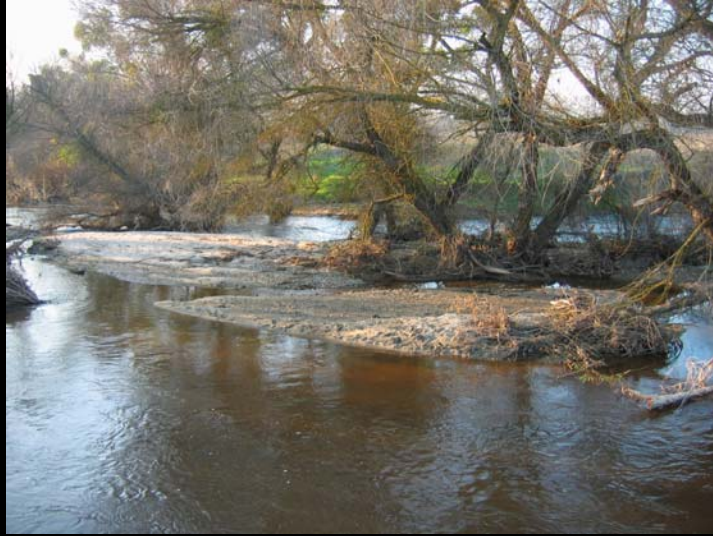
Little Dry Creek

Jan 2011, large amounts of sand deposition, sand splays

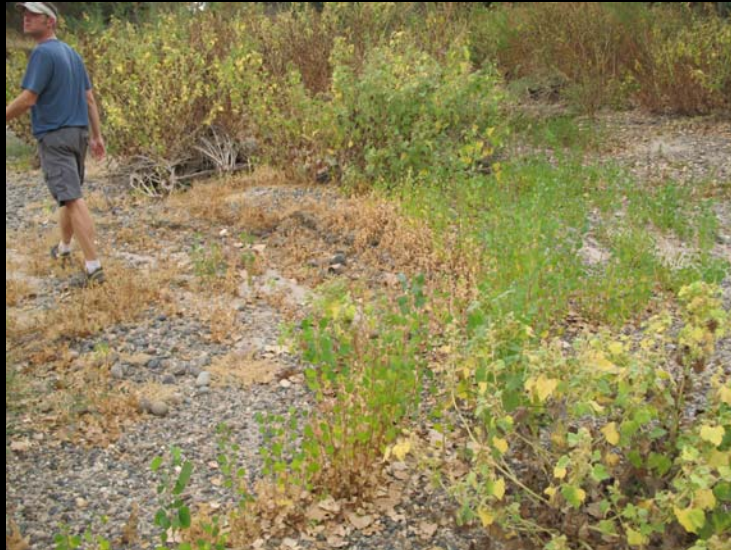
Little Dry Creek

Preliminary draft, subject to revision
Oct 2011, large successful recruitment of cottonwood seedlings

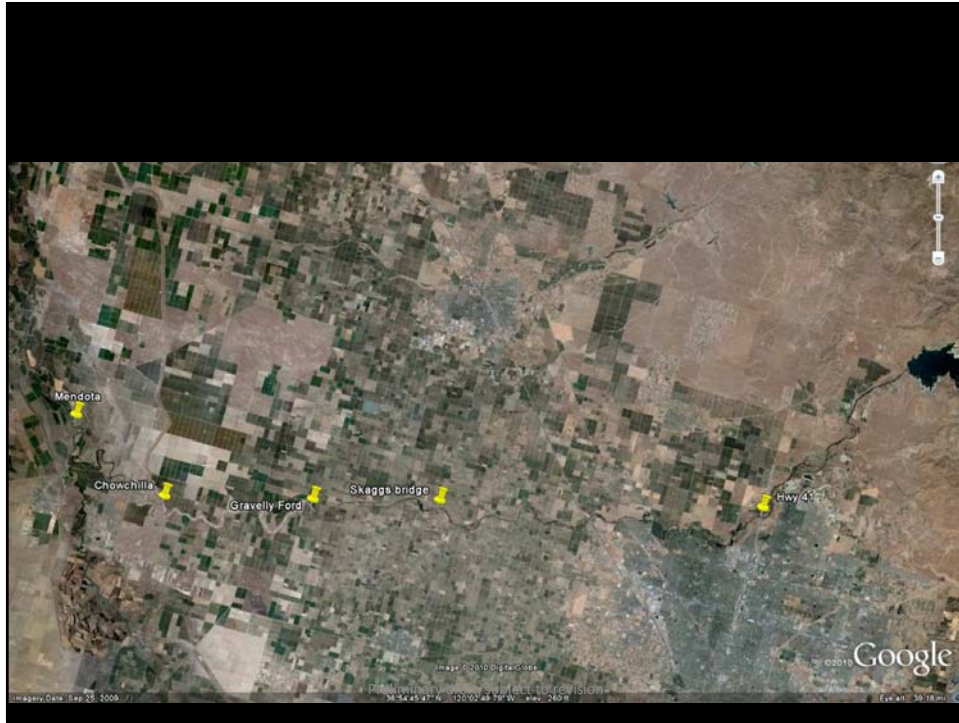
WY10 and 11 flows
