Benthic Macroinvertebrate Bioassessment in the San Joaquin River Restoration Area

Presenter:
Abimael León
Environmental Scientist
DWR – South Central Region
Restoration Goal Technical Feedback Group Meeting
March 15, 2012

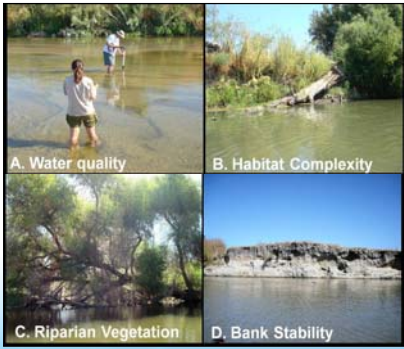
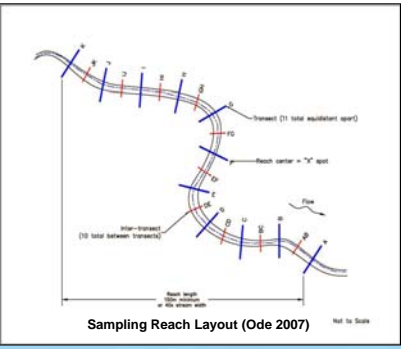
Sampling Reach Layout (Ode 2007) Not to Scale

A. Water quality

B. Habitat Complexity

C. Riparian Vegetation

D. Bank Stability

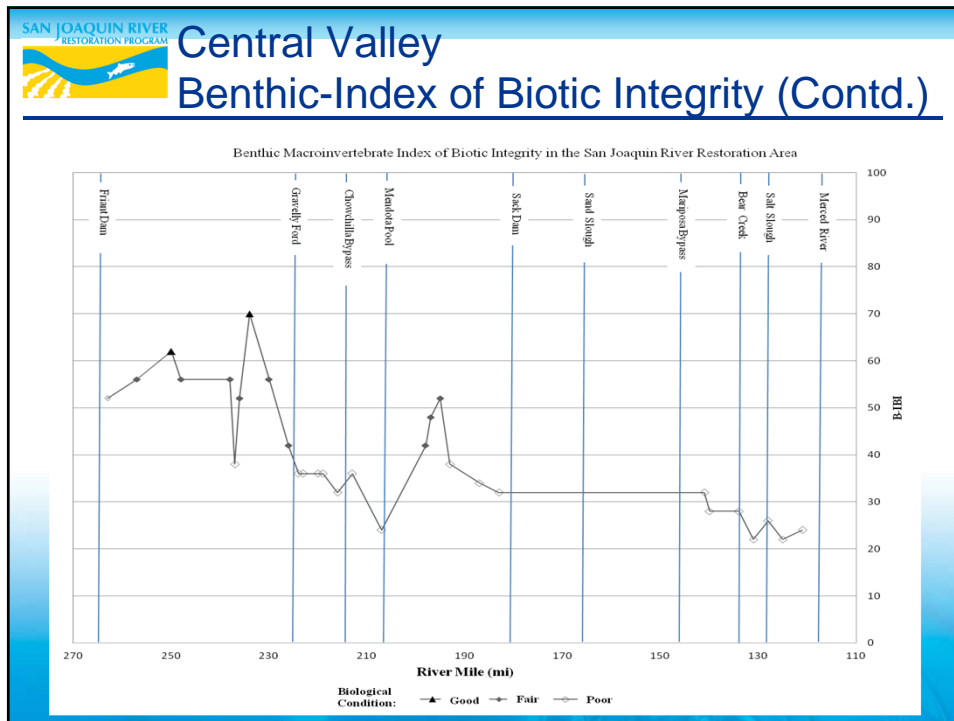
- **Preliminary results:** Most of the study sites are in “poor condition” (60%).
- The only two sites with “good condition” occur within Reach 1A and Reach 1B.
- Abundance and distribution of BMI taxa indicate a possible response to relative environmental degradation.
