Steelhead Monitoring Plan 2013 Results

2013 Monitoring Report

Central Valley Steelhead Monitoring Plan for the San Joaquin River Restoration Area

2013 Monitoring Results for National Marine Fisheries Service
Permit 16608

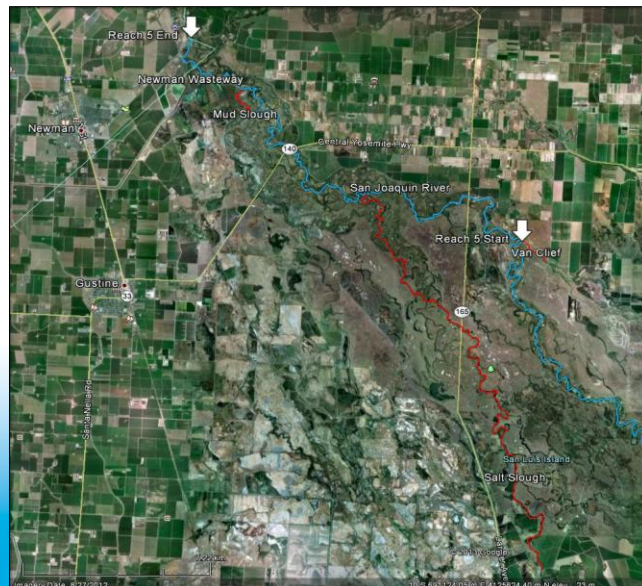
Monitoring Area

Total of
approximately
37.4 river miles
monitored:

- Approximately 18 SJR miles
- 19.4 miles of slough tributaries

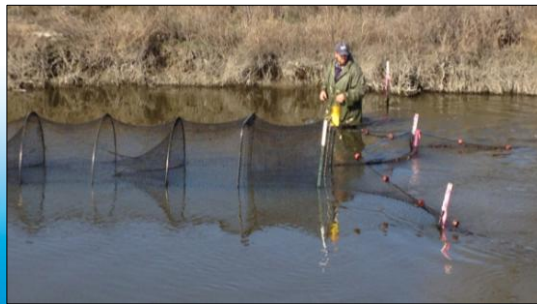
E-Fishing	Fyke Trap	Trammel Net
Species Captured	673	393	182
Native	36	9	30
Non-native	637	384	152
