Technical Memorandum ENV-2020-082

San Joaquin River Steelhead Monitoring Plan 2019-20

U.S. Bureau of Reclamation, Technical Science Center, Denver, CO 80225

September 2020

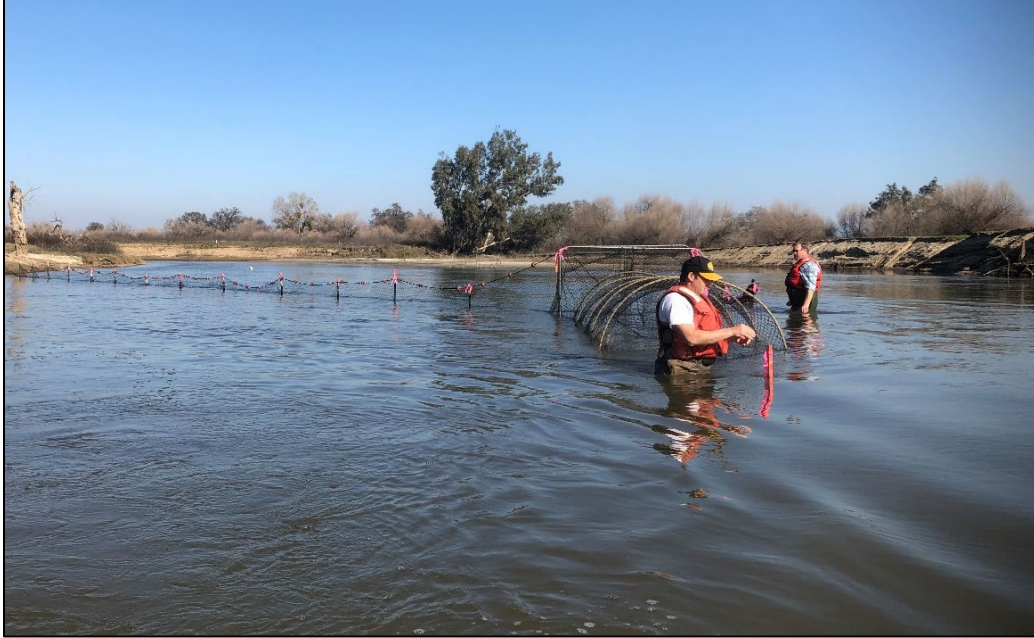
Figure 2. Deployed fyke net at Hills Ferry Barrier location, Reach 5 of the San Joaquin River Restoration Area. Note opening and v-shape of wing walls facing downstream.

Fyke nets are a passive fish sampling gear capable of spanning the full river width, and are, therefore, an efficient and effective tool to capture upstream moving adult fish. SMP fyke nets were constructed of 2.4-cm square #252 knotless nylon netting formed over 5 consecutive 1.2-m hoops and a 1.2-m square welded-conduit frame entrance. The nets contained two throats with a 25-cm diameter opening. Wing walls, attached to the sides of the net opening, were 1.2 m deep and spanned the majority of the river's width (leaving boat passage). The opening of the net faced downstream with the wing walls extending to shore in a v-shaped pattern and were held in place with t-posts (Figure 2).

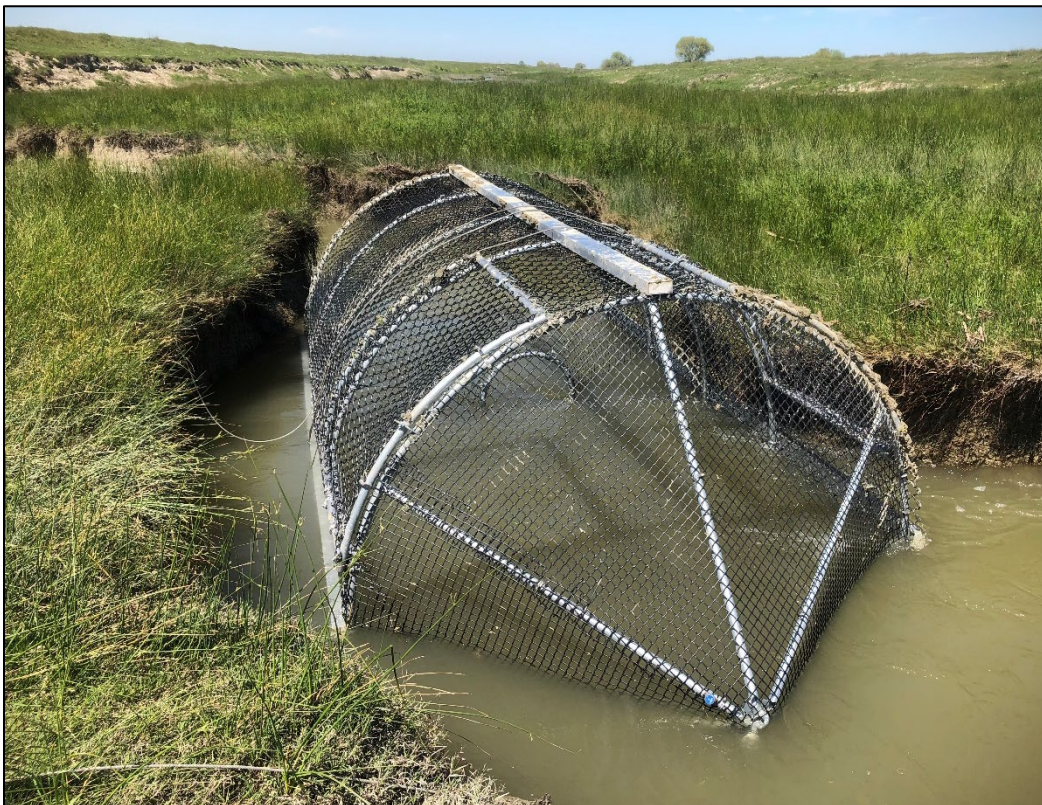
Figure 3. Fyke trap deployed in Eastside Bypass, Reach 4 of the San Joaquin River Restoration Area. Note downstream orientation of the trap opening and riverine bottleneck location.

Fyke traps are similar in design as fyke nets, but do not have wing walls and their construction allows them to be fished at deeper depths and elevated flows. Fyke traps were constructed of 5.0-cm chain link formed over 6 consecutive 3.0-m hoops. The traps contained two throats with the smaller opening of 60-cm. Traps were placed in natural riverine bottlenecks with a minimum depth of 1.5-m. The mouth of the trap faced downstream, and the trap was anchored utilizing t-posts and other readily available anchor points (Figure 3).

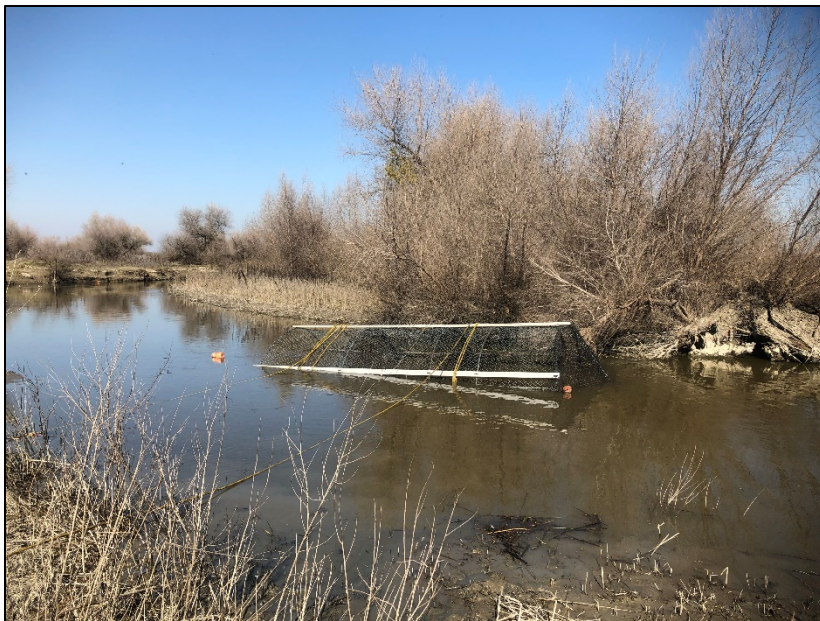
Figure A-2. Fyke trap monitoring, 2019-20 Steelhead Monitoring Plan, Mud Slough, Reach 5, San Joaquin River, CA.

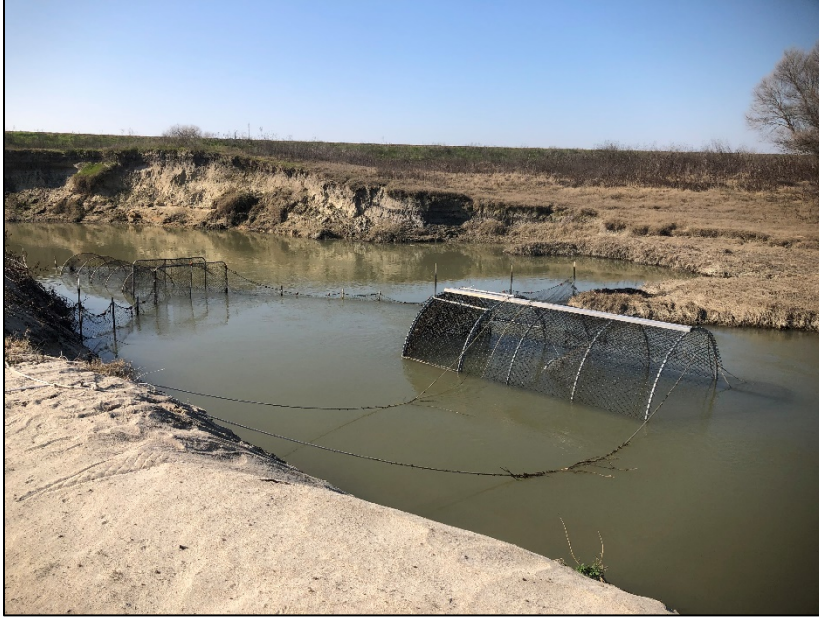
Figure A-3. Overlapping fyke trapping and netting during the 2019-20 Steelhead Monitoring Plan at Van Clief, Reach 4B2, Bear Creek, CA.

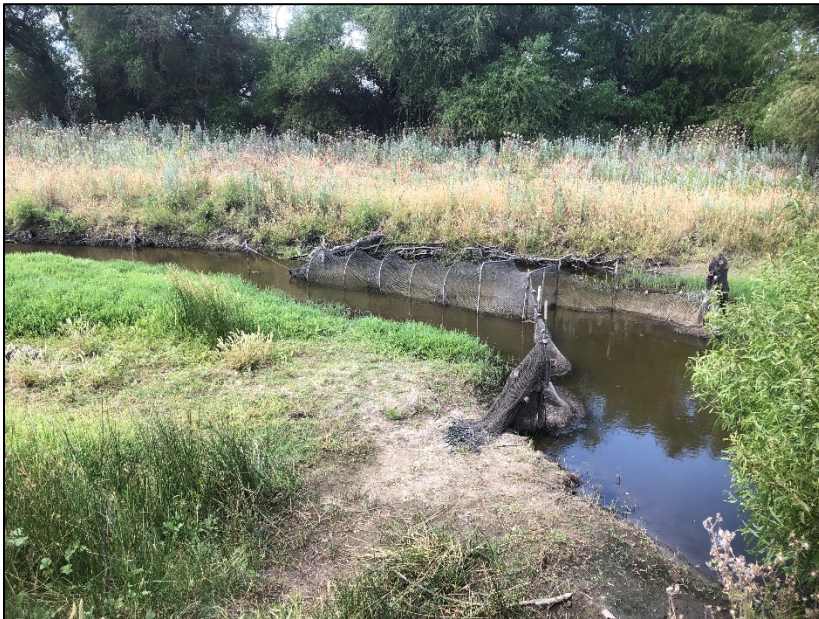
Figure A-4. Fyke netting during the 2019-20 Steelhead Monitoring Plan at Van Clief SJR. Reach 4B2, San Joaquin River, CA.
