Technical Memorandum

**Channel Capacity Report
2022 Restoration Year**

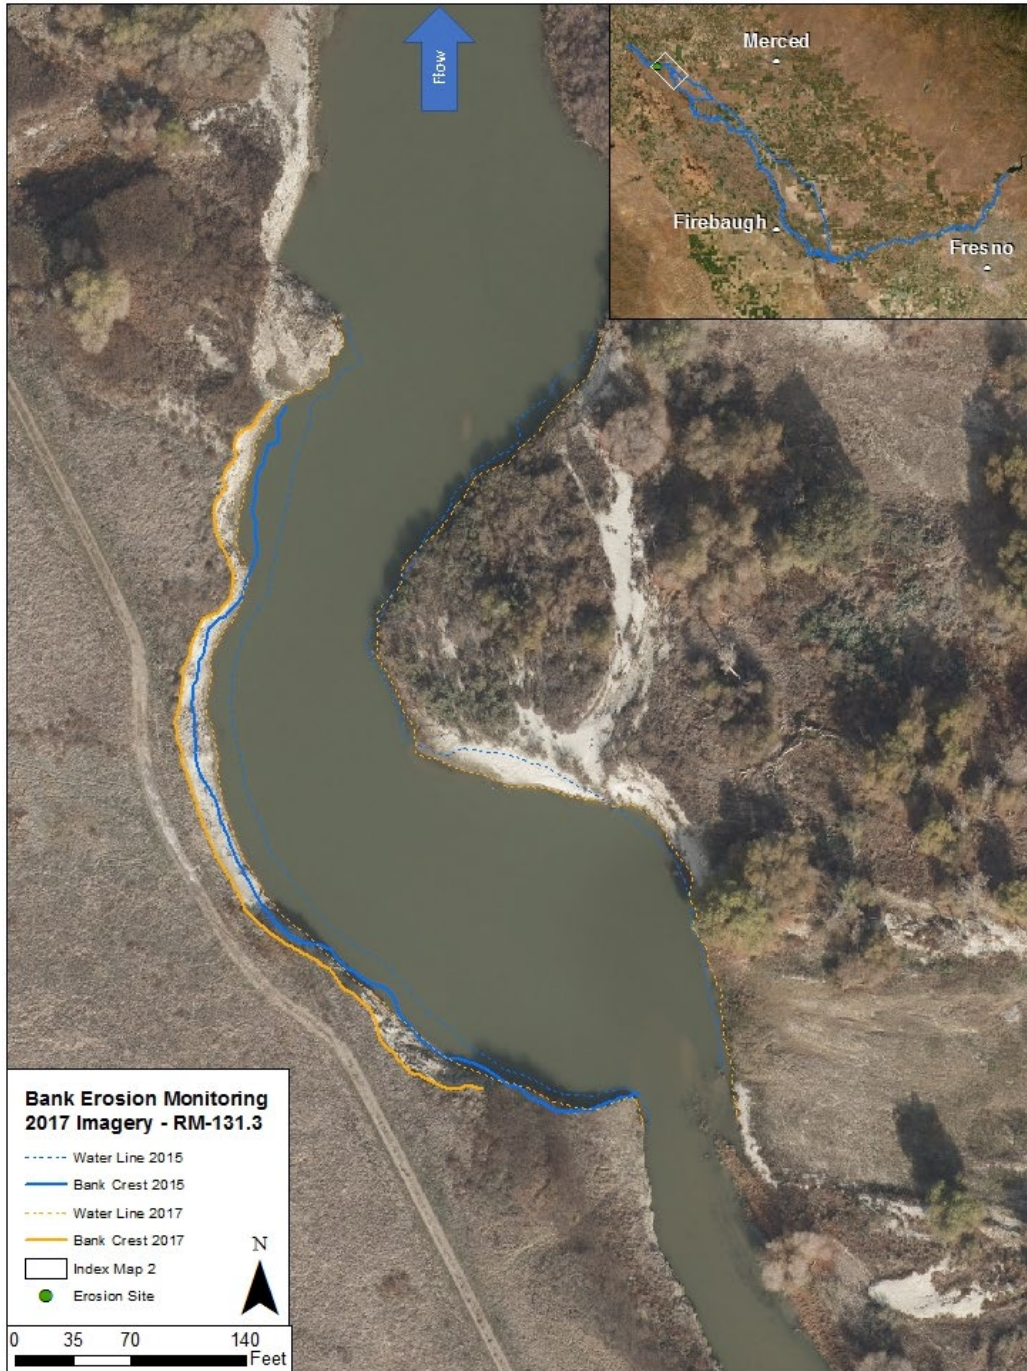
27 designated as a low threat. An example of a high threat from Reach 5 is shown in Figure 3-2. It is
28 a high threat because it has a threat ratio of 0.0 indicating that erosion has already occurred into a
29 structure. In this example, Figure 3-2 shows the river encroaching into a levee where an access
30 road veers away from the eroding bank escarpment.

Figure 3-2.
Example of a high threat erosion site in Reach 5
