# Technical Memorandum

## SAN JOAQUIN RIVER RESTORATION PROGRAM

# San Joaquin River Steelhead Monitoring Plan 2020-21

September 2021

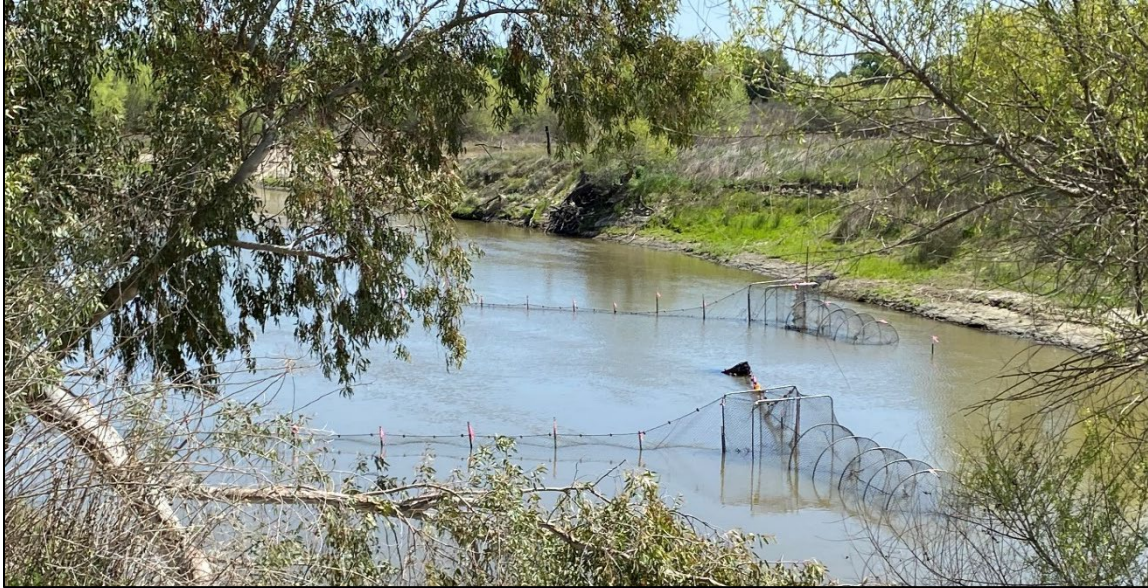
**Figure 2.** Deployed overlapping fykes net at Hills Ferry Barrier location, Reach 5 of the San Joaquin River Restoration Area. Note opening and v-shape of wing walls facing downstream.

Fyke nets are a passive fish sampling gear capable of spanning the full river width, and are, therefore, an efficient and effective tool to capture upstream moving adult fish. Steelhead Monitoring fyke nets were constructed of 2.4-cm square #252 knotless nylon netting formed over 5 consecutive 1.2-m hoops and a 1.2-m square welded-conduit frame entrance. The nets contained two throats with a 25-cm diameter opening. Wing walls, attached to the sides of the net opening, were 1.2 m deep and spanned the majority of the river's width (leaving boat passage). The opening of the net faced downstream with the wing walls extending to shore in a v-shaped pattern and were held in place with t-posts (Figure 2).

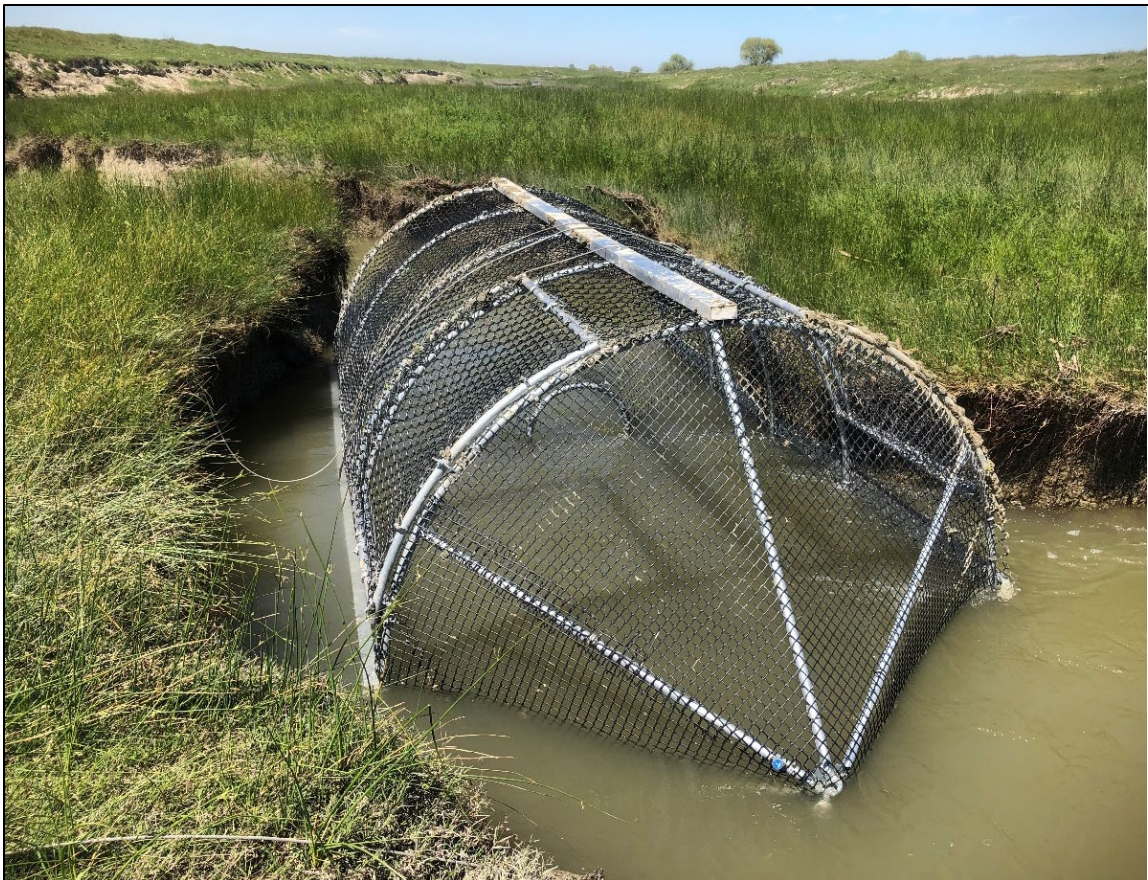
**Figure 3.** Fyke trap deployed in Eastside Bypass, Reach 4 of the San Joaquin River Restoration Area. Note downstream orientation of the trap opening and riverine bottleneck location.

Fyke traps are similar in design as fyke nets, but do not have wing walls and their construction allows them to be fished at deeper depths and elevated flows. Fyke traps have a larger opening (2.4-m or 3-m), and were constructed of 5.0-cm chain link formed over 6 consecutive 3.0-m hoops. The traps contained two throats with the smaller opening of 60-cm. Traps were placed in natural riverine bottlenecks with a minimum depth of 1.5-m. The mouth of the trap faced downstream, and the trap was anchored utilizing t-posts and other readily available anchor points (Figure 3).

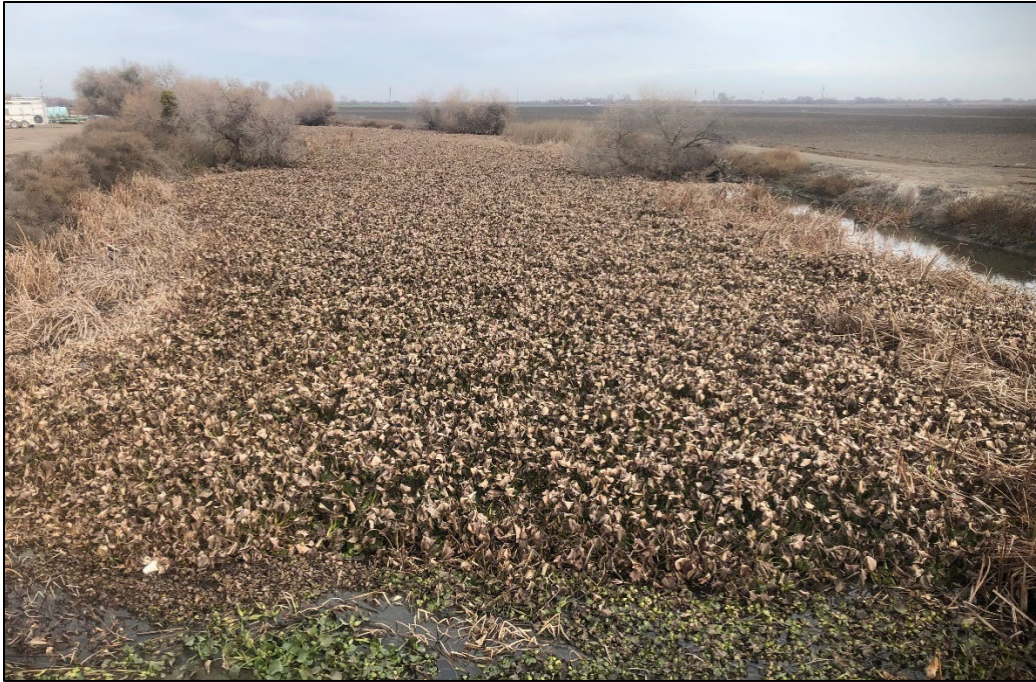
**Figure A-1.** Reach 4B2, Salt Slough, San Joaquin River, CA. Elevated water hyacinth restricted access, and likely fish passage, and monitoring was not completed at this location during 2020-21 Steelhead Monitoring Plan.

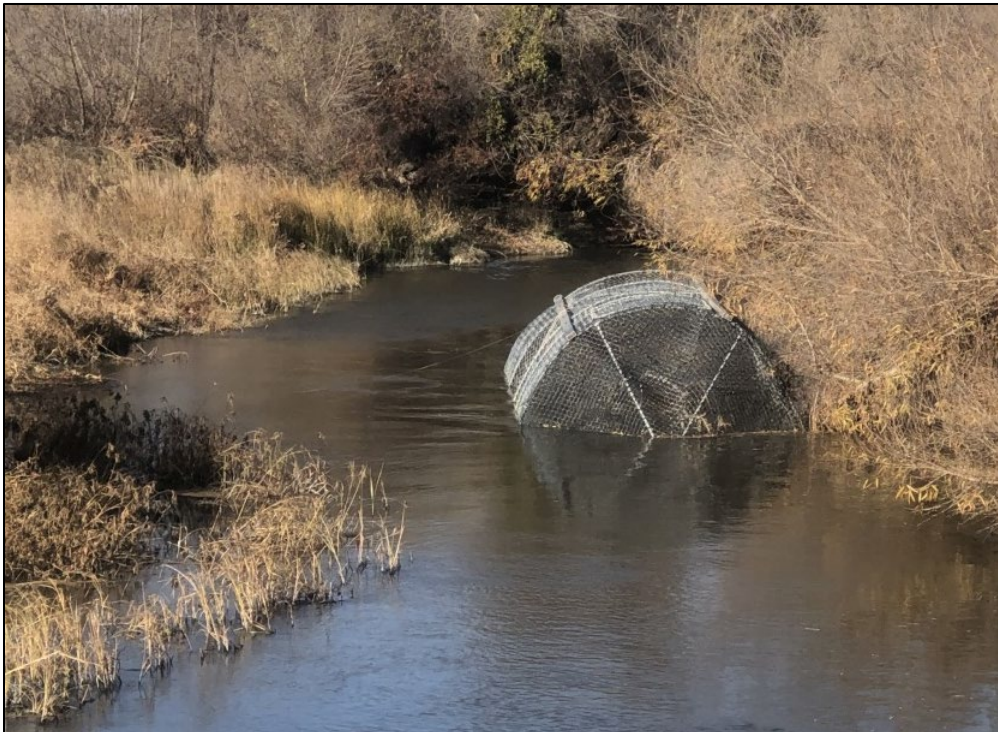
**Figure A-2.** Fyke trap monitoring, 2020-21 Steelhead Monitoring Plan, Mud Slough, Reach 5, San Joaquin River, CA.

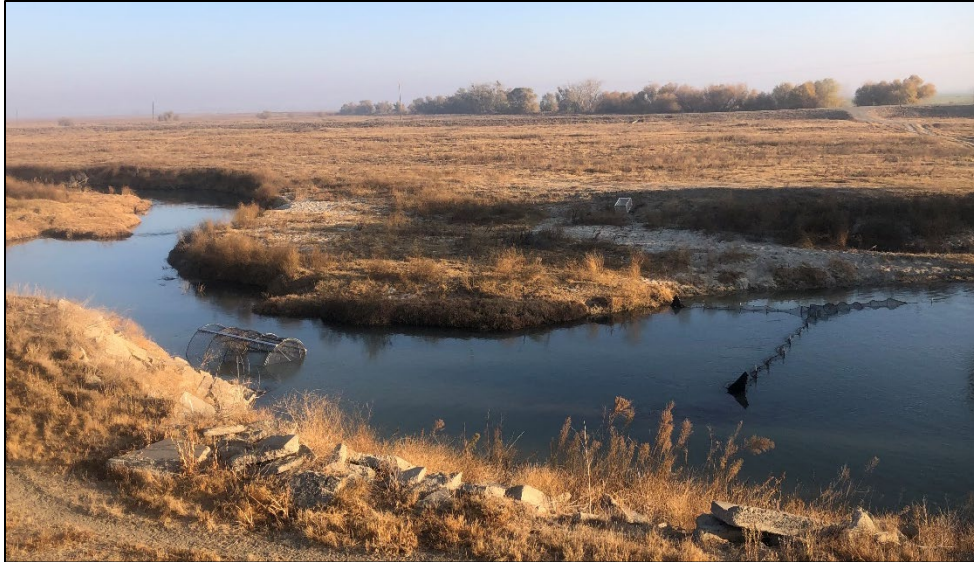
**Figure A-3.** Overlapping fyke trapping and netting during the 2020-21 Steelhead Monitoring Plan at Van Clief, Reach 4B2, Bear Creek, CA.

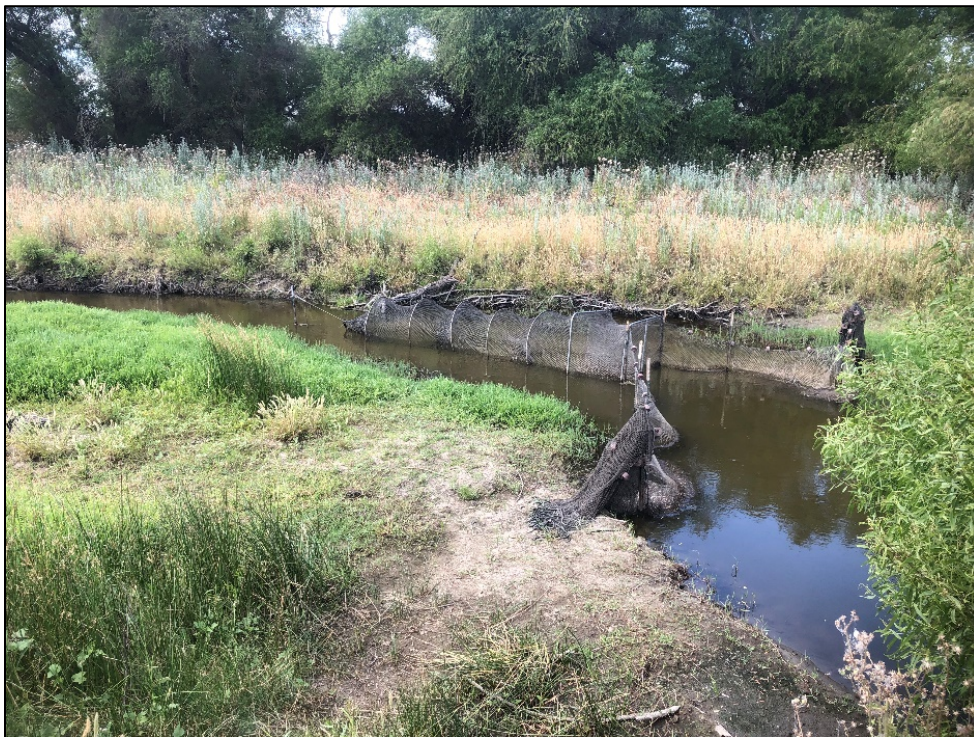
**Figure A-4.** Fyke netting during the 2020-21 Steelhead Monitoring Plan at Van Clief SJR. Reach 4B2, San Joaquin River, CA.
