Evaluation of Hills Ferry Barrier Effectiveness at Restricting Chinook Salmon Passage on the San Joaquin River

U.S. Department of the Interior
Bureau of Reclamation
Technical Service Center
Fisheries and Wildlife Resources Group
Denver, Colorado

October 2011

San Joaquin River Restoration Program

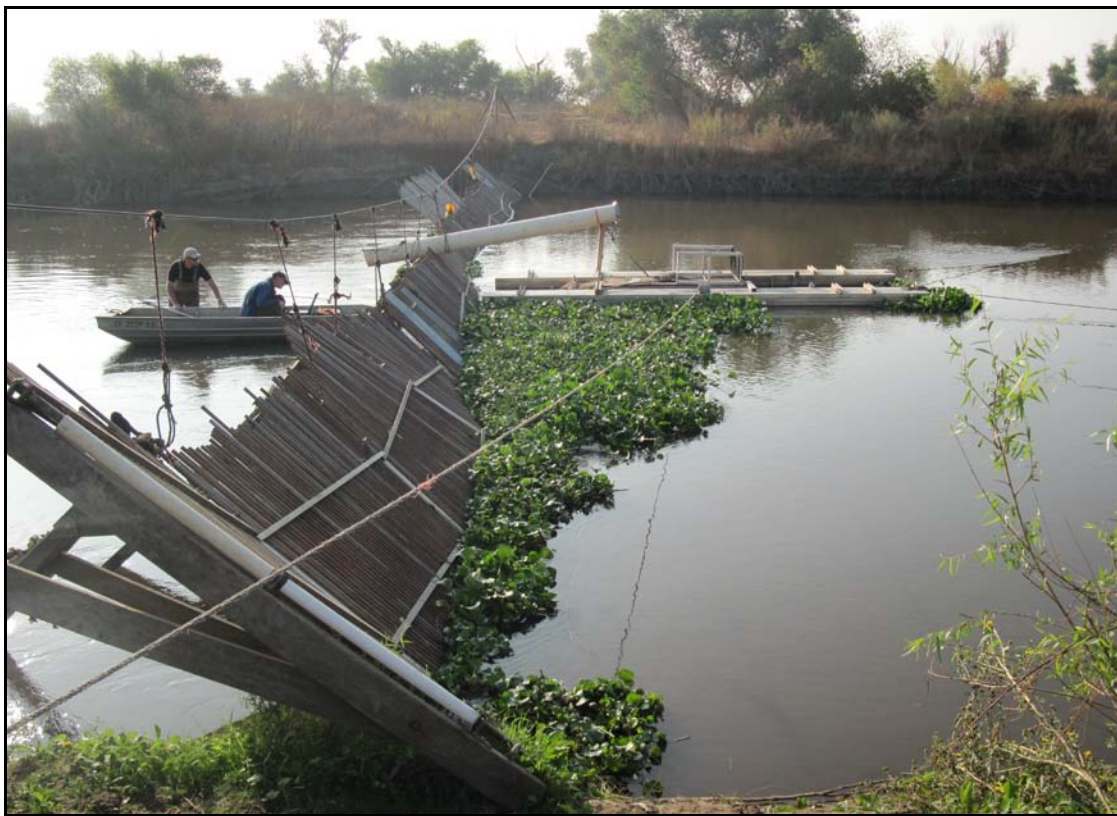
Figure 1.—Hills Ferry Fish Barrier and fish trap on the San Joaquin River, California.

HFB (Figure 1) is a sliding pipe weir located approximately 300 m (328 yd) upstream of the San Joaquin and Merced River confluence (Figure 2), 5.5 km (3.4 mi) east of Newman, California. The barrier is intended to impede passage of fall-run Chinook salmon from ascending the San Joaquin River above the confluence with the Merced River where habitat and water quality (temperature) are unsuitable for these fish. The HFB also blocks the Central Valley (CV) steelhead (*Oncorhynchus mykiss*) from moving upstream, although the HFB is not in place during the CV steelhead’s greatest potential to occur in the area (mid-December through mid-February). Identifying salmon, steelhead, and other native species use of the river is important to the SJRRP’s recovery program, and it is beneficial to determine fish species that are encountering the barrier. Information regarding the presence of non-native species such as catfish, carp, and striped bass may also be helpful but is a secondary priority.

The current design used since 2004 is a sliding pipe weir constructed with wooden tripod support structures and aluminum channel that have 2.5-cm (1-in) holes to allow pieces of 1.9-cm (.75-in) electrical conduit to slide into the riverbed. This type of weir has been

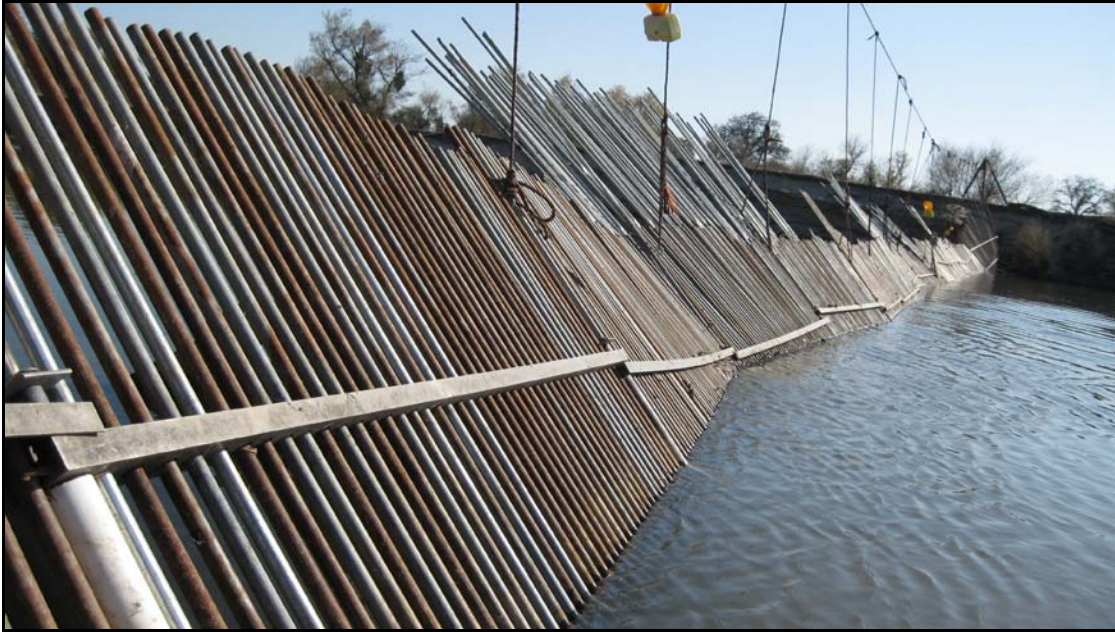
Figure 3.—Hills Ferry Barrier is a sliding pipe weir constructed of aluminum channel with 2.5-cm (1-in) holes that allow 1.9-cm (.75-in) electrical conduit to slide freely vertically in the corresponding holes and are pushed into the riverbed.

The HFB is a sliding pipe weir design used to exclude large migrating fish from swimming upstream while allowing water and other smaller species to pass. The barrier was installed August 31, 2010 and was removed December 9, 2010, which is the timeline of peak migration of fall-run Chinook salmon to Central Valley Rivers. The general principle of this type of weir is that an aluminum channel with 2.5 cm (1-in) holes allowed pieces of 1.9-cm (0.75-in) electrical conduit to slide freely vertically in the corresponding holes and can be pushed into the riverbed (Figure 3). The weir consisted of anchor points on each side of the river and a cable that spanned the river about 2–3 m (6.56–9.84 ft) above the water level. Eighteen, 2.5-m-high (8.20-ft-high) tripods spaced approximately 0.5 m (1.64 ft) apart at their base were tethered to the overhead cable. Two horizontal rows of aluminum channel with 2.5-cm (1-in) holes machined every 3.8 cm (1.5 in) were affixed to the tripods. The 1.9-cm (.75-in) electrical conduit pickets were then slid through these holes to make a fish tight weir. The fish trap that was retrofitted to the barrier consisted of a 1-m-wide x 2-m-long x 1-m-high (3.28-ft-wide x 6.56-ft-long x 3.28-ft-high) box frame with 2.5-cm (1-in) bars spaced at 2.5 cm (1 in) and a funnel opening to deter escapement once fish entered (Figure 4). The trap was suspended upstream of the barrier by two pontoons. An opening in the weir was made by removing conduit pickets and affixing a net-tube that led from the weir to the trap. The trap was checked for fish daily when in operation.

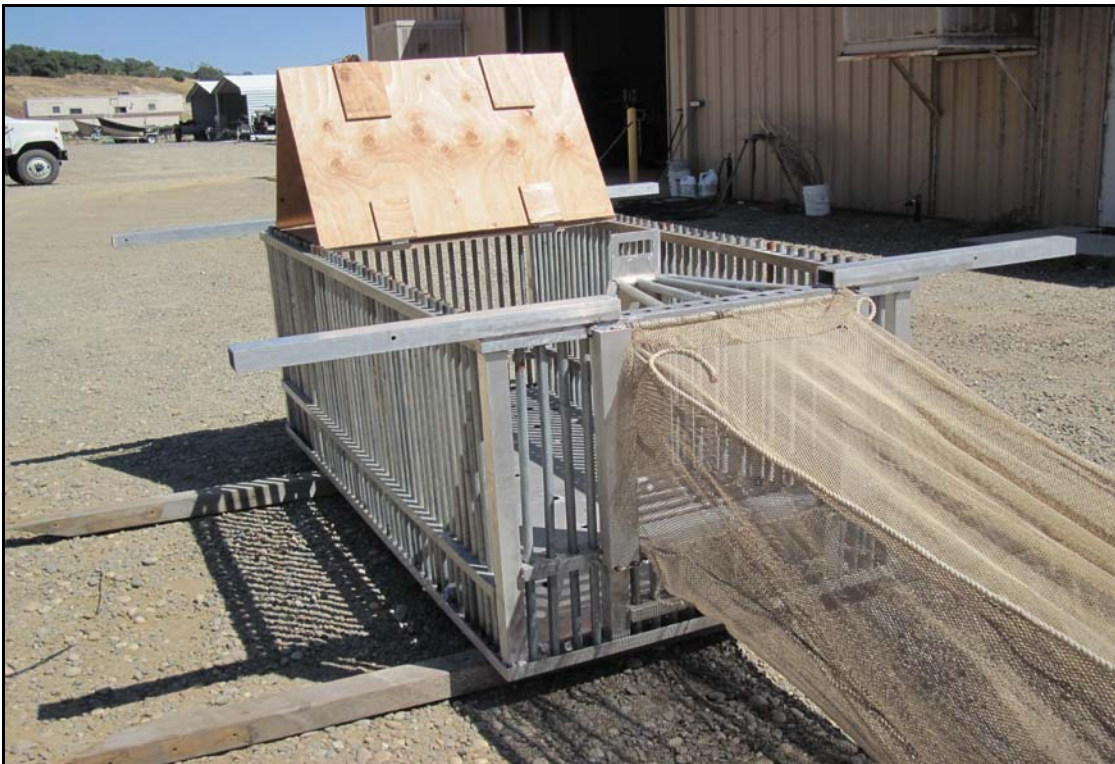
Figure 4.—Fish trap retrofitted to the Hills Ferry Barrier sliding pipe weir design that consisted of a 1-m-wide x 2-m-long x 1-m-high (3.28-ft-wide x 6.56-ft-long x 3.28-ft-high) box frame with 2.5-cm (1-in) bars spaced at 2.5 cm (1 in) and a funnel opening to deter escapement. The net entrance led from the weir to the trap.

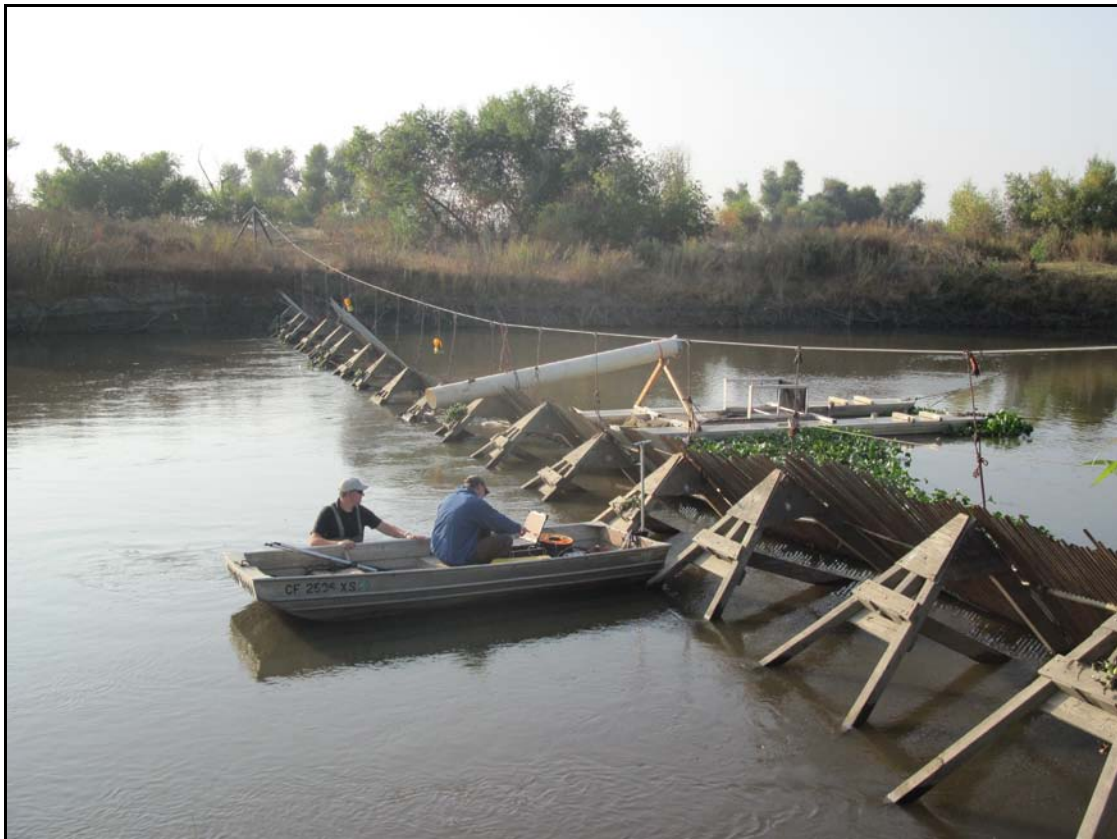
Figure 5.—River-wide transects were recorded along the barrier to monitor scouring and passage issues along with fish behaviors using a DIDSON camera affixed to a transom mount of a jon boat and manually maneuvered across the channel directly adjacent the barrier.

Barrier effectiveness at blocking migrating fish under a variety of flow conditions was evaluated by assessing the location and behavior of sediment scouring using a dual-frequency identification sonar underwater camera (DIDSON; Sound Metrics Corp., Chesapeake, Virginia). The near video quality images of the DIDSON allowed detailed underwater inspections of the barrier structure and substrate in turbid water. The DIDSON camera was also used to observe fish interactions with the weir and determine fish species that encounter the barrier. The DIDSON was configured with a remotely operated pan and tilt actuator that allowed a scan of the weir and river bottom. The DIDSON camera was affixed to a transom mount that allowed for easy attachment to a jon boat and manually maneuvered across the channel directly adjacent the barrier (Figure 5). River-wide transects recording barrier condition as well as fish behaviors were performed above and below the weir on September 21st, October 20th and November 18th.

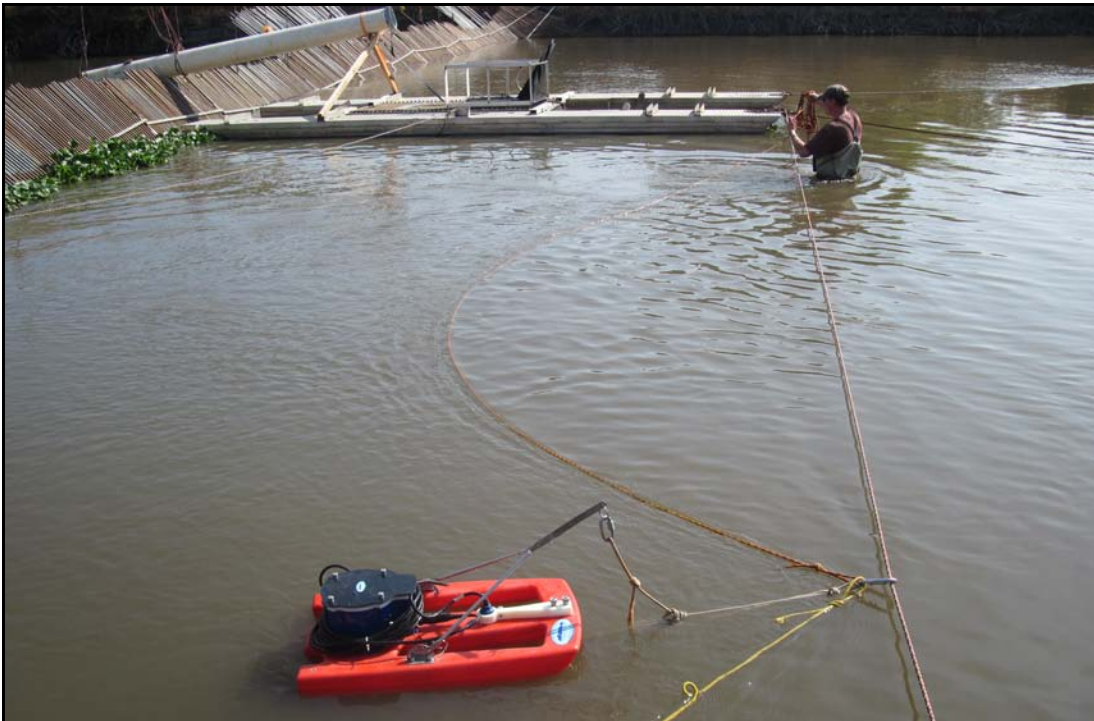
Figure 6.—Measuring river velocity and bathymetric transects utilizing the Acoustic Doppler Current Profiler.

River transects were measured upstream and downstream of the barrier with a Teledyne RD Instruments StreamPro Acoustic Doppler Current Profiler (ADCP; Teledyne RD Instruments, Poway, California) to map changes in bed elevations and velocity distributions and to identify scour and depositional zones during barrier operation (Figure 6). The StreamPro includes a 2.0 MHz ADCP with four transducers at a 20 degree beam angle mounted to a small float. The bottom-tracking capability of the StreamPro provides the ability to move the instrument continuously across the river. A tagline was set up at seven locations and the instrument was floated across the river at a velocity slower than the water velocity and raw data were processed with specialized StreamPro software. Velocity data were collected with a vertical cell size of 7.6–10.1 cm (0.25–0.33 ft) depending on the maximum water depth. Velocity resolution of the instrument is 0.1 cm/s (0.04 in/s). A handheld computer collected data via a Bluetooth transmitter and raw data were processed in specialized StreamPro software. River transects were collected 0.6, 1.5, 3.0, 9.1 m (2, 5, 10, and 30 ft) upstream of the barrier and 0.6, 1.5, 3.0, 9.1 m (2, 5, 10, and 30 ft) downstream of the barrier. Data were not collected 9.1 m (30 ft) downstream of the barrier since the 1.5-m (5-ft) and 3.0-m (10-ft) transects did not show significant changes in velocity or bed elevation during October. The river stage was recorded from USGS site 11273400 (San Joaquin R AB Merced R near Newman, California) staff gage directly upstream of the barrier. Data were collected on October 19–20, 2010 and November 16–17, 2010. Additional field trips were scheduled in December 2010 and January 2011, but field work was canceled due to very high river flows producing unsafe working conditions.

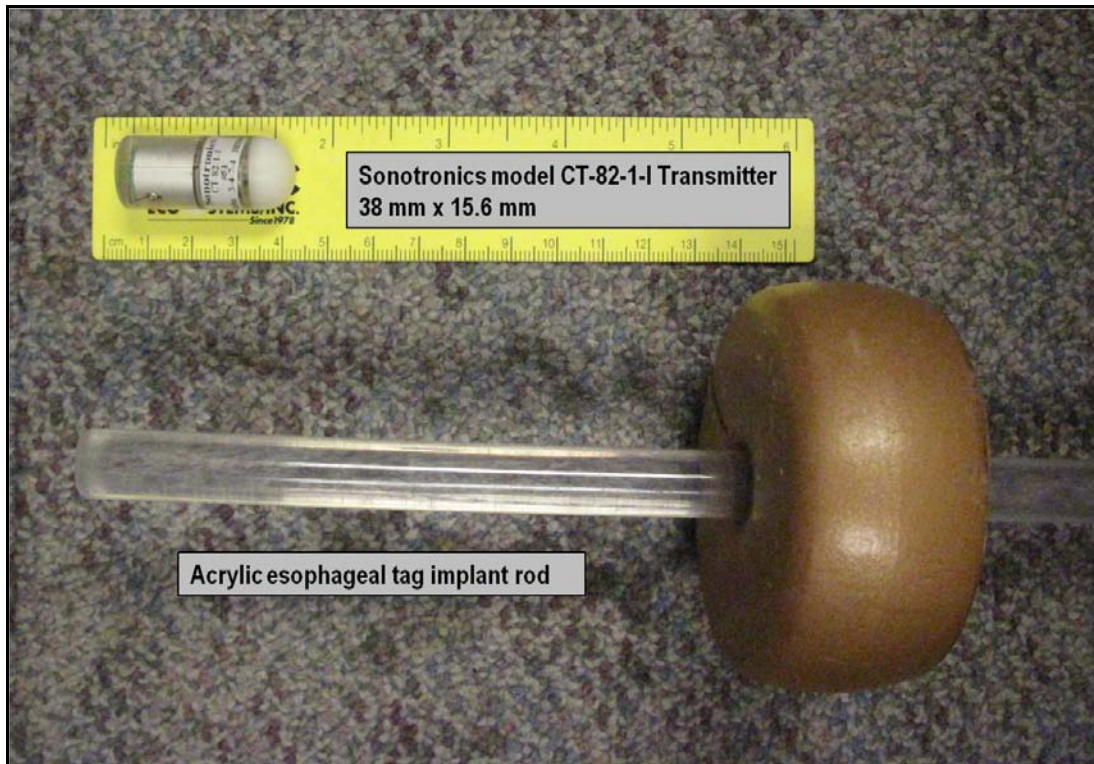
Figure 7.—Sonotronics model CT-82-1-I acoustic transmitter and acrylic rod used for esophageal tag insertion.

Tags were activated, coated with glycerin for lubrication, and pushed passed the aortic sphincter into the upper stomach of the fish using an acrylic rod similar in diameter to the tag (Figure 8). Fish were held by an assistant while the tag was inserted. The entire handling procedure was performed without the use of anesthetic and took less than 4 minutes. The fish was then cradled in the trap until recovered and normal swimming behavior obtained. An ultrasonic handheld receiver was used to check the acoustic frequency emission of the tag and the fish released.

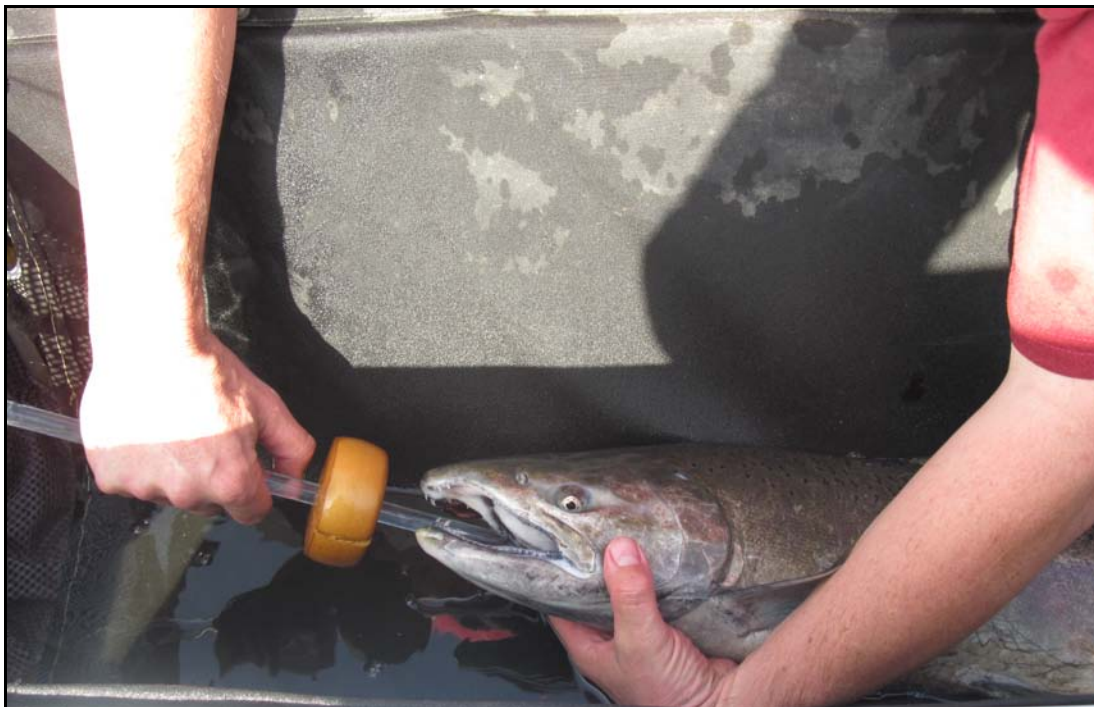
Figure 8.—Esophageal insertion of sonic transmitter into a Chinook salmon.

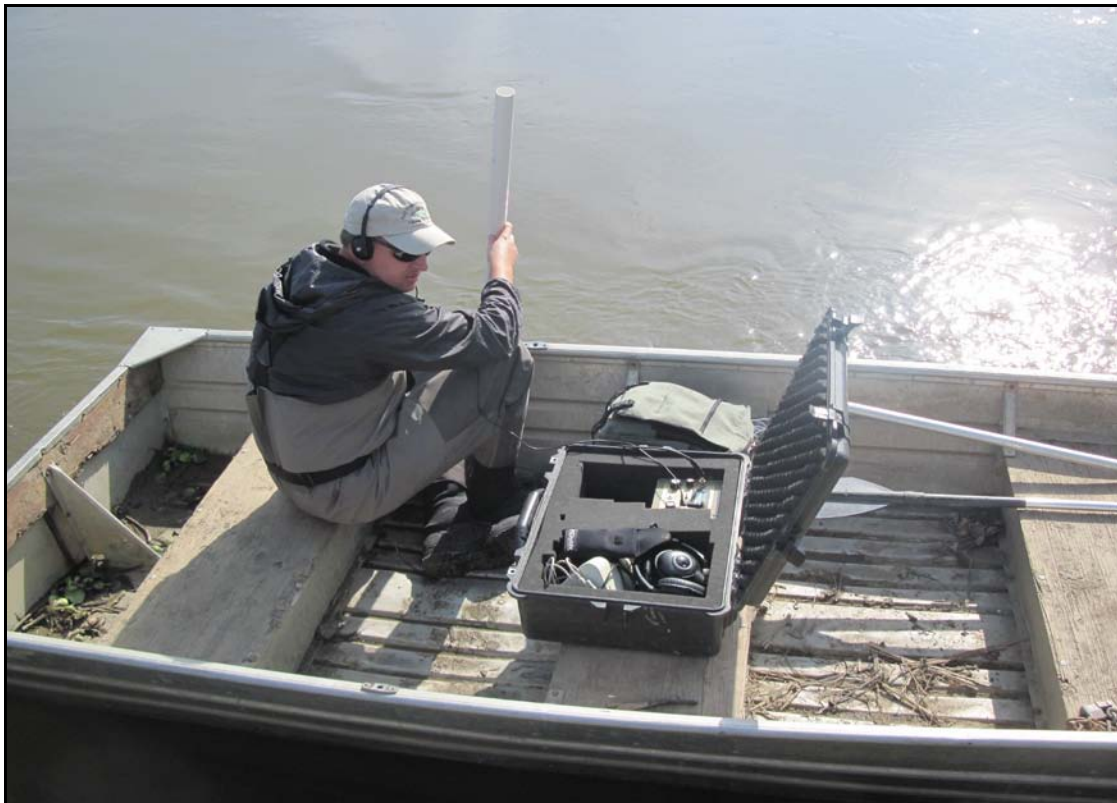
Figure 9.—Manual tracking of an acoustically-tagged Chinook salmon using a Sonotronics USR-5W wide band receiver with DH-4 directional hydrophone.

Manual tracking of acoustically-tagged fish was accomplished using a Sonotronics USR-5W wide band receiver with DH-4 directional hydrophone (Figure 9). Five SUR-1-2D submersible ultrasonic receivers (SUR; Figure 10) that allowed for fixed deployment and manual on-site download via laptop were strategically deployed. SURs are a stand-alone battery powered receiver that continuously scan for tags and can be deployed and stay unmaintained for months between downloads. Fixed deployment locations were SUR 1: ~180 m (~197 yd) upstream of HFB, SUR 2: attached to the HFB, SUR 3: ~220 m (~241 yd) below HFB, SUR 4: ~245 m (~268 yd) upstream of the San Joaquin-Merced River confluence in the Merced River, and SUR 5: ~540 m (591 yd) downstream of the San Joaquin-Merced River confluence in the San Joaquin River (Figure 11).

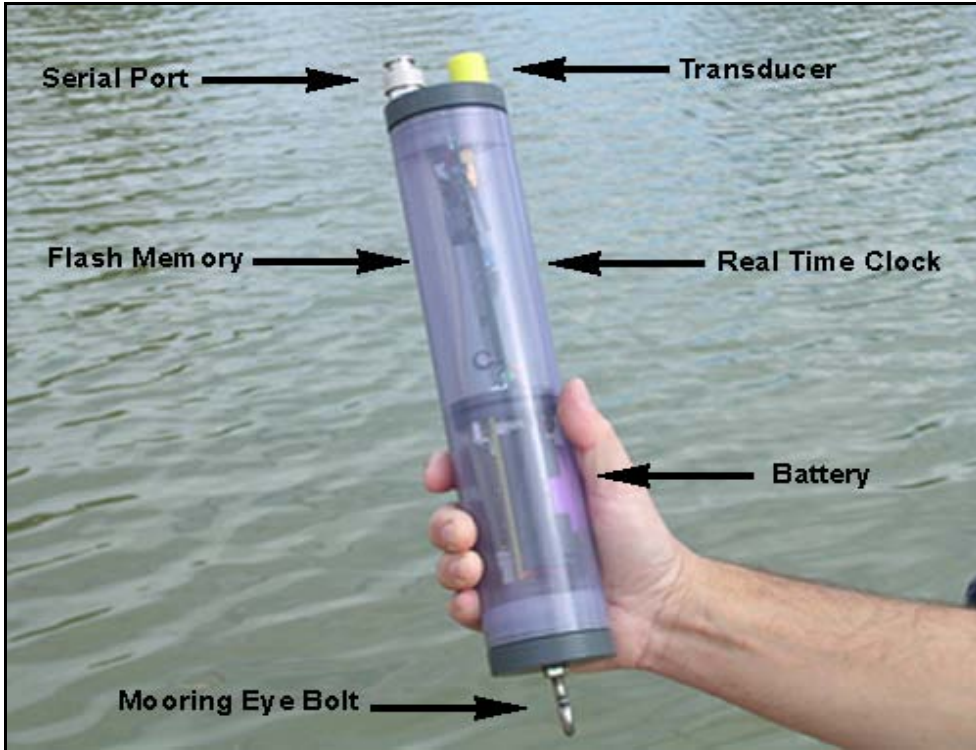
Figure 10.—Stand-alone submersible ultrasonic receiver (Photo courtesy of Sonotronics Inc.).

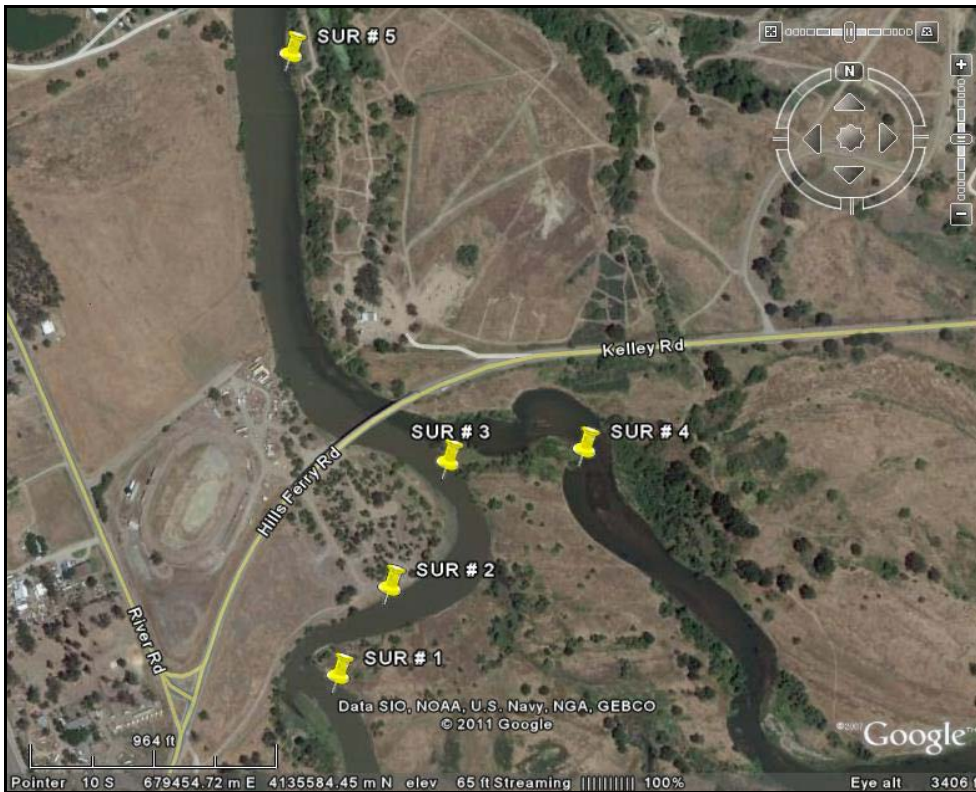
Figure 11.—Locations of fixed SUR-1-2D submersible ultrasonic receivers (SUR).

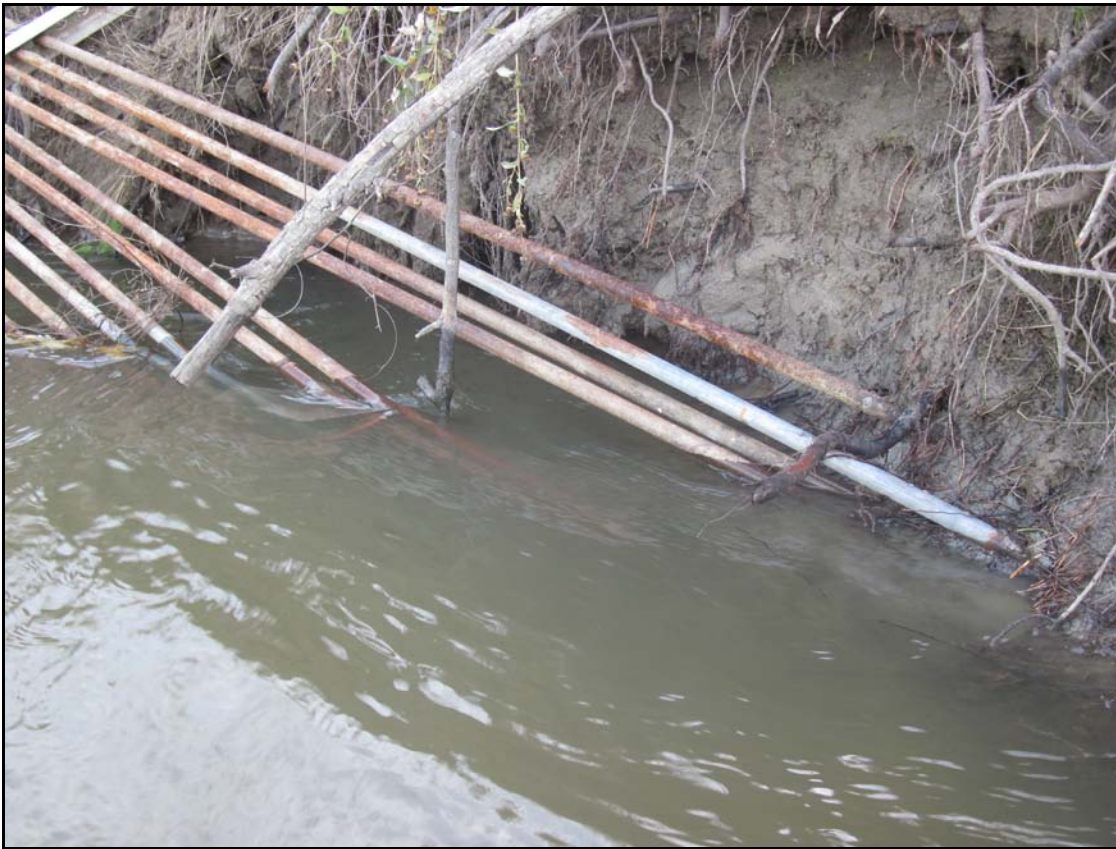
Figure 12.—Gaps in the conduit pickets can provide passage for adult Chinook salmon beyond the Hills Ferry Barrier.

An assessment of the relative effectiveness of the current HFB at blocking native and non-native fish species was performed from August 31, 2010 until high flows caused the failure of the barrier and erosion of the river banks at the anchoring points on November 26, 2010. The HFB was removed for the season on December 6, 2010. Observations from the DIDSON camera, ADCP, and visual accounts identified problems and limitations with the structure in fall 2010. The location of scouring, gaps in the pickets, and openings in the barrier were discovered with these instruments along with visual observations (*i.e.*, Figures 12 and 13).

Anecdotal information suggests that large fish pass through the barrier when excessive water hyacinth loads and vegetative debris become lodged against the sliding pipes and require a section of the barrier to be removed for a short period to allow the plant matter to travel downstream. The force created by the vegetative fouling on the pickets by water hyacinth and debris can cause weir failure if cleaning does not occur. Discussions to improve debris removal procedures are occurring to develop a strategy to maintain a “fish-tight” barrier design for fall 2011.

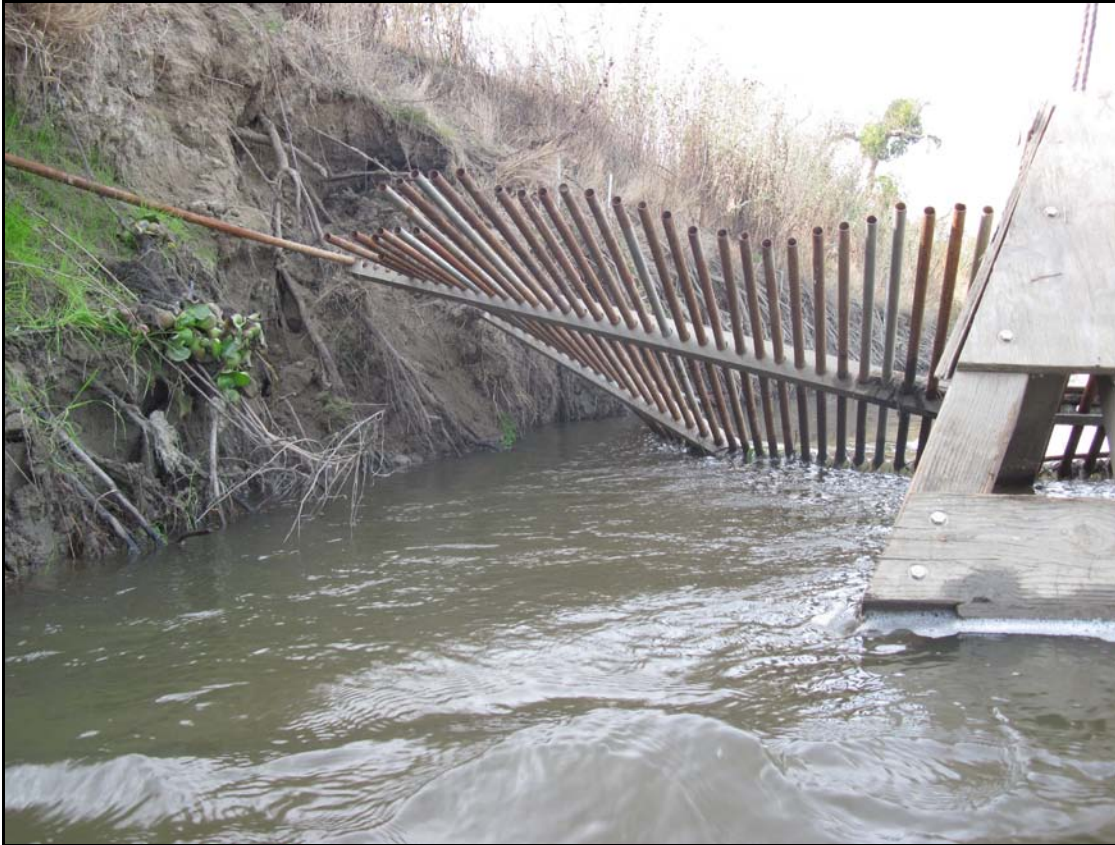
Figure 13.—Bank erosion and scoring causes holes in the barrier which may provide upstream passage at the Hills Ferry Barrier.

The river substrate poses a challenge to the integrity of the barrier. Loose benthic material and river hydraulics around weir support structures, barrier footings, base of conduit bars, and barrier panels cause substrate erosion resulting in scouring holes along the barrier and shoreline destabilization. Scour holes and eroding banks are fortified with sandbags and conduit picket extensions are driven further into the substrate on a daily basis to maintain a relatively “fish tight” barrier. Adult Chinook salmon have been observed in the past to take advantage of scour holes and elude the barrier. DFG personnel, when alerted to failures in the barrier, promptly respond to the issues by sandbagging, replacing conduit pickets, and making other minor changes.

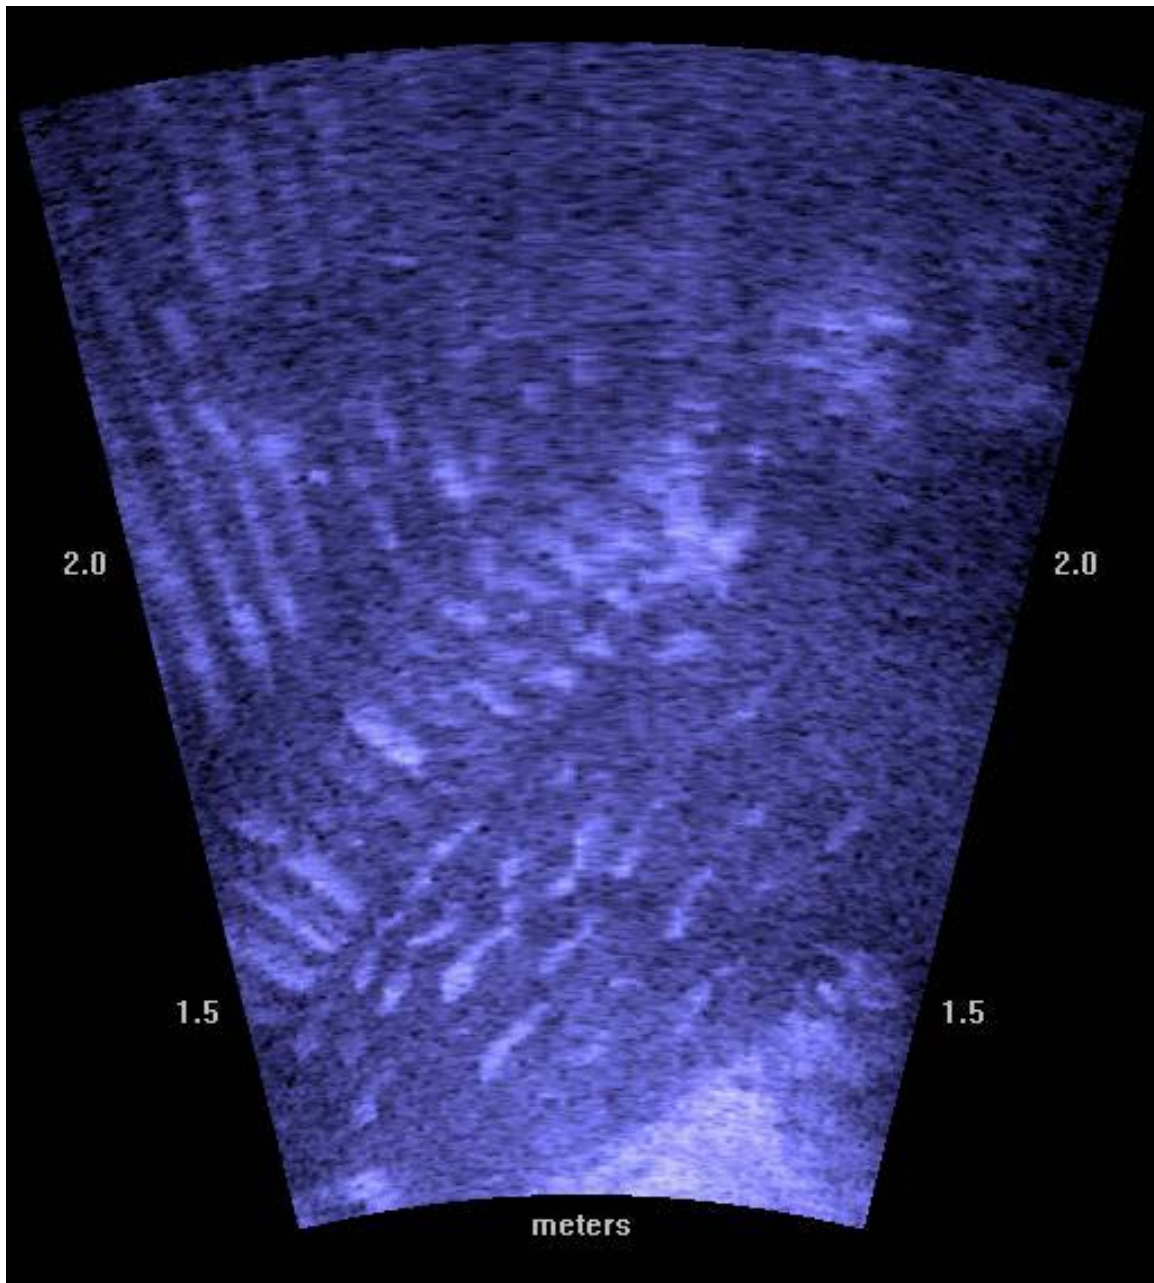
Figure 14.—DIDSON image of a school of threadfin shad swimming along the upstream side of the Hills Ferry Barrier.

The near-video quality images of the DIDSON allowed detailed underwater inspections of the barrier and substrate; however the angle of the weir and the surface reflection posed some difficulties on the downstream side of the barrier. Carp (*Cyprinus carpio*), channel catfish (*Ictalurus furcatus*), white catfish (*Ameiurus catus*), striped bass (*Morone saxatilis*), threadfin shad (*Dorosoma petenense*), and Chinook salmon were identified, especially on the downstream side where the barrier was inhibiting their movement up-river and/or providing structure. Schools of threadfin shad swam freely on both sides of the barrier and occasionally passed through the conduit pickets (Figure 14). Chinook salmon and carp were observed to move along the barrier looking for holes for passage opportunity (Figures 15 and 16). The DIDSON provided an interesting observation of an unidentifiable species (most likely a carp), using its body to attempt to burrow under the conduit pickets in the substrate at the barrier's base, accelerating the erosion process. Acoustic images of missing pickets, scour holes, and eroded areas were also identified.

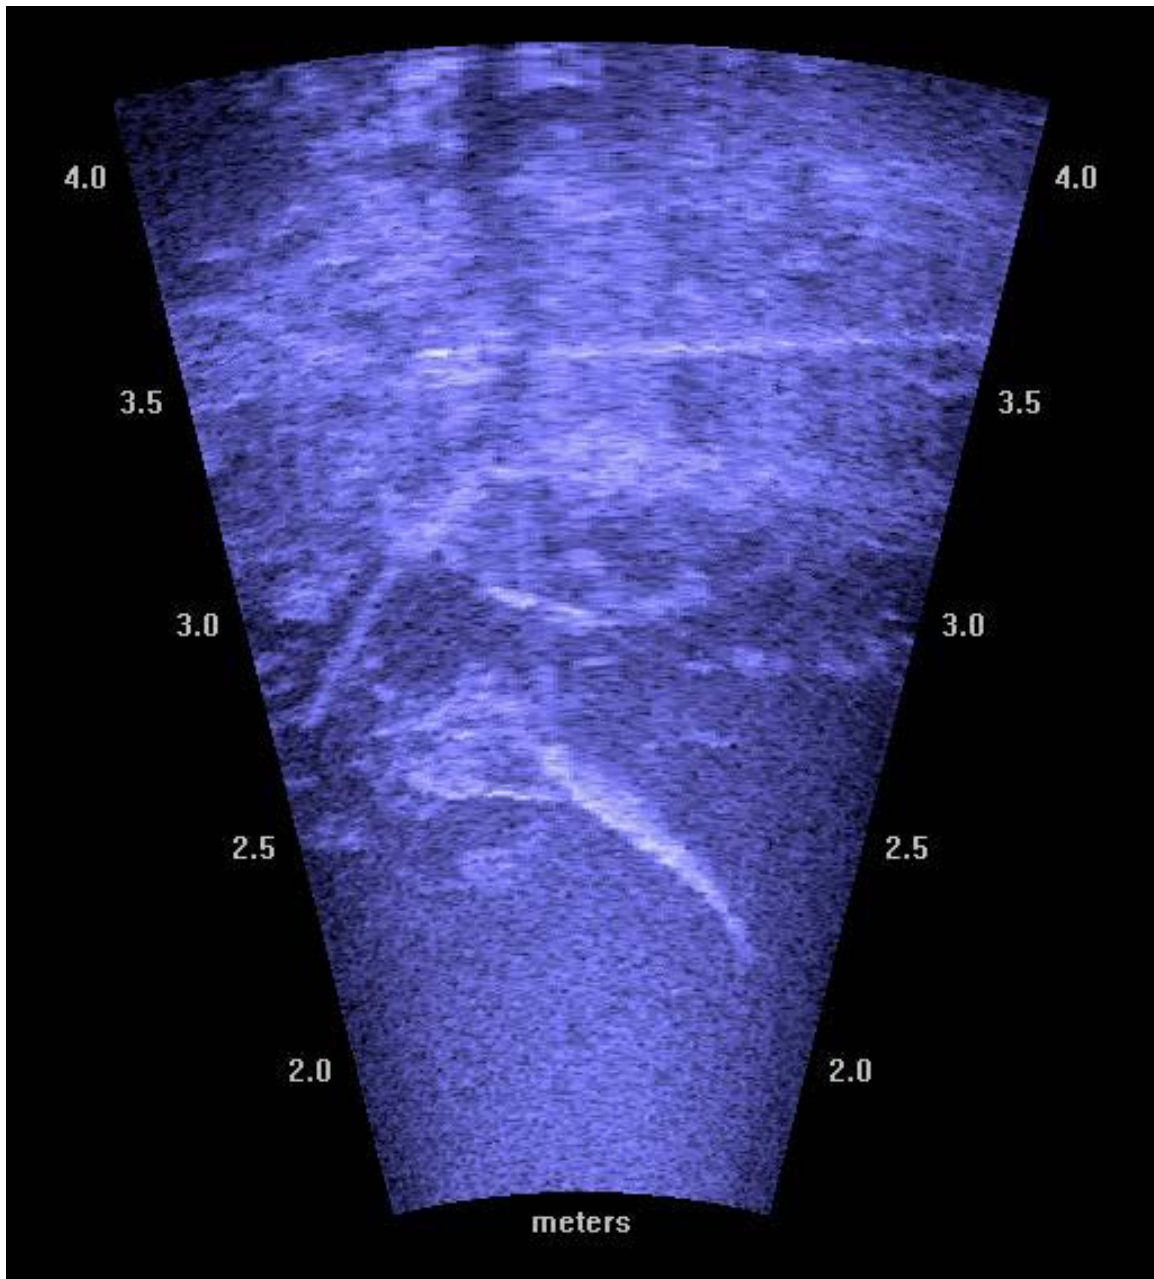
Figure 15.—Chinook salmon observed swimming directly downstream of the Hills Ferry Barrier searching for passage opportunity.

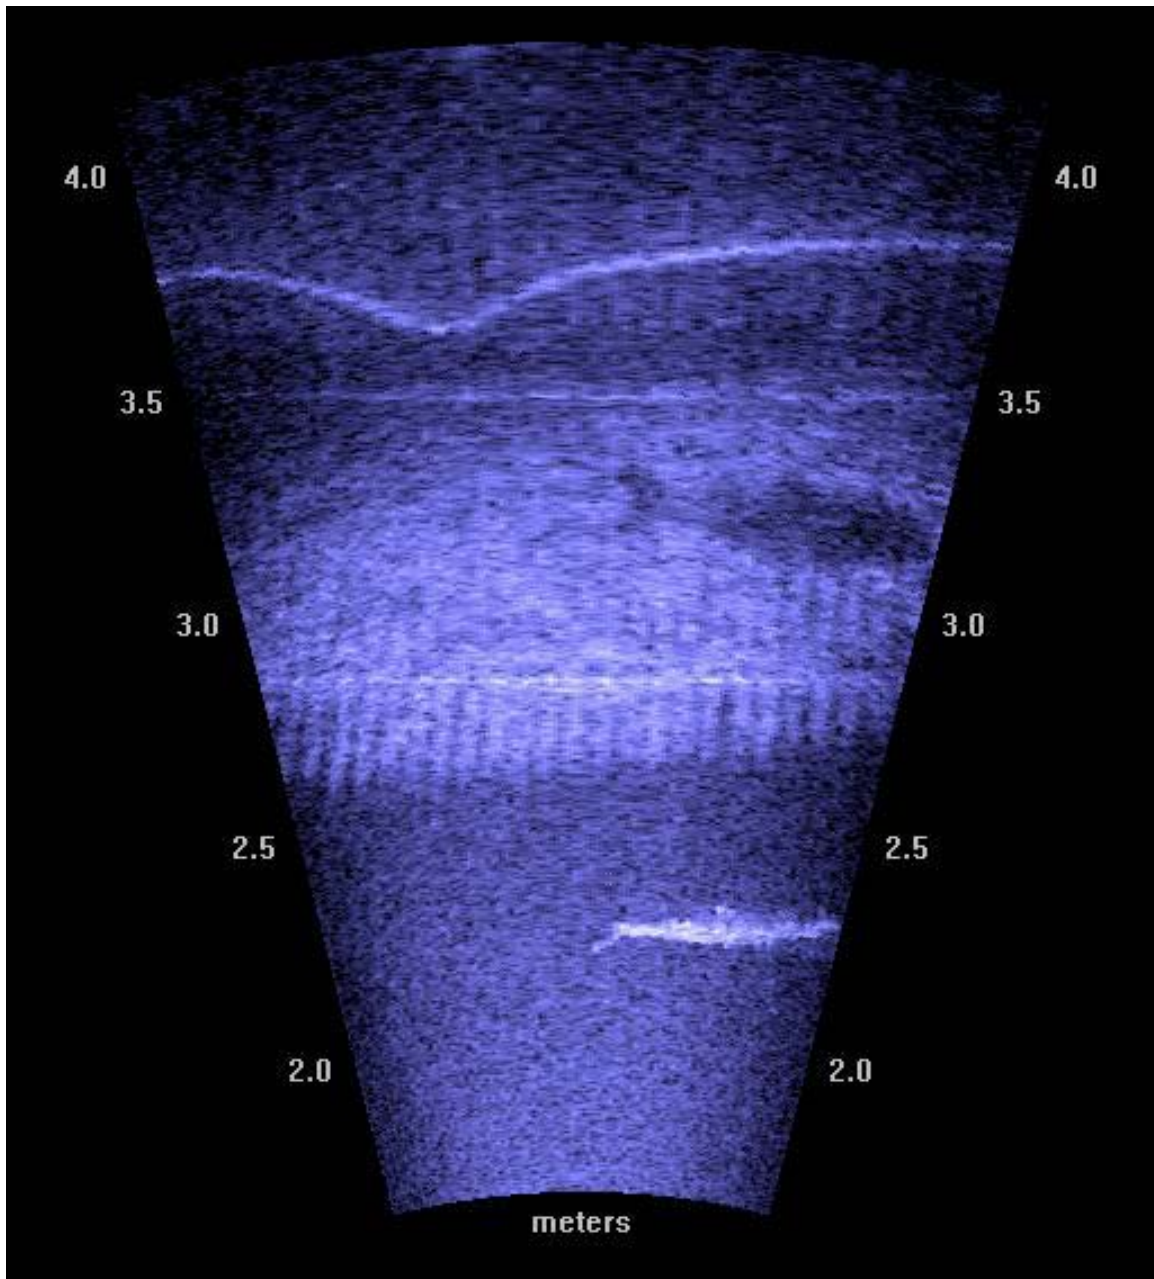
Figure 16.—A carp observed swimming along the downstream of the Hills Ferry Barrier seeking passage opportunity, note the conduit pickets in the background.

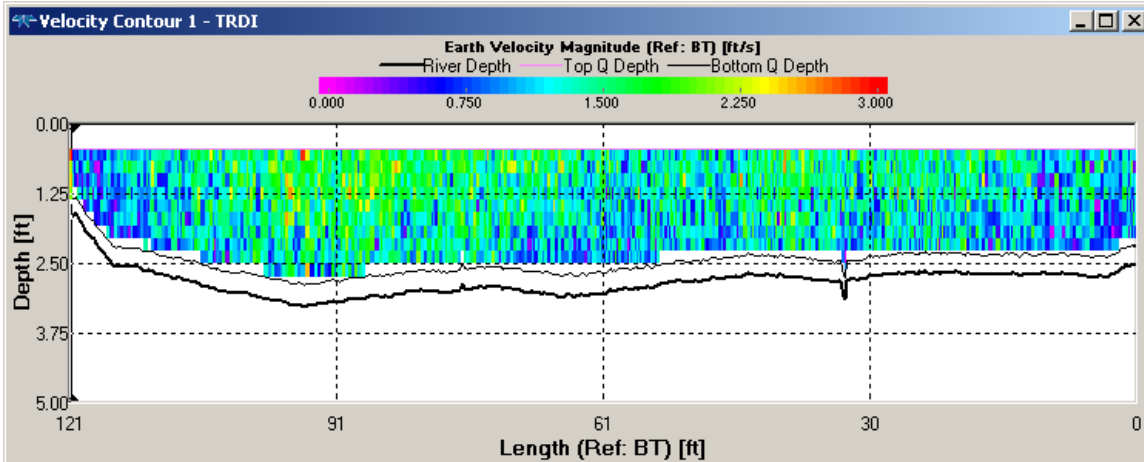
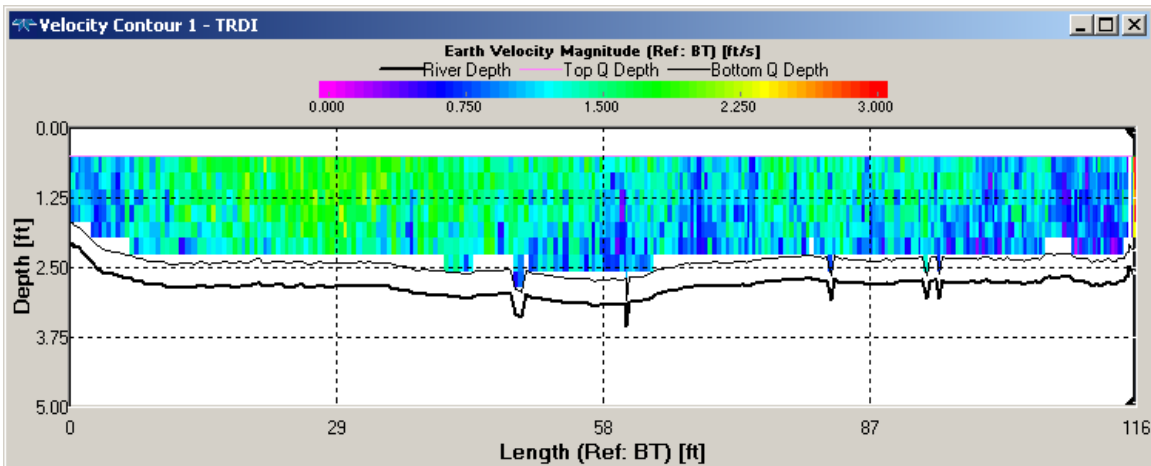
Full river transect collected October 2010. Flow rate 386.44 ft³/s, velocity 1.24 ft/s, flow area 327.82 ft².

Full river transect collected November 2010. Flow rate 371.13 ft³/s, velocity 1.20 ft/s, flow area 315.55 ft².

Figure 17.—River transect collected with an Acoustic Doppler Current Profiler at 9.1 m (30 ft) upstream of the Hills Ferry Barrier for October (top) and November (bottom). West riverbank on left and east riverbank on right. (0.3 m = 1 ft.)

Comparative data between October 19 and November 16, 2010 transects are displayed in Figures 17–23. The velocity magnitude is shown on a scale of 0–0.9 m/s (0–3 ft/s) across the width of the river. On the upstream side of the barrier, flow was distributed fairly uniformly in October. At 9.1 m (30 ft) upstream of the barrier, the average channel velocity was 0.38 m/s (1.24 ft/s; Table 1, Figure 12). At 0.61 m (2 ft) upstream of the barrier, the velocity on the left side of the fish trap was 0.38 m/s (1.24 ft/s) and the velocity of the right side of the trap was 0.36 m/s (1.18 ft/s; Table 1, Figure 20). In November, flow was greatly skewed to the left side of the channel. At 3.1 m (30 ft) upstream of the barrier, the average channel velocity was 0.37 m/s (1.20 ft/s). Average velocities were 0.61 m at (2 ft) upstream of the barrier, 0.52 m/s (1.70 ft/s) on the left side and 0.23 m/s (0.74 ft/s) on the right (Figure 20).

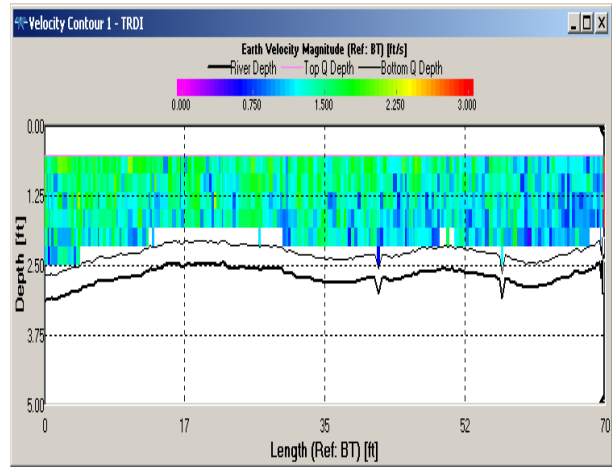
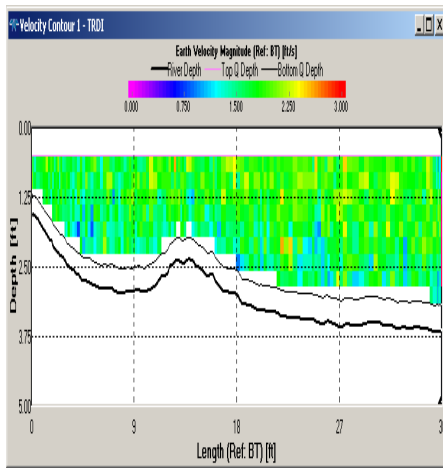
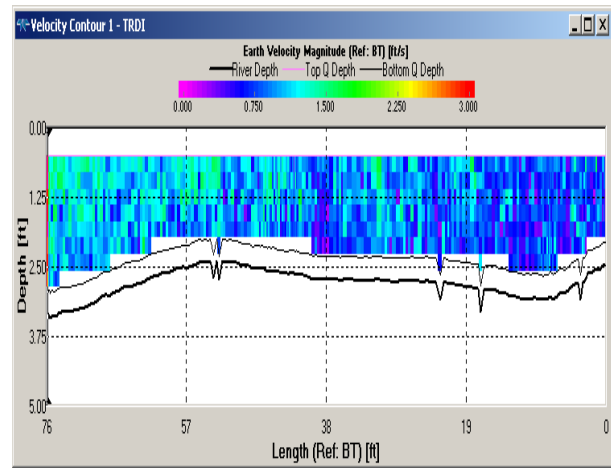
Left river transect collected October 2010. Flow rate 124.28 ft³/s, velocity 1.222 ft/s, flow area 108.89 ft².

Right river transect collected October 2010. Flow rate 224.43 ft³/s, velocity 1.28 ft/s, flow area 185.20 ft².

Left river transect collected November 2010. Flow rate 172.48 ft³/s, velocity 1.68 ft/s, flow area 108.82 ft².

Right river transect collected November 2010. Flow rate 181.88 ft³/s, velocity 0.91 ft/s, flow area 213.12 ft².

Figure 18.—River transect collected with an Acoustic Doppler Current Profiler at 3.0 m (10 ft) upstream of the Hills Ferry Barrier for October (top) and November (bottom). West riverbank on left and east riverbank on right. (0.3 m = 1 ft.)

Deposition of loose fine material occurs on right river transect in November (Figures 19 and 20), while mid-channel scouring was occurring 0.61–3.0 m (2–10 ft) downstream of barrier between October and November (Figures 21–23). More aggressive scouring is noticeable 0.61 m (2 ft) downstream of barrier behind fish trap (Figure 21). The armored, riprap sill, upstream of the barrier on the left river bank remained stable throughout the evaluation period, and is seen as an elevation rise (Figures 18–20).

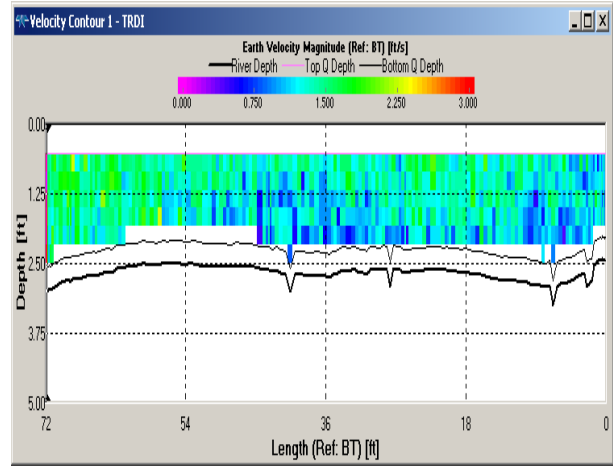
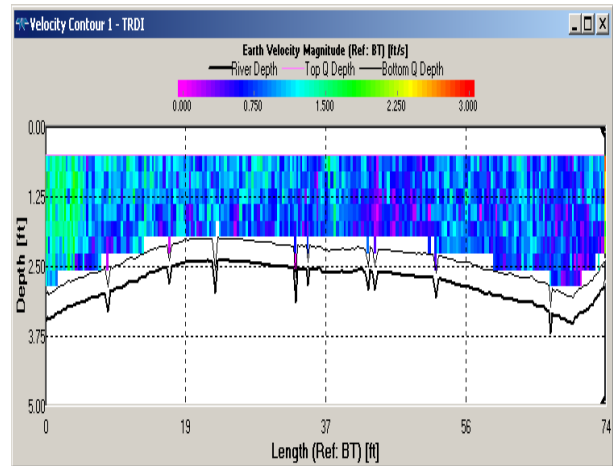
Left river transect collected October 2010. Flow rate 125.29 ft³/s, velocity 1.24 ft/s, flow area 107.34 ft².

Right river transect collected October 2010. Flow rate 226.73 ft³/s, velocity 1.27 ft/s, flow area 193.03 ft².

Left river transect collected November 2010. Flow rate 189.42 ft³/s, velocity 1.77 ft/s, flow area 110.50 ft².

Right river transect collected November 2010. Flow rate 156.28 ft³/s, velocity 0.83 ft/s, flow area 200.08 ft².

Figure 19.—River transect collected with an Acoustic Doppler Current Profiler at 1.5 m (5 ft) upstream of the Hills Ferry Barrier for October (top) and November (bottom). West riverbank on left and east riverbank on right. (0.3 m = 1 ft.)

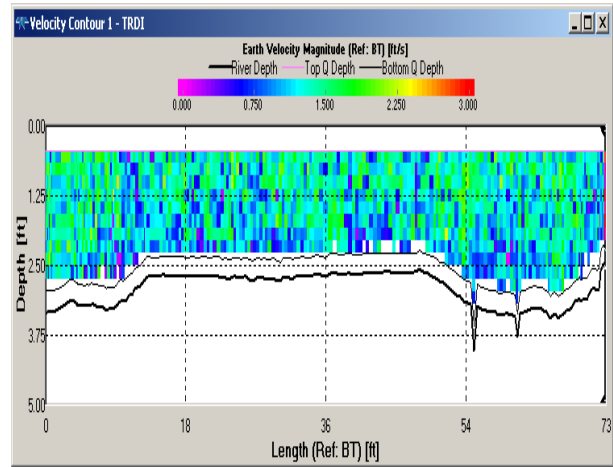
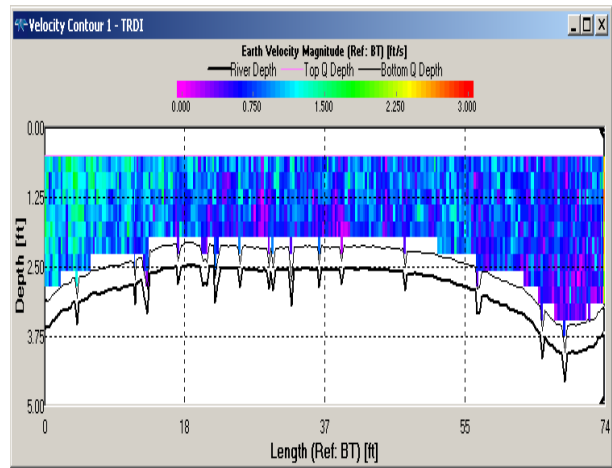
Left river transect collected October 2010. Flow rate 132.87 ft³/s, velocity 1.24 ft/s, flow area 114.12 ft².

Right river transect collected October 2010. Flow rate 229.78 ft³/s, velocity 1.18 ft/s, flow area 211.5 ft².

Left river transect collected November 2010. Flow rate 203.47 ft³/s, velocity 1.70 ft/s, flow area 125.21 ft².

Right river transect collected November 2010. Flow rate 140.25 ft³/s, velocity 0.74 ft/s, flow area 205.85 ft².

Figure 20.—River transect collected with an Acoustic Doppler Current Profiler at 0.61 m (2 ft) upstream of the Hills Ferry Barrier for October (top) and November (bottom). West riverbank on left and east riverbank on right. (0.3 m = 1 ft.)
