Evaluation of Hills Ferry Barrier Effectiveness at Restricting Chinook Salmon Passage on the San Joaquin River

U.S. Department of the Interior
Bureau of Reclamation
Technical Service Center
Fisheries and Wildlife Resources Group
Denver, Colorado

October 2011

San Joaquin River Restoration Program

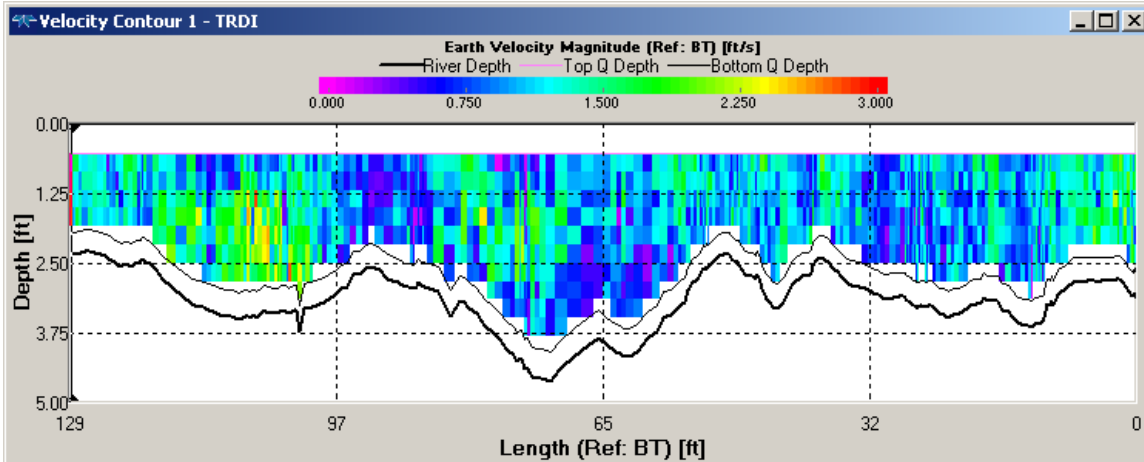
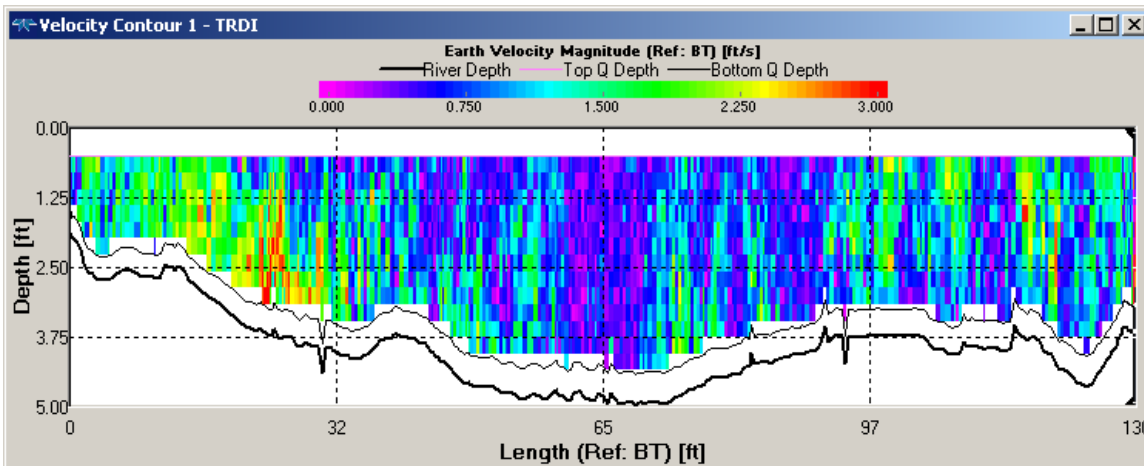
Full river transect collected October 2010. Flow rate 381.45 ft³/s, velocity 0.97 ft/s, flow area 383.74 ft².

Full river transect collected November 2010. Flow rate 343.88 ft³/s, velocity 0.65 ft/s, flow area 453.45 ft².

Figure 21.—River transect collected with an Acoustic Doppler Current Profiler at 0.61 m (2 ft) downstream of the Hills Ferry Barrier for October (top) and November (bottom). West riverbank on left and east riverbank on right. (0.3 m = 1 ft.)

Deposition of loose fine material occurs on right river transect in November (Figures 19 and 20), while mid-channel scouring was occurring 0.61–3.0 m (2–10 ft) downstream of barrier between October and November (Figures 21–23). More aggressive scouring is noticeable 0.61 m (2 ft) downstream of barrier behind fish trap (Figure 21). The armored, riprap sill, upstream of the barrier on the left river bank remained stable throughout the evaluation period, and is seen as an elevation rise (Figures 18–20).

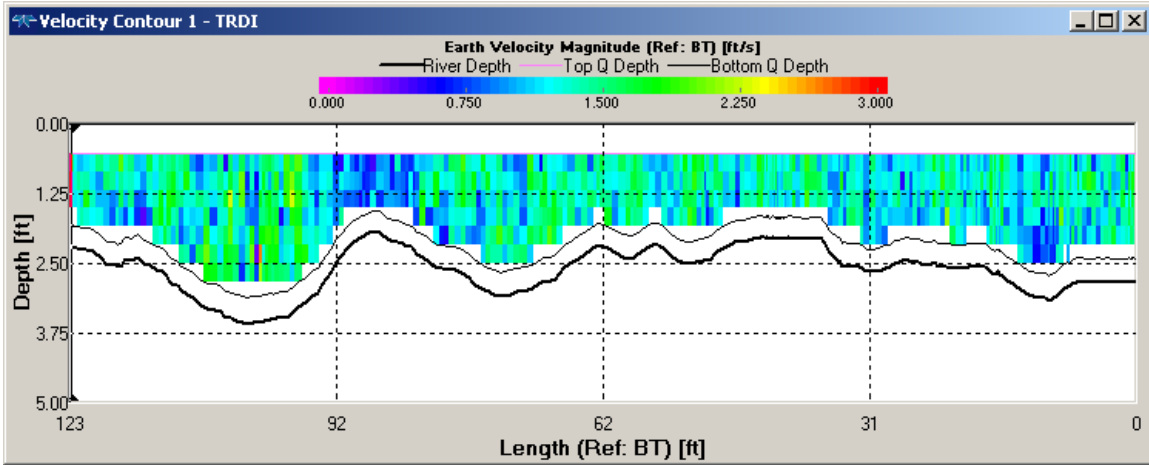
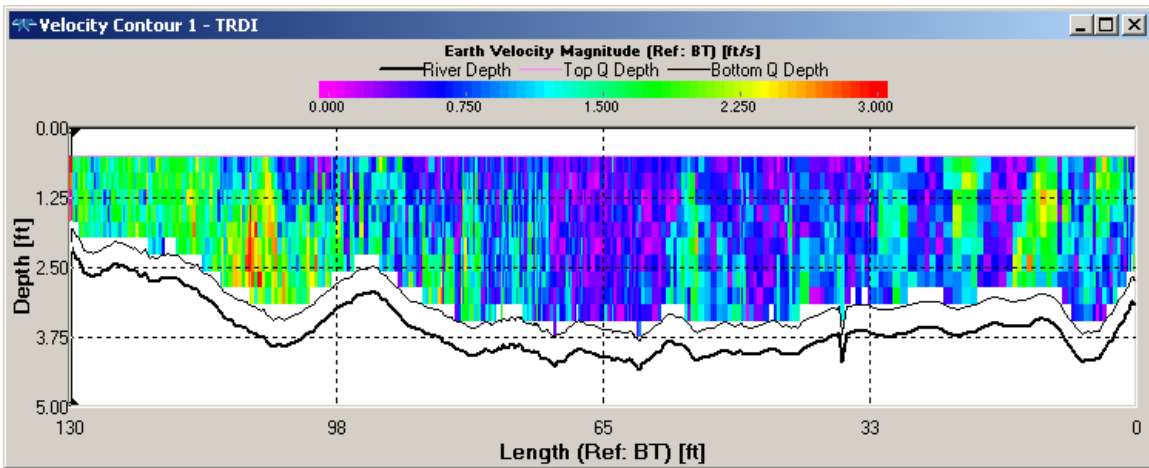
Full river transect collected October 2010. Flow rate 370.74 ft³/s, velocity 1.22 ft/s, flow area 318.45 ft².

Full river transect collected November 2010. Flow rate 348.58 ft³/s, velocity 0.76 ft/s, flow area 427.82 ft².

Figure 22.—River transect collected with an Acoustic Doppler Current Profiler at 1.5 m (5 ft) downstream of the Hills Ferry Barrier for October (top) and November (bottom). West riverbank on left and east riverbank on right. (0.3 m = 1 ft.)

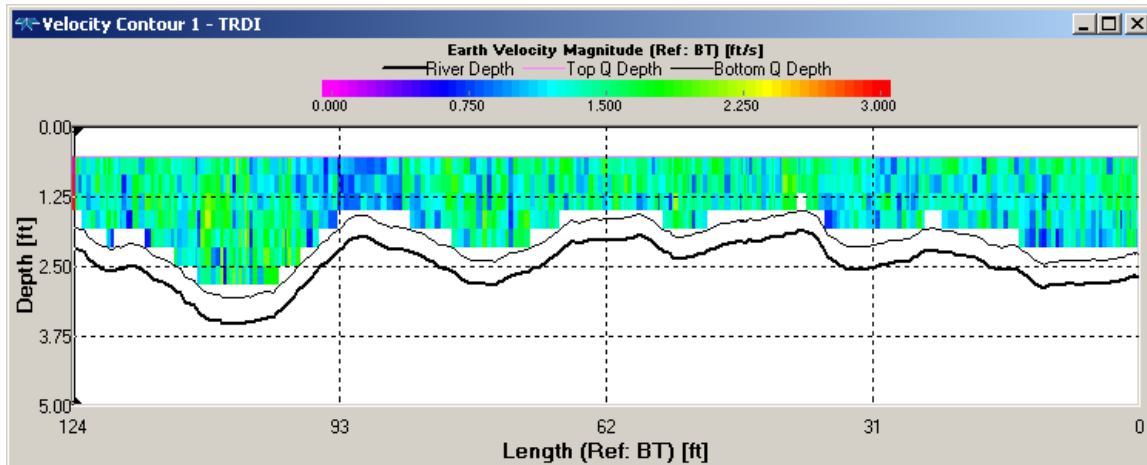
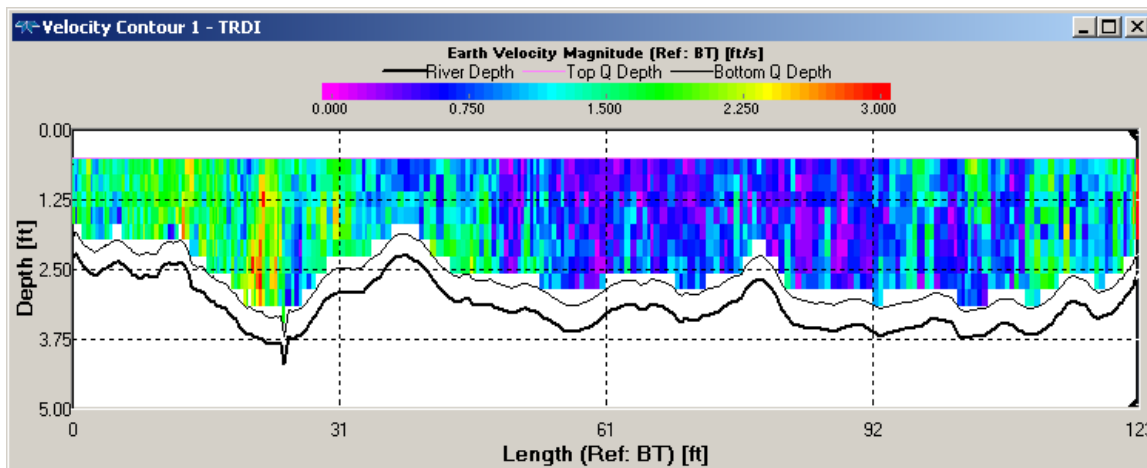
Full river transect collected October 2010. Flow rate 371.14 ft³/s, velocity 1.30 ft/s, flow area 303.93 ft².

Full river transect collected November 2010. Flow rate 347.01 ft³/s, velocity 0.95 ft/s, flow area 363.24 ft².

Figure 23.—River transect collected with an Acoustic Doppler Current Profiler at 3.0 m (10 ft) downstream of the Hills Ferry Barrier for October (top) and November (bottom). West riverbank on left and east riverbank on right. (0.3 m = 1 ft.)
