# Appendix E

## Technical Memorandum Subsidence Monitoring (2011-2013)

# Technical Memorandum

## Subsidence Monitoring

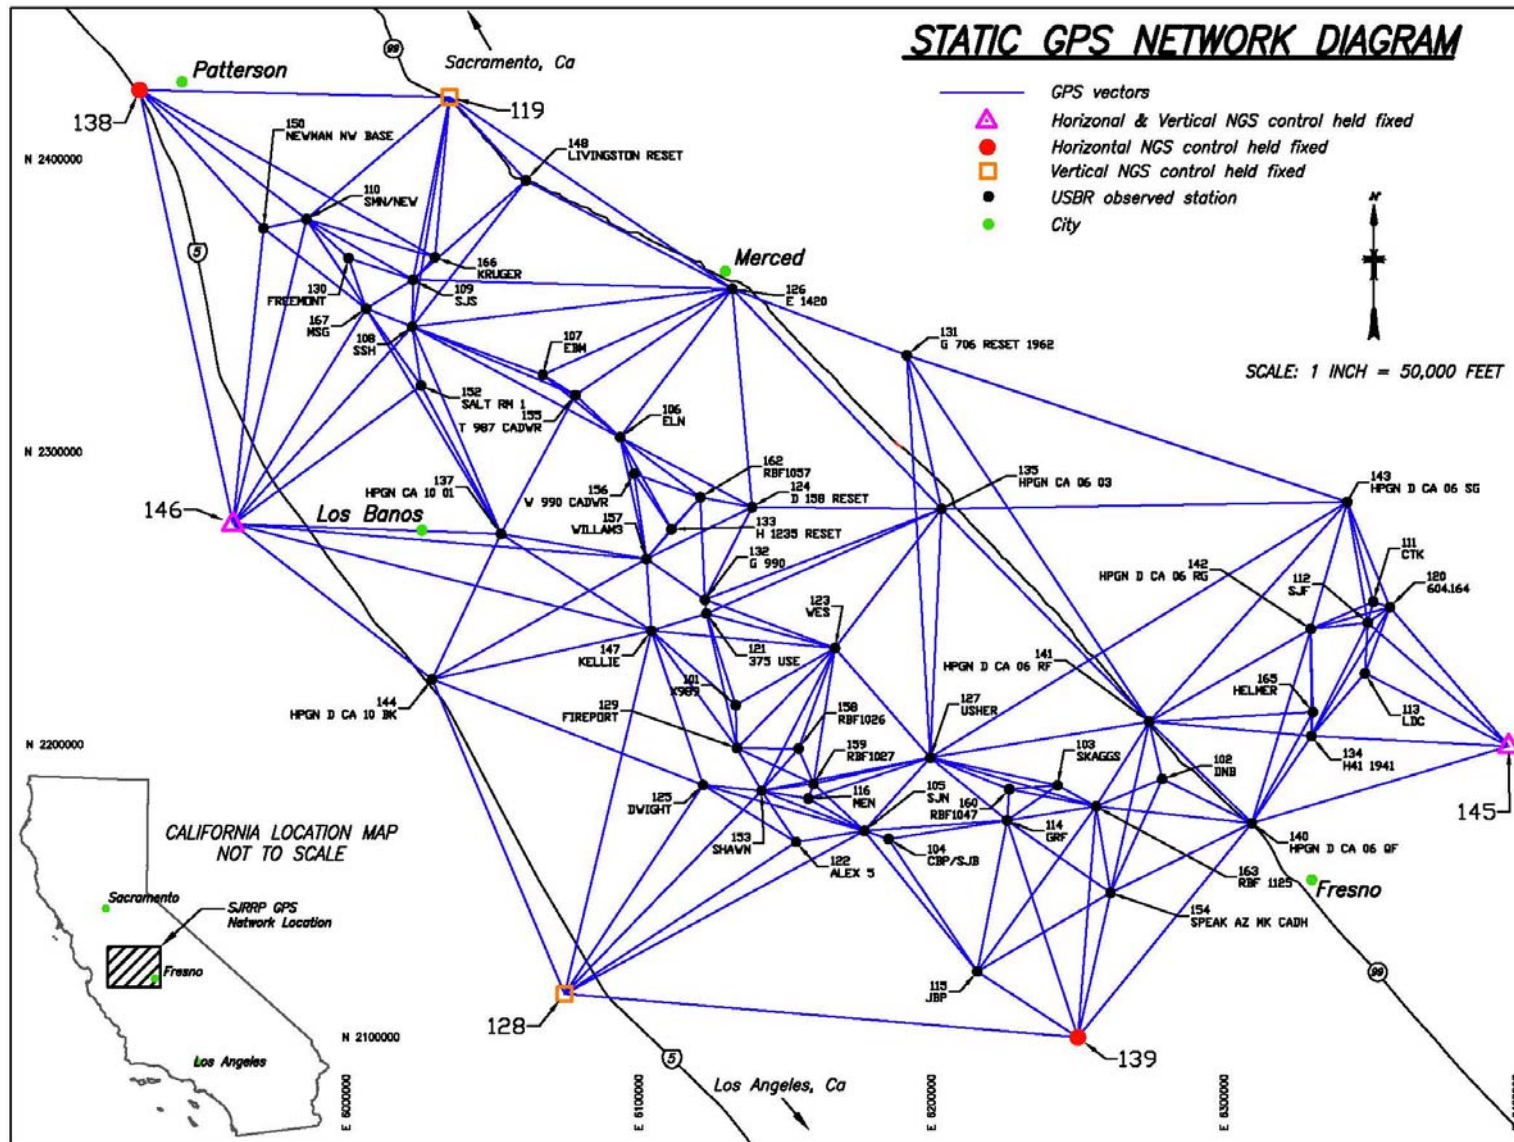
Figure 1. Static GPS Network Diagram

In 2011, Reclamation established the SJRRP Geodetic Control Network (**Figure 1**), using static GPS methods, to investigate subsidence within the SJRRP study area. To monitor the rate of subsidence over time, Reclamation conducts bi-annual surveys, in July and December, of the

established network. The network is made up of National Geodetic Survey, Reclamation, USGS, California Department of Transportation, and DWR benchmarks and in 2011 originally contained approximately 60 control points, but over the last few years has expanded to over 85 points. The benchmark elevations are updated after each survey and are used by the SJRRP to study subsidence, as well as to provide more accurate horizontal and vertical control for other studies.

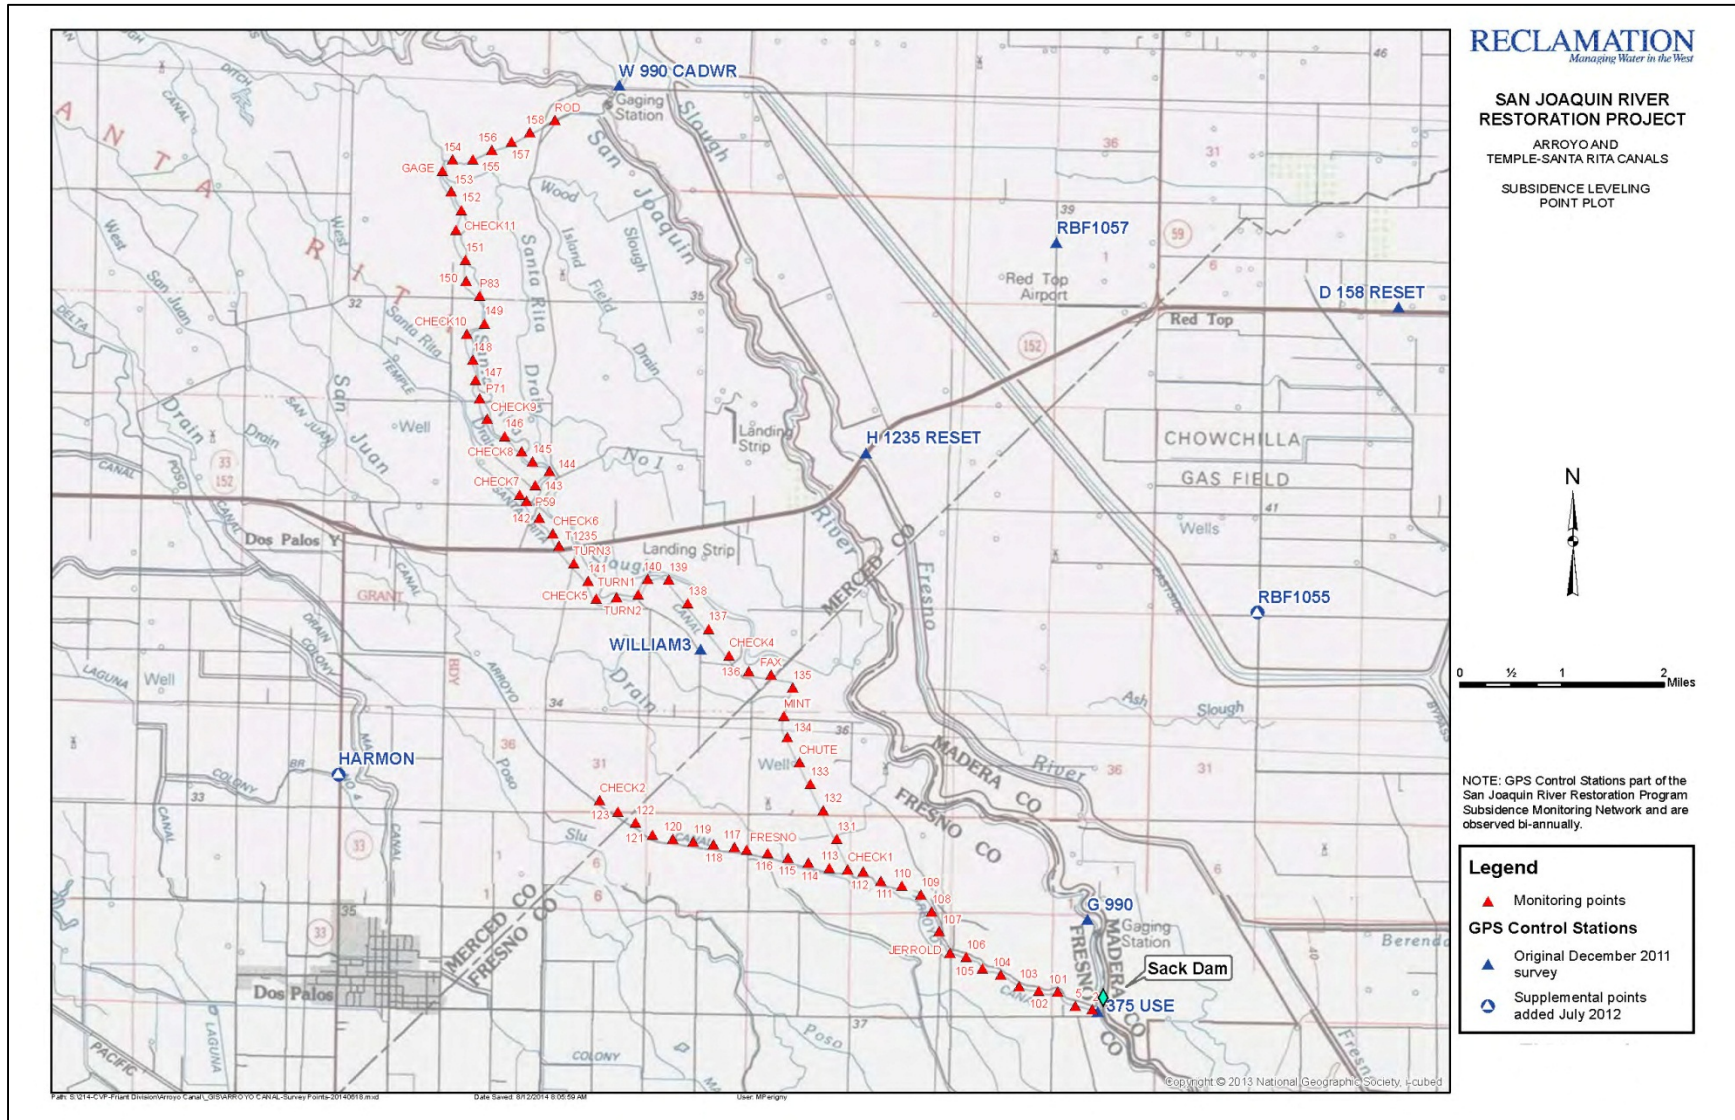
Figure 2. Location map of precise levels along the Arroyo and Temple-Santa Rita Canals

Beginning in May 2012 Reclamation began monitoring the Arroyo and Temple-Santa Rita (TSR) Canals to clarify localized subsidence near Sack Dam. To accomplish this, two precise leveling networks were established; Arroyo Canal starting at Sack Dam running approximately 6 miles westerly; and the Temple-Santa Rita Canal starting at Check Structure 1 on the Arroyo Canal running approximately 11 miles northerly (**Figure 2**). These level networks were surveyed monthly for just over a year. The next phase of the subsidence monitoring project has been shifted to the Henry Miller Reclamation District for any future monitoring surveys.

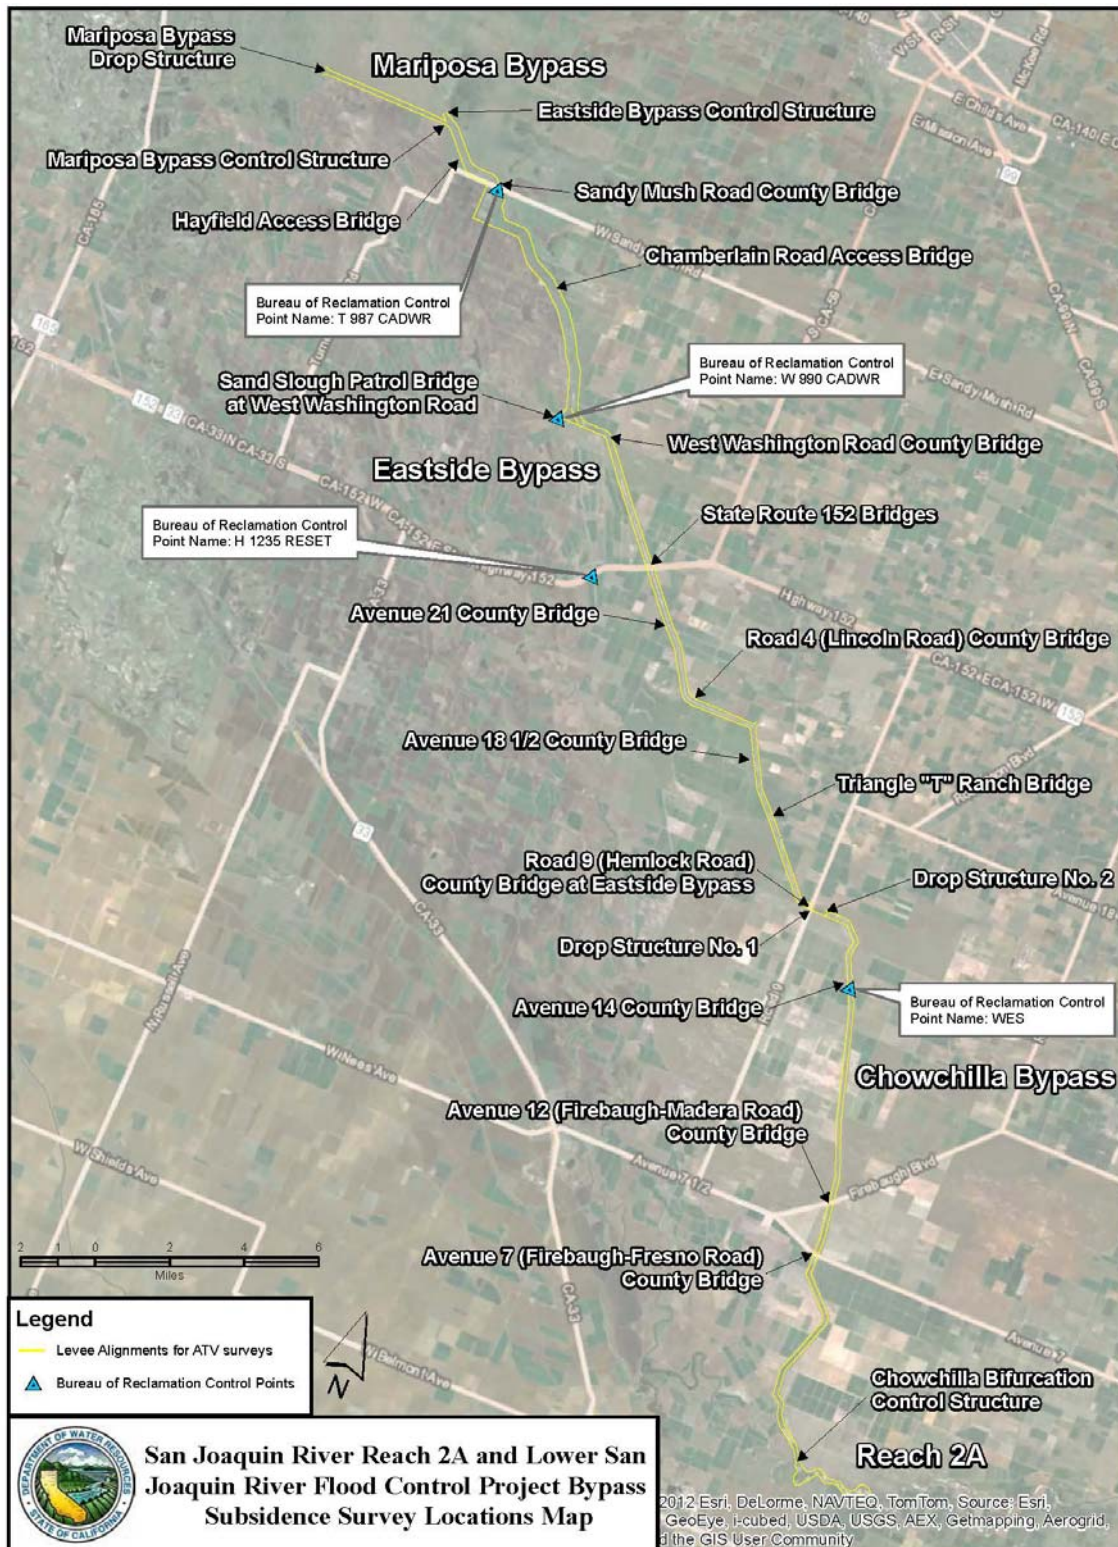
Figure 3. Longitudinal levee surveys within Reach 2A and Bypass survey completed in 2012 and 2013

In 2012 and later in 2013, DWR-SCRO collected topographic ground elevations to help further refine the estimated annual rates in the lower 3 miles of Reach 2A, the Chowchilla Bypass (from the Chowchilla Bifurcation Control Structure to its confluence with the Fresno River), the Upper Eastside Bypass (from its confluence with the Fresno River to the Sand Slough Connector), the Middle Eastside Bypass (from the Sand Slough Connector to the Eastside Bypass Control Structure), and the Mariposa Bypass (**Figure 3**). This survey was completed to help further refine Reclamation's estimated annual subsidence rates along the flood bypasses. In addition to the above surveys, DWR also completed surveys in 2013 and 2014 of the levee and channel in the lower portion of Reach 3, Reach 4A, and the Middle Eastside Bypass; however, this data is considered preliminary and has not been finalized for public release at the time of the preparation of this report.

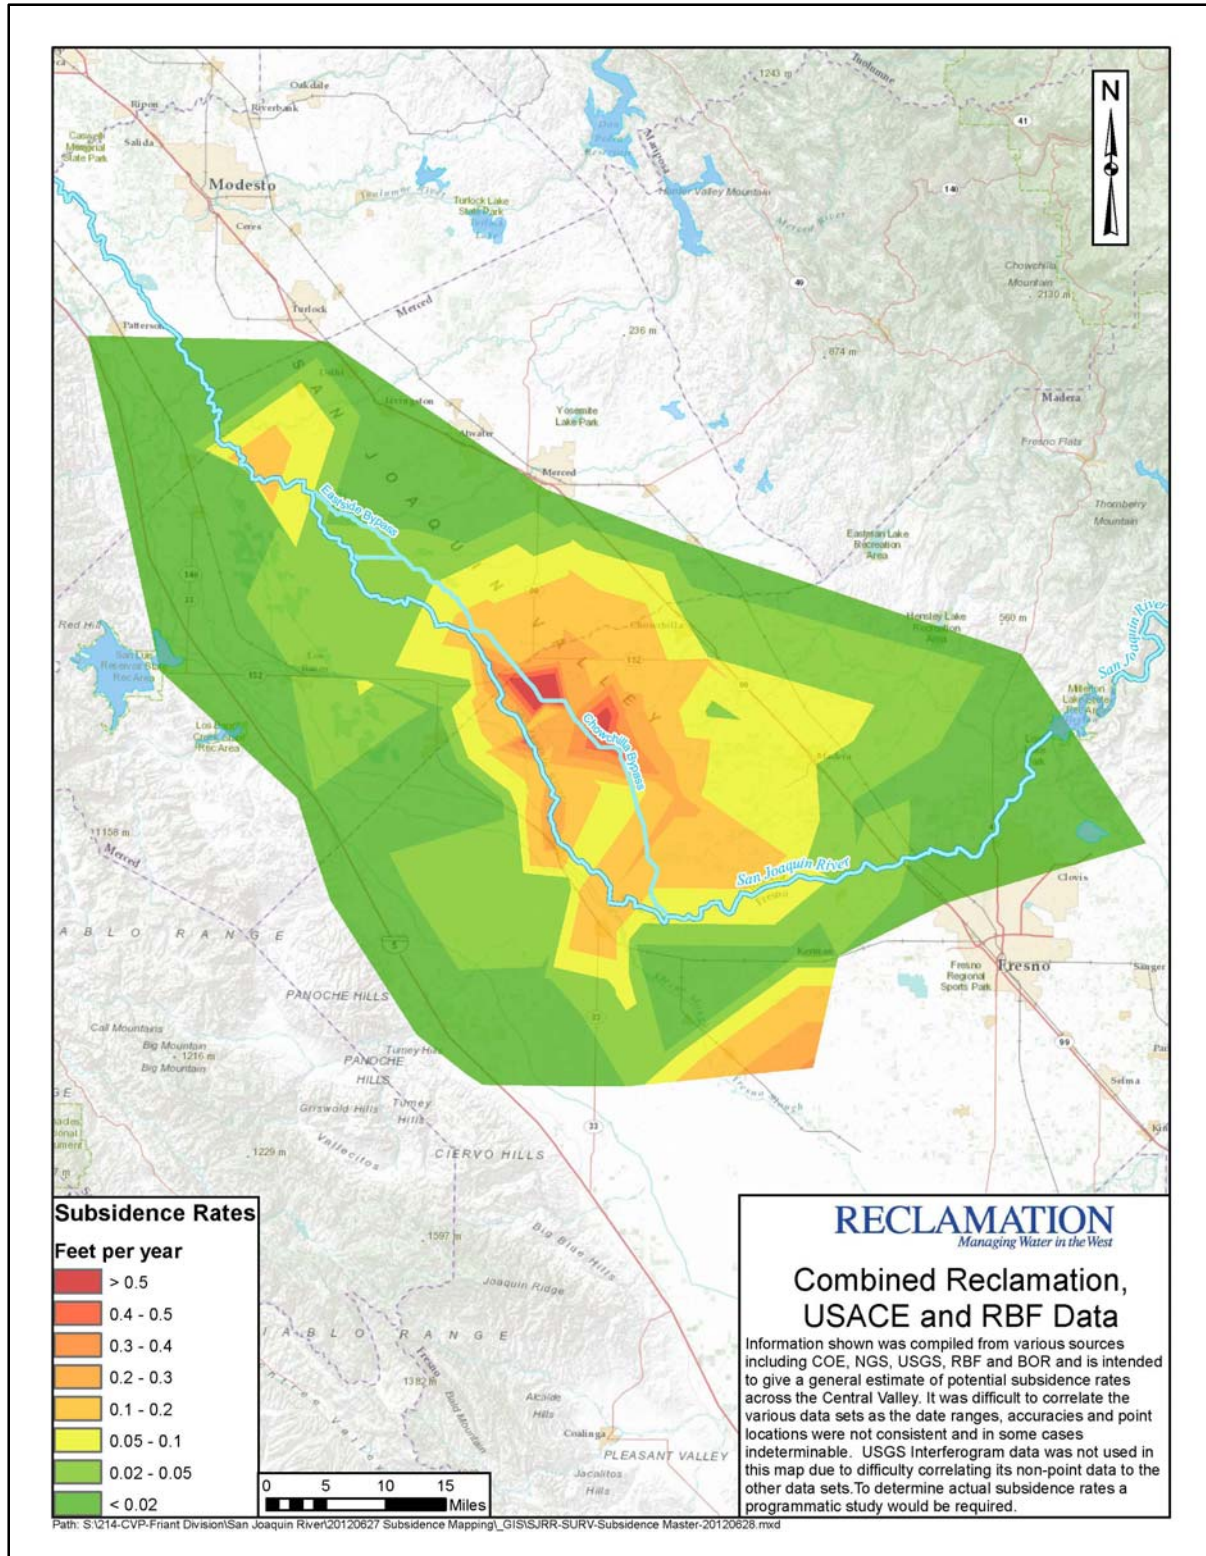
Figure 4. Combined calculated subsidence rates

To provide a general estimate of the potential subsidence rates and trends within the Restoration and surrounding areas, Reclamation developed an exhibit map that combined data from various sources prior to the 2011 data collection effort, including Reclamation, USACE, and RBF (**Figure 4**). The map shows annual subsidence rates ranging from less than 0.02' to more than 0.5' per year. However, more recent surveys by Reclamation and DWR show from 2011 to 2013 that the rates have either stayed or have more than doubled in some areas.

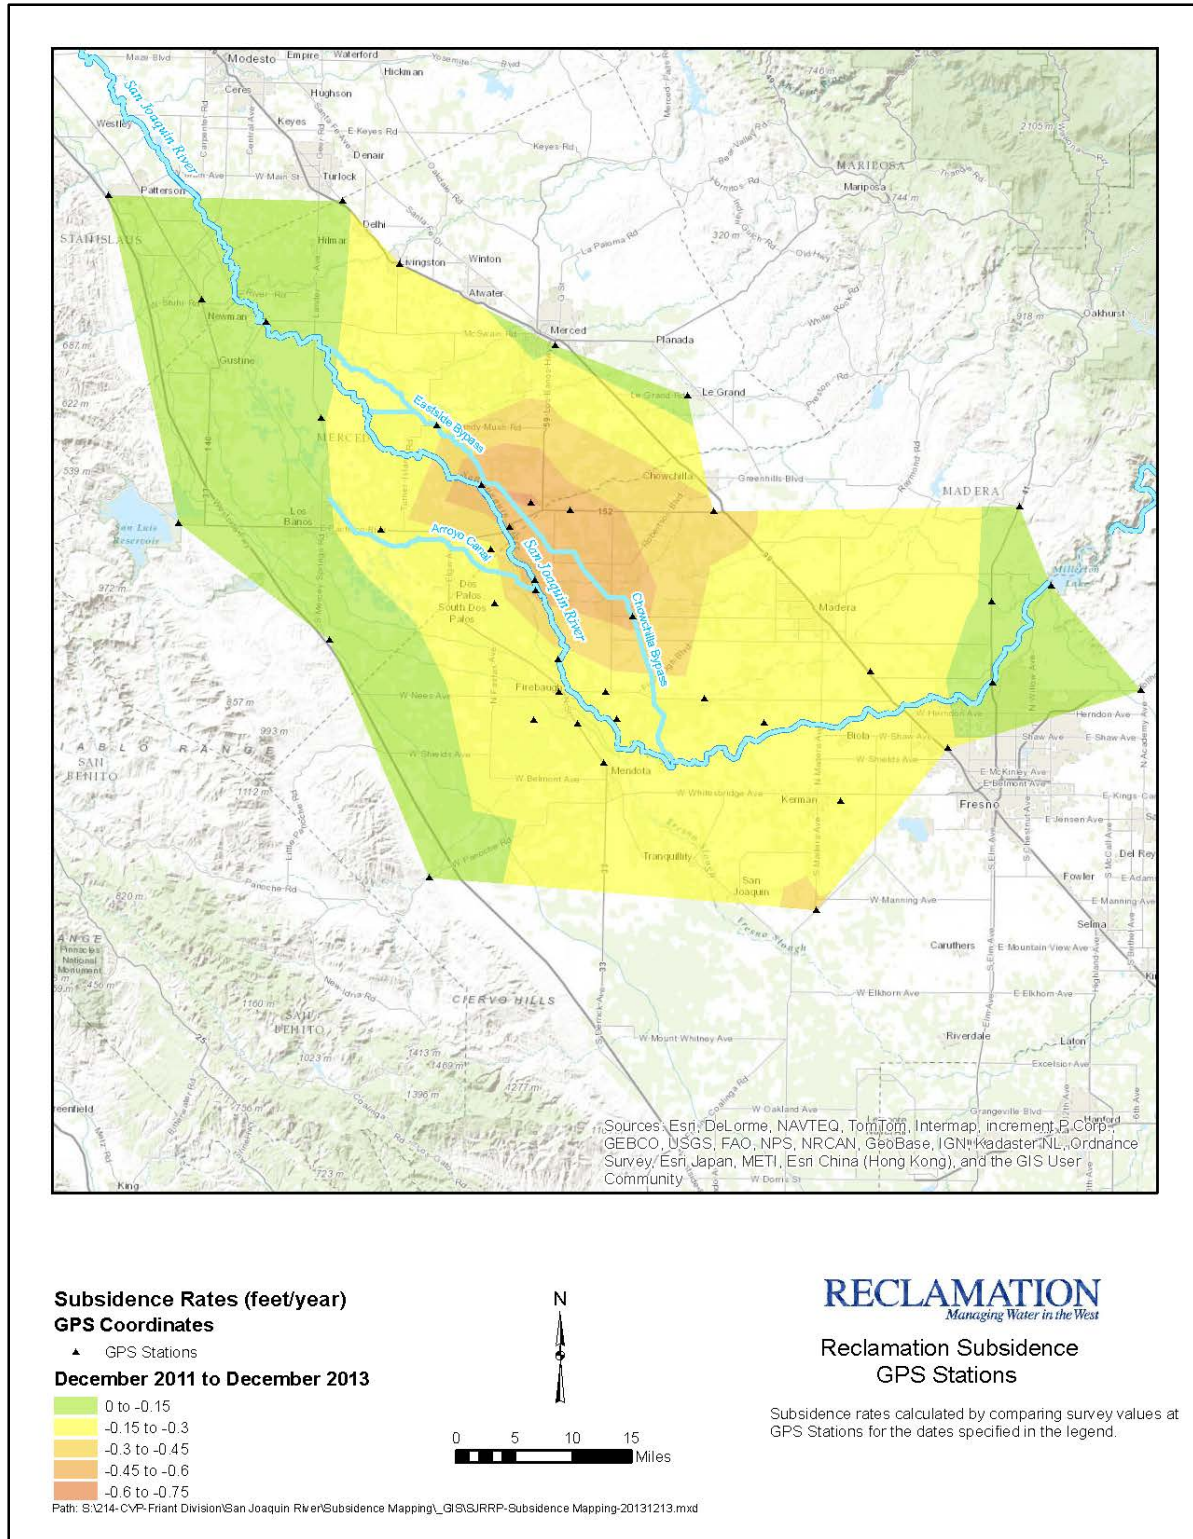
**Figure 5. Calculated annual subsidence rates from December 2011 to December 2013**

After each survey, Reclamation prepares exhibit maps that compare the most recent data with the data from the previous survey, as well as from previous years. The exhibit maps give a good overall picture of the subsidence trends within the SJRRP Restoration Area. **Figure 5** shows the calculated annual subsidence rates ranging from about 0.15 ft/year to 0.75 ft/year based on survey data collected in December 2011 and December 2013, and averaged over a two year period. The calculated annual subsidence rates vary with time, but in general, appear to either remain constant, or in some areas increase since the start of the surveys. **Appendix A** includes exhibit maps comparing the six month survey monitoring (calculated as annual subsidence rates) from December 2011 through December 2013. **Table 1** summarizes the cumulative elevation differences for 2012 and 2013 for a select number of points within the area of subsidence since the start of the 2011 surveys.

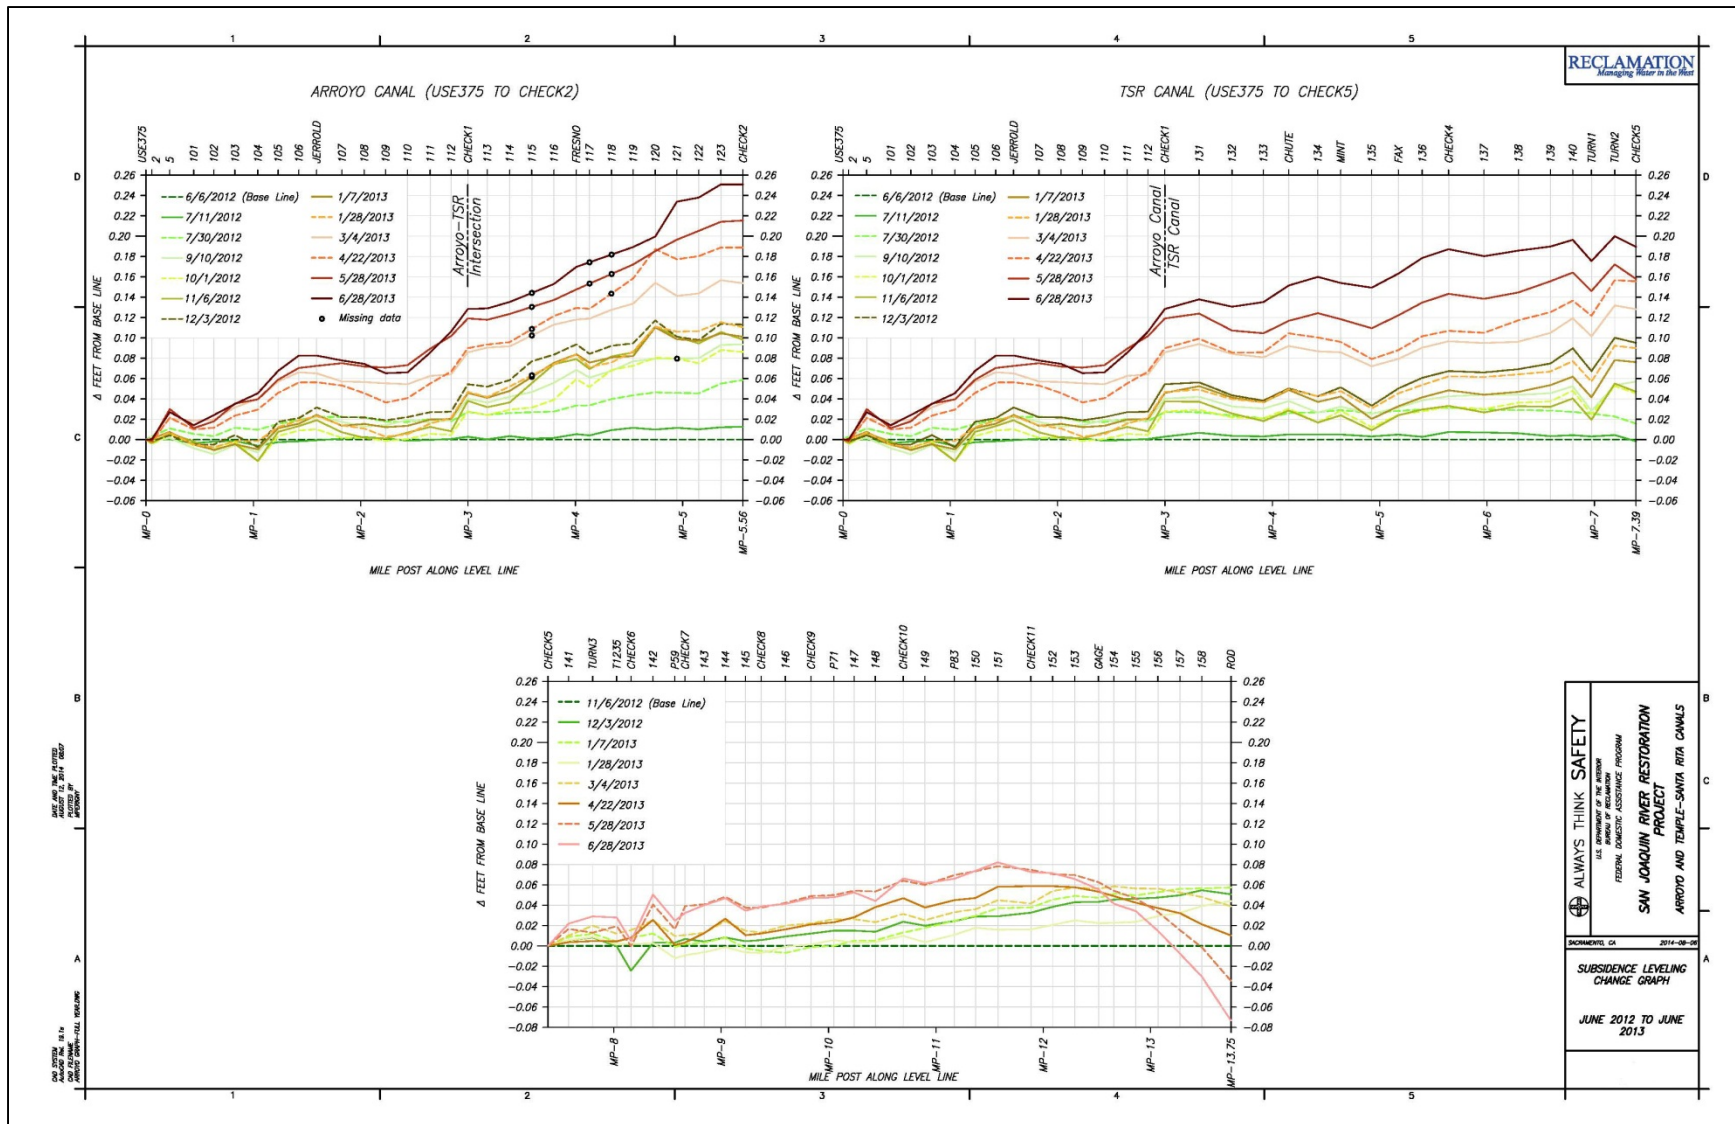
Figure 6. Survey results showing relative changes in elevation along the Arroyo and Temple-Santa Rita Canals

Reclamation has monitored the Arroyo and Temple-Santa Rita (TSR) Canals by surveying regular monitoring points monthly from June of 2012 through June of 2013. The results of each survey were compared in Excel by calculating the relative change in elevation along the Arroyo and Temple-Santa Rita Canals in relation to the benchmark at Sack Dam (375 USE). The surveys are not directly tied to the ongoing SJRRP's Geodetic Network surveys, but provide a relative change compared to the initial "baseline" survey. The survey results are shown in **Figure 6**.

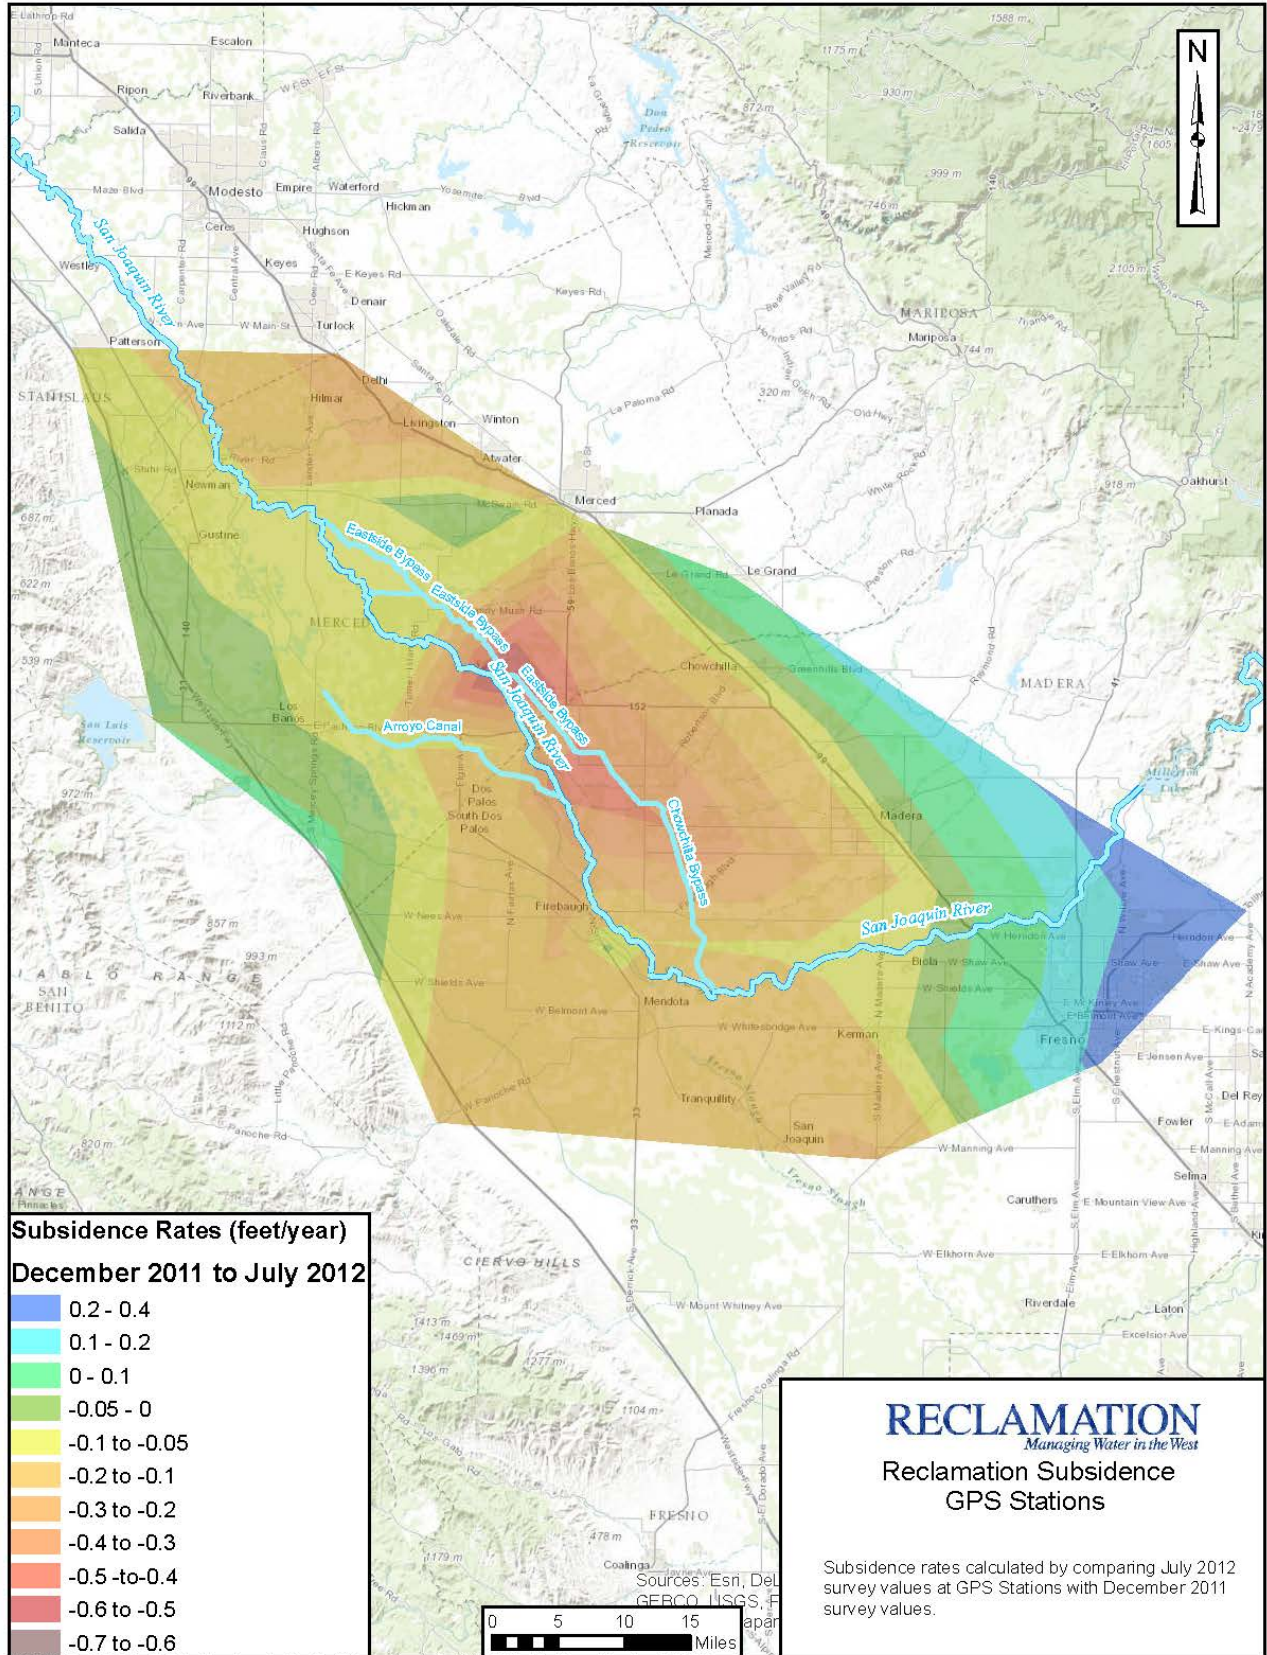
Figure A.1. Annual Subsidence Rate Exhibit Map for December 2011 to July 2012

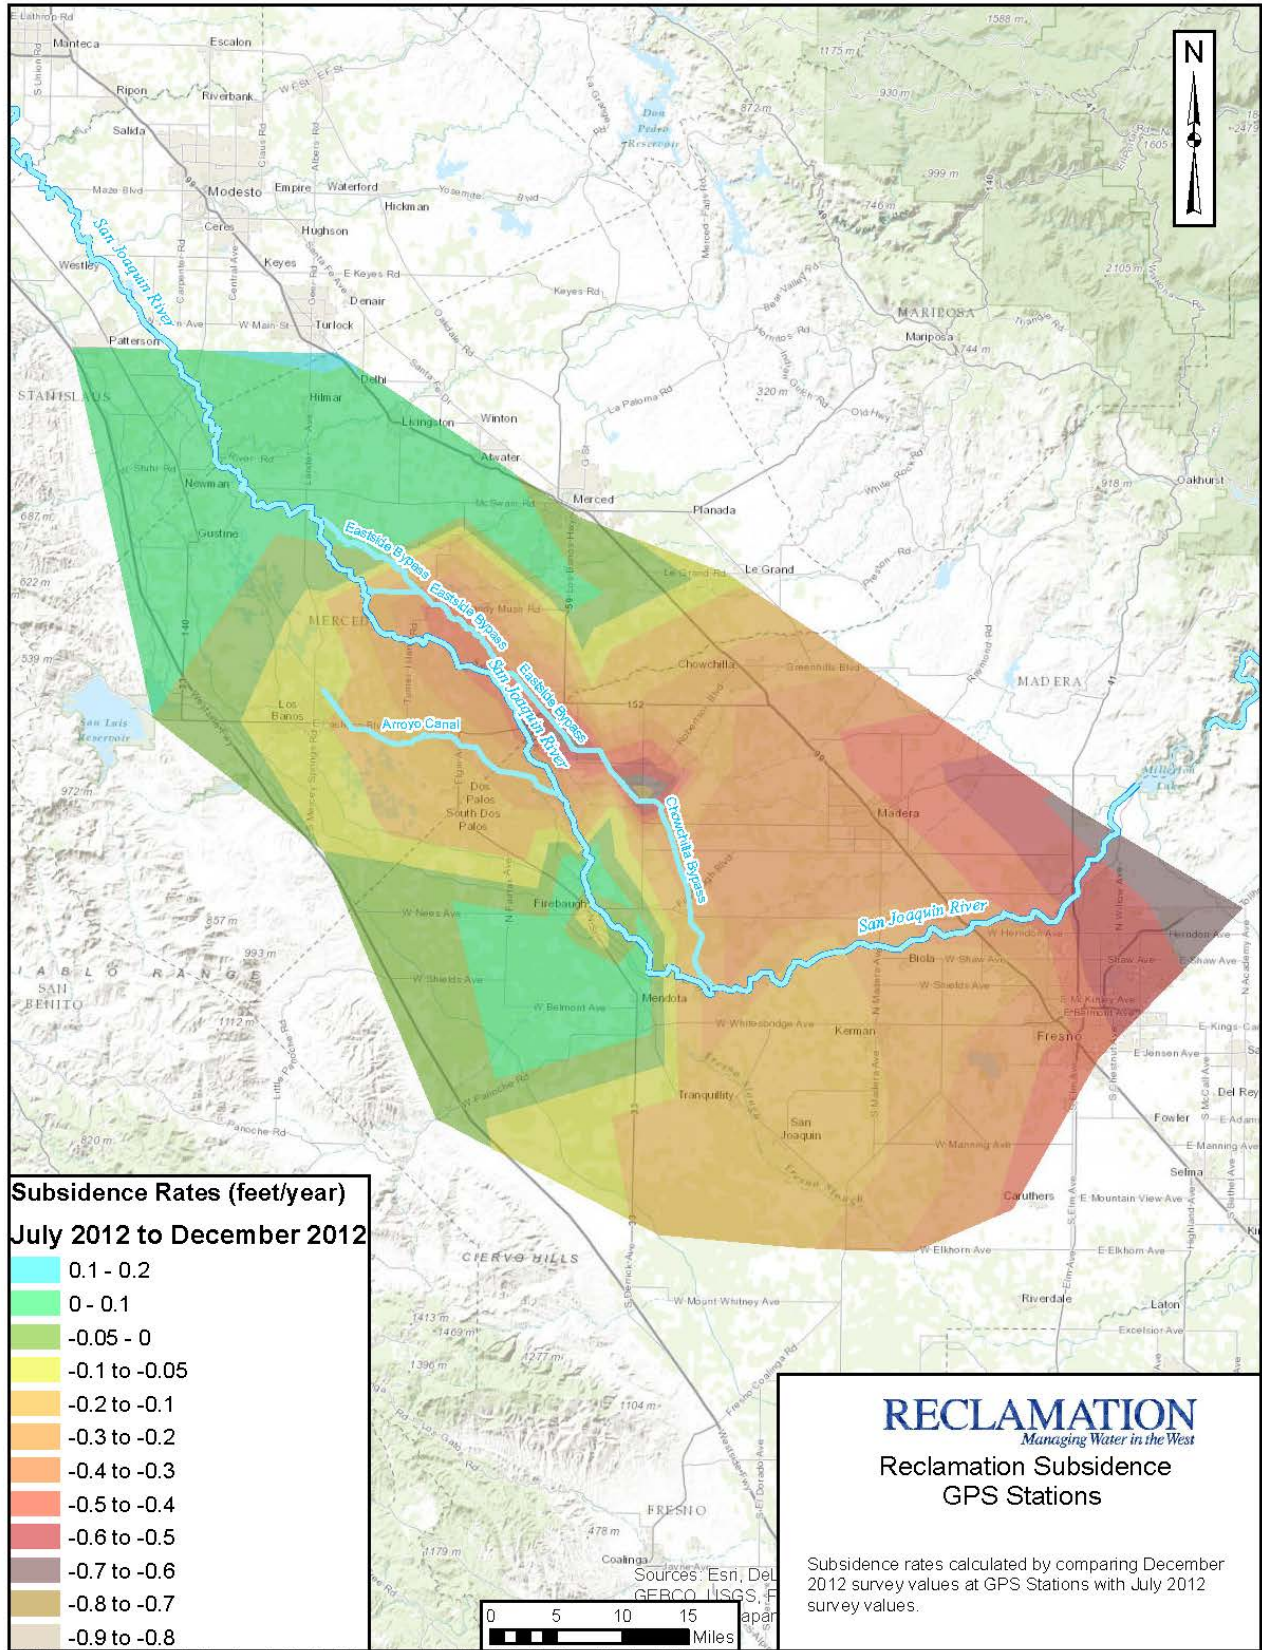
Figure A.2. Annual Subsidence Rate Exhibit Map for July 2012 to December 2012

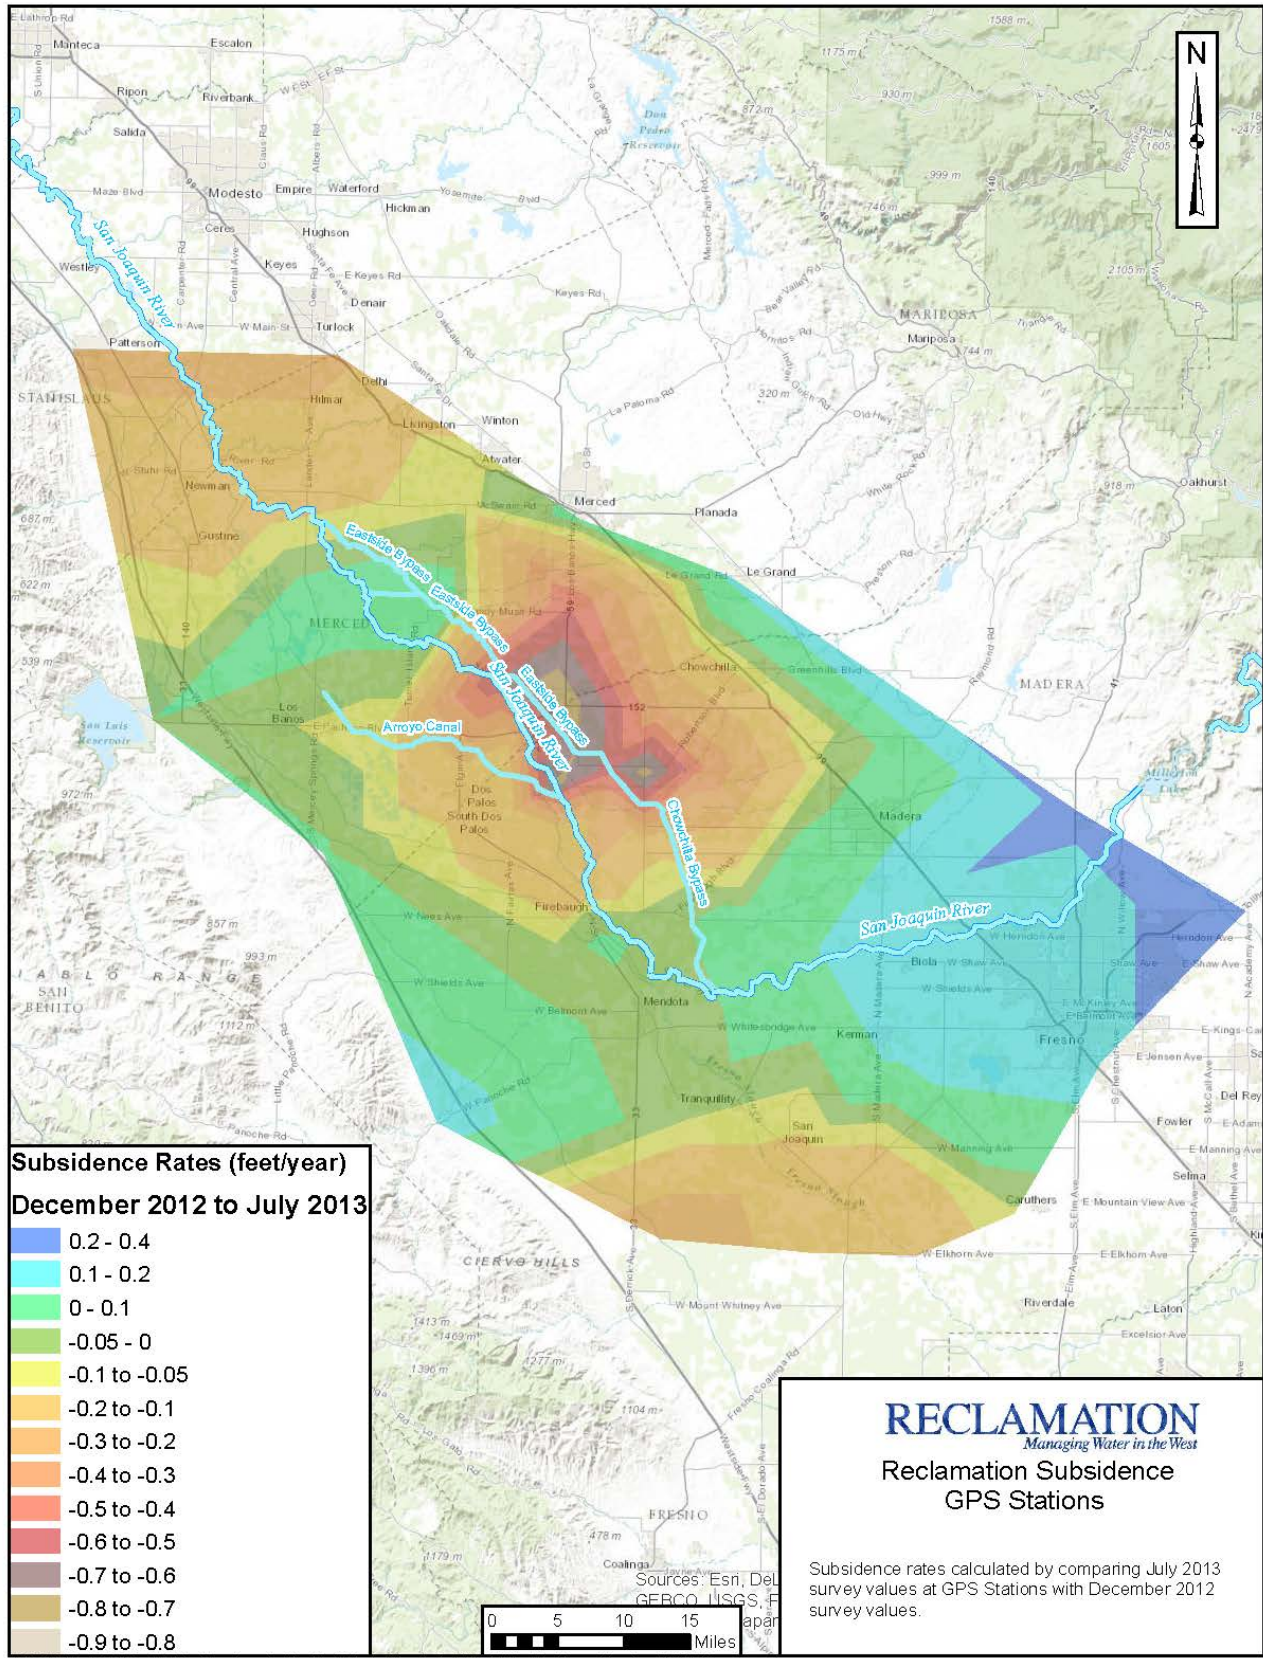
Figure A.3. Annual Subsidence Rate Exhibit Map for December 2012 to July 2013

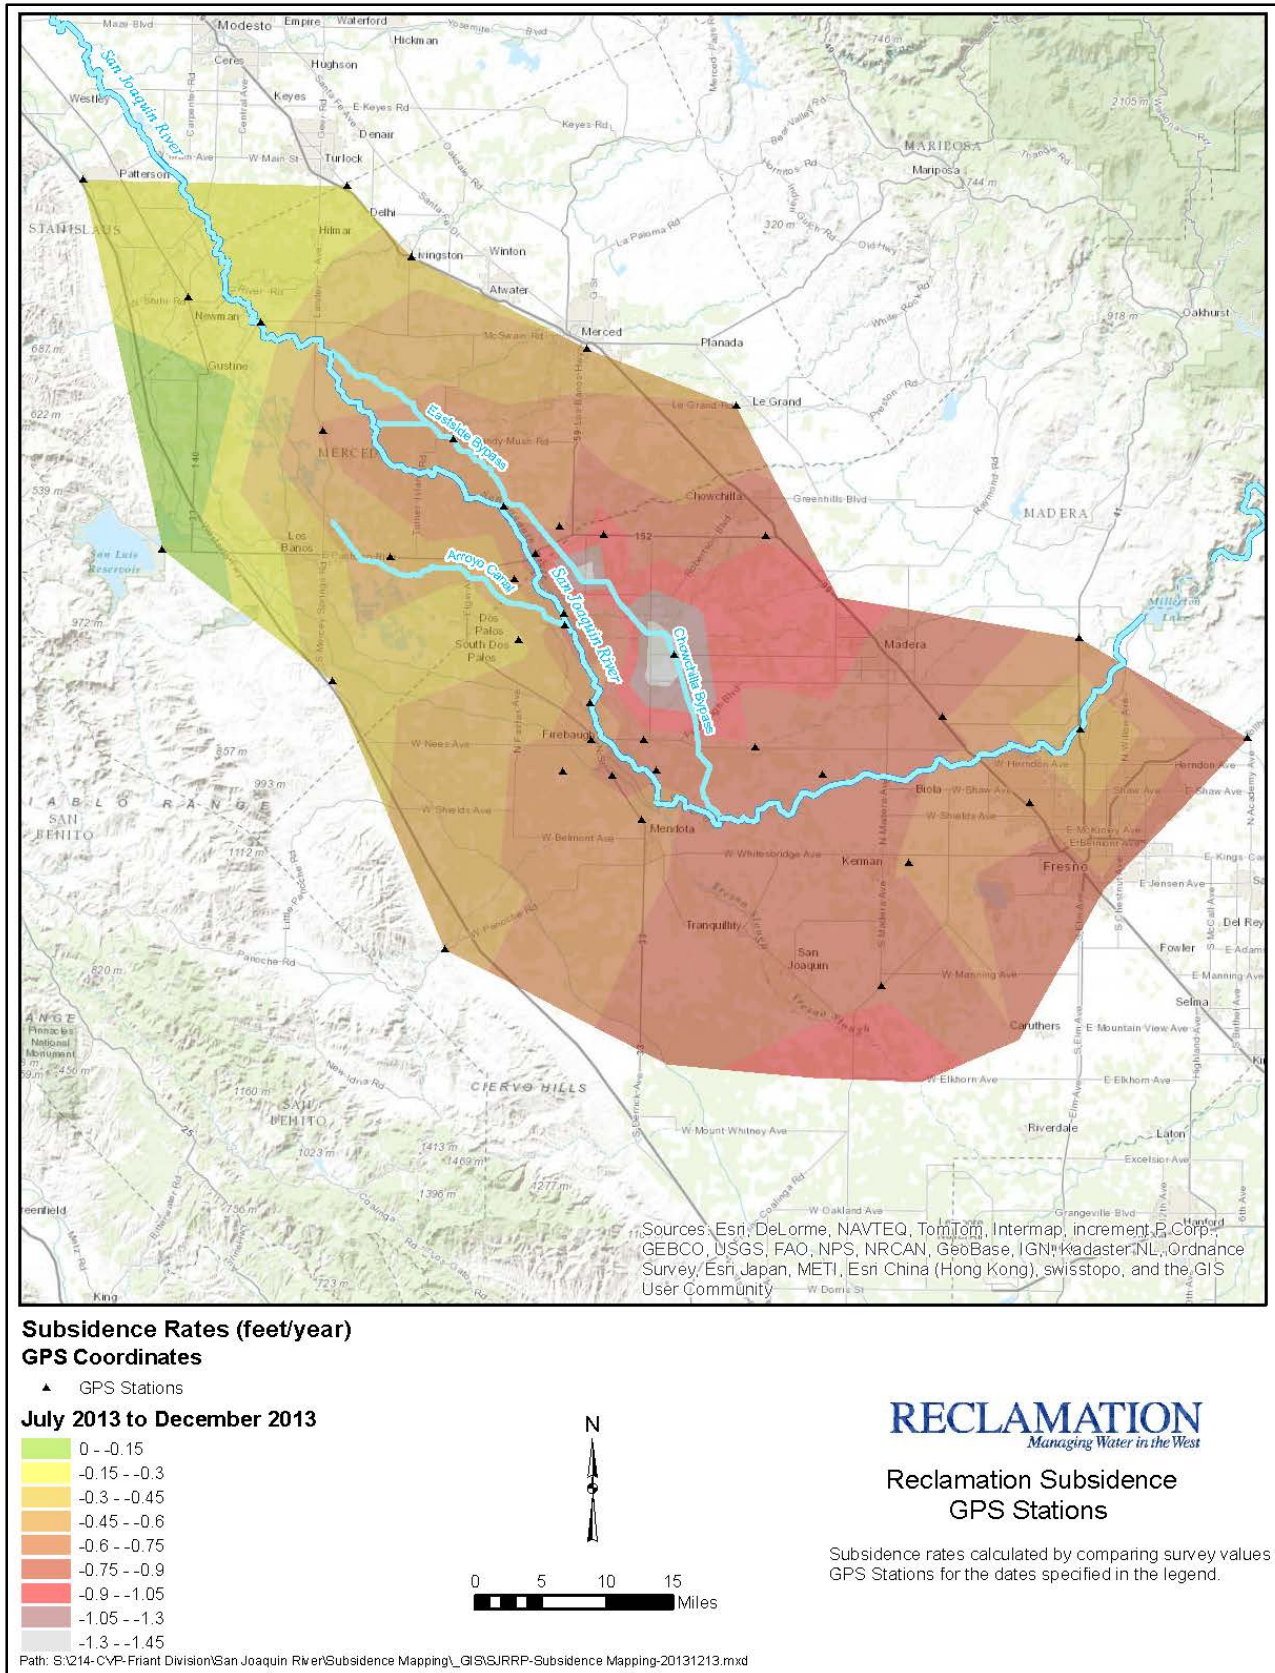
Figure A.4. Annual Subsidence Rate Exhibit Map for July 2013 to December 2013

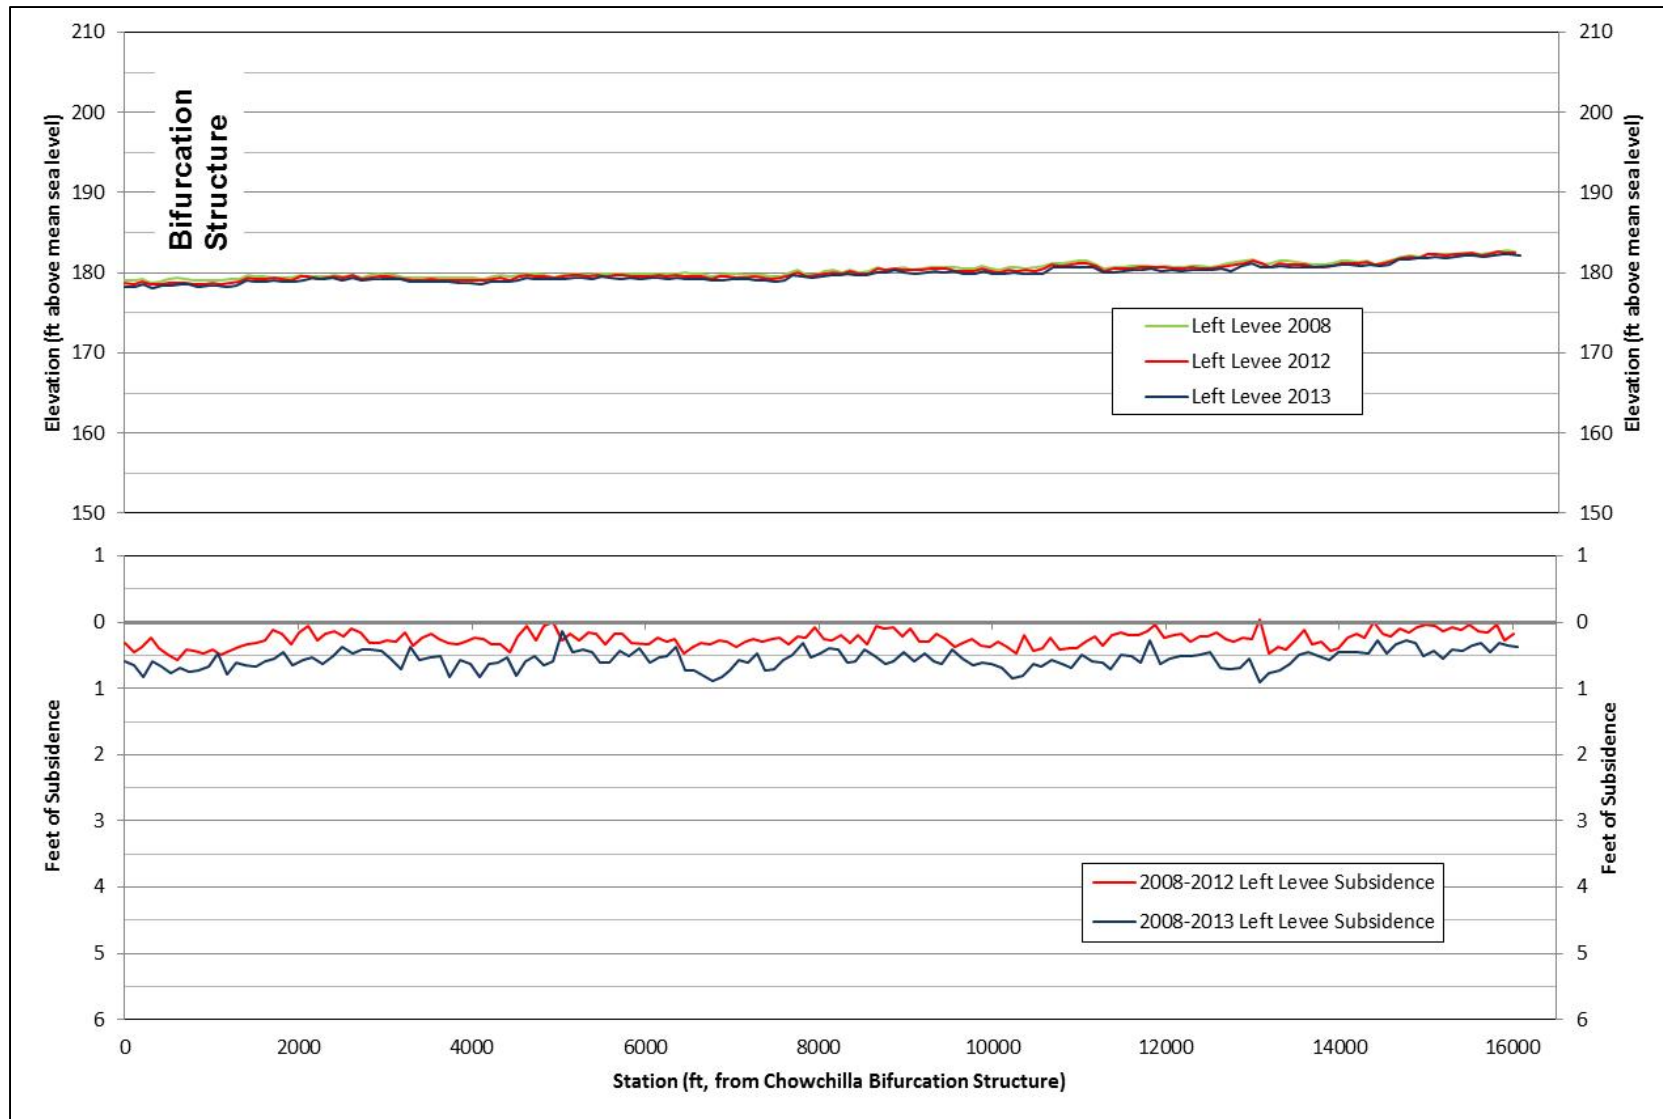
Figure B.1 Ground subsidence along the left levee in Reach 2A upstream of the San Joaquin River Bifurcation Structure based on the 2012 and 2013 survey and 2008 LiDAR.

To better define, as well as confirm the overall subsidence trends shown in Reclamation's initial exhibit maps, in 2012 and again in 2013, DWR-SCRO collected elevation data along about 65 miles of bypass and Reach 2A levee crowns. Profiles showing the levee crown elevations from the 2008 LiDAR mapping completed by DWR and the 2012 and 2013 surveys are shown in Appendix B of this report. In general, the profiles show that subsidence is occurring at various rates along the bypasses from almost 6 ft in the Upper Eastside Bypass from 2008 to 2013 to less than 0.5' in Reach 2A and the lower portion of the Middle Eastside Bypass and Mariposa Bypass. In addition, a comparison of the DWR-SCRO survey data in some areas show that the ground during the 2012 surveys appears higher (up to about 0.5'), and to a lesser extent the 2013 survey than the LiDAR data. Some of these differences may be a result of physical changes to the levees (e.g., placement of material on top of the levees after the LiDAR surveys), data collection methods (GPS when compared to LiDAR), or the accuracy of the LiDAR data itself; but the specific source of these anomalies were not investigated (DWR-SCRO, 2013).
