# Appendix E

## Technical Memorandum Subsidence Monitoring (2011-2013)

# Technical Memorandum

## Subsidence Monitoring

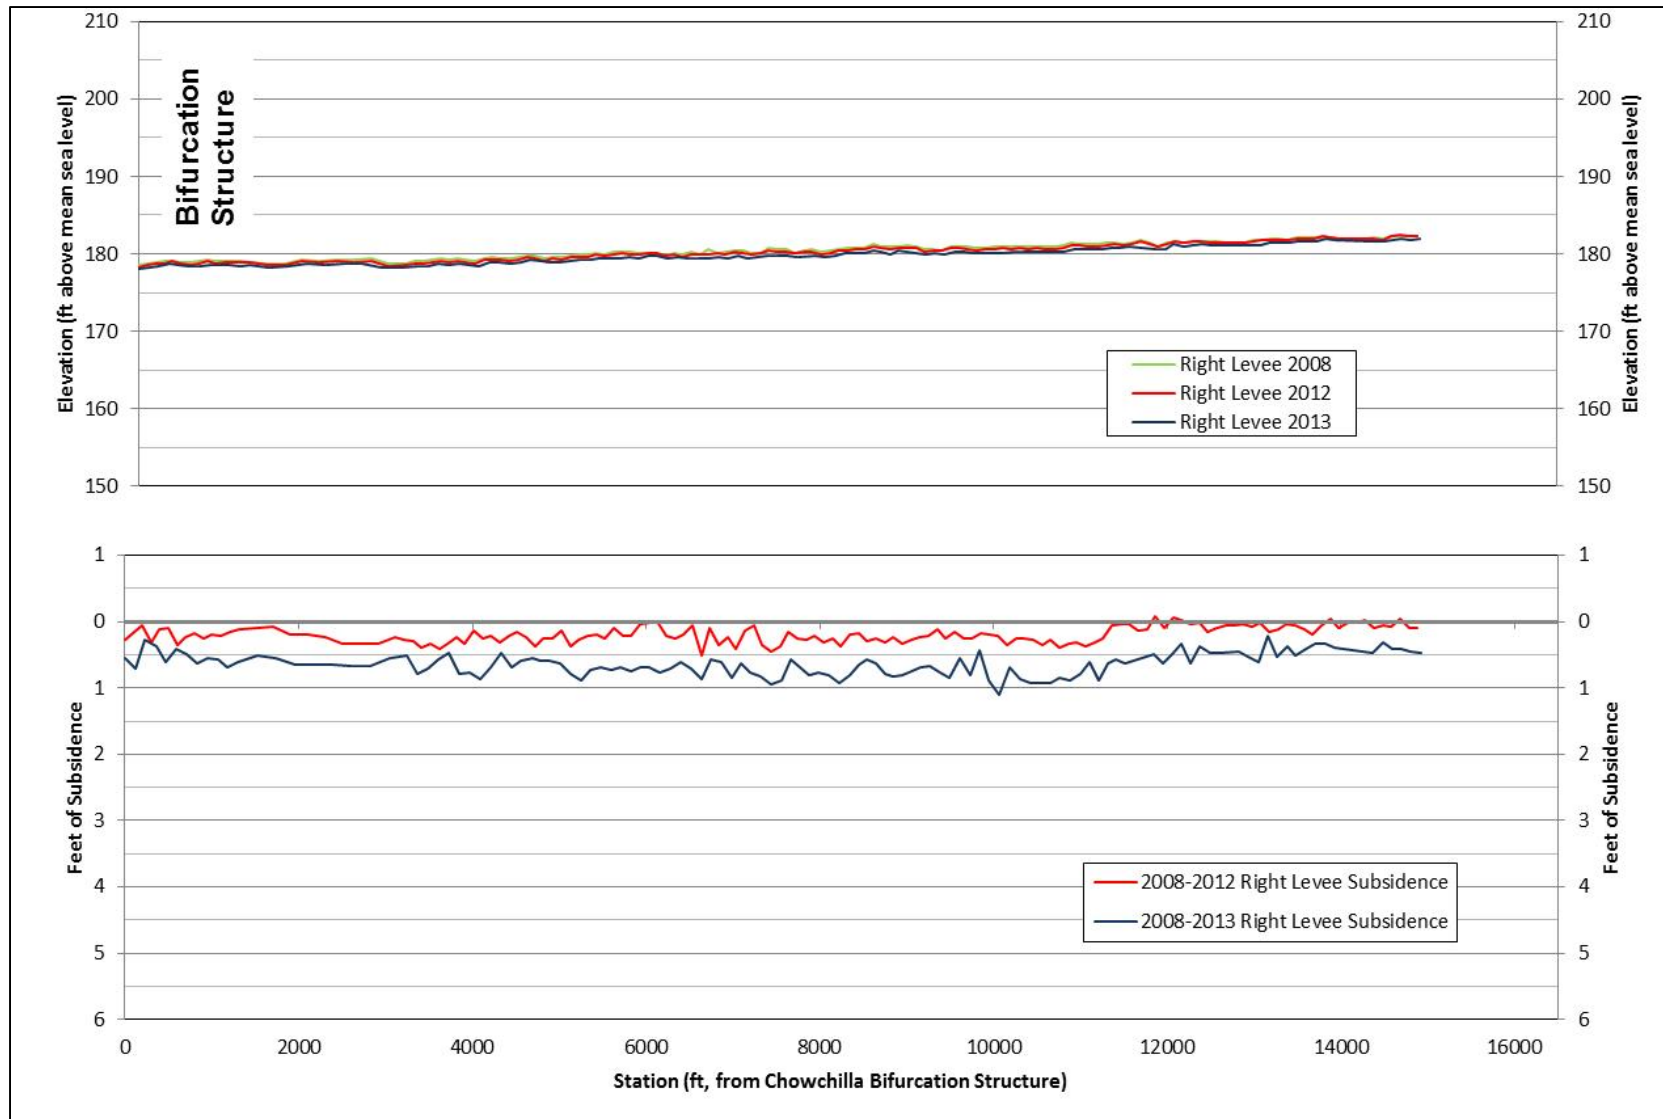
**Figure B.2. Ground subsidence along the right levee in Reach 2A upstream of the San Joaquin River Bifurcation Structure based on the 2012 and 2013 survey and 2008 LiDAR.**

To better define, as well as confirm the overall subsidence trends shown in Reclamation's initial exhibit maps, in 2012 and again in 2013, DWR-SCRO collected elevation data along about 65 miles of bypass and Reach 2A levee crowns. Profiles showing the levee crown elevations from the 2008 LiDAR mapping completed by DWR and the 2012 and 2013 surveys are shown in Appendix B of this report. In general, the profiles show that subsidence is occurring at various rates along the bypasses from almost 6 ft in the Upper Eastside Bypass from 2008 to 2013 to less than 0.5' in Reach 2A and the lower portion of the Middle Eastside Bypass and Mariposa Bypass. In addition, a comparison of the DWR-SCRO survey data in some areas show that the ground during the 2012 surveys appears higher (up to about 0.5'), and to a lesser extent the 2013 survey than the LiDAR data. Some of these differences may be a result of physical changes to the levees (e.g., placement of material on top of the levees after the LiDAR surveys), data collection methods (GPS when compared to LiDAR), or the accuracy of the LiDAR data itself; but the specific source of these anomalies were not investigated (DWR-SCRO, 2013).

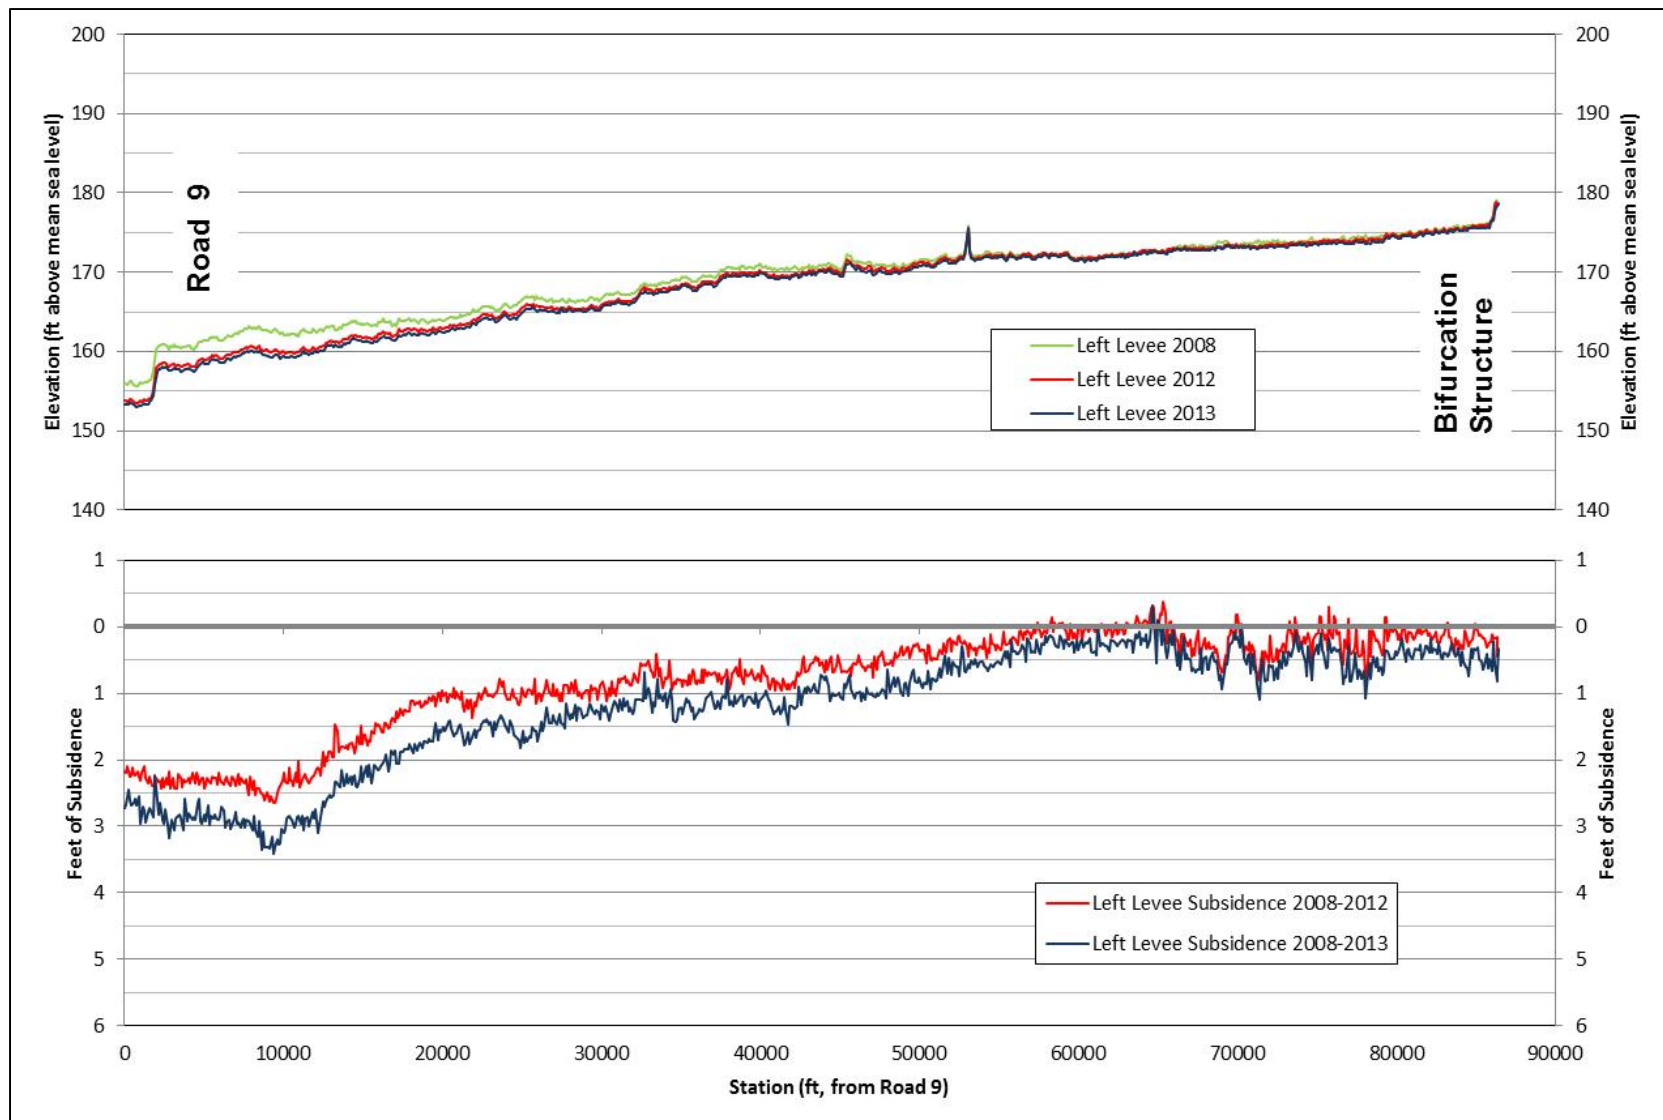
Figure B.3. Ground subsidence along the left levee in the Chowchilla Bypass from the San Joaquin River Bifurcation to Road 9 based on the 2012 and 2013 survey and 2008 LiDAR.

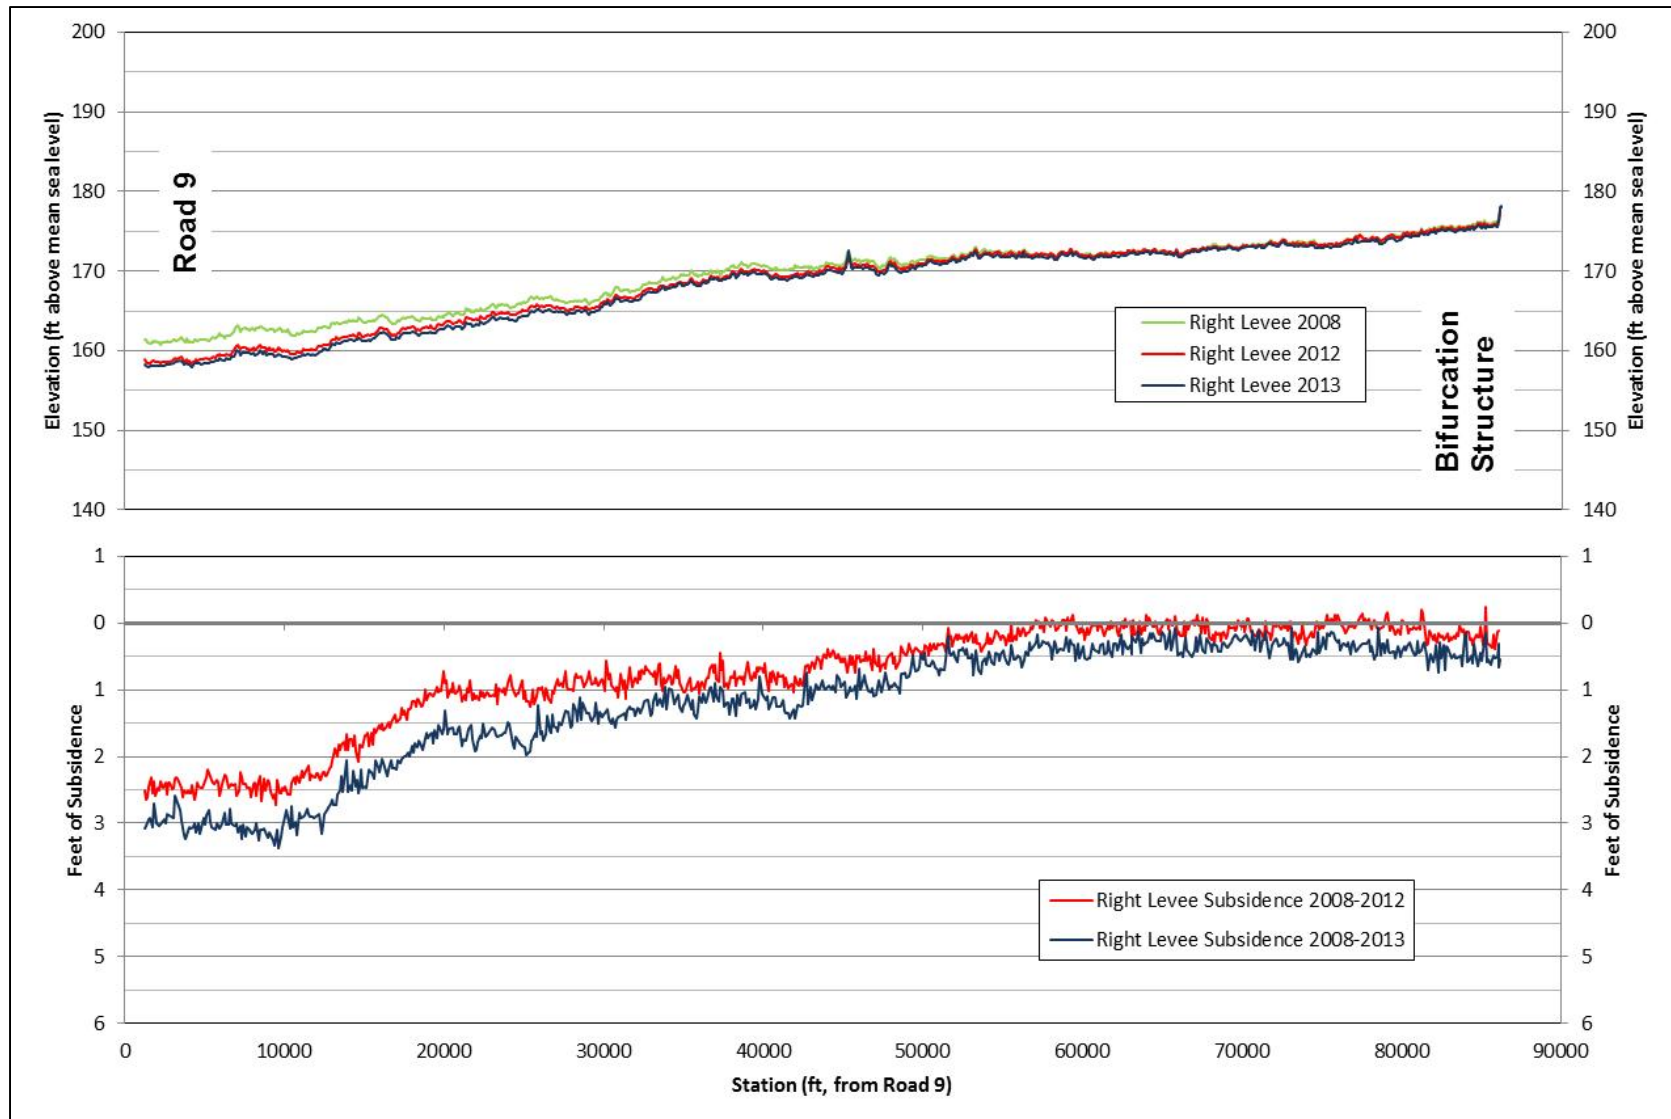
Figure B.4. Ground subsidence along the right levee in the Chowchilla Bypass from the San Joaquin River Bifurcation to Road 9 based on the 2012 and 2013 survey and 2008 LiDAR.

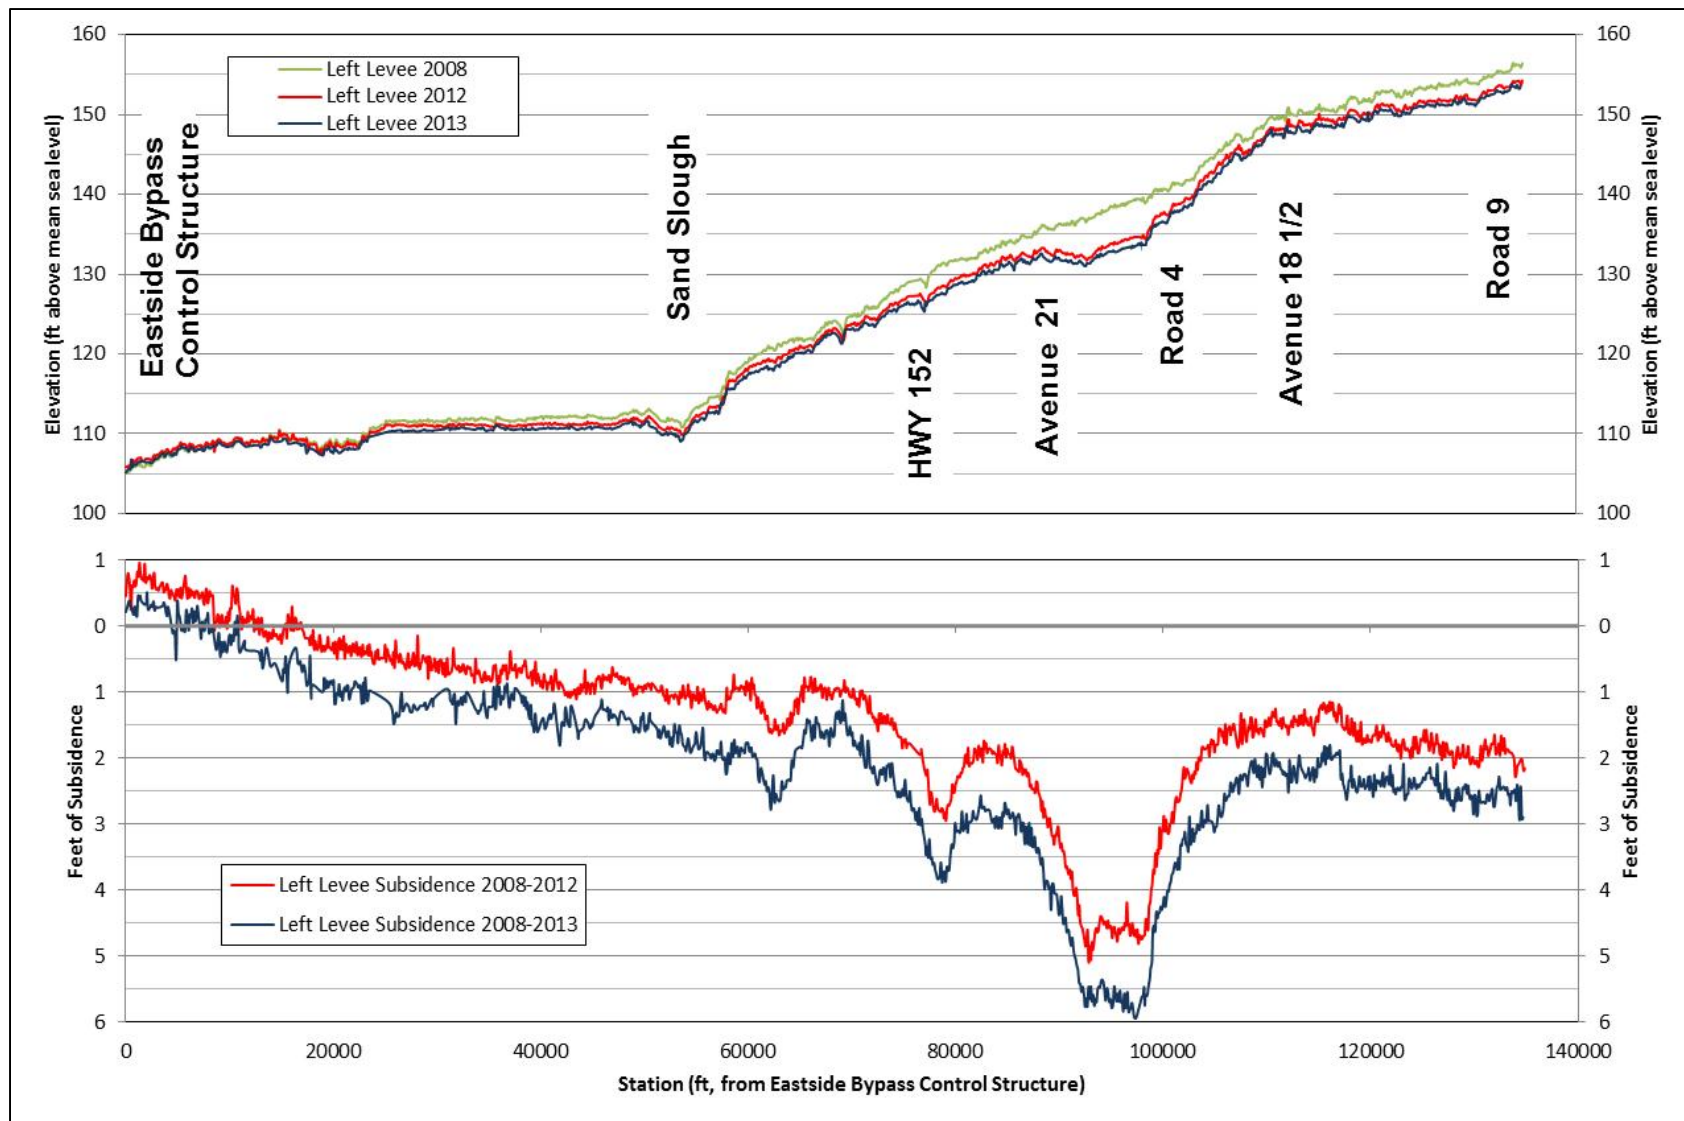
Figure B.5. Ground subsidence along the left levee in the Upper and Middle Eastside Bypasses from Road 9 to the Eastside Bypass Control Structure based on the 2012 and 2013 survey and 2008 LiDAR.

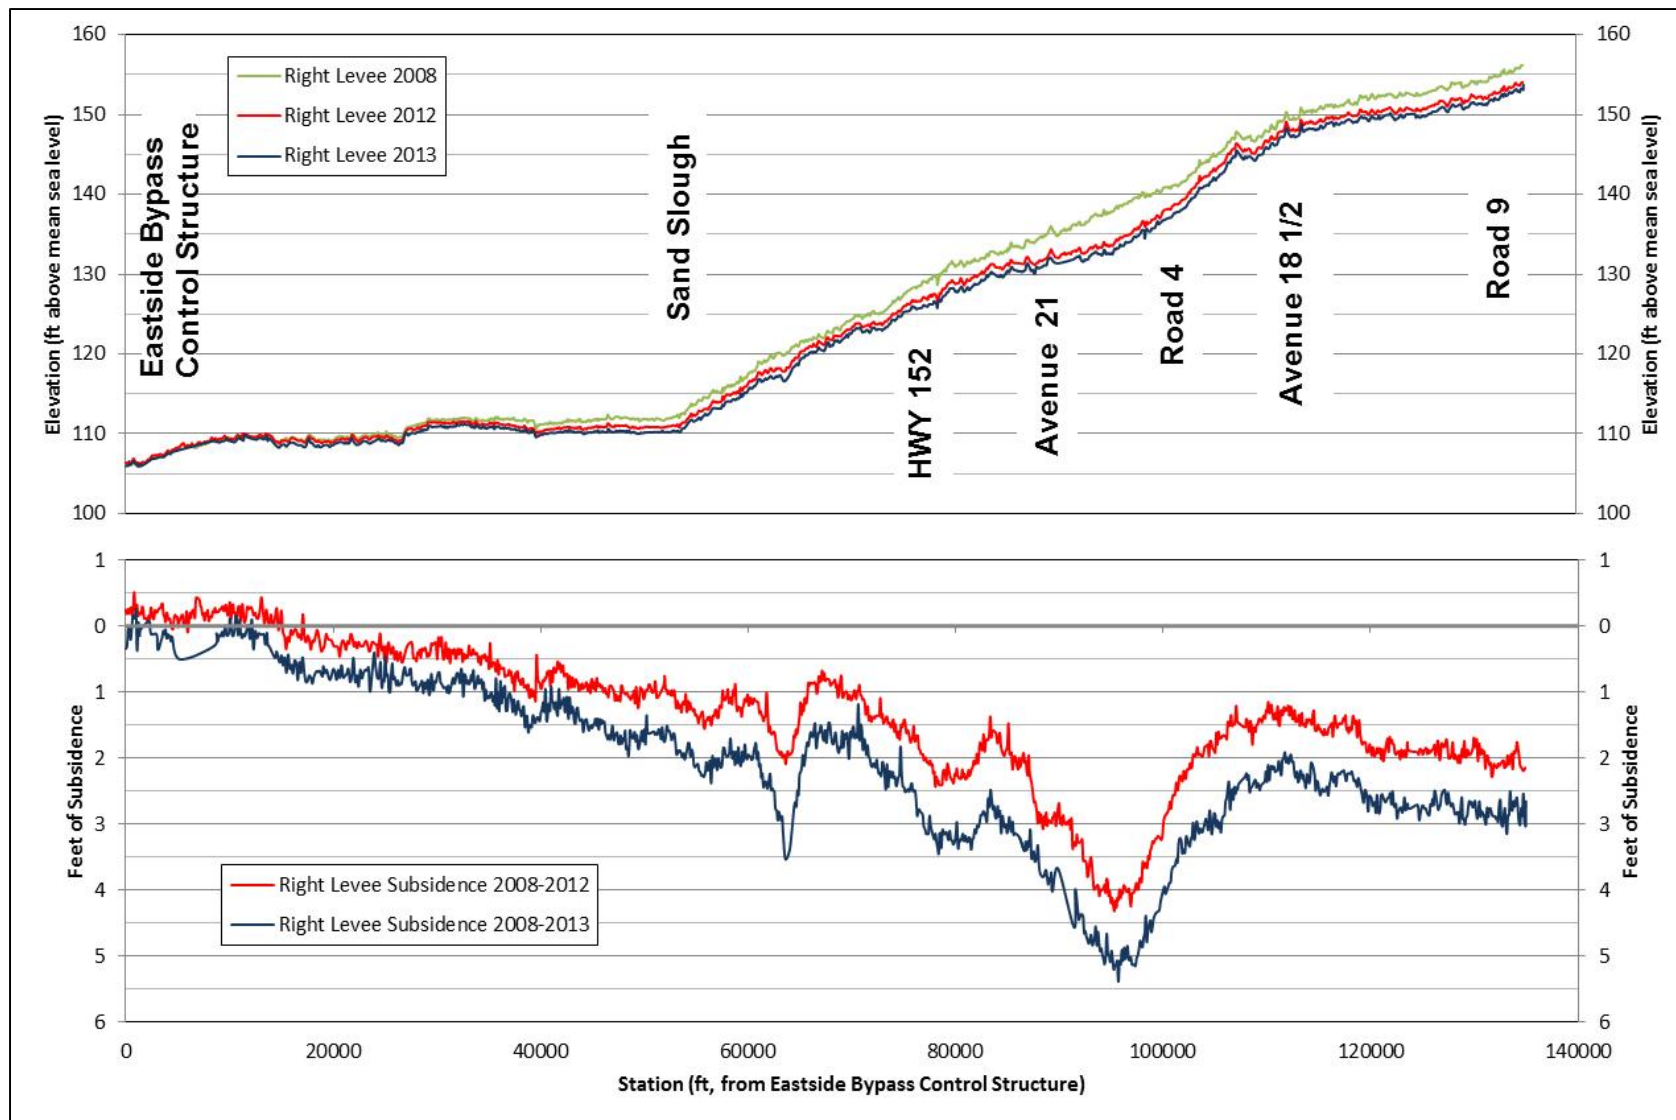
Figure B.6. Ground subsidence along the right levee in the Upper and Middle Eastside Bypasses from Road 9 to the Eastside Bypass Control Structure based on the 2012 and 2013 survey and 2008 LiDAR.

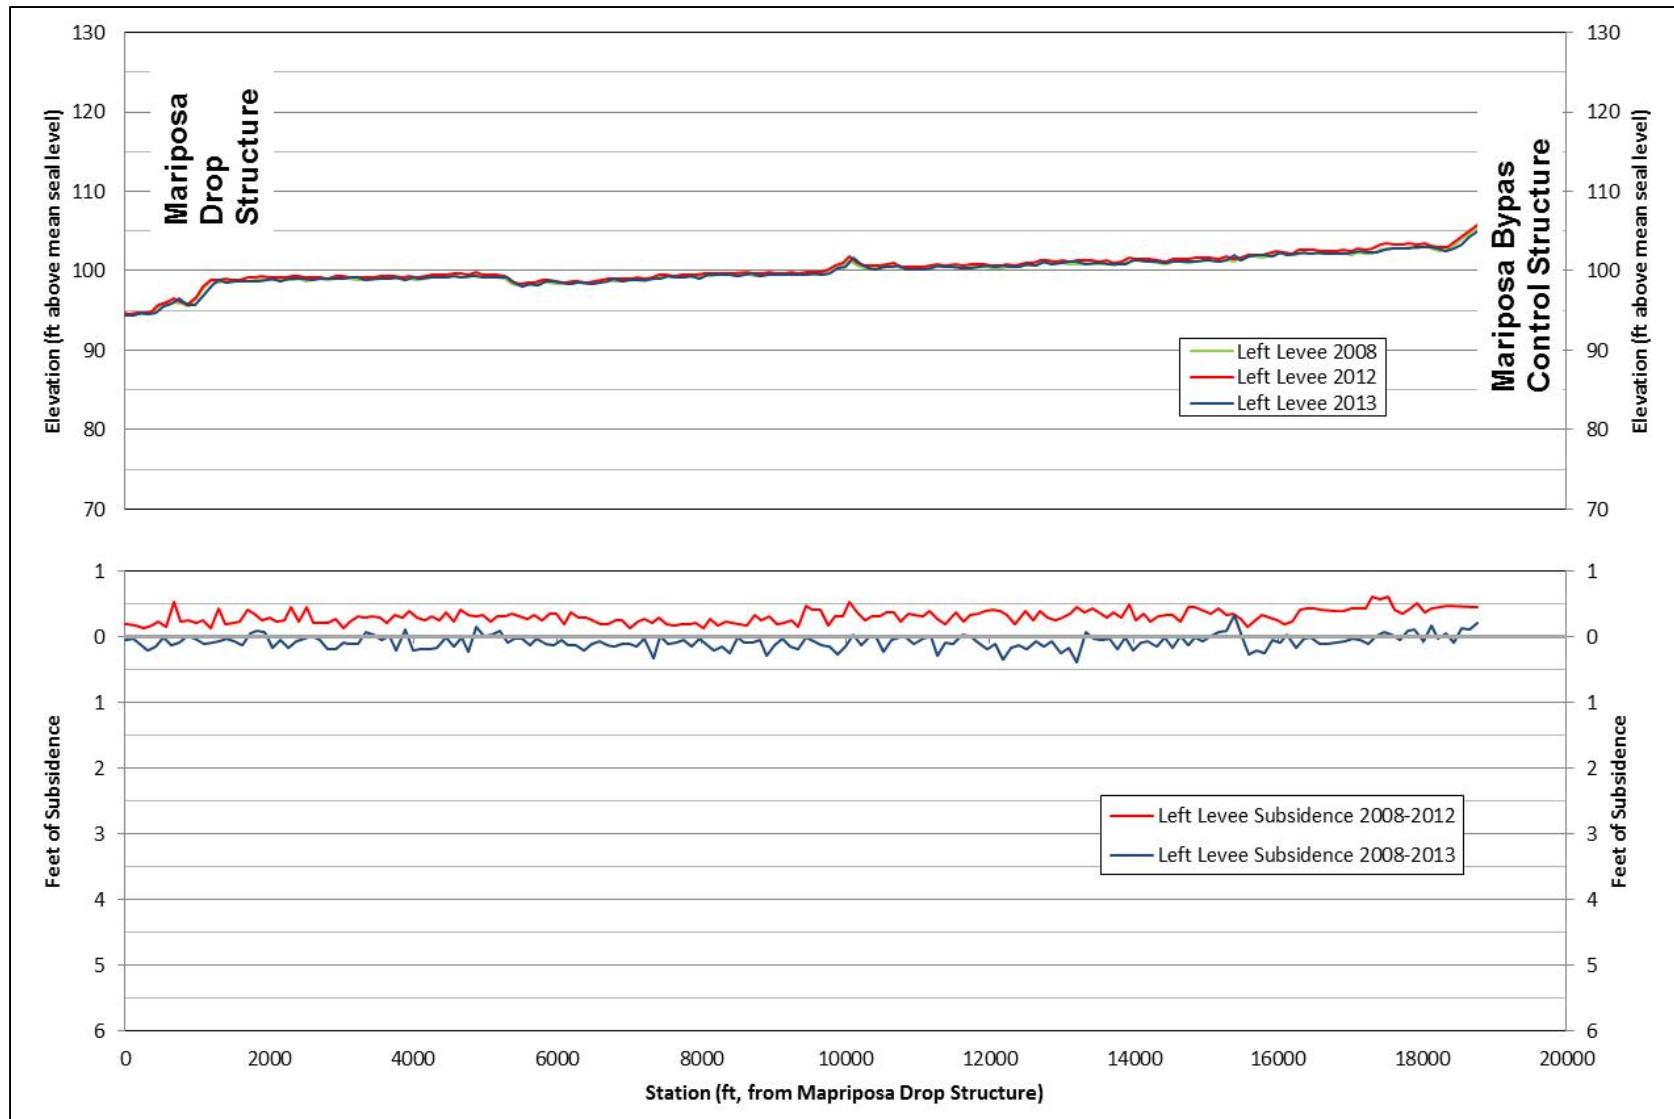
**Figure B.7. Ground subsidence along the left levee in the Mariposa Bypass based on the 2012 and 2013 survey and 2008 LiDAR.**

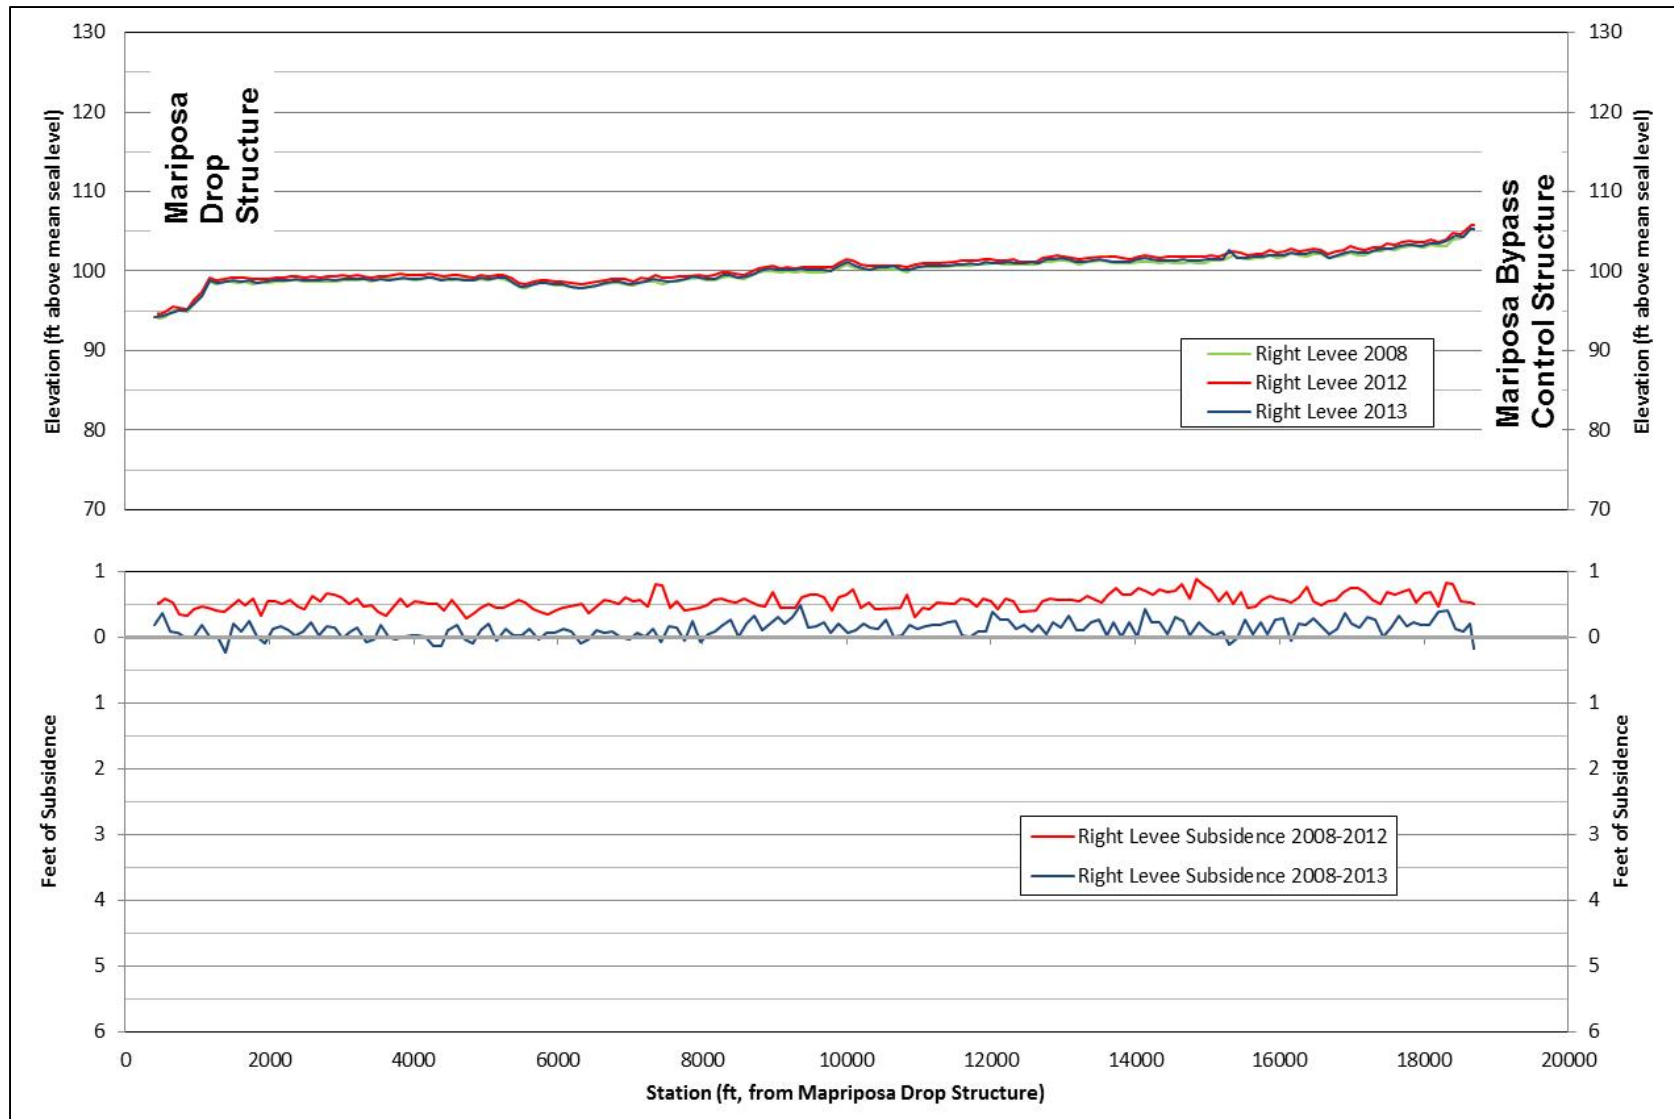
Figure B.8. Ground subsidence along the right levee in the Mariposa Bypass based on the 2012 and 2013 survey and 2008 LiDAR.
