Appendix D

Reach 2A Sedimentation Evaluation (2011)

**SAN JOAQUIN RIVER
RESTORATION PROGRAM**

April 17, 2012

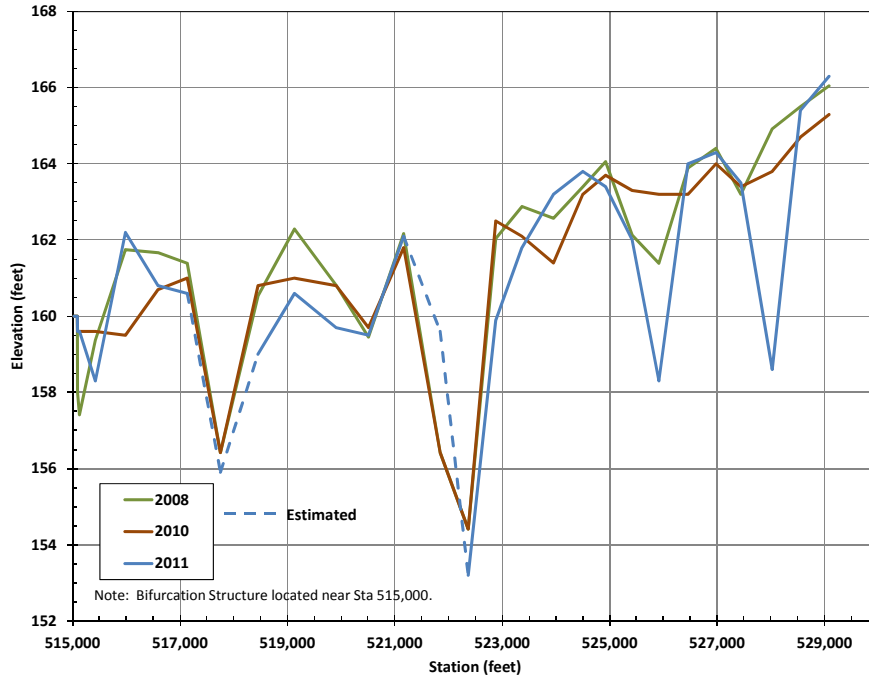
Figure 4a. Thalweg profiles for the downstream three miles of Reach 2A based on the 2008 LiDAR mapping, and the November 2010 and November 2011 cross-section surveys.

To further quantify aggradation/degradation trends along the reach, minimum bed (i.e., thalweg) and mean bed elevation profiles were developed from each survey and compared (**Figures 4 and 5, respectively**). Changes in thalweg elevation from 2008 to 2010 ranged from about 2.3 feet of degradation (XS 515,986, about 400 feet upstream from the CBBS) to 2.2 feet of aggradation (XS 515,130, about 100 feet upstream from the CBBS), with an overall average change of -0.1 feet. The thalweg lowered at 13 of the cross sections, raised at nine and did not change at five (Figure 4)². From November 2010 to November 2011, the thalweg lowered by an average of approximately 0.4 feet over the reach, with a decrease in elevation at 14 cross sections, an increase at nine cross sections and little or no change at three cross sections. Over the entire period from 2008 through 2011, the thalweg lowered by an average of 0.5 feet, with 16 of the cross sections lowering, nine raising and three having little or no change.

The results of this analysis indicate that most of the approximately 3.0-mile portion of Reach 2A upstream from the CBBS is degradational under flow conditions that have occurred over the past three years. Between March/April 2008, when the LiDAR data were collected, and the November 2010 survey, about 10.2 ac-ft of sediment was evacuated from the reach, and an additional approximately 16.3 ac-ft of material was evacuated between November 2010 and November 2011. The total degradation volume in this portion of Reach 2A was, thus, about 26.5 ac-ft over the entire period. With the exception of the approximately 400-foot reach immediately upstream from the CBBS and a few local areas scattered through the reach, both the thalweg and mean bed elevations generally lowered during the period as a result of the sediment evacuation. Based on the thalweg data in Figure 4a, deepening of the pools may be occurring as part of the degradational process.

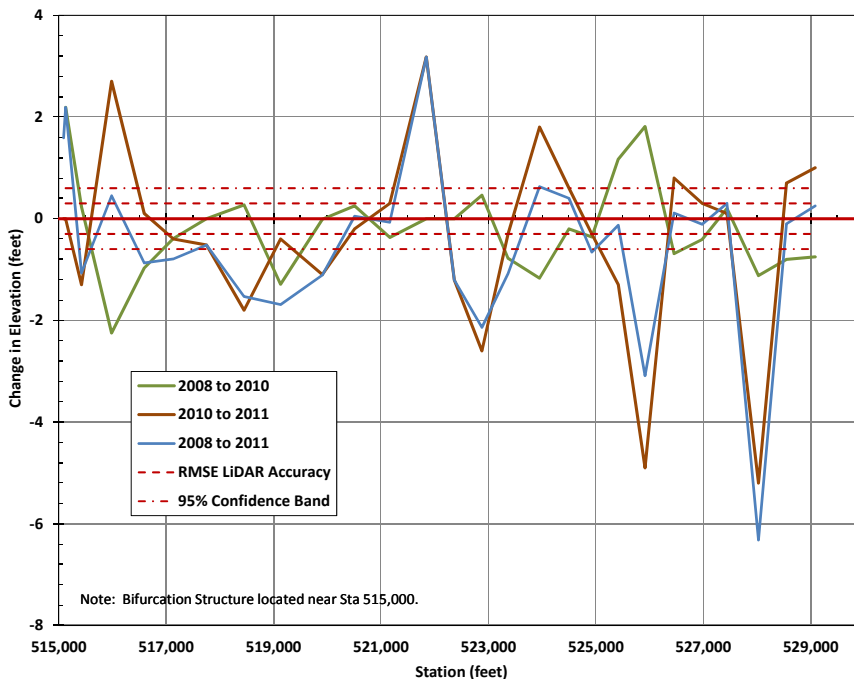
Figure 4b. Change in thalweg elevations in the downstream three miles of Reach 2A based on the 2008 LiDAR mapping, and the November 2010 and November 2011 cross-section surveys. RMSE and 95% Confidence Bands from LiDAR map accuracy standards are also shown. Error in surveyed cross section points is believed to be of similar magnitude.

² The changes in thalweg elevation between 2008 and 2010 at 9 of the cross sections are within the 0.3' RMSE accuracy standard for the LiDAR data and within the +/-0.6' 95% confidence bands at 14 of the cross sections. The potential vertical error in the surveyed points is believed to be of similar magnitude; thus, the indicated changes are significant at one-half to two-thirds of the cross sections.

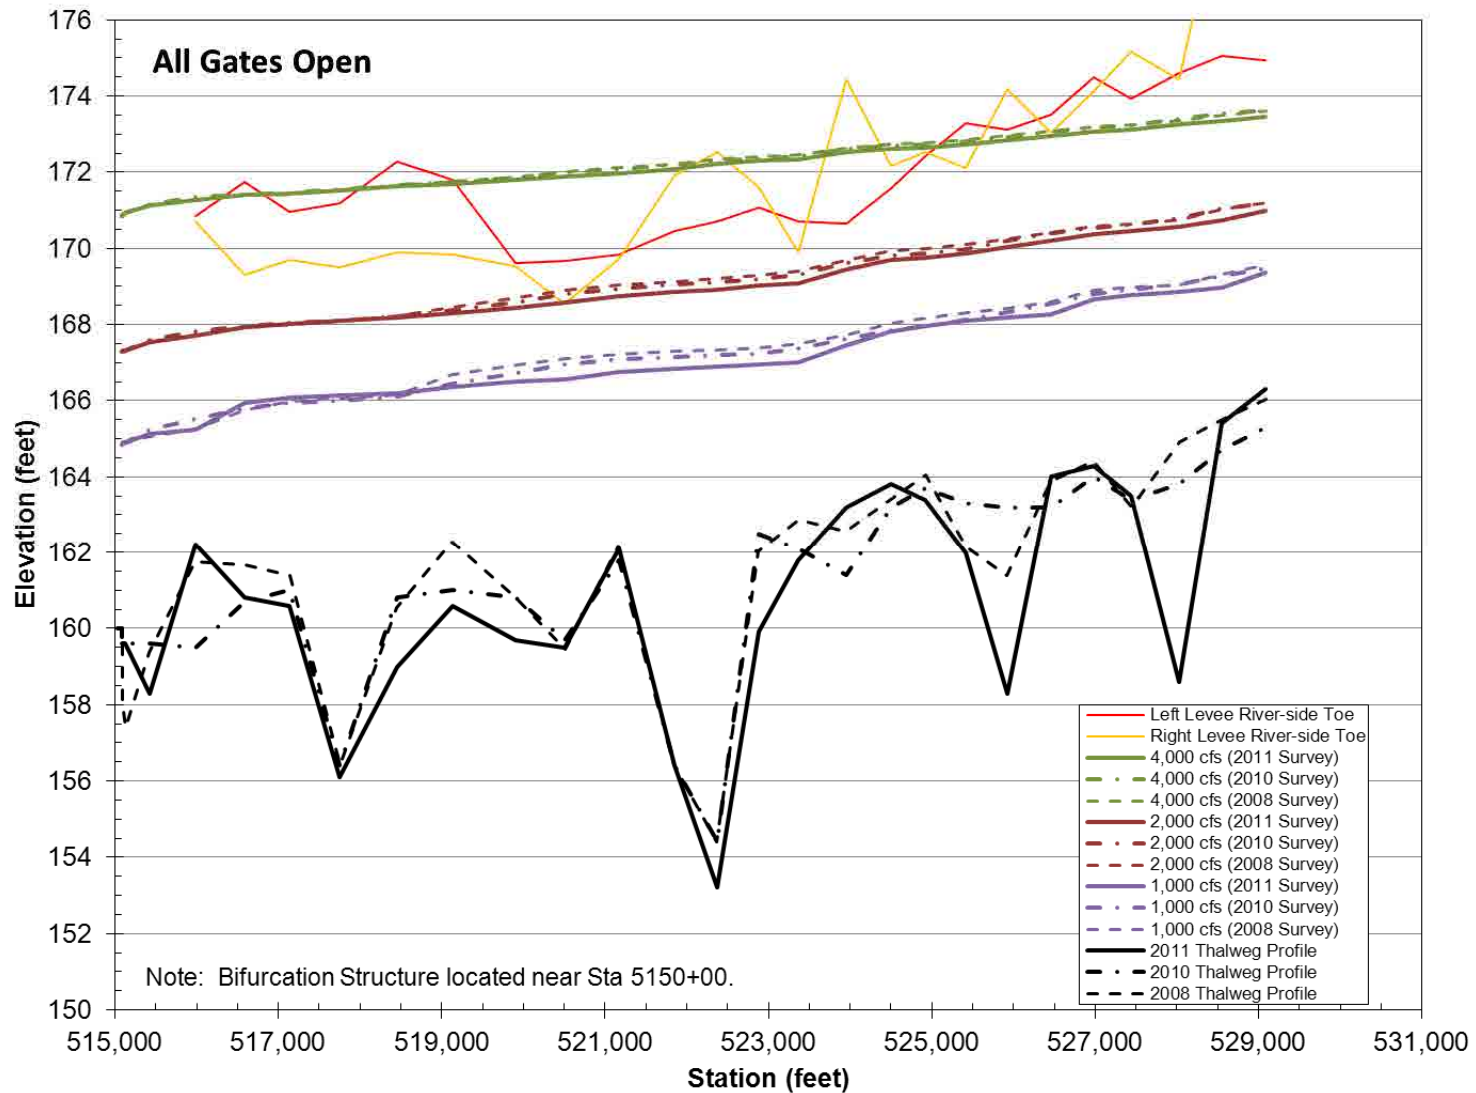
Figure 11. Water-surface profiles for discharges of 1,000, 2,000 and 4,000 cfs predicted by the HEC-RAS models with the 2008 LiDAR cross sections, November 2010 cross sections and November 2011 cross sections.

After completion of the calibration check the model was executed for a range of flows up to 4,000 cfs and the predicted water-surface profiles were compared with the profiles developed using the 2008 LiDAR data and the 2010 survey data (**Figures 11 and 12**). Comparison of the three sets of profiles indicates that the predicted water surface in the approximately 1,500-foot reach just upstream from the CBBS is up to 0.3 feet higher at 1,000 cfs using the 2010 model than with the 2008 model, but is about the same as 2008 using the 2011 model. In the middle and upstream portions of the reach, the 1,000-cfs water surface is 0.1 to 0.2 feet lower with the 2010 model than with the 2008 model. The 1,000-cfs water surface in this part of the reach lowers even farther with the 2011 model, with differences from the 2008 model of up to 0.5 feet in the middle portion of the reach between about Sta 519,000 and Sta 524,000. Similar trends occur at the two higher discharges of 2,000 and 4,000 cfs, but the differences from the 2008

model decrease with increasing discharge. At 4,000 cfs, the water-surface elevations from the 2010 model in the portion of the reach upstream from Sta 519,000 are very consistent with those from the 2008 model, averaging less than 0.01 feet lower with a maximum difference of less than 0.1 feet.³ The difference is somewhat larger, but still relatively small between the 2011 and 2008 models, averaging about 0.12 feet lower with a maximum difference of about 0.16 feet. These results suggest that the degradation in Reach 2A has tended to lower the water-surface elevations by a small amount at high flows, and this trend can be expected to continue with continued degradation.
