## Technical Memorandum Subsidence Monitoring (2011-2013)

# **Draft Technical Memorandum**

## **Subsidence Monitoring**

**2011 - 2013**

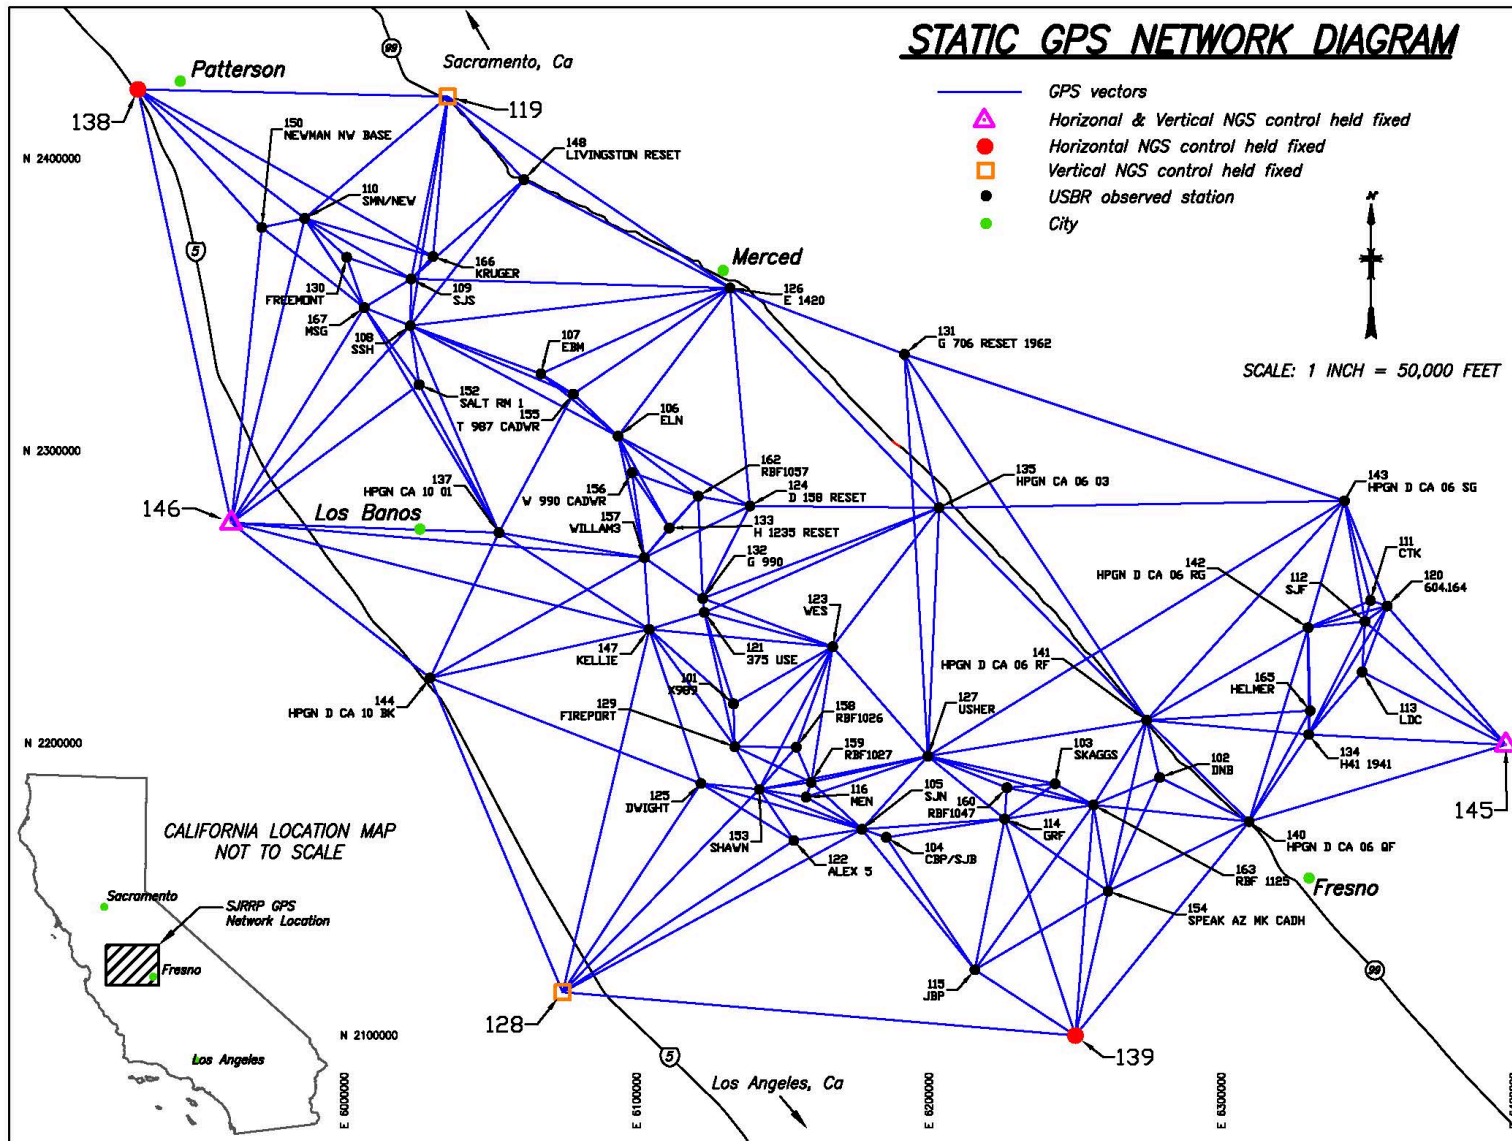
Figure 1. Static GPS Network Diagram

In 2011, Reclamation established the SJRRP Geodetic Control Network (**Figure 1**), using static GPS methods, to investigate subsidence within the SJRRP study area. To monitor the rate of subsidence over time, Reclamation conducts bi-annual surveys, in July and December, of the

established network. The network is made up of National Geodetic Survey, Reclamation, USGS, California Department of Transportation, and DWR benchmarks and in 2011 originally contained approximately 60 control points, but over the last few years has expanded to over 85 points. The benchmark elevations are updated after each survey and are used by the SJRRP to study subsidence, as well as to provide more accurate horizontal and vertical control for other studies.

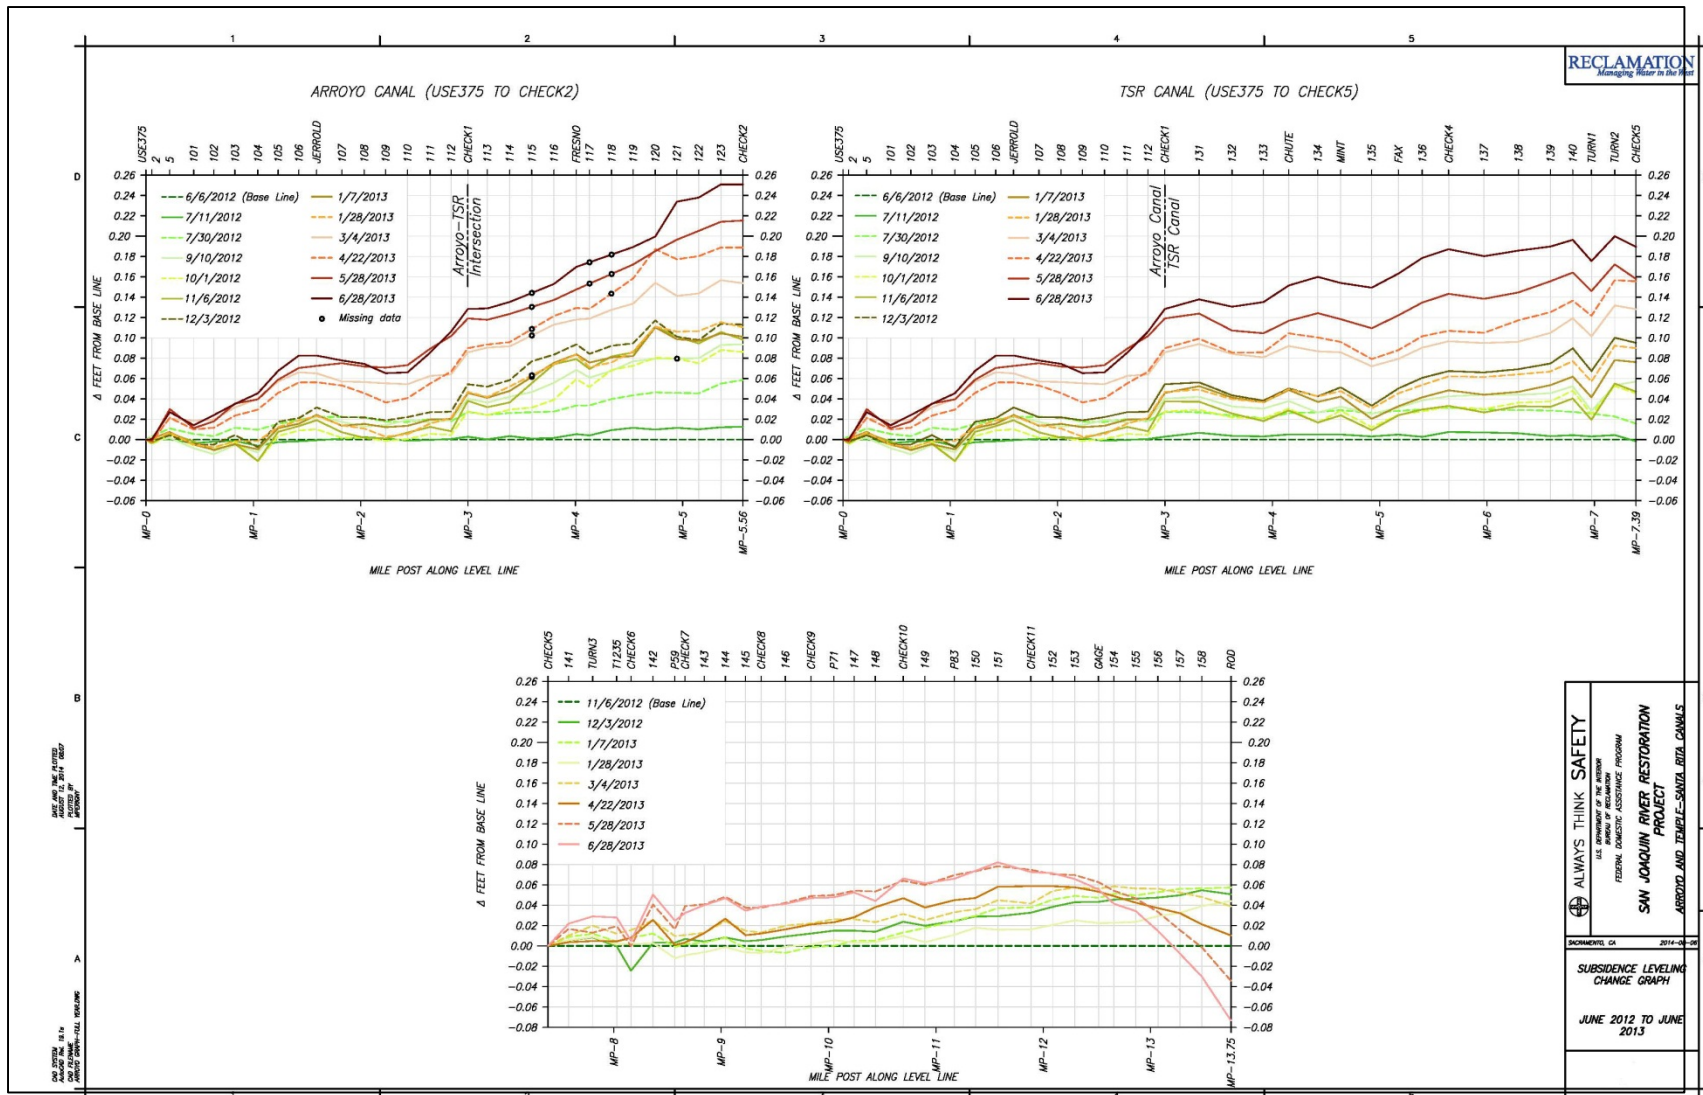
Figure 6. Survey results showing relative changes in elevation along the Arroyo and Temple-Santa Rita Canals

Reclamation has monitored the Arroyo and Temple-Santa Rita (TSR) Canals by surveying regular monitoring points monthly from June of 2012 through June of 2013. The results of each survey were compared in Excel by calculating the relative change in elevation along the Arroyo and Temple-Santa Rita Canals in relation to the benchmark at Sack Dam (375 USE). The surveys are not directly tied to the ongoing SJRRP's Geodetic Network surveys, but provide a relative change compared to the initial "baseline" survey. The survey results are shown in **Figure 6**.

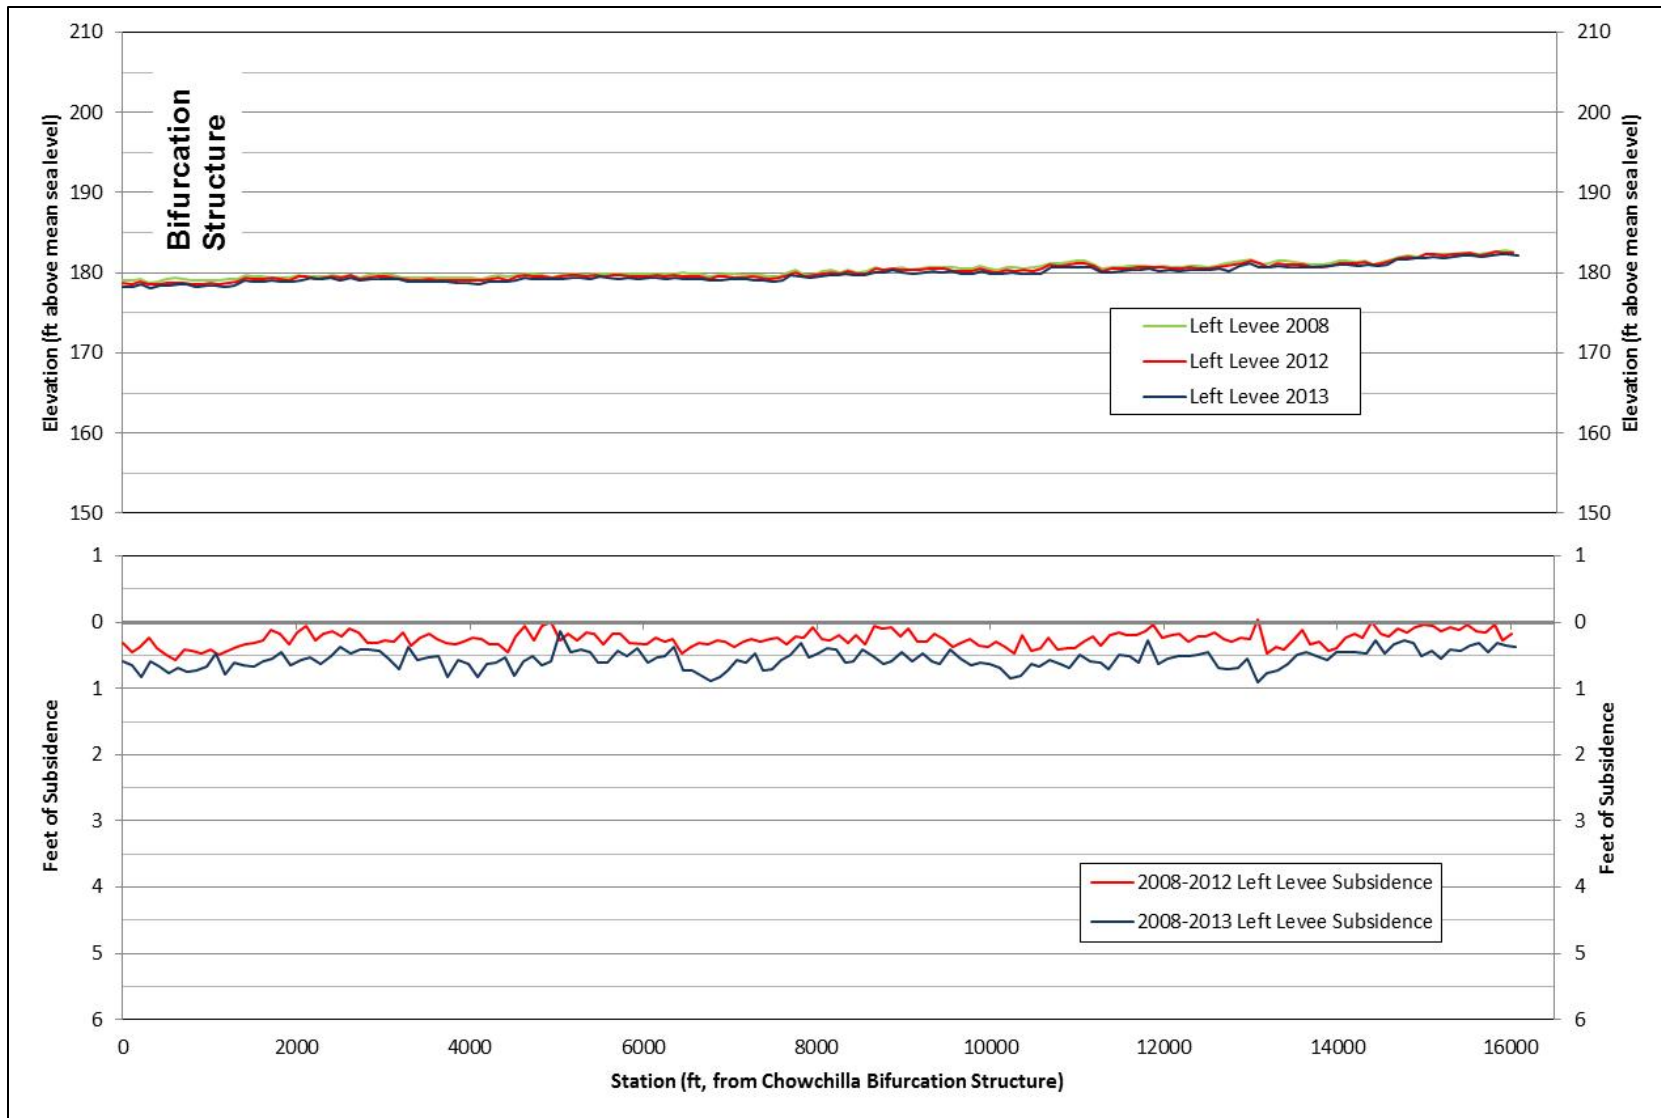
**Figure B.1 Ground subsidence along the left levee in Reach 2A upstream of the San Joaquin River Bifurcation Structure based on the 2012 and 2013 survey and 2008 LiDAR.**

To better define, as well as confirm the overall subsidence trends shown in Reclamation's initial exhibit maps, in 2012 and again in 2013, DWR-SCRO collected elevation data along about 65 miles of bypass and Reach 2A levee crowns. Profiles showing the levee crown elevations from the 2008 LiDAR mapping completed by DWR and the 2012 and 2013 surveys are shown in Appendix B of this report. In general, the profiles show that subsidence is occurring at various rates along the bypasses from almost 6 ft in the Upper Eastside Bypass from 2008 to 2013 to less than 0.5' in Reach 2A and the lower portion of the Middle Eastside Bypass and Mariposa Bypass. In addition, a comparison of the DWR-SCRO survey data in some areas show that the ground during the 2012 surveys appears higher (up to about 0.5'), and to a lesser extent the 2013 survey than the LiDAR data. Some of these differences may be a result of physical changes to the levees (e.g., placement of material on top of the levees after the LiDAR surveys), data collection methods (GPS when compared to LiDAR), or the accuracy of the LiDAR data itself; but the specific source of these anomalies were not investigated (DWR-SCRO, 2013).

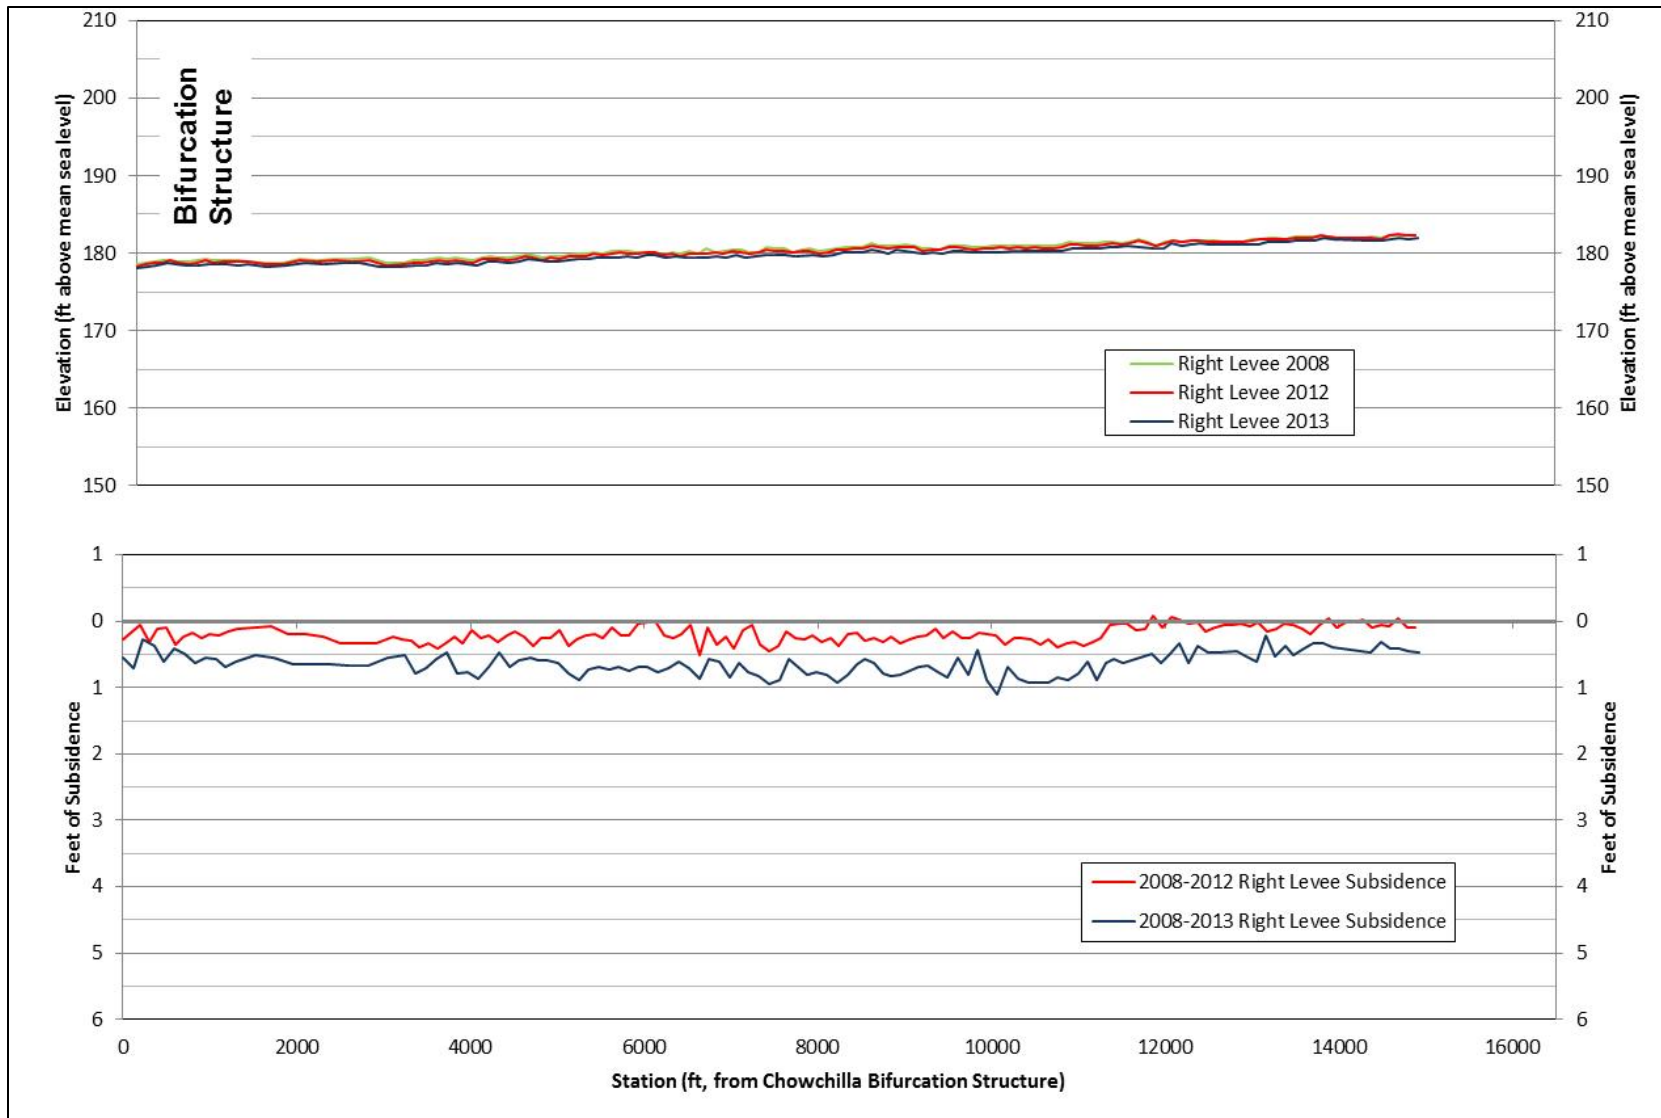
Figure B.2. Ground subsidence along the right levee in Reach 2A upstream of the San Joaquin River Bifurcation Structure based on the 2012 and 2013 survey and 2008 LiDAR.

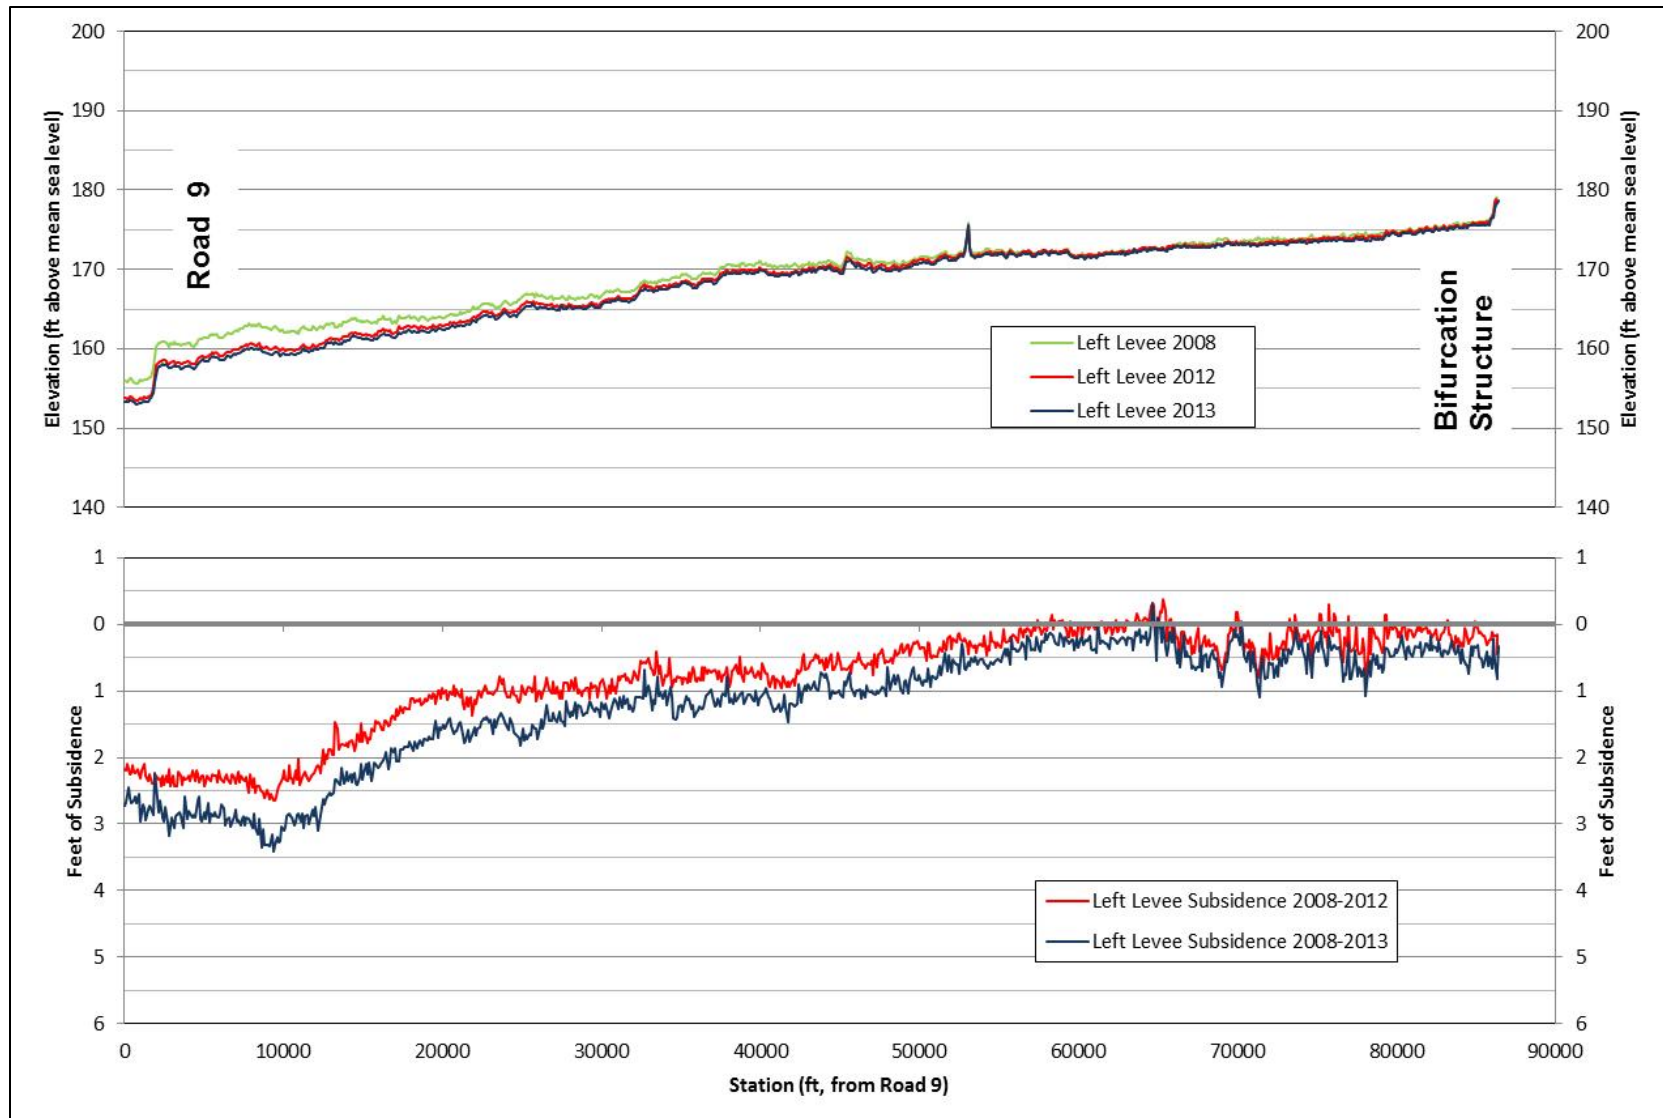
Figure B.3. Ground subsidence along the left levee in the Chowchilla Bypass from the San Joaquin River Bifurcation to Road 9 based on the 2012 and 2013 survey and 2008 LiDAR.

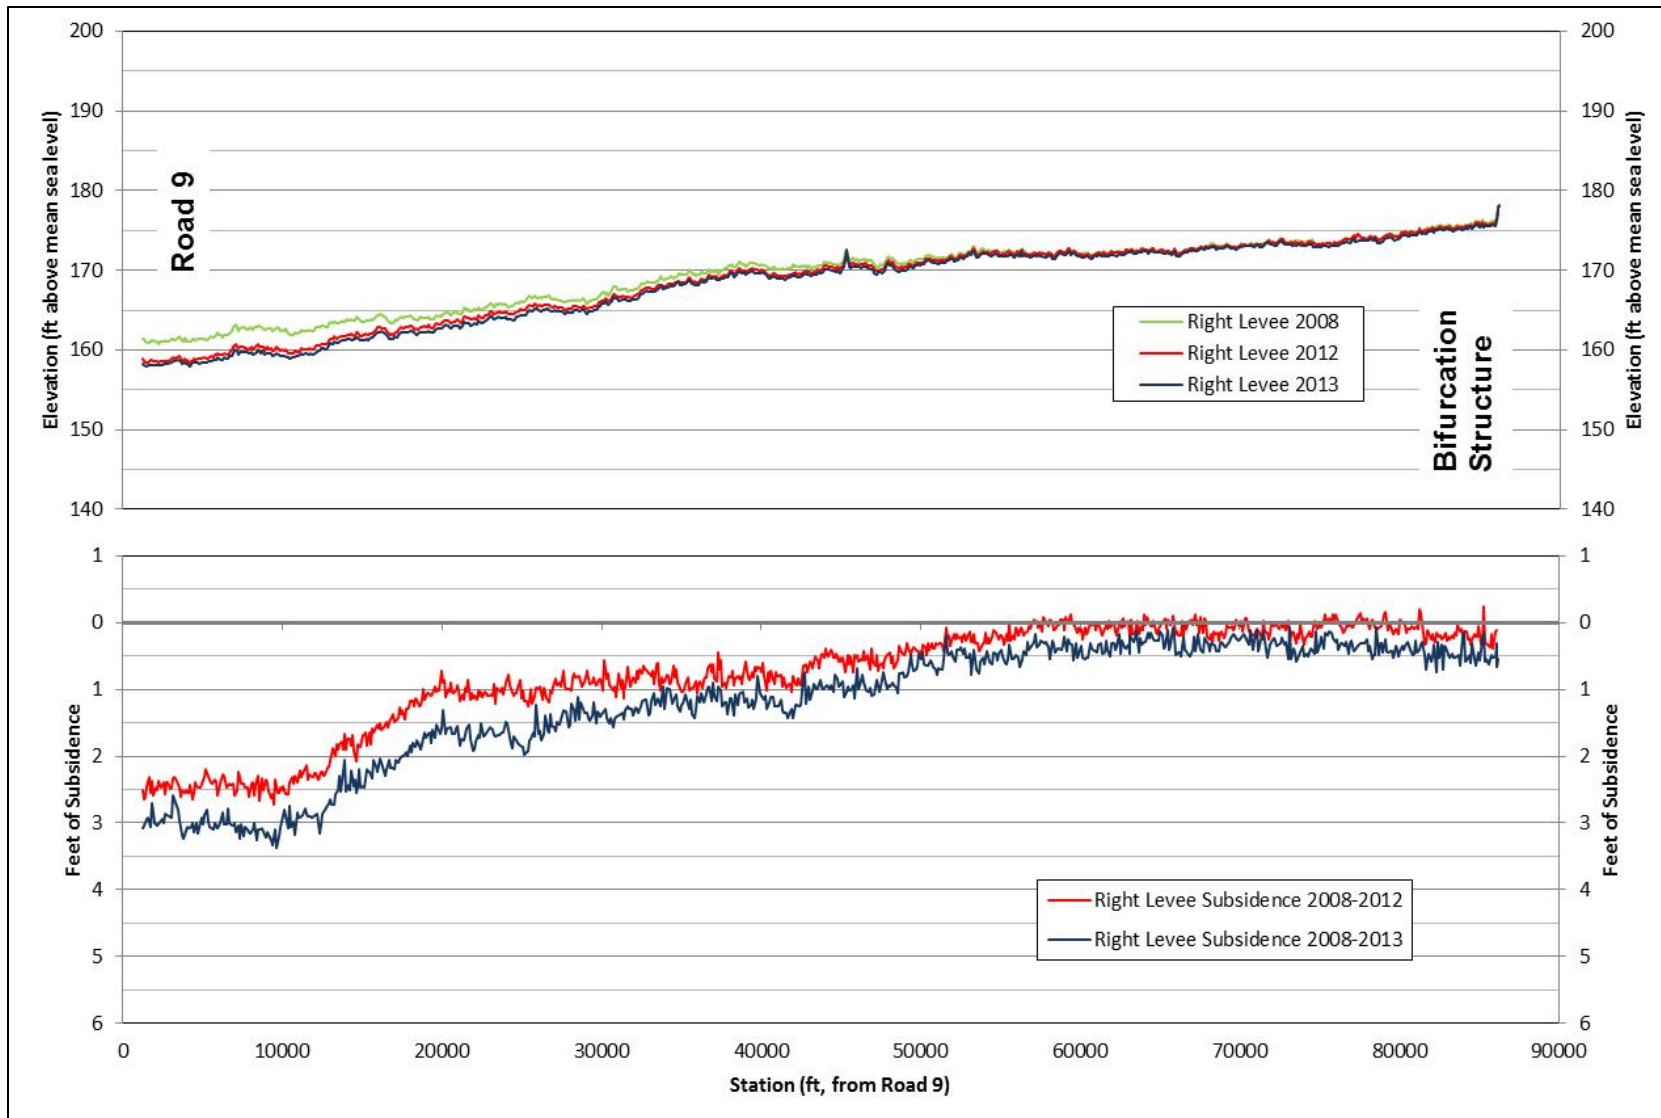
Figure B.4. Ground subsidence along the right levee in the Chowchilla Bypass from the San Joaquin River Bifurcation to Road 9 based on the 2012 and 2013 survey and 2008 LiDAR.

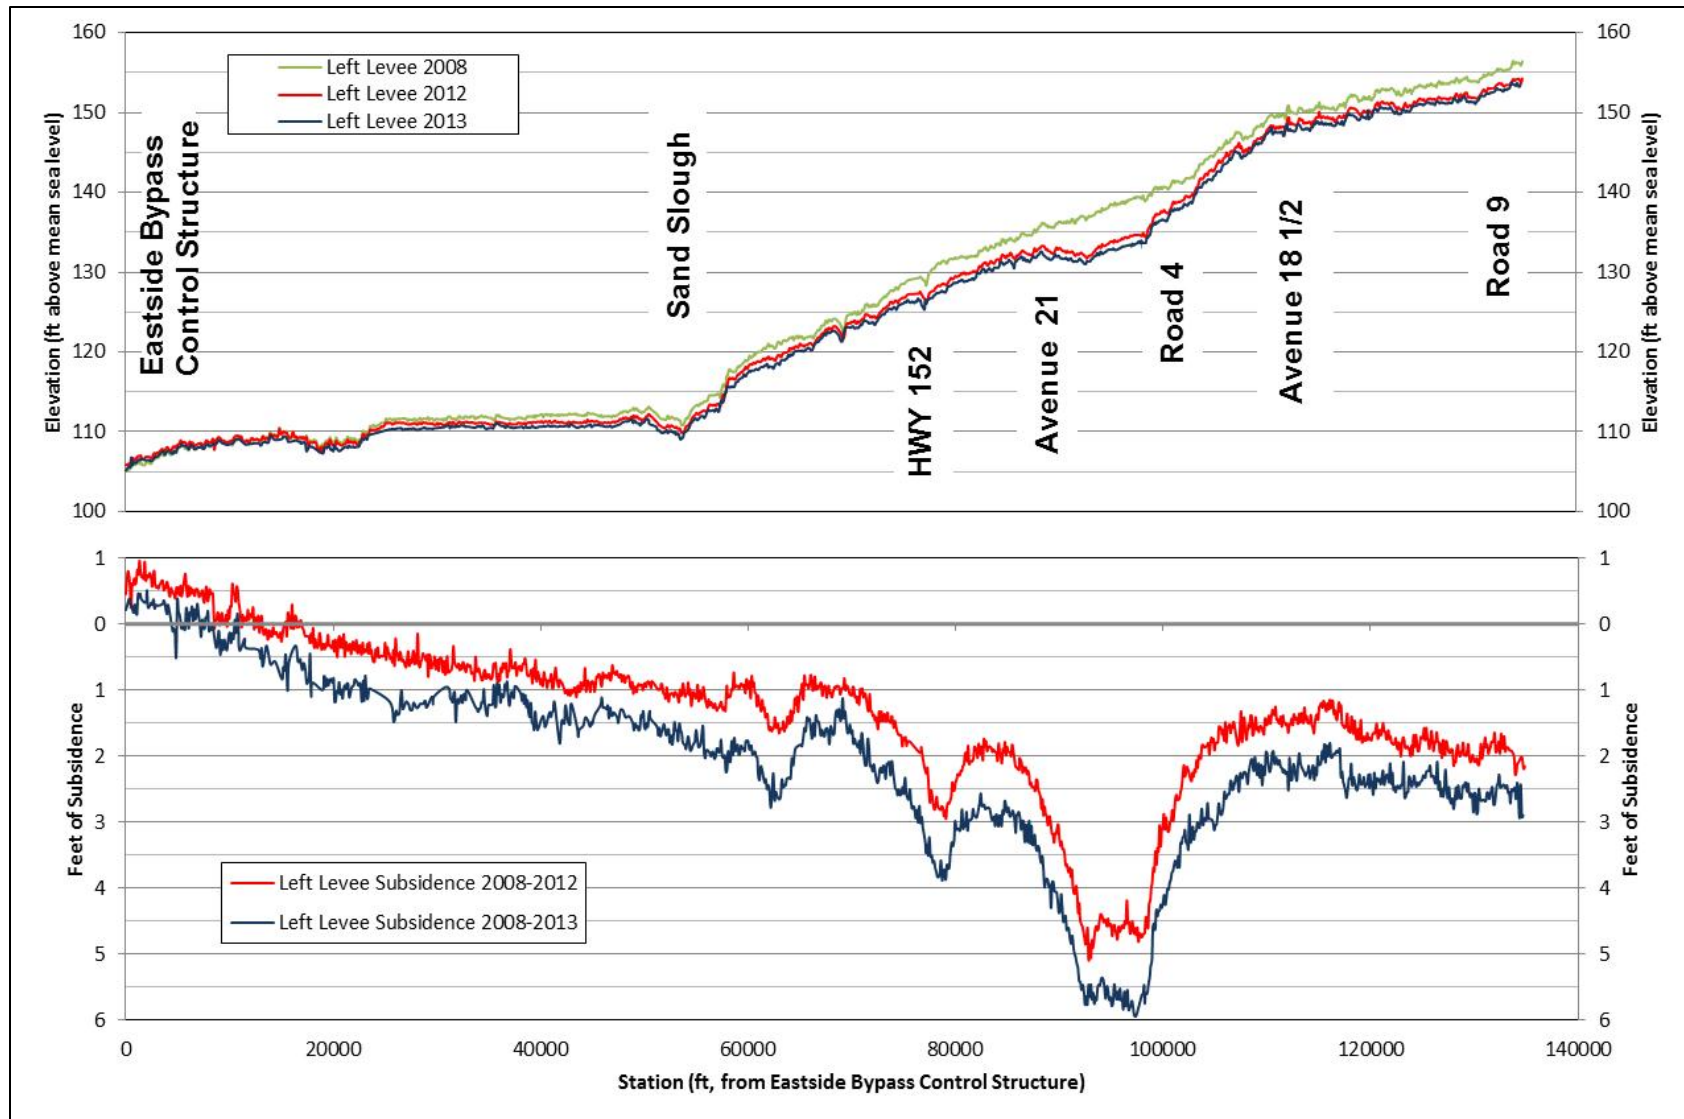
**Figure B.5. Ground subsidence along the left levee in the Upper and Middle Eastside Bypasses from Road 9 to the Eastside Bypass Control Structure based on the 2012 and 2013 survey and 2008 LiDAR.**

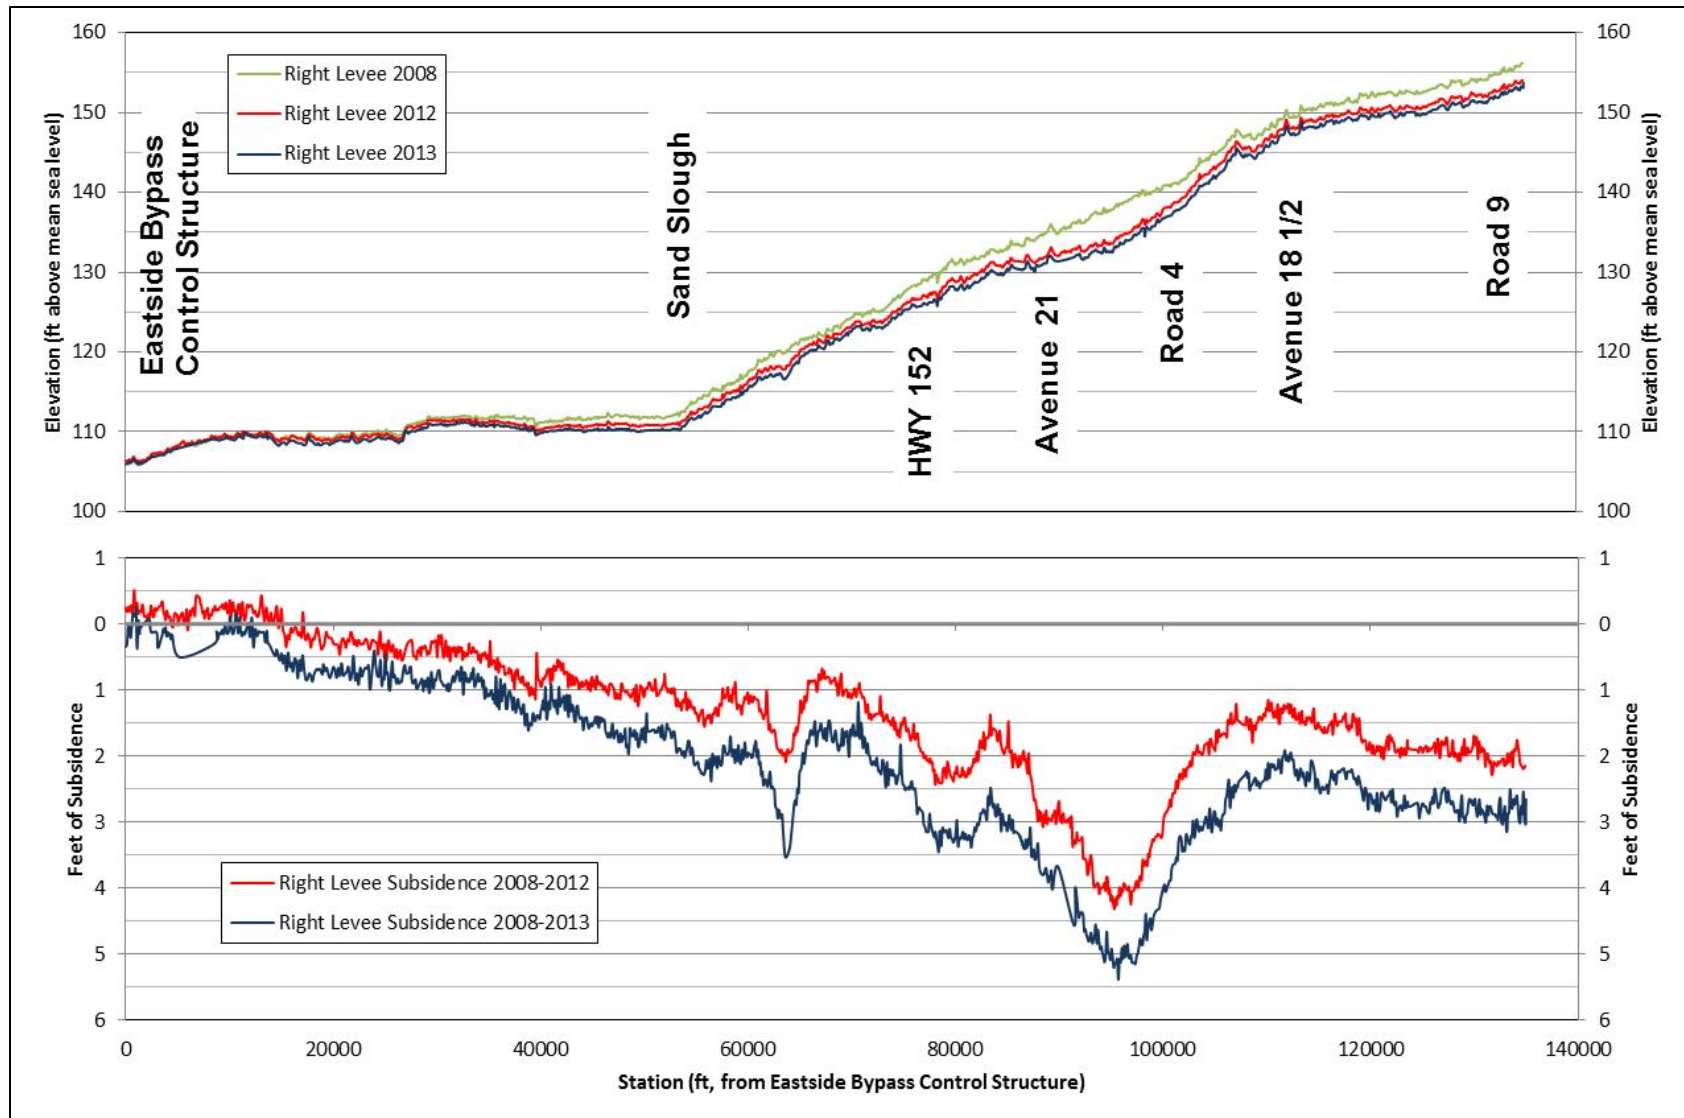
**Figure B.6. Ground subsidence along the right levee in the Upper and Middle Eastside Bypasses from Road 9 to the Eastside Bypass Control Structure based on the 2012 and 2013 survey and 2008 LiDAR.**

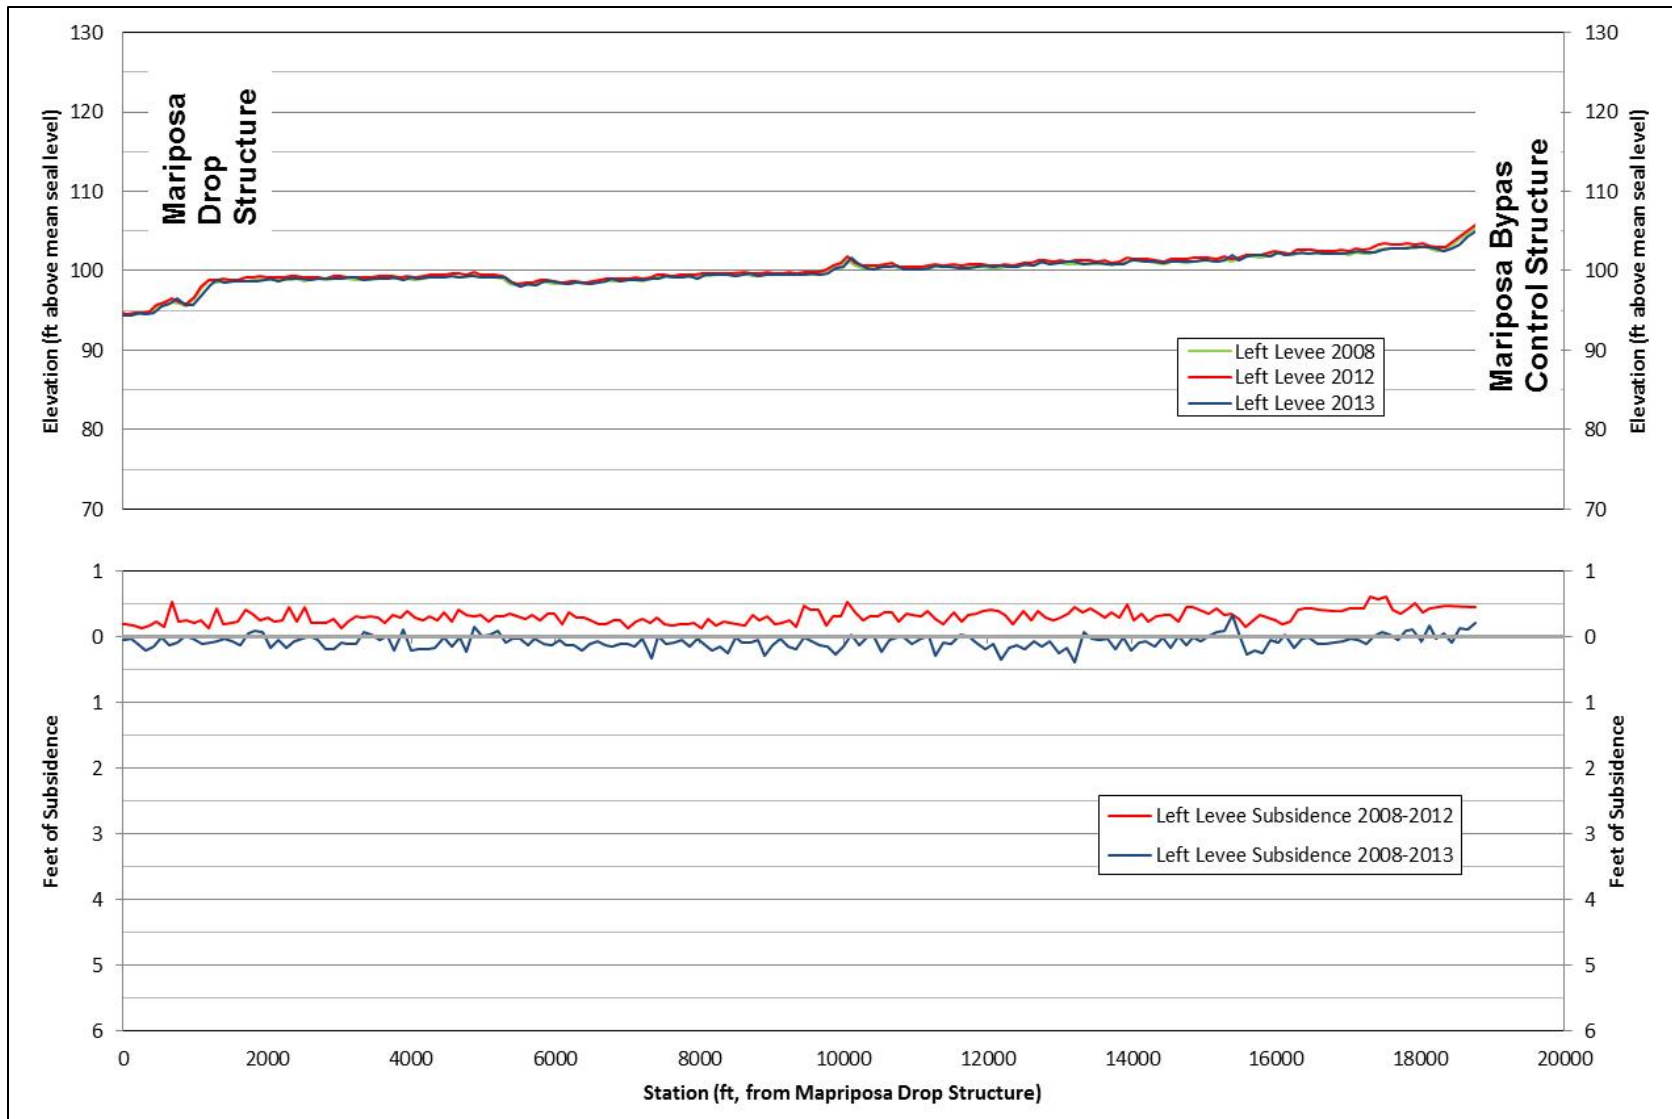
**Figure B.7. Ground subsidence along the left levee in the Mariposa Bypass based on the 2012 and 2013 survey and 2008 LiDAR.**

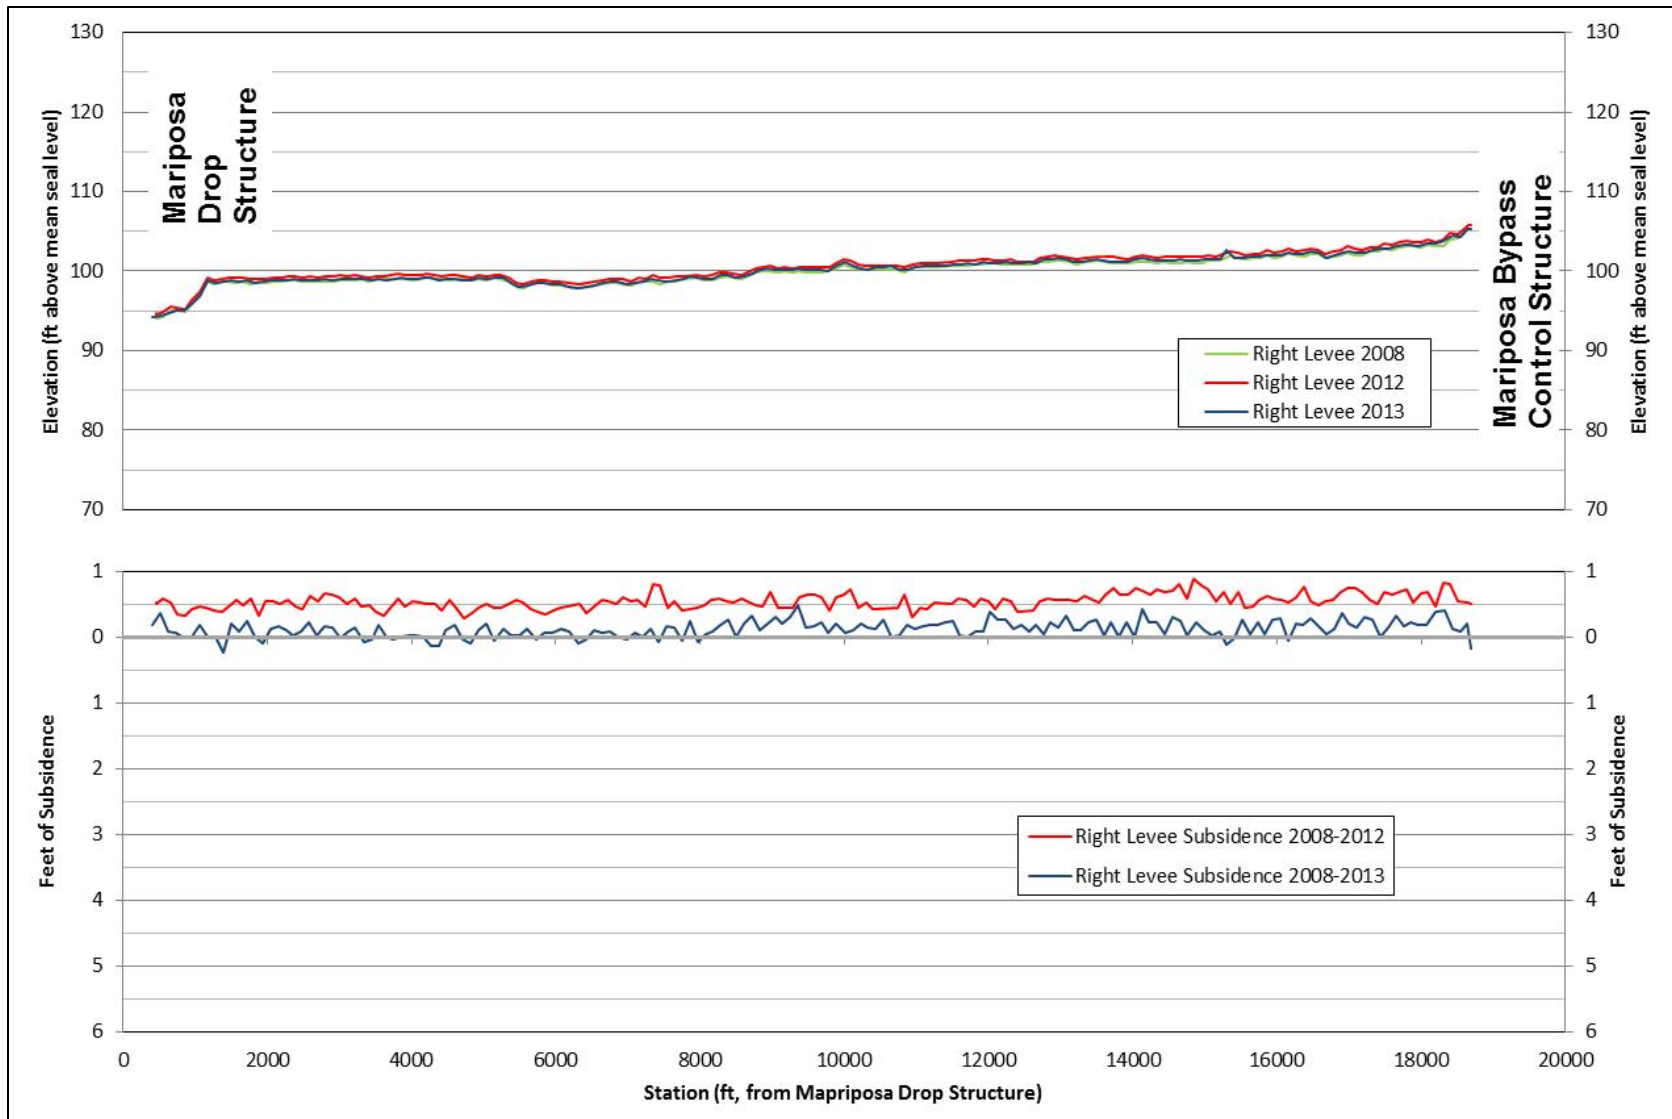
**Figure B.8. Ground subsidence along the right levee in the Mariposa Bypass based on the 2012 and 2013 survey and 2008 LiDAR.**
