Vegetation Response to Interim Flows in the San Joaquin River

Annual Report 2014

**U.S. Department of the Interior
Bureau of Reclamation
Technical Service Center
Denver, Colorado**

March 2015

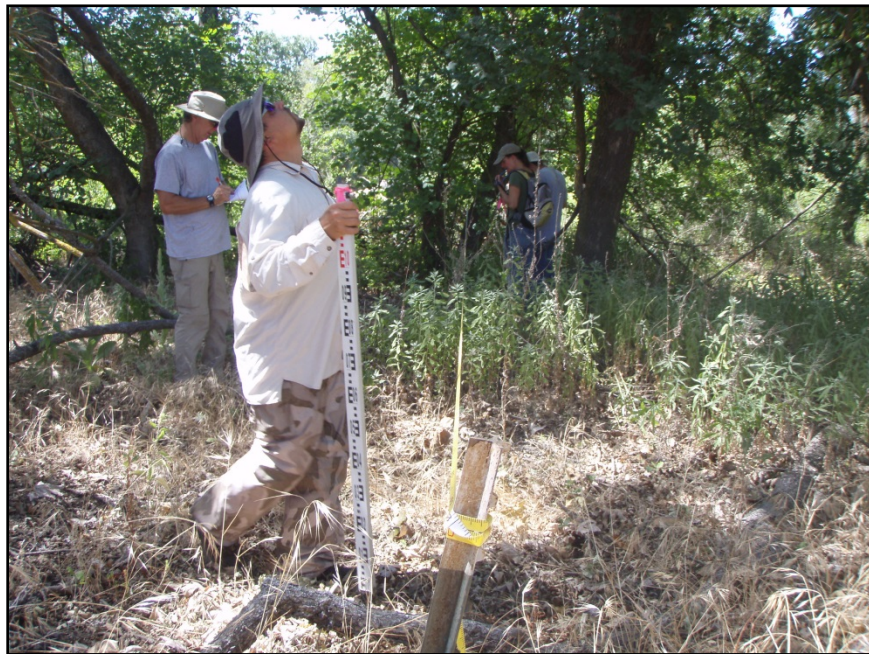
Figure 4—Measuring overstory cover along transect.

The line-intercept method was used for measuring woody overstory cover. Overstory cover was measured along the transect by noting the point along the tape where the canopy began and the point at which it ended for each woody species over 1 m tall (Figure 4). Because species overlapped in some cases, the sum of the cover for all species did not necessarily reflect the actual percentage of overstory cover along the tape. The percentage of the tape covered by overstory was also calculated. The height of the tallest vegetation within each continuous stretch of the same species was measured.

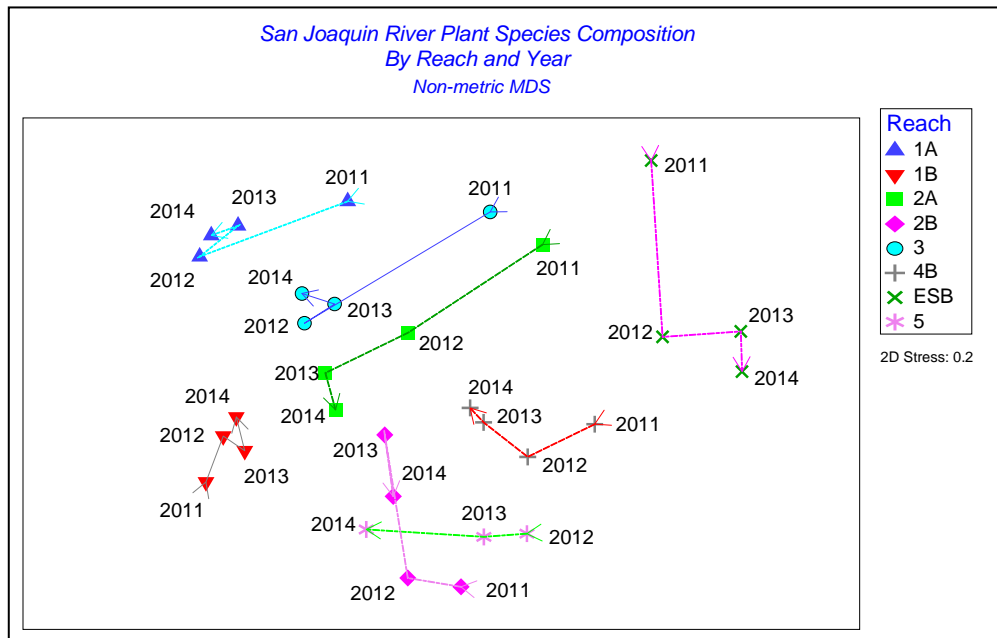
Figure 8.— MDS ordination of sample sites (i.e. reaches) by year using Bray-Curtis similarities of plant species based on fourth root transformation of total percent cover data along the San Joaquin River in years 2011 to 2014.

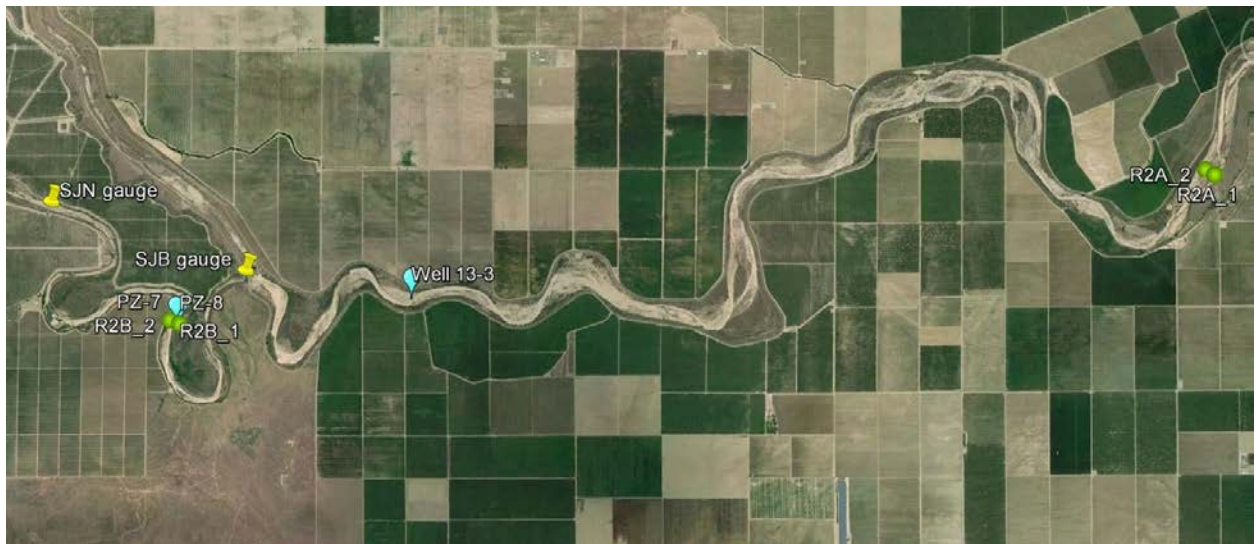
Figure 9.—Locations of wells PZ-7 (floodplain), PZ-8 (upper terrace) and 13-3 (floodplain); staff gauges SJN and SJB; and vegetation transects 1 and 2 within Reaches 2A and 2B. Google Earth imagery April 2014.

(Figure 9). When the river is dry, however, as it was from February to May and again in October in 2014, the water table fell to 5.3 ft (depth of sensor) or more from the surface, which is not conducive to establishment of young riparian vegetation. Riparian condition remained moderate with a ranking of 5.3 in 2014 (Table 6), with lowest scores in the variables coverage and spatial diversity (i.e. cover and diversity of native riparian species), structural diversity (i.e. different size- and age- classes of riparian vegetation), and biogeochemical processes (i.e. vegetation with woody debris, leaf litter, detritus in channel).

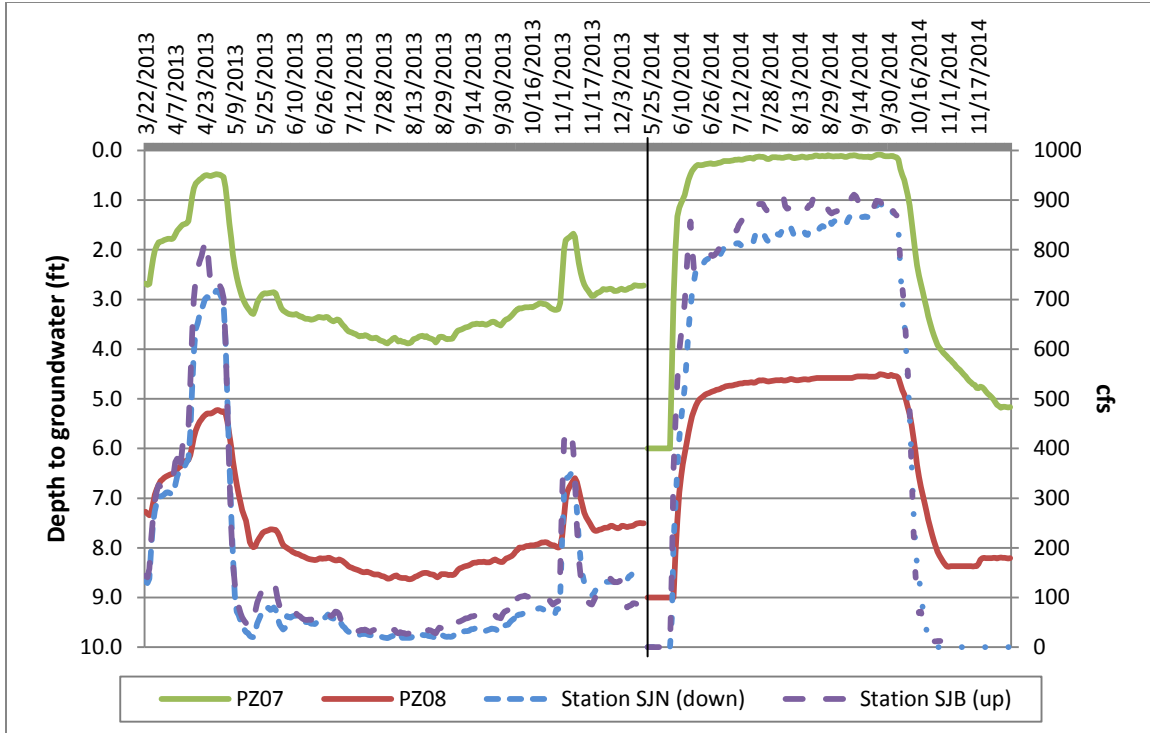
Figure 10. —Depth to groundwater at wells PZ-7 and -8 and San Joaquin River discharge at gauges SJN and SJB from March to December 2013 and May to November 2014 in Reach 2B.

Groundwater wells from 2 locations were examined in relation to vegetation transects. Piezometers were installed in association with transects in Reach 2B in February 2013 (PZ-7 and PZ-8 in Figure 9). The hydrograph in Figure 10 shows groundwater depths at these wells from March through December 2013 and May to November 2014 and uses flow data gathered at Station SJB (approximately 1.5 mi upstream) and Station SJN (approximately 2 mi downstream). A correlation between flows and the depth of the water table is apparent, which indicates connectivity of the floodplain and river. In well PZ7, which is located in the floodplain, the water table remained less than 4 ft from the surface when the channel held water and <1 ft when flows reached around 700 cfs or higher. From March to December 2013, ground water within the floodplain (PZ7) remained at a shallow enough depth (<4 ft) necessary to sustain woody riparian plant species (Figure 10). In 2014, the river was completely dry in Reach 2b from mid-February to late May and groundwater levels reflected this, falling below piezometer sensor levels in the wells (sensors were placed at approximately 5.3 and 8.5 ft below surface level in wells PZ07 and PZ08, respectively). When irrigation flows were released in late May, discharge increased dramatically to between 750 to 900 cfs and groundwater remained at less than 1 ft until October of 2014. At that time, discharge returned to 0 cfs

and groundwater again fell to near sensor levels. Vegetation was observed to be stressed within transects at Reach 2b, most likely due to the very dry conditions prior to monitoring in May. Any effects from the shallower water table that occurred after the 2014 monitoring period may be observed with monitoring in 2015; however if drought conditions continue, the temporary increase in available water may not have been sufficient to benefit riparian species at this site.

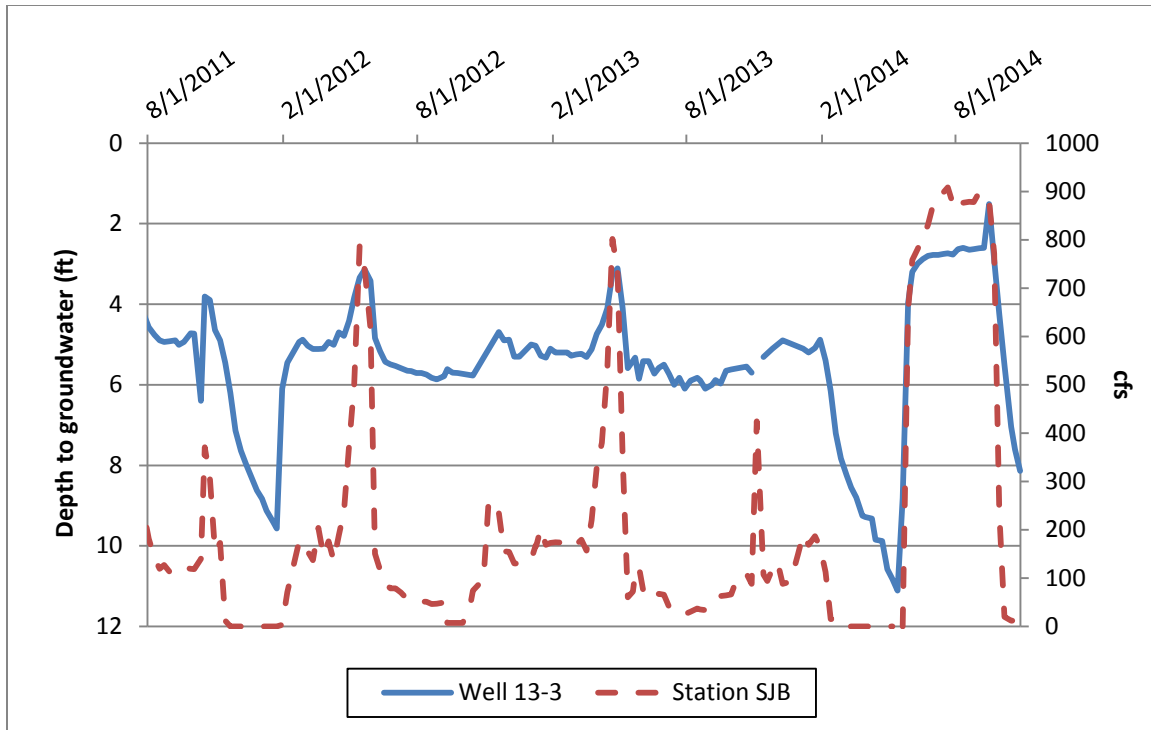
Figure 11. —Depth to groundwater at Well 13-3 and San Joaquin River discharge at gauge SJB from July 2011 through October 2014 in the lower Reach 2A.

Data from 2011 to 2014 associated with an existing Reclamation groundwater well (Transect 13-3) was also examined. This well is located at the downstream end of Reach 2A, approximately 6.5 miles downstream of Transects 2A, and approximately 3.2 miles upstream of Transects 2B (Figure 9). Although Well 13-3 is not closely associated with vegetation transects, it provides supplemental information about groundwater levels in floodplain areas of Reach 2. There is also a correlation between flows and the depth of groundwater at this site, however the water table seldom reaches less than 4 ft from the ground surface and is more commonly 5 to 6 ft deep (Figure 11), which is generally not shallow enough to support riparian plant seedlings. Recruitment and establishment of woody riparian vegetation depends on plant available water for prolonged periods so that young plants can develop a deeper root system, at which point a deeper water table should suffice. Because this data tracks time over a longer and continuous period in comparison to PZ-7 data, the extremely low river and associated groundwater levels are more apparent beginning in February 2014.

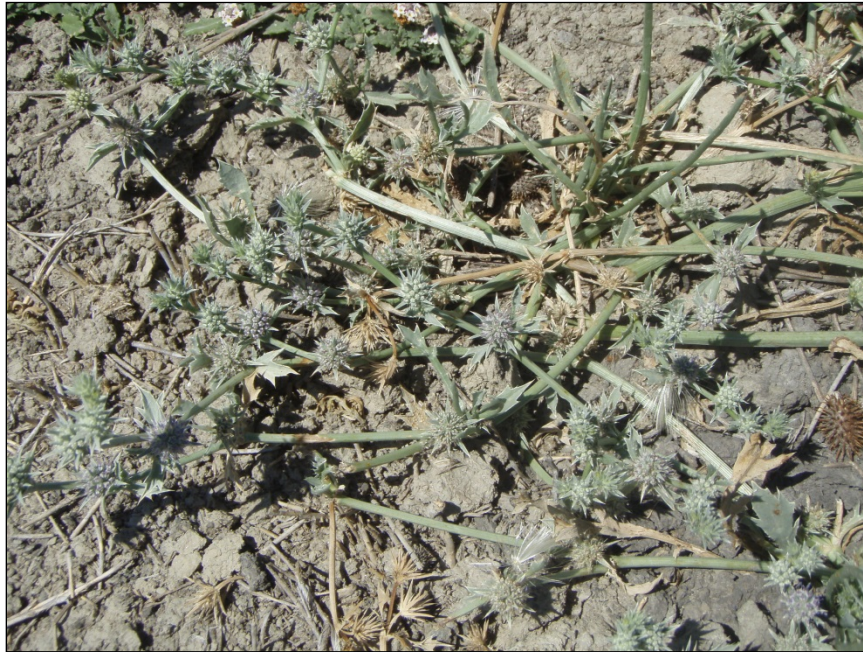
Figure 12.—Delta button celery (*Eryngium racemosum*), a State-listed endangered plant, was detected in transects within the Merced NWR in the East Side Bypass Reach, June 2012.

year-round water supply could make it difficult to identify changes in vegetation from Interim Flows. There has never been water in the channel adjacent to the other transects (1 and 2) during monitoring. Delta button celery, which is a State-listed endangered plant, was detected in the Merced NWR within this reach (Figure 12). This plant was documented in transect monitoring in 2011 (Table E-2, Appendix E). Although it was not intercepted in transect cover measurements in 2012, it was observed in the area surrounding transect 3. It was not observed at all during 2013 and 2014 sampling when the area was heavily grazed by cattle.
