# **Effects Of A Riparian Forest On Water Temperatures In The Restoration Area**

**2014 Mid-Year Technical Report**

**SAN JOAQUIN RIVER  
RESTORATION PROGRAM**

July 2014

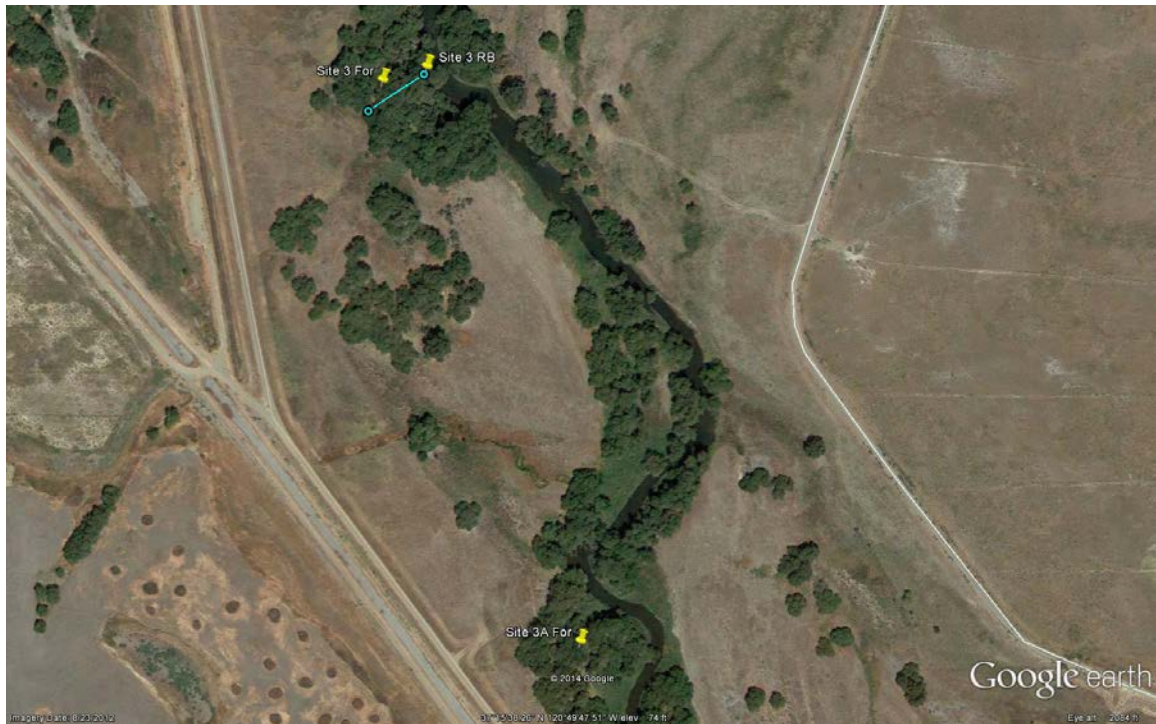
**Figure 3. Google Earth Image of Sites 3 and 3A in the San Luis National Wildlife Refuge Near River Mile 138**

Note: The blue line shows the botanical transect, which was about 40 meters in length. The yellow pins show the locations of the weather stations near the riverbank (RB) and middle of the forest (For). The non-forested site, which is not shown, is about 1 mile downstream.

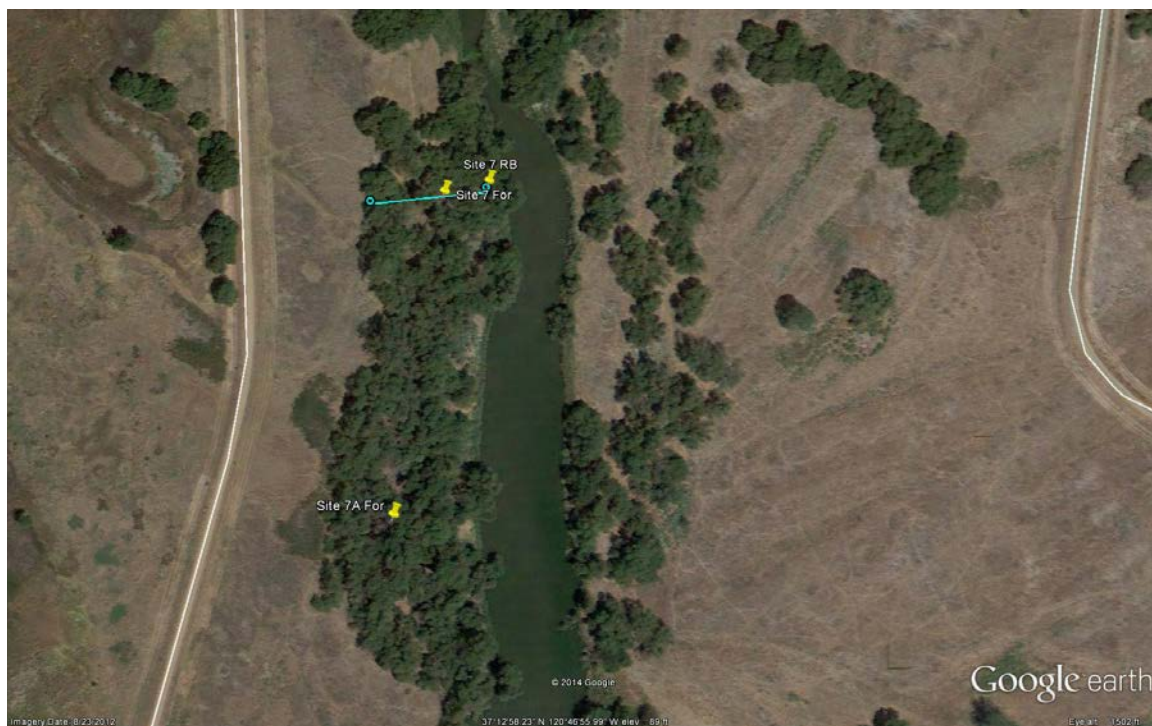
**Figure 4. Google Earth Image of Site 7 in the San Luis National Wildlife Refuge Near River Mile 144**

Note: The blue line shows the botanical transect, which was about 50 meters in length. The yellow pins show the locations of the weather stations near the riverbank (RB) and middle of the forest (For). The non-forested site, which is not shown, is about 2 miles downstream.

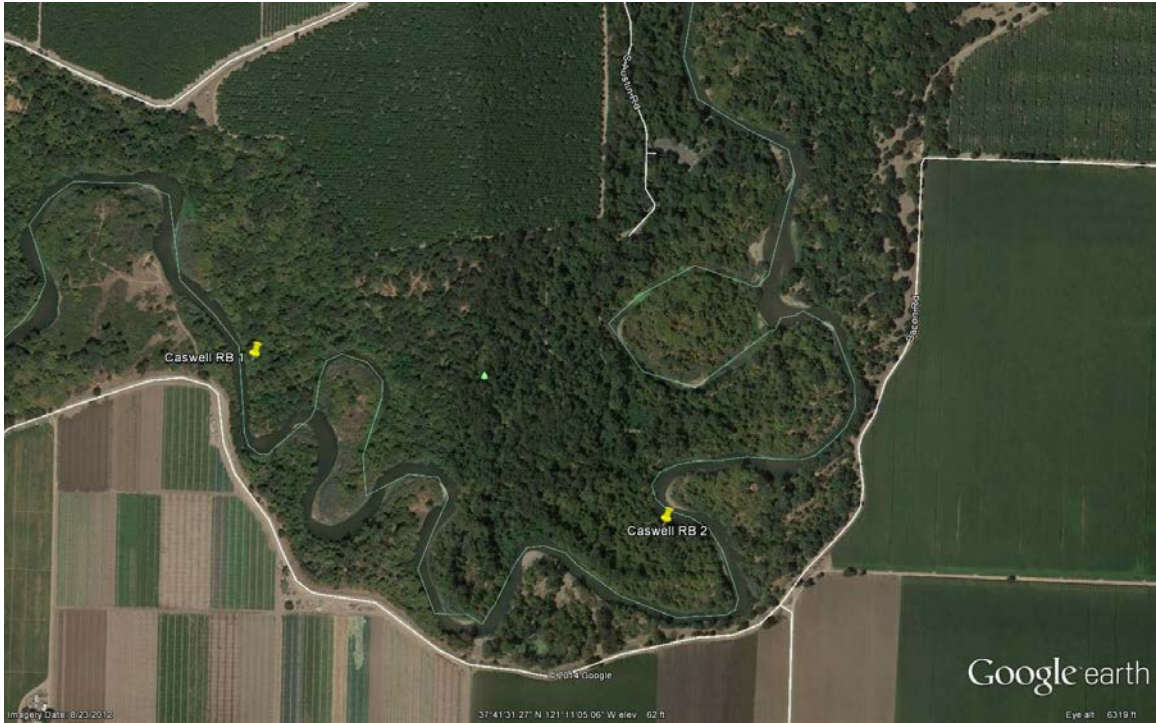
**Figure 5. Google Earth Image of Caswell Memorial State Park Sites 1 and 2 on the Stanislaus River Near River Mile 7**

Note: The yellow pins show the locations of the weather stations near the riverbank (RB).

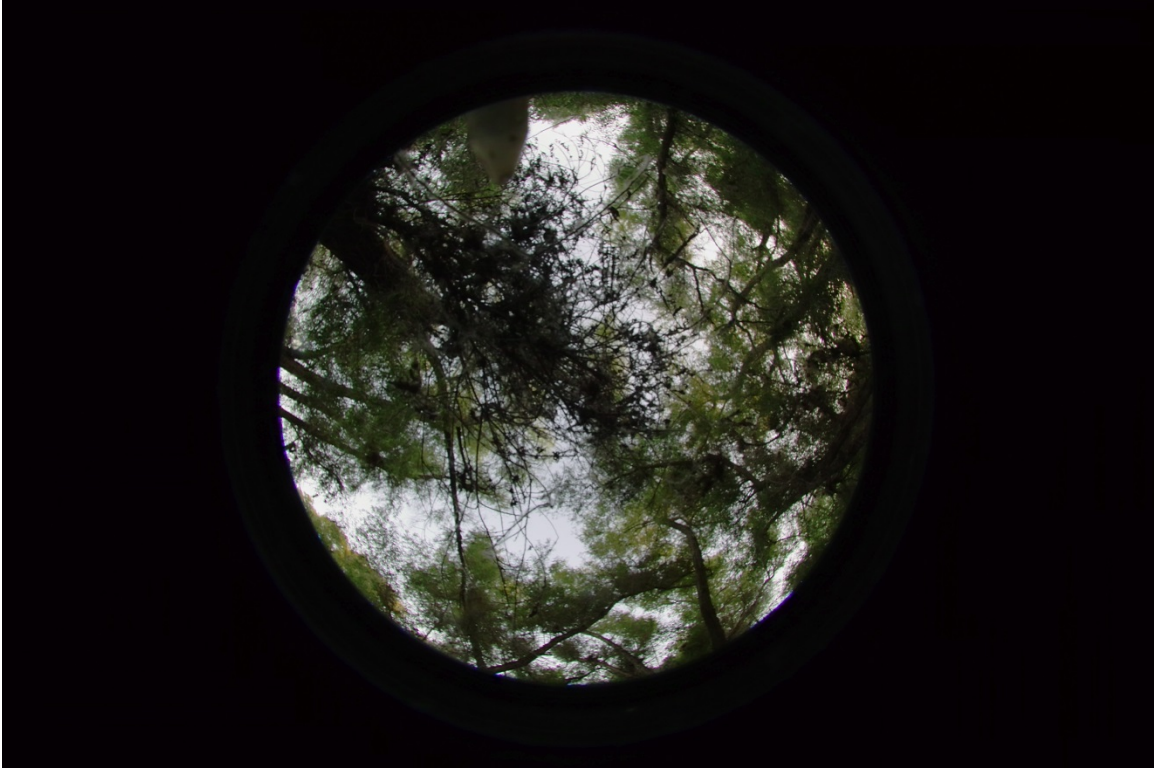
**Figure 7. Hemispherical photo of the forested Site 3 in the San Luis National Refuge**

Location	Photo	% Cover
Site 1	725	74.4
Site 2	730	66.7
Site 3	738	86.9
Site 4	746	74.3
Site 5	758	81.5
Site 6	795	60.1
Site 7	773	58.3
Site 8	785	63.4

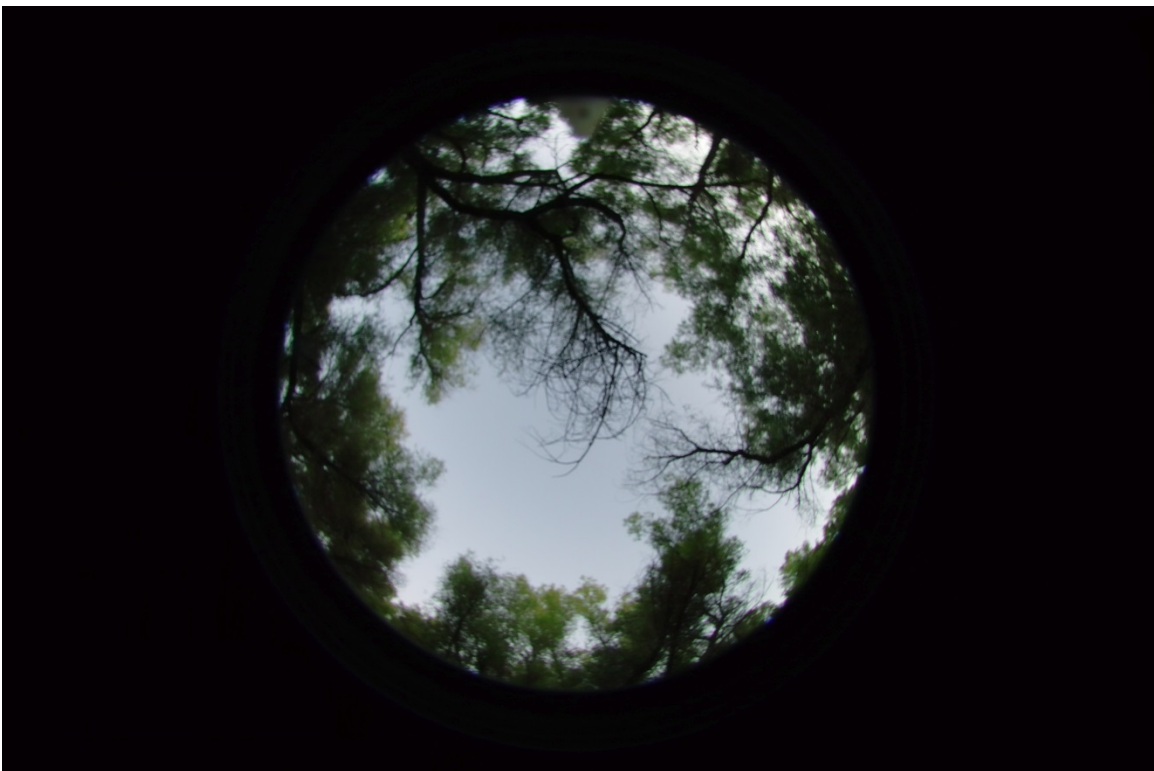
**Figure 8. Hemispherical photo of the forested Site 7 in the San Luis National Refuge**

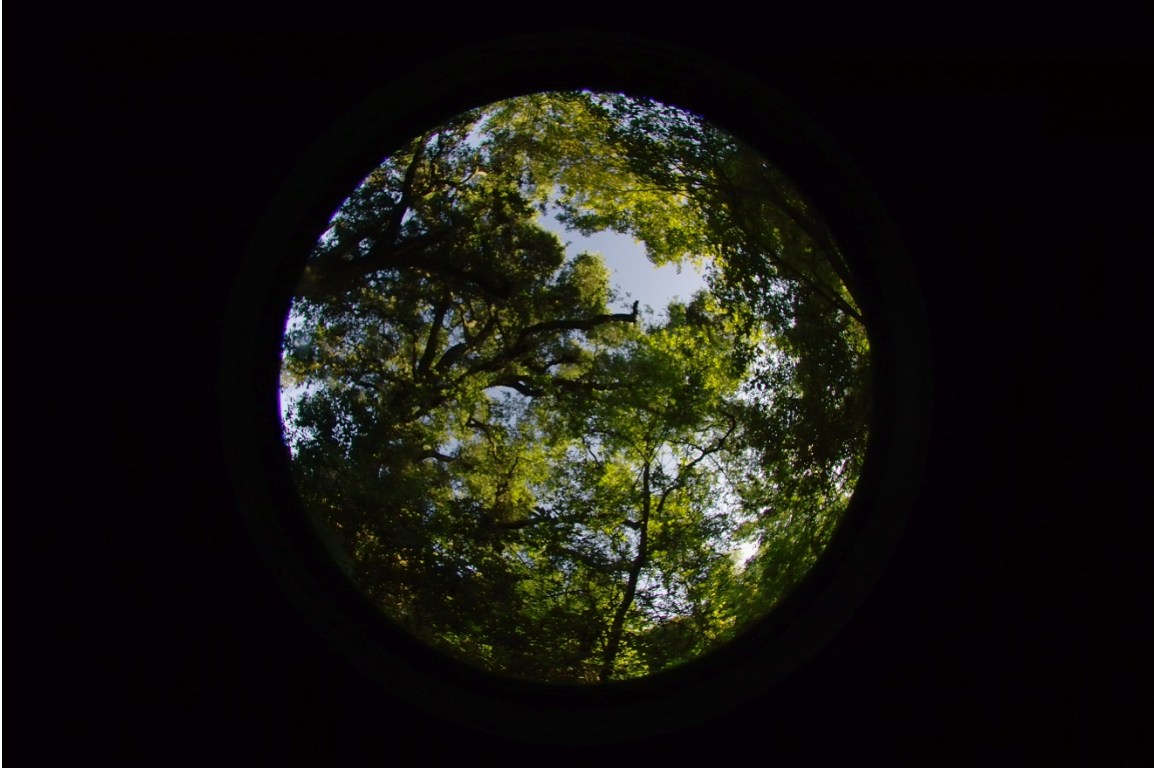
**Figure 9. Hemispherical Photo of Caswell Site 1 on the Stanislaus River**

The riparian tree species in the San Luis National Refuge study sites 1-8 were predominately Goodding's Willow (*Salix gooddingii*). The dominant tree and shrub species at Site 9 in Reach 1 include arroyo willow (*S. lasiolepis*), white alder (*Alnus rhombifolia*), buttonbush (*Cephalanthus occidentalis*), valley oak (*Quercus lobata*), and Oregon ash (*Fraxinus latifolia*). At Site 10 in Reach 1, the species are buttonbush, valley oak, Oregon ash, and sycamore (*Platanus racemosa*). The percentage of tree canopy cover at forested sites 1-8 ranged from 58 percent at Site 7 to 87 percent at Site 3 based on the hemispherical photos (Table 1). Botanical surveys had not been conducted at the Stanislaus River sites when this report was written. Hemispherical photos, which shows a 360-degree image from the middle of the botanical transects, are presented for Site 3 (Figure 7), Site 7 (Figure 8), Caswell Site 1 (Figure 9), Caswell Site 2 (Figure 10), and ACOE Park Site 1 (Figure 11). The hemispherical photos show that the forest canopies are much denser at the Caswell and ACOE Park sites than at Sites 3 and 7 in the San Luis National Refuge.

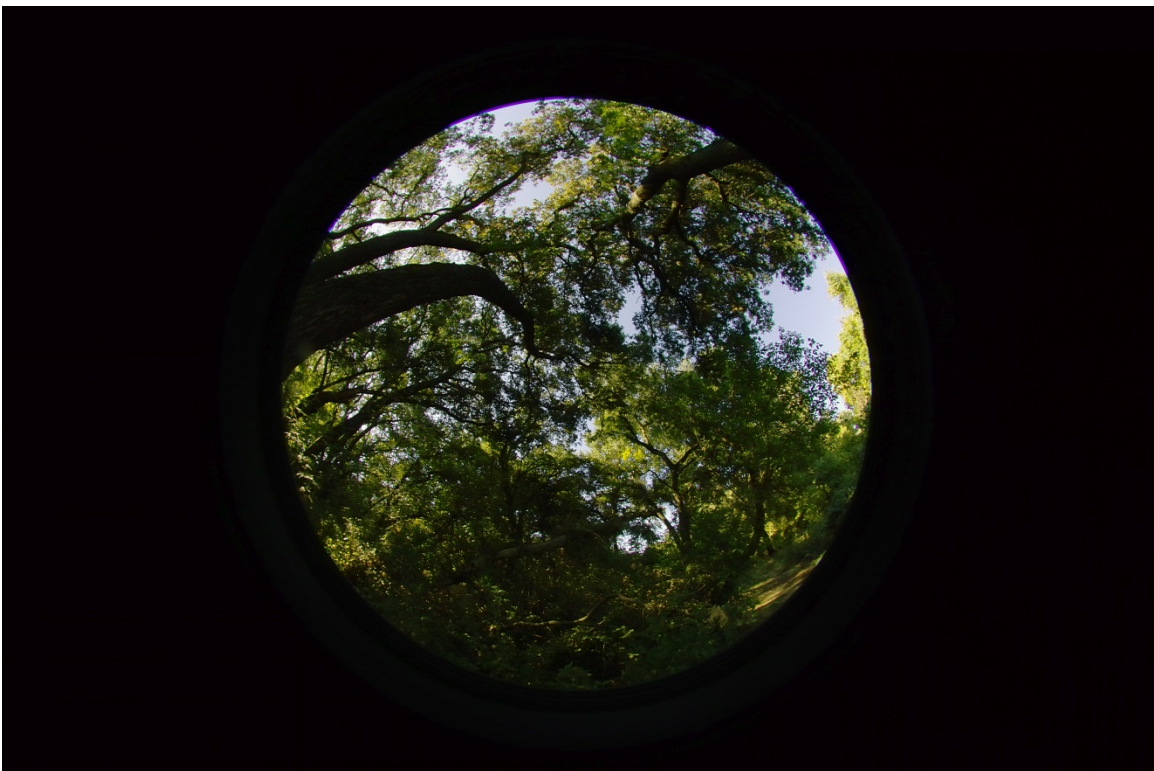
**Figure 10. Hemispherical Photo of Caswell Site 2 on the Stanislaus River**

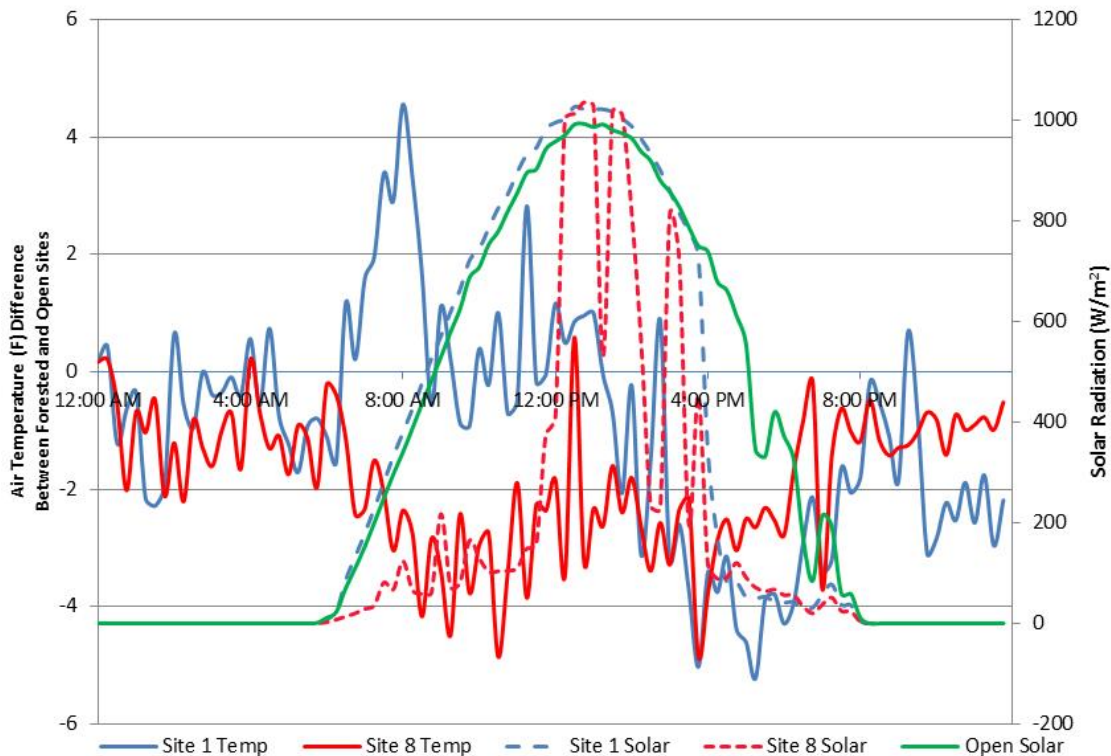
**Figure 12. Difference in Air Temperatures (Temp) Between the Forested and Non-forested Areas and the Observed Solar Radiation ( $W/m^2$ ) at the Forested and Non-forested (Open) Areas at Sites 1 and 8 in the San Luis National Refuge on May 23, 2014**

Note: Negative values indicate that the forested areas were cooler than the open areas.

of cooling was highly variable during the day (Figure 12). The high variability was presumably a result of the sensors alternately receiving warm air from open areas and cool air from the forest. To resolve this problem, some weather stations were relocated to the middle of the largest forests in the San Luis National Refuge and new sites were selected within large forests on the Stanislaus River as described in the Methods.

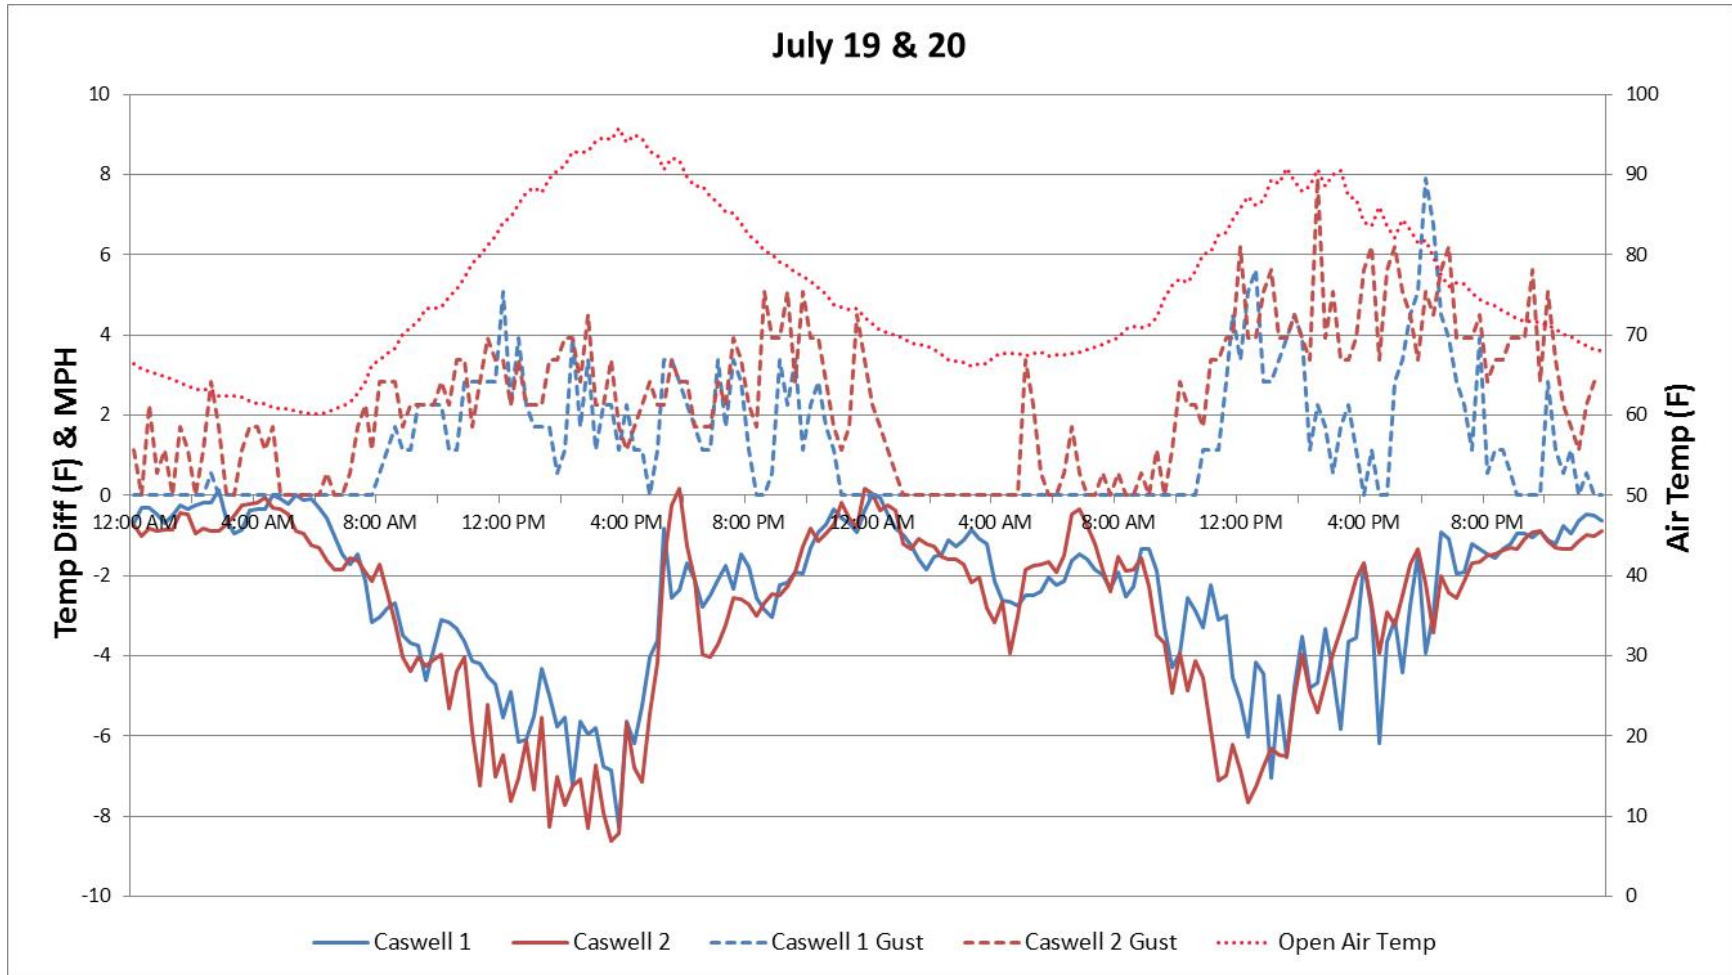
**Figure 13. Air Temperature at the Non-forested Ripon Open Site 1**

Note: Air temperature at the non-forested Ripon Open Site 1, wind gust speeds (mph) at forested sites Caswell 1 and Caswell 2, and the difference in air temperatures between forested site Caswell 1 and the non-forested Ripon Open Site 1 and forested site Caswell 2 and the non-forested Ripon Open Site 2 in 15-minute intervals on July 19 and July 20, 2014.

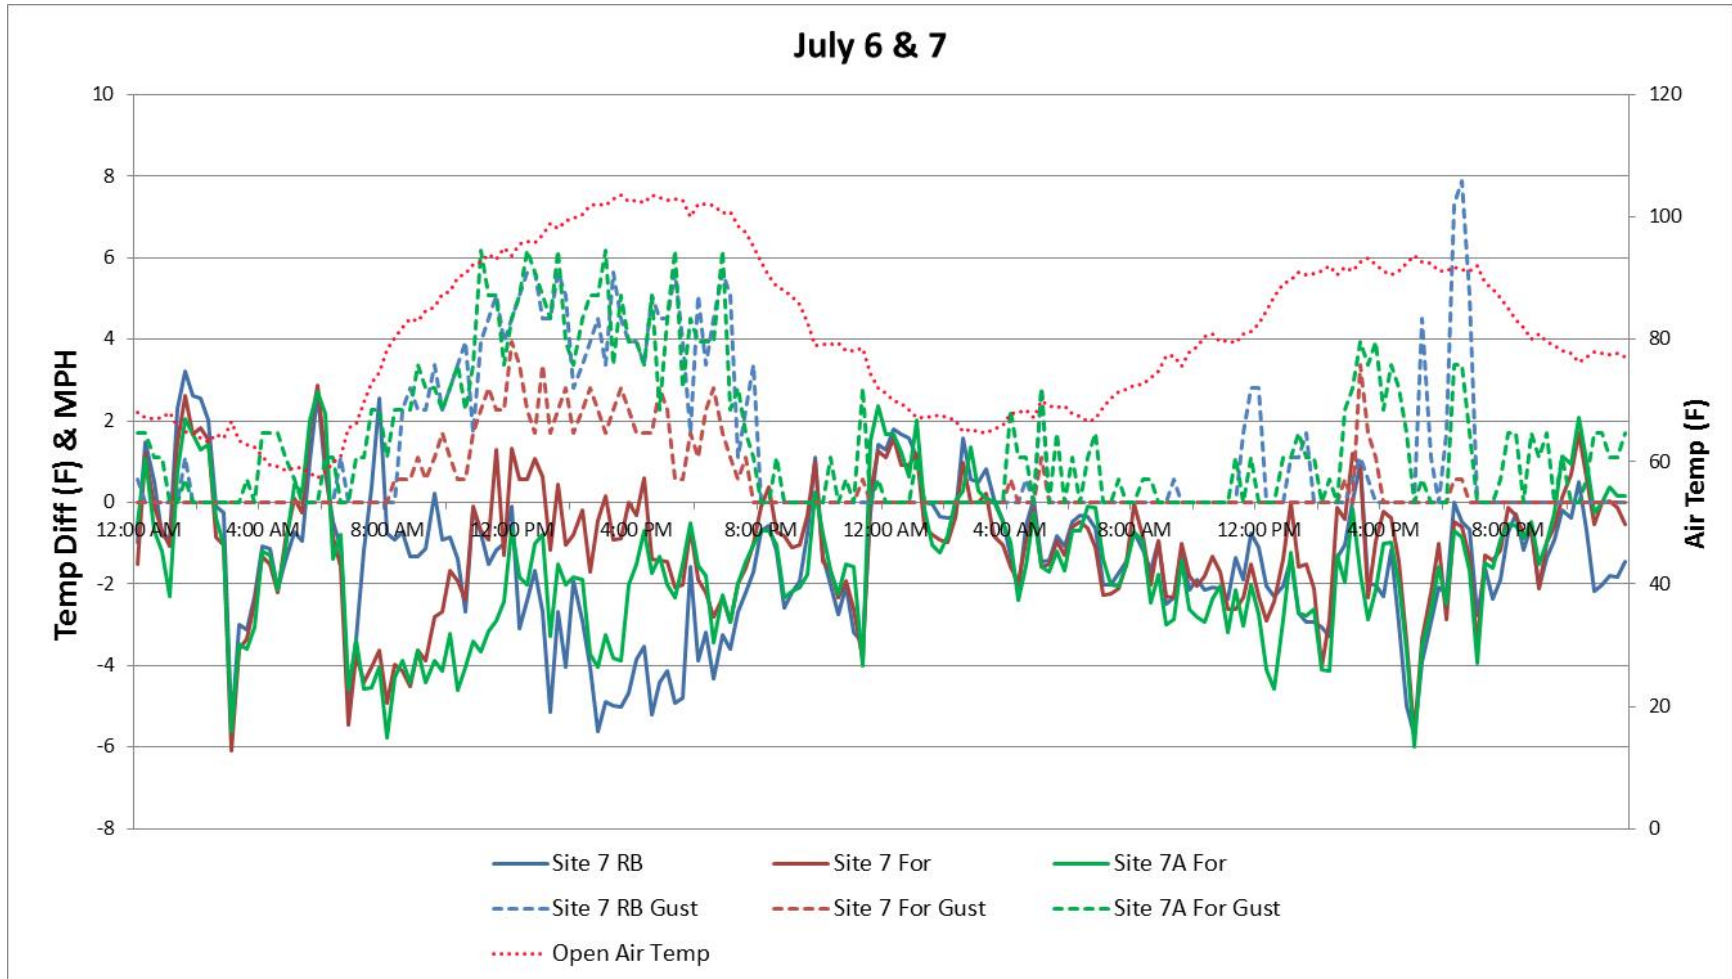
**Figure 15. Air Temperature at the Non-forested Open Site**

Note: Air temperature at the non-forested open site, wind gust speeds (mph) at the riverbank (RB) and mid-forest (For) weather stations, and the difference in air temperatures between forested sites and the non-forested open site in 15-minute intervals at Site 7 in the San Luis National Wildlife Refuge on July 6 and July 7, 2014.
