## Central Valley Steelhead Monitoring Plan for the San Joaquin River Restoration Area

2014 Monitoring Results for National Marine Fisheries Service  
Permit 16608

U.S. Department of the Interior  
Bureau of Reclamation  
Mid-Pacific Region and  
Denver Technical Service Center

May 2014

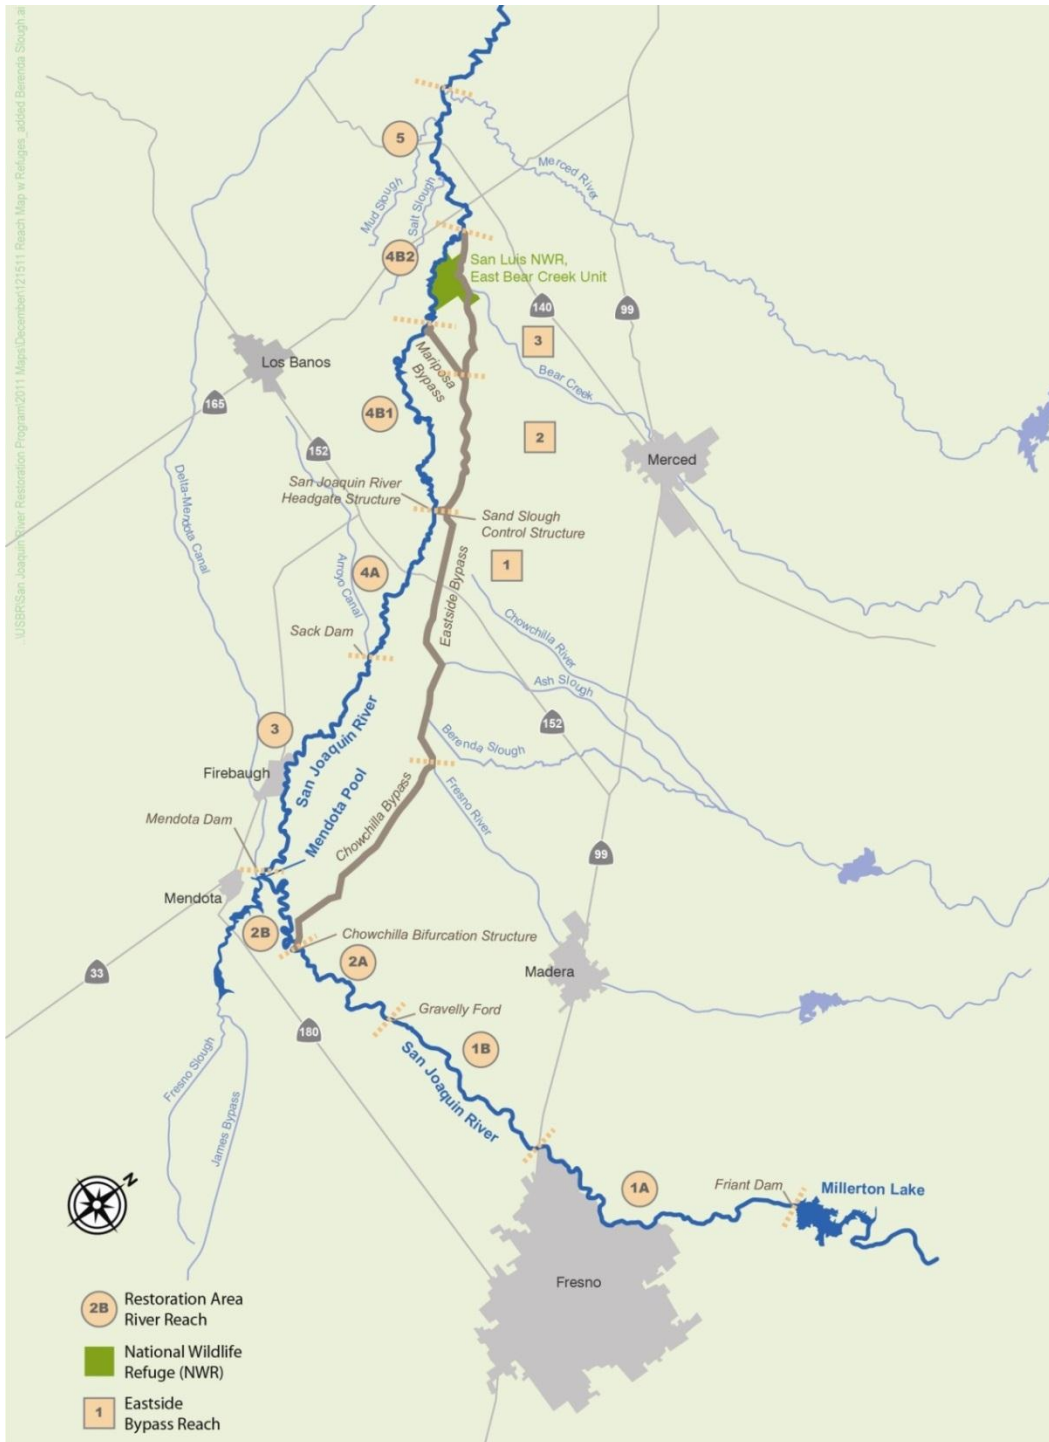
**Figure 1.**—Reaches within the San Joaquin River Restoration Area, San Joaquin Watershed, Central Valley, California.

The Restoration Area for the SJRRP includes the SJR between Friant Dam and its confluence with the Merced River (Figure 1). Steelhead monitoring activities were proposed as the area of the SJR below Sack Dam, or to the uppermost contiguous wetted section of the SJR, to the confluence with the Merced River, including the adjoining sloughs. During the 2014 survey period, the confluence of the Eastside Bypass with the SJR was considered the furthest upstream extent for CV steelhead migration because of low water conditions and impassable upstream barriers. A total of approximately 18 river miles along the San Joaquin River were monitored as well as slough tributaries (totaling approximately 19.4 river miles) for a total of approximately 37.4 river miles monitored (Figure 2).

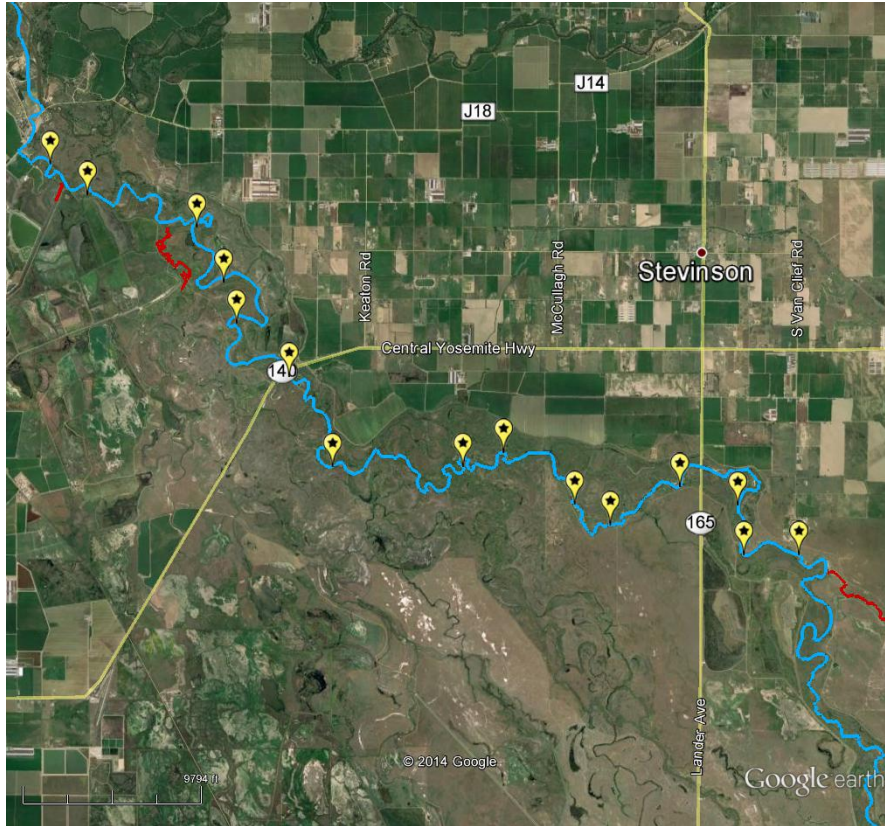
**Figure 3.**—General starting locations for boat electroshocking in Reach 5 of the San Joaquin River Restoration Area. The blue line indicates the mainstem San Joaquin River while the red lines indicate connecting waterways (*i.e.*, bypasses, sloughs, and wasteways).

Sampling was done monthly from January–March 2014. Sampling sites were selected at various locations in the survey area (Figure 3). Repeated capture of resident fish was anticipated, thus intervals between sampling periods helped provide recovery time from sampling and handling stress. Electrofishing methods followed the NMFS guidelines for sampling waters with anadromous fish (NMFS 2000). However, stated guidelines were for backpack electrofishing, though SMP biologists were not precluded from boat electrofishing. NMFS were given sufficient documentation that proposed techniques and equipment were necessary for the study, and that listed species were safeguarded, and state scientific collecting permits were obtained for these sampling techniques.

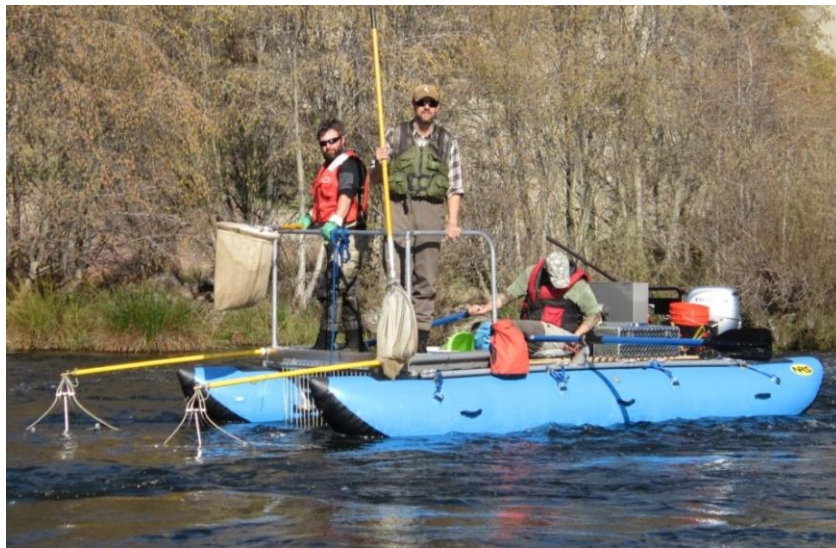
**Figure 4.**—Electrofishing raft and crew. Note extended boom array (ring anodes with vertically hanging cables not visible) and vertical cathode array (attached to the crew deck on the bow).

A Smith-Root 5.0 GPP raft-mounted electrofisher (Smith Root, Vancouver, WA) was used on January 22–23, February 20–21, 2013, and March 14–15, 2014 for the SMP (Figure 4). Additionally, sampling data was also provided from I&M surveys on January 12–14, 2014. Pulsed direct current was used. Voltage range was set at 50–500 V, with a power output range of 10–60%, and cycle frequency from 15–60 Hz. Settings were determined by water conductivity and adjusted to maximize capture efficiency while minimizing electrical exposure (*i.e.*, lowest setting required to elicit response without extended shocking times). All fish captured were placed in a live well aboard the raft. Following an electrofishing period, fish were enumerated, measured (total length, TL, and fork length, FL), weighed, and then released (given that it wasn't a steelhead).

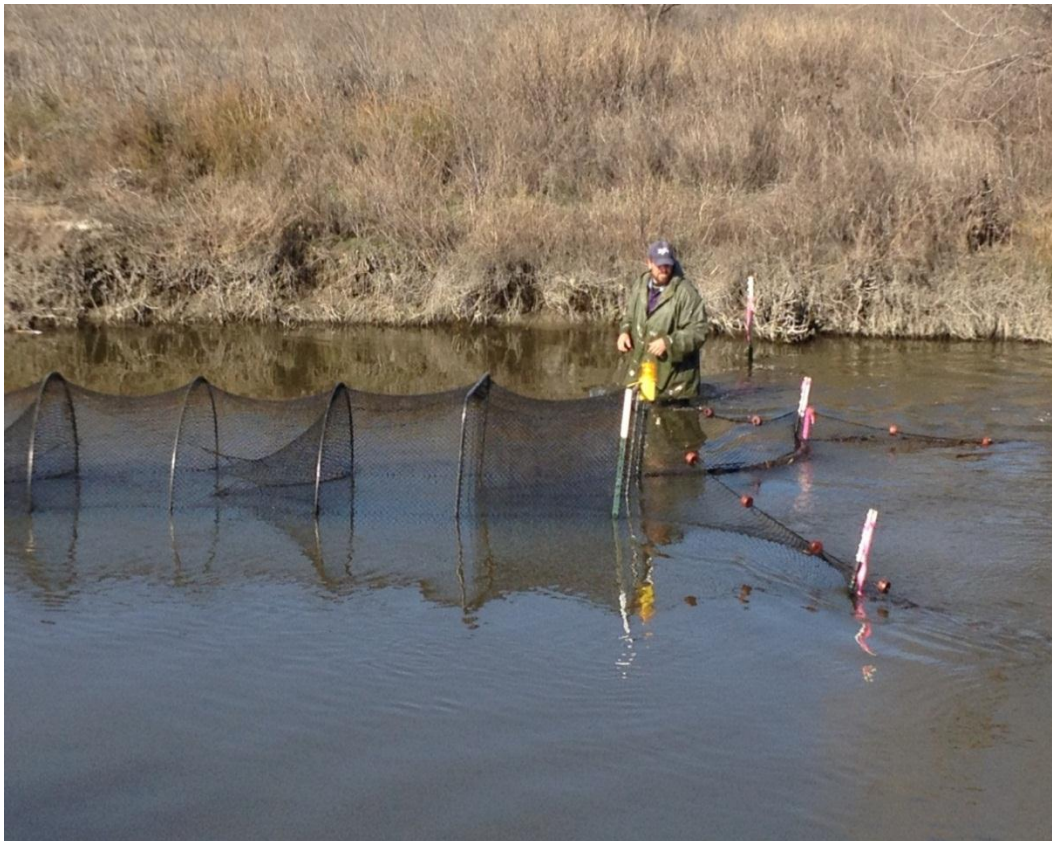
**Figure 5.**—Reclamation biologist deploying a fyke net in Mud Slough, Reach 5 of the San Joaquin River Restoration Area.

Fyke nets were used to survey for upstream migrating CV steelhead (Figure 5). The nets were constructed of 2.4-cm square #252 knotless nylon netting formed over 5 consecutive 1.2-m hoops and a 1.2-m square, welded-conduit frame entrance. The traps contained 2 throats with a 25-cm diameter opening. Wings walls, attached to the sides of the net opening, were 1.2 m deep and long enough to span the river (max wing length 30.5 m), with small floats spaced every 61 cm on top, and a lead line on bottom. Nets were held in place with anchored t-posts. The opening of the net faced downstream with the wing walls extending to shore in a v-shaped pattern. Fyke nets were placed in four locations during the 2014 SMP (Figure 6): approximately 0.8 river mile upstream from the confluence of the Merced River with the SJR (Casey site), Mud Slough, Salt Slough, and near the confluence of the Eastside Bypass with the SJR (Van Clief site). Fyke netting took place January 16–24, 2014. Marker buoys were placed up- and downstream of each fyke net, and flashing amber lights and visibility tape were affixed to the net and wing walls to alert boaters of the net's presence. The nets were checked daily to reduce the likelihood of injuring fish. Similar data, as with fish collected from electrofishing, were collected for fish recovered from the fyke nets. Fish were released upstream of the net to prevent recapture.
