# **ATTACHMENT 1 – Comparison of Electrical Conductivity Extract Data from 2010, 2011, and 2012**

## **Soil Salinity Monitoring Report**

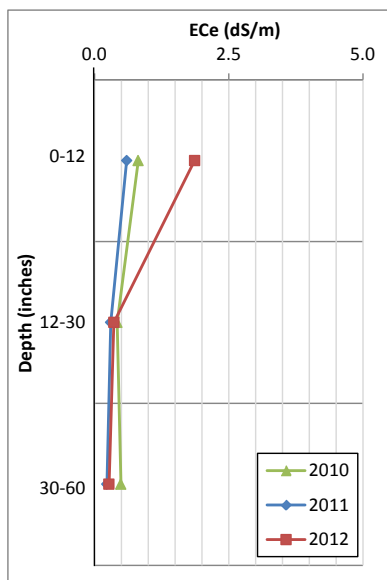
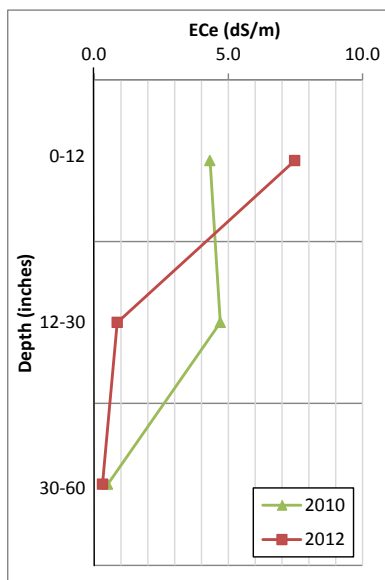
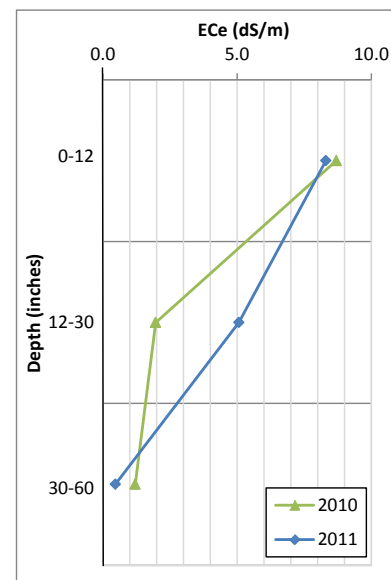
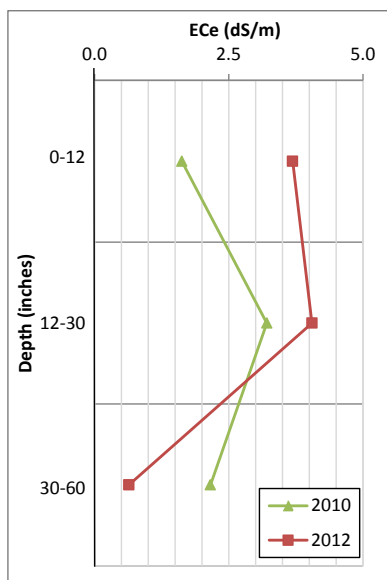
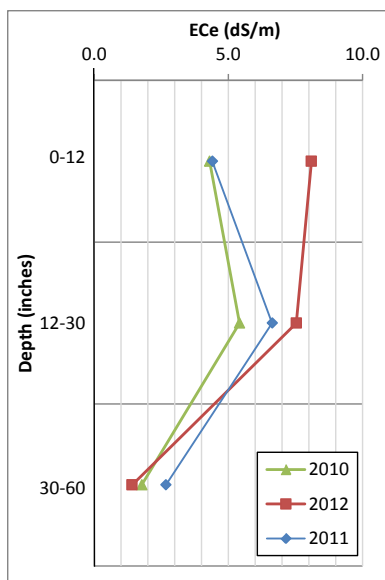
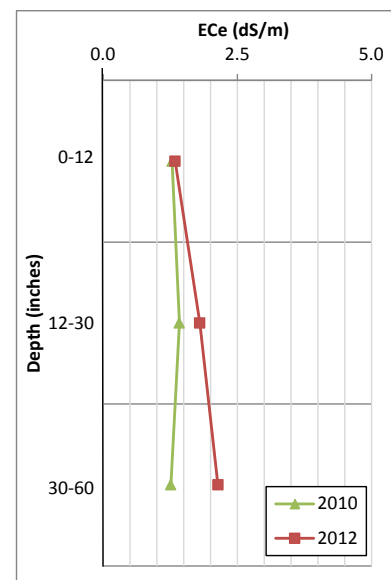
Figures 1a-f. ECe Versus Depth for Sites 1 through 6

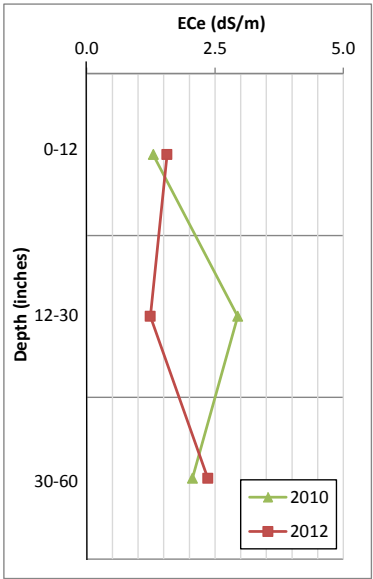
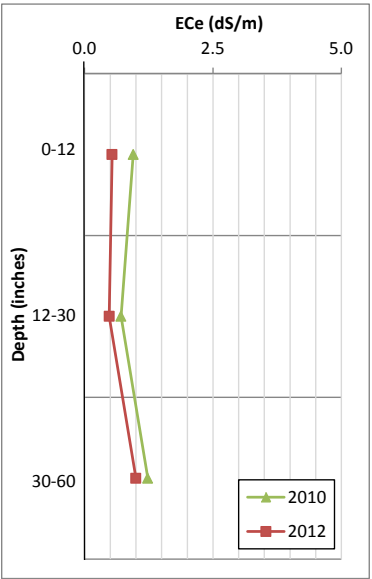
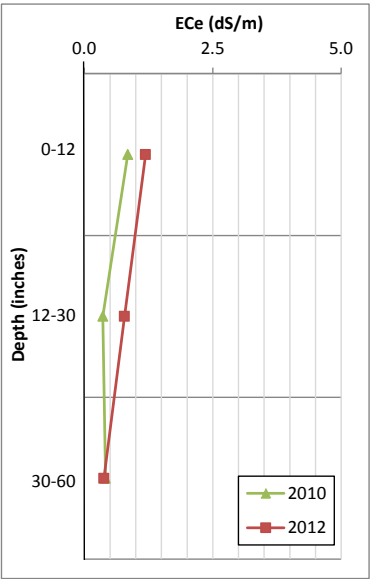
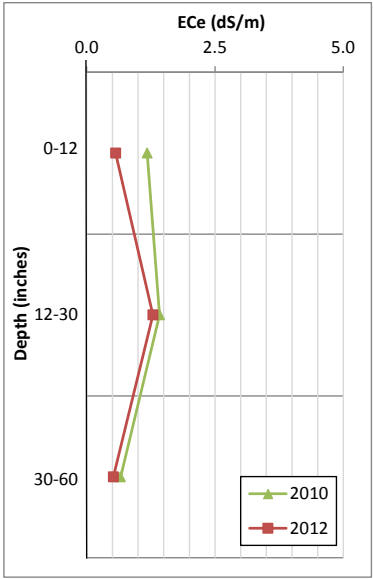
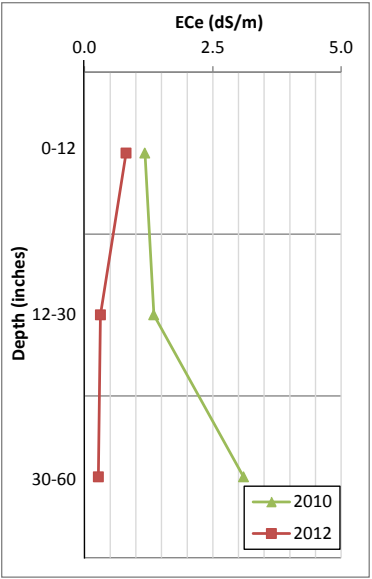
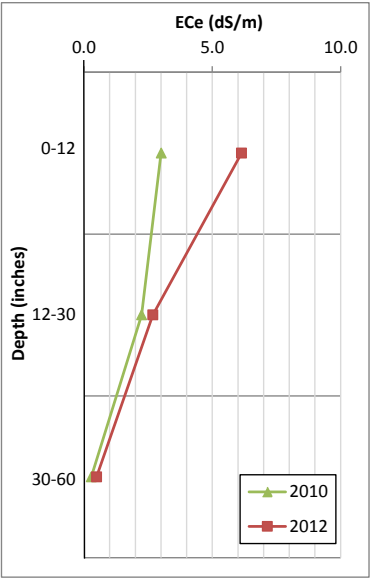
Figures 1g-l. ECe Versus Depth for Sites 7 through 12

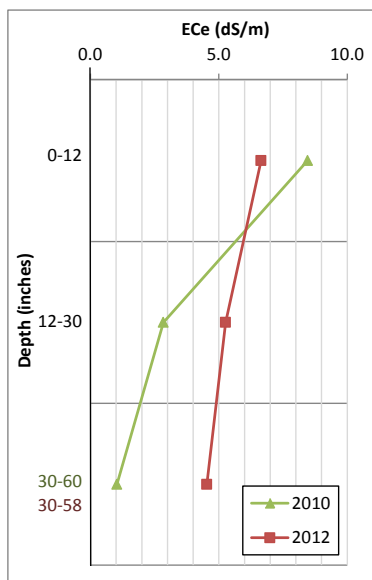
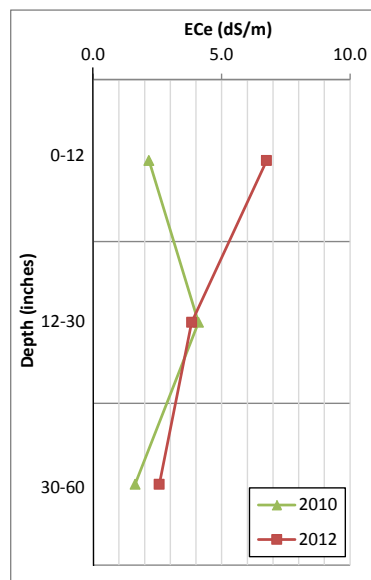
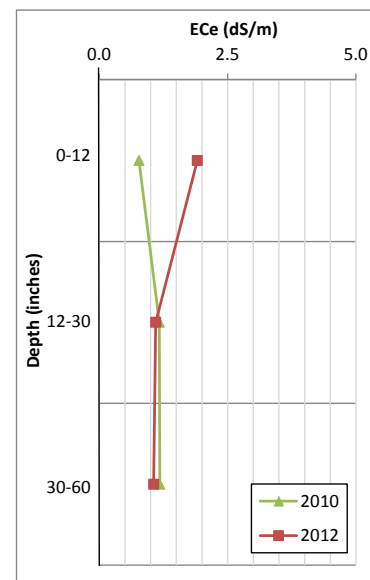
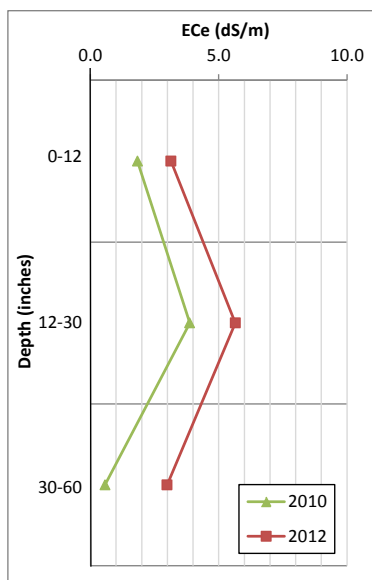
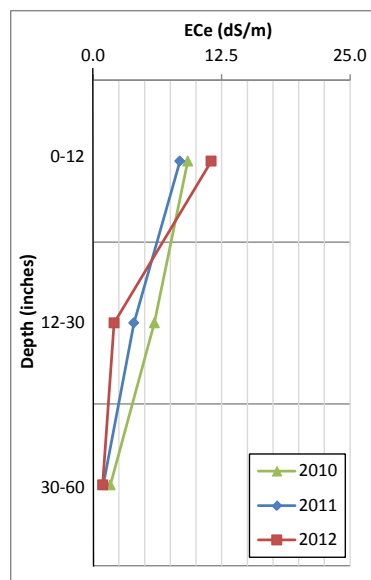
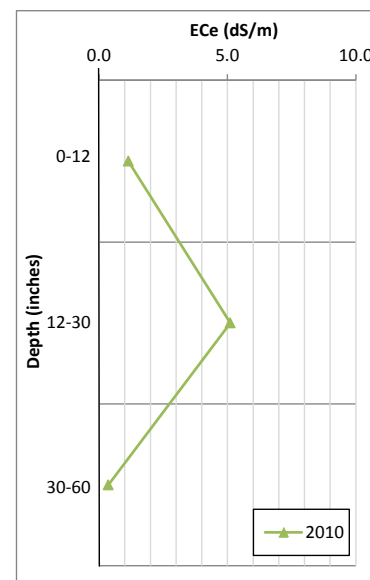
Figures 1m-r. ECe Versus Depth for Sites 13 through 18

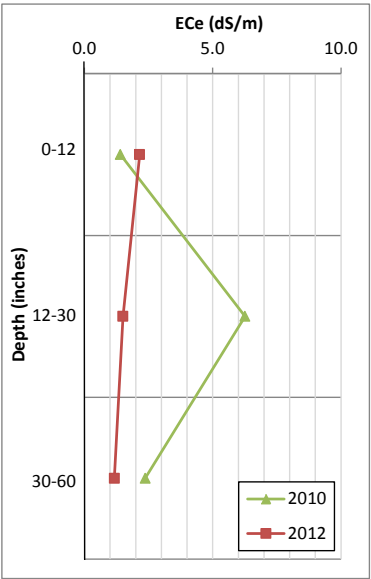
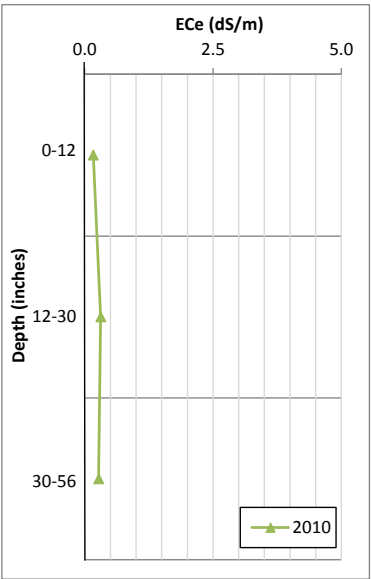
Figures 1s-x. ECe Versus Depth for Sites 19 through 24

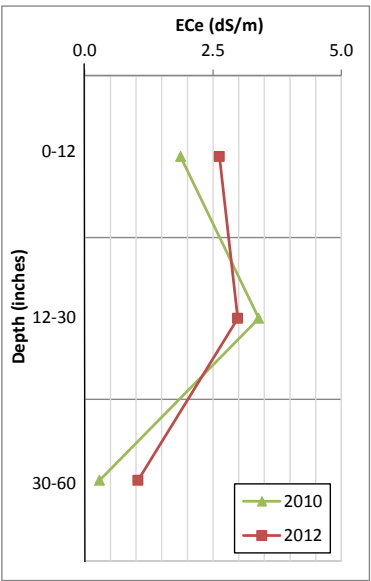
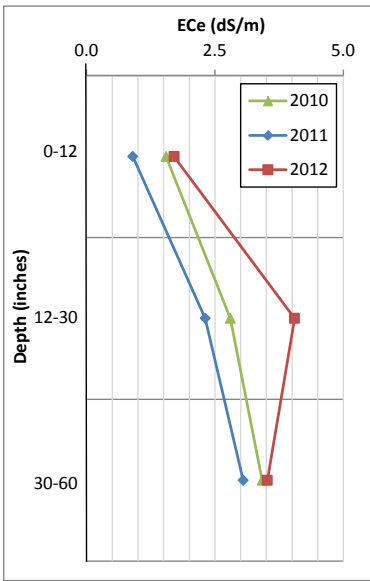
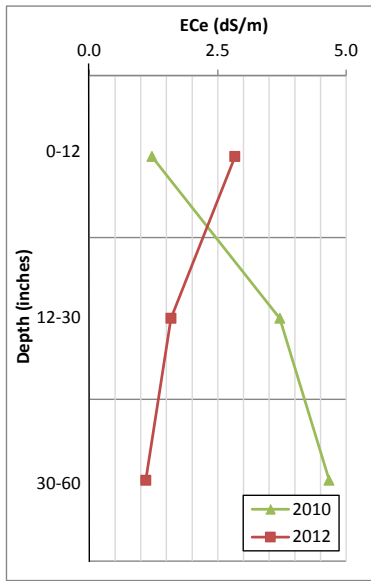
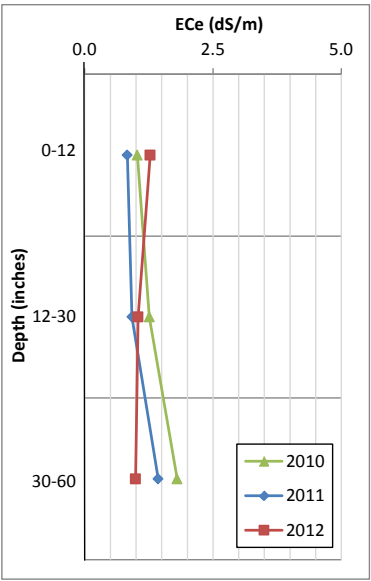
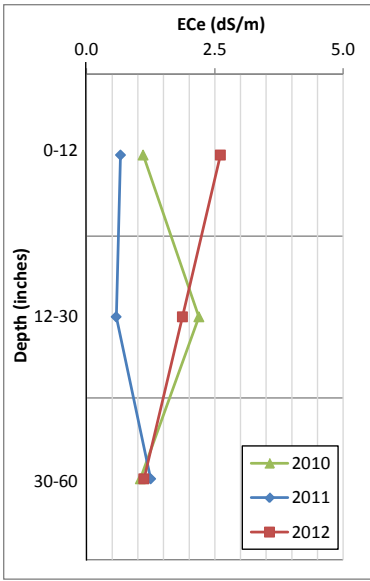
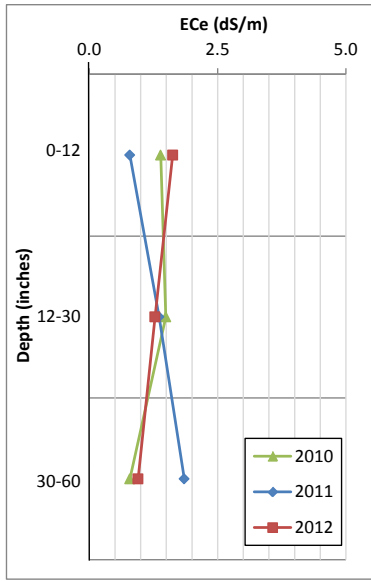
Figures 1ae-aj. ECe Versus Depth Sites 31 through 36

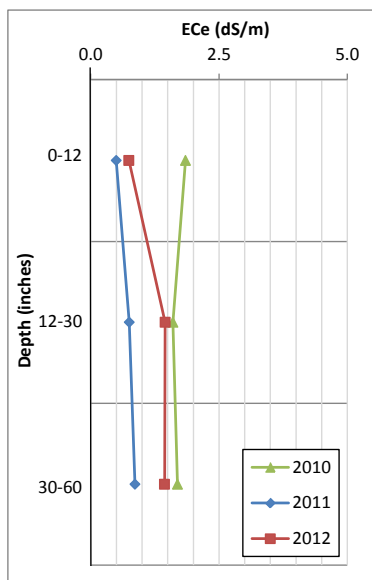
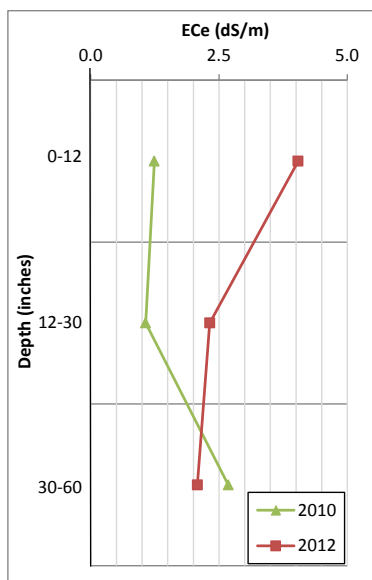
Figures 1ak-ap. ECe Versus Depth Sites 37 through 42

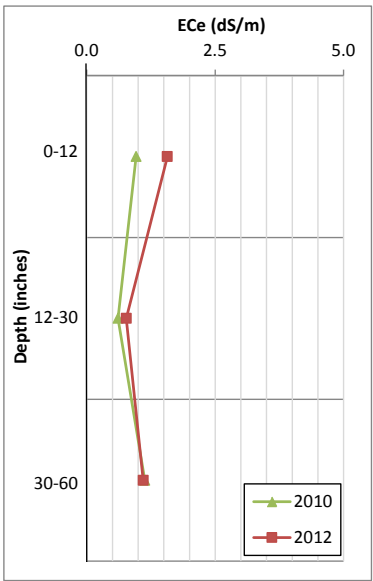
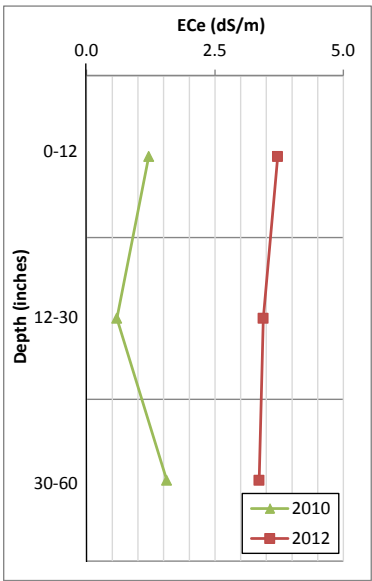
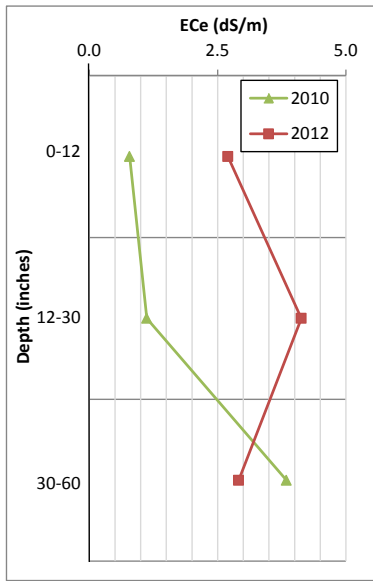
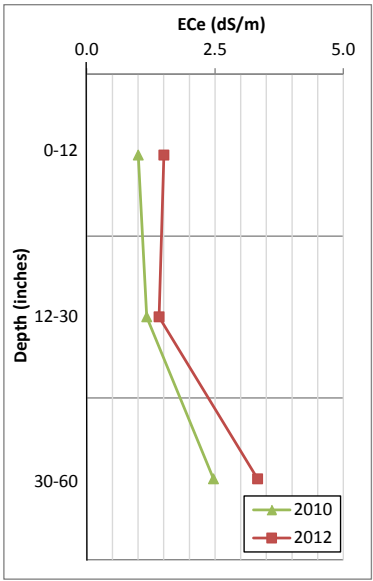
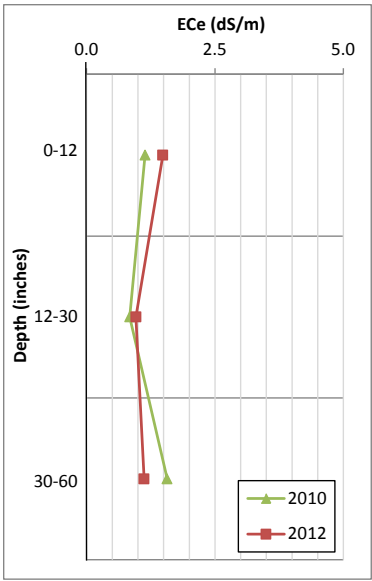
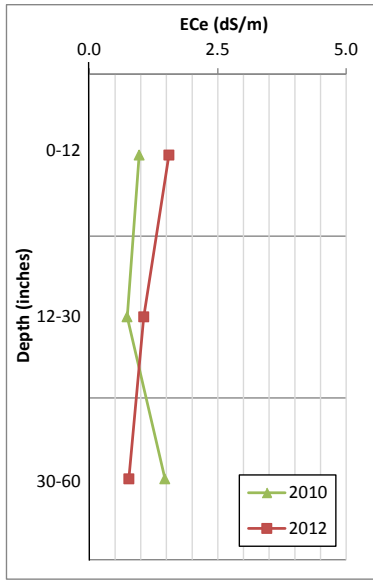
Figures 1aq-av. ECe Versus Depth Sites 43 through 48

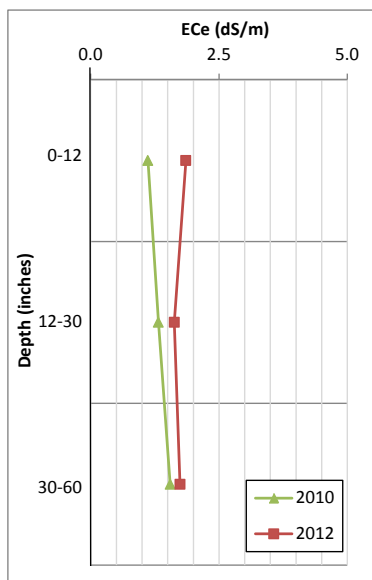
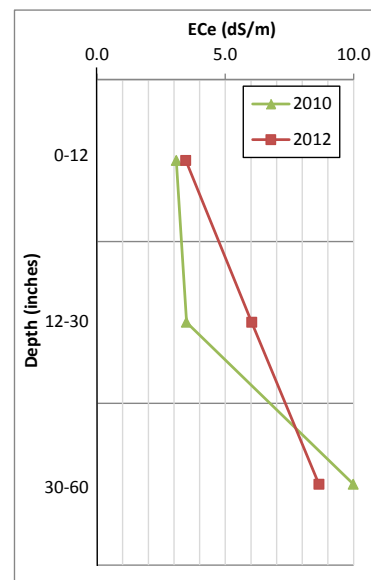
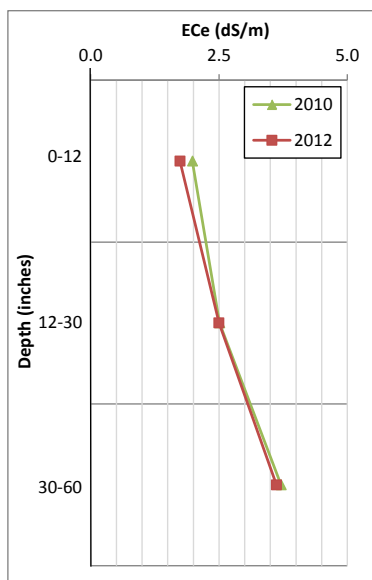
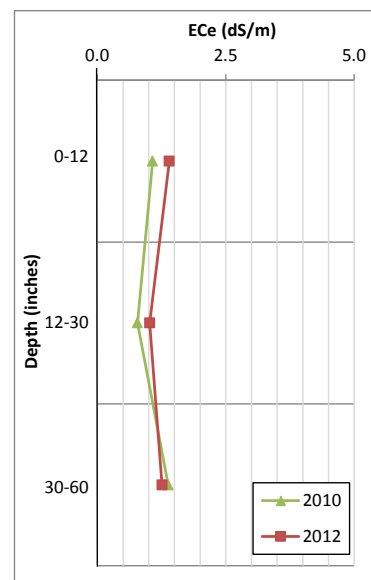
Figures 1aw-bb. ECe Versus Depth Sites 49 through 54

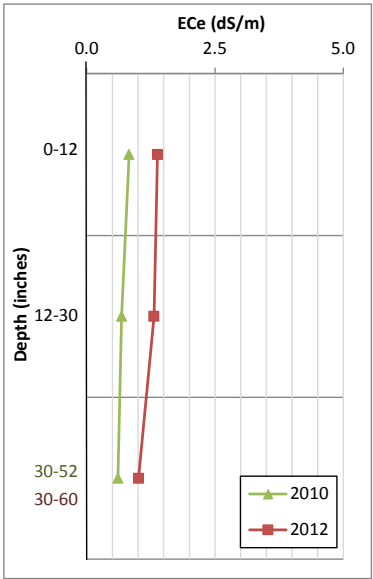
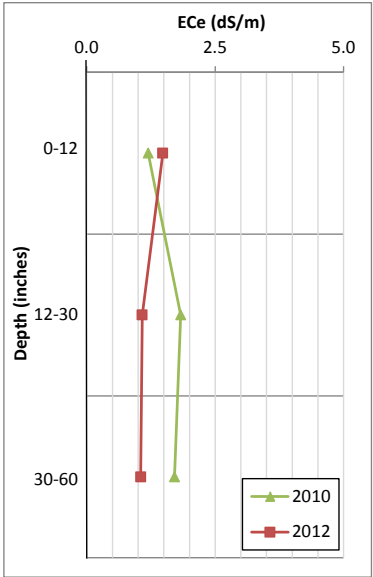
Figures 1bc-bh. ECe Versus Depth for Sites 55 through 60

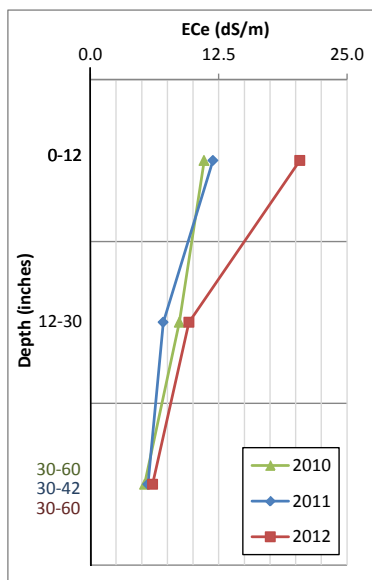
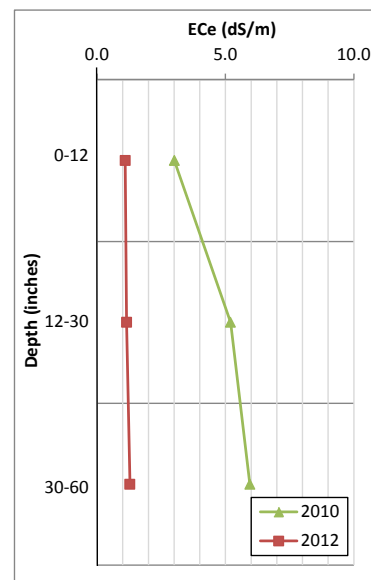
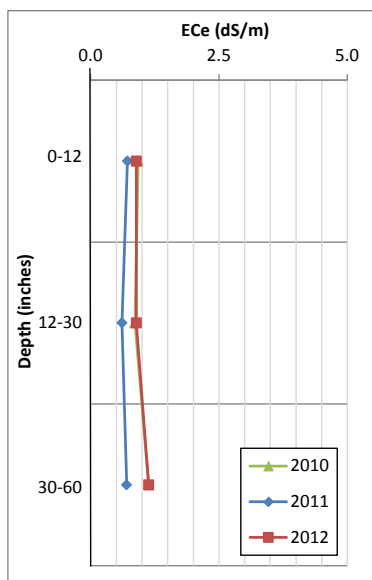
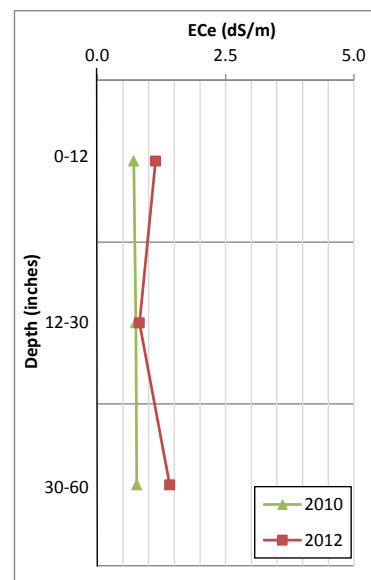
Figures 1bi-bn. ECe Versus Depth for Sites 61 through 66

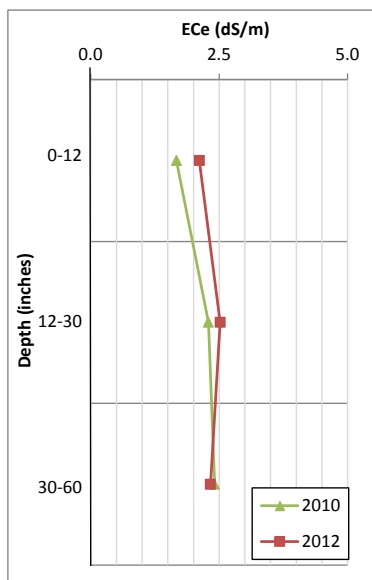
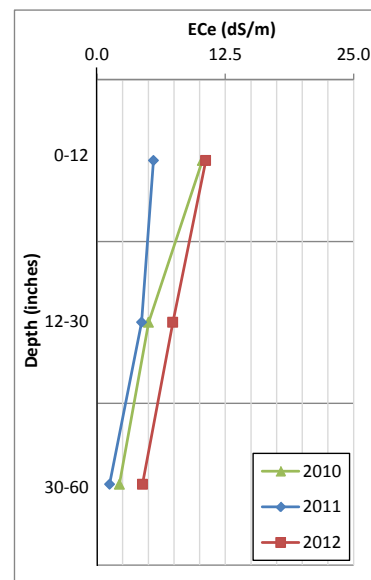
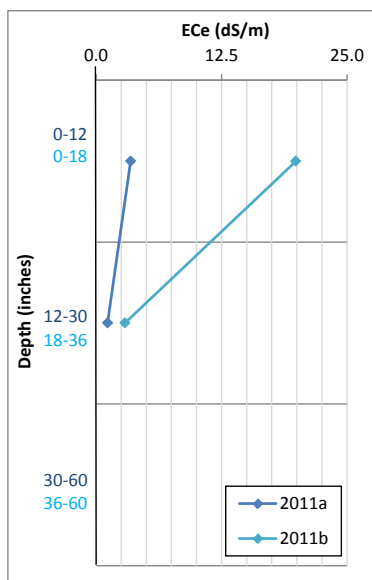
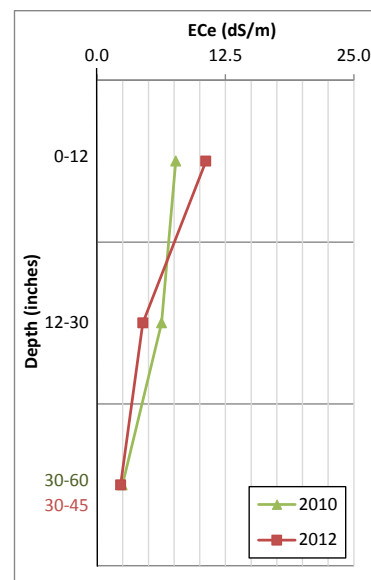
Figures 1bu-bz. ECe Versus Depth for Sites 74 through 76, 76a, 77, and 79

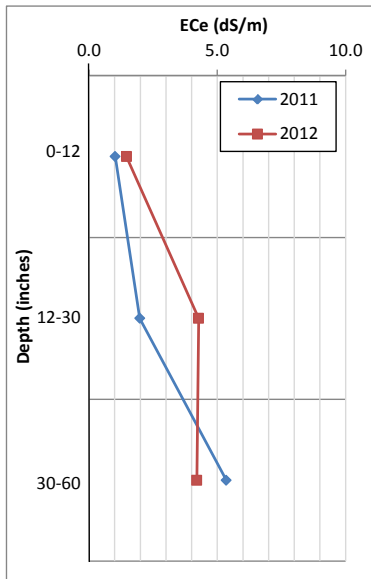
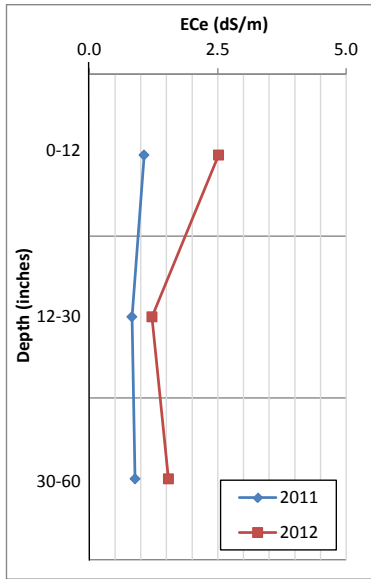
Figures 1ca-cf. ECe Versus Depth for Sites 80 through 85

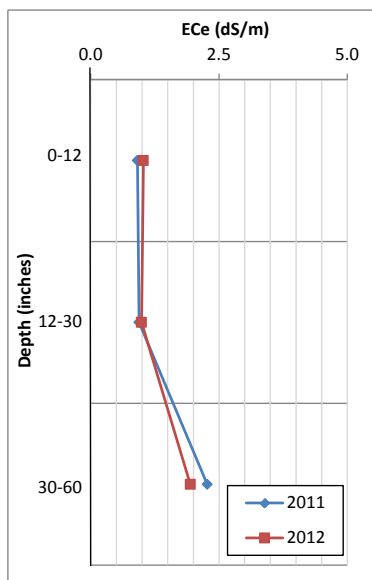
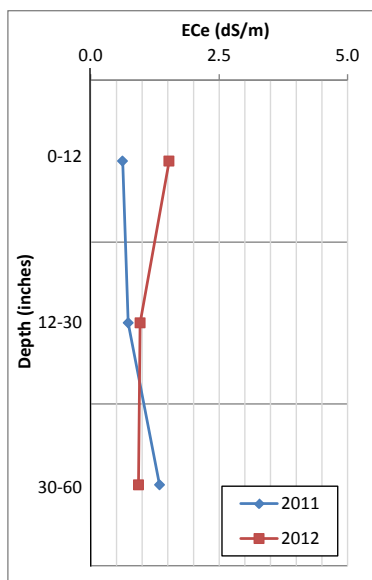
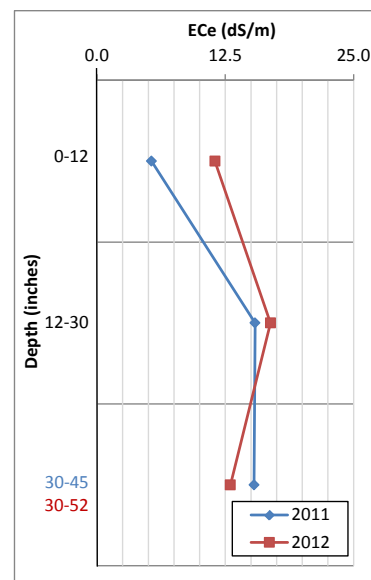
Figures 1cg-cl. ECe Versus Depth for Sites 86 through 91

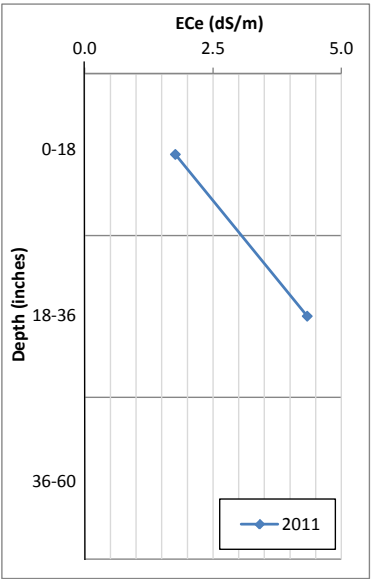
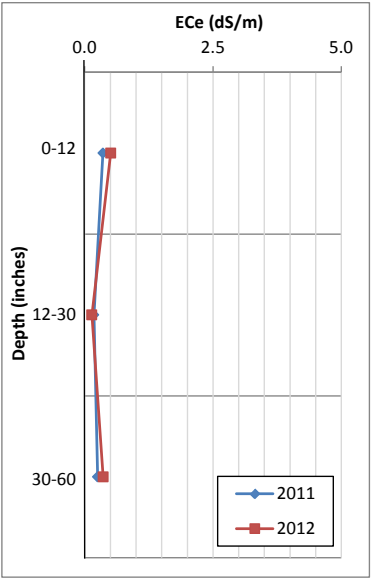
Figures 1cm-cr. ECe Versus Depth for Sites 92 through 97

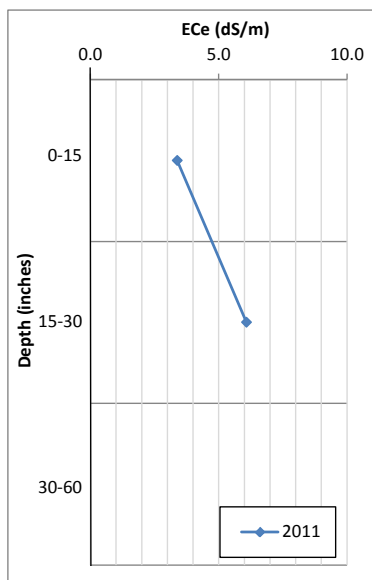
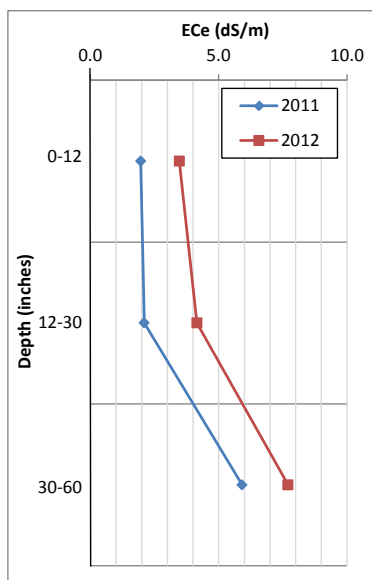
Figures 1cs-cx. ECe Versus Depth for Sites 98 through 103

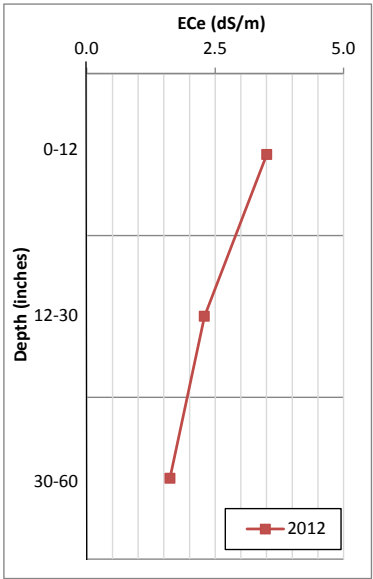
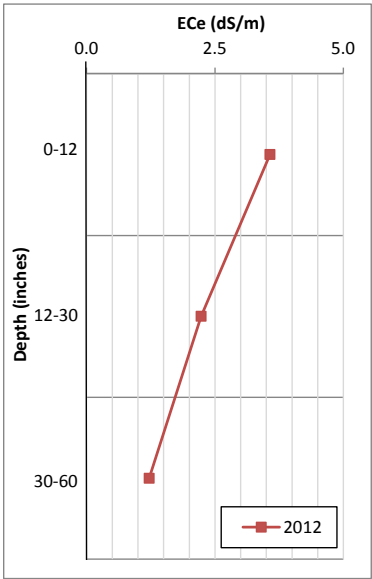
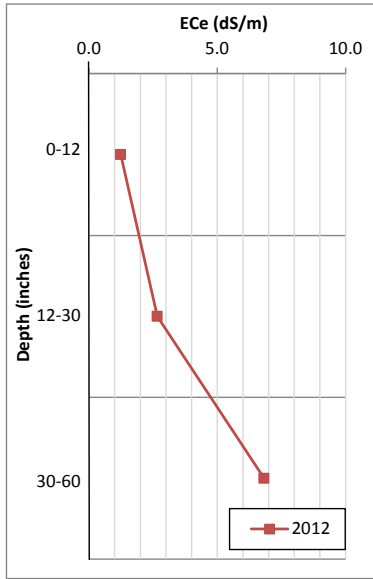
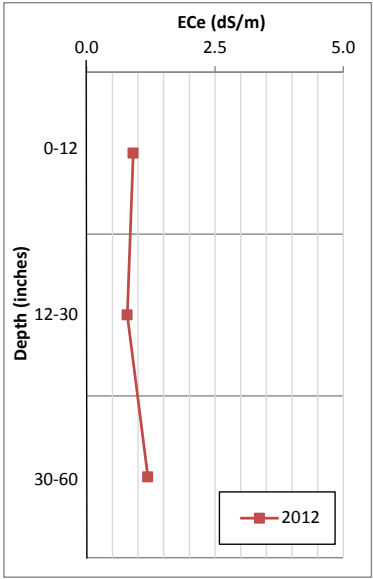
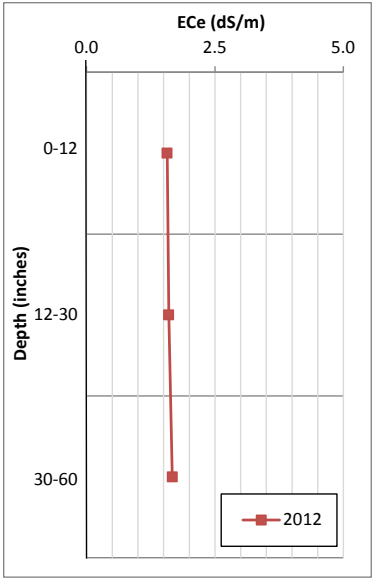
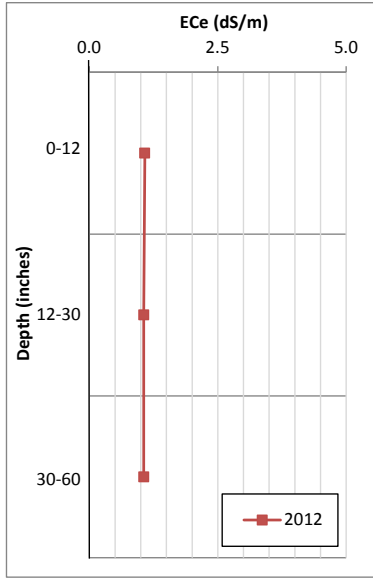
Figures 1cy-dd. ECe Versus Depth for Sites 104 through 109

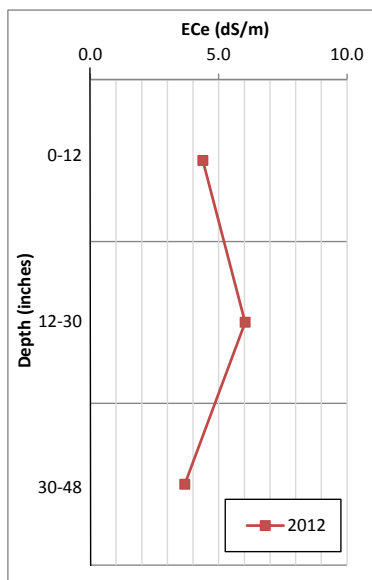
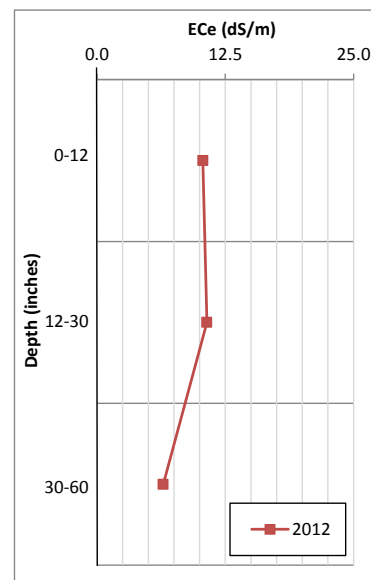
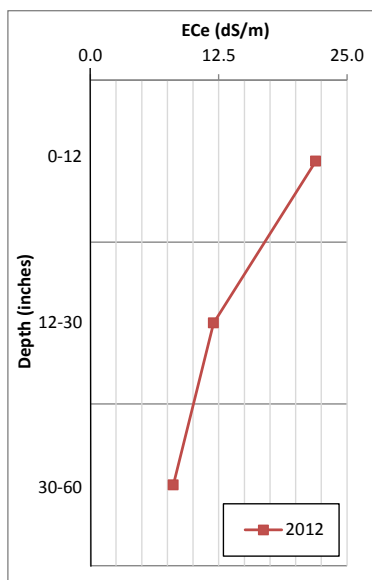
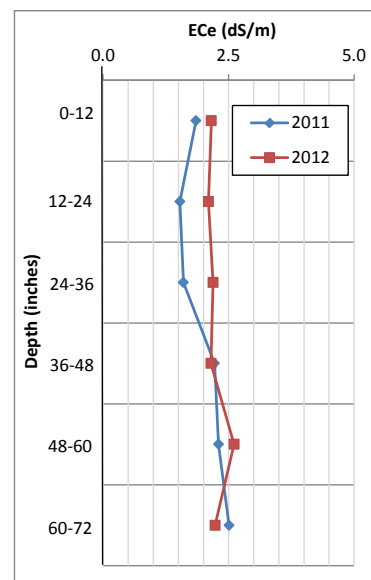
Figures 1de-dj. ECe Versus Depth for Sites 110 through 113, 116 and L21

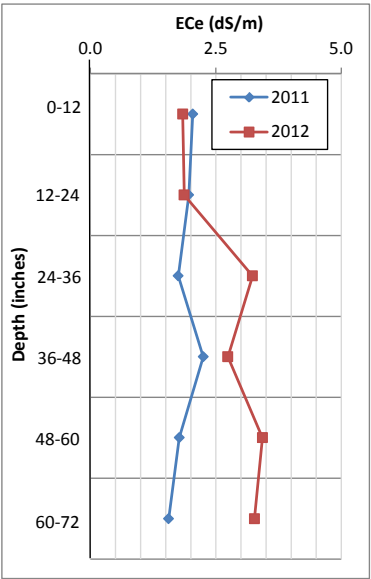
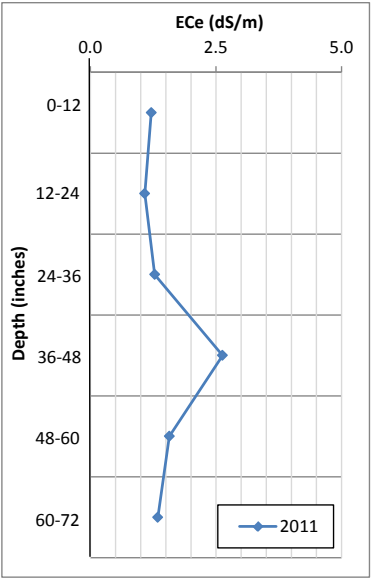
Figures 1dk-dp. ECe Versus Depth for Sites L26, L28, L48, L50, L66 and L68
