Vegetation Response to Interim Flows in the San Joaquin River

Annual Report 2013

U.S. Department of the Interior
Bureau of Reclamation
Technical Service Center
Denver, Colorado

April 2014

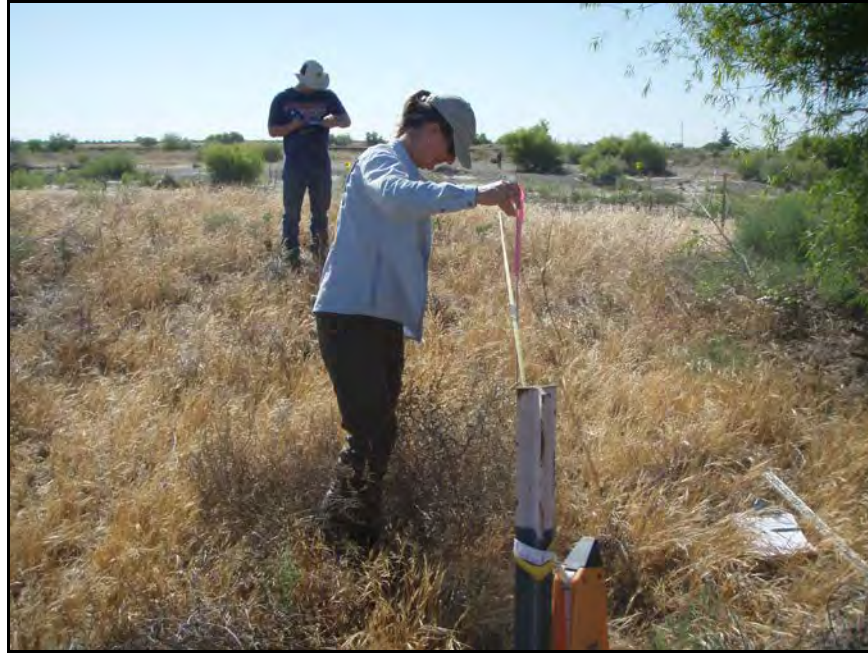
Figure 3—Measuring understory cover along transect.

For understory measurements, cover and species composition were measured either every 0.5 or 1 m along the transect depending on the length of the transect. The point-intercept method was used, which entailed recording the first “hit” for herbaceous plants and for woody species under 1 m tall by species (Figure 3). If a plant was not intercepted, then bare soil, litter, rock, or water were recorded. The location and extent of invasive weed species were documented when encountered.

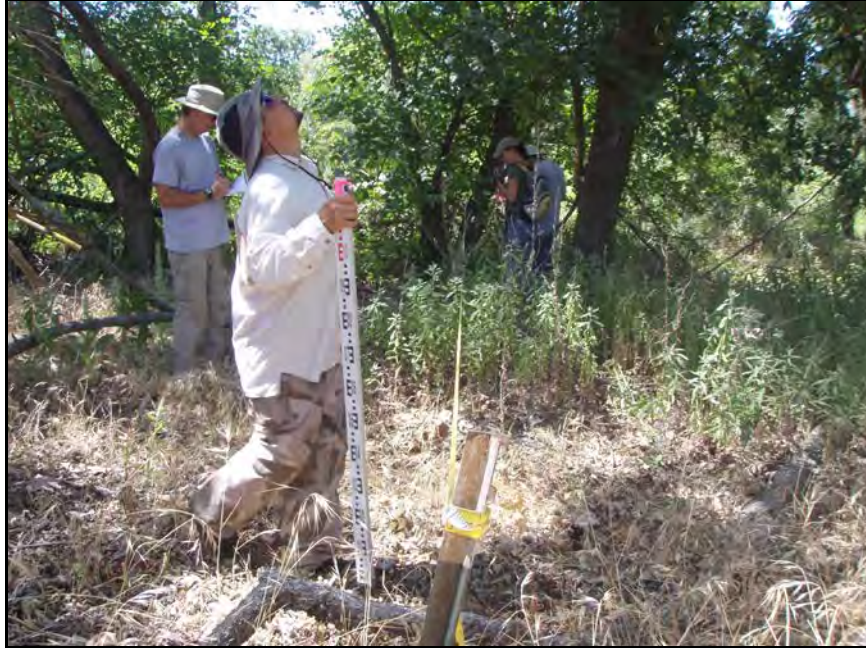
Figure 4—Measuring overstory cover along transect.

The line-intercept method was used for measuring woody overstory cover. Overstory cover was measured along the transect by noting the point along the tape where the canopy began and the point at which it ended for each woody species over 1 m tall (Figure 4). Because species overlapped in some cases, the sum of the cover for all species did not necessarily reflect the actual percentage of overstory cover along the tape. The percentage of the tape covered by overstory was also calculated. The height of the tallest vegetation within each continuous stretch of the same species was measured.

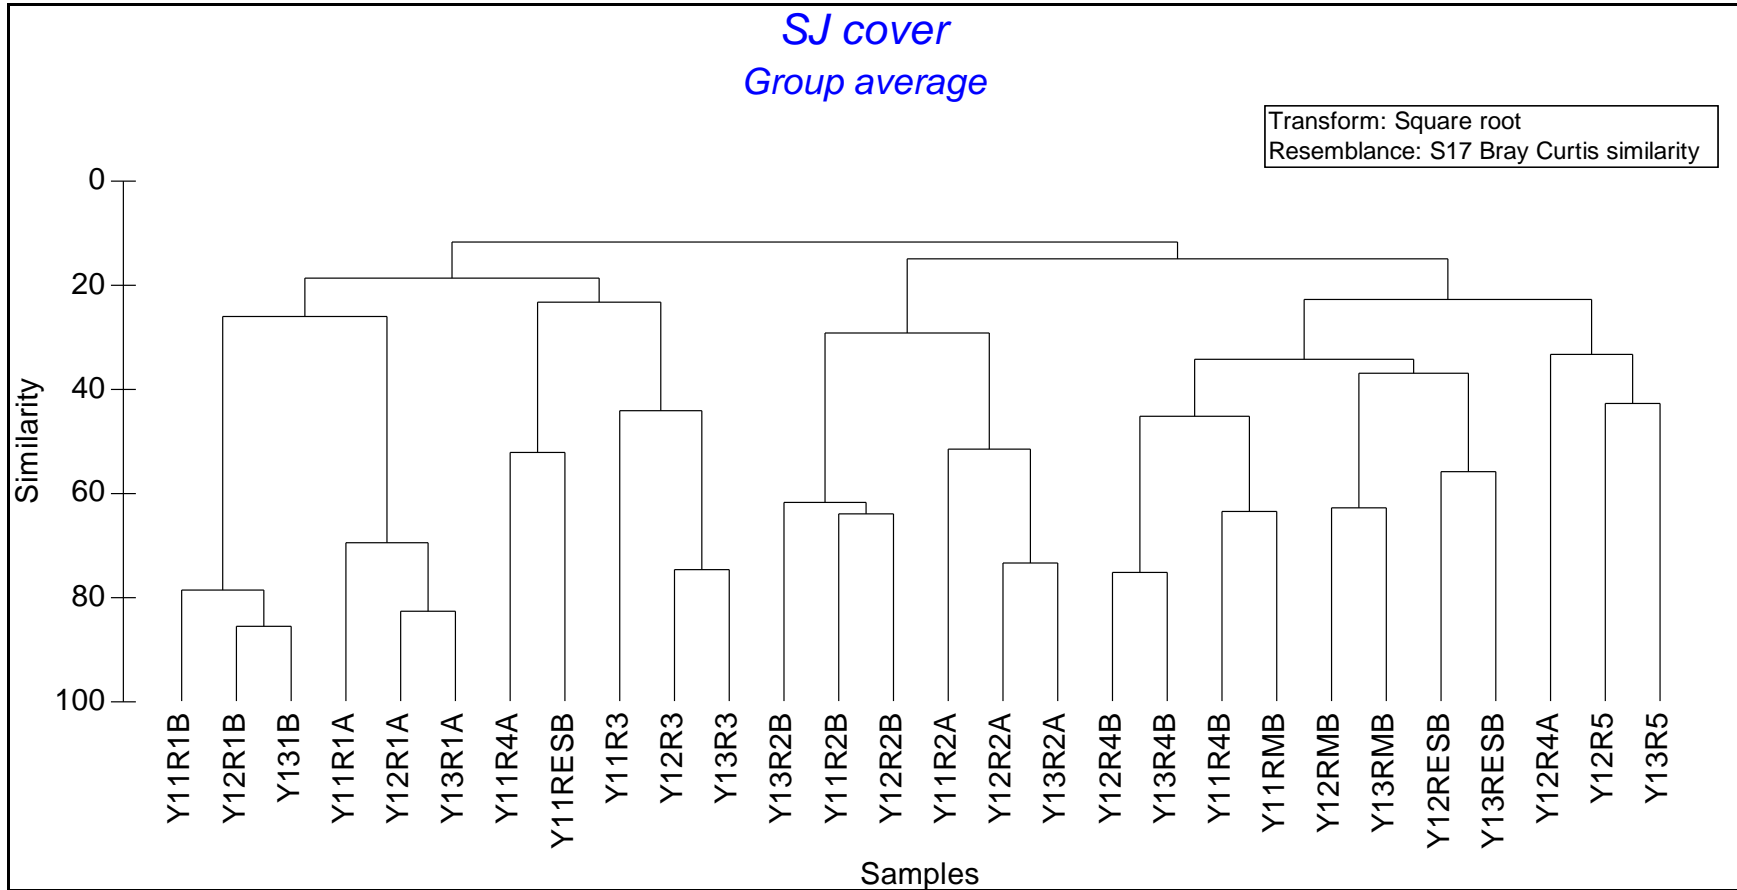
Figure 7.— Cluster analysis using Bray-Curtis similarities of plant species based on square root transformation of total percent cover data between reaches along the San Joaquin River in years 2011 to 2013 (Y11 to Y13). The most similar reaches are grouped together.

Total cover and density data were compared between sampling periods for upstream reaches (Reaches 1 to 3) and downstream reaches (Reaches 4, 5, and Bypasses) to evaluate any statistically significant changes in vegetation over time. The repeated measures ANOVA was applied to test for relationships between cover or density and year, while Fisher's least significant difference (LSD) procedure was used as a multiple comparison test to evaluate statistically significant differences between years ($\alpha=0.05$) utilizing StatGraphics statistical software. The Fisher's LSD analysis is a post-test to the repeated measures ANOVA and provides a more focused analysis of individual years. Primer (Plymouth Routines in Multivariate Ecological Research; see www.primer-e.com) statistical software was used to create a similarity matrix and cluster diagram of plant species between reaches and between years using the Bray-Curtis measure.

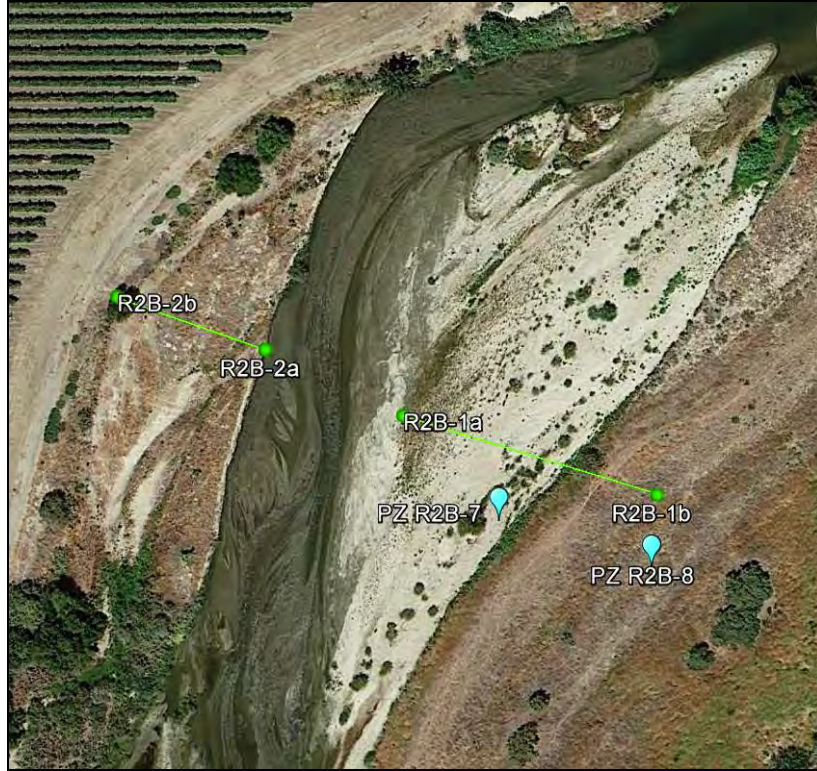
Figure 8.—Locations of piezometers 7 and 8 and vegetation transects 1 and 2 within Reach 2B. Google Earth imagery August 2012.

Reclamation installed piezometers to measure groundwater levels on vegetation transects in Reach 2B and 4A following the 2012 vegetation monitoring season. Groundwater recession rates have been closely tied to riparian vegetation establishment and survival in the San Joaquin Valley and elsewhere (Stillwater Sciences 2003b). Groundwater data from wells installed near transects will be used to determine if any correlations are observed between growth and development of vegetation and water table levels.

Piezometers were installed in association with vegetation transects in Reach 2B in February 2013 (Figure 8). The hydrograph in Figure 9 shows groundwater depths at these wells from March through December and uses flow data gathered at Station SJB (approximately 1.5 mi upstream) and Station SJN (approximately 2 mi downstream). A correlation between flows and the depth of the water table is apparent, which indicates connectivity of the floodplain and river. In 2013, ground water within the floodplain (PZ7) remained at a shallow enough depth (<4 ft) necessary to sustain woody riparian plant species.

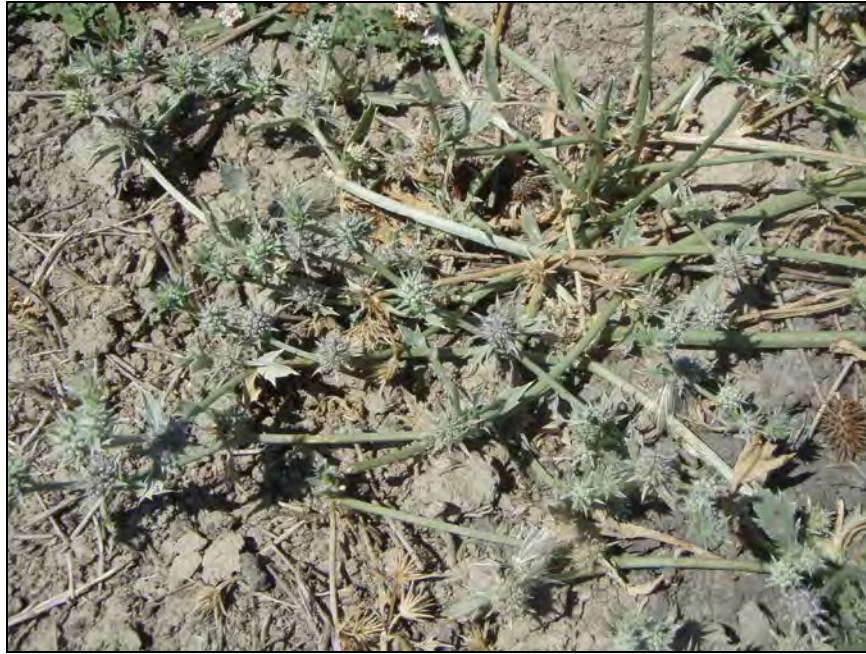
Figure 10.—Delta button celery (*Eryngium racemosum*), a State-listed endangered plant, was detected in transects within the Merced NWR in the East Side Bypass Reach, June 2012.

Total understory cover within this reach remained between 37 and 47 percent in all years, with litter cover increasing from 22.7 to 49.3 percent and bare cover decreasing from 30.0 to 13.8 percent. Unlike other reaches, native herbaceous species remained dominant relative to introduced species throughout the entire monitoring period (Table 3), with native grasses the most common life form. Herbaceous species richness increased from 16 to 20, which is high relative to other transects, although fewer of the species detected were native (8 in 2013; Table 2). In 2012 and 2013, transects in this reach fell within exclusively herbaceous habitat; in 2011, 0.2 percent overstory cover was documented (Table 4) but no woody species were detected in understory or stem density measurements. The East Side Bypass received a score of 4.53 in riparian condition in 2013. Rankings were relatively low in all but 2 variables, which were contiguity of habitats and % invasive woody vegetation (only because there were no woody species). Two of four transects were located within the Merced NWR where an existing year-round water supply could make it difficult to identify changes in vegetation from Interim Flows. Delta button celery, which is a State-listed endangered plant, was detected in the Merced NWR within this reach (Figure 10). This plant was documented in transect monitoring in 2011 (Table E-2, Appendix E). Although it was not intercepted in transect cover measurements in 2012, it was observed in the area surrounding transect 3. It was not observed at all during 2013 sampling when the area showed signs of recent and heavy grazing.

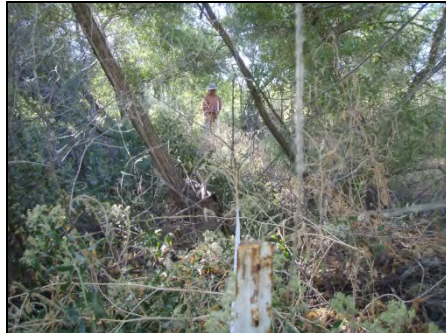
June 2013

2b – Away from transect
