DRAFT Technical Memorandum

Subsidence Monitoring

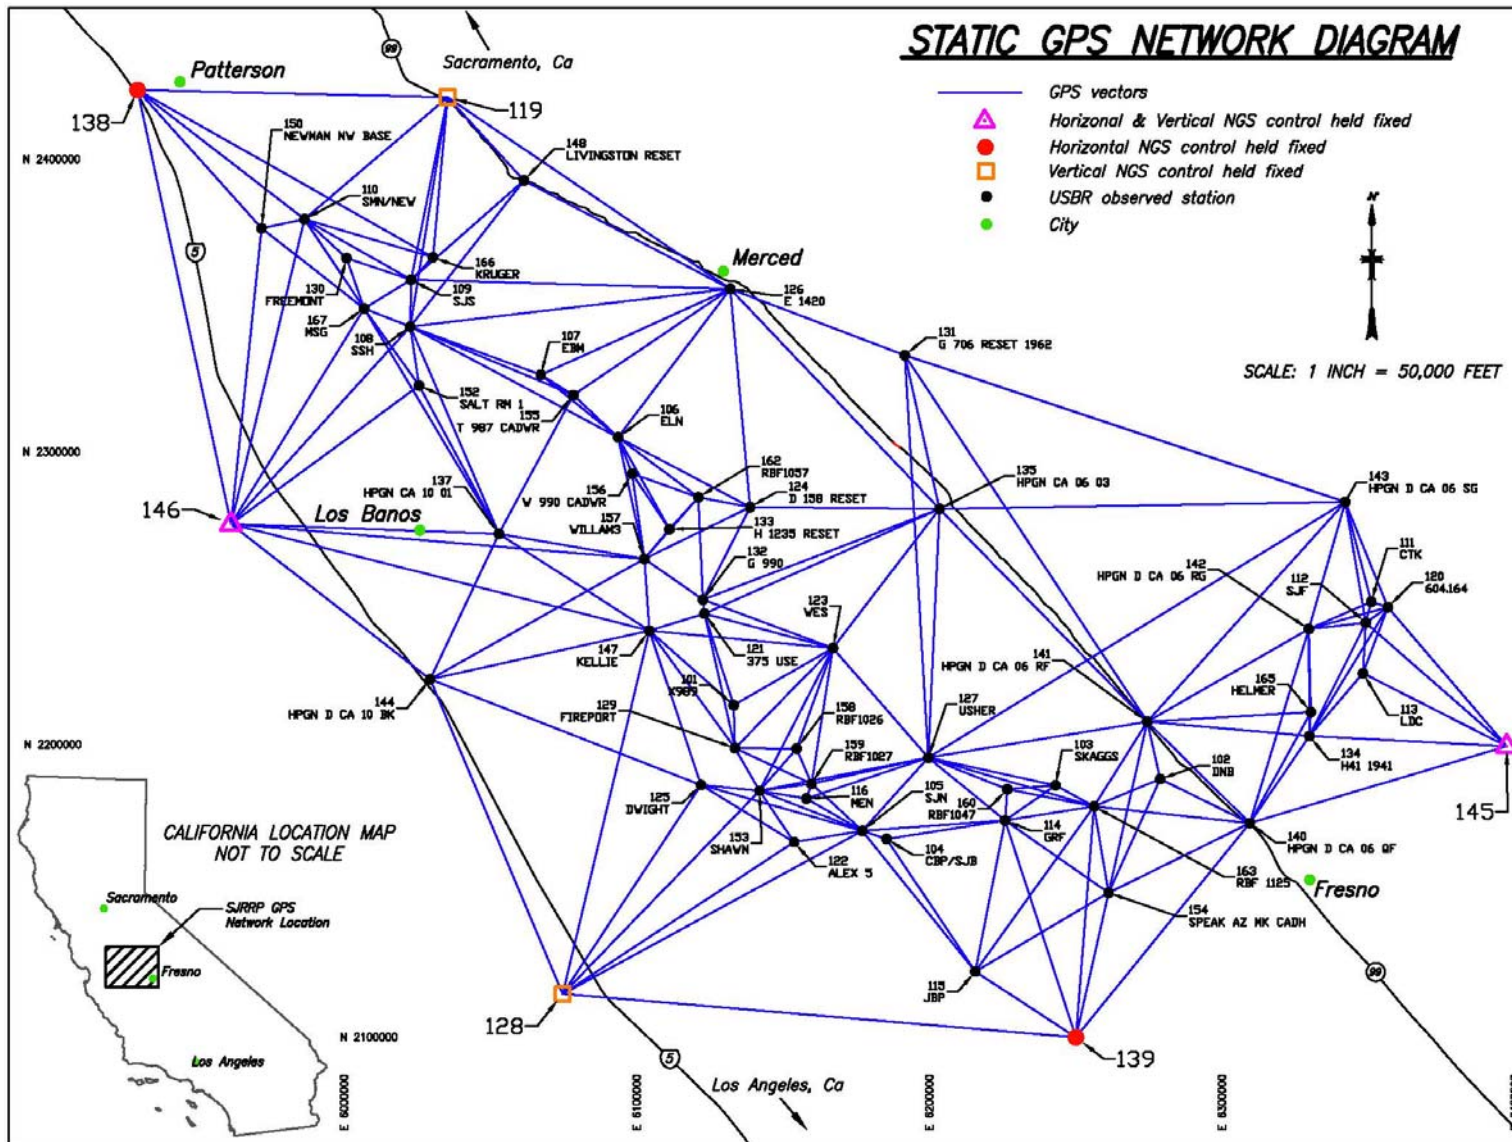
Figure 1. Static GPS Network Diagram

In 2011, Reclamation established the SJRRP Geodetic Control Network (**Figure 1**), using static GPS methods, to investigate subsidence within the SJRRP study area. To monitor the rate of subsidence over time, Reclamation conducts bi-annual surveys, in July and December, of the

established network. The network is made up of National Geodetic Survey, Reclamation, USGS, California Department of Transportation, and DWR benchmarks and in 2011 originally contained approximately 60 control points, but over the last few years has expanded to over 85 points. The benchmark elevations are updated after each survey and are used by the SJRRP to study subsidence, as well as to provide more accurate horizontal and vertical control for other studies.

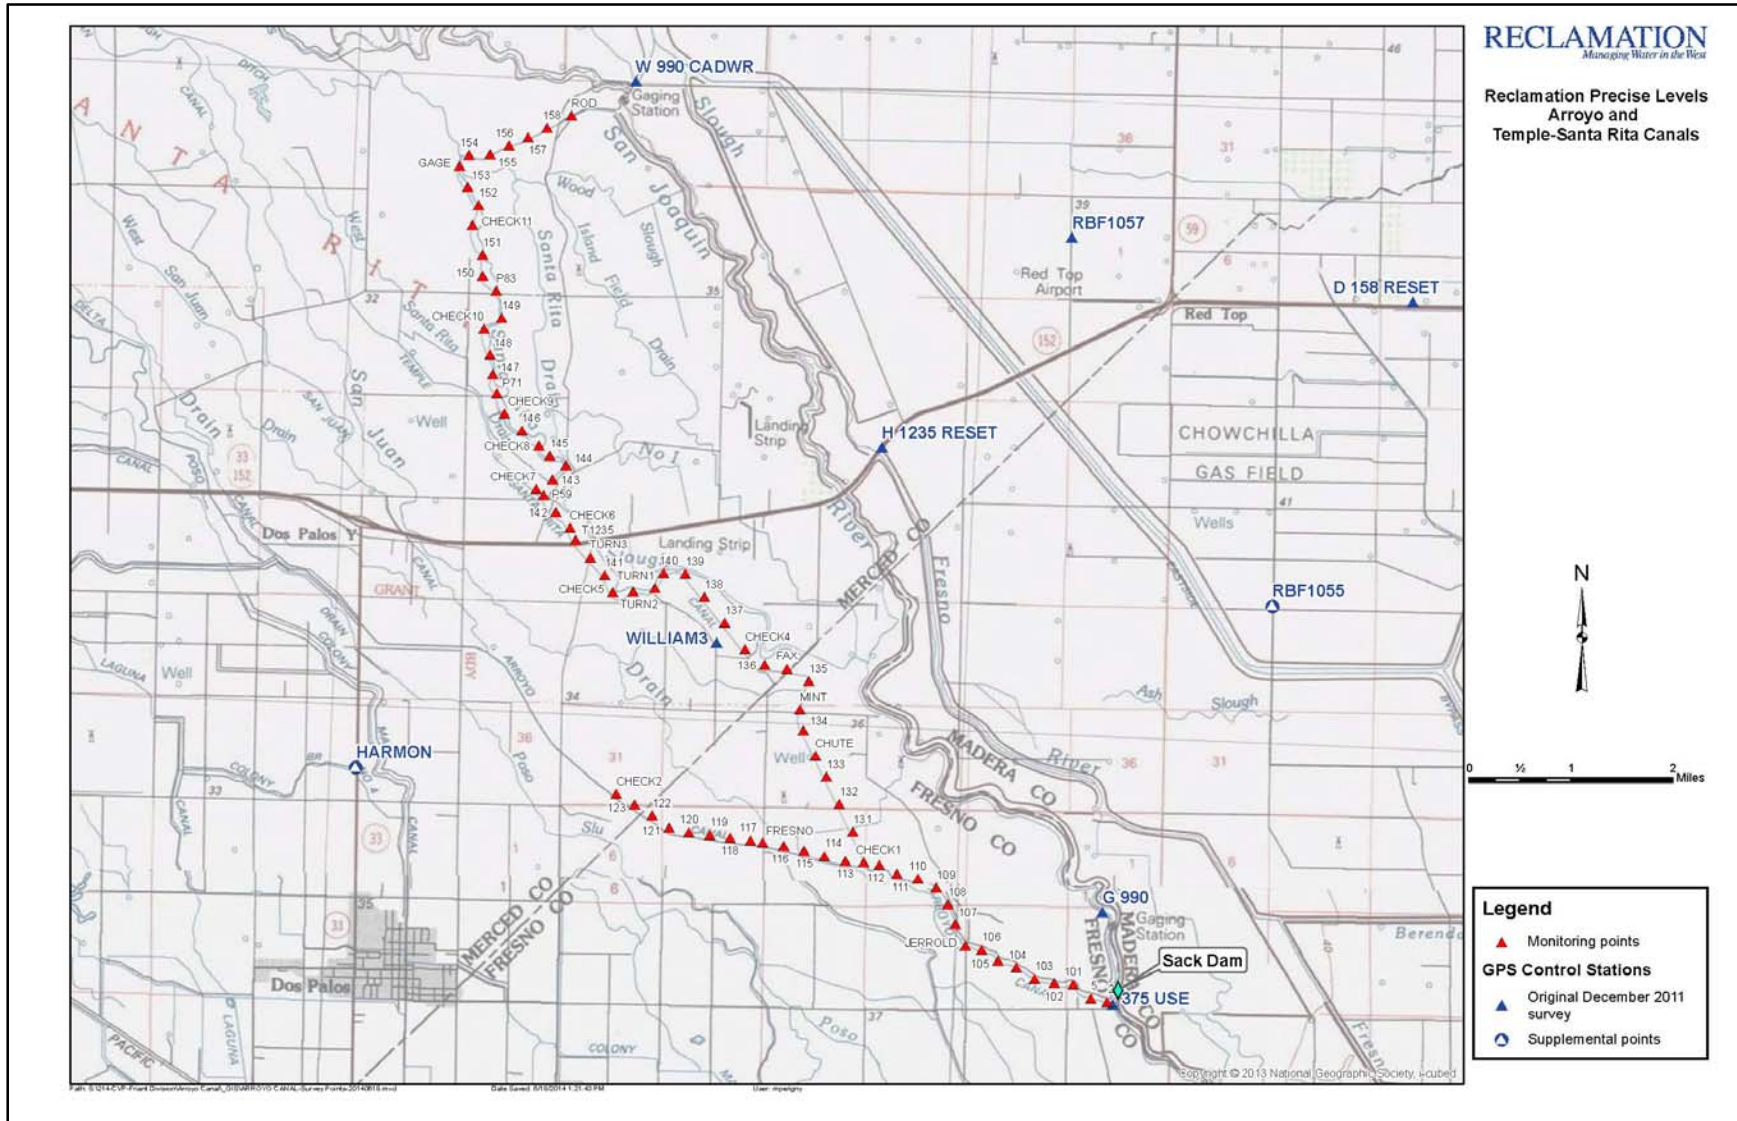
Figure 2. Location map of Precise Levels along the Arroyo and Temple-Santa Rita Canals

Beginning in May 2012 Reclamation began monitoring the Arroyo and Temple-Santa Rita (TSR) Canals to clarify localized subsidence near Sack Dam. To accomplish this, two precise leveling networks were established; Arroyo Canal starting at Sack Dam running approximately 6 miles westerly; and the Temple-Santa Rita Canal starting at Check Structure 1 on the Arroyo Canal running approximately 11 miles northerly (**Figure 2**). These level networks were surveyed monthly for just over a year. This phase of the subsidence monitoring project has been shifted to the Henry Miller Reclamation District for any future monitoring surveys.

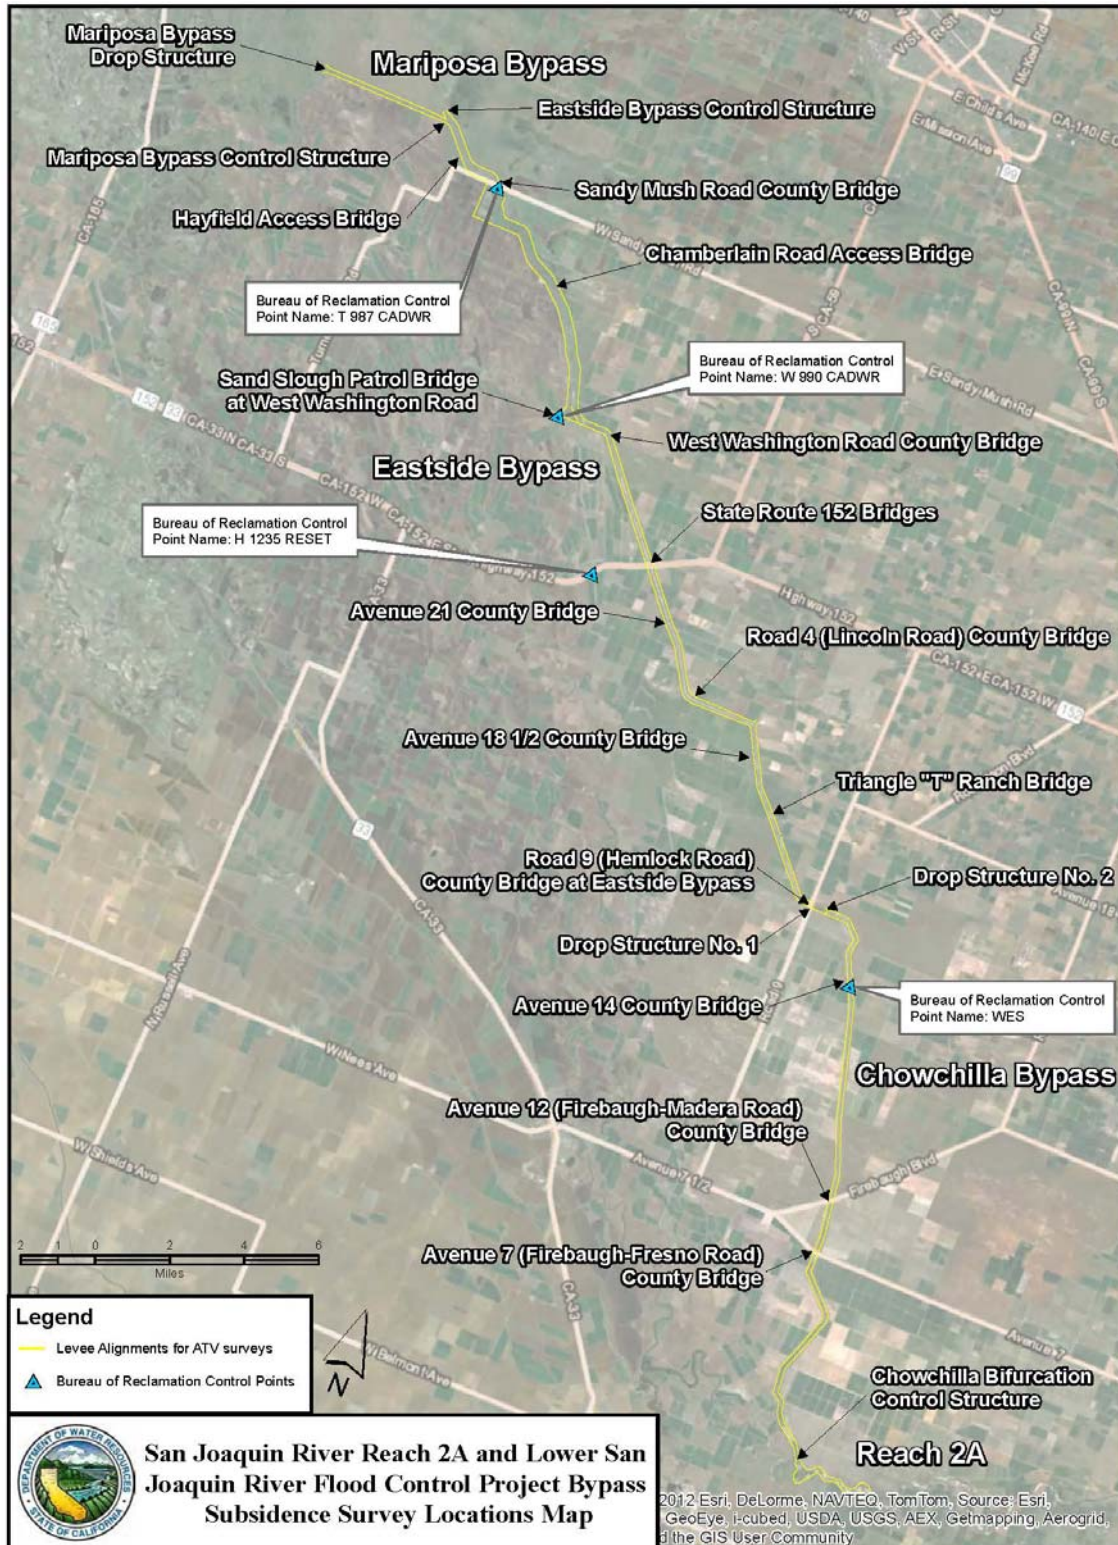
Figure 3. Longitudinal levee surveys within Reach 2A and Bypass survey completed in 2012 and 2013

In 2012 and later in 2013, DWR-SCRO collected topographic ground elevations to help further refine the estimated annual rates in the lower 3 miles of Reach 2A, the Chowchilla Bypass (from the Chowchilla Bifurcation Control Structure to its confluence with the Fresno River), the Upper Eastside Bypass (from its confluence with the Fresno River to the Sand Slough Connector), the Middle Eastside Bypass (from the Sand Slough Connector to the Eastside Bypass Control Structure), and the Mariposa Bypass (**Figure 3**). This survey was completed to help further refine Reclamation's estimated annual subsidence rates along the flood bypasses. In addition to the above surveys, DWR also completed surveys in 2013 and 2014 of the levee and channel in the lower portion of Reach 3, Reach 4A, and the Middle Eastside Bypass; however, this data is considered preliminary and has not been finalized for public release at the time of the preparation of this report.

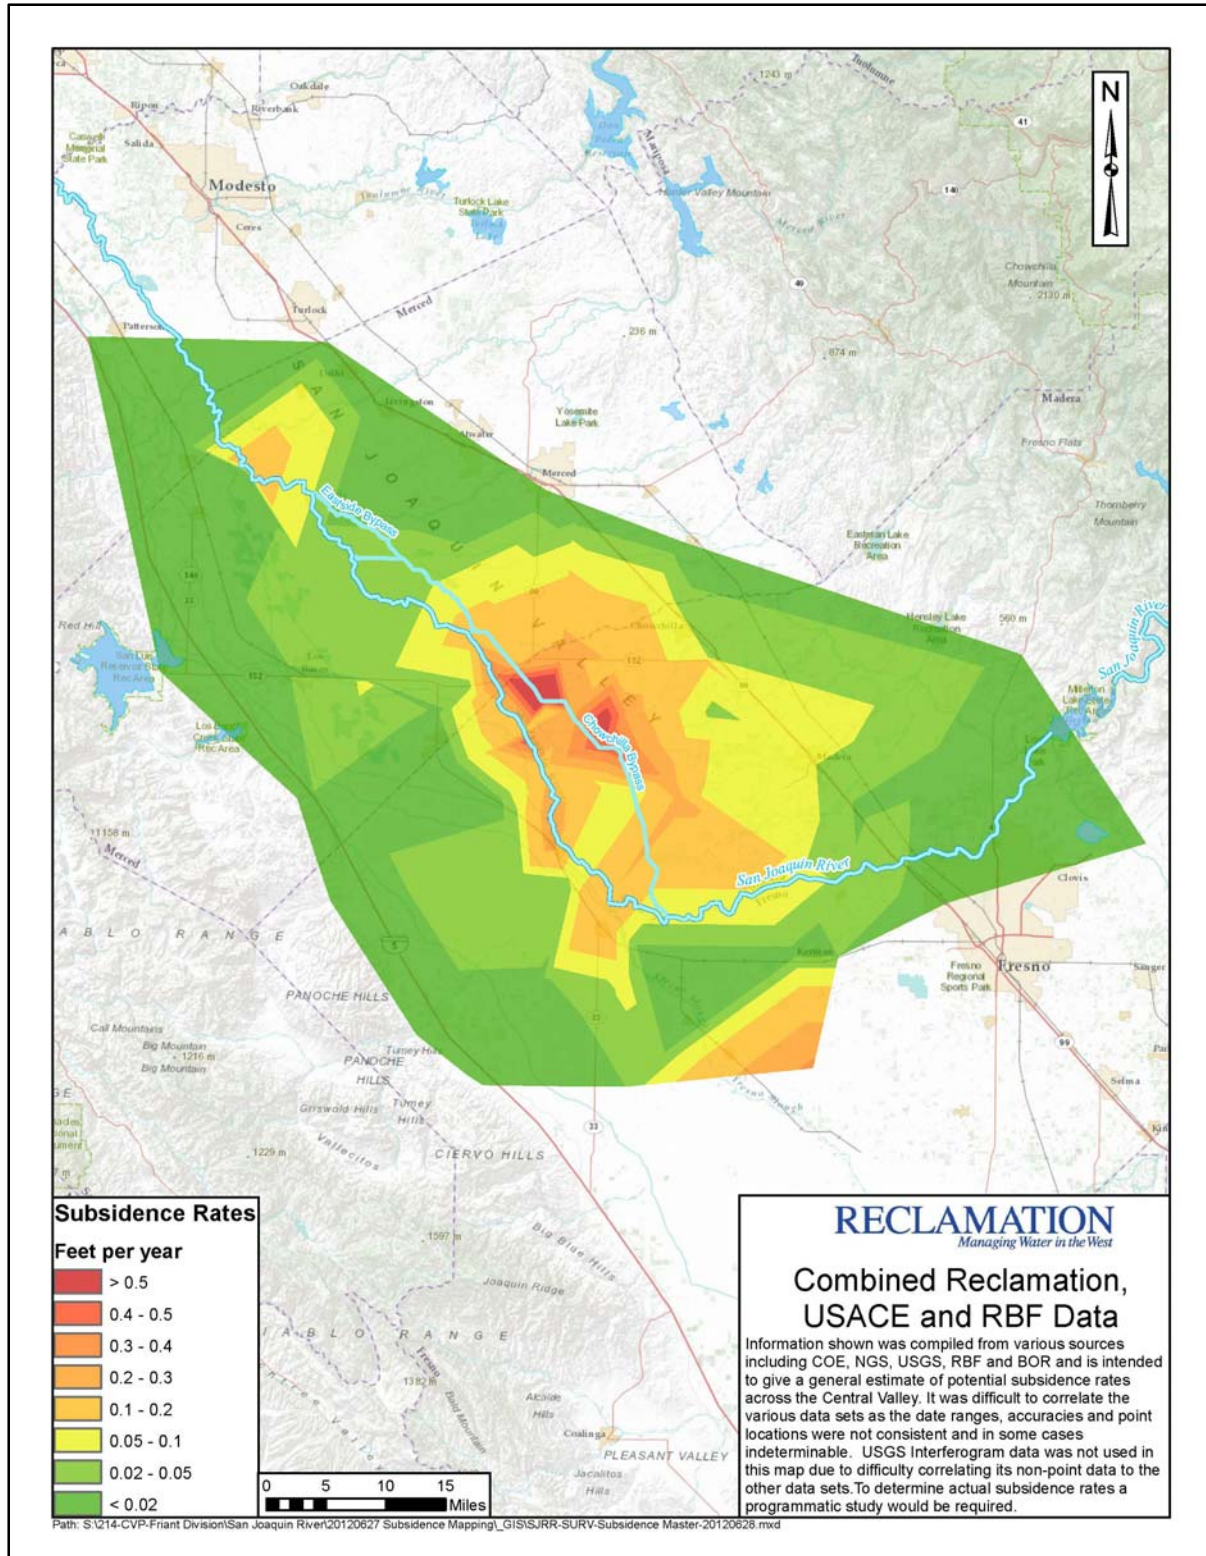
Figure 4. Combined calculated subsidence rates

To provide a general estimate of the potential subsidence rates and trends within the Restoration Area and surrounding areas, Reclamation developed an exhibit map that combined data from various sources prior to the 2011 data collection effort, including Reclamation, USACE, and RBF (**Figure 4**). This showed annual subsidence rates ranging from less than 0.02' to more than 0.5' per year. However, Reclamation and DWR surveys show from 2011 to 2013 that the rates have either stayed or have more than doubled in some areas.

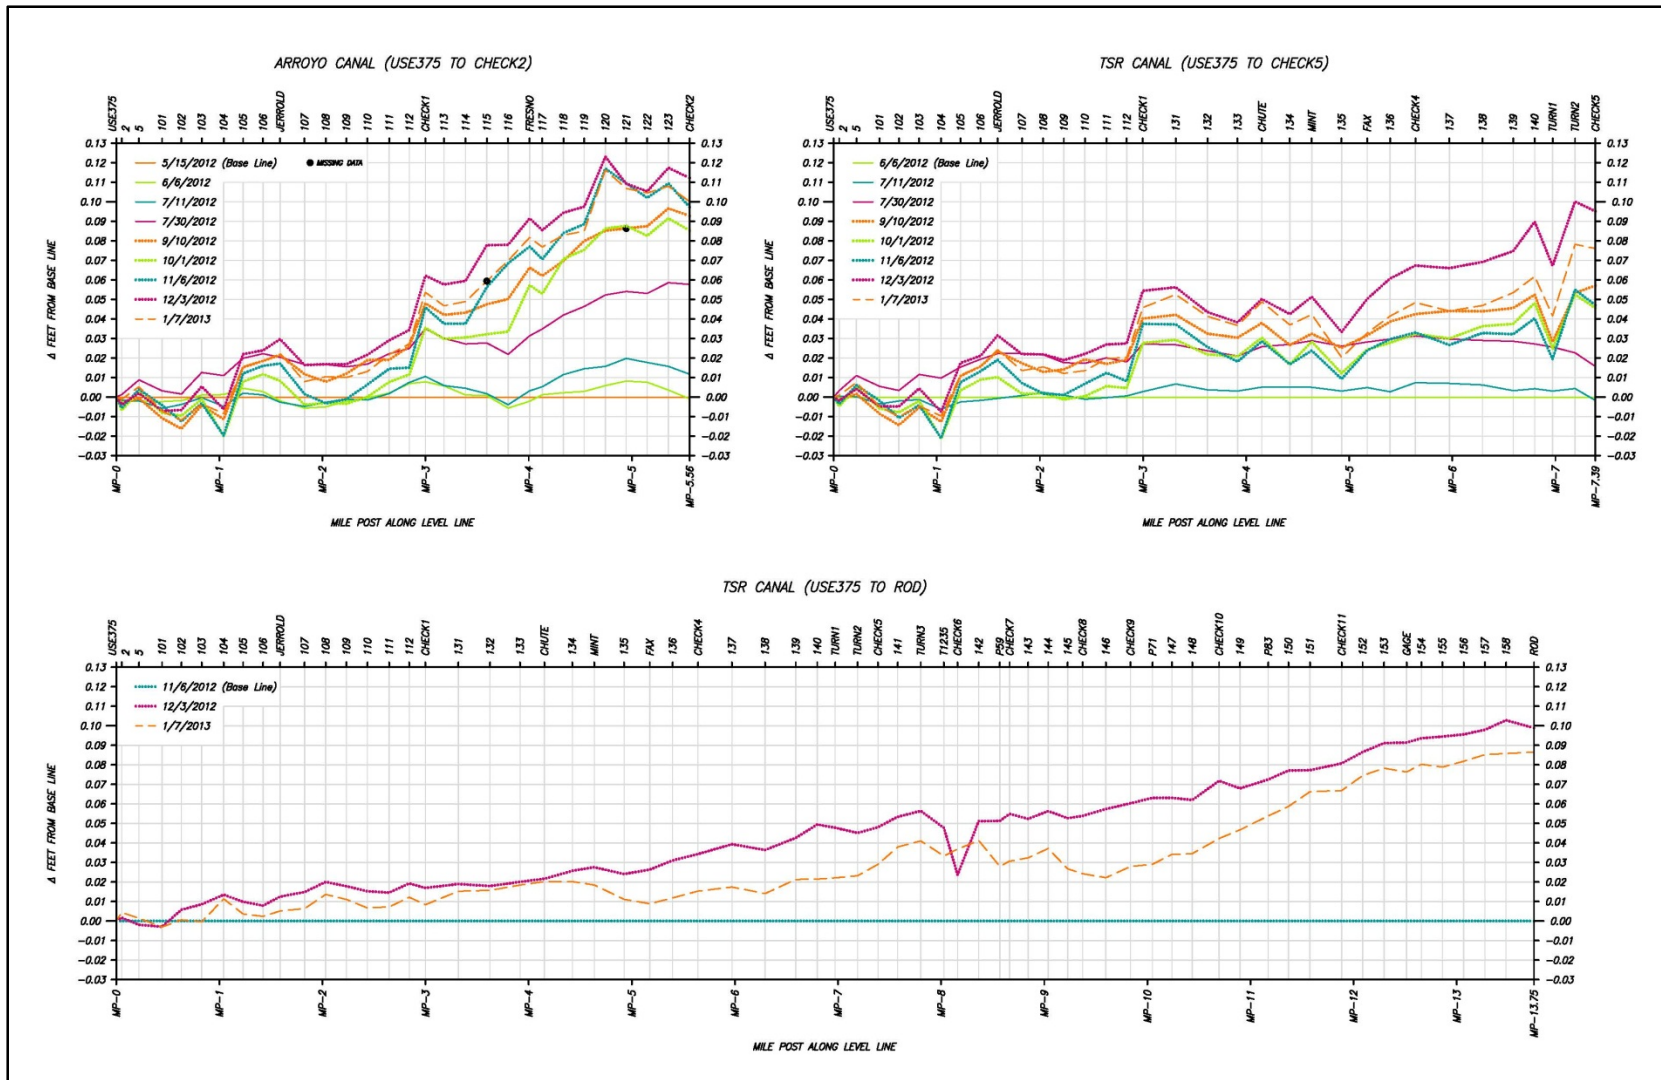
Figure 6. Survey results showing relative changes in elevation along the Arroyo and Temple-Santa Rita Canals

Reclamation has monitored the Arroyo and Temple-Santa Rita (TSR) Canals by surveying regular monitoring points monthly from March of 2012 through March of 2013. The results of each survey were compared in Excel calculating the relative change in elevation along the Arroyo and Temple-Santa Rita Canals in relation to the benchmark at Sack Dam (375 USE). The survey is not directly tied to the ongoing SJRRP's Geodetic Network updates, but provides a relative change compared to the initial "baseline" survey. The survey results are shown in **Figure 6.**

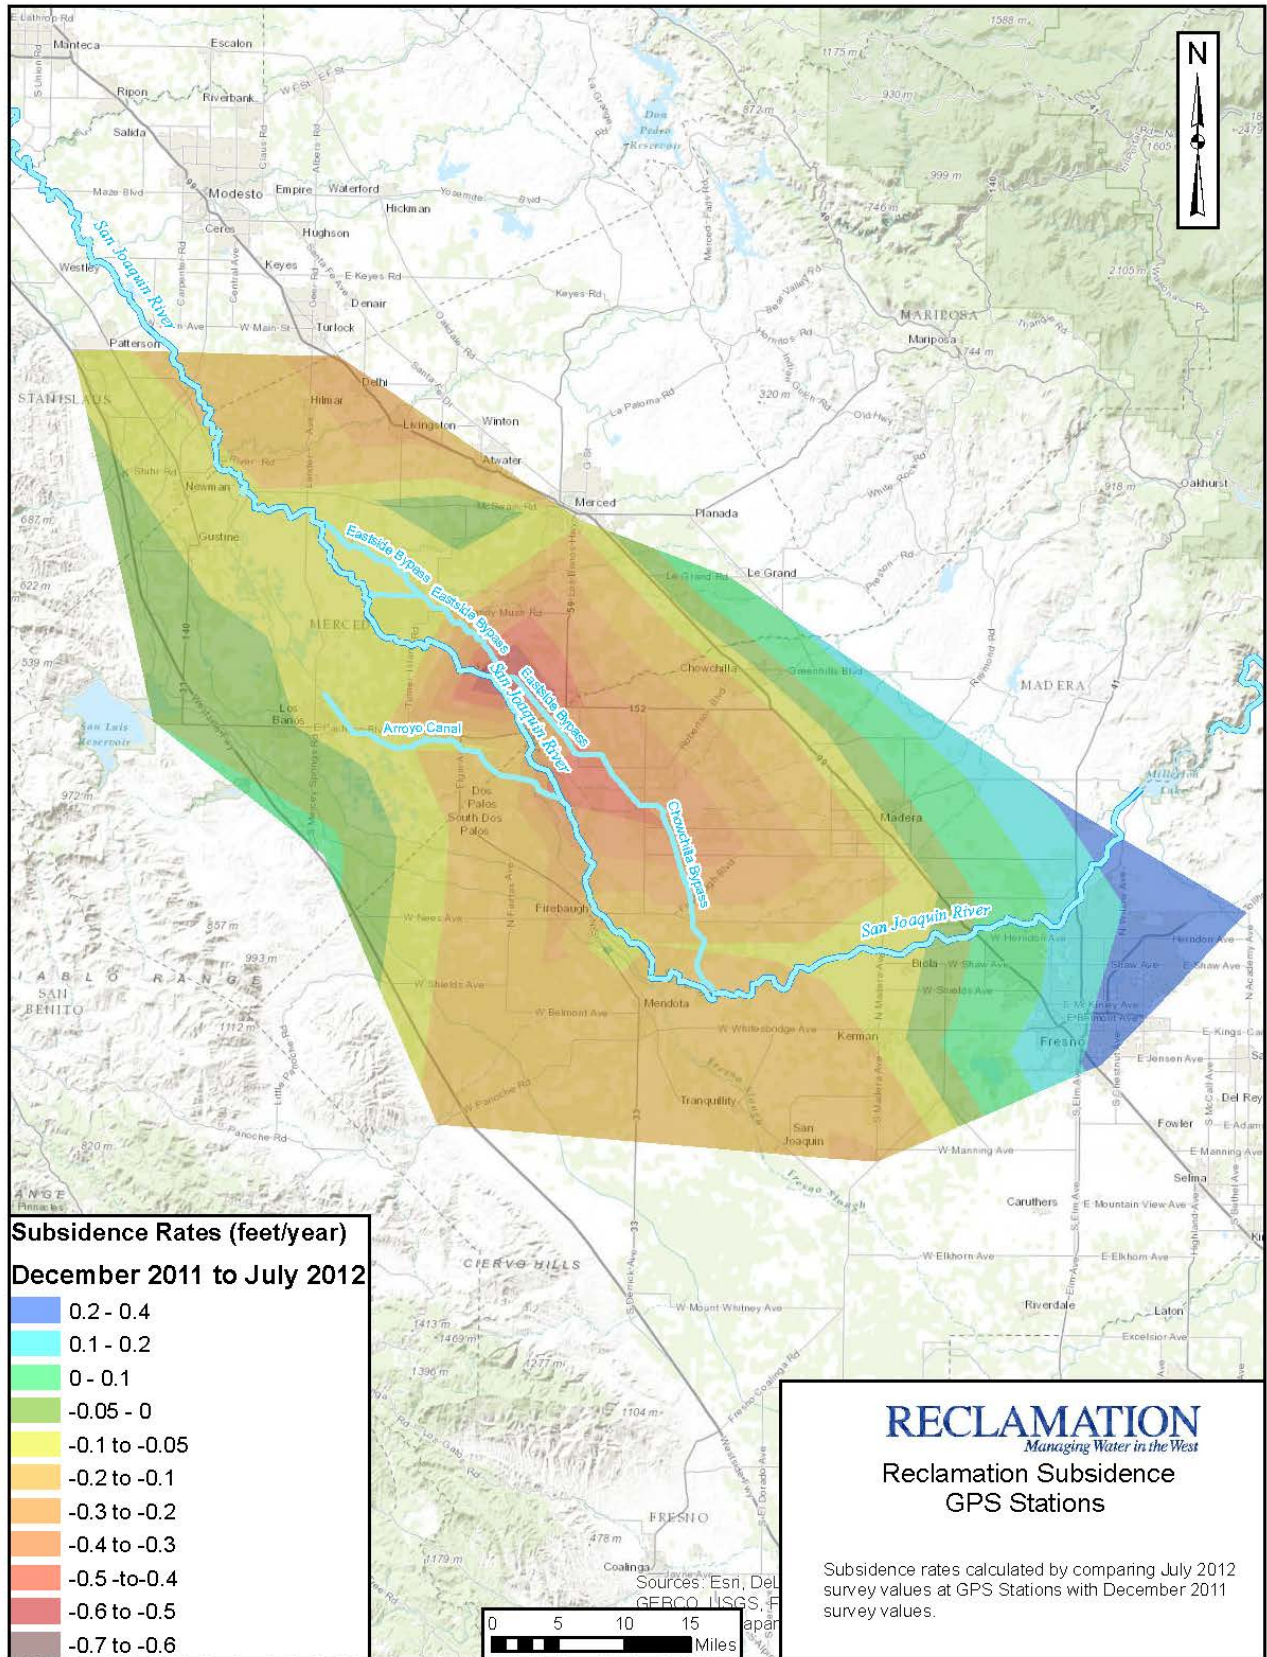
Figure A.1. Annual Subsidence Rate Exhibit Map for December 2011 to July 2012

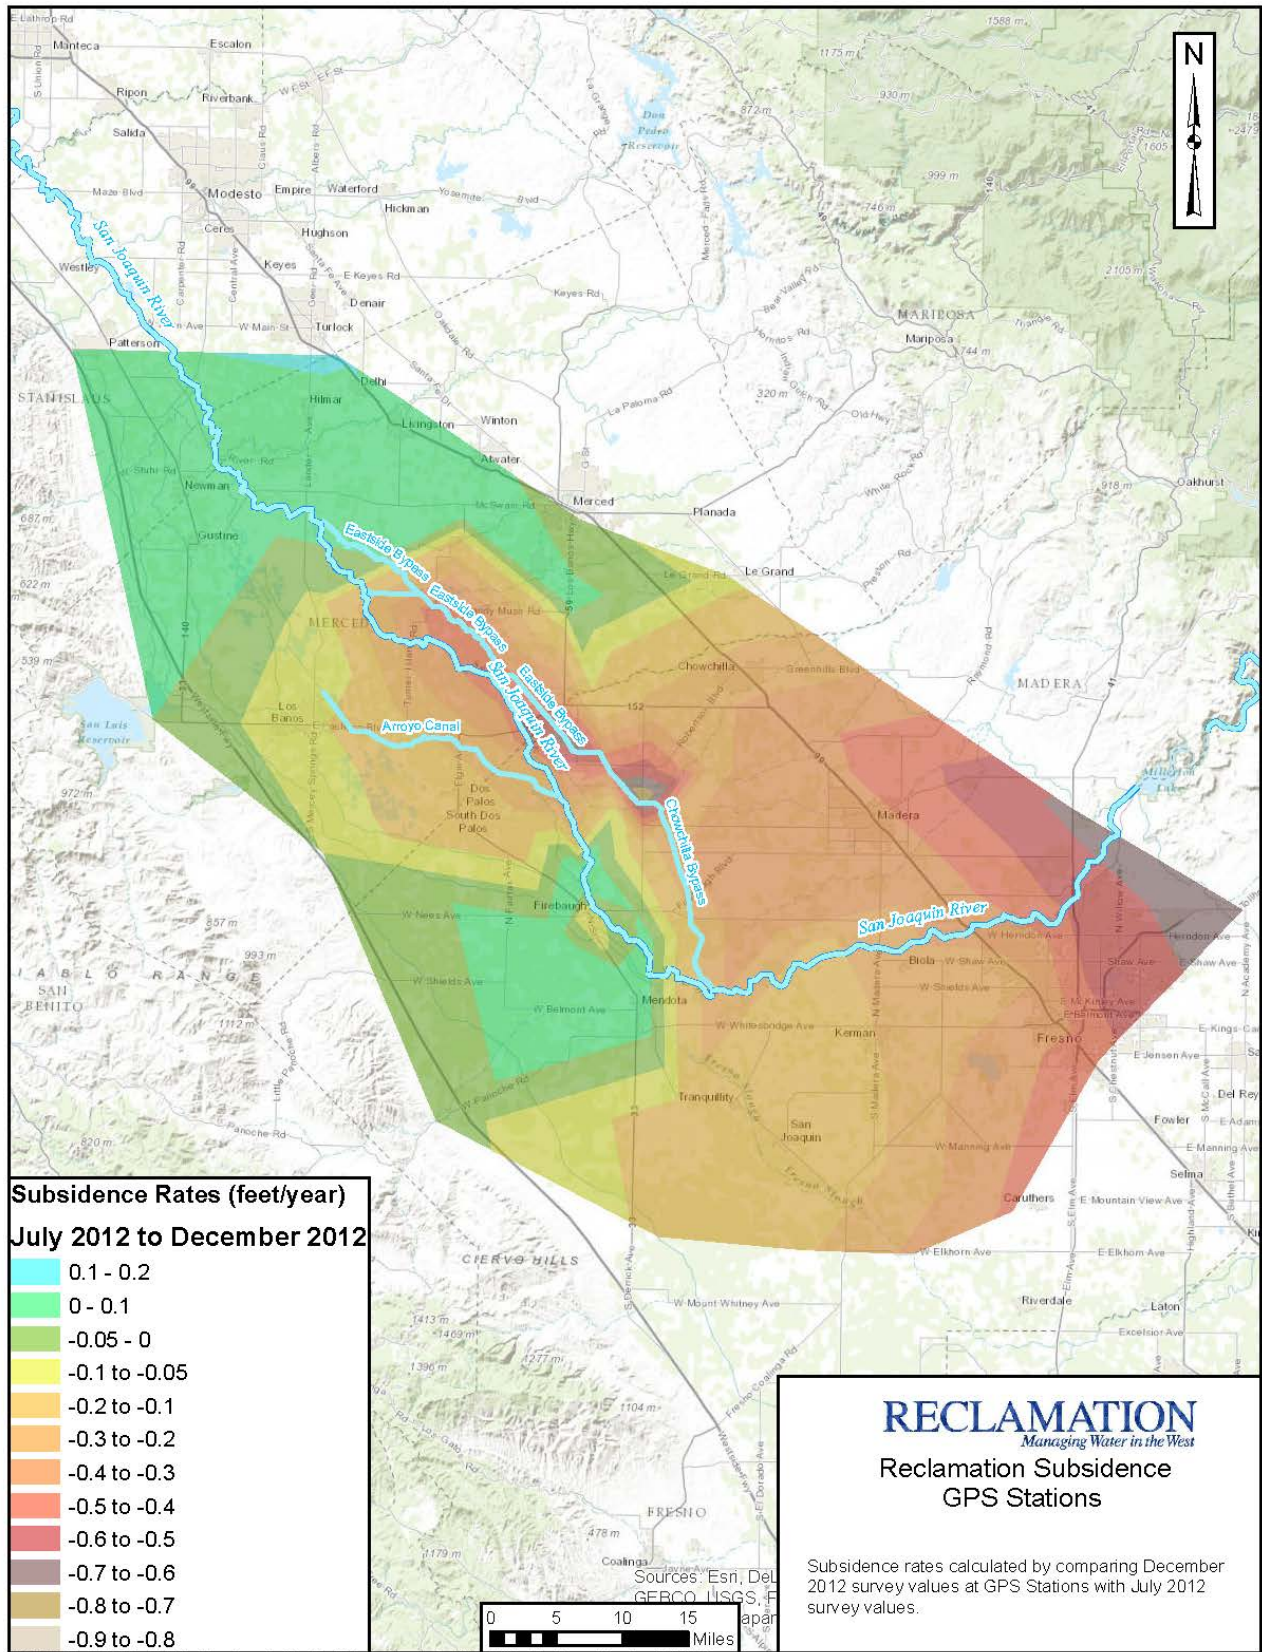
Figure A.2. Annual Subsidence Rate Exhibit Map for July 2012 to December 2012

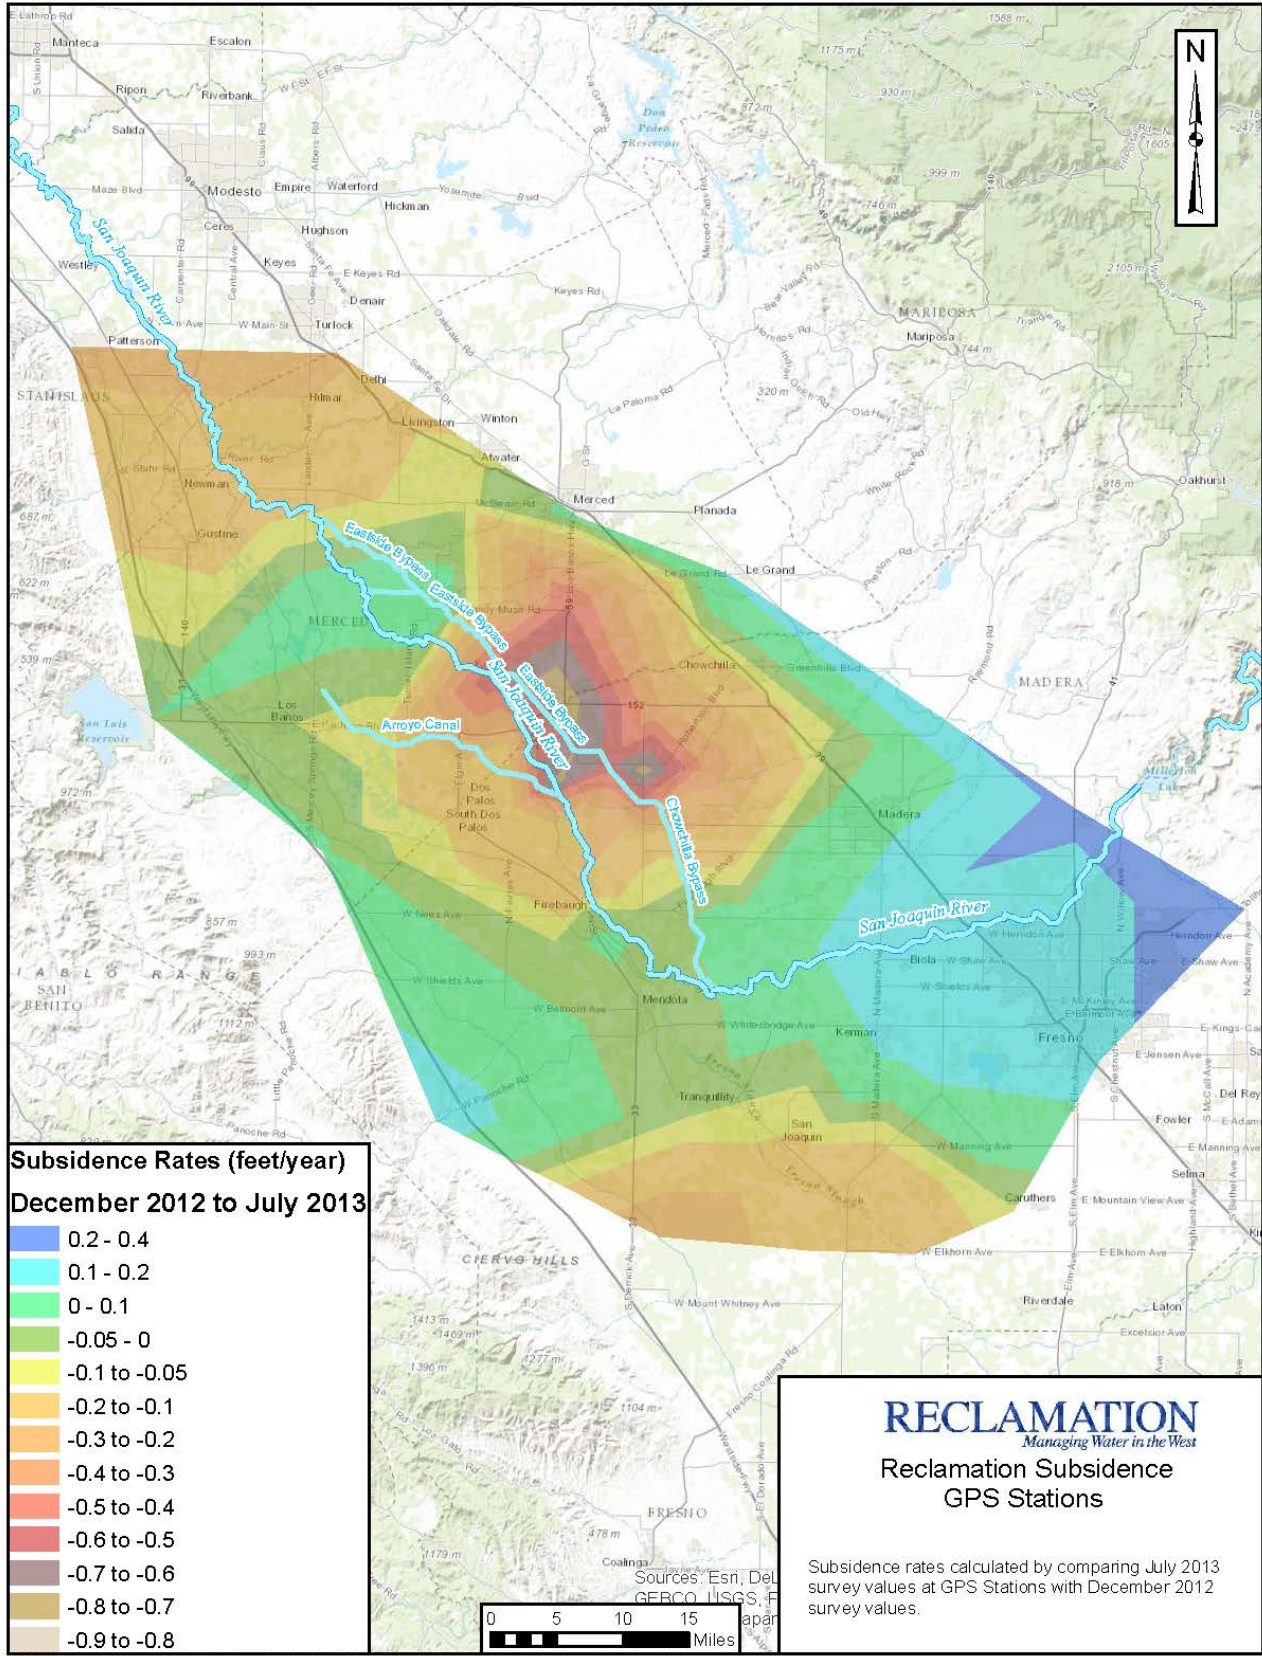
Figure A.3. Annual Subsidence Rate Exhibit Map for December 2012 to July 2013

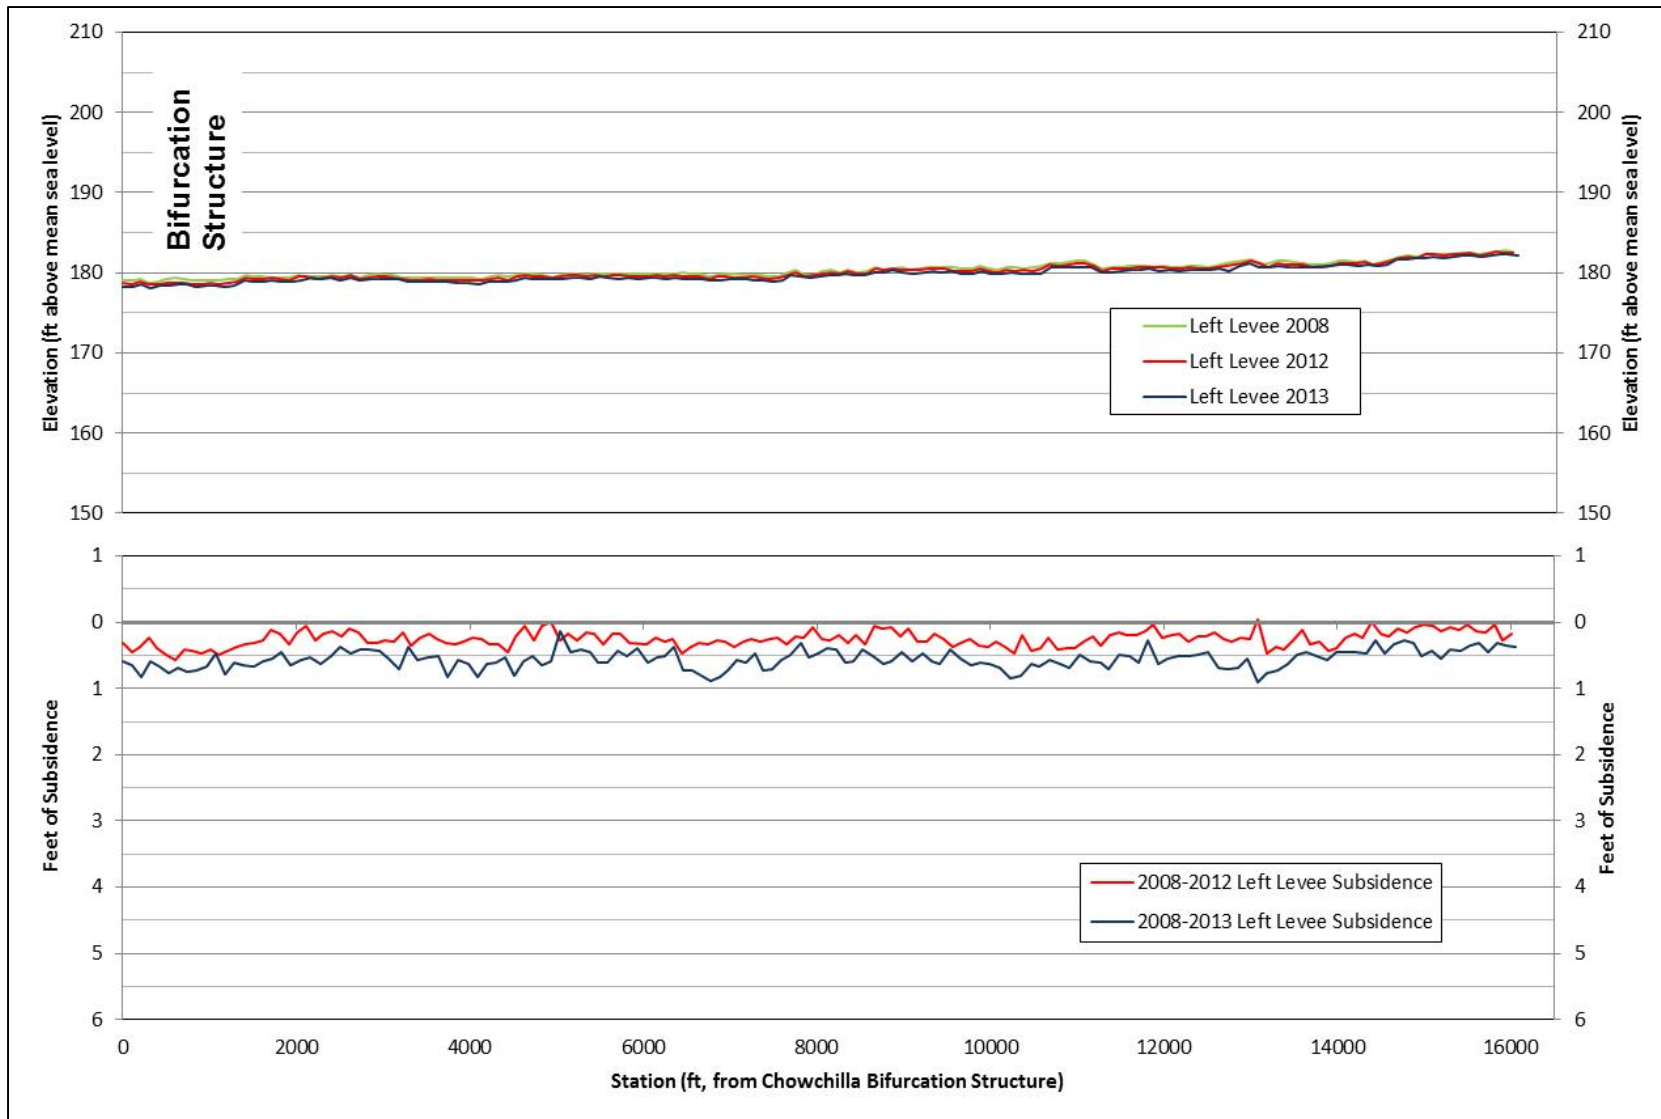
Figure B.1 Ground subsidence along the left levee in Reach 2A upstream of the San Joaquin River Bifurcation Structure based on the 2012 and 2013 survey and 2008 LiDAR.

To better define, as well as confirm the overall subsidence trends shown in Reclamation's initial exhibit maps, in 2012 and again in 2013, DWR-SCRO collected elevation data along about 65 miles of bypass and Reach 2A levee crowns. Profiles showing the levee crown elevations from the 2008 LiDAR mapping completed by DWR and the 2012 and 2013 surveys are shown in Appendix B of this report. In general, the profiles show that subsidence is occurring at various rates along the bypasses from almost 6 ft in the Upper Eastside Bypass since 2013 to less than 0.5' in Reach 2A and the lower portion of the Middle Eastside Bypass and Mariposa Bypass. In addition, a comparison of the DWR-SCRO survey data in some areas shows that the ground during the 2012 surveys appears higher (up to about 0.5'), and to a lesser extent the 2013 survey than the LiDAR data. Some of these differences may be a result of physical changes to the levees (e.g., placement of material on top of the levees after the LiDAR surveys), data collection methods (GPS when compared to LiDAR), or the accuracy of the LiDAR data itself; but the specific source of these anomalies were not investigated (DWR-SCRO, 2013).

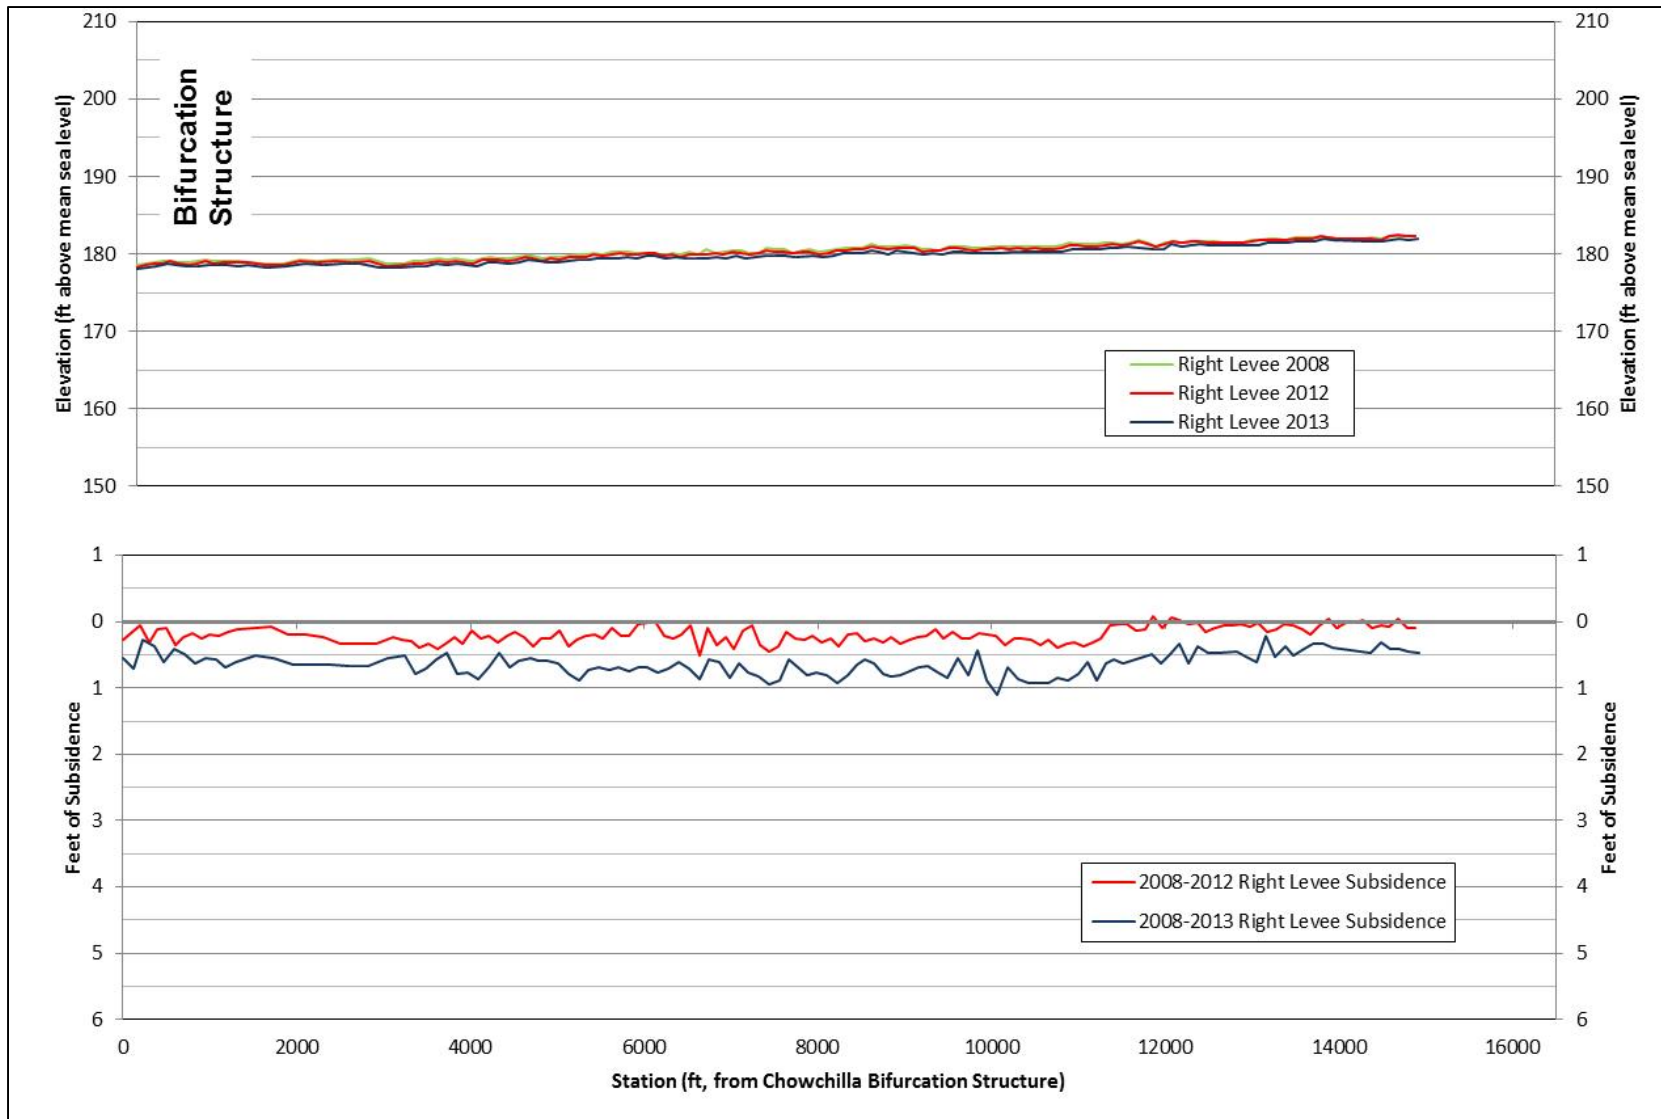
Figure B.2. Ground subsidence along the right levee in Reach 2A upstream of the San Joaquin River Bifurcation Structure based on the 2012 and 2013 survey and 2008 LiDAR.

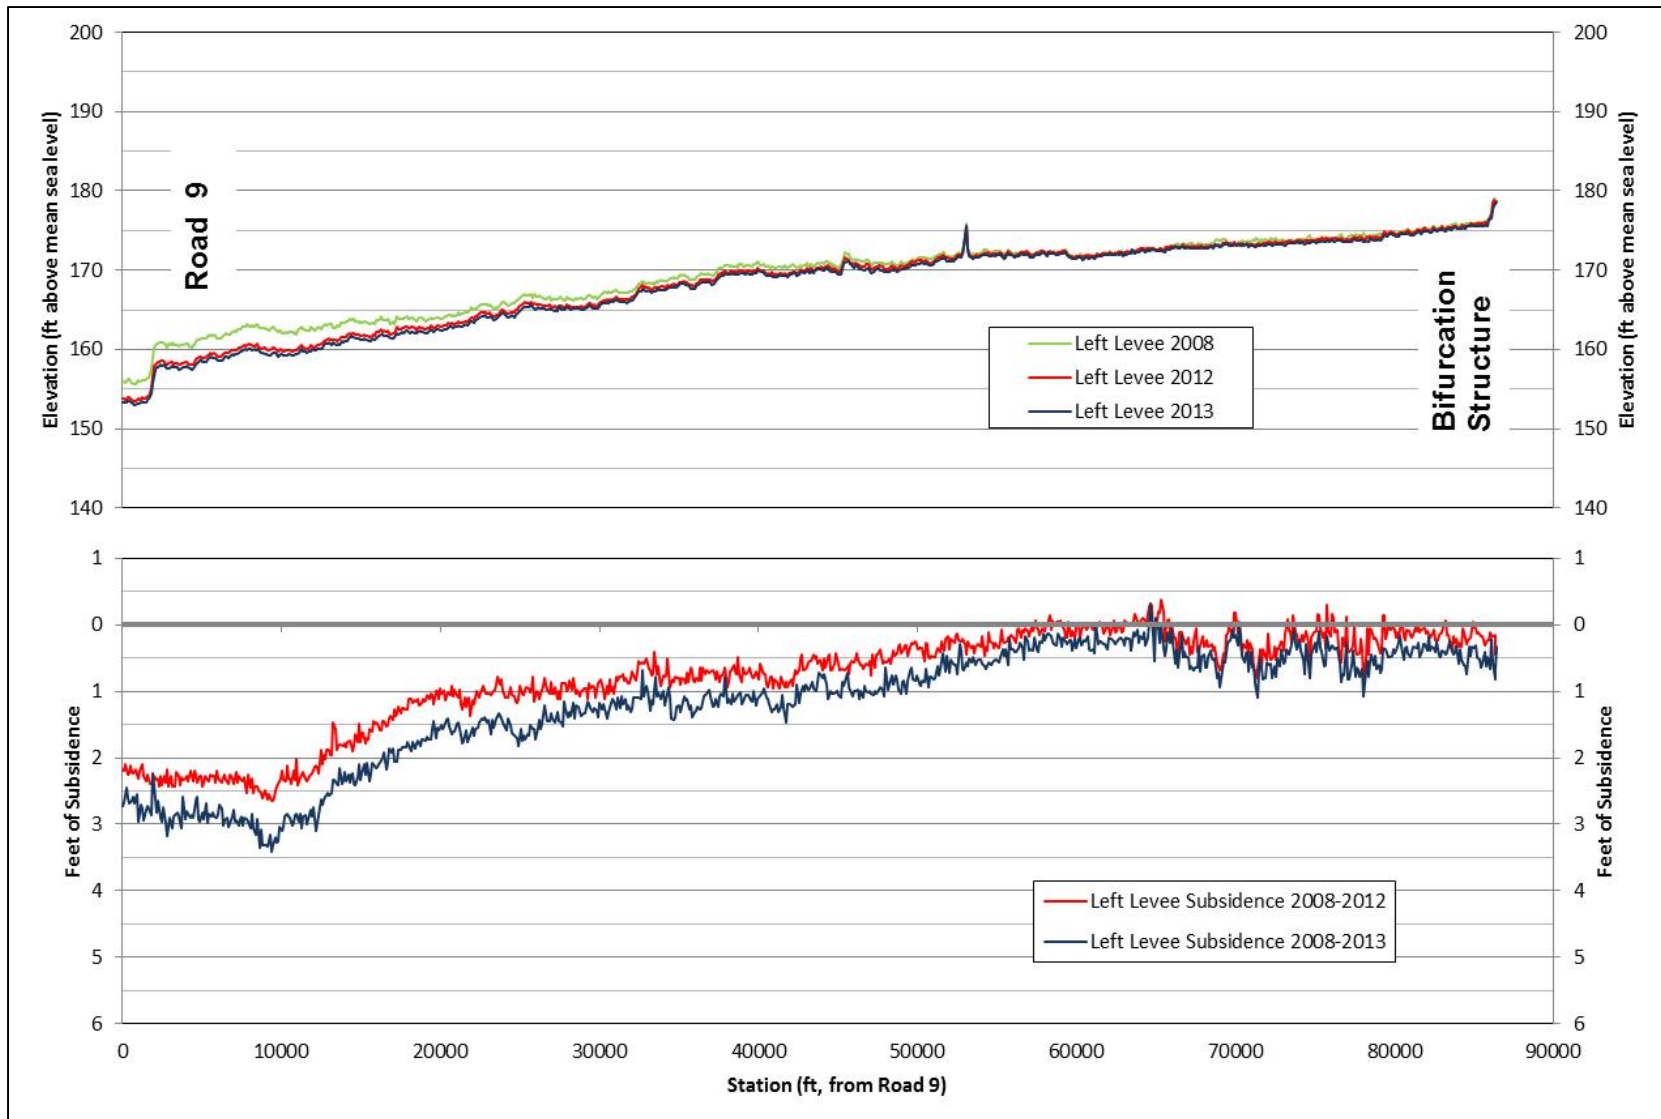
Figure B.3. Ground subsidence along the left levee in the Chowchilla Bypass from the San Joaquin River Bifurcation to Road 9 based on the 2012 and 2013 survey and 2008 LiDAR.
