DRAFT Technical Memorandum

Subsidence Monitoring

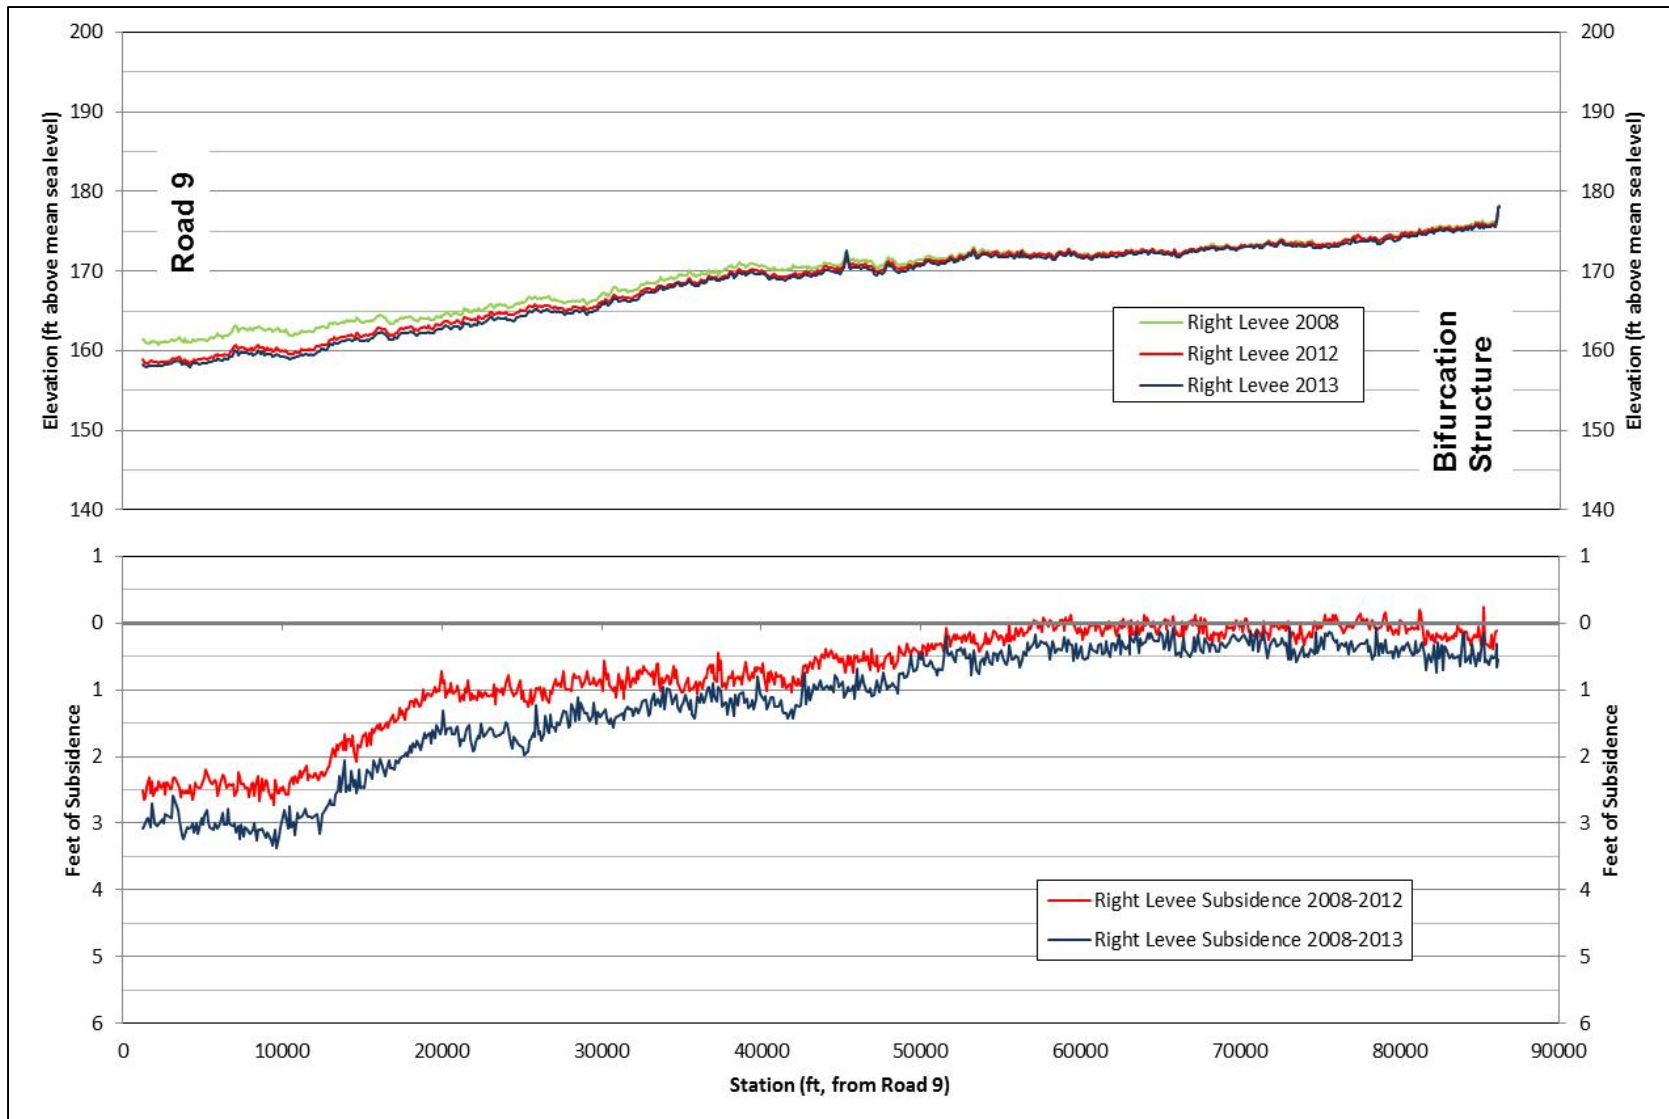
Figure B.4. Ground subsidence along the right levee in the Chowchilla Bypass from the San Joaquin River Bifurcation to Road 9 based on the 2012 and 2013 survey and 2008 LiDAR.

To better define, as well as confirm the overall subsidence trends shown in Reclamation's initial exhibit maps, in 2012 and again in 2013, DWR-SCRO collected elevation data along about 65 miles of bypass and Reach 2A levee crowns. Profiles showing the levee crown elevations from the 2008 LiDAR mapping completed by DWR and the 2012 and 2013 surveys are shown in Appendix B of this report. In general, the profiles show that subsidence is occurring at various rates along the bypasses from almost 6 ft in the Upper Eastside Bypass since 2013 to less than 0.5' in Reach 2A and the lower portion of the Middle Eastside Bypass and Mariposa Bypass. In addition, a comparison of the DWR-SCRO survey data in some areas shows that the ground during the 2012 surveys appears higher (up to about 0.5'), and to a lesser extent the 2013 survey than the LiDAR data. Some of these differences may be a result of physical changes to the levees (e.g., placement of material on top of the levees after the LiDAR surveys), data collection methods (GPS when compared to LiDAR), or the accuracy of the LiDAR data itself; but the specific source of these anomalies were not investigated (DWR-SCRO, 2013).

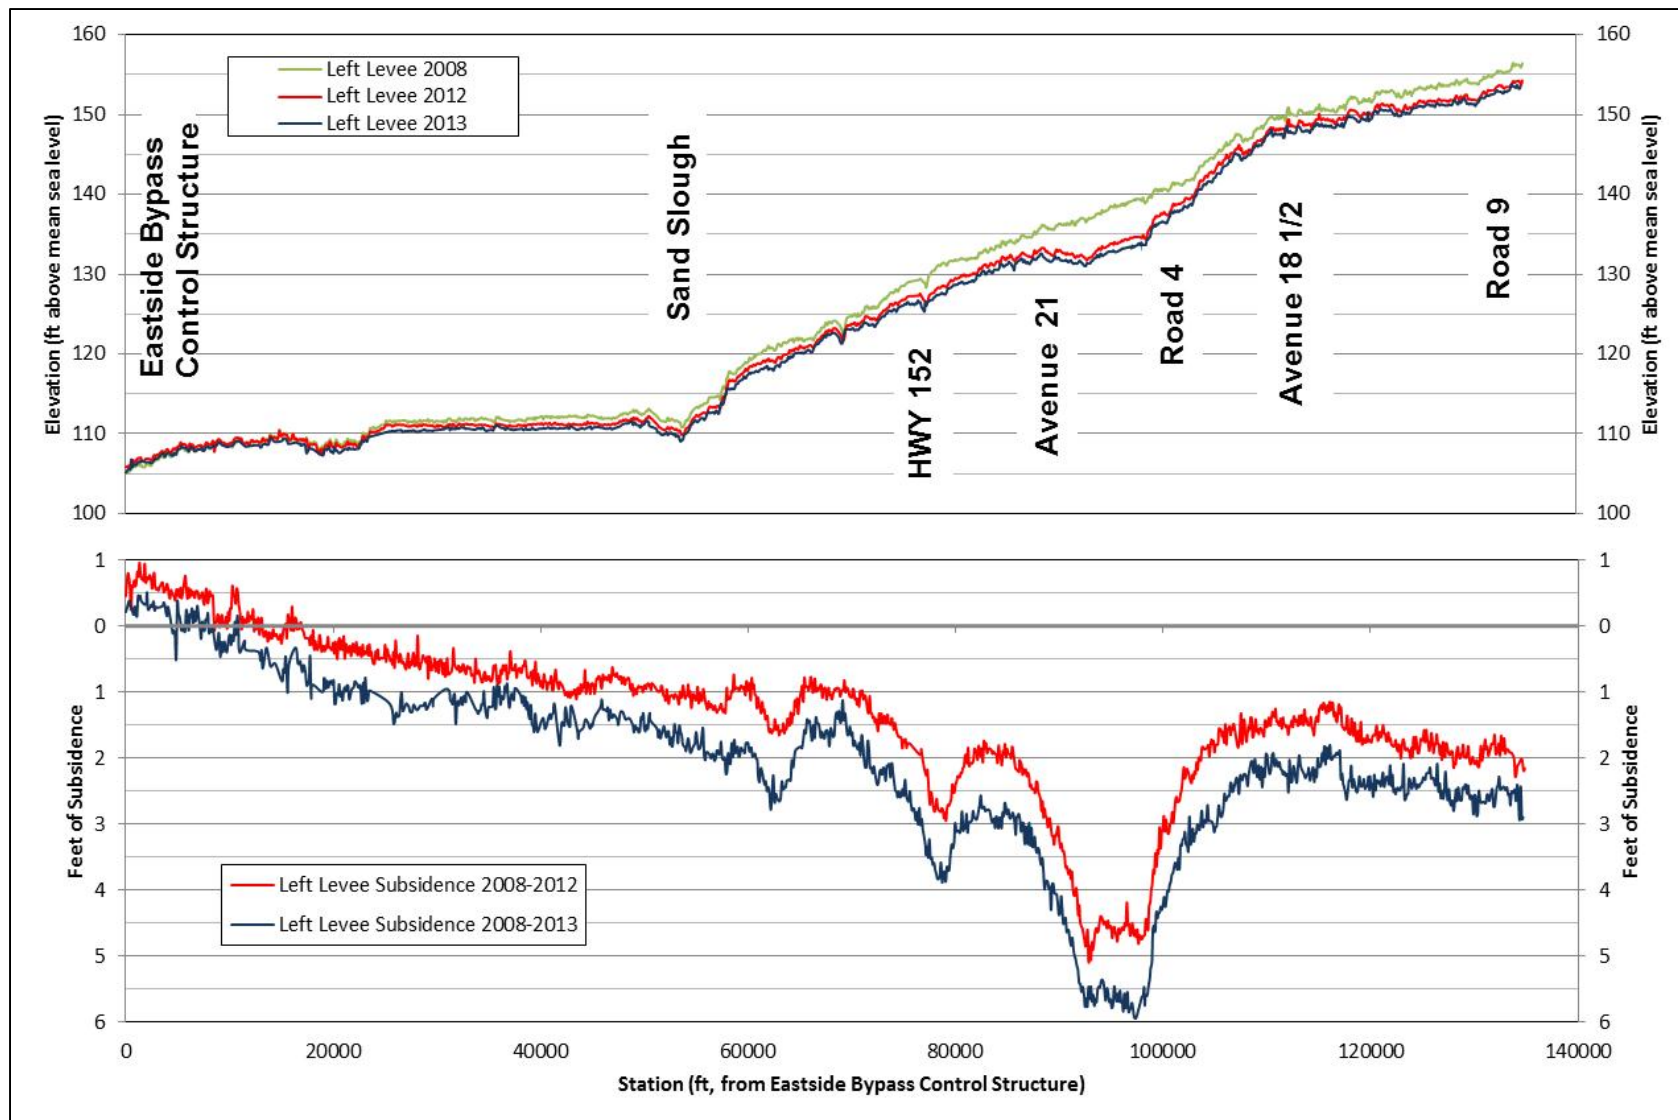
Figure B.5. Ground subsidence along the left levee in the Upper and Middle Eastside Bypasses from Road 9 to the Eastside Bypass Control Structure based on the 2012 and 2013 survey and 2008 LiDAR.

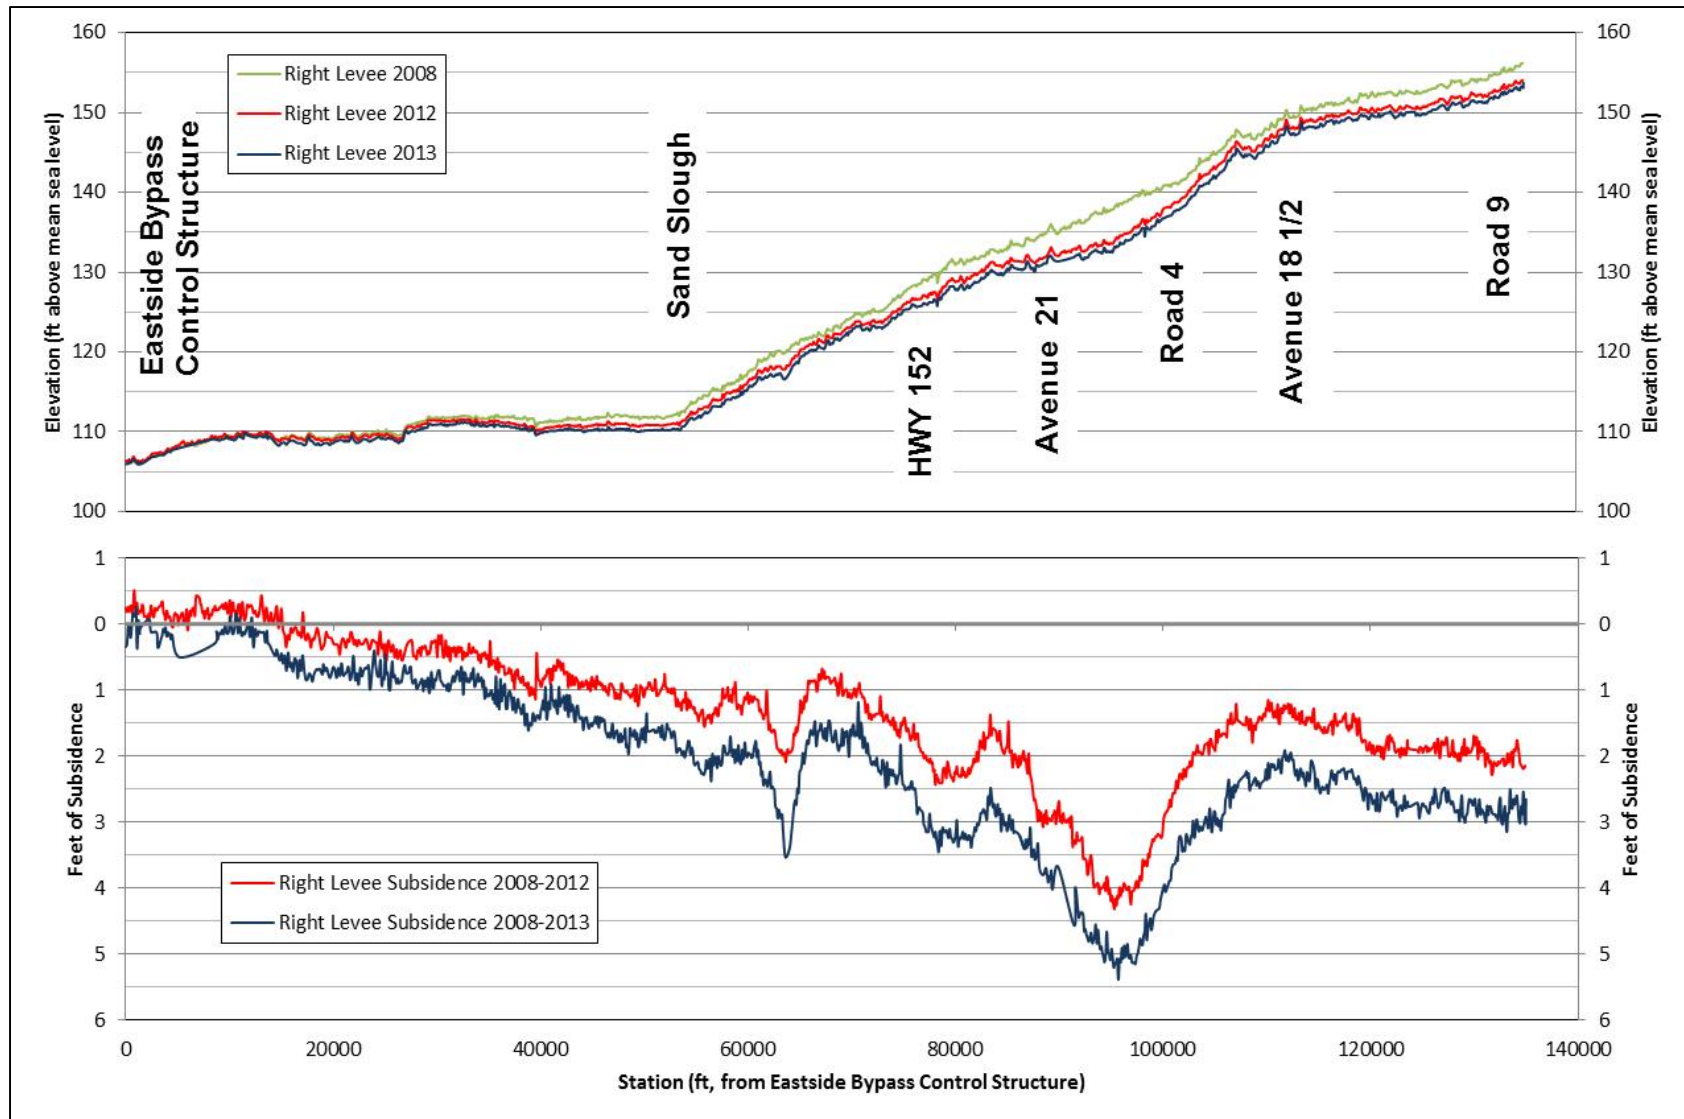
Figure B.6. Ground subsidence along the right levee in the Upper and Middle Eastside Bypasses from Road 9 to the Eastside Bypass Control Structure based on the 2012 and 2013 survey and 2008 LiDAR.

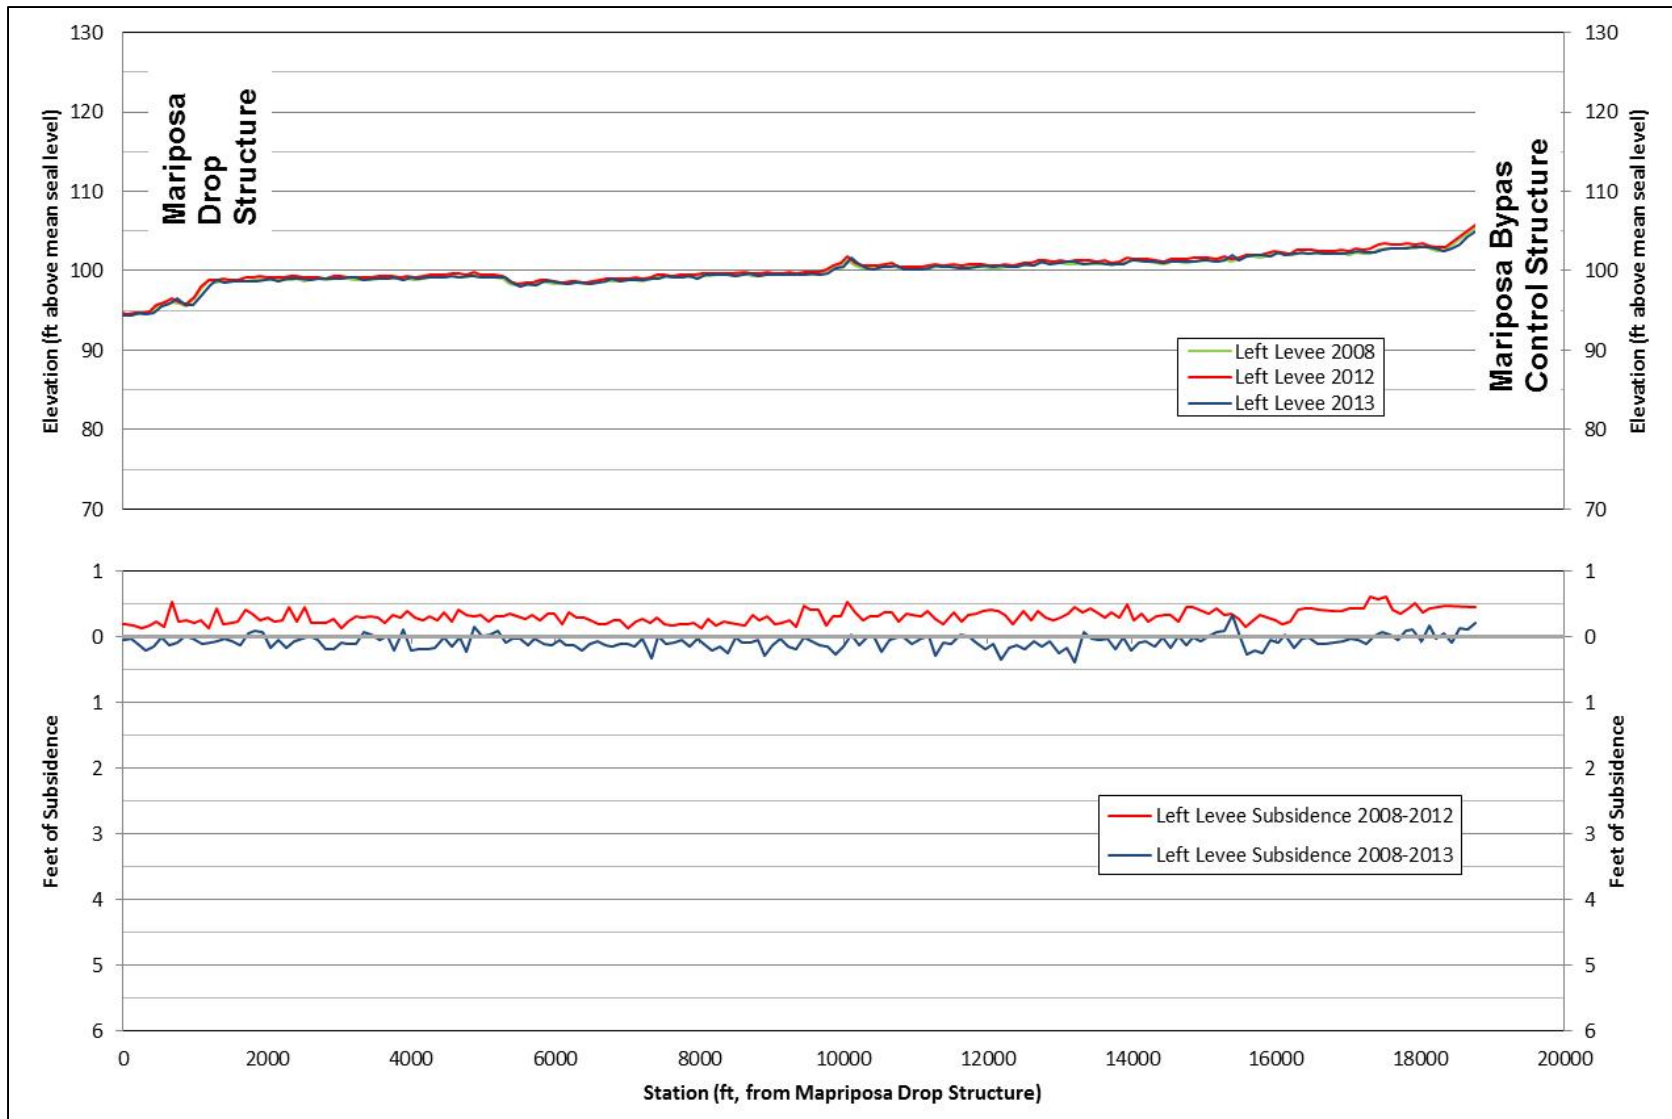
Figure B.7. Ground subsidence along the left levee in the Mariposa Bypass based on the 2012 and 2013 survey and 2008 LiDAR.

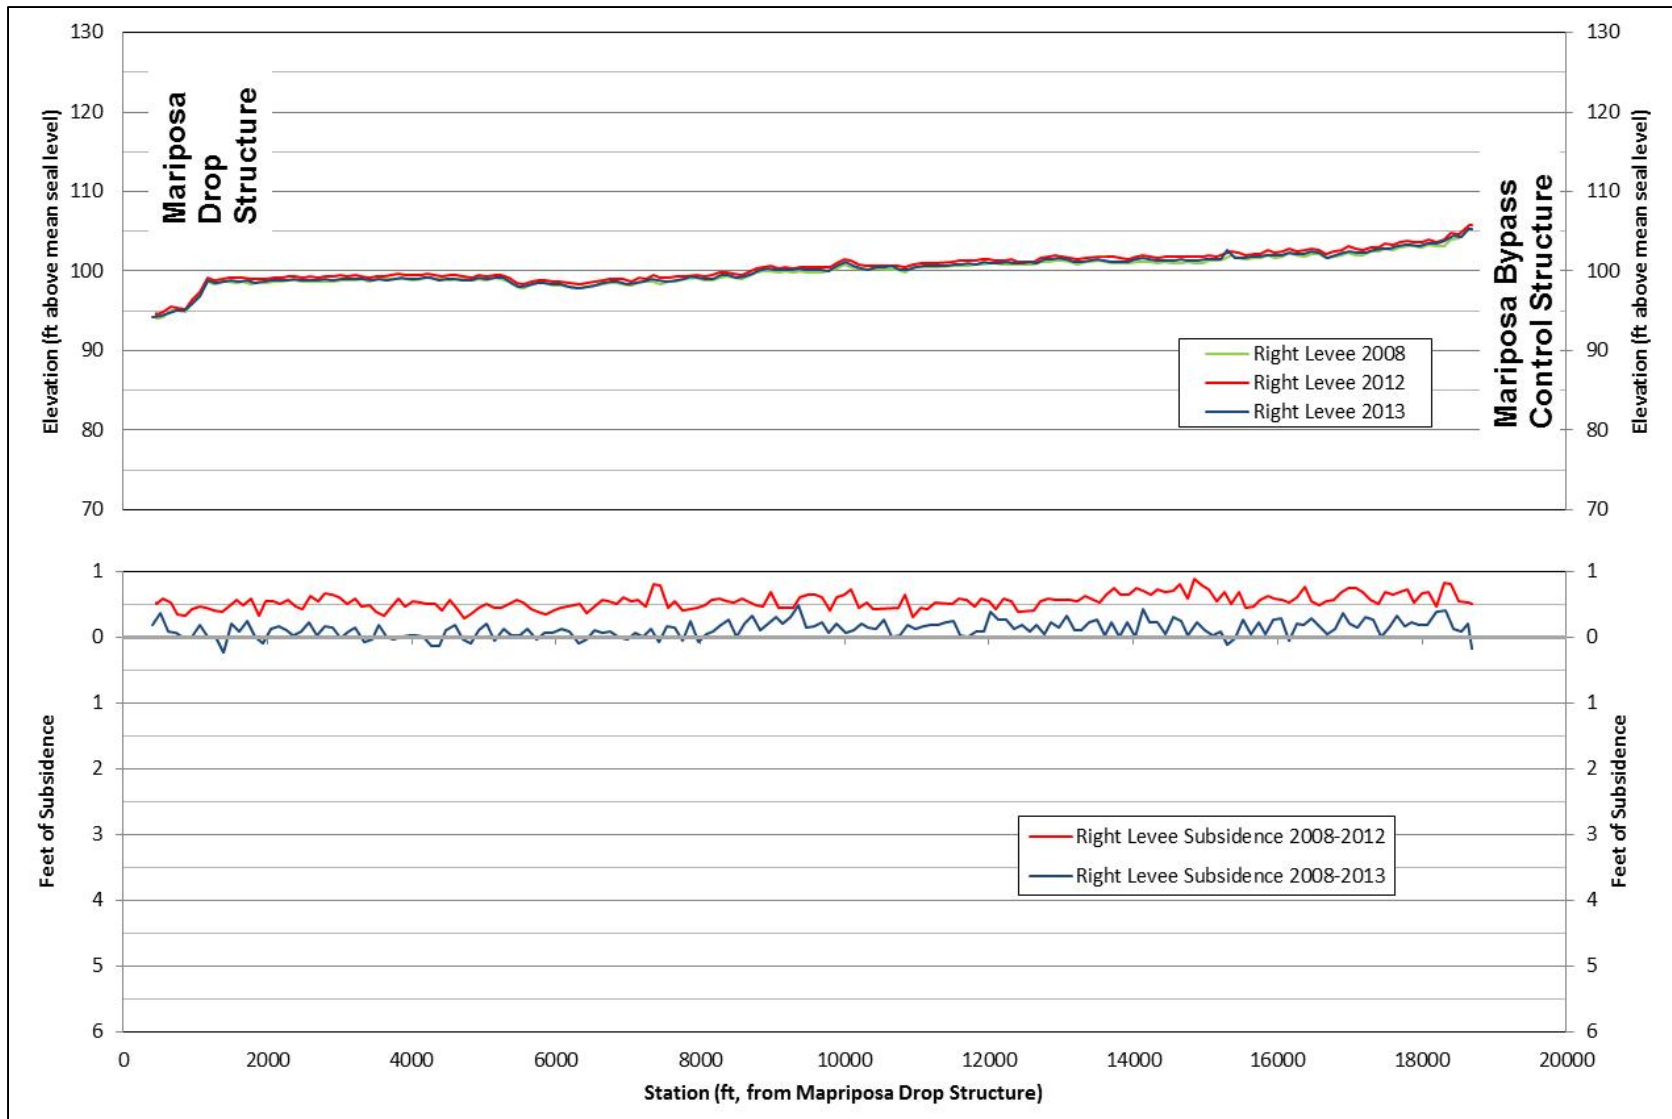
Figure B.8. Ground subsidence along the right levee in the Mariposa Bypass based on the 2012 and 2013 survey and 2008 LiDAR.
