Middle Eastside Bypass Geotechnical Assessment

August 2013

Technical Memorandum

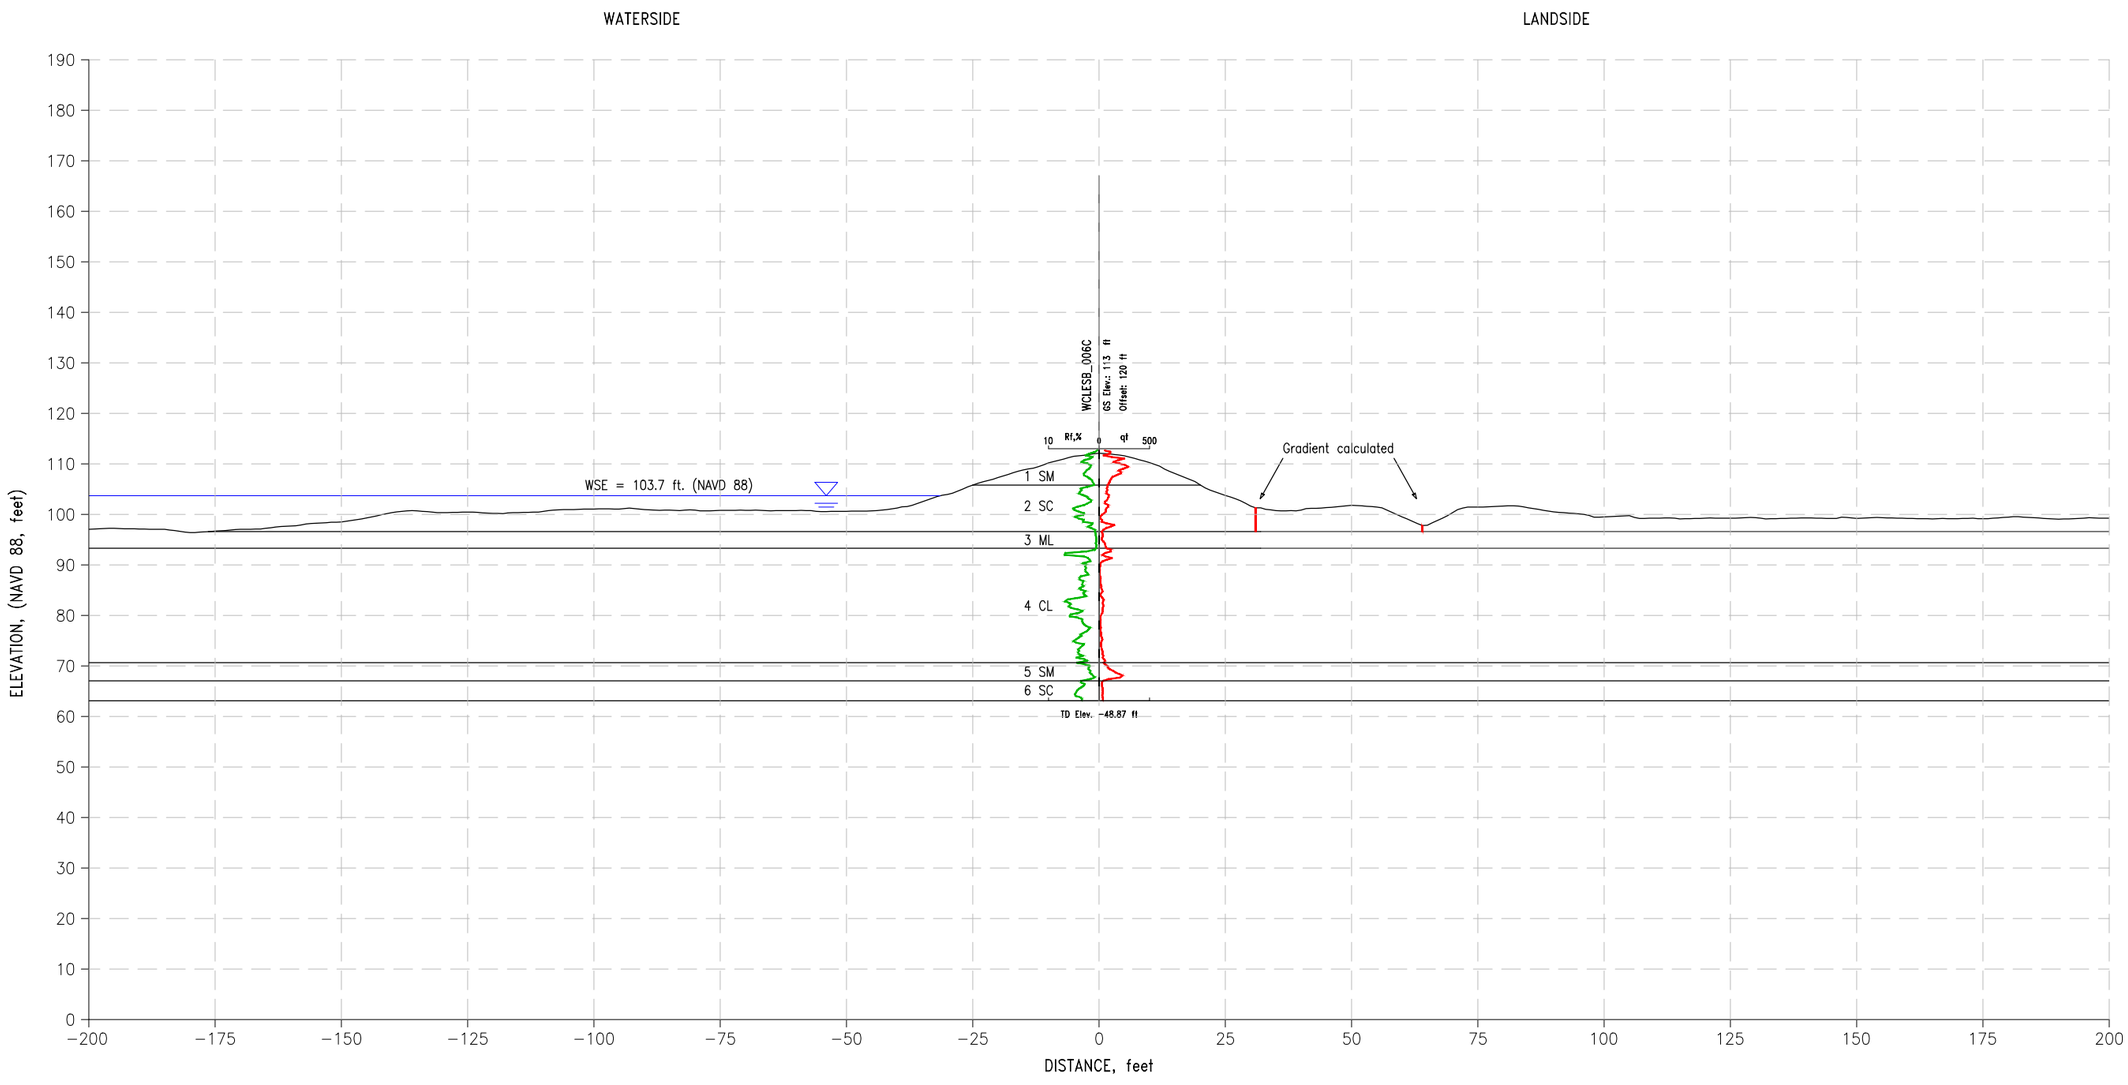
FIGURE
2

The analysis cross section for Site 1 is along the left bank of the levee at Station 1460+00. The levee in this portion of the system has a height of around 11 feet to 13 feet, with a levee crown width of 10 feet to 15 feet. Waterside and landside slopes are approximately 3.6H:1V and 2.5H:1V, respectively. This section of levee has a 3 feet to 4 feet deep landside ditch located approximately 30 feet from the landside levee toe. The analysis cross section is shown in Figure 2.

Based on the exploration data available, the levee embankment comprises a mixture of silty and clayey sand, silt and clay. Subsurface materials consist of silts and clays with interbeds of silty sand and clayey sand. A variable landside blanket thickness is indicated by the explorations. For the purpose of analysis, a base model was established using information from cone penetrometer test (CPT) WCLESB_006C, which indicates a landside blanket condition approximately 4 feet thick. Due to the presence of a landside ditch, the blanket thickness is reduced to a thickness of around 1.5 feet (Figure 2).

The analysis results show that underseepage is the controlling geotechnical failure mode for Site 1 assuming ditch empty conditions, but when modeling ditch full conditions landside slope stability controls. According to the levee maintenance district, the landside ditches normally run full during the wet season. However, given that it is not clear when water could be released from Friant dam, it is possible that the levee could experience water with ditch full or ditch empty conditions.

Based on the above, it is considered that sensitivity case 3 is representative for the ditch empty condition taking into account the potential for cracking of the blanket layer at the bottom of the ditch and that sensitivity case 4 is representative for the ditch full condition. Therefore, a WSE of between +100.7 feet (NAVD88) and+104.7 feet (NAVD88) is acceptable at this location for ditch empty and ditch full conditions respectively. This corresponds to between approximately 1-foot (ditch empty) and 4 feet (ditch full) of water on the waterside of the levee relative to the landside toe elevation.

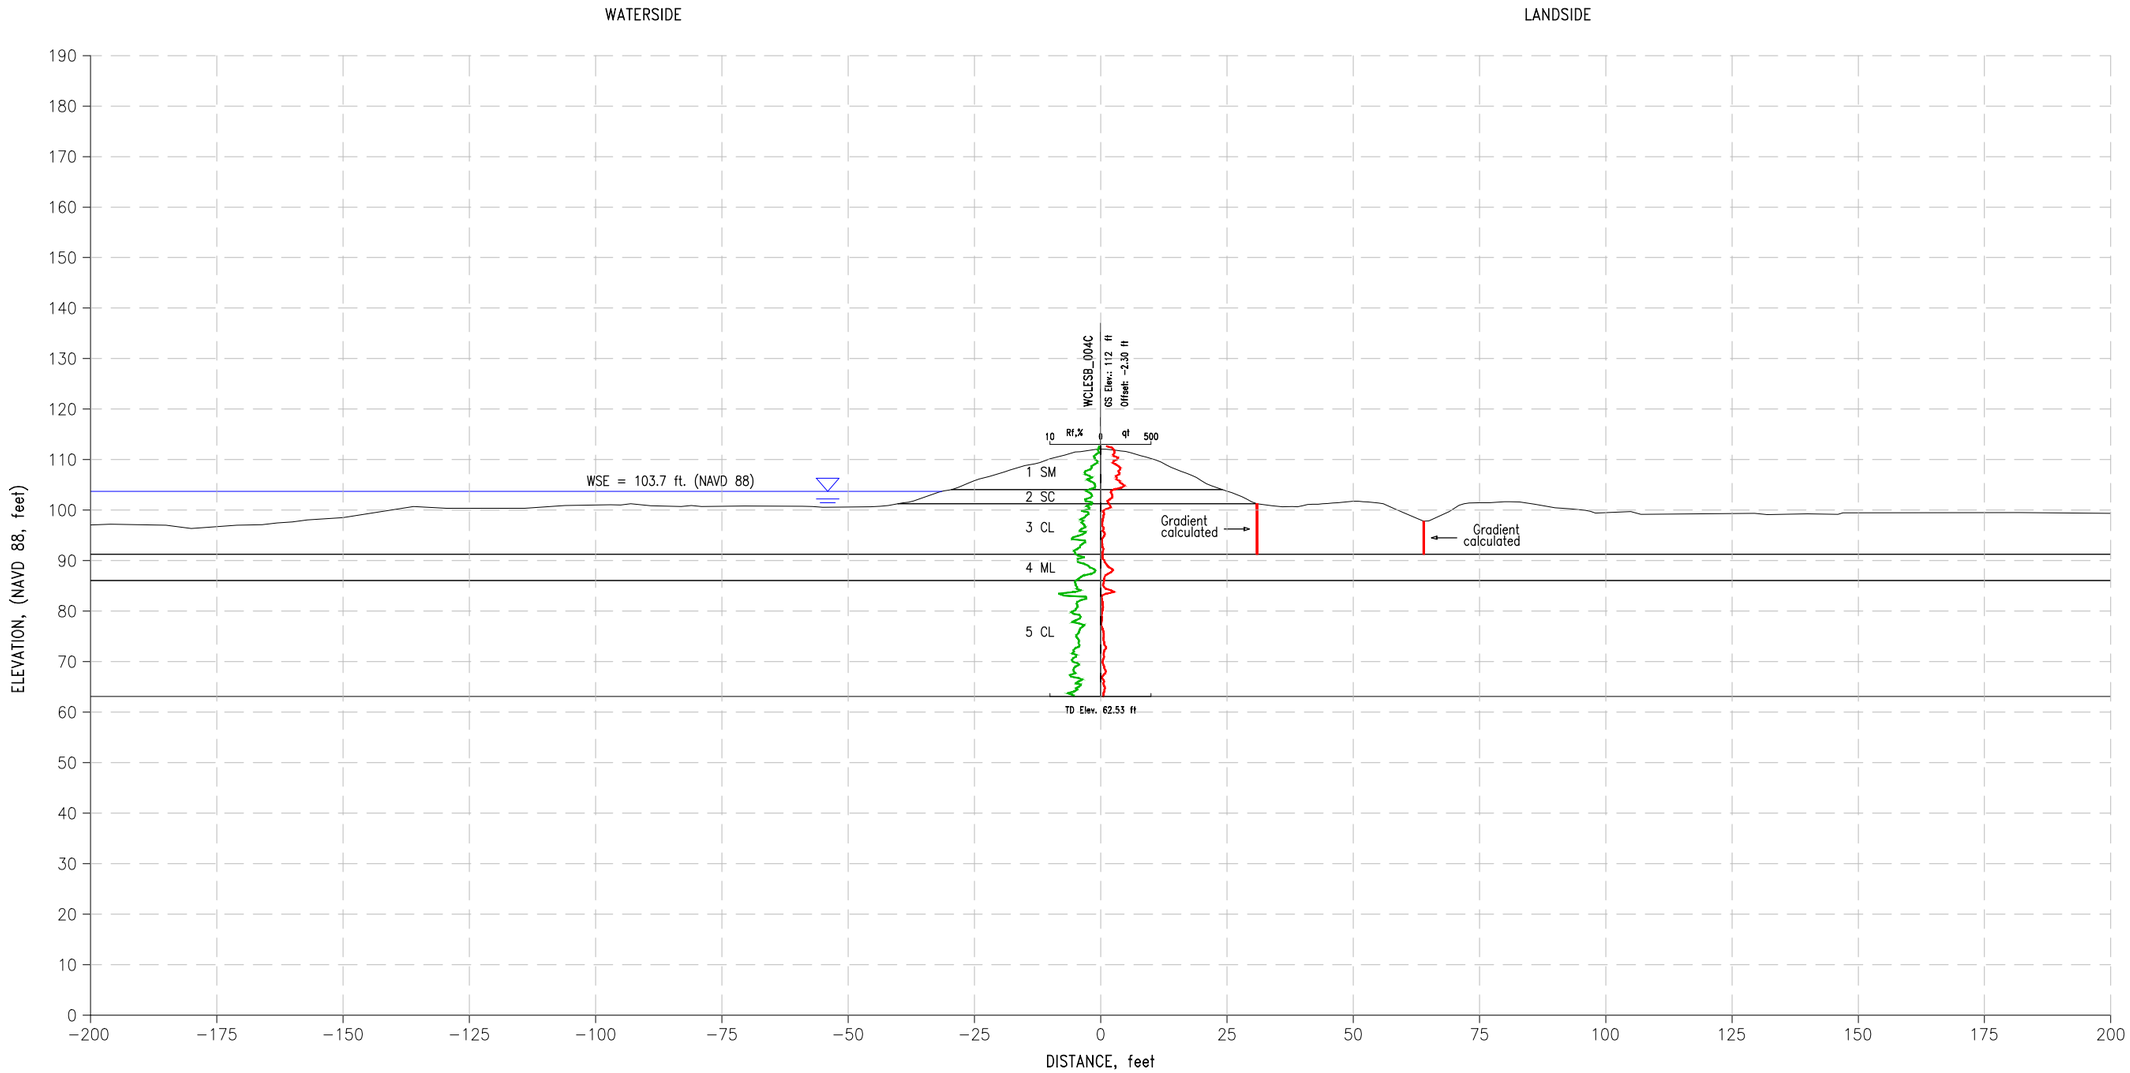
FIGURE
3

Due to the variability in blanket thickness in this section of the levee, an additional analysis model was created using information obtained from CPT WCLESB_004C. This exploration shows a 10-foot-thick landside blanket. The analysis cross section is shown in Figure 3. The purpose for this additional model was to assess the sensitivity of the levee to underseepage with a range of blanket thicknesses.

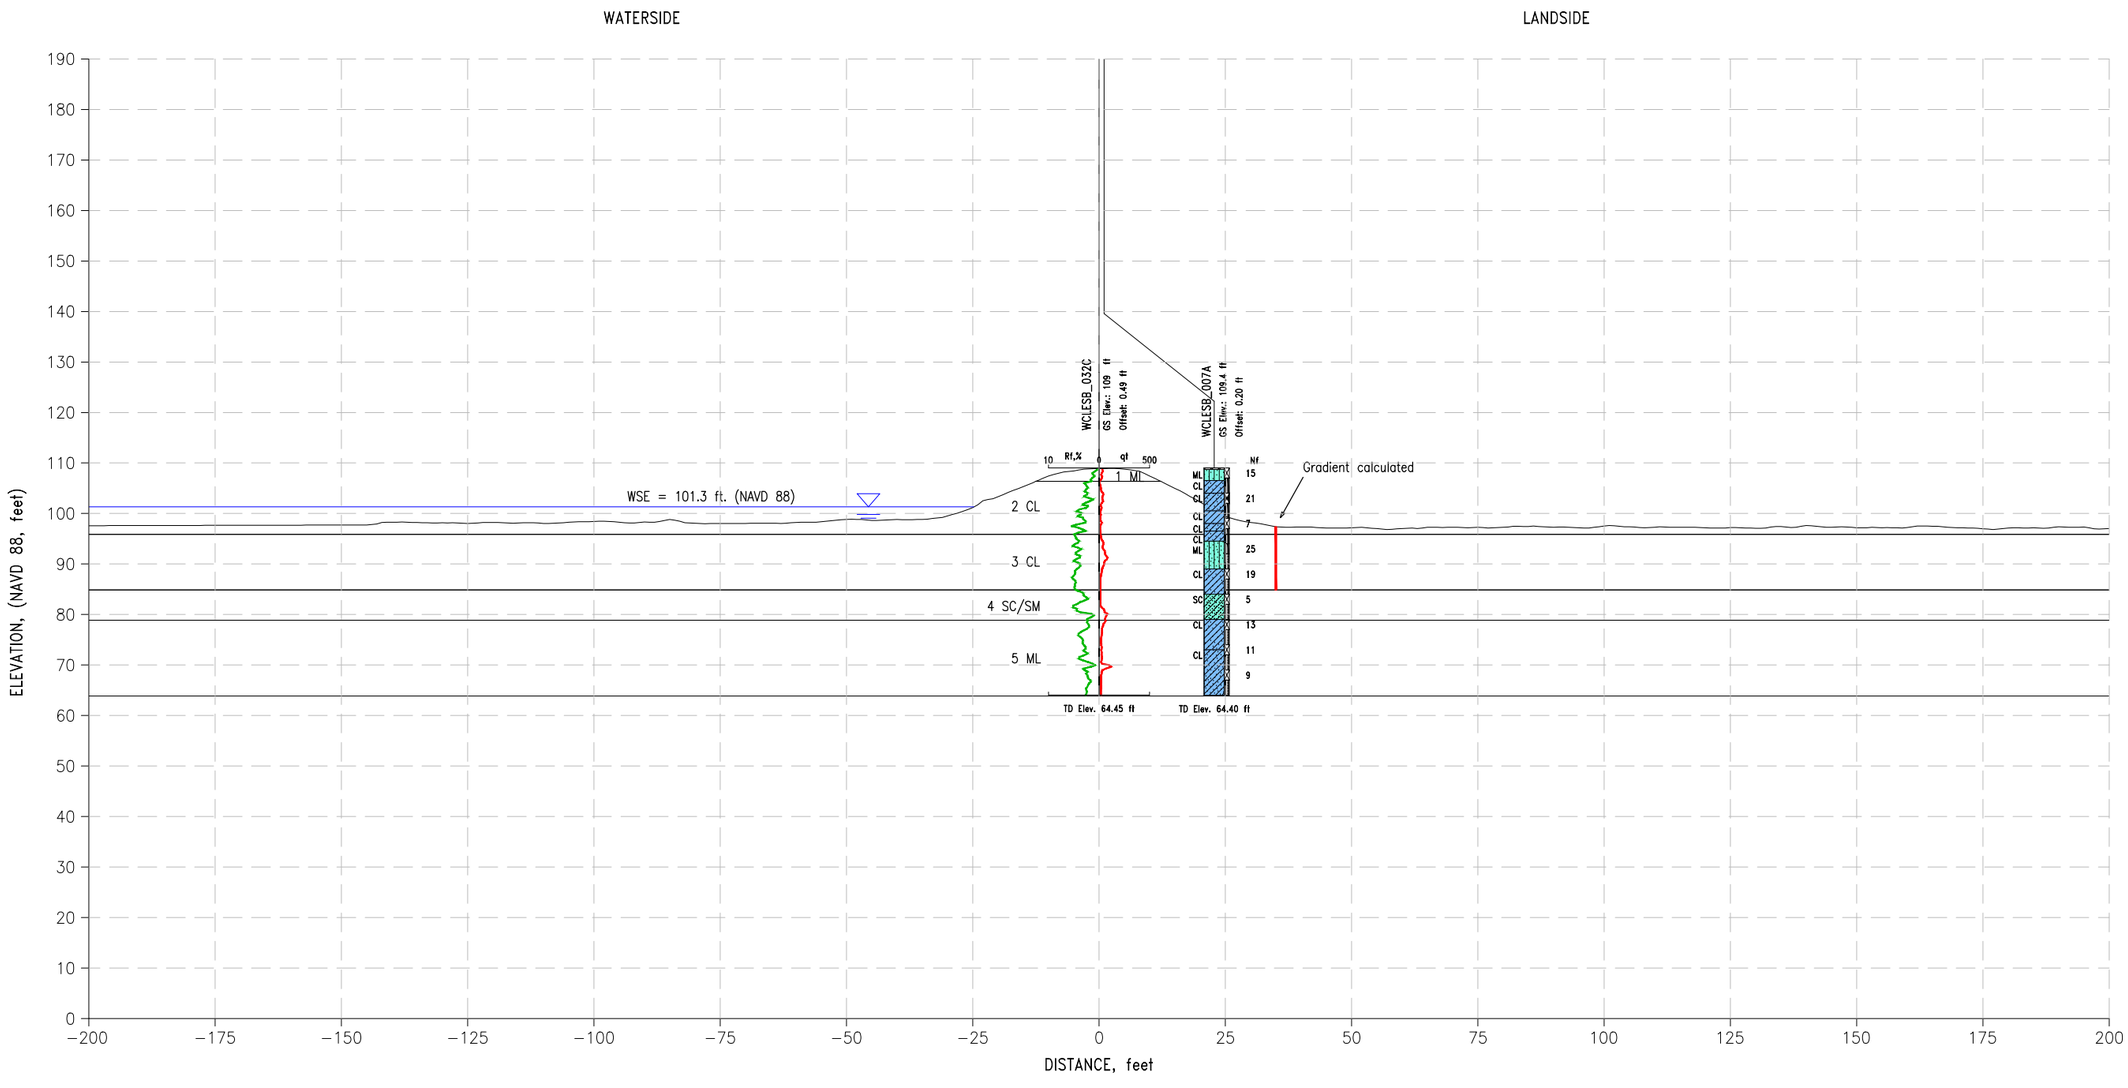
FIGURE
4

The analysis cross section for Site 2 is along the left bank of the levee at Station 1191+00. The levee in this portion of the system has a height of around 11 feet to 13 feet, with a levee crown width of 10 feet to 15 feet. Waterside and landside slopes are approximately 2.9H:1V and 2.4H:1V, respectively. This section of levee does not have a landside ditch and no noticeable landside depressions that could thin the blanket. The analysis cross section is shown in Figure 4.

Based on the exploration data available, the levee embankment comprises silts and clays. Foundation materials consist of silts and clays with interbeds of silty sand and clayey sand. A landside blanket in excess of 12 feet is present in this portion of the levee. For the purpose of analysis, a base model was established using information from CPT WCLESB_032C and boring WCLESB_007A, which indicates a 12.5-foot-thick landside blanket overlying a clayey sand/silty sand aquifer (Figure 4).

The analysis results show that landside slope stability is the controlling geotechnical failure mode for Site 2. Of the different models analyzed, sensitivity case 1 with reduced strength parameters is considered representative given that we do not have any laboratory test data available. Therefore, a critical factor of safety WSE, i.e. a WSE that corresponds to a factor of safety of 1.4, of +104 feet (NAVD88) is acceptable at this location. This corresponds to approximately 6.5-foot of water on the waterside of the levee relative to the landside toe elevation.

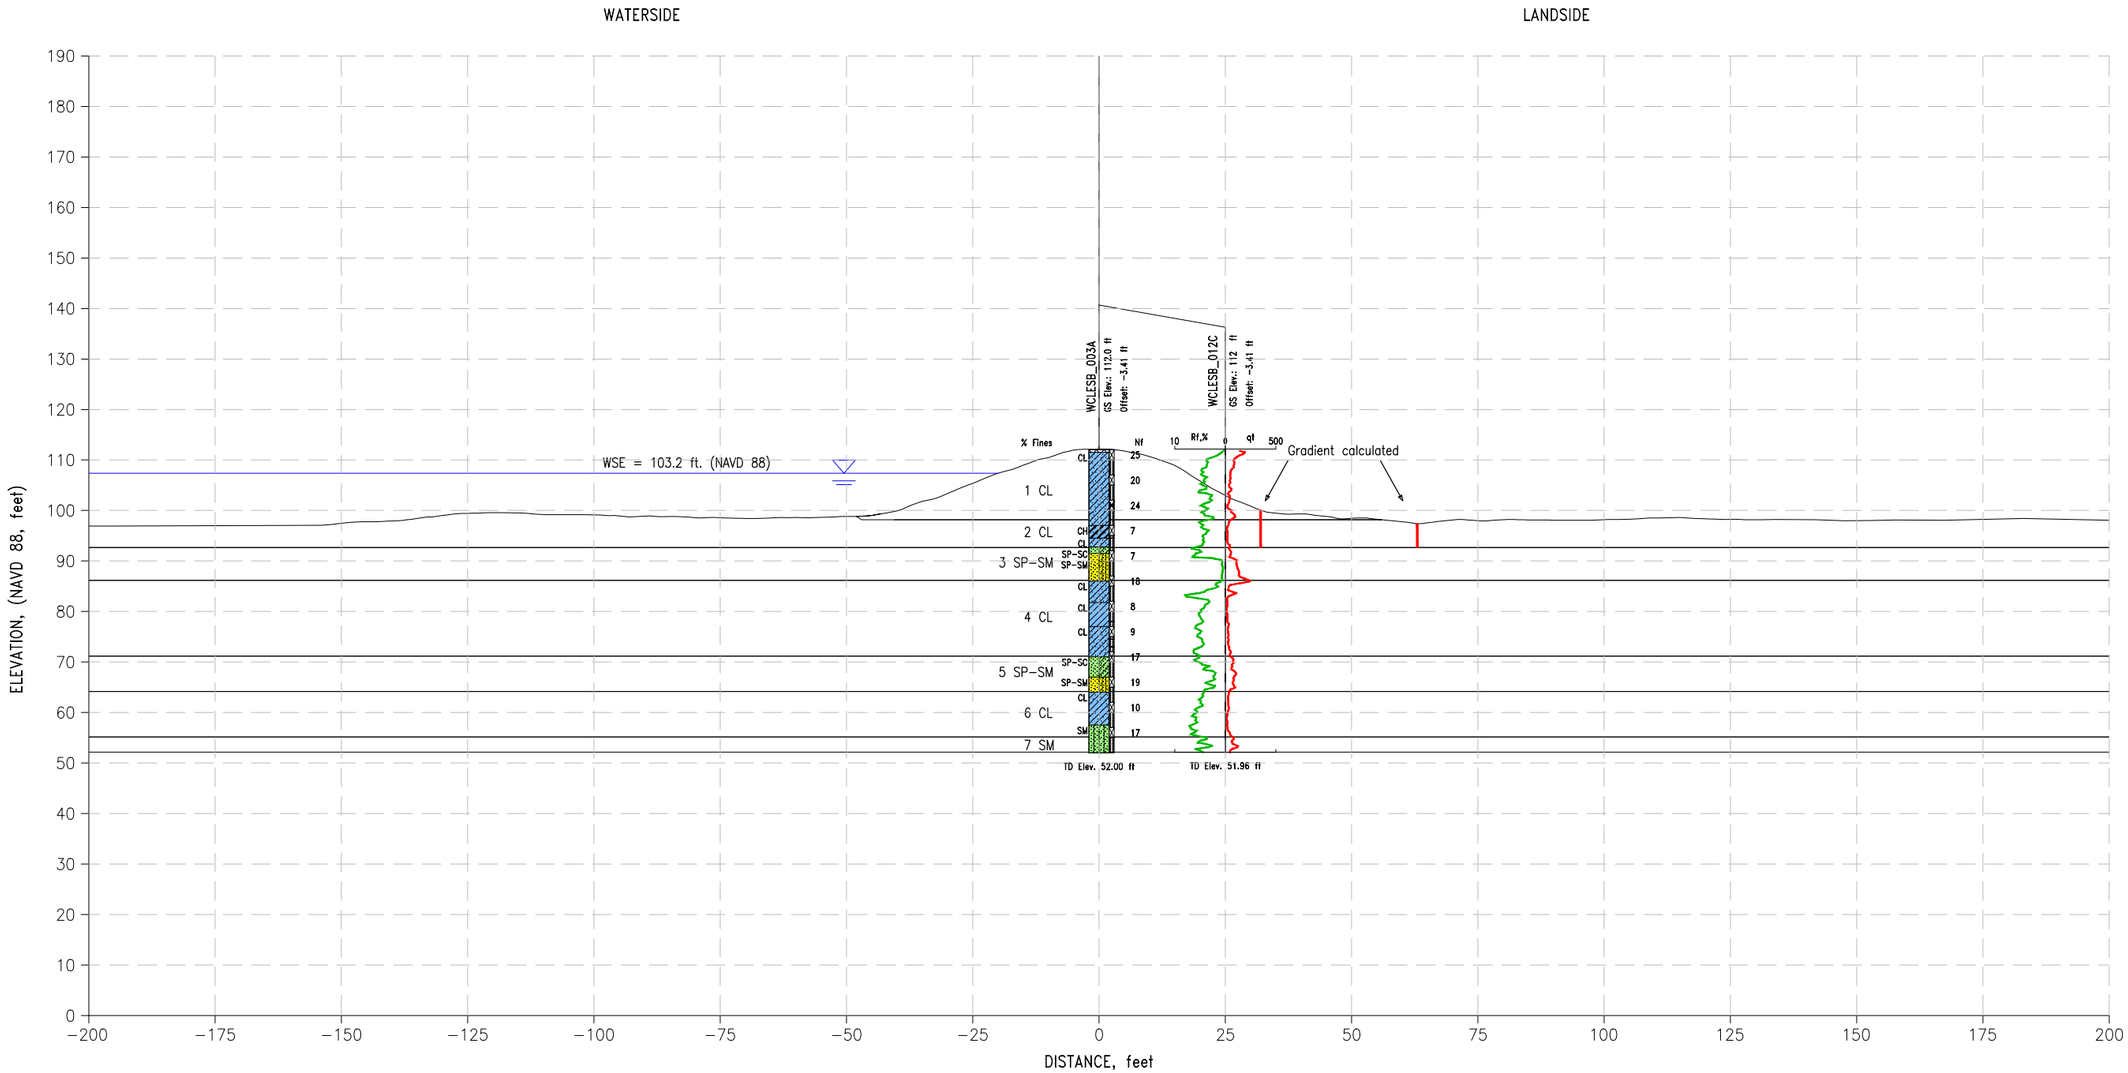
FIGURE
5

The analysis cross section for Site 3 is located along the left bank of the levee at Station 1396+50. The levee in this portion of the system has a height of around 12 feet to 15 feet, with a levee crown width of 10 feet to 15 feet. Waterside and landside slopes are approximately 2.9H:1V and 2.1H:1V, respectively. This section of levee does not have a landside ditch, but there is a slight landside depression approximately 30 landward of the landside levee toe. The analysis cross section is shown in Figure 5.

Based on the exploration data available, the levee embankment comprises silts and clays. Subsurface materials consist of silts and clays with interbeds of sand, silty sand and clayey sand. A variable landside blanket thickness is indicated by explorations. For the purpose of analysis, a base model was established using information from CPT WCLESB_012C and boring WCLESB_003A, which indicates a 5- to 6-foot-thick landside blanket overlying a sand and silty sand aquifer (Figure 5).

The analysis results show that underseepage is the controlling geotechnical failure mode for Site 3. Of the different models analyzed, sensitivity case 2 is considered representative given that the waterside blanket could have been eroded during past flood events, thereby providing a direct connection to the aquifer layer. Therefore, a critical gradient WSE, i.e. a WSE that corresponds to a hydraulic gradient that matches criteria, of +101.7 feet (NAVD88) is acceptable at this location. This corresponds to approximately 3.5-foot of water on the waterside of the levee relative to the landside toe elevation.
