Bank Erosion Monitoring Report

San Joaquin River Restoration Program

July 2021

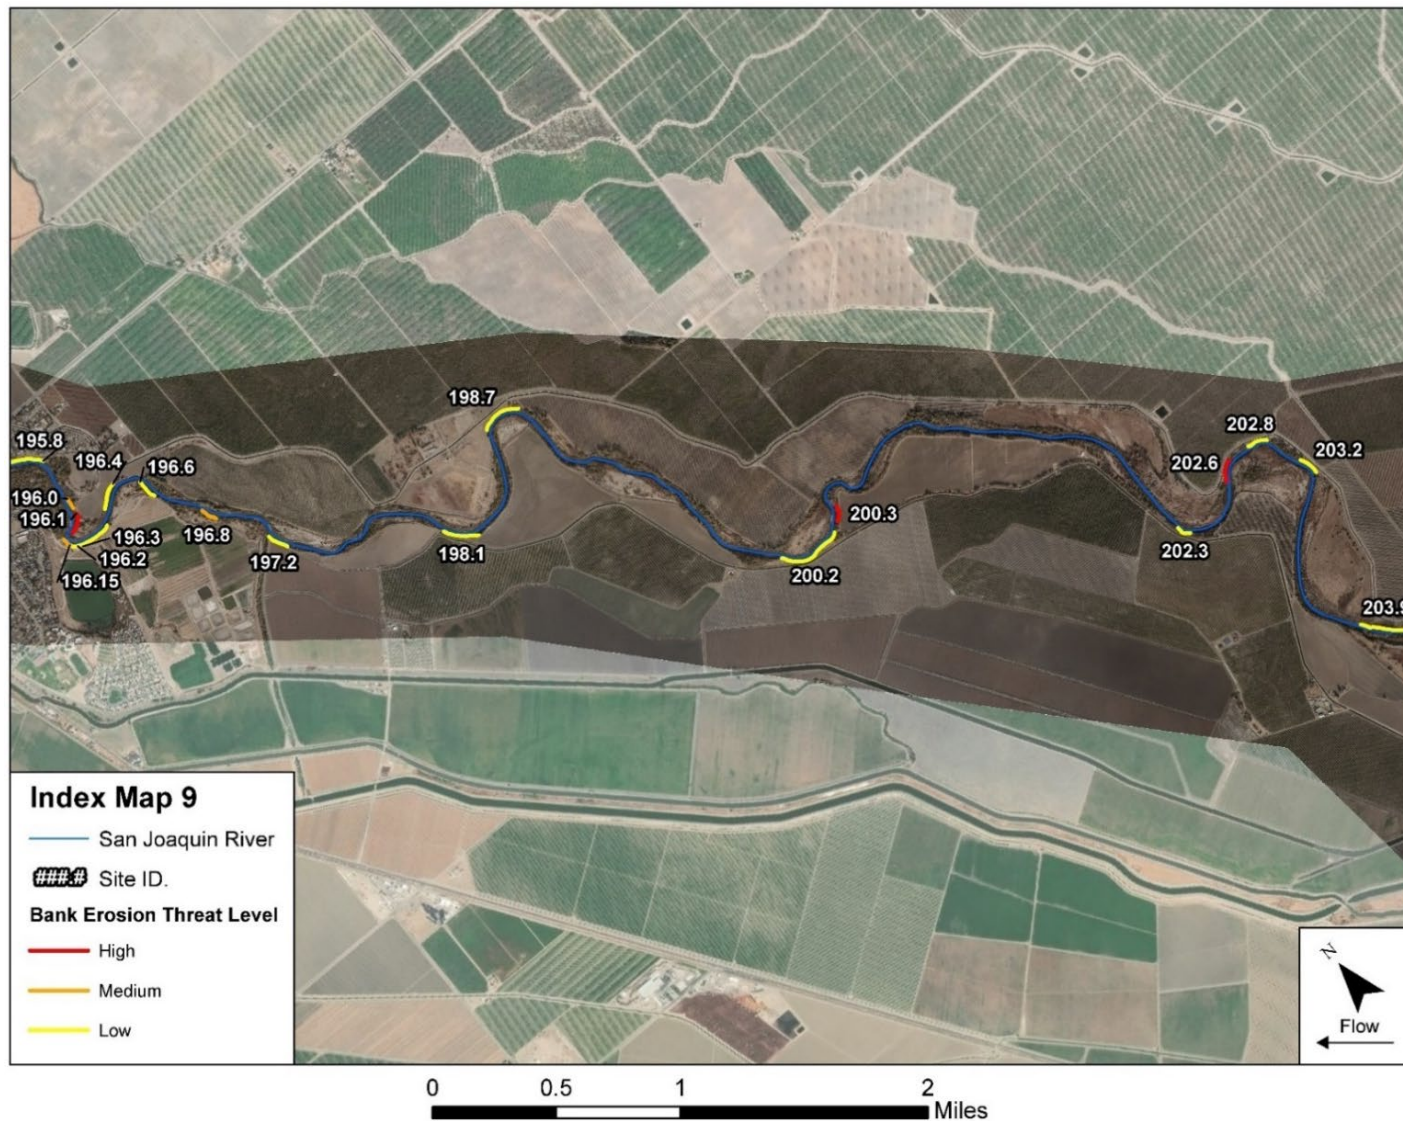
Figure 21 Index Map 9 with Overview of Footprint Identified in Figure 4

This site is in Reach 3 and depicts a sparsely vegetated bank with no bank protection. The nearest threatened structure is a service road and canal 20 feet from the bank crest. Evidence of 12 feet of lateral erosion is apparent from a missing tree and scalloped bank for 112 feet longitudinally on the river-right side. The bank scarp is noticeably encroaching on the service road and canal embankment. Threat ratio 1.6; threat level high; see Figure 10 and Index Map 9.

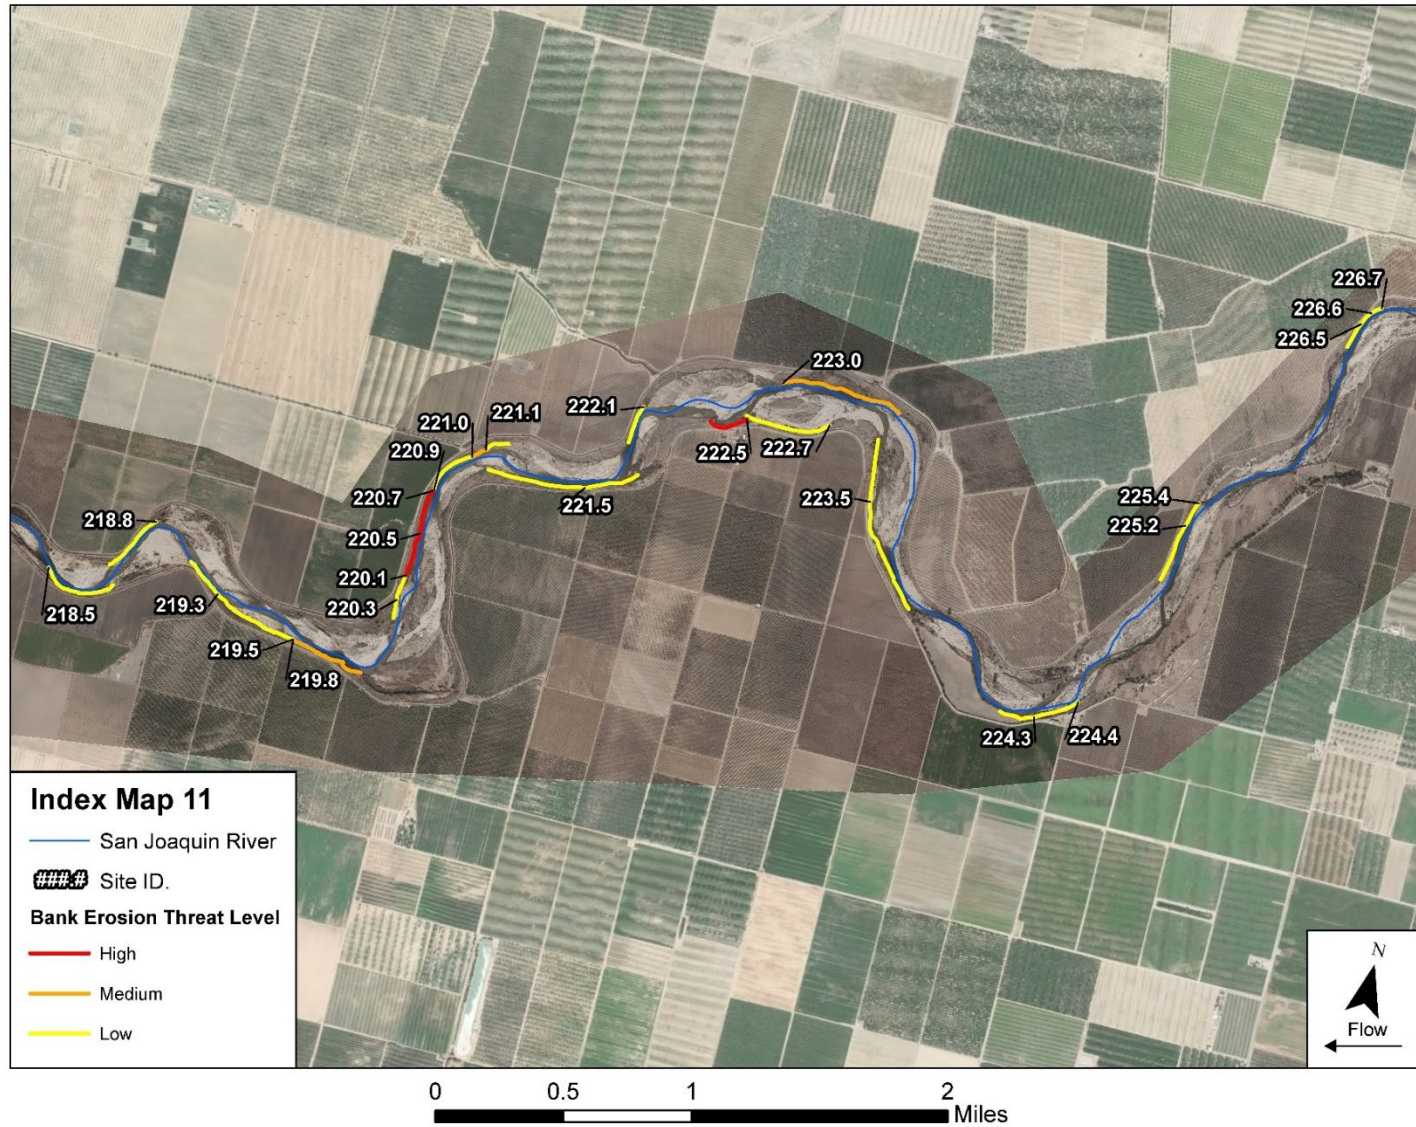
Figure 23 Index Map 11 with Overview of Footprint Identified in Figure 4

This site is in Reach 2A and depicts sparse vegetation with no bank protection. The nearest threatened structure is a levee 75 feet away and row crops beyond. This is a shallow braided channel where the riverbed was dry in 2015. There is a maximum of 37 feet of lateral erosion along 900 feet of river-right bankline. As shown in Figure 12, the area is between the two high risk sites RM 220.5 and RM 220.7. Although this site endured similar flows and durations in 2011, the flood releases from 2017 appear to have caused most of the erosion. Threat ratio is 2.0; threat level is high; see Figure 12 and Index Map 11.
