Public Draft
Channel Capacity Report
2025 Restoration Year

Bank Erosion Monitoring Report (2024 Update)

San Joaquin River Restoration Program

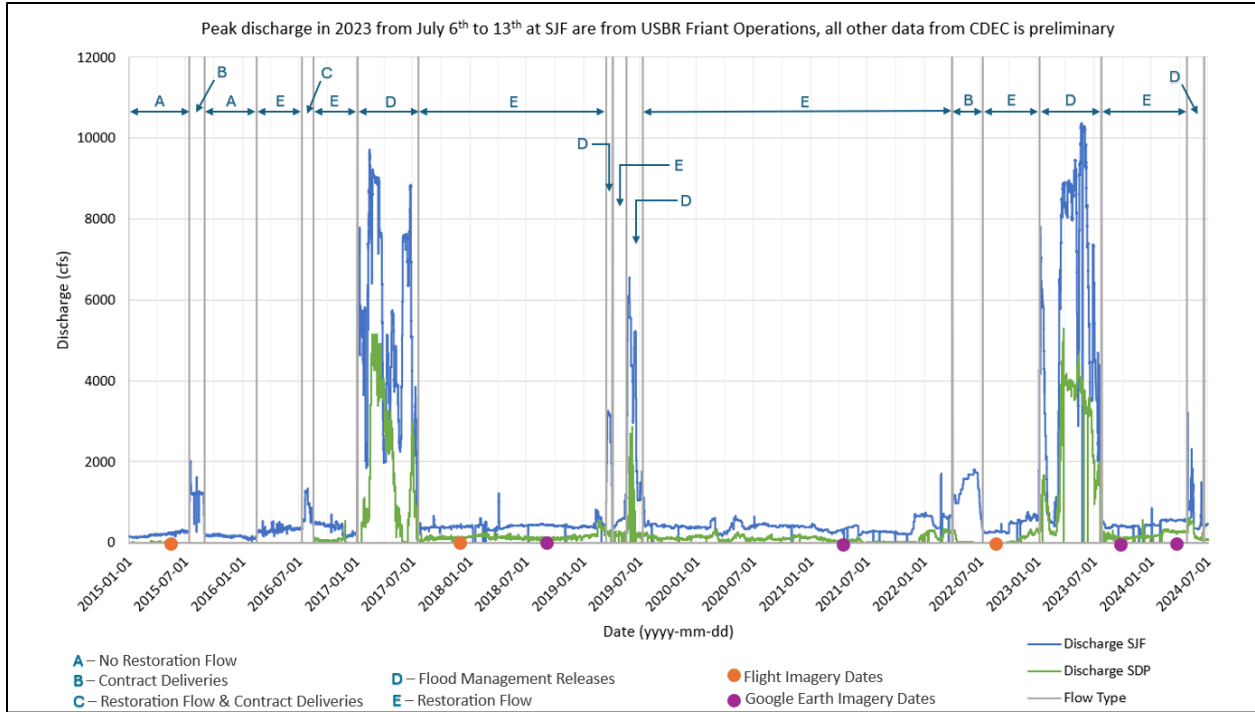
3 **Figure 1. San Joaquin River Hydrograph of Mean Daily Discharge at SJF (RM 266.0) and SDP**
4 **(RM 181.2) Stream Gages.**

30 Based on the updated erosion monitoring, Restoration Flows are likely not the cause of most of
31 the erosional impacts, rather, most of the erosion is more likely the result of the FMRs in 2019
32 and particularly high FMRs in 2023, which had significantly higher flowrates and WSEs. A
33 hydrograph showing the various flow types is shown in Figure 1. During the 2019 FMRs
34 flooding event, FMRs commenced intermittently but mostly in March and June with flows as
35 high as 6,000 cfs. In 2023, FMRs occurred continuously from January to early February and then
36 from early March through most of July. Peak FMRs of 10,000 cfs occurred from mid-May to
37 early June. In general, these flows were much greater than the maximum combined Restoration
38 Flows and contract deliveries of up to 2,000 cfs.

39 Based on the 2024 monitoring report, the recent erosion is most likely the result of the high
40 FMRs that occurred in 2019 and 2023. It should be noted that during wet hydrology, Restoration
41 Flows may be accounted for as part of FMRs consistent with the Settlement.

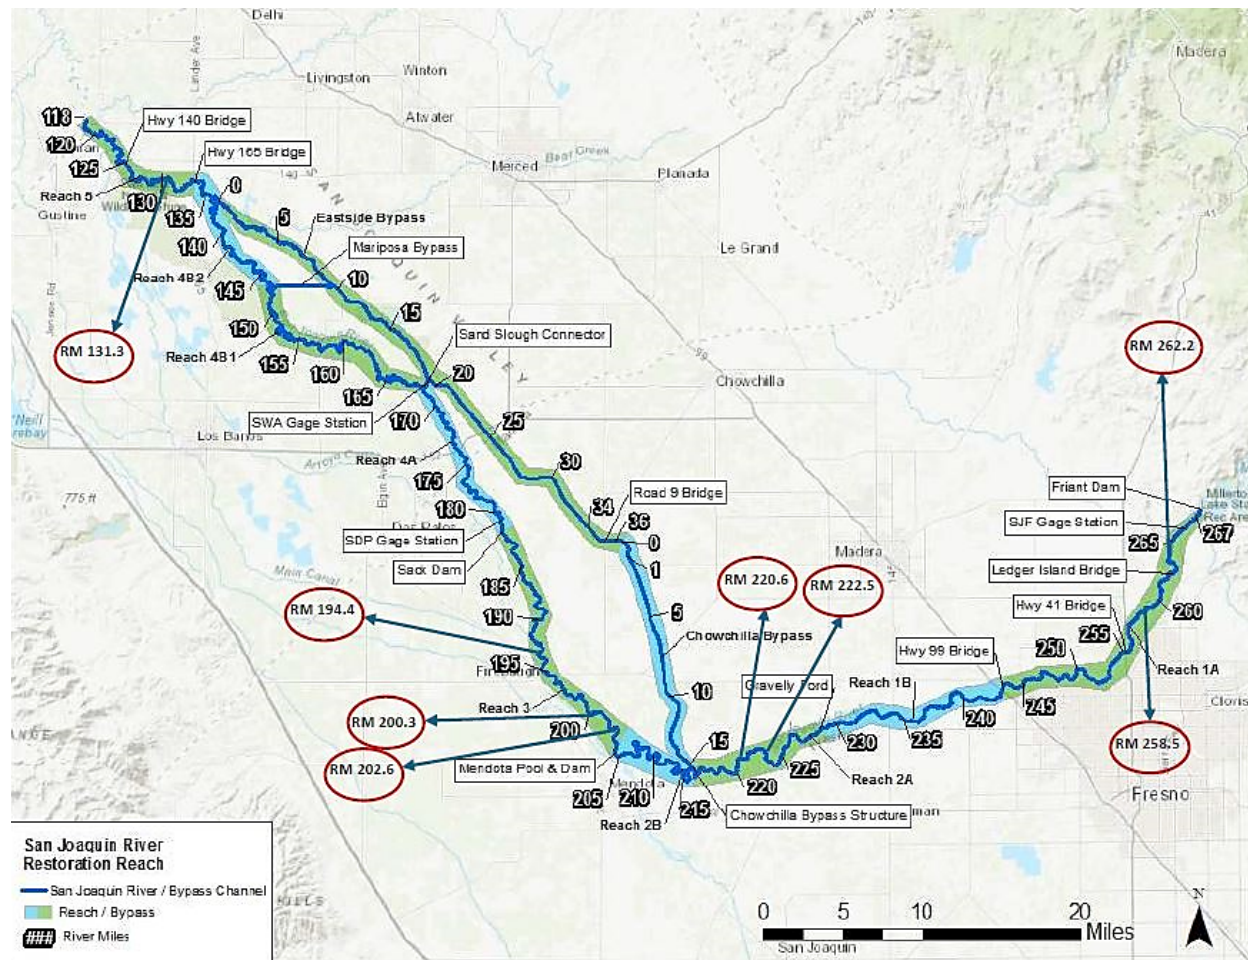
Figure 1 San Joaquin River Study Area by Reach and High Threat Site Locations Identified by DWR in 2021

The 2021 report served as an initial step in identifying and monitoring critical erosion sites. It developed a baseline for future evaluations and recommended monitoring highest threat sites to determine potential causes and changes in erosion patterns related to Restoration Flows. This report provides an update to the 2021 report and evaluates eight high-threat erosion sites that were identified in the previous report. This update uses aerial imagery before and after flood management releases in 2019 and 2023 to relate erosion extents to the different flow types released from Friant Dam. In addition to the sites previously identified by DWR, this report also includes a cursory review of flood-threat sites identified in 2023 by the Lower San Joaquin Levee District (LSJLD) as another entity observing erosion for flood control purposes.

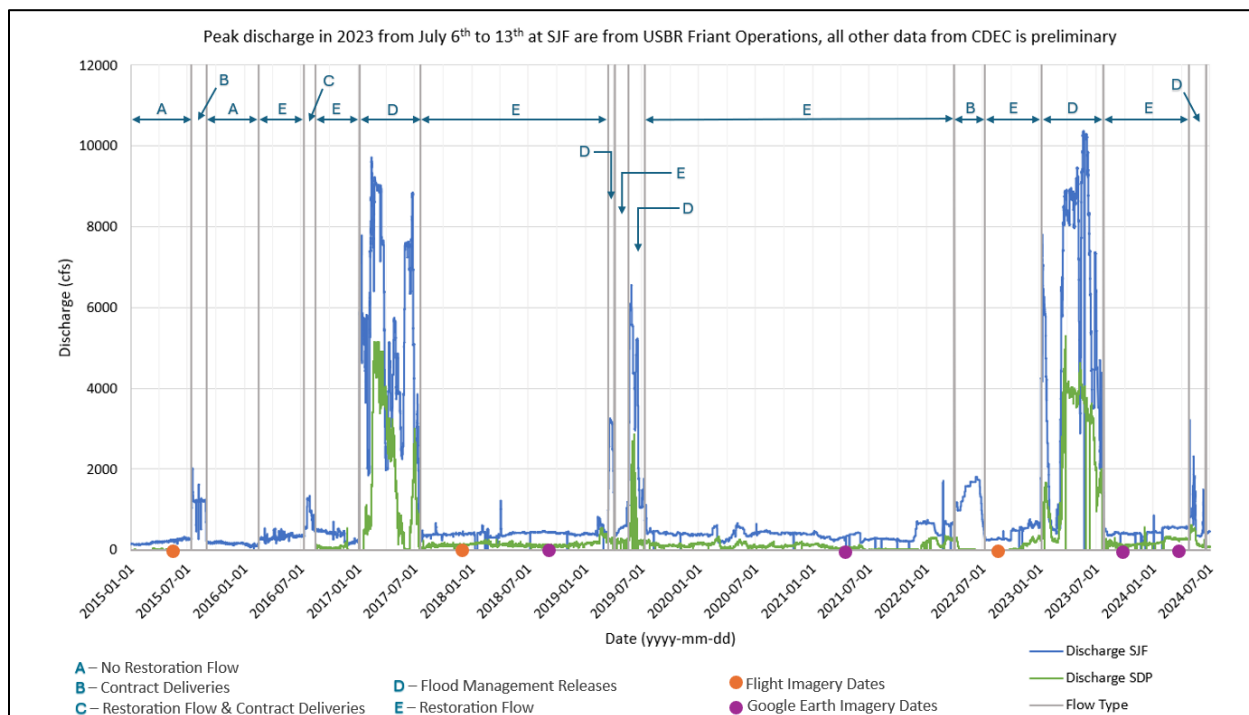
Figure 2 San Joaquin River Hydrograph of Mean Daily Discharge at SJF (RM 266.0) and SDP (RM 181.2) Stream Gages

The hydrograph data used for this analysis is a continuation of the one created for the 2021 report and adds flow releases through April 2024 as shown in Figure 2. The vertical gray lines show when flow types changed with the flow types labeled at the top of the chart. Imagery dates are also identified at the bottom of the chart.

Since the last update in 2021, flood management releases occurred in 2019, spanning from March 15th to April 5th, May 19th to July 11th, and again in 2023 from January 8th to February 5th and from March 8th to July 26th. Restoration Flows covered most of the remaining duration through 2024 except for a 3-month

period in 2022 when Restoration Flows were reduced for contract deliveries and for temperature management of the reservoir. Specific flow types, the number of days released, and their start and end date since 2017 are summarized in Table 1.
