Technical Memorandum

Channel Capacity Report 2025 Restoration Year

Bank Erosion Monitoring Report (2024 Update)

San Joaquin River Restoration Program

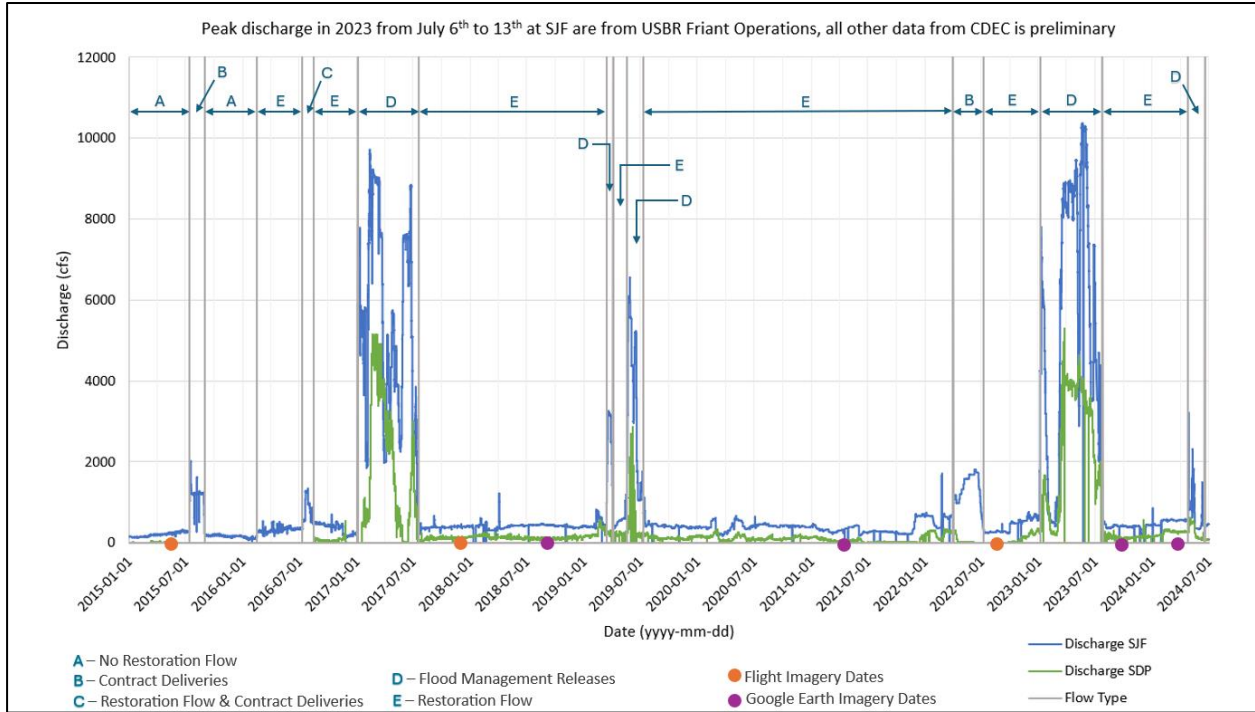
3 **Figure 1. San Joaquin River Hydrograph of Mean Daily Discharge at SJF (RM 266.0) and SDP**
4 **(RM 181.2) Stream Gages.**

15 Based on the updated erosion monitoring, Restoration Flows are likely not the cause of most of
16 the erosional impacts, rather, most of the erosion is more likely the result of the FMRs in 2019
17 and particularly high FMRs in 2023, which had significantly higher flowrates and WSEs. A
18 hydrograph showing the various flow types is shown in Figure 1. During the 2019 FMRs
19 flooding event, FMRs commenced intermittently but mostly in March and June with flows as
20 high as 6,000 cfs. In 2023, FMRs occurred continuously from January to early February and then
21 from early March through most of July. Peak FMRs of 10,000 cfs occurred from mid-May to
22 early June. In general, these flows were much greater than the maximum combined Restoration
23 Flows and contract deliveries of up to 2,000 cfs.

24 Based on the 2024 monitoring report, the recent erosion is most likely the result of the high
25 FMRs that occurred in 2019 and 2023. It should be noted that during wet hydrology, Restoration
26 Flows may be accounted for as part of FMRs consistent with the Settlement.

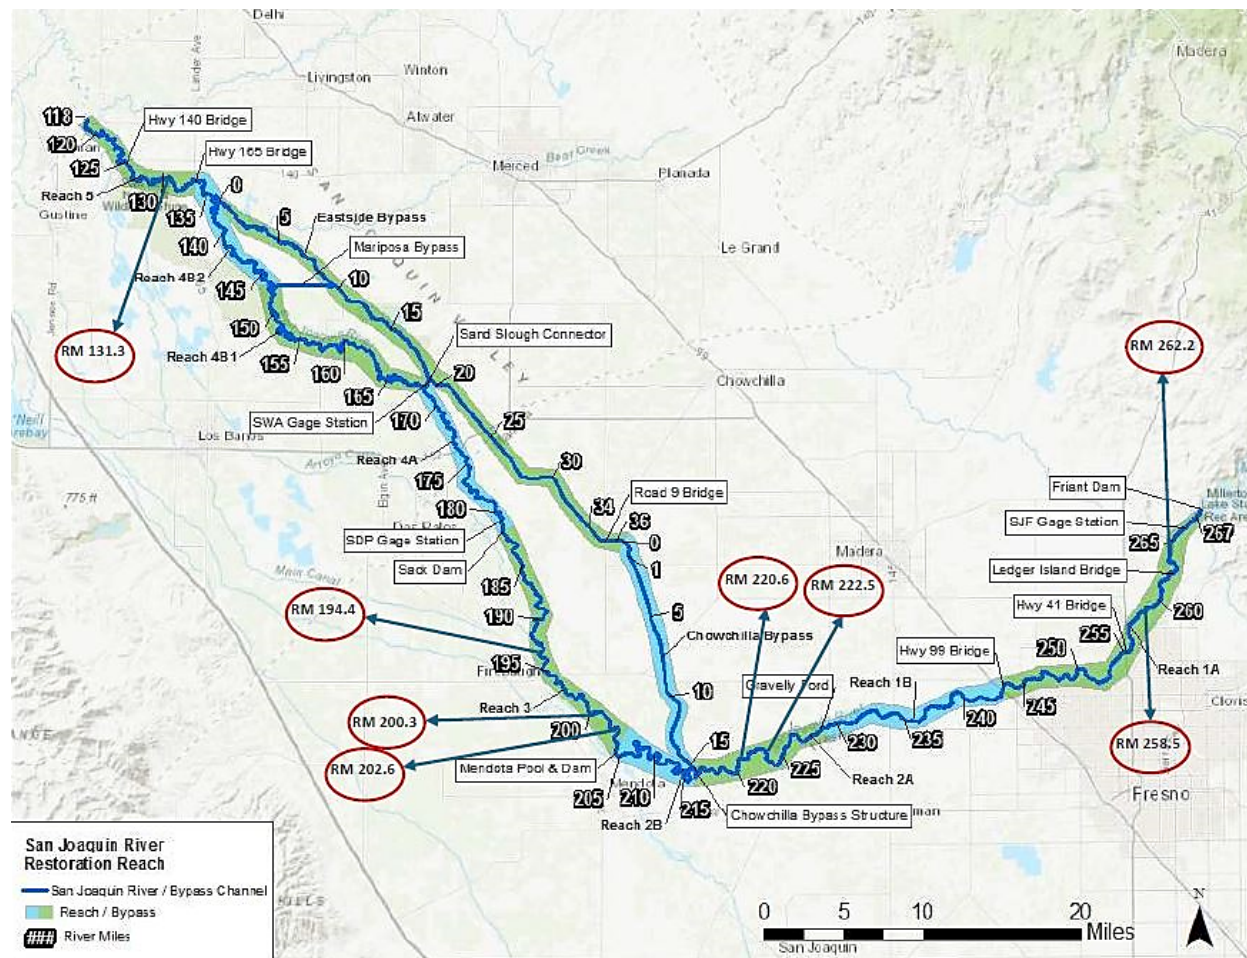
Figure 1 San Joaquin River Study Area by Reach and High Threat Site Locations Identified by DWR in 2021

The 2021 report served as an initial step in identifying and monitoring critical erosion sites. It developed a baseline for future evaluations and recommended monitoring highest threat sites to determine potential causes and changes in erosion patterns related to Restoration Flows. This report provides an update to the 2021 report and evaluates eight high-threat erosion sites that were identified in the previous report. This update uses aerial imagery before and after flood management releases in 2019 and 2023 to relate erosion extents to the different flow types released from Friant Dam. In addition to the sites previously identified by DWR, this report also includes a cursory review of flood-threat sites identified in 2023 by the Lower San Joaquin Levee District (LSJLD) as another entity observing erosion for flood control purposes.

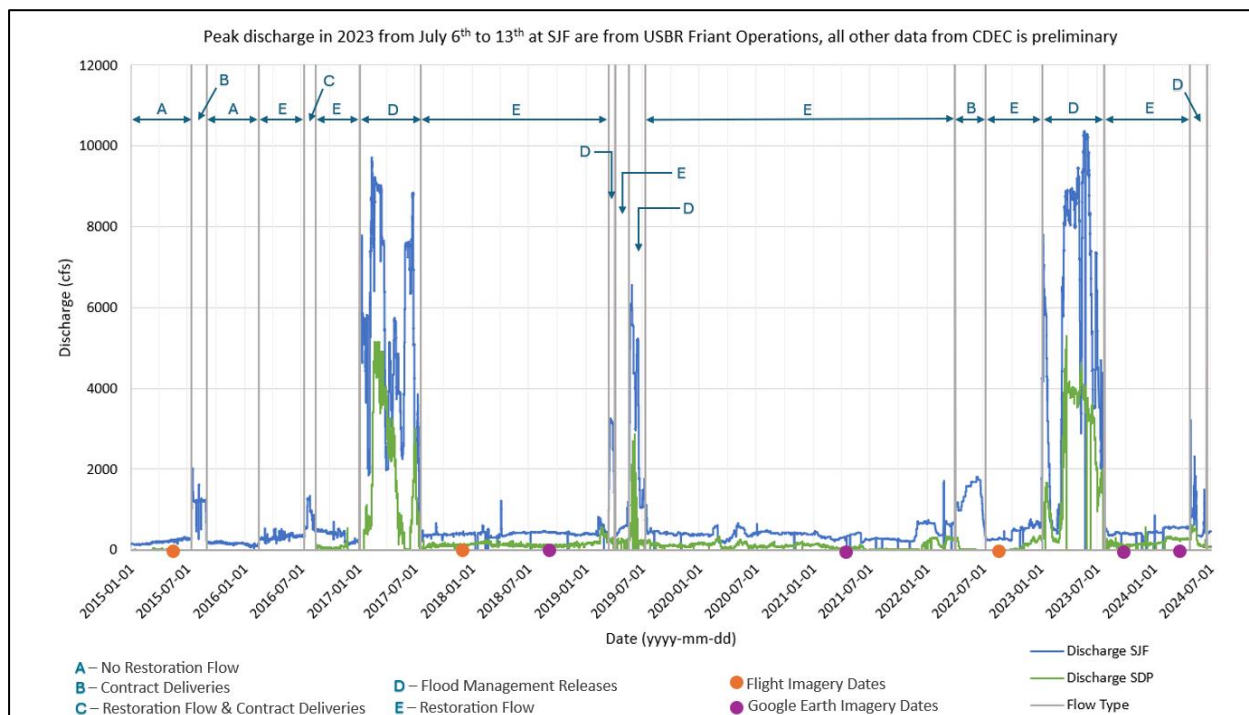
Figure 2 San Joaquin River Hydrograph of Mean Daily Discharge at SJF (RM 266.0) and SDP (RM 181.2) Stream Gages

The hydrograph data used for this analysis is a continuation of the one created for the 2021 report and adds flow releases through April 2024 as shown in Figure 2. The vertical gray lines show when flow types changed with the flow types labeled at the top of the chart. Imagery dates are also identified at the bottom of the chart.

Since the last update in 2021, flood management releases occurred in 2019, spanning from March 15th to April 5th, May 19th to July 11th, and again in 2023 from January 8th to February 5th and from March 8th to July 26th. Restoration Flows covered most of the remaining duration through 2024 except for a 3-month

period in 2022 when Restoration Flows were reduced for contract deliveries and for temperature management of the reservoir. Specific flow types, the number of days released, and their start and end date since 2017 are summarized in Table 1.
