## Appendix B

# Reports

### 2011 Draft Annual Technical Report

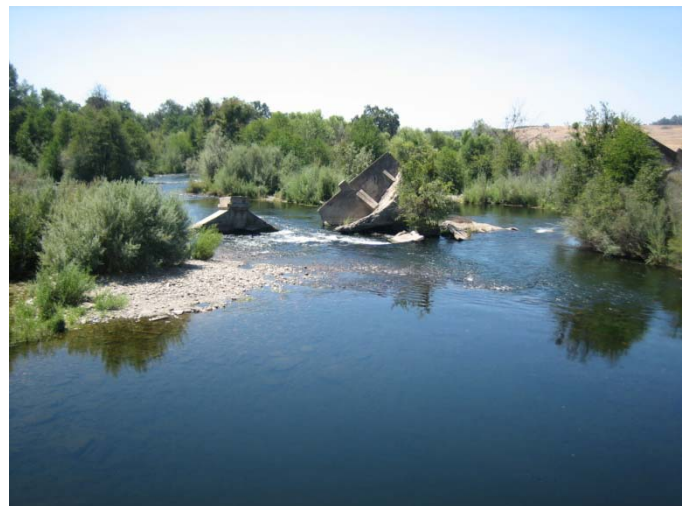
About 200 feet downstream the bridge is an older bridge that was demolished and large sections of the bridge were left in the channel. The sections in the channel average between 50 – 100 feet apart. Two sections just downstream the bridge are located in the center of the active channel and have created a cascading drop (Photo 2\_B). This section does not appear to be a fish passage issue since it can be bypassed.

Photo 2\_B. Bridge debris from Road 206 Bridge looking downstream

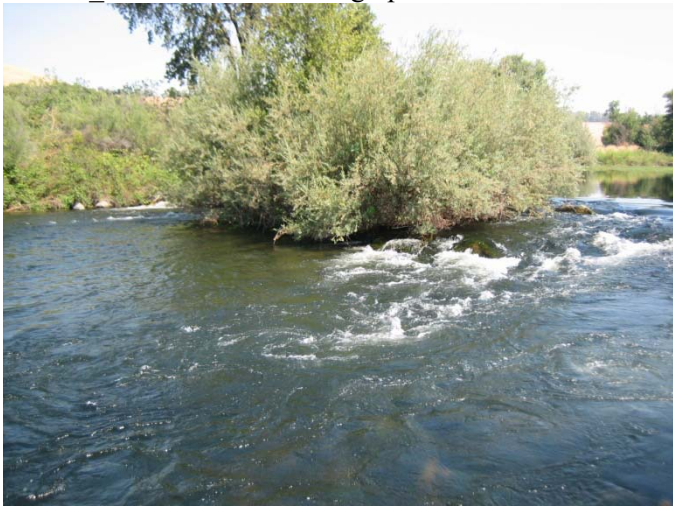
Description: The rock weir is located in Lost Lake Park on the San Joaquin River near river mile 266. This site is publicly accessible through the Lost Lake Park campgrounds, a Fresno County operated facility, and is not accessible for day use visitors. The weir cannot be bypassed and extends the length of the active channel. The weir appears to be man made with large boulders placed into the channel. Large vegetation has taken root at the center of the weir (Photo 4\_A). The weir width was measured at 50 feet with a length of 77 feet from the left bank to the vegetation (Photo 4\_B). Total weir length is estimated at 115 feet. The water surface elevation upstream the weir was measured as 4.1 feet. The pool depth downstream the weir within five feet was measured as a water surface of at 2.6 feet. The weir was submerged during the survey with only the tops of the boulders visible. There were rainbow trout seen upstream the weir.

Photo 4\_A. Rock weir looking upstream from downstream

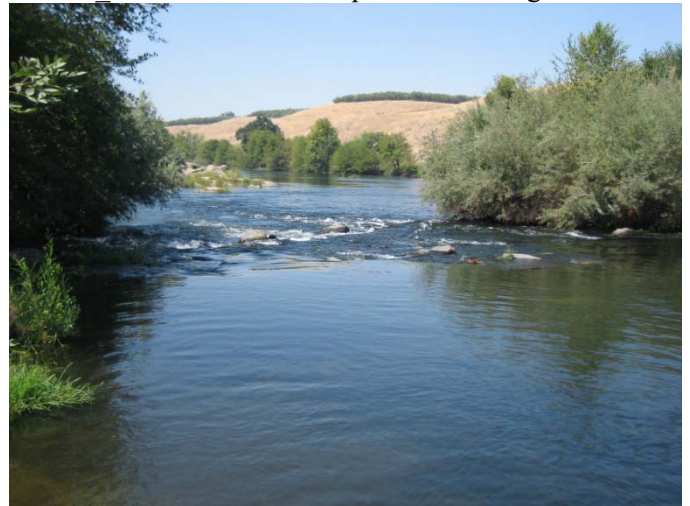
Photo 4\_B. Rock weir from upstream looking downstream

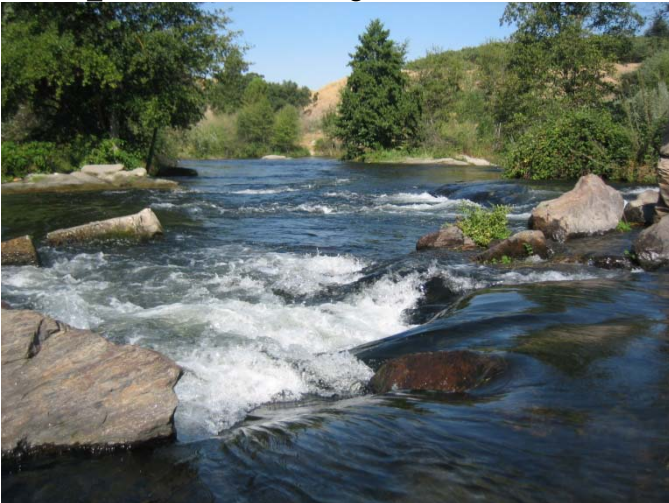
Photo 5 A. Rock weir looking downstream

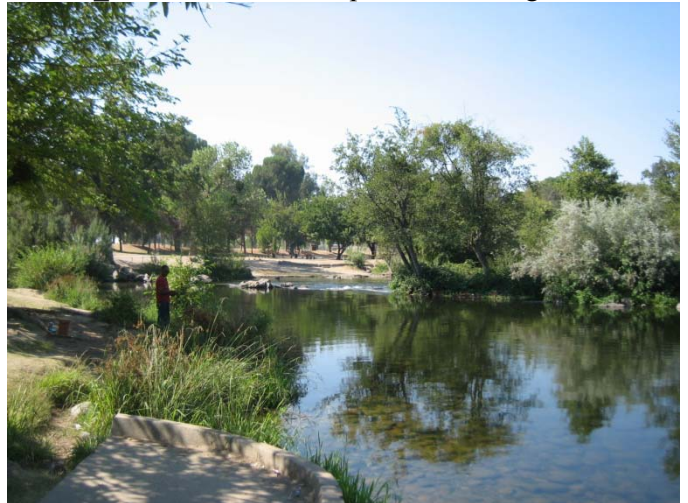
Photo 5 B. Rock weir from upstream looking downstream

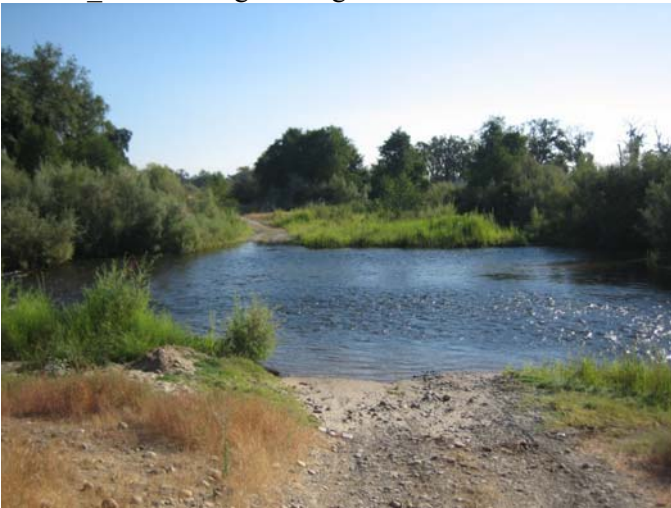
Description: The crossing is located near river mile 258.5 on private property in the Vulcan mining operations. The Vulcan crossing is not publicly accessible, but is used for mining operations during flows that are passable (Photo 9\_A). There were three separate equipment crossing in a half-hour during the survey. The crossing is maintained and consists mostly of cobble with some gravel and sand. The crossing is at stream grade upstream and gradually slopes downstream creating a riffle, so there is no dramatic drop. Downstream the channel narrows and the flow velocity increases (Photo 9\_B). The crossing height from 77 feet downstream was measured as 2.6 feet. The crossing height used for the ranking was zero, or at stream grade since there is a gradual slope downstream. The water surface elevation was 1.8 feet at the center of the crossing. The crossing width was measured as 41 feet at the widest with a length of 137 feet with the bankfull channel width at the crossing measured as 110 feet.

Photo 9\_A. Crossing looking north

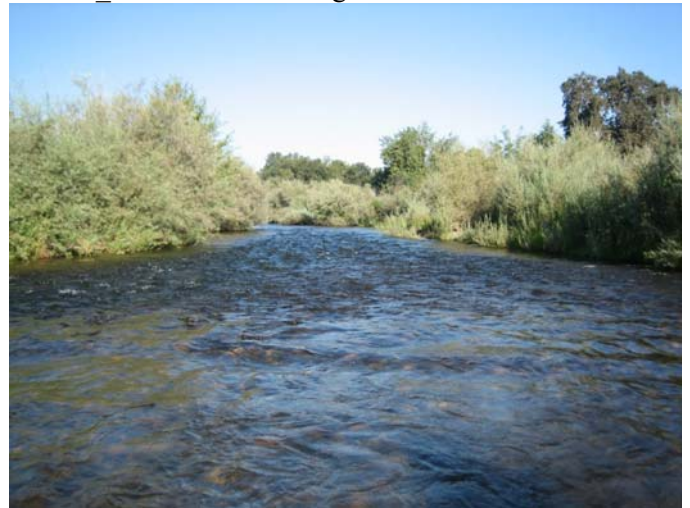
Photo 9\_B. Channel looking downstream from the crossing

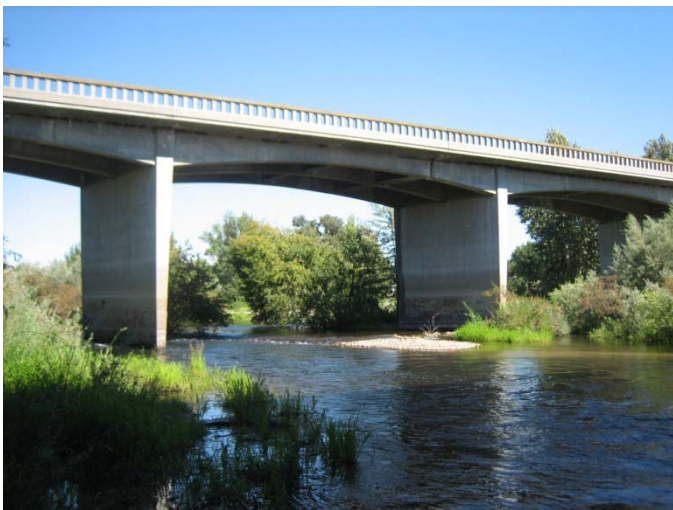
Photo 10\_A. Bridge looking upstream

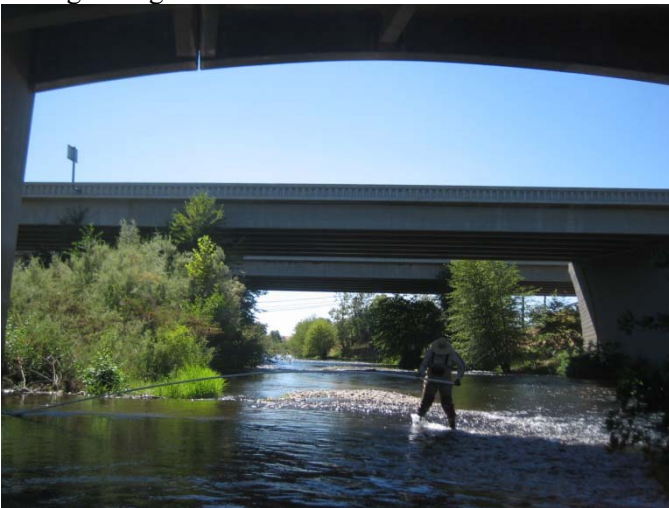
Photo 11\_A. Bridges looking downstream from the frontage bridge

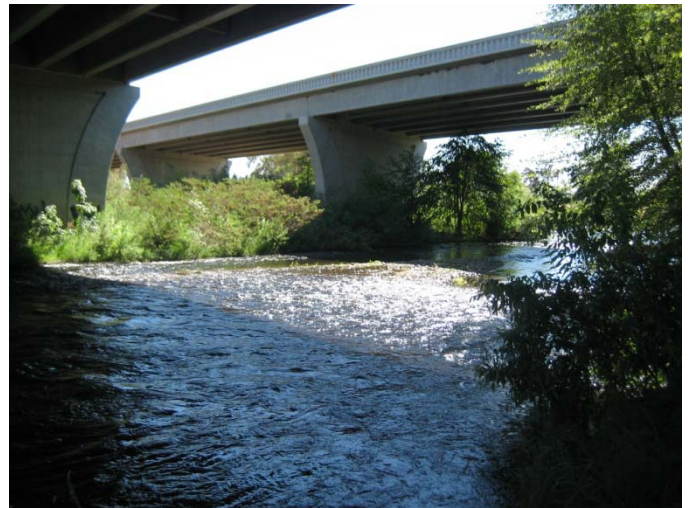
Photo 11\_B. Channel between bridges looking downstream

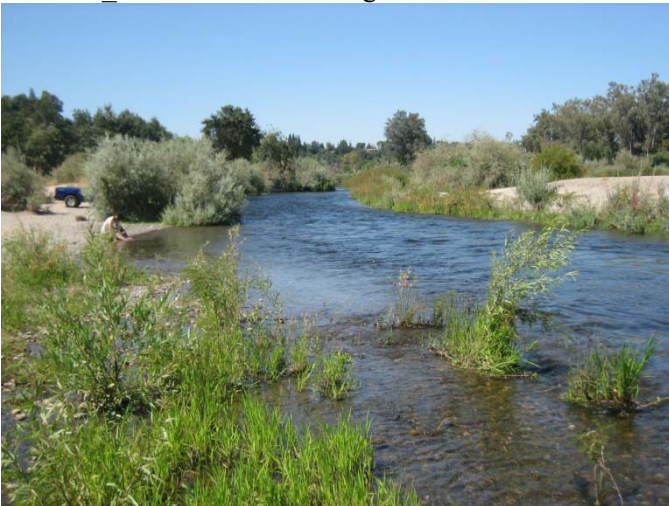
Photo 13\_A. Removed crossing

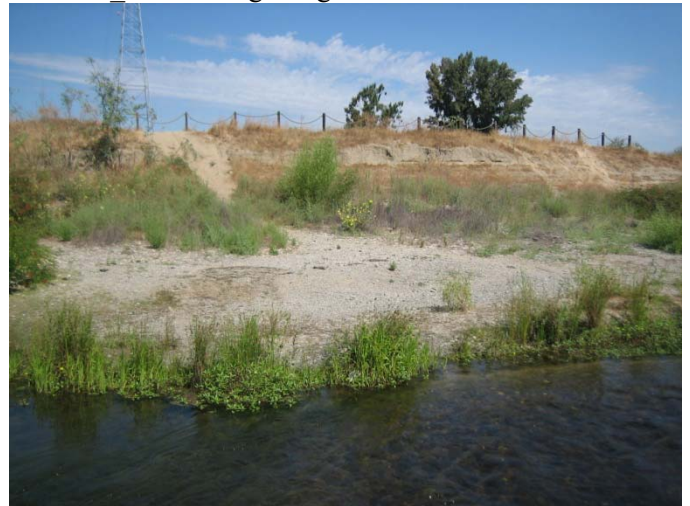
Photo 13\_B. Crossing at right bank

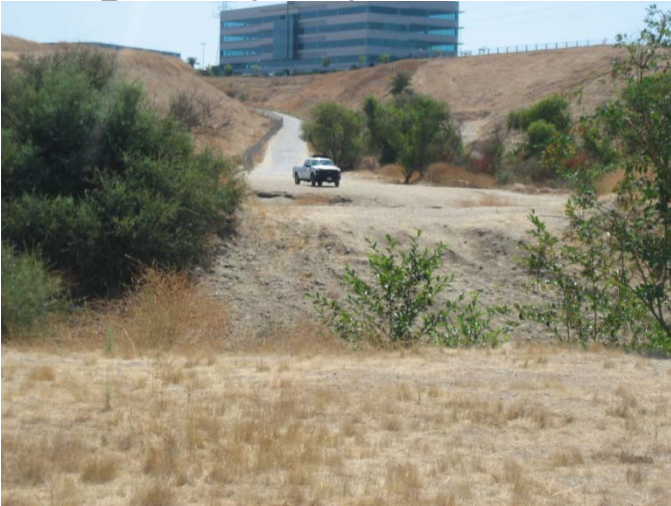
Photo 13\_C. Crossing looking east at Nees Avenue

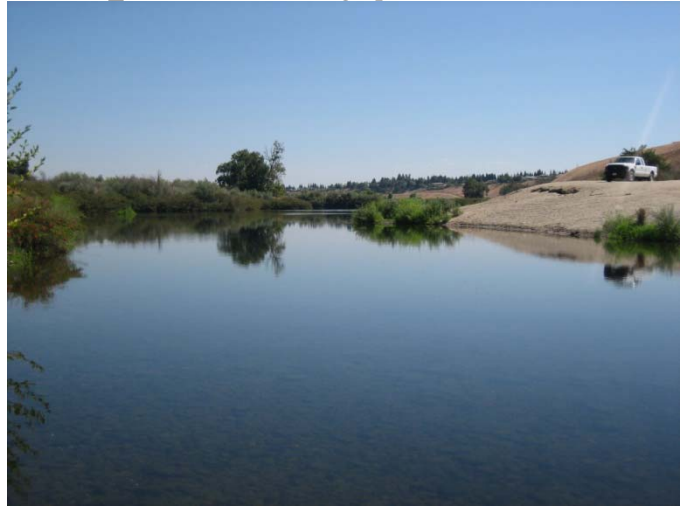
Photo 13\_D. Channel looking upstream

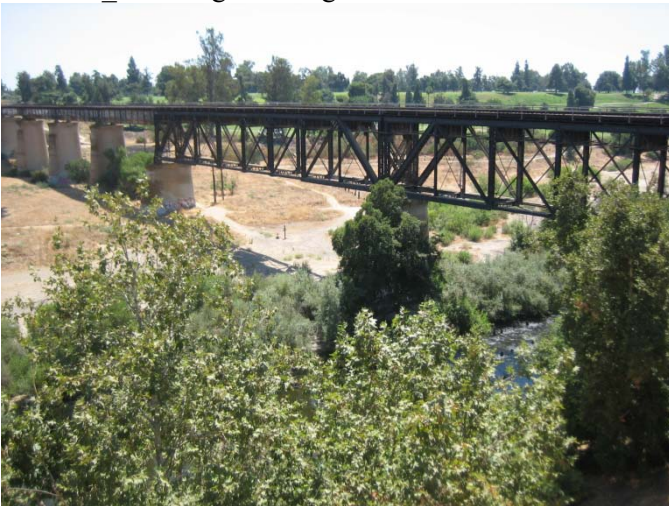
Photo 14\_A. Bridge looking downstream

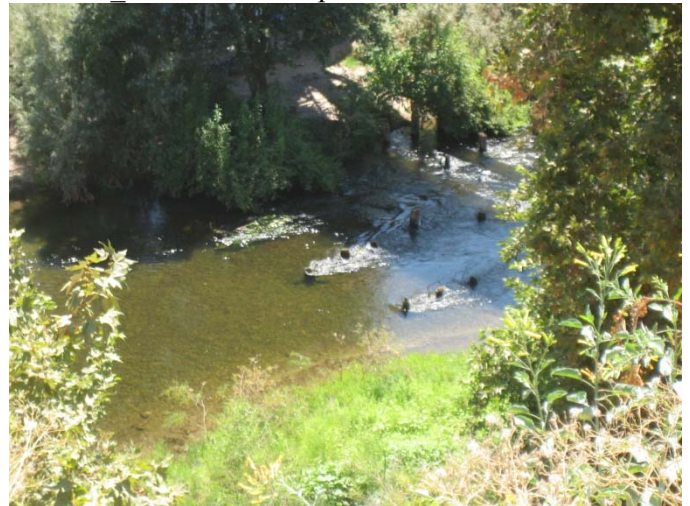
The channel is clean with brush and large woody trees on the banks with tall annual grasses in the floodplain. There were remnants of an older crossing remaining in the channel and seen as jagged broken wooden piers (Photo 14\_B). These piers would not restrict fish migration since they can be bypassed.

Photo 14\_B. Old wooden piers in channel

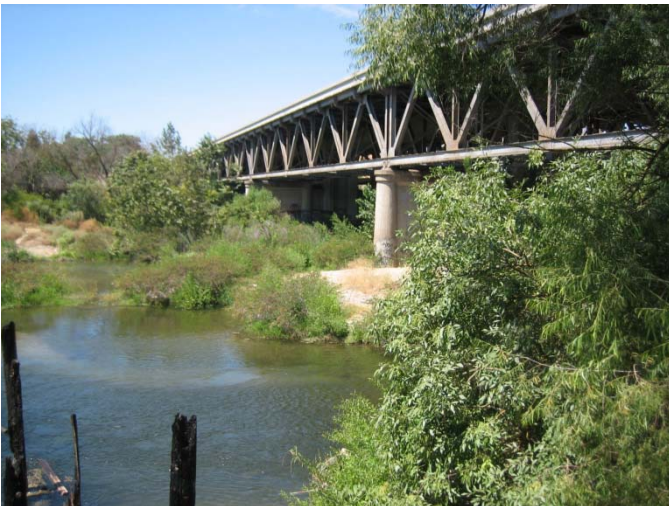
Photo 16\_A. Bridge looking upstream

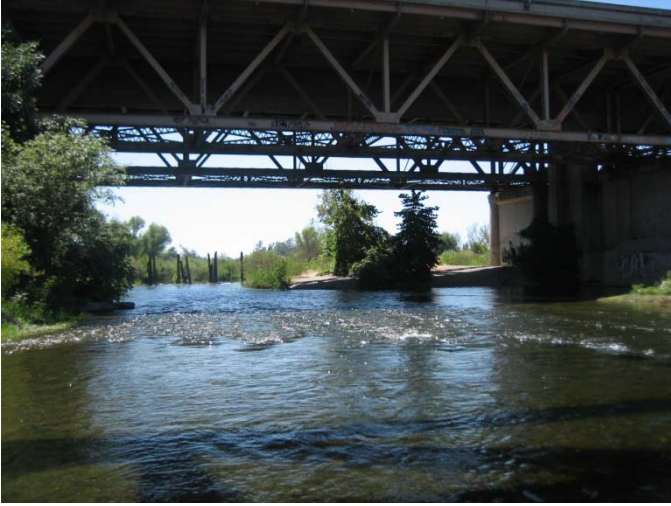
Photo 16\_C. Channel upstream bridges looking downstream

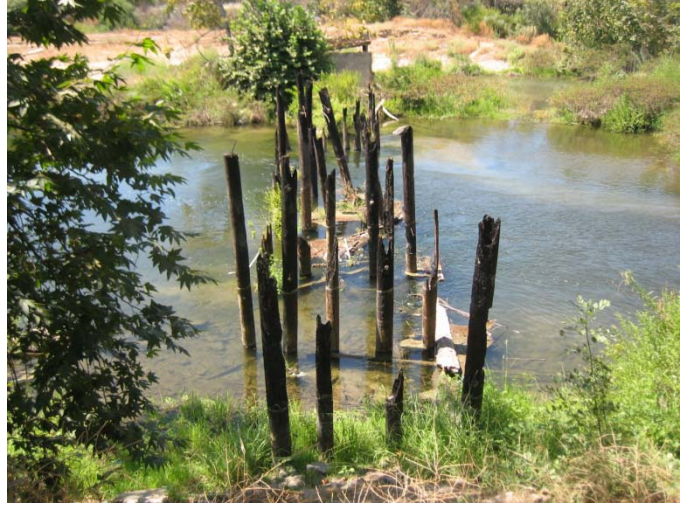
Photo 16\_D. Wooden piers from old crossing

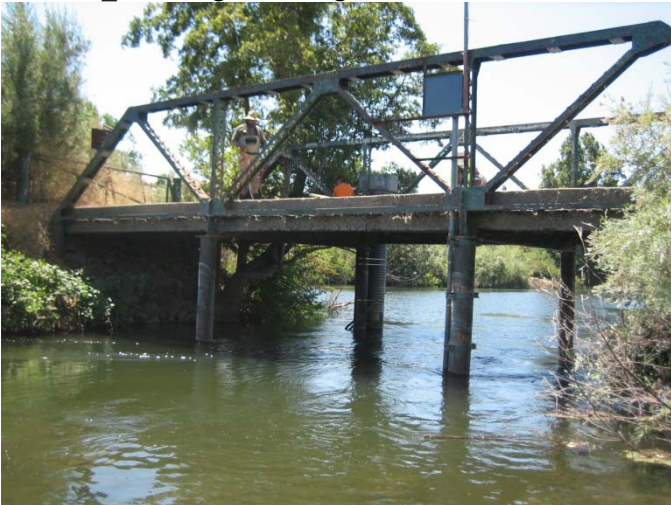
Description: Donny Bridge has private access and does not look like it is currently being used, but appears to be maintained for water data collection (Photo 17\_A). The bridge was likely used for private equipment crossing. There is a concrete bridge deck with a metal truss and 12 inch diameter steel pipes for the piers. The bridge height was measured as 13.4 feet from the channel thalweg with a width of 16 feet and a span of about 52 feet. The total number of bridge piers is four and measured 17.1 feet apart.

Photo 17\_A. Bridges looking downstream

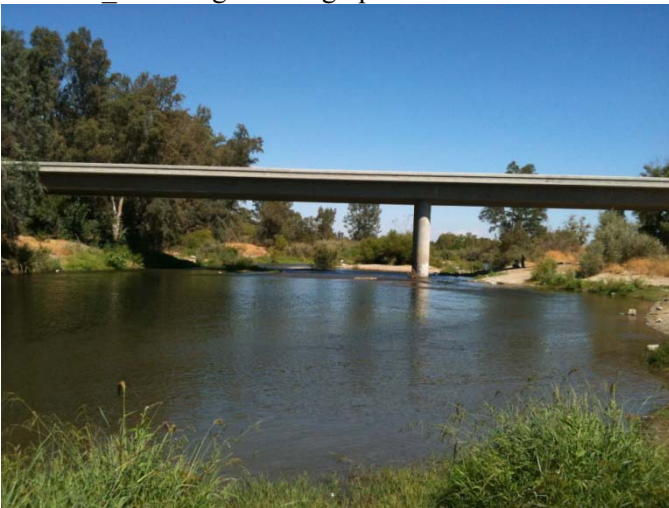
Description: The two lane bridge is located on the San Joaquin River near river mile 234.2 (Photo 18\_A). There are a total of four bridge piers. The bridge channel was too deep to wade to take measurements from under and it is not safe to take measurements from the bridge deck. Just downstream the bridge there is an island that is the remnants of an old ferry landing (Photo 18\_B). The location is publicly accessible from a Fresno County Park.

Photo 18\_A. Bridge looking upstream

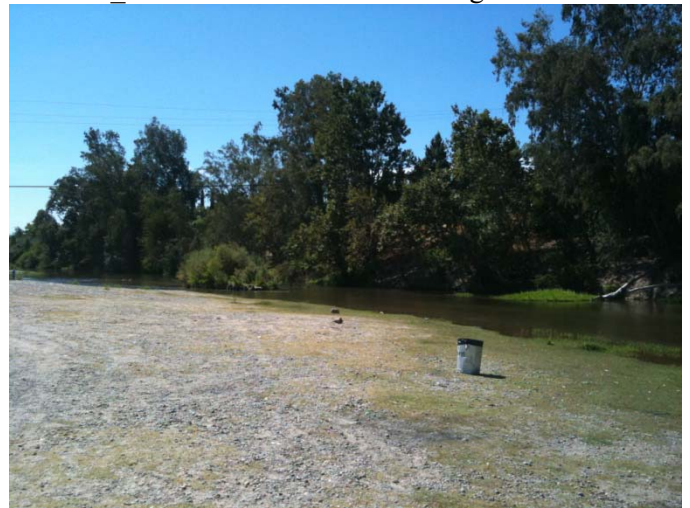
Photo 18\_B. Channel downstream bridge

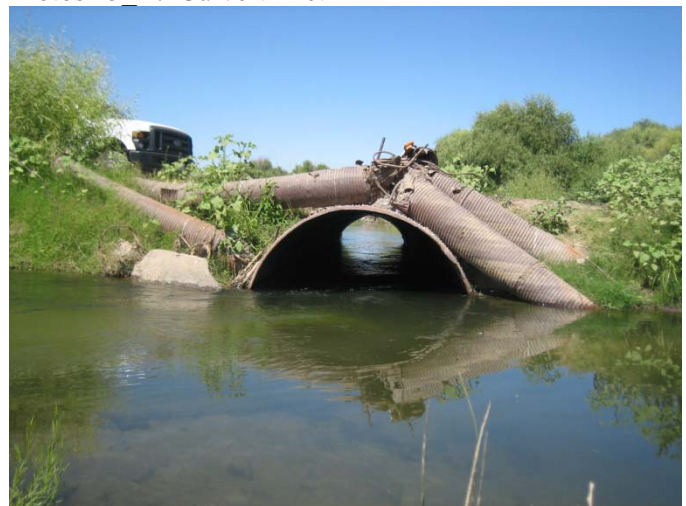
Photos 23\_B. Culvert inlet

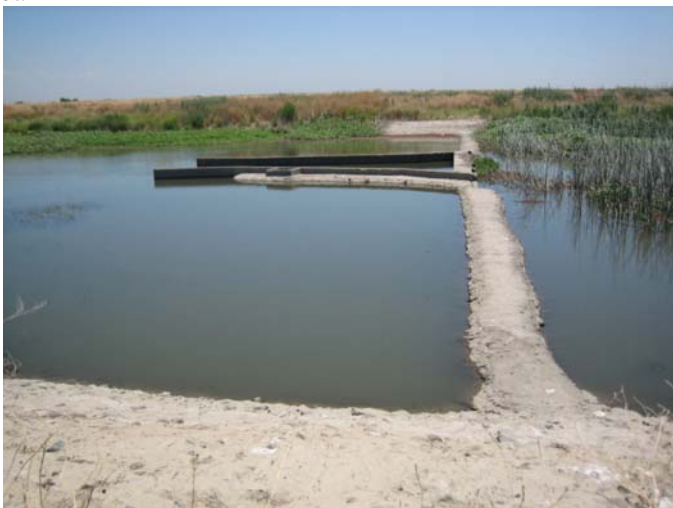
Photo 29\_A. Sand Slough Control Structure from the left bank

Description: The Sand Slough Control Structure is located at the apex of the San Joaquin River and the Sand Slough near river mile 168.47 (Photo 29\_A). The headgates to Reach 4B are located downstream on the right bank. The control structure is currently acting like a broad-crested weir with 6 rectangular openings each 5.1 x 5 feet (Photo 29\_B). Each opening is designed for slide gates or stop logs that are manually dropped. At the time of the survey the openings were open. The structure has a cobble and concrete headwall that extends the structure to the right and left banks of the channel for a total length of 186 feet from bank to bank. The structure is about 2.5 feet wide and about 5.1 feet high. The structure was partially submerged during the survey.

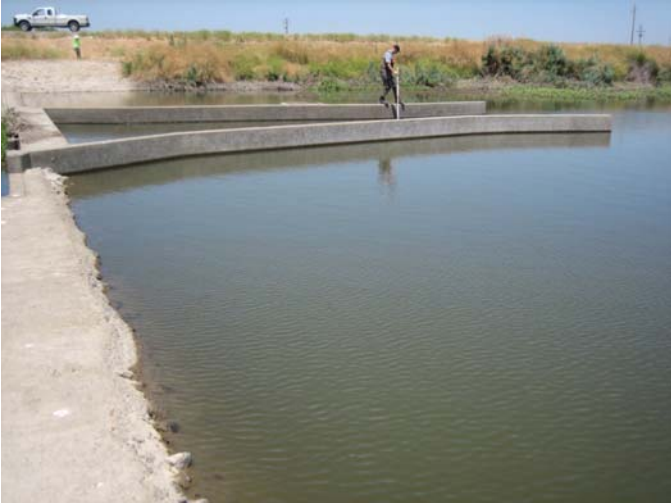
Photo 29\_C. Sand Slough Control Structure flume from right bank

There is a concrete flume downstream the weir openings that had a concrete apron (Photo 29\_C), so the pool depth downstream is dependent on the amount of flow allowed to enter the structure. The flume is 48.5 feet long and about 15 feet wide at the narrowest part with a height of 4.7 feet. The end of the concrete apron is about 18 feet past the end of the flume, but is sloped down about three feet at the end of the flume and continues to slope down into the channel. The pool depth within three feet downstream had a water surface elevation of 3.3 feet.

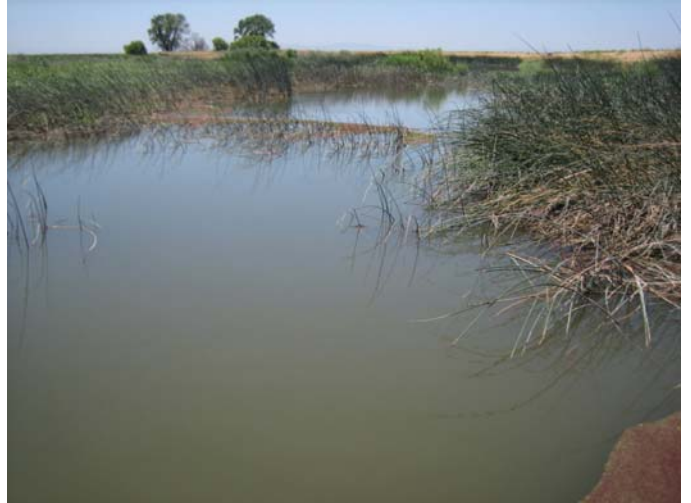
Photo 29\_D. Looking upstream from structure headwall

The channel upstream had heavy weeds with tall annual grasses in the floodplain and vegetation growing in the openings of the weir (Photo 29\_D). Downstream the channel had light weeds with tall annual grasses in the floodplain (Photo 29\_E).

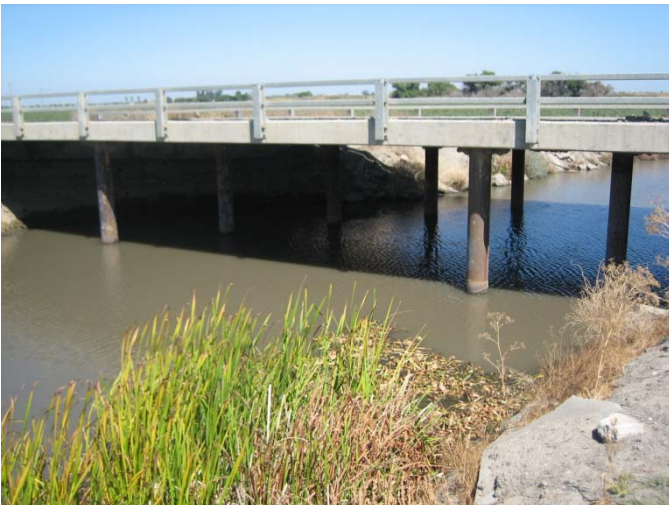
Photo 32\_A. Bridge, upstream looking downstream

Description: The Turner Island bridge crosses the San Joaquin River near river mile 157.2 (Photo 32\_A) at a bend in the river. The bridge has two lanes with a 150 feet span and 34.4 feet wide bridge deck and a height of 10 feet. The concrete bridge has a total of ten piers with two rows off five that are about 30 feet apart. The active channel width was measured at 65 feet.

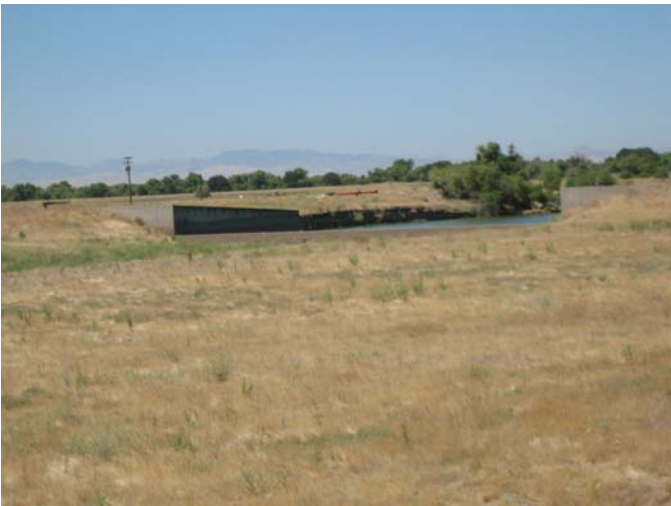
Photo 35\_A. Structure, upstream looking downstream

Description: The Mariposa Bypass weir is located near the apex of the Mariposa Bypass and the Sand Slough. The weir is acting like a drop structure. The structure is a concrete sharp-crested weir rectangular weir with openings for low flow (Photo 35\_A). The weir height at the opening is 5 feet with a length of 149.5 feet. There is a 17.6 feet drop from downstream. There are 7 openings that are 2 x 2 feet each spaced at 18 feet on center that are at channel grade. The openings are armored upstream with cobble and concrete just at the openings (Photo 35\_B).

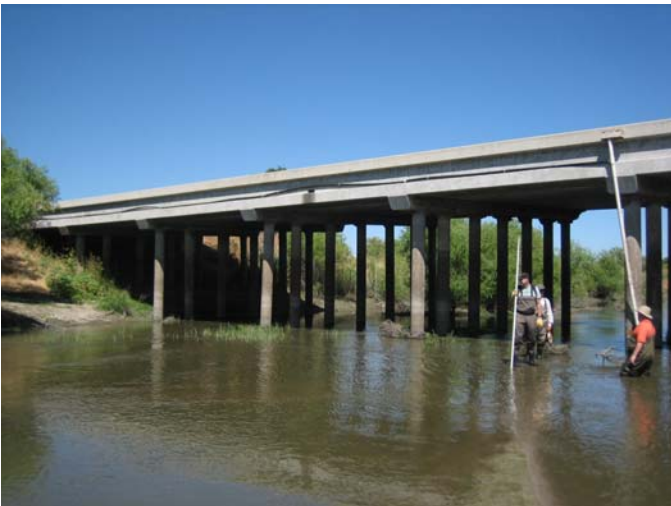
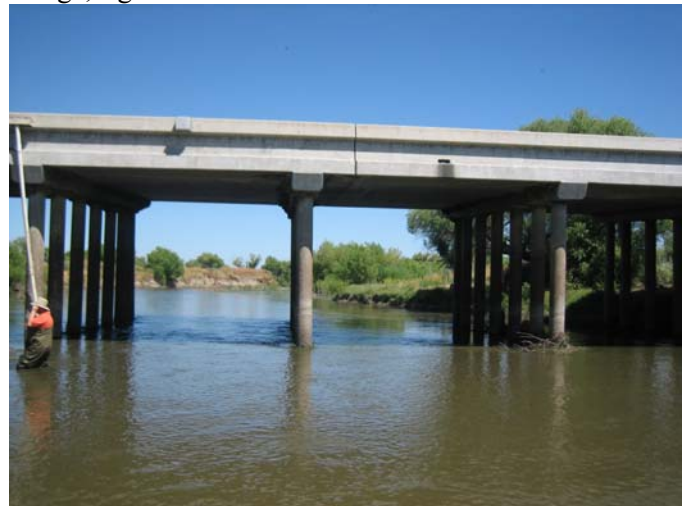
Description: The Highway 140 bridge crosses perpendicular to the San Joaquin River near river mile 125.1 (Photo 43\_A and 43\_B). The Highway 140 bridge has two lanes and has a 516 feet span and 22 feet wide bridge deck. The concrete bridge has 168 piers configured in 24 parallel rows of 7. The rows are about 22 feet apart. The active channel width was measured at 146 feet. There was no apron under the bridge.

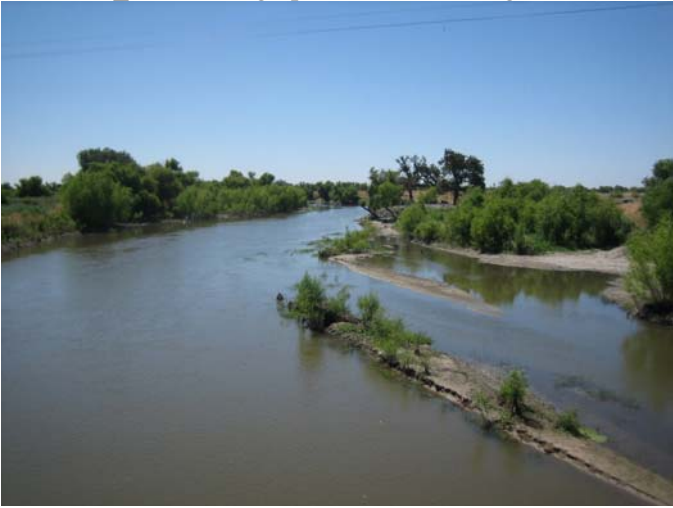
Photos 43\_C. Looking upstream from bridge

The river channel upstream is clean except there are short trees on the sandbars with tall annual grasses in the floodplain and large woody trees on the banks edge. Downstream there are tall weeds on a sand bar in the middle of the channel (Photo 43\_C) and the floodplain vegetation was similar to upstream. Trees appear to be mostly willows. The channel is mostly shallow with the more defined trapezoidal channel on the right bank at about 70 width. The channel substrate is a majority of silty-clay.

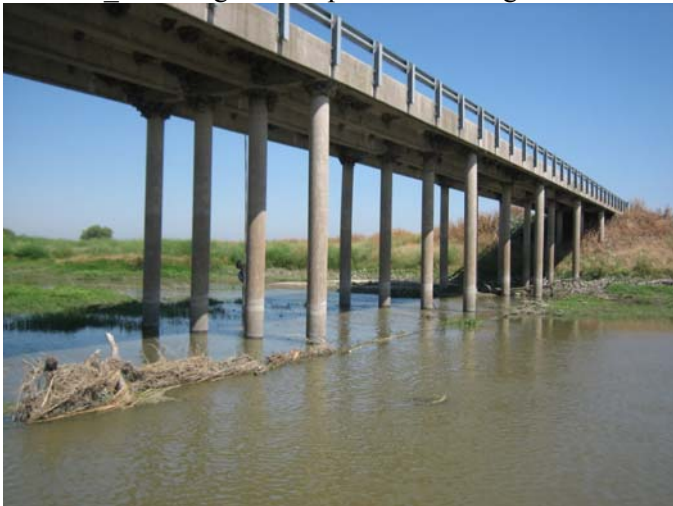
Photo 44 A. Bridge from upstream looking downstream

Description: The bridge crosses perpendicular to the Eastside Bypass (Photo 44\_A). The bridge has one lane with a 254.4 feet span, is 18.5 feet high and 18.4 feet wide. The concrete bridge has 28 piers configured in seven parallel rows of four. The rows are about 33 feet apart. The active channel width was measured at 90 feet with about five sets of piers in the water. There was no apron or rip rap under the bridge.

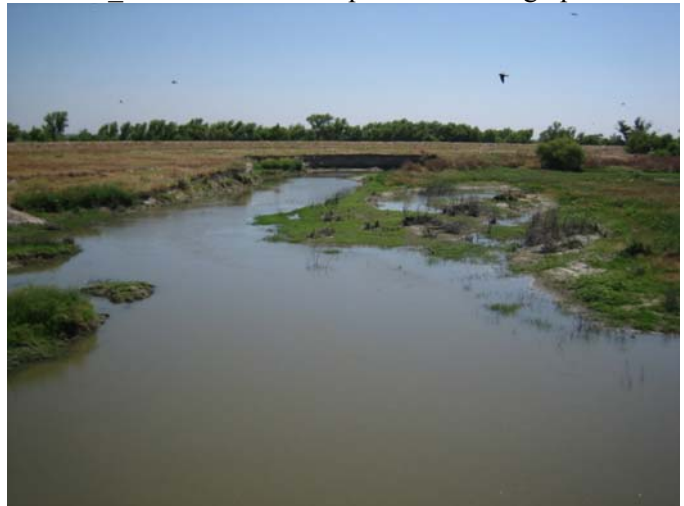
Photo 44 B. Channel from upstream looking upstream

The bypass is bounded by manmade levees upstream and downstream. The channel upstream (Photo 44\_B) and downstream had light weeds in the channel with tall annual grasses in the floodplain and levee with sparse brush and sparse tall woody trees on the banks. There is a pumping station downstream on the left bank (Photo 44\_C).

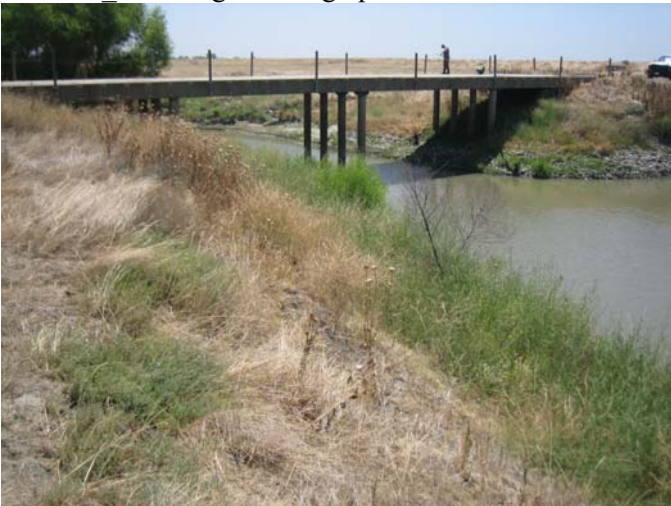
Photo 45\_A. Bridge looking upstream

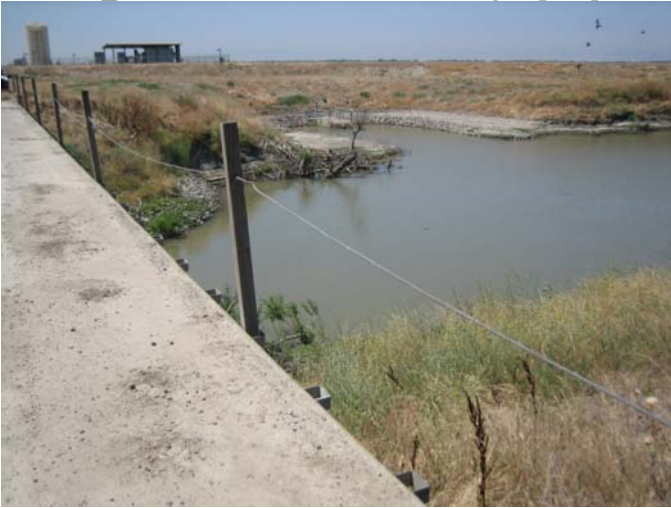
Photo 45\_C. Channel downstream looking at pump

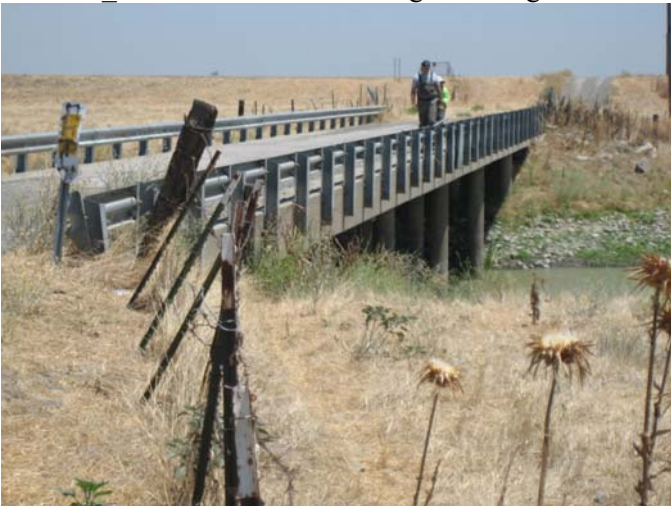
Description: The Greenhorn Road bridge crosses slightly skewed to the Eastside Bypass (Photo 47\_A). The bridge has one lane with a 181 feet span, is 18.7 feet high and 18.4 feet wide. The concrete bridge has 20 piers configured in five parallel rows of four. The rows are about 30.5 feet apart. The active channel width was measured at 102 feet with about three sets of piers in the water. There was no apron or rip rap under the bridge.

Photo 47\_A. Greenhorn Road bridge from right bank

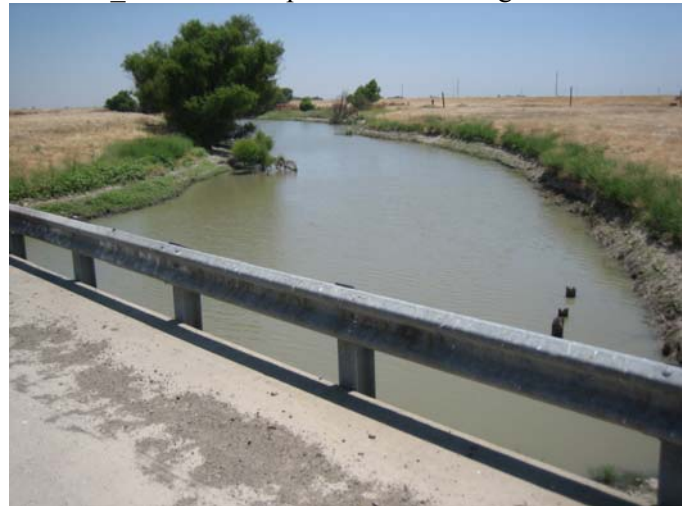
The bypass is bounded by manmade levees upstream and downstream. The channel upstream (Photo 47\_B) and downstream (Photo 47\_C) has light weeds in the channel with tall annual grasses in the floodplain and levee with sparse brush and sparse tall woody trees on the banks. The channel at the bridge had a water surface of 7.6 feet at the deepest. The channel substrate majority is silty-clay.

Photo 47\_B. Channel upstream from bridge deck

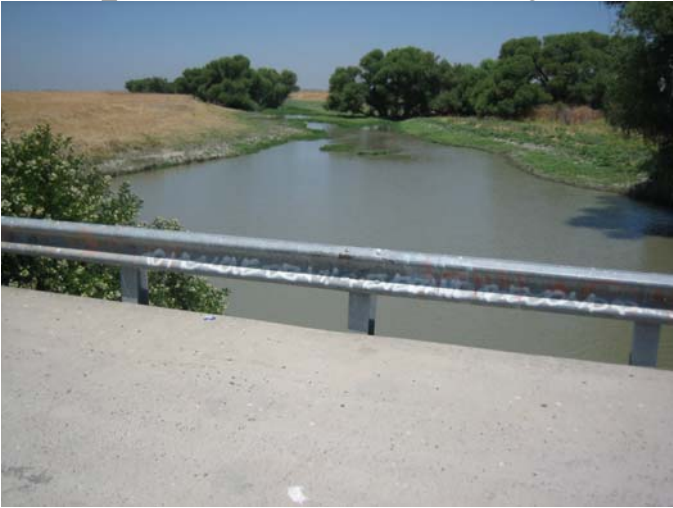
Photo 47\_C. Channel downstream from bridge deck

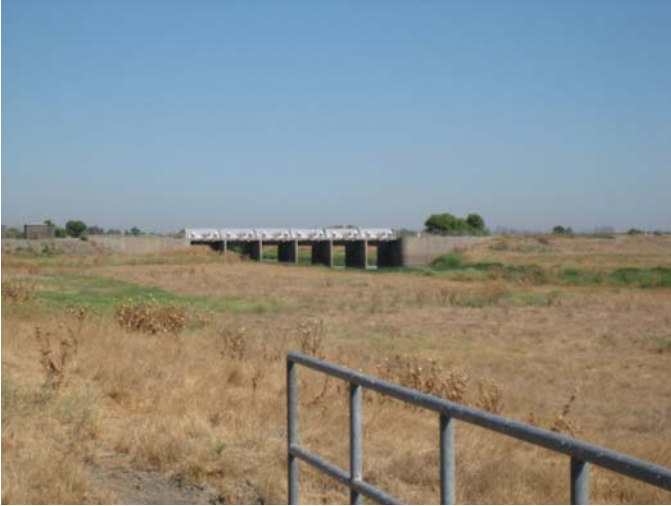
Description: The bifurcation structure is located at the apex of the Eastside Bypass and the Mariposa Bypass (Photo 48\_A). The control structure has six radial gates that were open during the survey. Each gate opening is 19 feet in height and 20 feet wide. The structure height is about 21.5 feet and measures 130.3 feet in total length from the top deck. This structure is very similar to the bifurcation structure located on the San Joaquin River downstream.

Photo 48\_A. Structure, upstream looking downstream

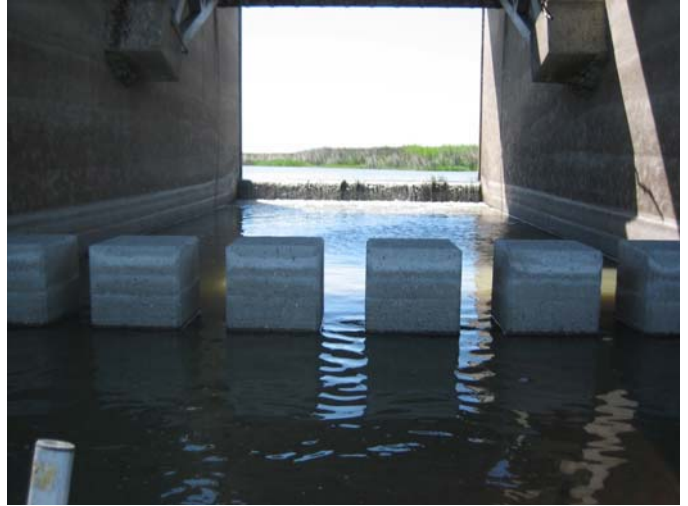
The structure has a maintenance road that crosses over the rear of the gate bay with an opening in the center to access the radial gate arms. The hoist motors are located at the top of each bay on the upstream end. There is a solid concrete headwall that extends to the levee to the east and west. The bays are 45.5 feet in length with a 15 foot concrete apron downstream. There are six 2 x 2 x 4 foot concrete block diffusers about 55 feet from the radial gate (Photo 48\_B).

Photo 48\_B. Downstream looking upstream from end of bay

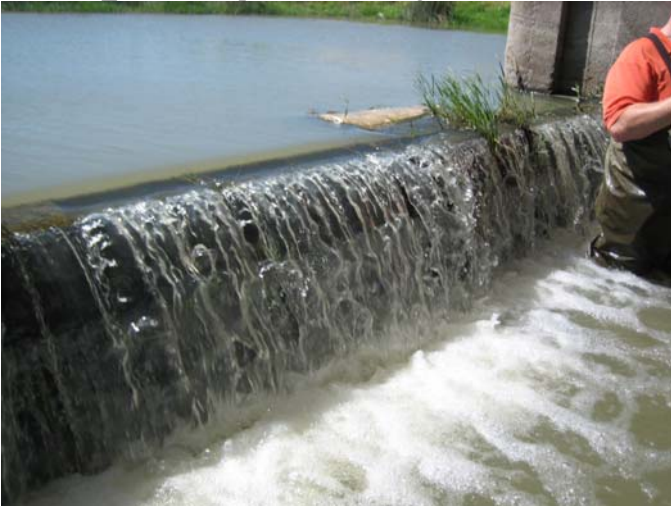
The concrete apron has a short weir downstream that is about 2 feet tall and 1 foot wide. There is a large pool downstream with rip rap to protect the concrete apron and weir from erosion. The rip rap protection extends about 30 feet downstream. The depth of the pool was not determined due to the depth exceeding what was able to be waded. Upstream there is a weir at the inlet that is 4 feet tall. The water surface elevation in the bays was 2.2 feet (Photo 48\_C).

Photo 48\_C. Weir upstream radial gate seal

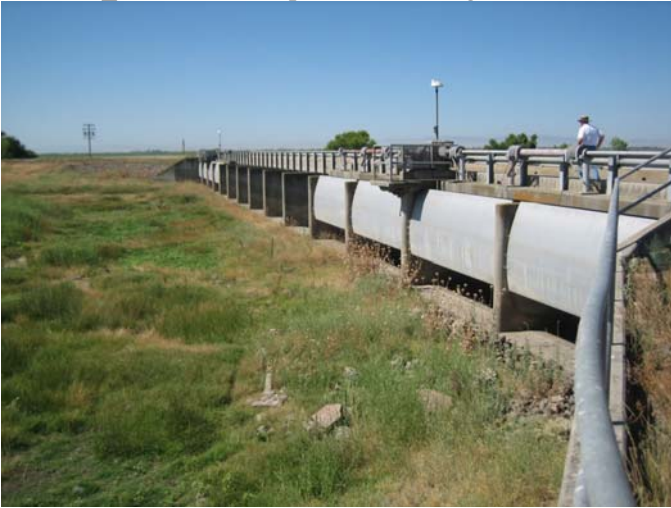
Photo 49\_A. Structure,upstream looking downstream

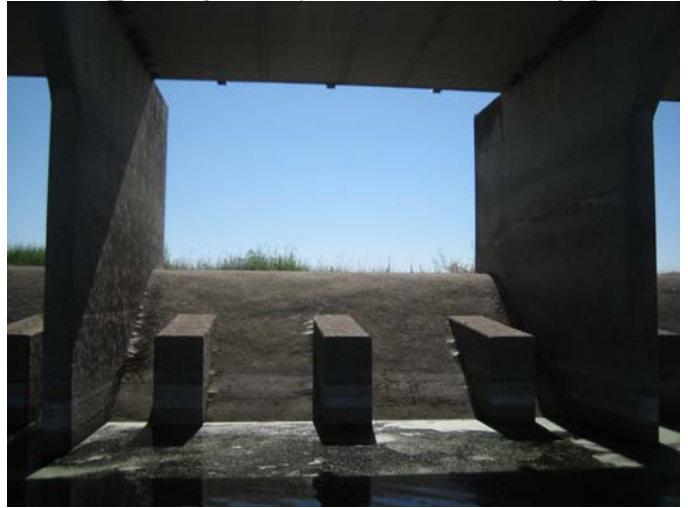
Photo 49\_B. Ungated bay, downstream looking upstream

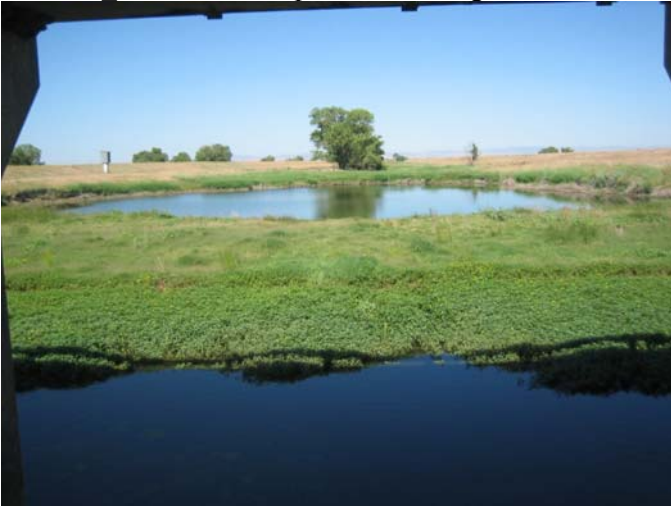
Photo 49\_C. Structure, upstream looking downstream

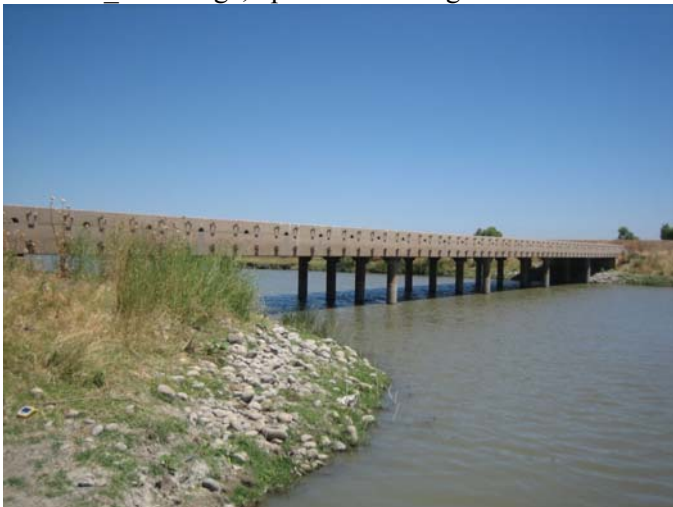
Photo 50\_A. Bridge, upstream looking downstream

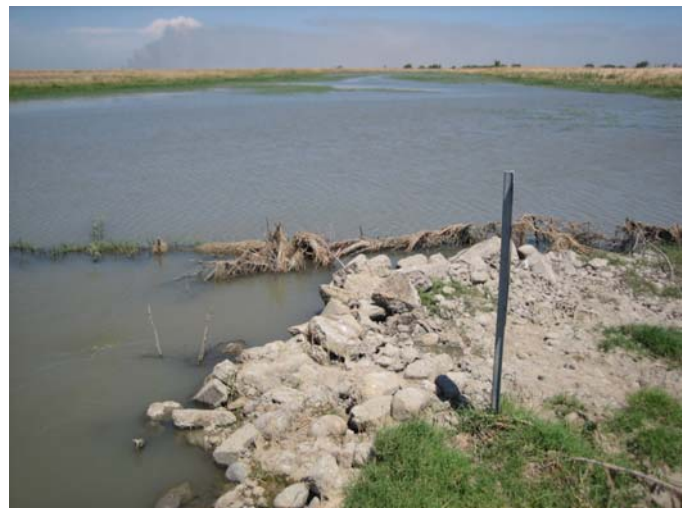
Photo 51\_B. Looking upstream from the crossing near the culvert inlet

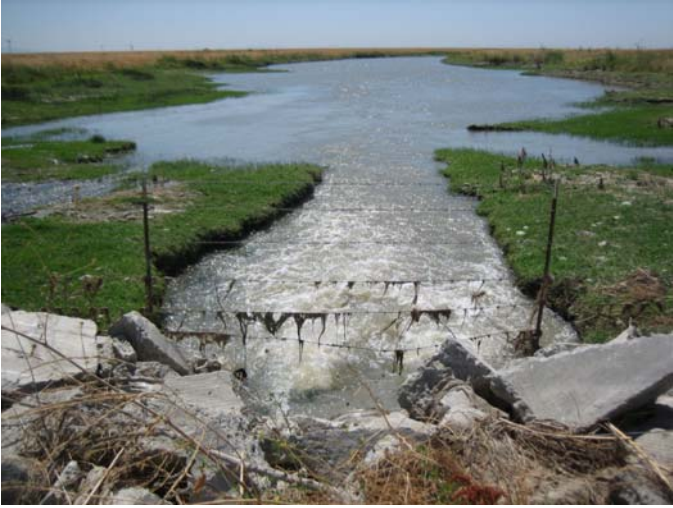
Photo 51\_C. Looking downstream from the crossing at the culvert outlet

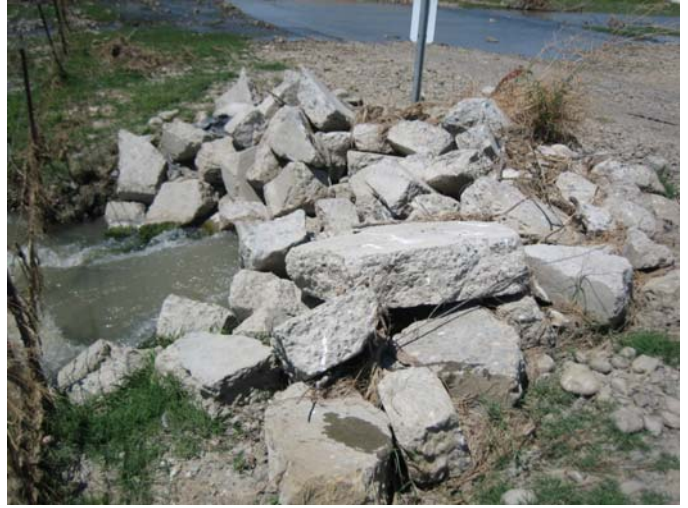
Photo 51\_D. Culvert outlet

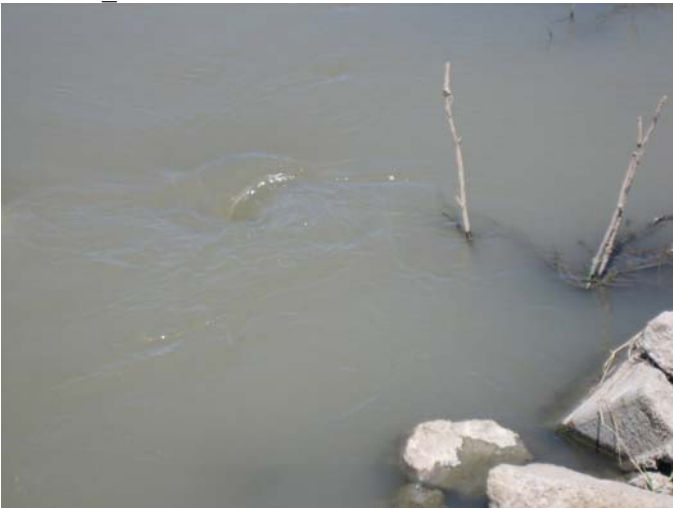
Photo 51\_E. Culvert inlet

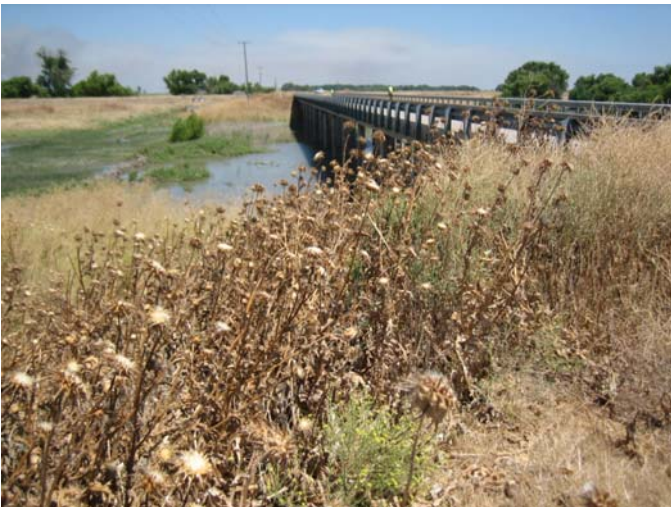
Photo 52\_A. Sandy Mush Road Bridge looking downstream

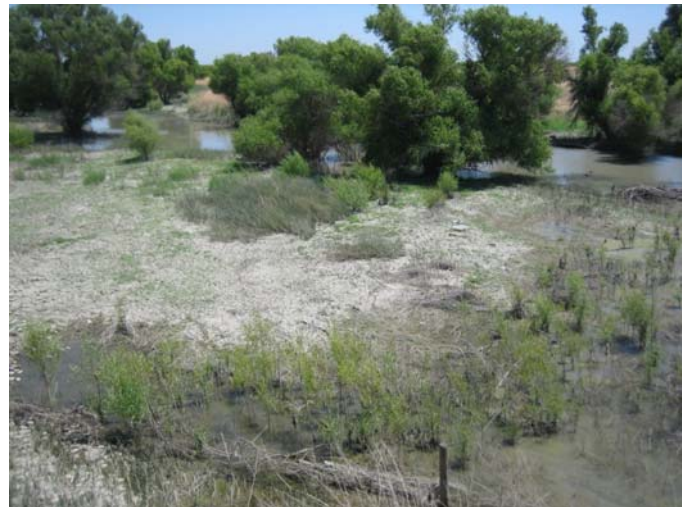
Photo 52\_B. Looking upstream from bridge abutment

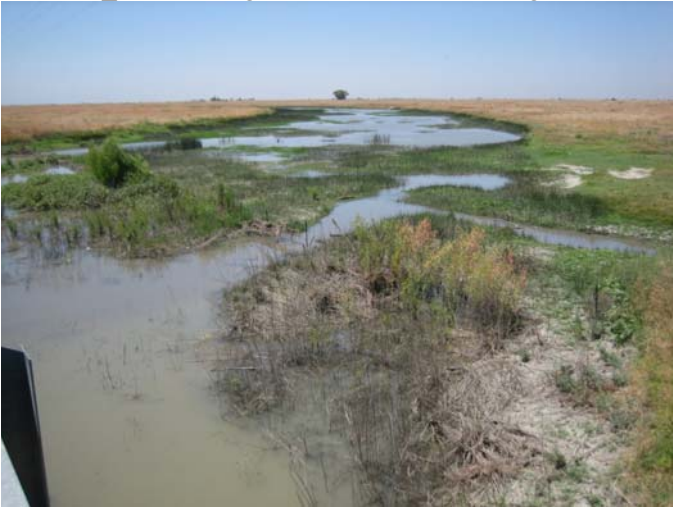
Photo 52\_C. Looking downstream from bridge

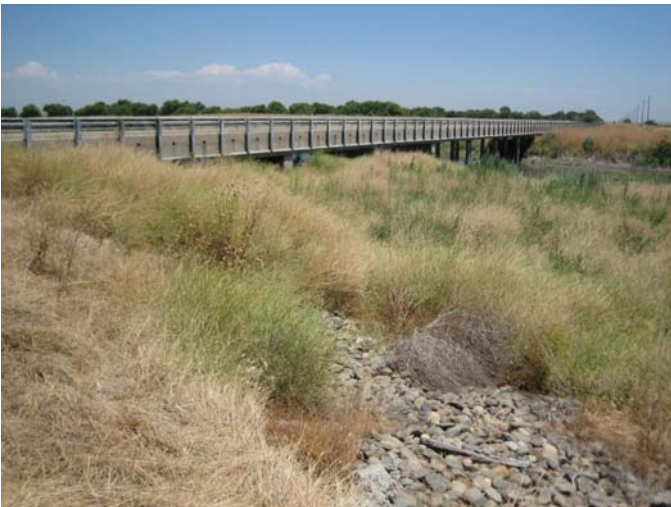
Description: The Washington Road bridge crosses perpendicular to the Sand Slough near river mile 127.7 (Photo 55\_A). The bridge has a one lane 570.9 feet span, is 15.1 feet high and 18.5 feet wide. The concrete bridge has 60 piers configured in 15 parallel rows of 4. The rows are about 35.5 feet apart. The active channel width was estimated at 165 feet with about five sets of piers in the water. There was no apron or rip rap under the bridge.

Photo 55\_A. Washington Bridge looking downstream

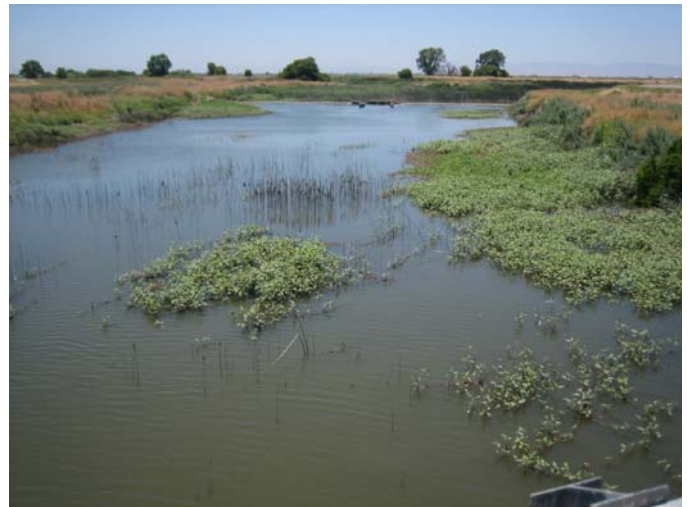
The slough is bounded by manmade levees upstream and downstream. Just downstream is the Sand Slough control structure (Photo 55\_B). The channel upstream and downstream (Photo 55\_C) has light weeds in the channel with tall annual grasses in the floodplain and levee banks. The channel at the bridge had a water surface of 4.9 feet at the deepest. The channel substrate has a majority of silty-clay.

Photo 55\_B. Channel looking upstream, sand slough control structure
