Friant-Kern Canal Subsidence

May 18, 2017

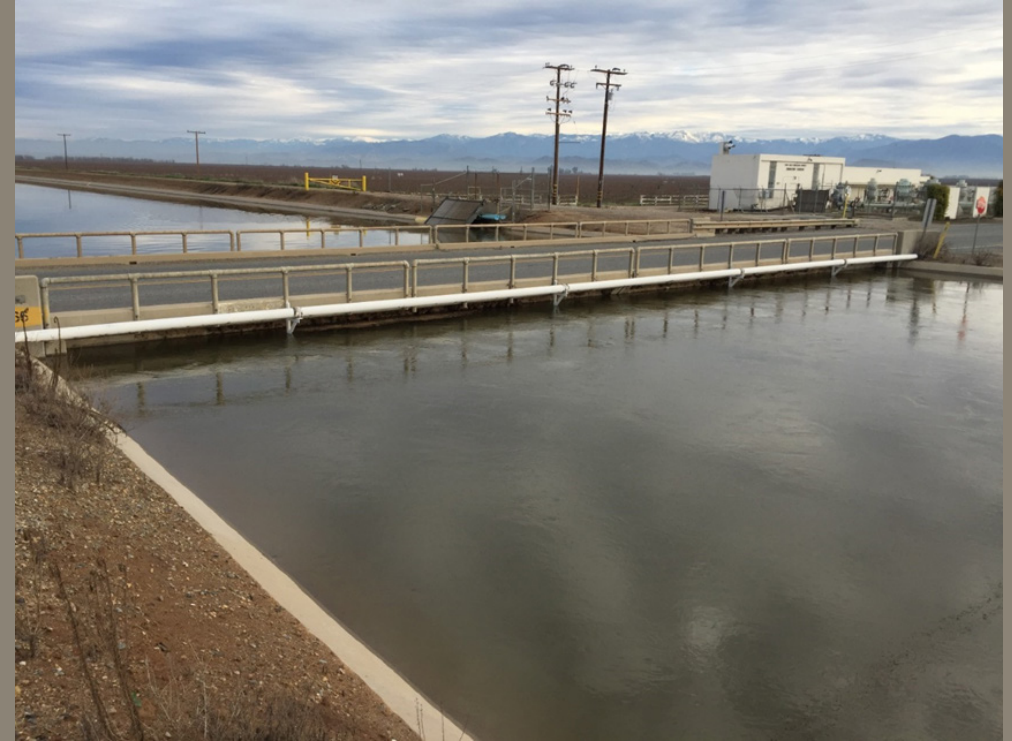
- January of this year 1,900 cfs saw water on 5 county bridges in area
- Water surface above bridge low chord at Ave 96, Rd 208, Ave 88, Ave 80, Rd 192

January high flows

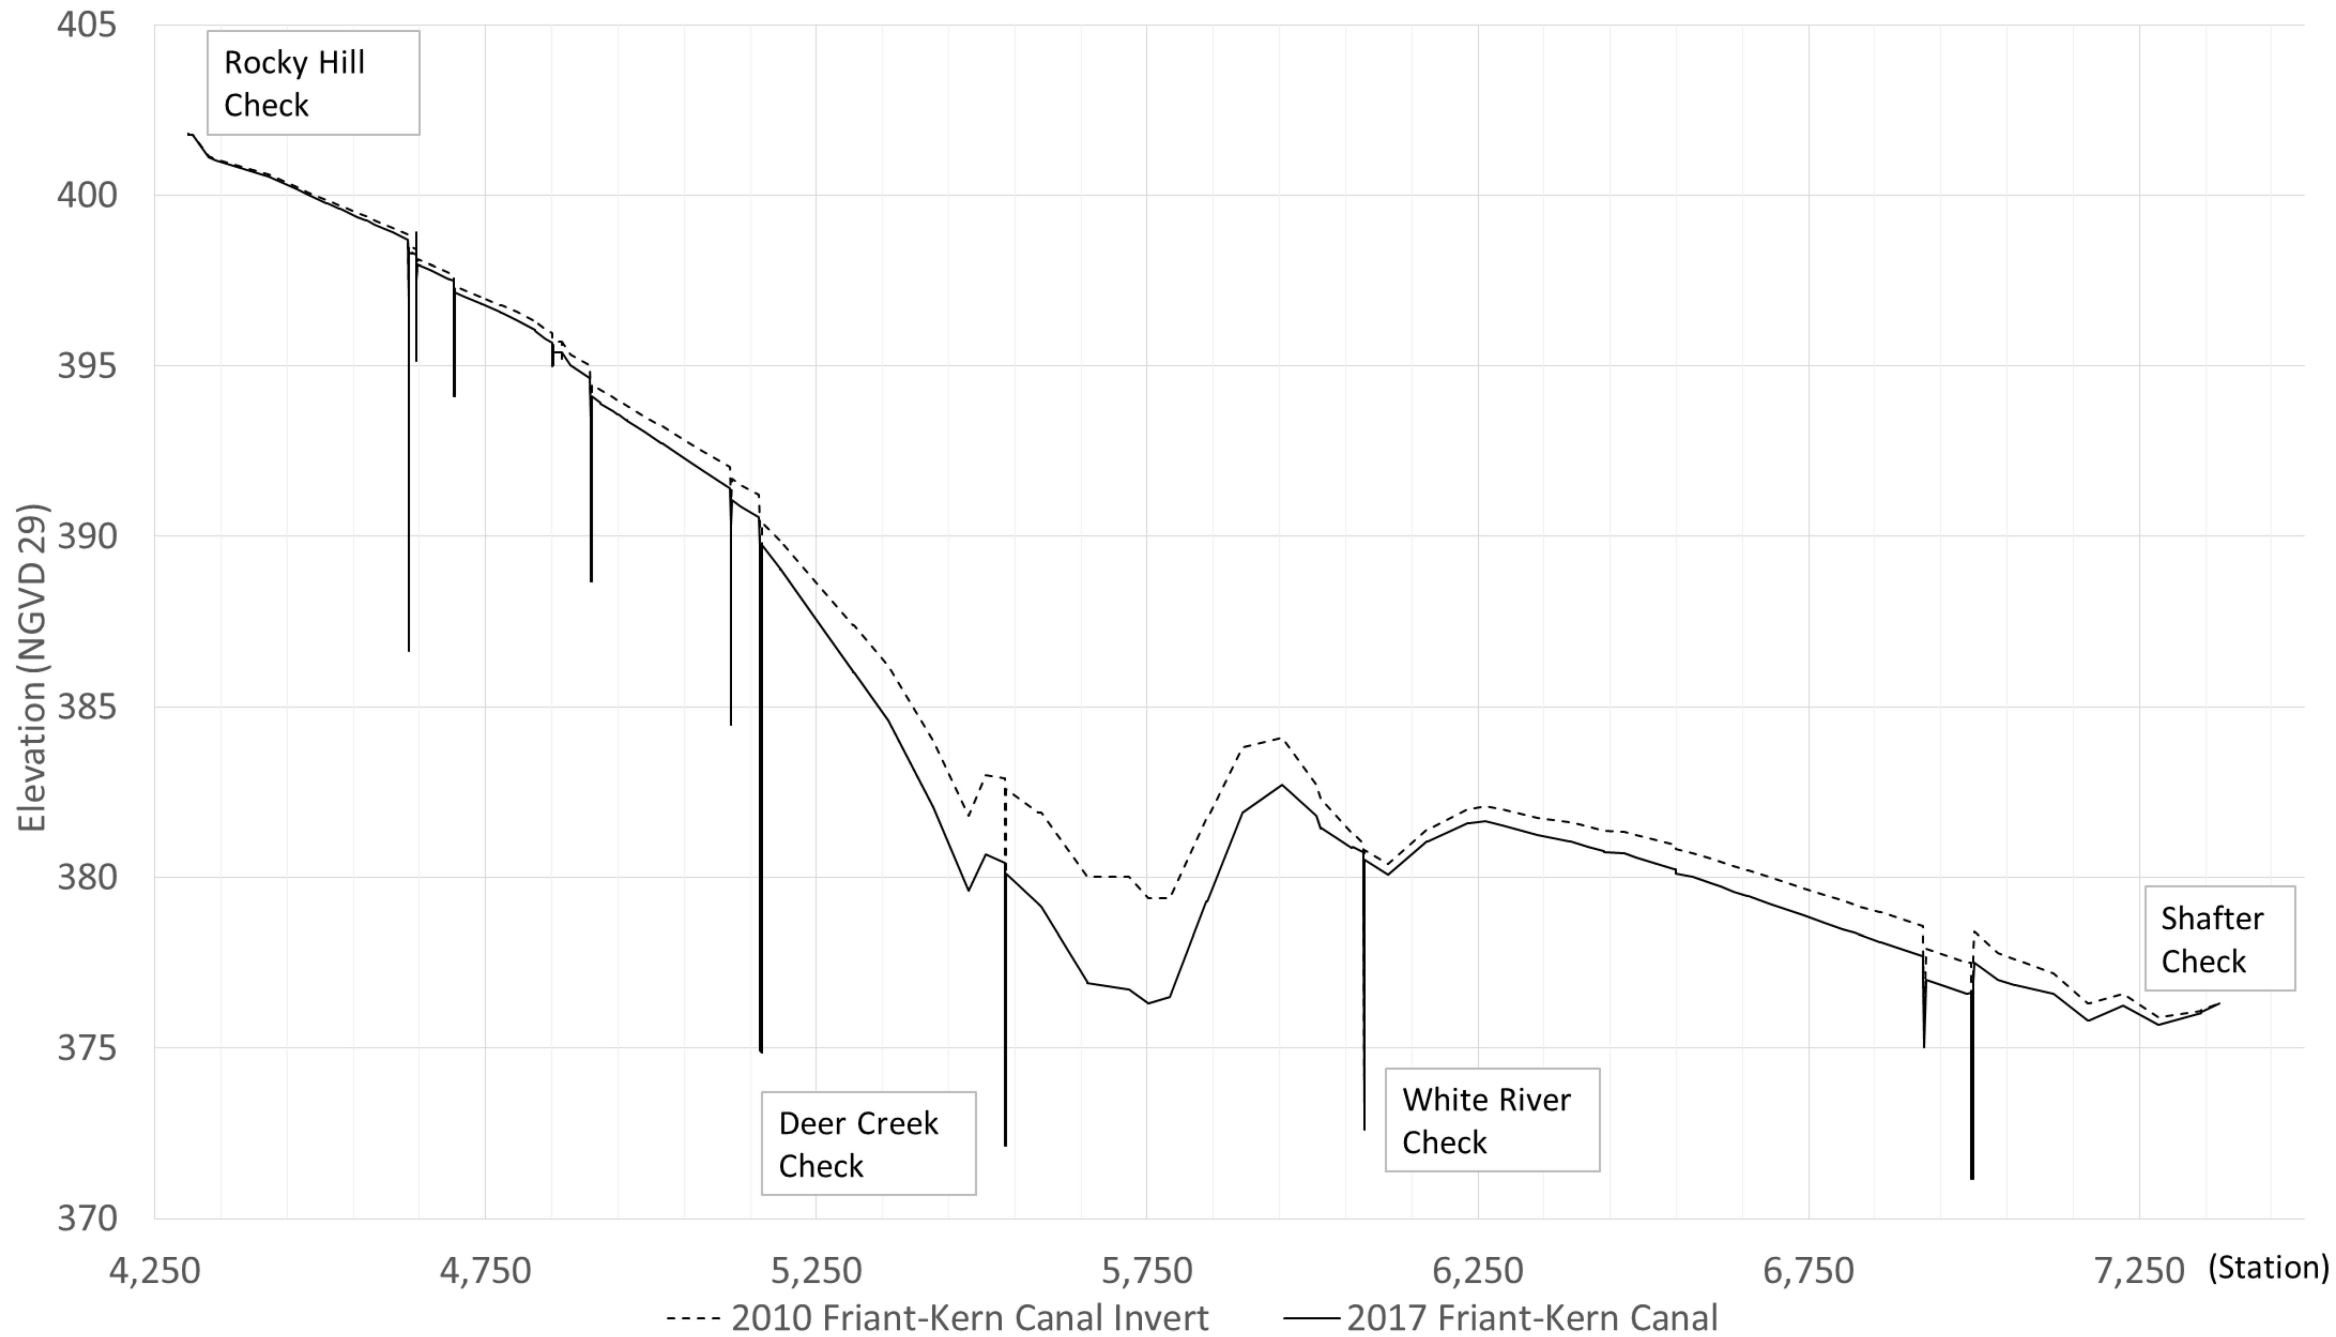
- 2017 Benchmark survey completed by Reclamation
- Using 2017 Benchmarks, Friant Water Authority surveyed canal inverts and points of interest between Fifth Avenue and Poso Creek Check
- Approximately 3.25' of subsidence in some areas since 2010 survey

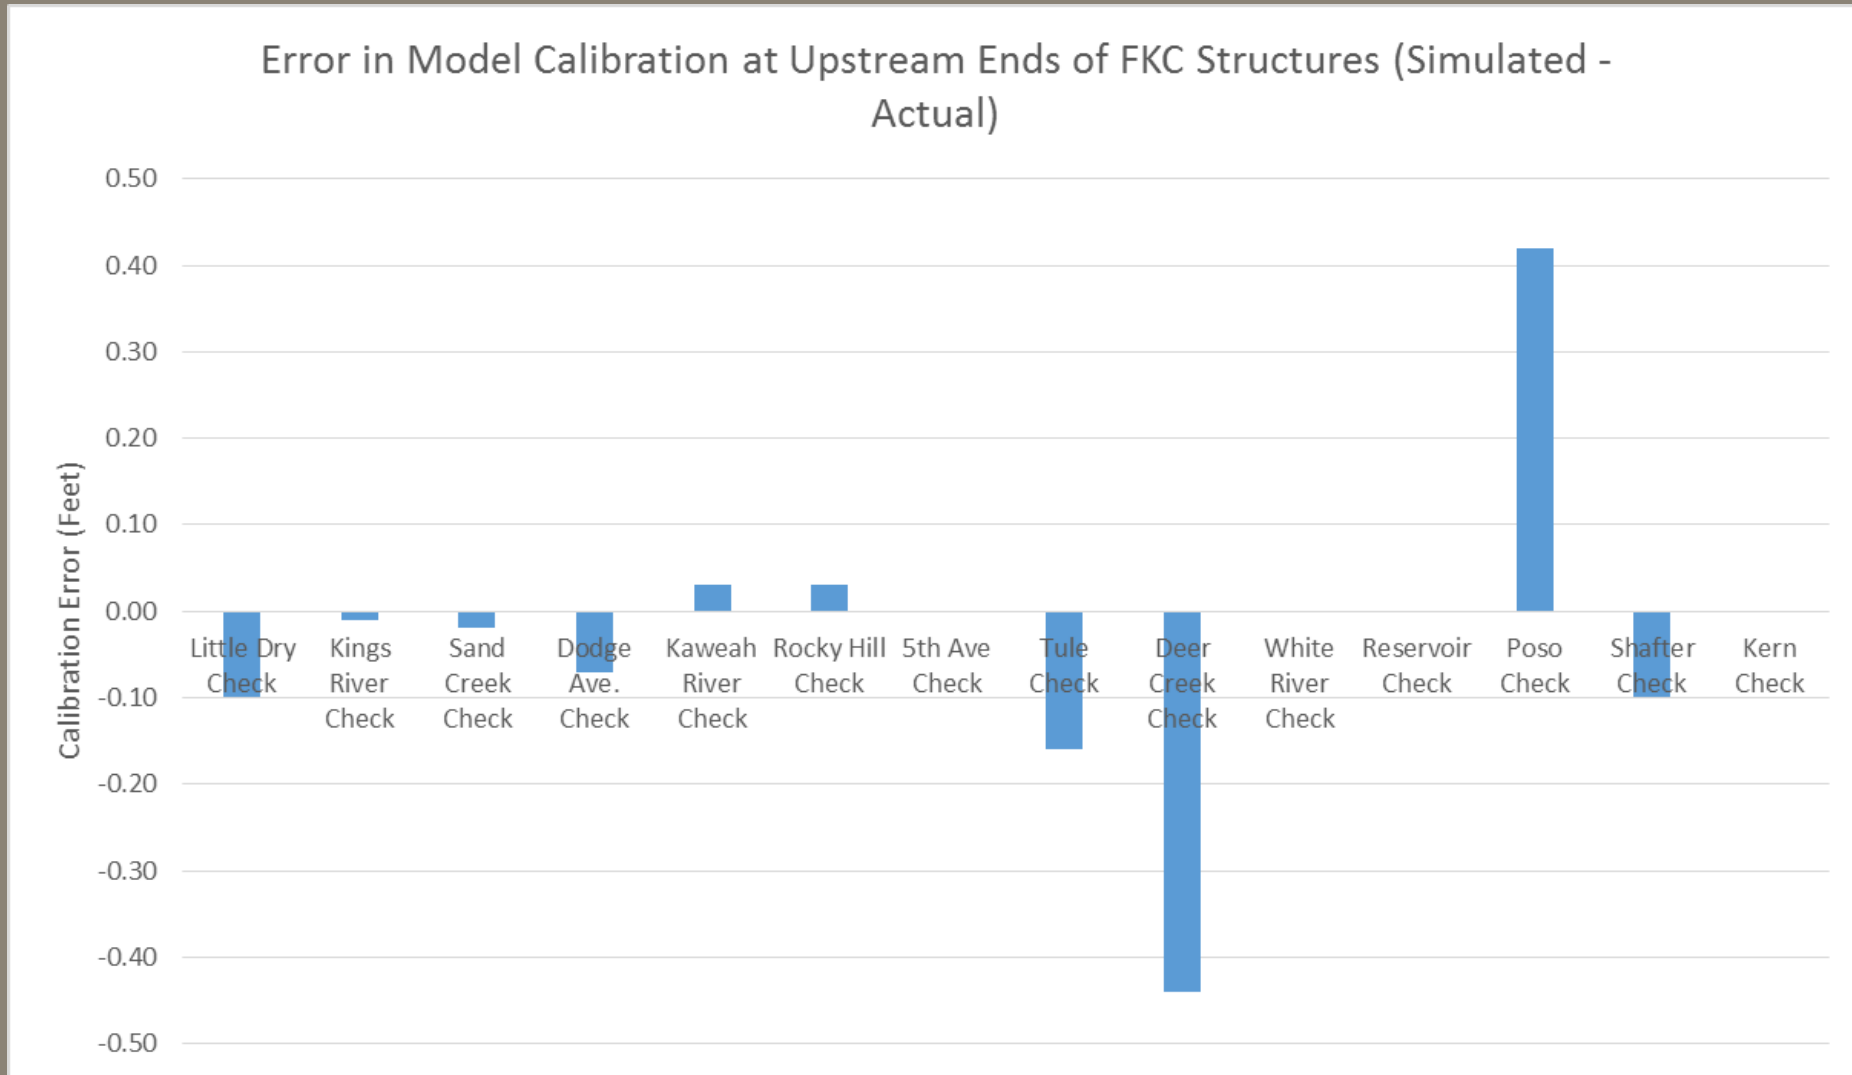
Existing Conditions Model: Calibration

- Input gate operations, and flows from January 18th, 2017 SCADA reports
- Adjusted loss factors at each check structure
- Adjusted friction factor in the canal
- Visual Inspections at Check Structures to validate results

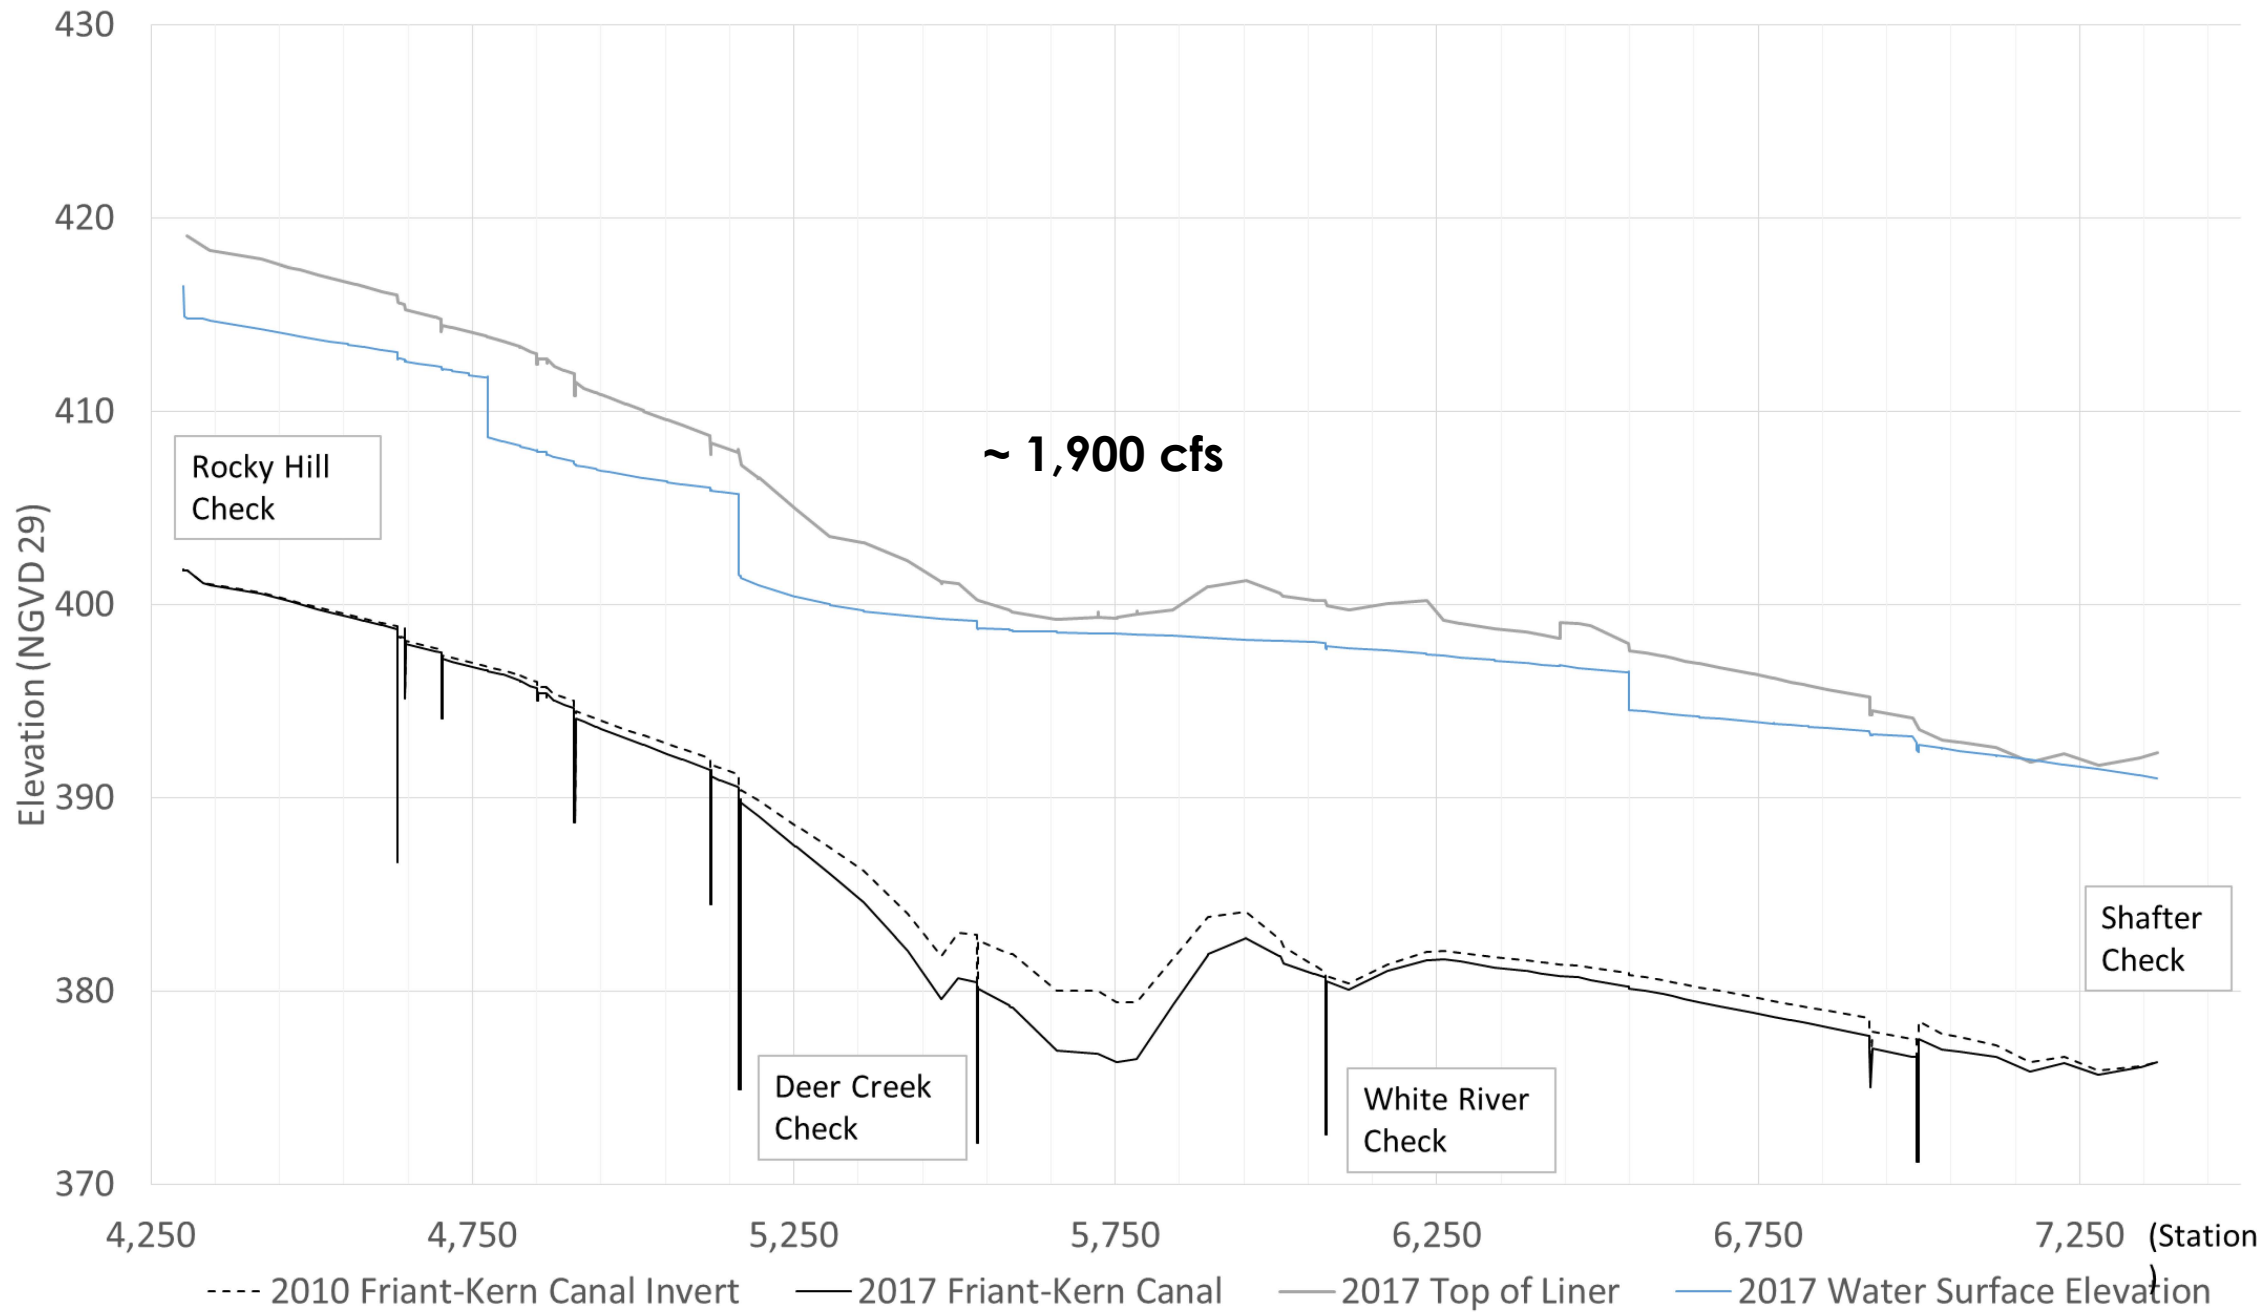
- Using January 18th Data approximately 1,900 cfs through Deer Creek Check
- Water on 5 bridges below Deer Creek Check
- Using calibrating model tried to push the design normal flows in the canal with all gates open
- Reduced flows until passed from Rocky Hill to Shafter Check

Rocky Hill Check

~ 1,900 cfs

Deer Creek Check

White River Check

Shafter Check

---- 2010 Friant-Kern Canal Invert

— 2017 Friant-Kern Canal

— 2017 Top of Liner

— 2017 Water Surface Elevation
