Technical Memorandum

**Channel Capacity Report
2018 Restoration Year**

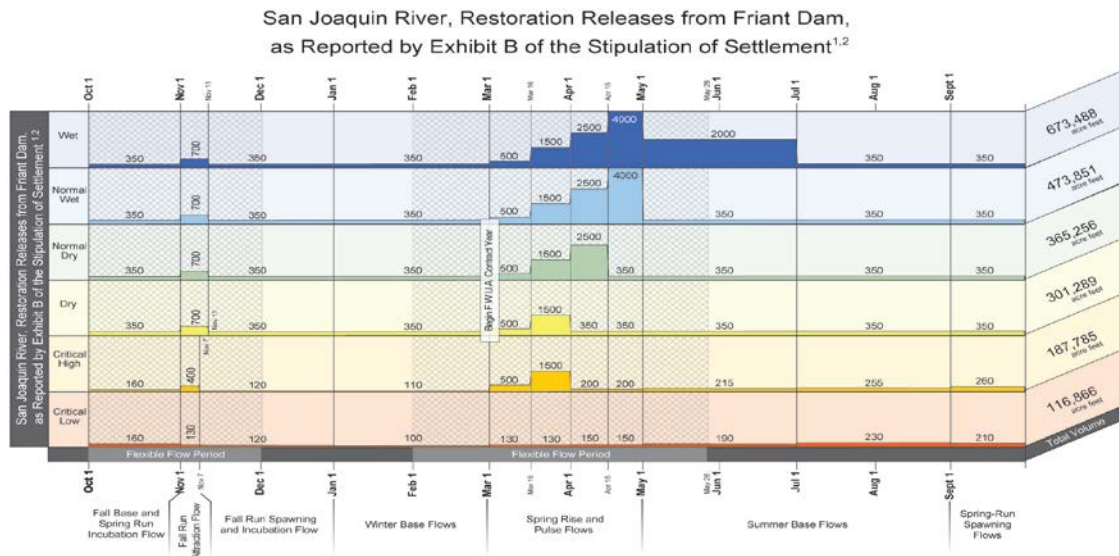
Figure 5 - 1

1 - NRDC v. Rodgers, Stipulation of Settlement, CIV NO. S-88-1658 - LK9CGGH Exhibit B, September 13, 2006
 2 - Hydrographs reflect assumptions about seepage losses and tributary inflows which are specified in the settlement

10 The SJRRP flow hydrograph involves a spring and a fall pulse with base flow releases of 350 cfs
11 from Friant Dam in the summer and winter months in most year types. These hydrographs are
12 provided in Exhibit B of the Settlement and the Restoration Flow hydrograph at Friant Dam is
13 summarized in Figure 5-1. Spring flow pulses range from 1,500 cfs maximum release in a
14 critical-high year type, to a 4,000 cfs release in a wet year type. The Restoration Administrator,
15 an independent individual called for in the Settlement, makes recommendations to the Secretary
16 of the Interior on how best to shape the hydrograph to meet the Restoration Goal of the
17 Settlement. The Restoration Administrator has the flexibility to adjust the hydrographs,
18 consistent with the Settlement, including releasing buffer flows of up to 10 percent, mobilizing
19 gravel with an up to 8,000 cfs pulse, and flexibly scheduling the spring pulse volume within a

20 period defined as 28 days in advance of the Settlement Exhibit B hydrographs (i.e., beginning on
21 February 1 with 500 cfs), and 28 days later than the Exhibit B hydrographs (ending on May 28 at
22 4,000 cfs). The fall pulse volume may be flexibly scheduled from October 1 to November 30. In
23 wet year types, an additional volume is available for riparian recruitment that can extend 60 to 90
24 days past the end of the spring pulse flow.
25

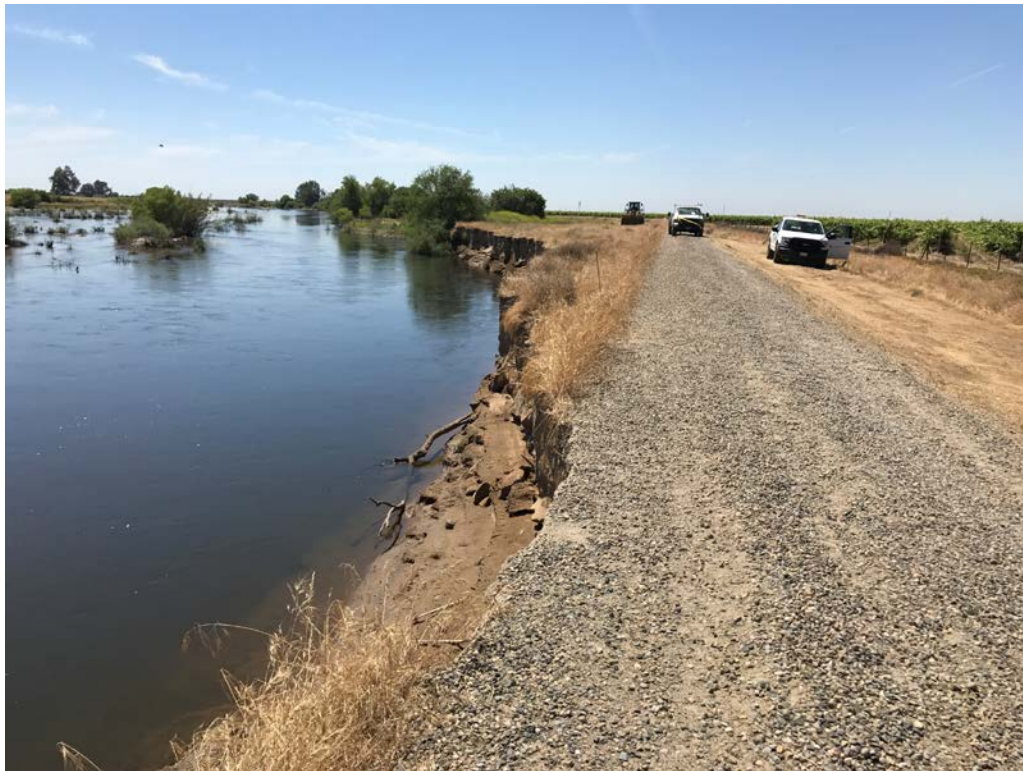
**Figure 11-2.
Photo of Erosion Site Prior to Repairs (looking upstream)**

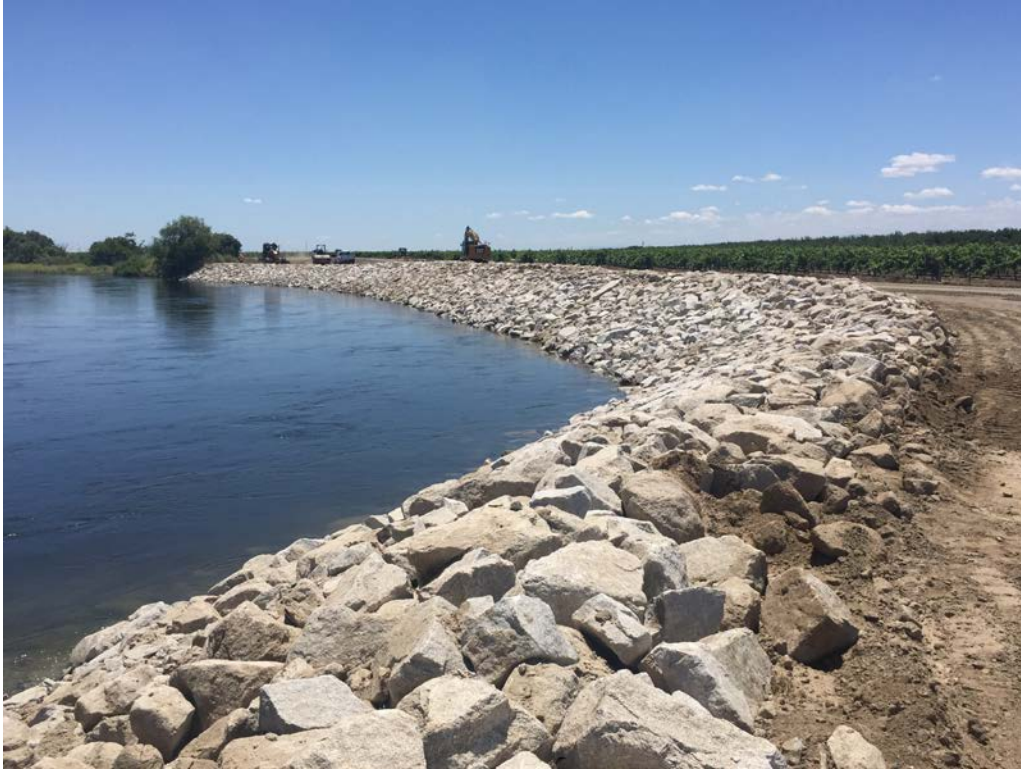
Figure 11-3.
Photo of Erosion Site After Repairs were Completed (looking upstream)
