Technical Memorandum

Channel Capacity Report 2018 Restoration Year

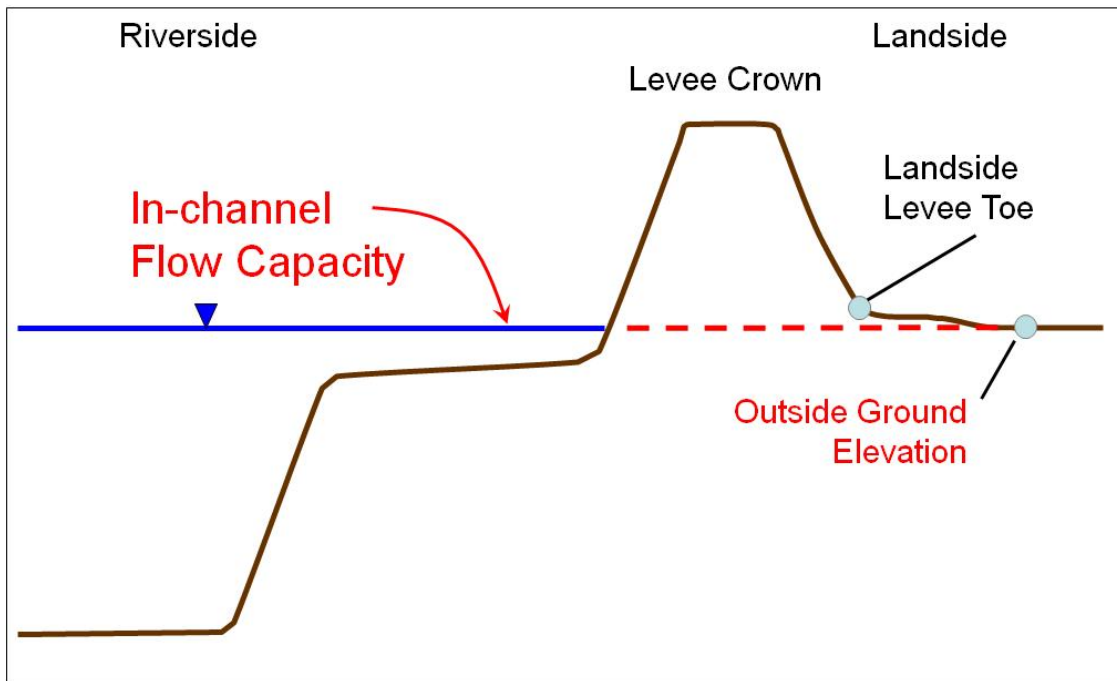
19
 20 **Figure 7-1.**

9 To determine the outside ground to which the models results would be compared to determine
 10 in-channel capacities, the landside levee toe elevations were identified for each reach. In this
 11 analysis, the outside ground elevation adjacent to the landside levee toe was selected to represent
 12 the elevation of the landside levee toe. The elevations were identified at each hydraulic model
 13 cross-section primarily through inspection of the cross-sectional topography and were verified
 14 through review of the aerial photography, contour mapping, and topographic surveys. The
 15 outside ground elevations were selected for both the left and right levees. In-channel capacities
 16 reported in this analysis are based on water-surface profiles developed by running the models
 17 over a series of local flows. Figure 7-1 is a conceptual figure of the outside ground elevation
 18 location and the in-channel flow capacity.

21 **Levee Schematic Defining Levee Features and In-channel Capacity**

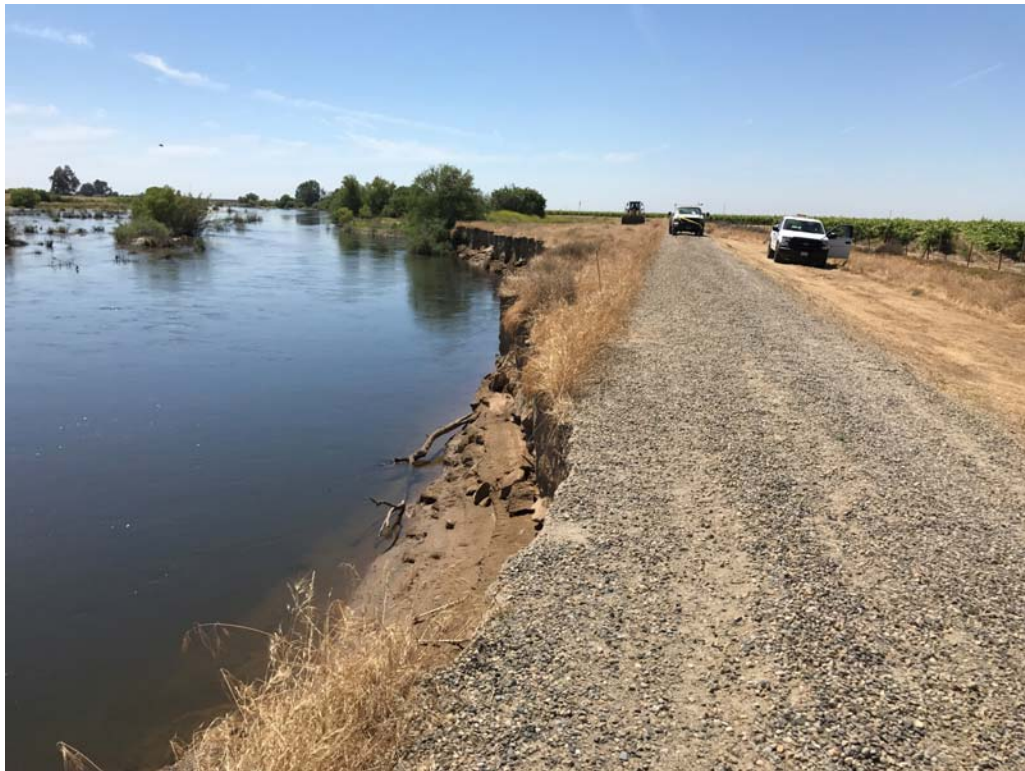
Figure 11-2.
Photo of Erosion Site Prior to Repairs (looking upstream)

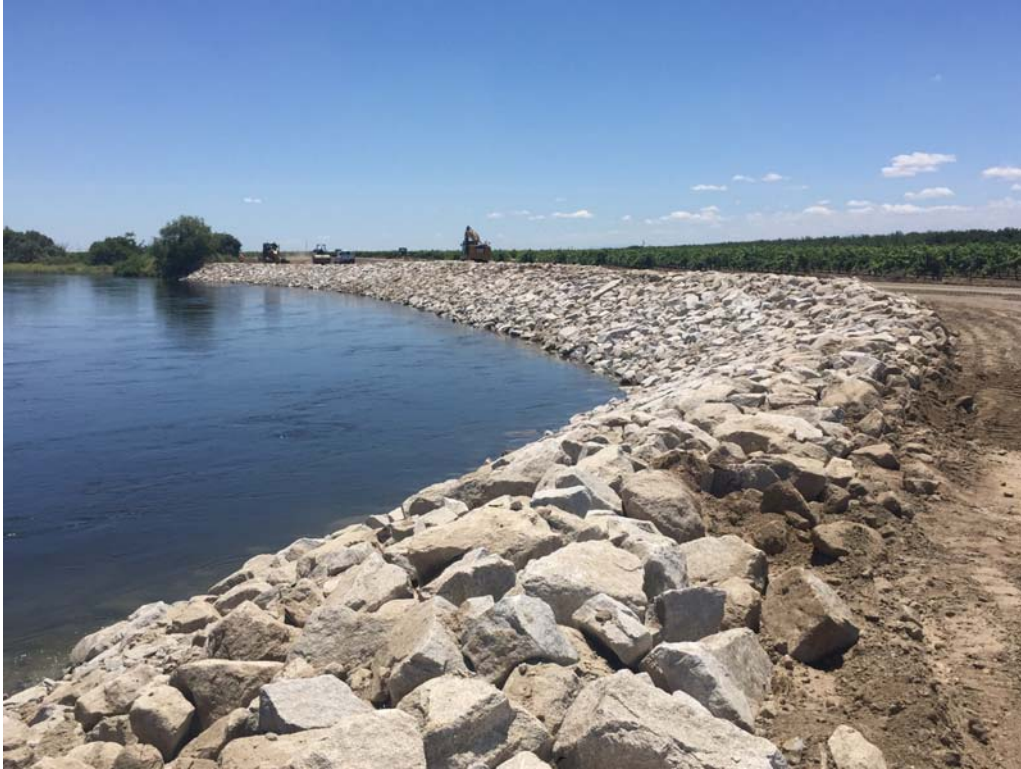
Figure 11-3.
Photo of Erosion Site After Repairs Were Completed (looking upstream)
