# Appendix B

## Update San Joaquin River In-channel Capacity Analysis

# San Joaquin River In-channel Capacity Analysis

August 12, 2015

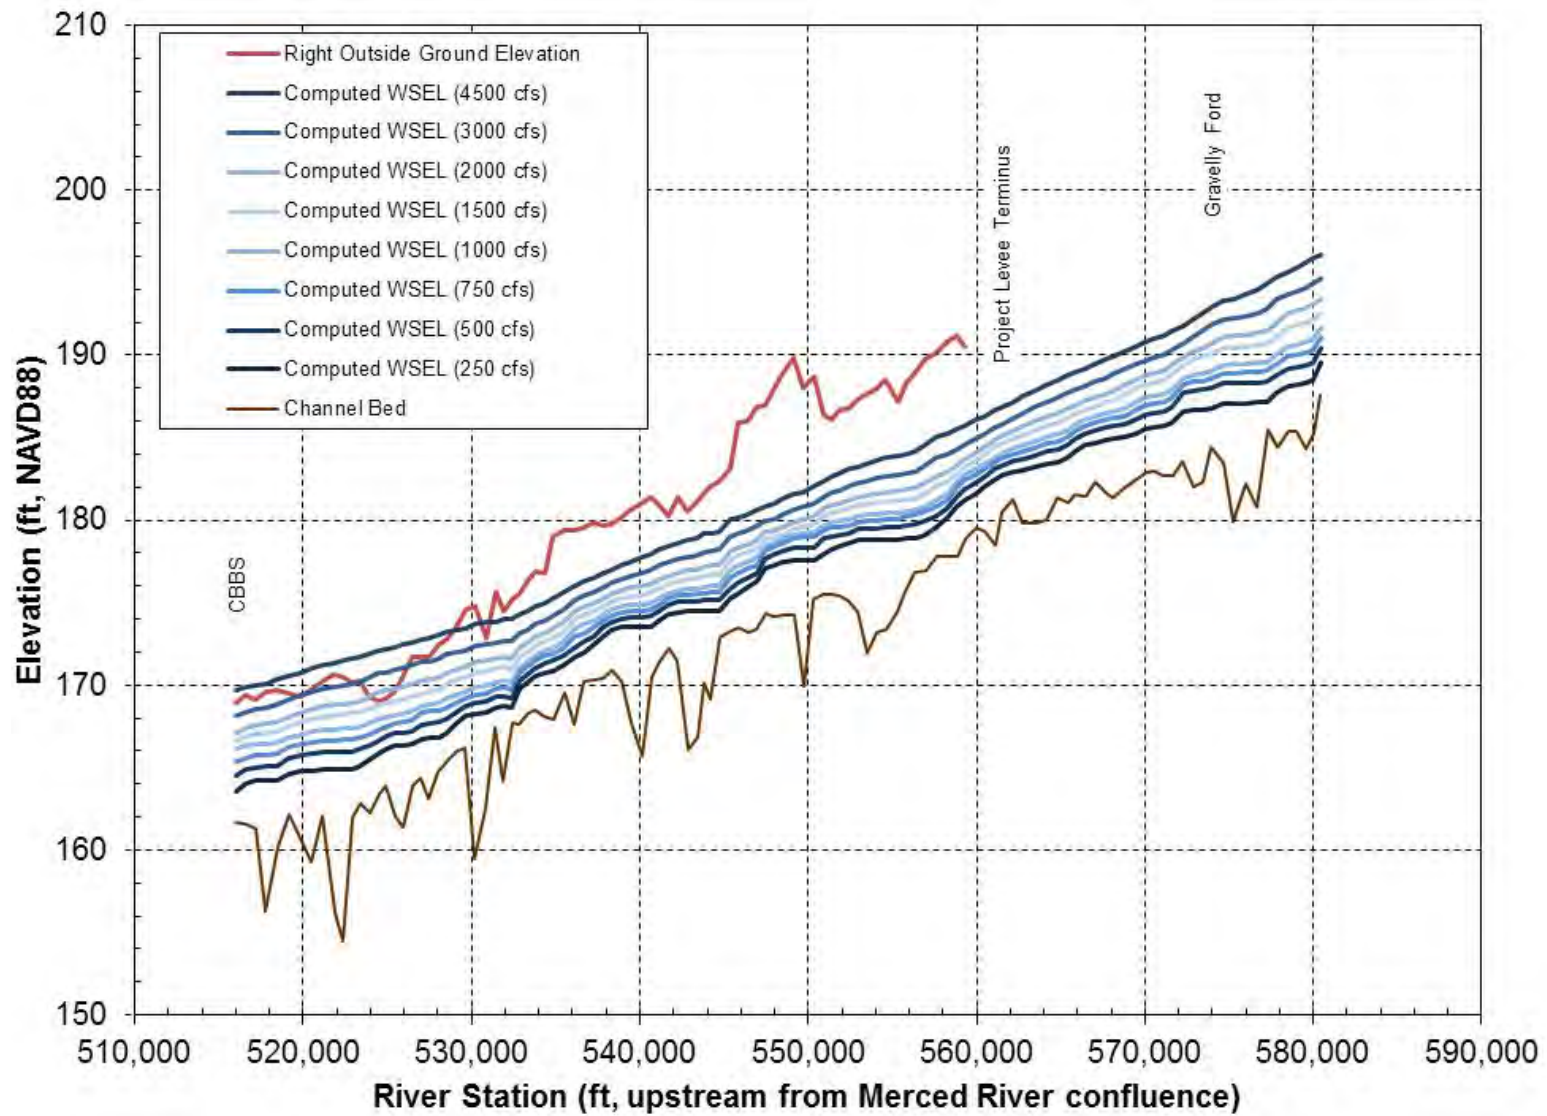
Figure 3. Comparison of outside ground profile with computed water-surface elevations along right levee in Reach 2A.

right and left levees in Reach 2A, the highest local discharge for which the water surface is at or below the outside ground elevation is 1,630 and 2,430 cfs, respectively (**Figures 3 and 4**). At 2,000 cfs, water-surface elevations exceed the outside ground elevations only along the right levee, at a total length of 1,240 feet. At 4,500 cfs, water-surface elevations exceed the outside ground elevations along 7,410 feet of left levee, and 10,100 feet of right levee (**Table 2**). Segments of levee where ground elevations are exceeded by water-surface elevations at a local discharge of 2,000 and 4,500 cfs are delineated in **Figures 5 and 6**.

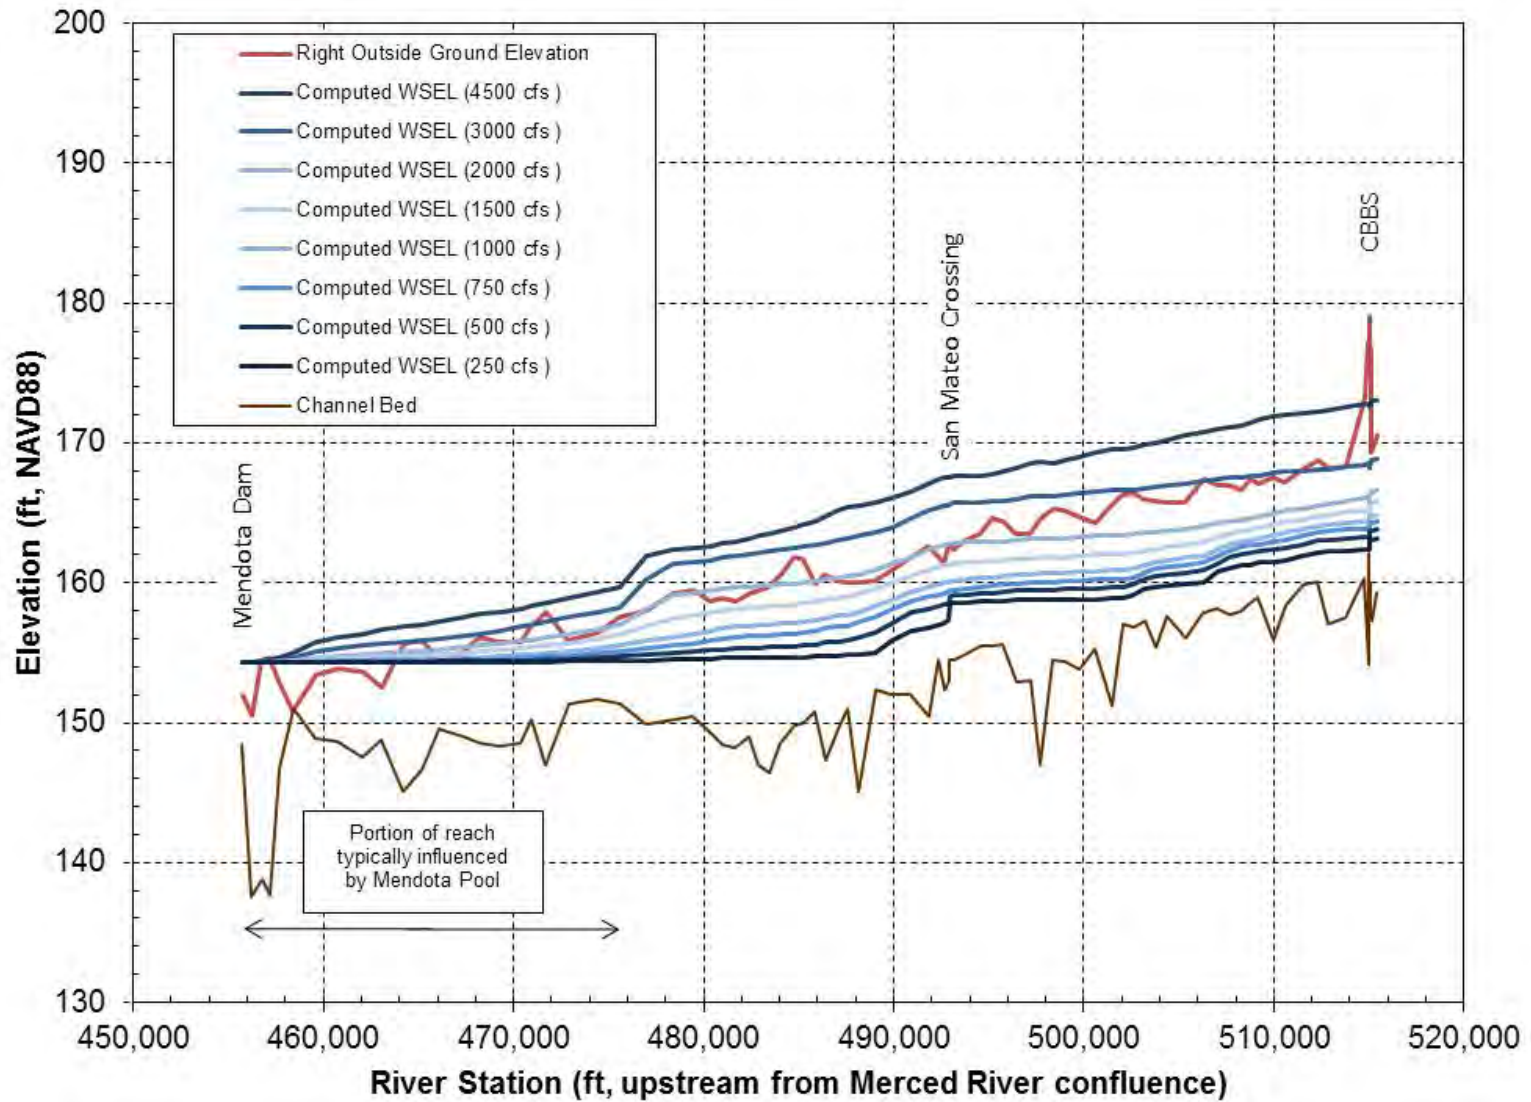
Figure 7. Comparison of outside ground elevation with computed water-surface elevations along right levee in Reach 2B.

When considering the entire reach, including Mendota Pool, the capacity along both sides of the channel is 0 cfs (**Figures 7 and 8**). At a local discharge of 2,000 cfs, water-surface elevations exceed ground elevations over approximately 4 miles (21,200 feet) along the left levee and 3.6 miles (18,800 feet) along the right levee (Table 2). At 4,500 cfs<sup>1</sup>, the length where water-surface elevations exceed ground elevations along the left levee increases to about 10 miles (53,300 feet), and the length along the right levee increases to about 7.7 miles (40,400 feet). If only the portion of the reach upstream from the influence of the pool is considered, the highest local discharge in which the water surface is at or below the outside ground elevation is about 1,120 cfs along the left levee and 1,550 cfs along the right levee (Table 2). In this portion of the reach, water-surface elevations at 2,000 cfs exceed the outside ground elevations along 8,730 feet of levee on the left side of the channel and 8,320 feet along the right. At a local flow of 4,500 cfs, the lengths increase significantly to 7 miles (36,800 feet) along the left levee and 4.5 miles (23,900 feet) along the right levee. The portions of levee along the entire reach where ground elevations are exceeded by water-surface elevations at a local discharge of 2,000 and 4,500 cfs are delineated in **Figures 9 and 10**.

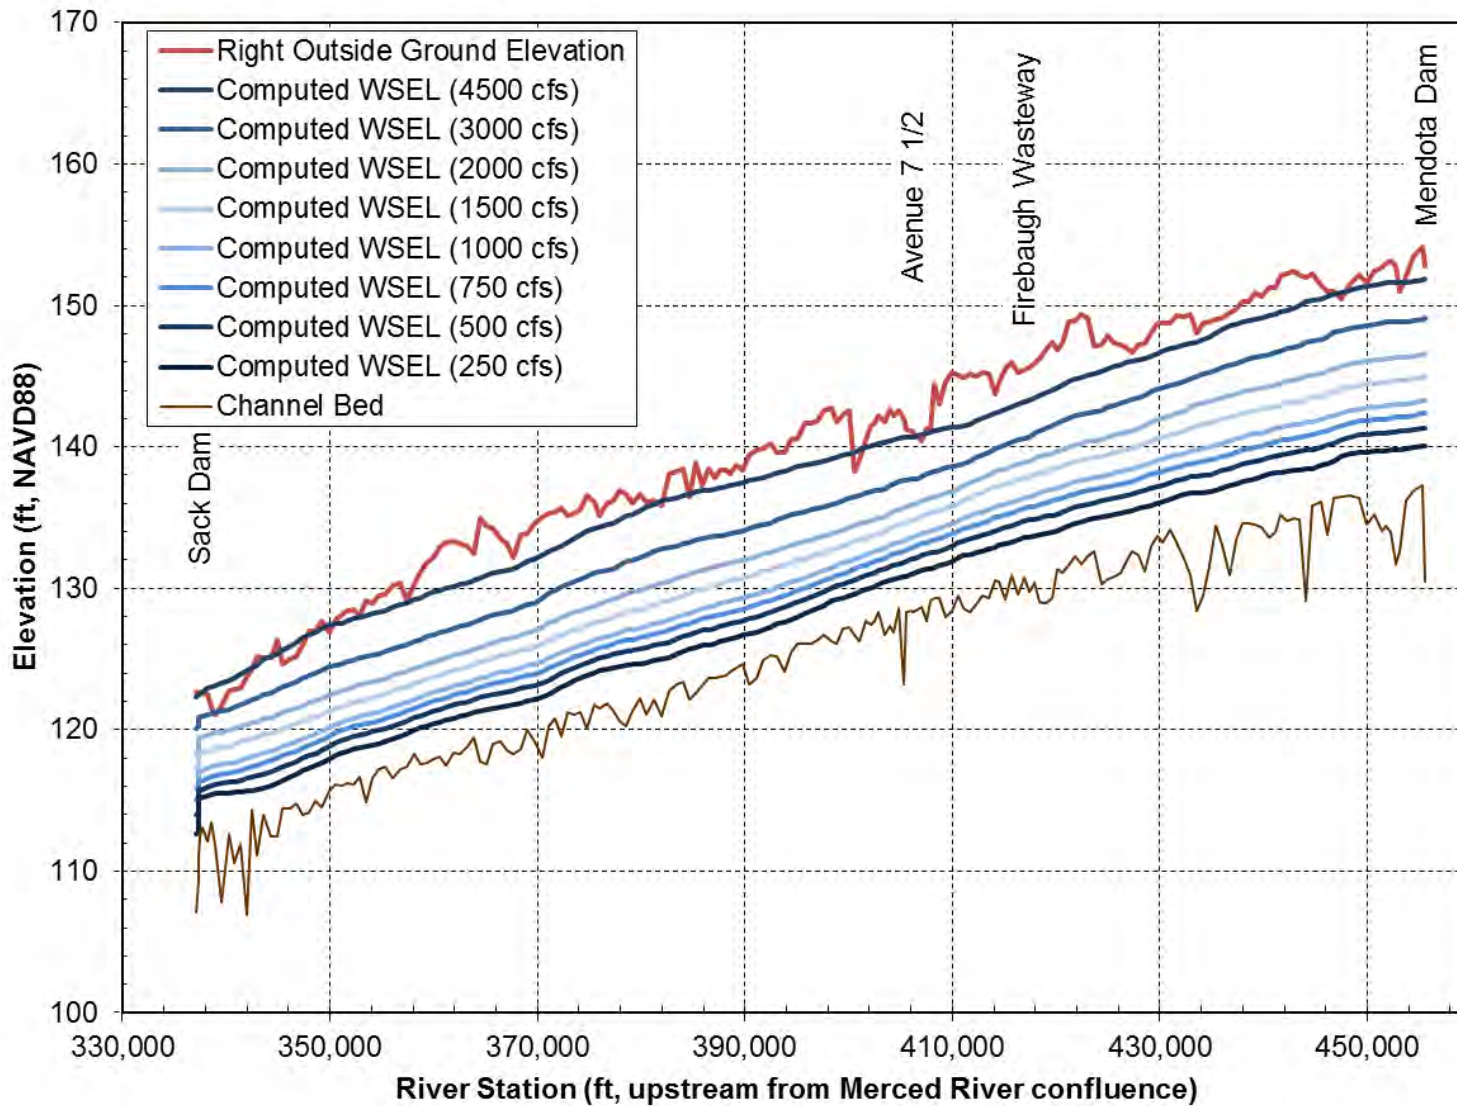
Figure 11. Comparison of outside ground elevation with computed water-surface elevations along right levee in Reach 3.

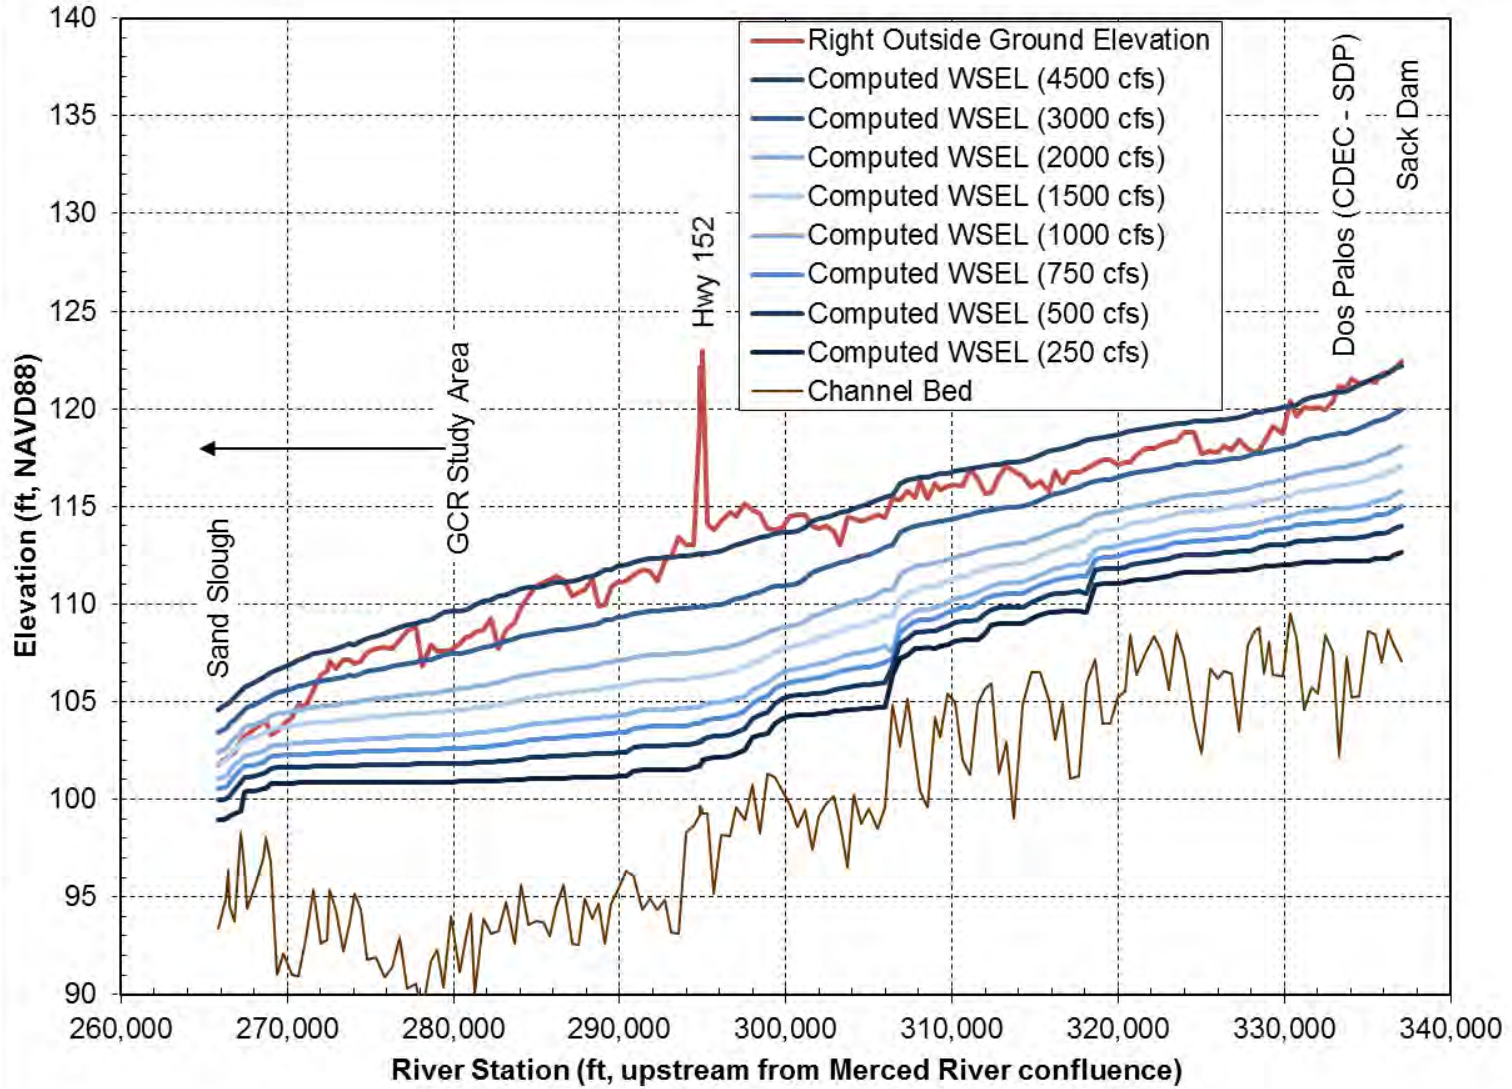
Figure 14. Comparison of outside ground elevation with computed water-surface elevations along right levee in Reach 4A.

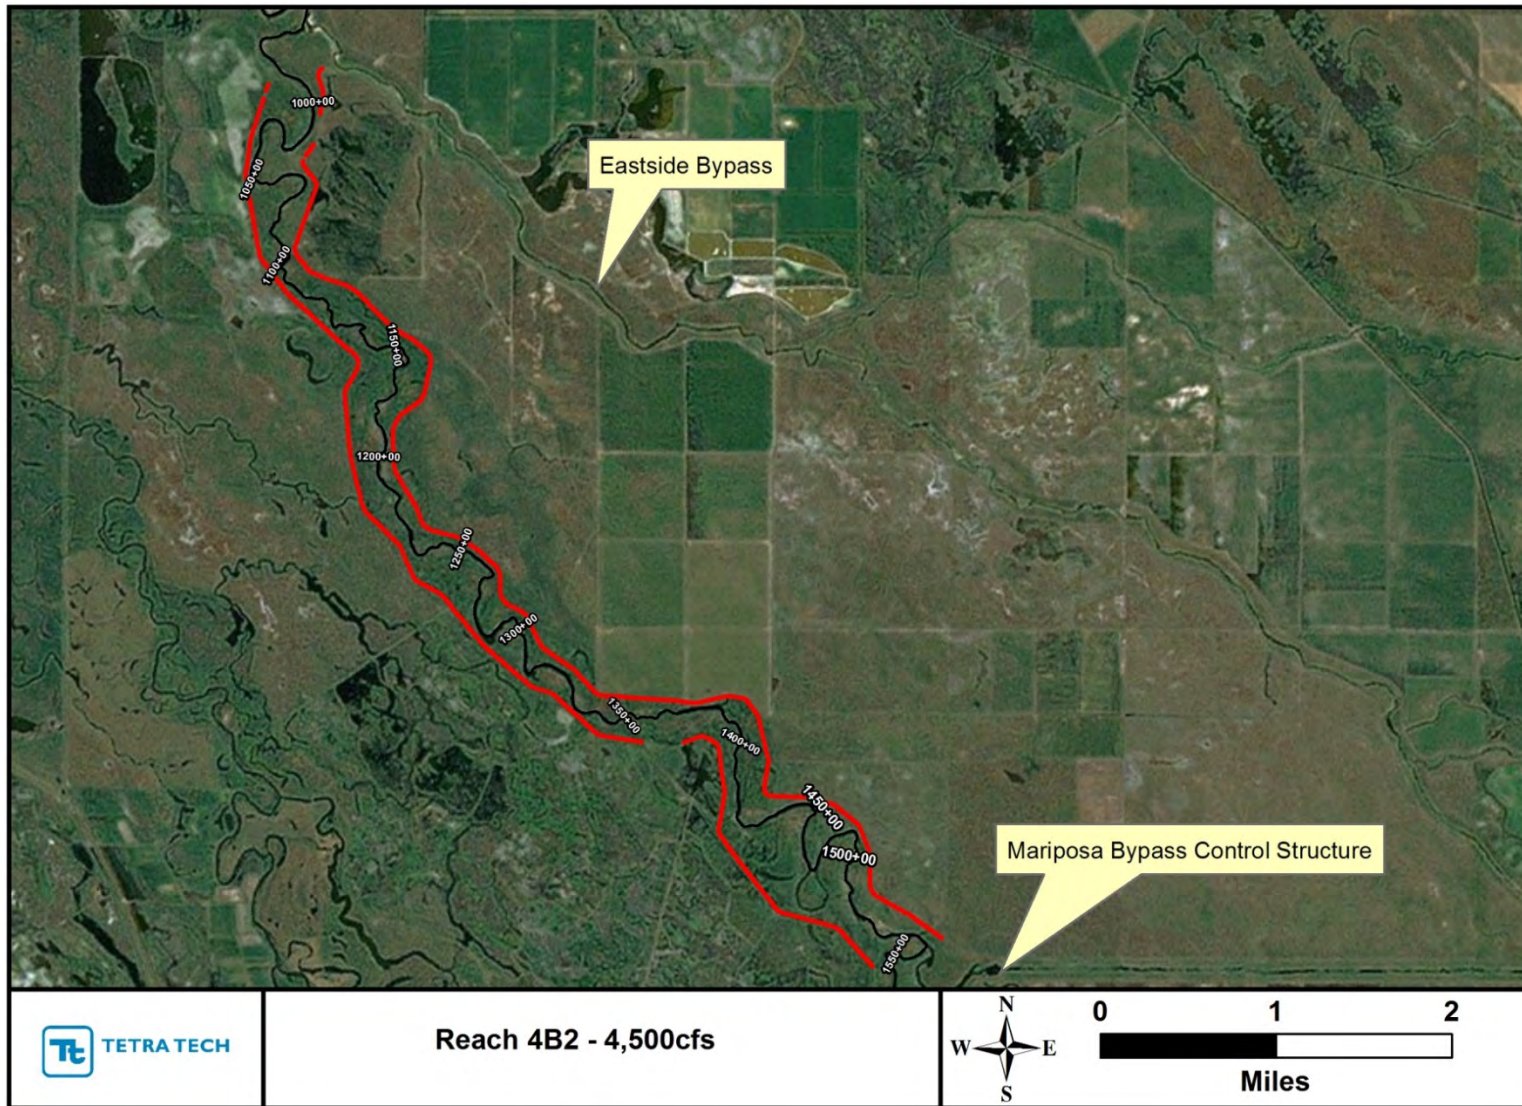
Figure 21. Portions of levee in Reach 4B2 where the 4,500-cfs water-surface elevation is above the existing outside ground elevation.

Reach 4B2 extends approximately 12 miles from the Mariposa Bypass downstream to the confluence with the Lower Eastside Bypass and Bear Creek (Figure 1). Computed water-surface elevations in this reach were developed based on a downstream boundary condition that assumes no additional flow from the Eastside Bypass. The ground adjacent to the right levee in Reach 4B2 has a localized, but deep depression, near Sta 1205+89, which is similar to many other depressions in this reach (see Figure A.3) that limits the in-channel capacity to about 50 cfs (**Figure 18**; Table 2). However, aerial photographs and contour mapping indicate that these depressions are not on or adjacent to agricultural land, are relatively small, and can contain water even at low flows (Tt-MEI, 2011). If these local, right-side depressions are excluded from the analysis, the capacity along the right levee increases to about 930 cfs (Figure 18). The outside ground along the left levee is not as low, which results in an in-channel capacity of approximately 1,370 cfs (**Figure 19**; Table 2). Based on a local discharge of 2,000 cfs, water-surface elevations would exceed ground elevations along about 6,060 feet of the left levee and about 14,750 feet along the right levee (Table 2). At 4,500 cfs, water-surface elevations exceed the outside ground elevations on either side of the channel over approximately 7 miles of the reach. Segments of levee in Reach 4B2 where ground elevations are exceeded by water-surface elevations at a local discharge of 2,000 and 4,500 cfs are presented in **Figures 20 and 21**.

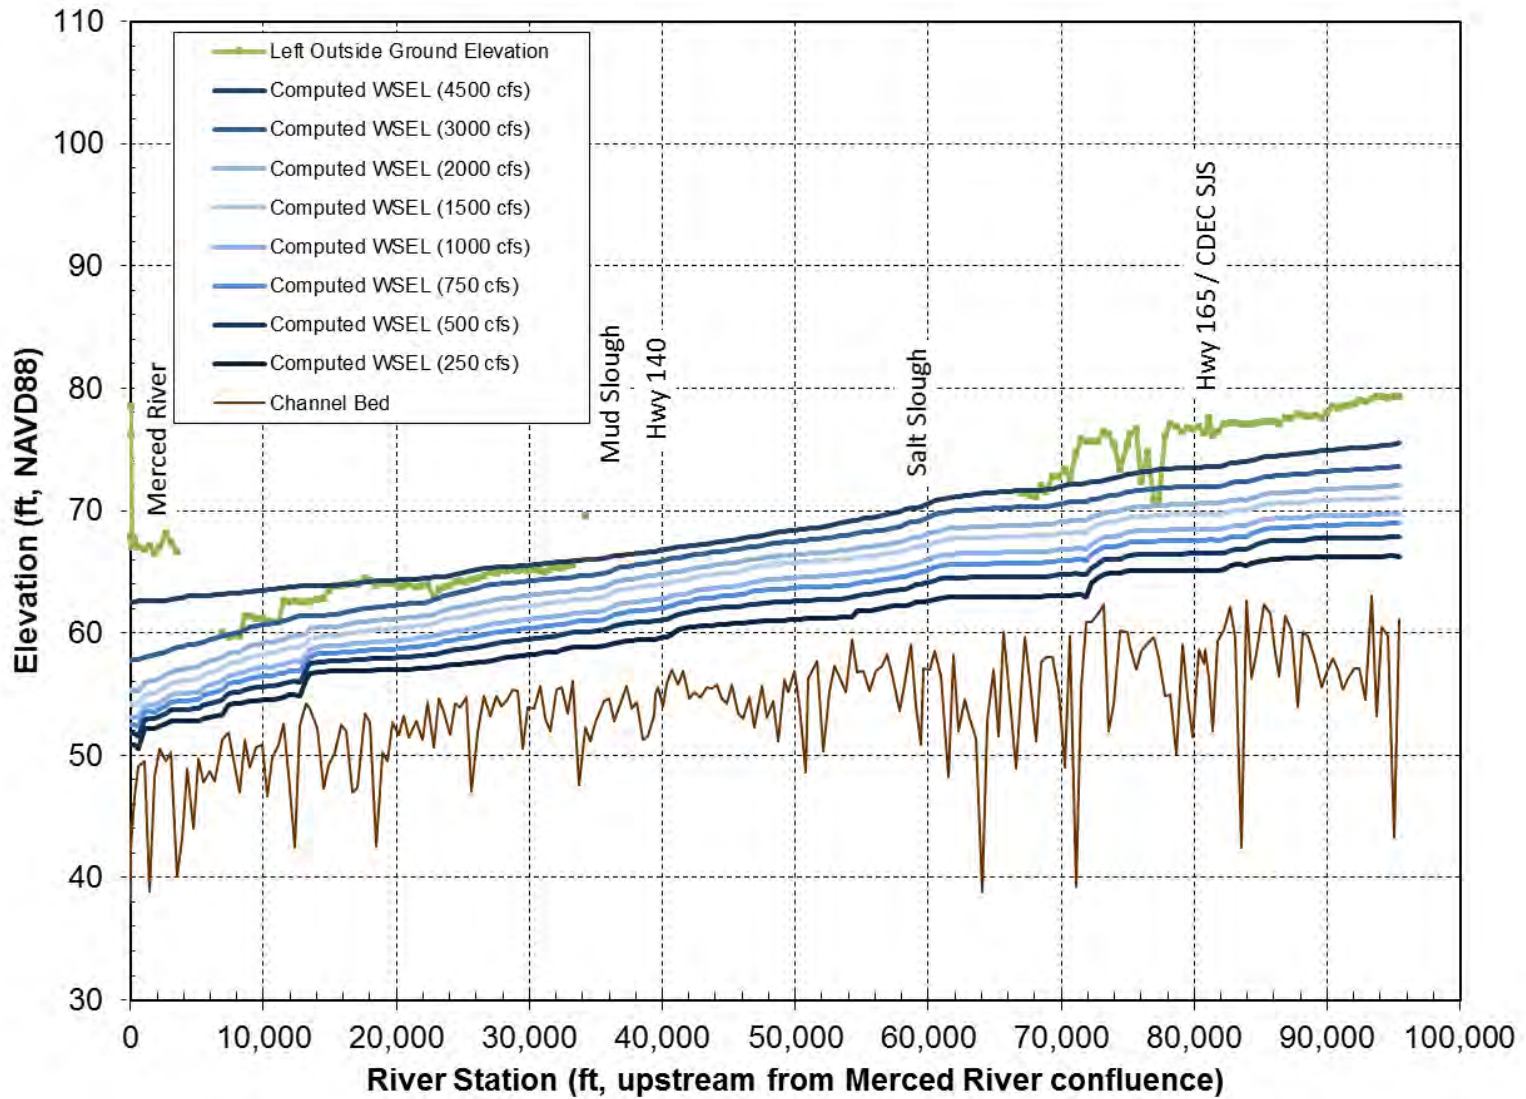
Figure 23. Comparison of outside ground elevation with computed water-surface elevations along left levee in Reach 5.

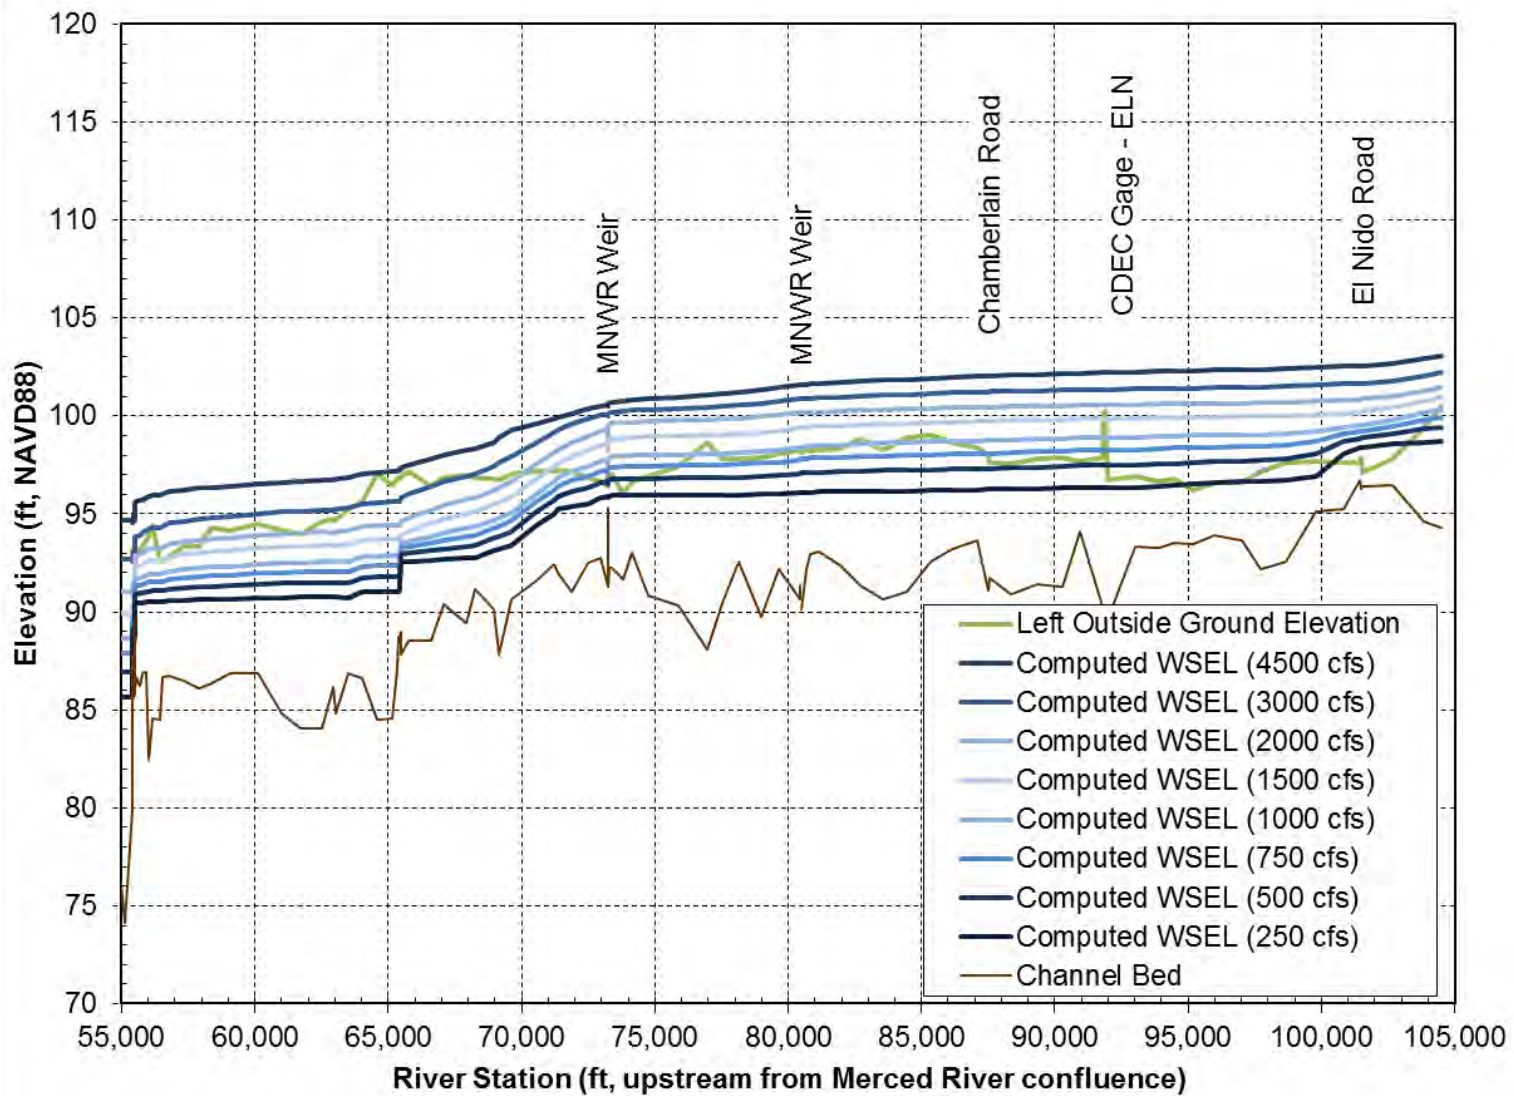
Figure 26. Comparison of outside ground elevation with computed water-surface elevations along left levee in Middle Eastside Bypass. Profiles represent the Boards Out condition.

At the upstream end of this reach, the channel bed is very near the elevation of the ground outside of the levees on both the right and left sides (**Figures 25 and 26**). The slightly raised El Nido Road also creates a backwater condition that has the potential to impact the water-surface

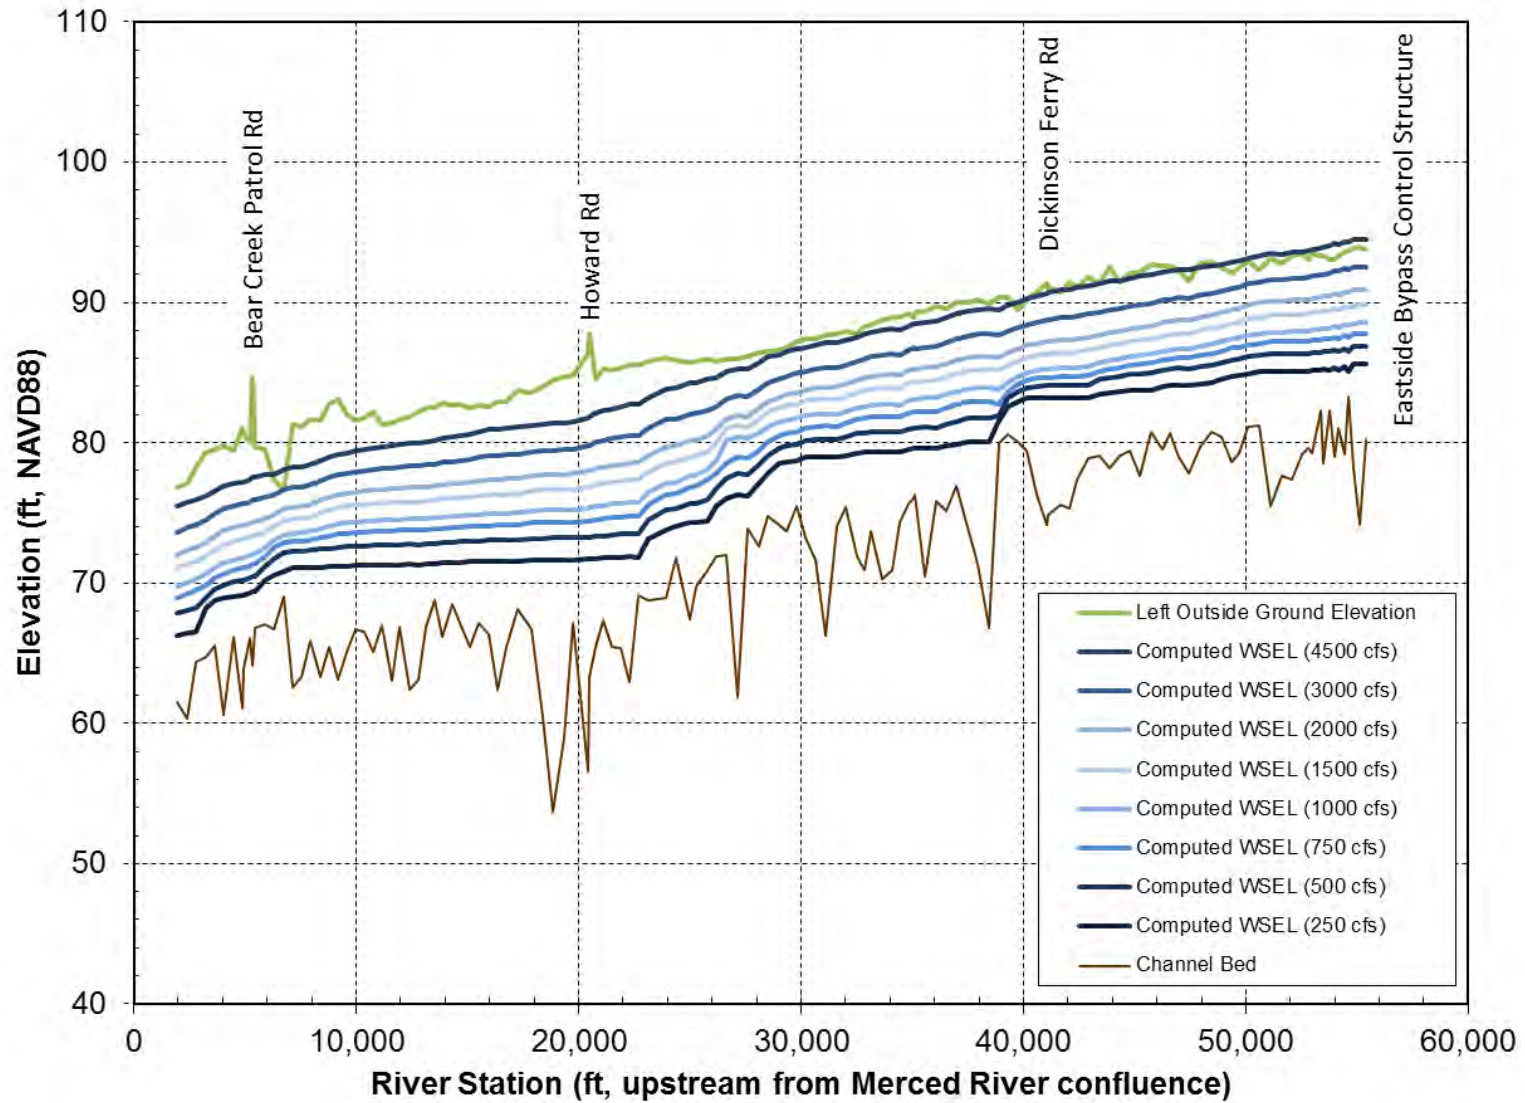
Figure 30. Comparison of outside ground elevations with computed water-surface elevations along left levee in Lower Eastside Bypass.

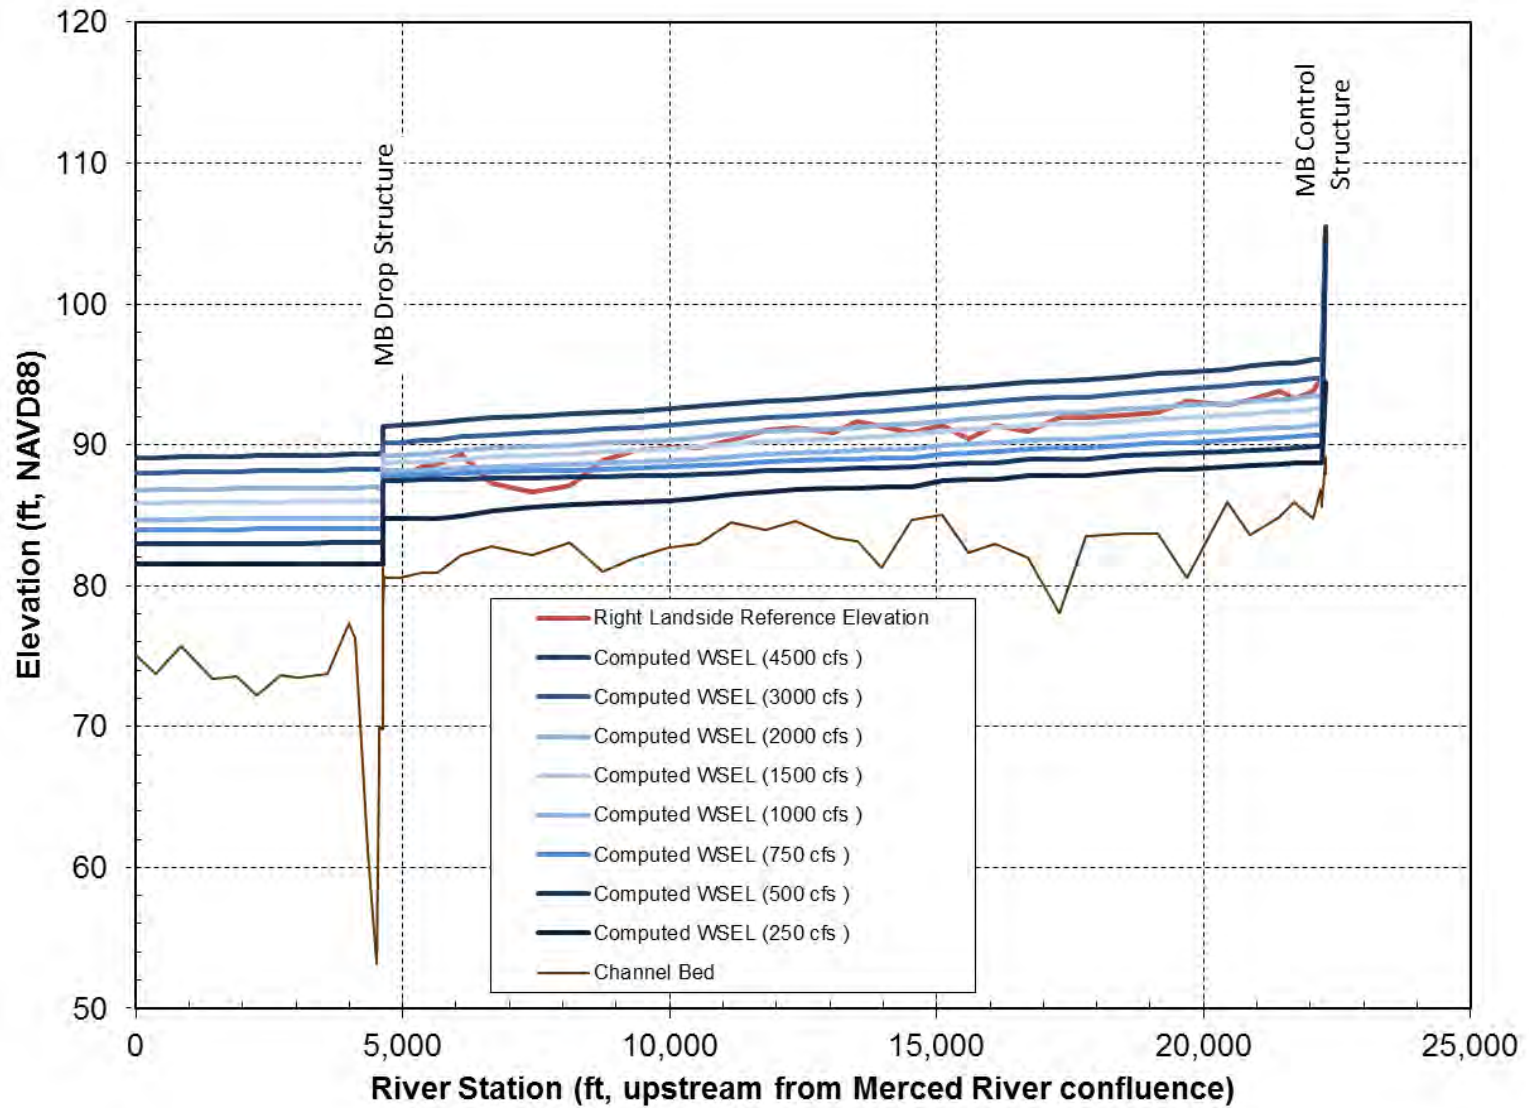
Figure 32. Comparison of outside ground elevation with computed water-surface elevations along right levee in Mariposa Bypass.
