Technical Memorandum

**Channel Capacity Report
2024 Restoration Year**

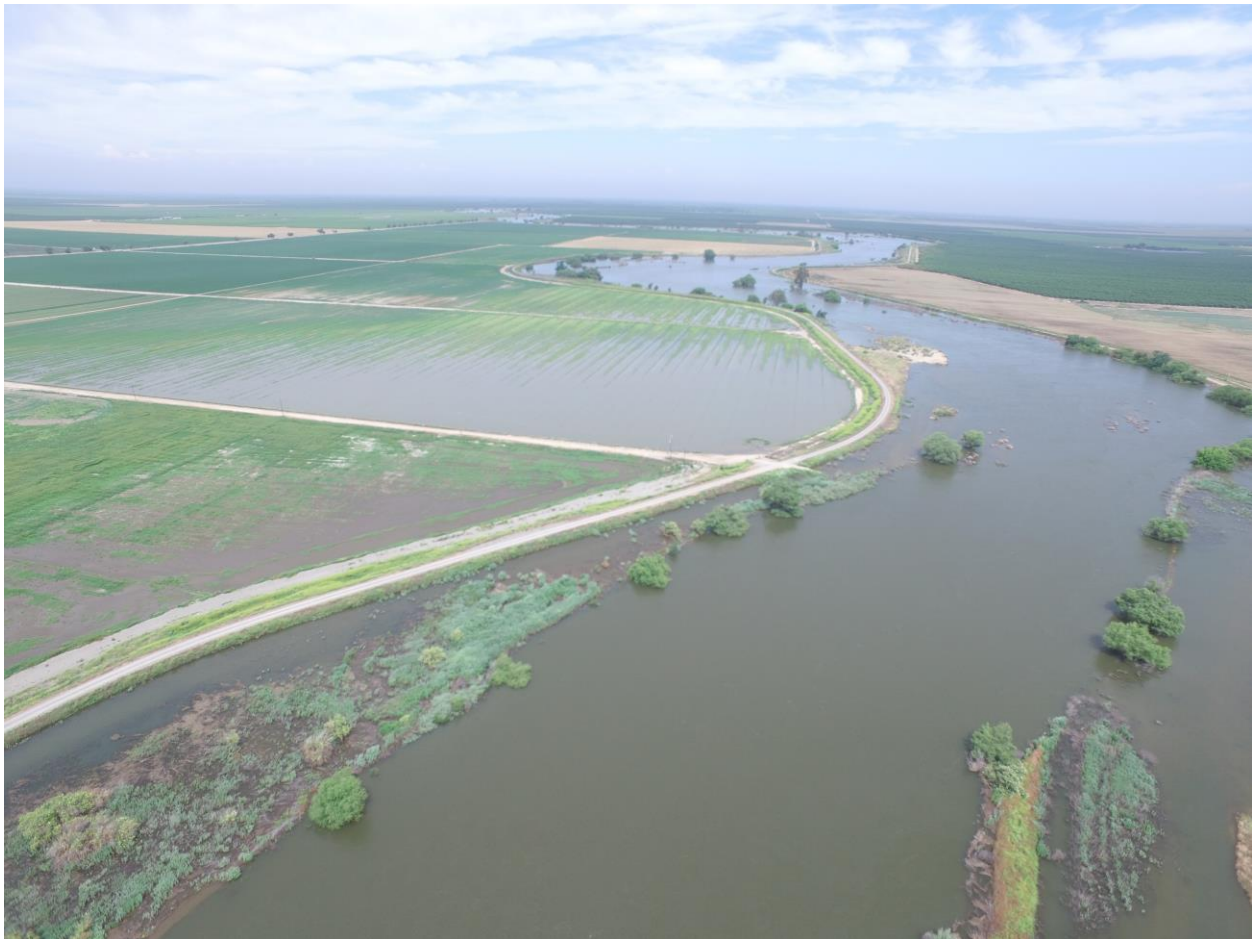
1 management releases reached a maximum of 10,058 cfs on May 21 and exceeded 8,000 cfs from
2 Friant Dam for a total of 74 days. There were long periods where then-existing channel capacity
3 was exceeded, resulting in widespread levee seepage and erosion, particularly in Reach 2A and
4 in portions of Reach 2B and the flood bypasses. Figure 1 shows an example of levee seepage on
5 the right landside of the levee caused by flood management releases estimated to be 9,350 cfs in
6 Reach 2A.

7 **Figure 1.**
8 **Drone photograph by LSJLD looking upstream (east) into**
9 **Reach 2A from upstream of the Bifurcation Structure.**

9 **Figure 1. Drone photograph by LSJLD looking upstream (east) into Reach 2A from**
 10 **upstream of the Bifurcation Structure. 6**
