## Appendix B

# Reports

### 2011 Draft Annual Technical Report

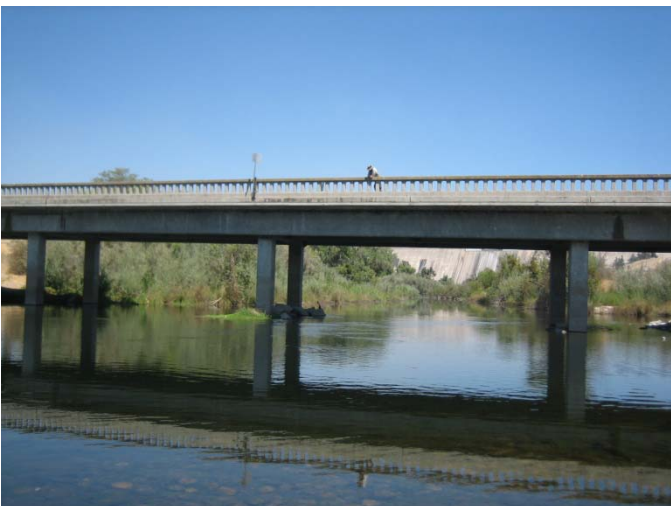
Description: The Road 206 Bridge (Photo 2\_A) is a two lane bridge about 0.7 miles downstream Friant Dam in the town of Friant. The bridge crosses perpendicular to the San Joaquin River near river mile near 266.8. The bridge has a span of 306 feet with a width of about 36 feet and height of 26.5 feet. The active channel width at the bridge was measured at 135 feet. There are a total of ten bridge piers, five sets of two each. The distance between the piers was measured at 45 feet. The maximum water surface elevation just upstream the bridge was measured as 7 feet. The channel substrate was mostly cobble with some boulders.

Photo 2\_A. Bridge looking upstream from downstream

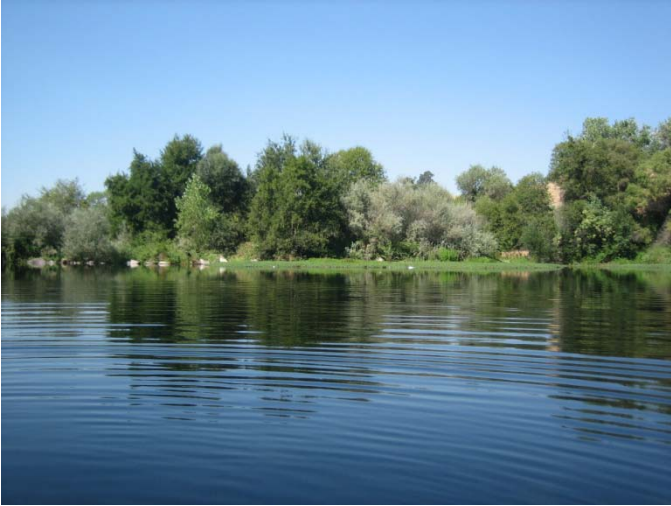
Photo 5\_C. Rock weir vegetation from upstream looking downstream

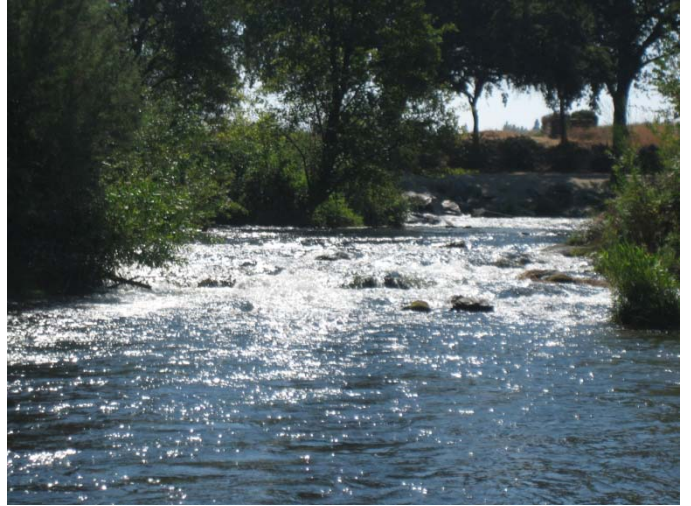
Photo 5\_D. Rock weir from downstream looking upstream

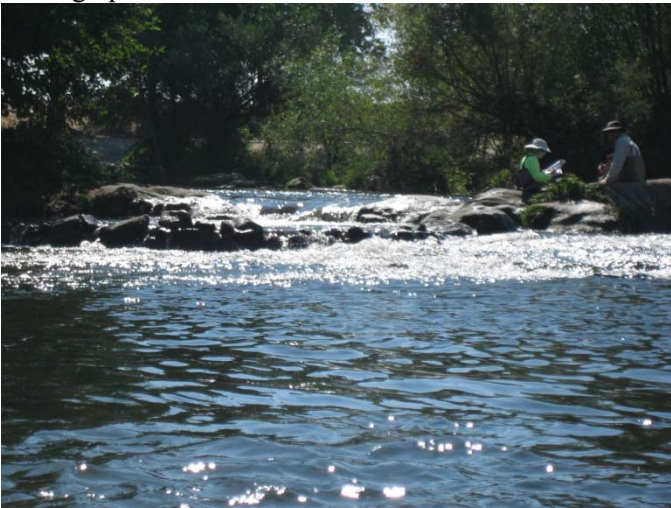
Photo 5\_E. Falls downstream of weir from downstream looking upstream

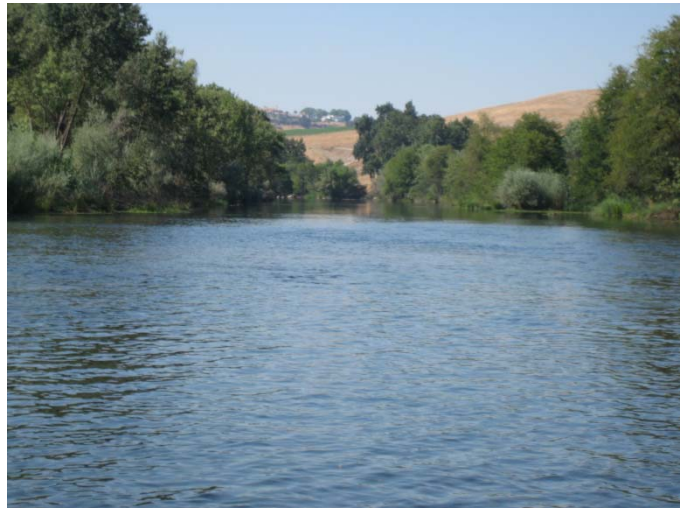
Photo 5\_F. Channel downstream falls and weir

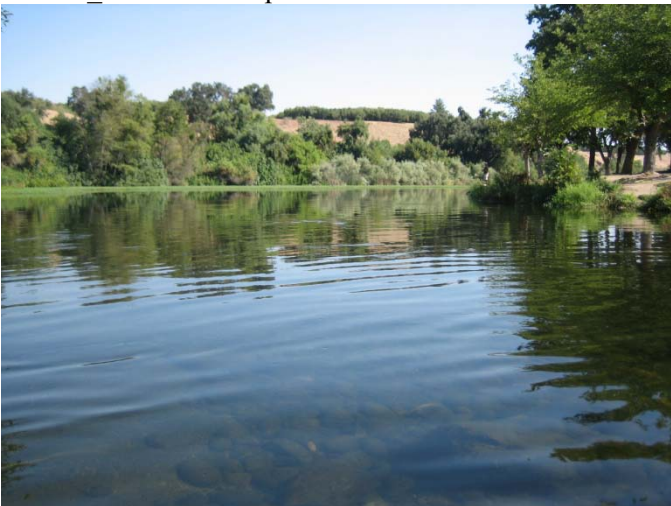
Photo 5\_G. Channel upstream weir

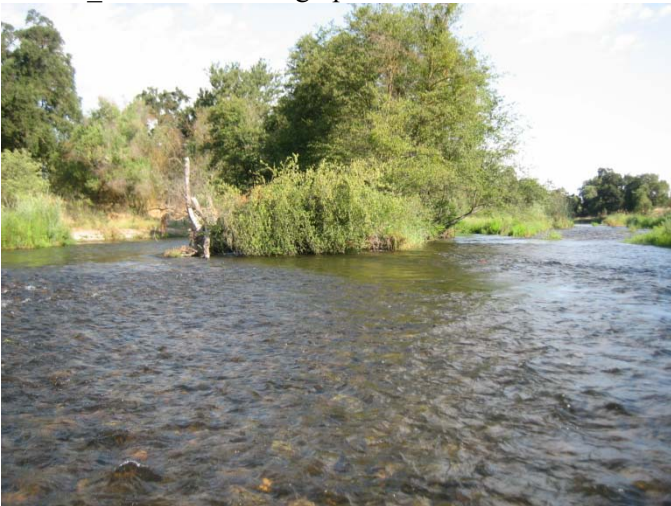
Description: The riffle is located on the San Joaquin River near river mile 260.7. This site has an active sediment transport study and limited disturbance to the channel substrate is requested. Measurements were not taken as a result, but were provided by the project lead, Matt Meyers. At low flow conditions the maximum velocity is 3 feet-per-second (ft/s) and the bankfull maximum velocity is about 10 ft/s. The bankfull width is from 175 feet to 120 feet. The riffle length is about 400 feet. The bankfull depth is about 4 feet at the riffle crest (most shallow point). The maximum bed slope is estimate at 0.01 with an average bedslope of 0.006 for the riffle.

Photo 7\_A. Riffle looking upstream

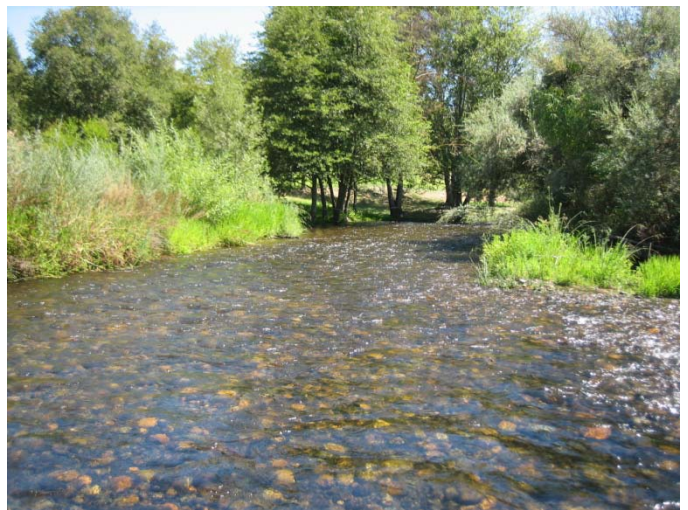
The channel substrate is mostly cobble and gravel. There were small minnows observed just upstream the bridge.

Photo 10\_B. Channel from upstream left bank looking downstream

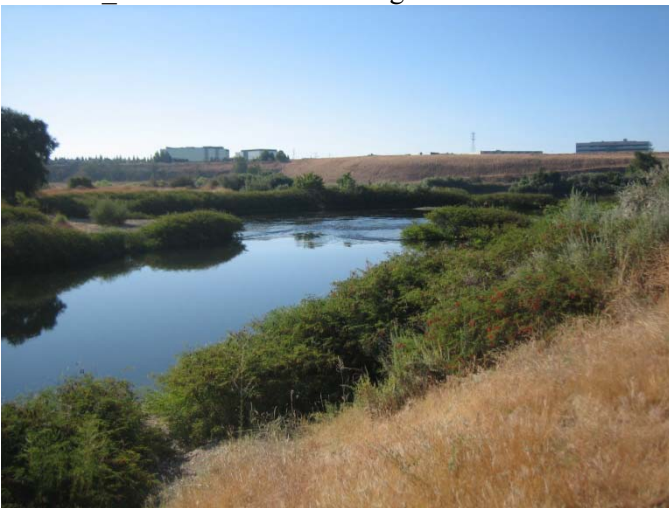
Photo 12\_A. Washed out crossing

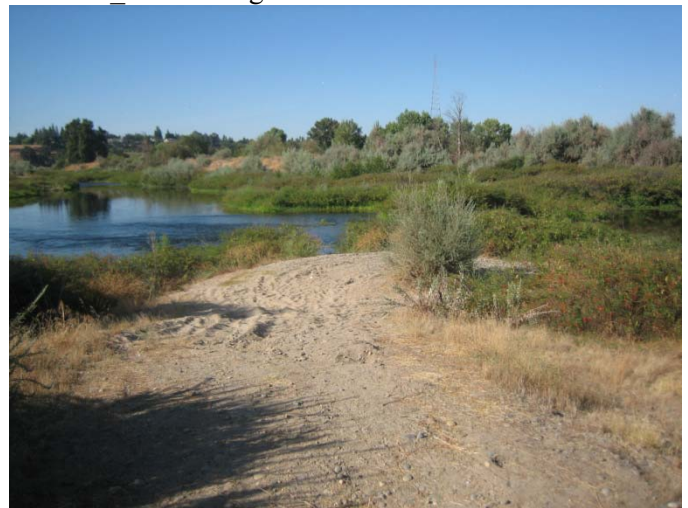
Photo 12\_B. Crossing from left bank

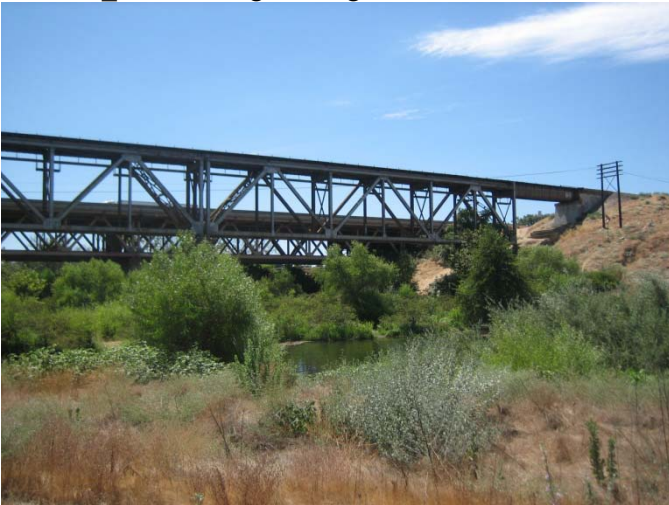
Photo 15\_A. Crossing looking downstream

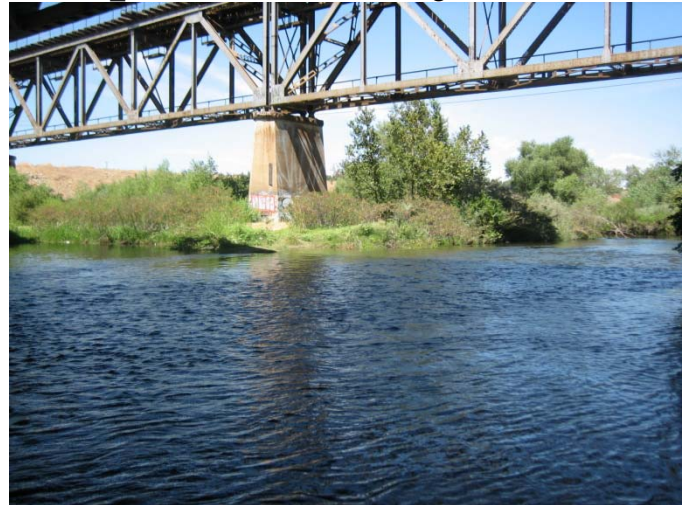
Photo 15\_B. Pier near channel on right bank

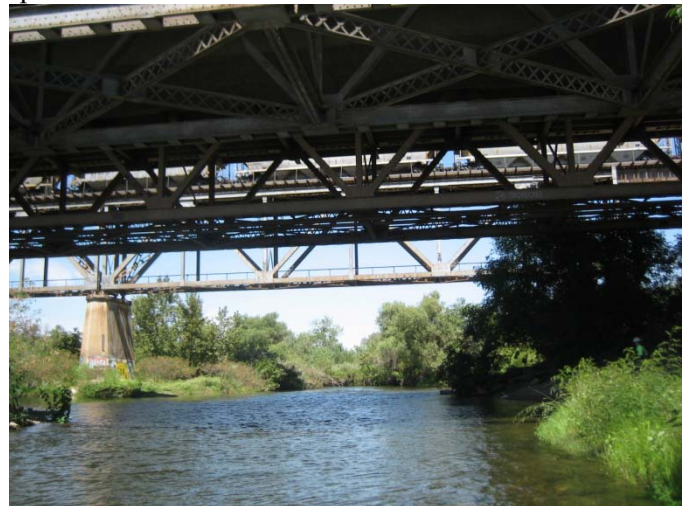
Photo 16\_B. Channel downstream bridges looking upstream

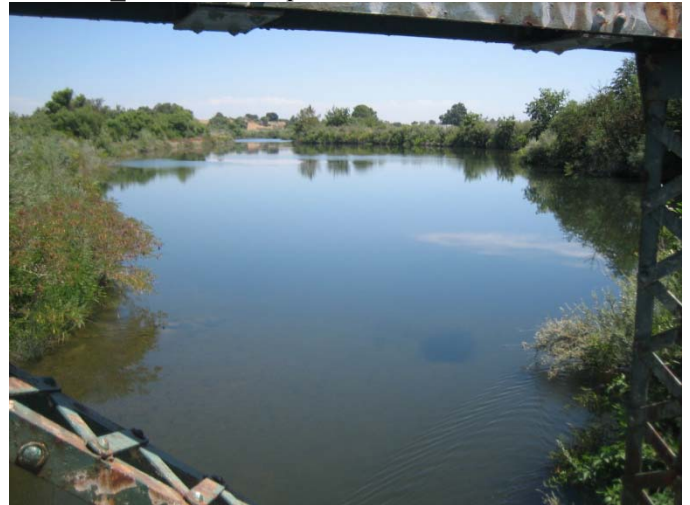
The water surface elevation upstream the bridge was measured as 6.5 feet. The channel substrate is mostly sand with gravel and some cobble and boulders. The channel is clean with brush and large woody trees on the banks with tall annual grasses in the floodplain. The active channel width at the bridge measured as 37.5 feet. The channel upstream and downstream is much wider and was estimated at about 150 feet (Photo 17\_B).

Photo 17\_B. Channel upstream

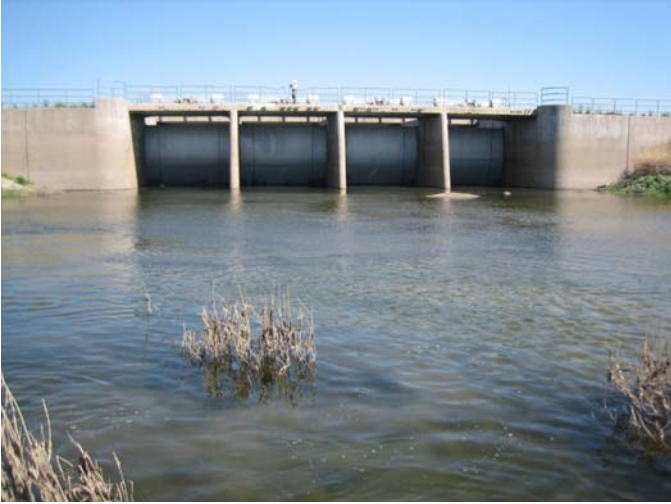
Description: The Chowchilla bifurcation structure is located at the apex of the Chowchilla Bypass and the San Joaquin River near river mile 168.5 (Photo 21\_A). The control structure has four radial gates that were closed during the survey. Each gate opening, bay, is 18 feet in height and 20 feet wide. The structure height is about 19.4 feet and measures 87.6 feet in total length from the top deck. The structure controls flood releases into the Chowchilla Bypass from the San Joaquin River. This structure is very similar to the bifurcation structure located on the San Joaquin River downstream.

Photo 21\_A. The Chowchilla Bifurcation structure looking downstream

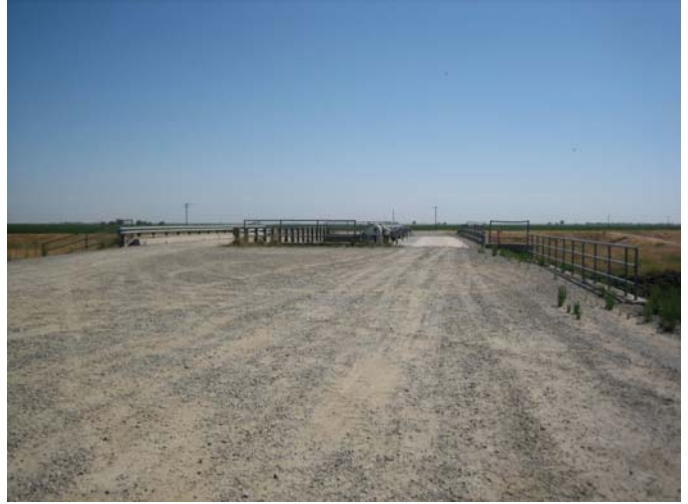
The structure has a maintenance road that crosses over the gate openings with an opening in the center to access the radial gate arms (Photo 21\_B). The hoist motors are located at the top of each bay on the upstream deck. There is a solid concrete headwall that extends to the levee to the east and the levee connecting to the San Joaquin River Bifurcation structure to the west. The bays are 56.75 feet in length with a 15 foot concrete apron downstream. There are five 2 x 2 x 4 foot concrete block diffusers about 28.6 feet from the radial gate (Photo 21\_C).

Photo 21\_B. The Chowchilla Bifurcation structure maintenance roads

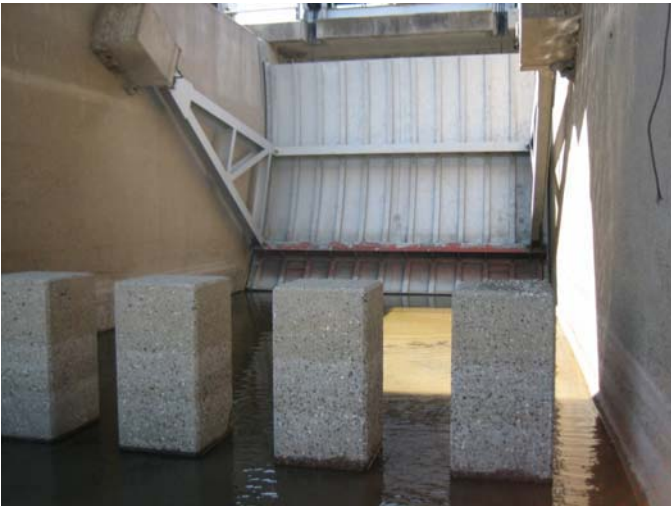
Photo 21\_C. Diffusers and gate

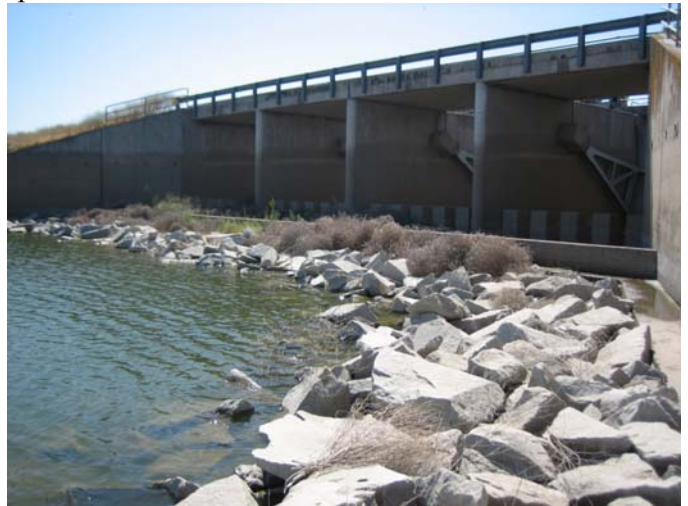
The concrete apron has a short weir downstream that is about 2.5 feet tall and 1 foot wide (Photo 21\_D). There is a large pool downstream with rip rap to protect the concrete apron and weir from erosion. The rip rap protection extends about 30 feet downstream. The depth of the pool was not determined due to the depth exceeding what was able to be waded.

Photo 21\_D. The Chowchilla Bifurcation structure looking upstream

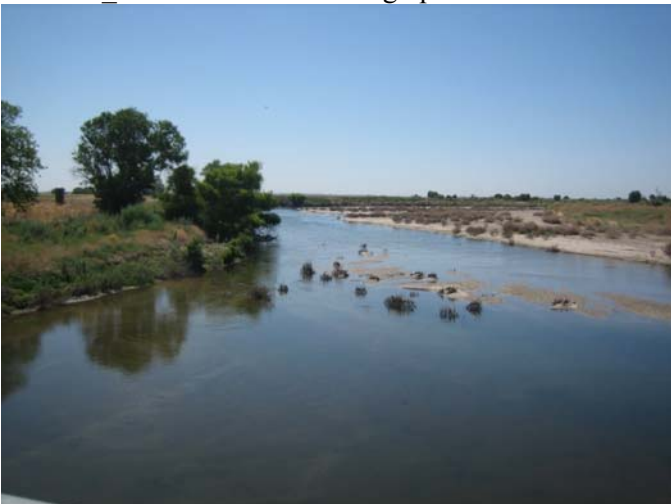
The channel upstream was clean with a sand bar in the middle of the channel (Photo 21\_E). The channel downstream had a large pool just downstream the structure and was clean with annual grasses and short brush in the channel downstream the pool (Photo 21\_F). The channel substrate majority was silt/clay/sand.

Photo 21\_E. The channel looking upstream

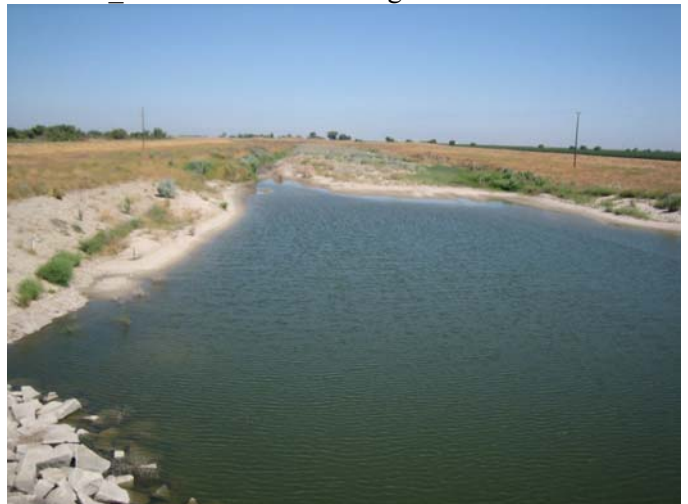
Photo 21\_F. The channel looking downstream

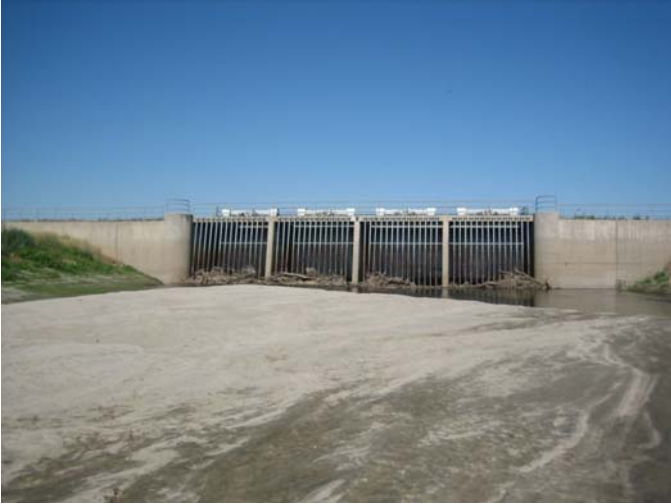
Description: The bifurcation structure is located at the apex of the Chowchilla Bypass and the San Joaquin River near river mile 168.5 (Photo 22\_A). The control structure has four radial gates that were partially open during the survey. Each gate opening is 18 feet in height and 20.5 feet wide. The structure height is about 19.4 feet and measures 87.3 feet in total length from the top deck. The structure controls flood releases into the San Joaquin River. This structure is very similar to the bifurcation structure located on the Chowchilla structure upstream.

Photo 22\_A. San Joaquin River Bifurcation structure looking downstream

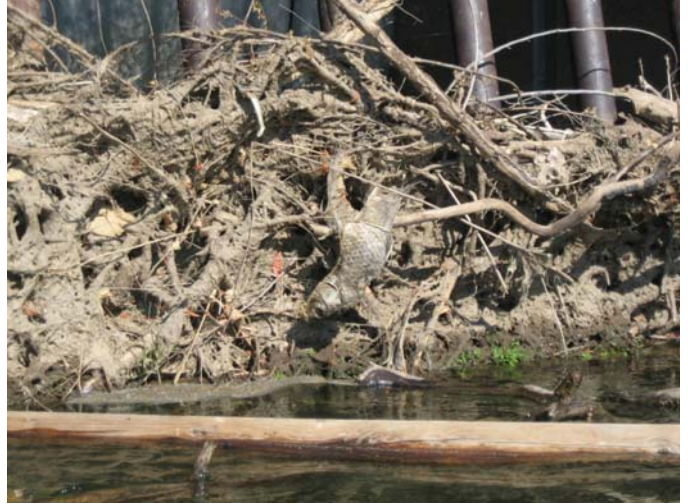
There is a trash rack at the inlet to the gate bays. The trash rack has 14 four inch galvanized pipe poles that are spaced 1.35 feet on center for each bay. It was estimated that there was a 20 degree angle on the trash rack. Large woody tree limbs and smaller debris has layered onto the trash racks that averaged about three feet in width. There was a fish carcass on the debris (Photo 22\_B).

Photo 22\_B. Fish Carcass

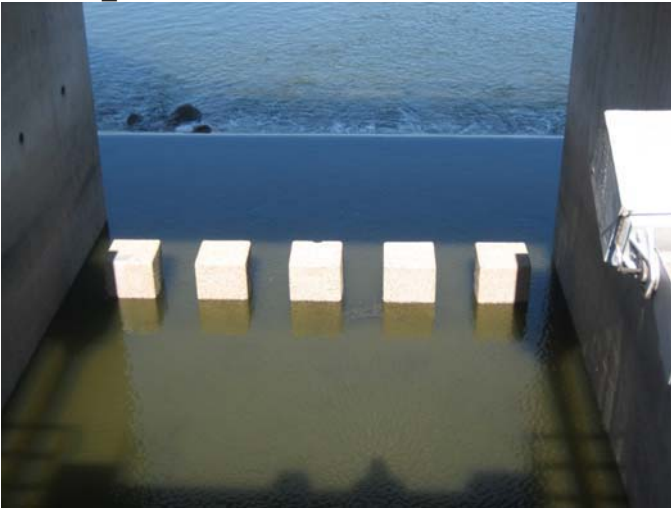
Photo 22\_C. Concrete diffusers

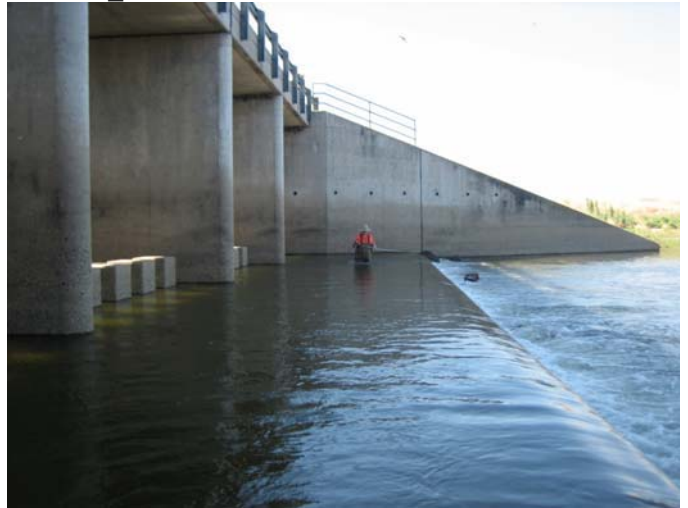
The structure has a maintenance road that crosses over the gate openings with an opening in the center to access the radial gate arms. The hoist motors are located at the top of each bay on the upstream deck. There is a solid concrete headwall that extends to the levee to the south and the levee connecting to Chowchilla Bifurcation structure to the north. The bays are 57.6 feet in length with a 15 foot concrete apron downstream. There are five 2 x 2 x 4 foot concrete block diffusers about 28.6 feet from the radial gate (Photo 22\_C). The concrete apron has a short weir downstream that is about 2 feet tall and 1 foot wide (Photo 22\_D). The water surface elevation in the bays was 2.4 feet.

Photo 22\_D. Concrete weir downstream

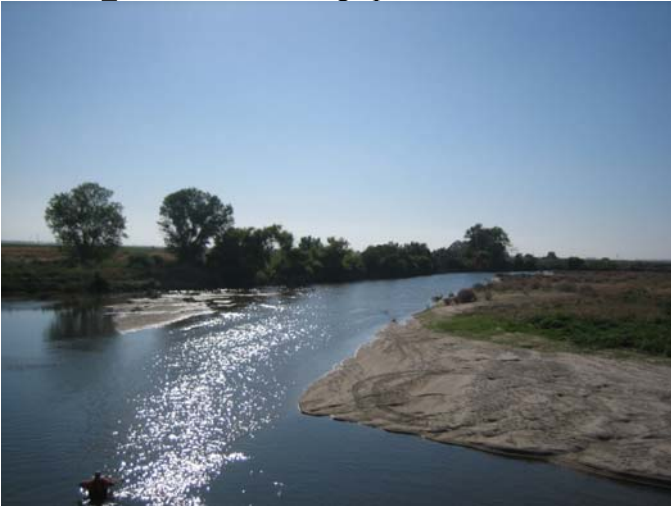
Photo 22\_E. Channel looking upstream

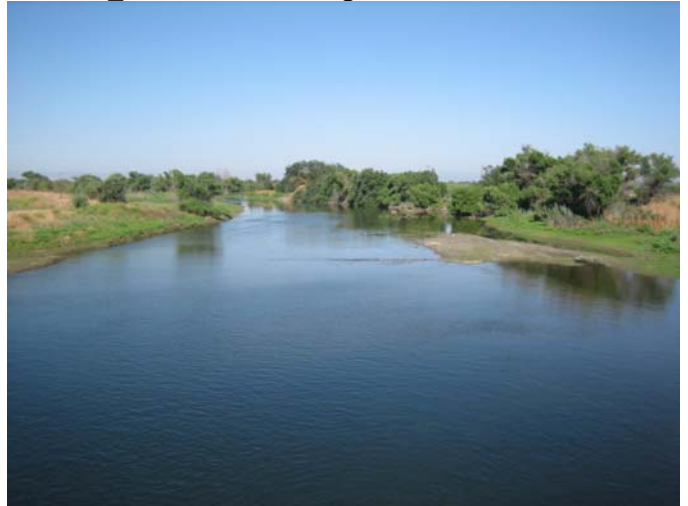
Photo 22\_F. Channel looking downstream

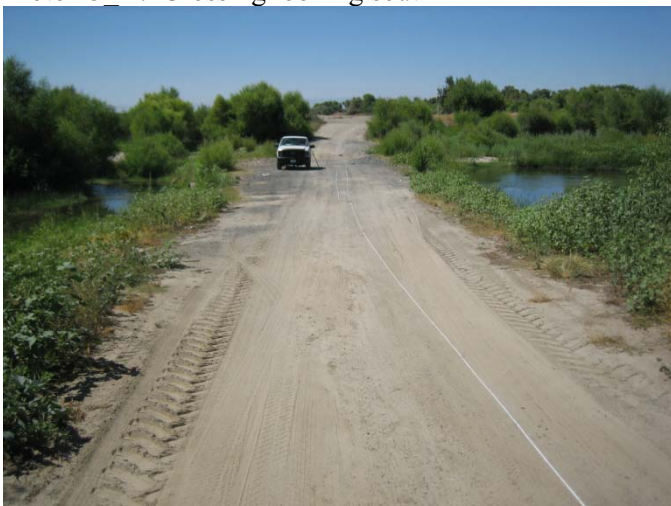
Photo 23\_A. Crossing looking south

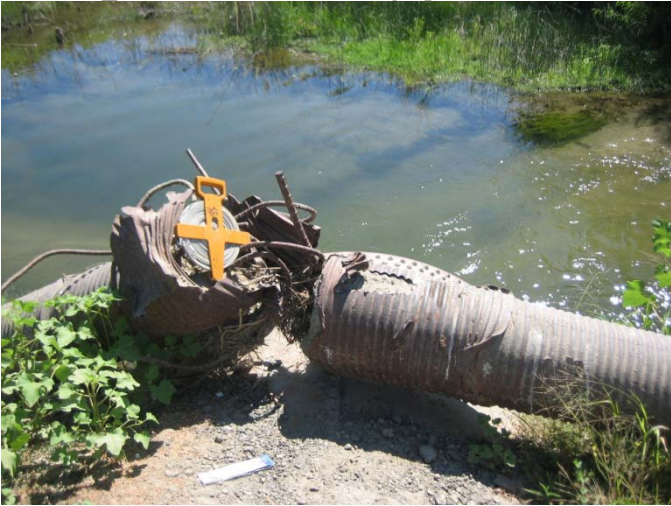
Photo 23\_C. Culvert inlet looking upstream

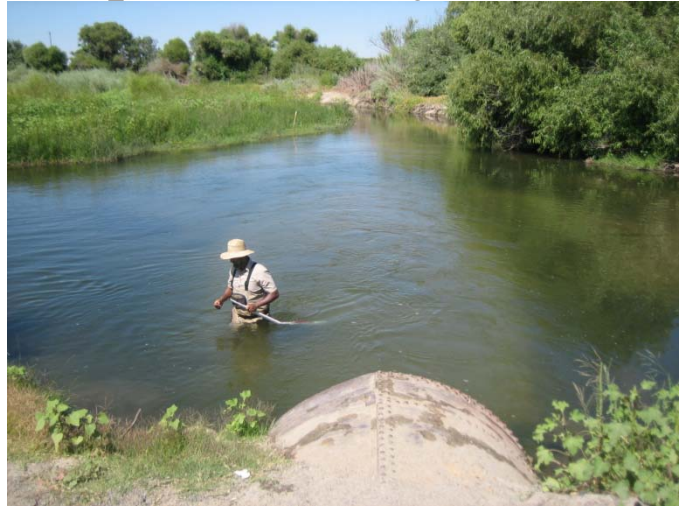
Photo 23\_D. Culvert outlet looking downstream

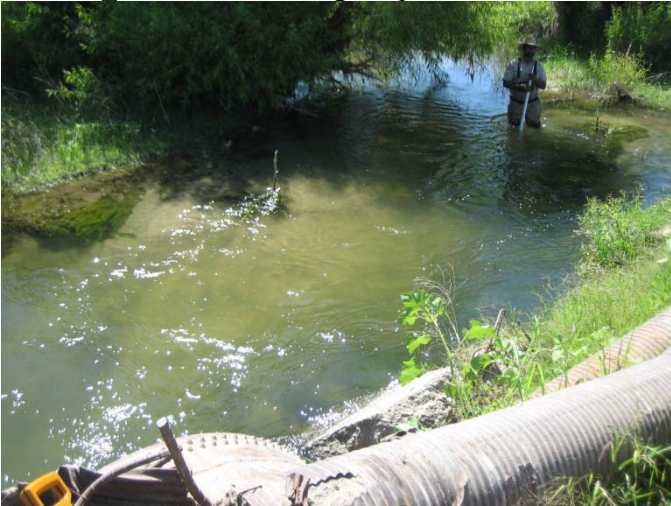
Photo 23\_E. Channel, 90 angle, upstream inlet

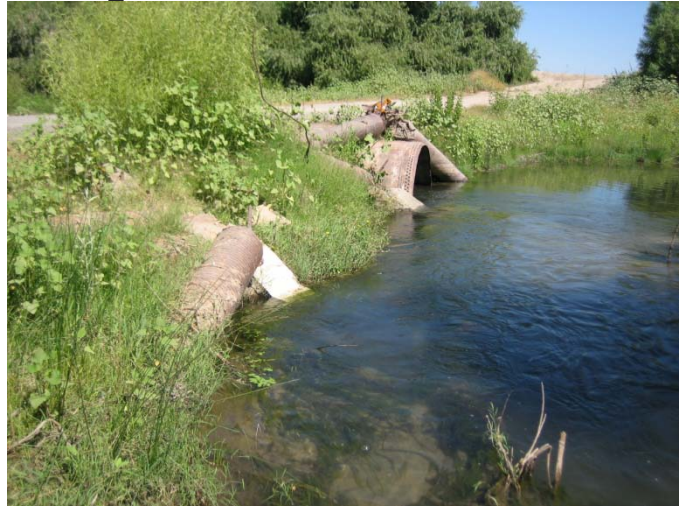
Photo 23\_F. Culvert inlet

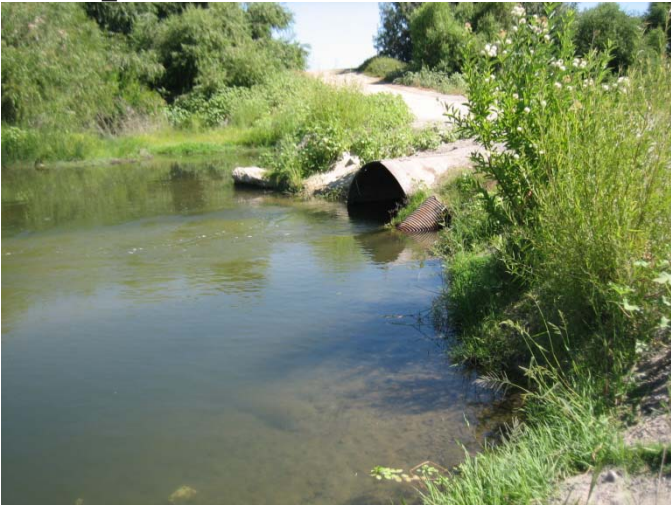
Photo 23\_G. The culvert outlet

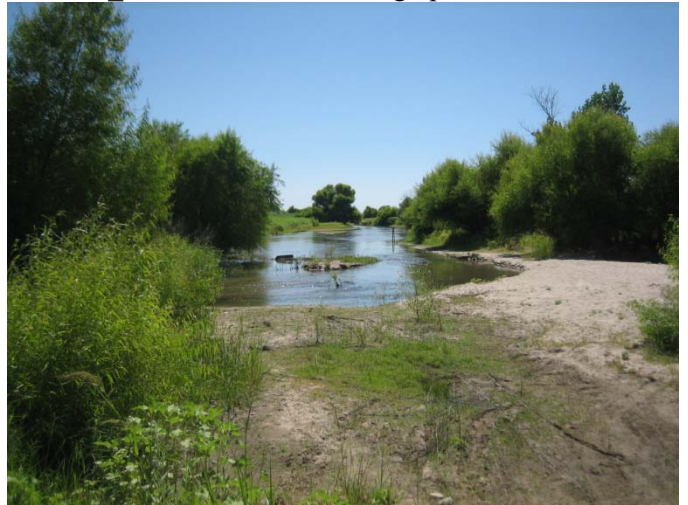
Photo 23\_H. The channel looking upstream

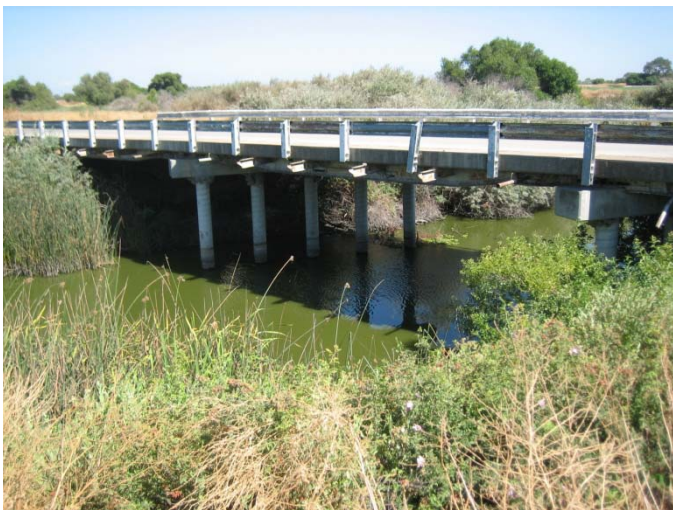
Photo 30\_A. Bridge, downstream looking upstream

Description: The Washington/Indiana bridge crosses perpendicular to the San Joaquin River near river mile 168.0 (Photo 30\_A). The bridge has two lanes with a 124 feet span and 25 feet wide bridge deck and a height of 14.2 feet. The concrete bridge has a total of ten piers with two rows of five that are about 41.5 feet apart. The active channel width was measured at 68 feet.

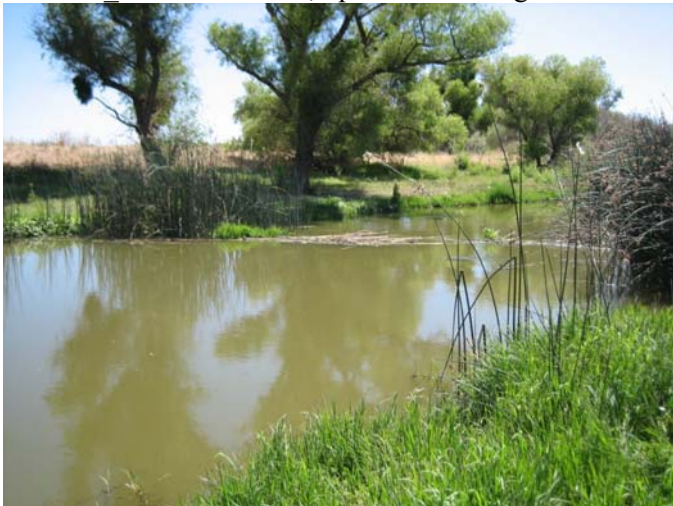
Photo 36 A. Beaver Dam, upstream looking downstream

Description: The beaver dam was located on the San Joaquin River near river mile 146.1 on private property near the San Luis Wildlife Refuge. A section of the dam was submerged about two feet under the current water surface elevation at a height of 1.6 feet for a length of 17 feet (Photo 36\_A). The dam had a width of 10 feet and a height of 3.6 feet. The water surface elevation upstream was 3.3 feet and 3.6 feet downstream. Vegetation is growing on the top of the exposed section of the dam. There is no defined pool downstream the dam.

Evaluation: The dam cannot be bypassed and at lower flows has a drop of less than two feet, but without a staging pool it is going to be recommended to complete a hydraulic model to determine at what flows, if any, it is a barrier.

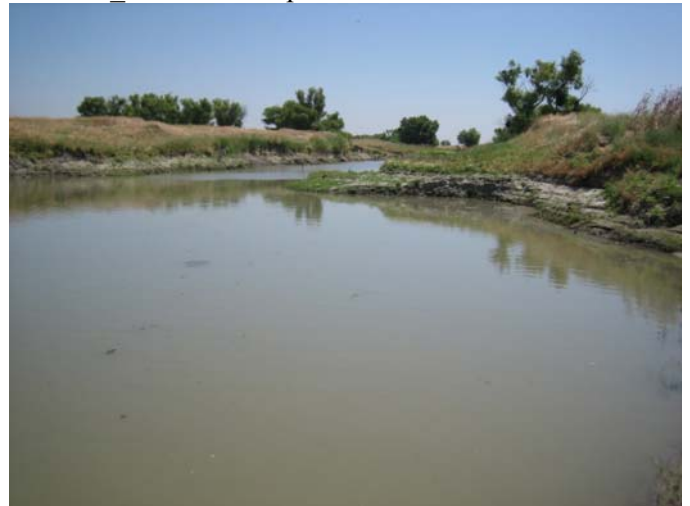
Photo 45\_B. Channel upstream

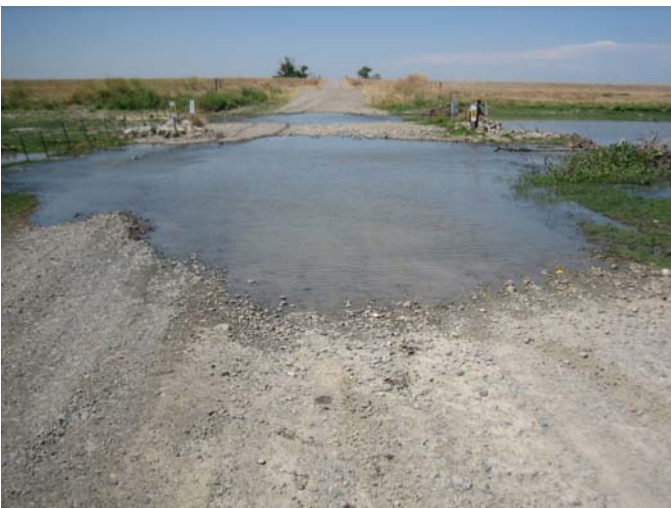
Photo 51\_A. Dan McNamara Road

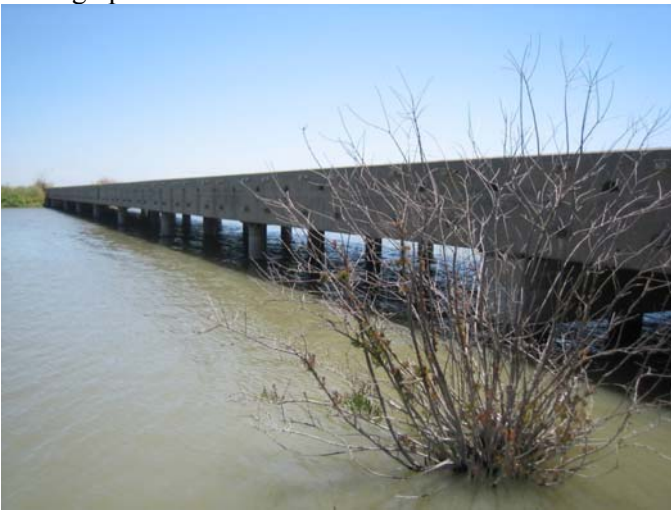
Description: Chamberlain Road Bridge (Photo 53\_A) is not publicly accessible and had to be accessed through the Merced Wildlife Refuge. The bridge is located on the Eastside Bypass about 3.5 miles upstream the Sandy Mush Road bridge. The one land bridge has a span of 276 feet with a width of 18.4 feet and height of 8.4 feet. The water surface elevation was 5.3 feet, so at high flows it is likely that the bridge is submerged. The concrete bridge has 24 piers configured in eight parallel rows of four. The rows are about 27 feet apart. The active channel width was measured at 247 feet. There was no apron or rip rap under the bridge.

Photo 53\_A. Chamberlain Road Bridge, downstream looking upstream

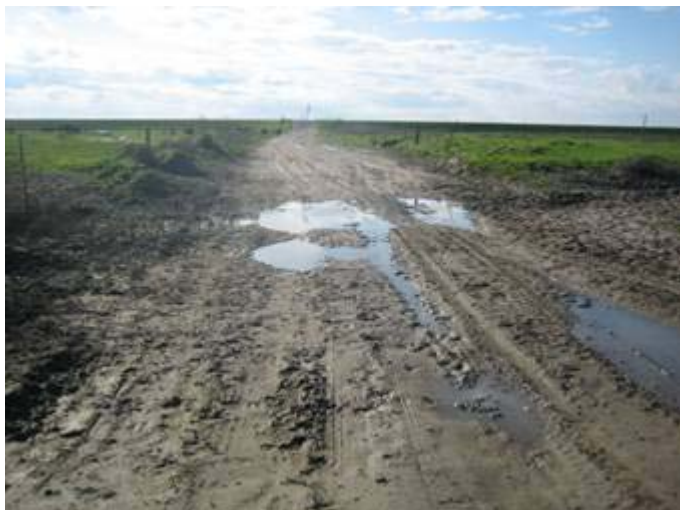
Description: This site was not accessed, but a description and photo was provided by program staff that had permission to access the site. There is a non armored low flow crossing (Photo 54\_A) located at W. El Nido Road on the Eastside Bypass one mile north of Washington Road near that is used as a farm equipment crossing to provide quick access to farmland west of the bypass. The dirt road appears to be poorly maintained. The road cannot be bypassed.

Photo 54\_A. Crossing at main channel looking west

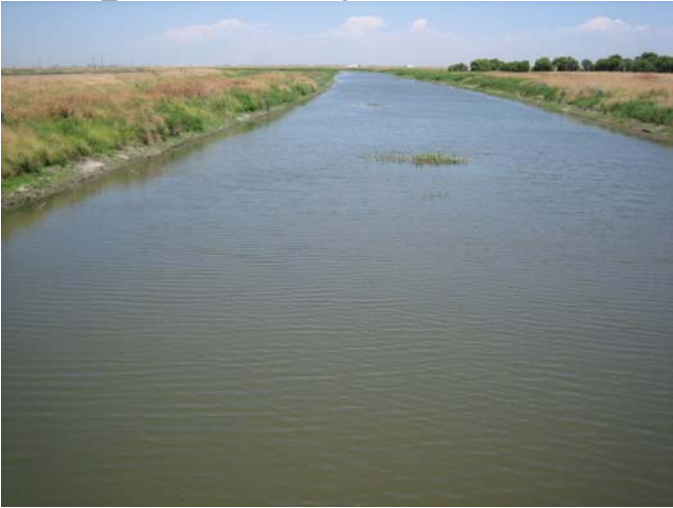
The slough is bounded by manmade levees upstream and downstream. Just downstream is the Sand Slough control structure (Photo 55\_B). The channel upstream and downstream (Photo 55\_C) has light weeds in the channel with tall annual grasses in the floodplain and levee banks. The channel at the bridge had a water surface of 4.9 feet at the deepest. The channel substrate has a majority of silty-clay.

Photo 55\_C. Channel looking downstream

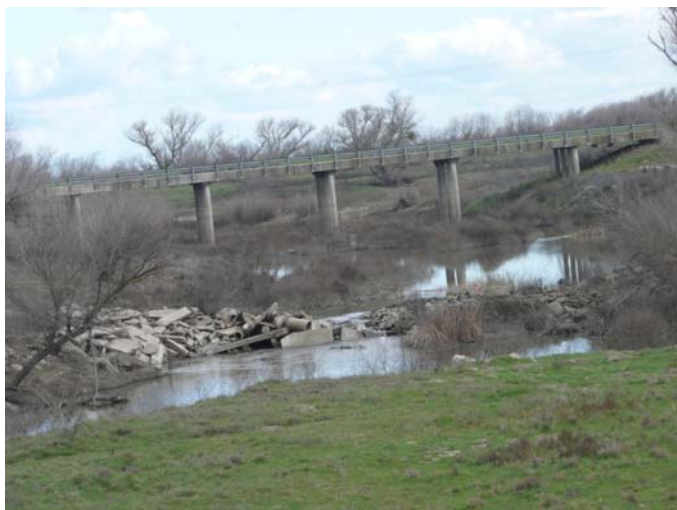
Photo 69\_A. Rock weir from downstream looking upstream

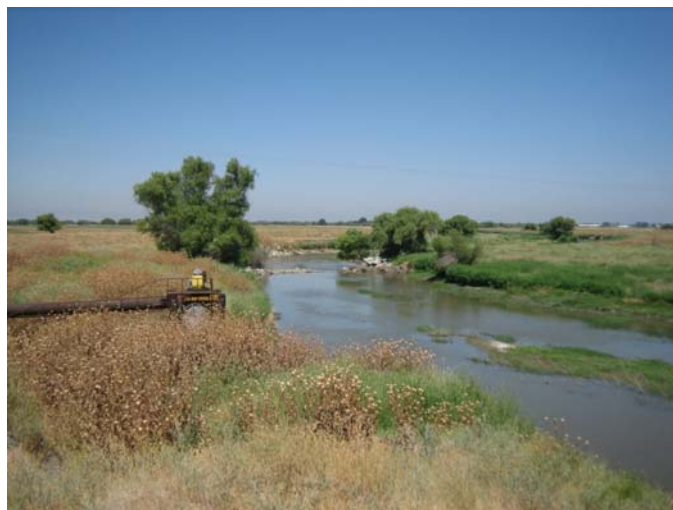
Photo 69\_B. Rock weir from upstream looking downstream
